Solid Home Inspections

PROPERTY INSPECTION REPORT

Concerning: 2021 build - 4232 sf, Cypress, TX 77433
(Address or Other Identification of Inspected Property)

By: David Gibbs, Lic #7406 TREC Professional Inspector 01/28/2021
(Name and License Number of Inspector) (Date)

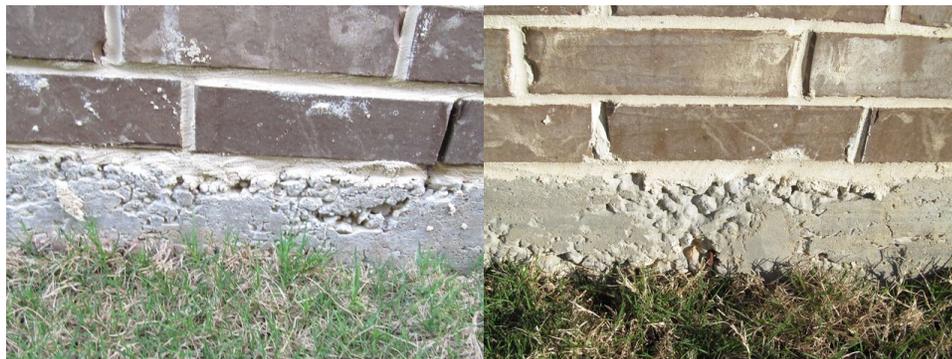
Observed uneven surface at foundation edge / aggregate visible. This is primarily a cosmetic condition.

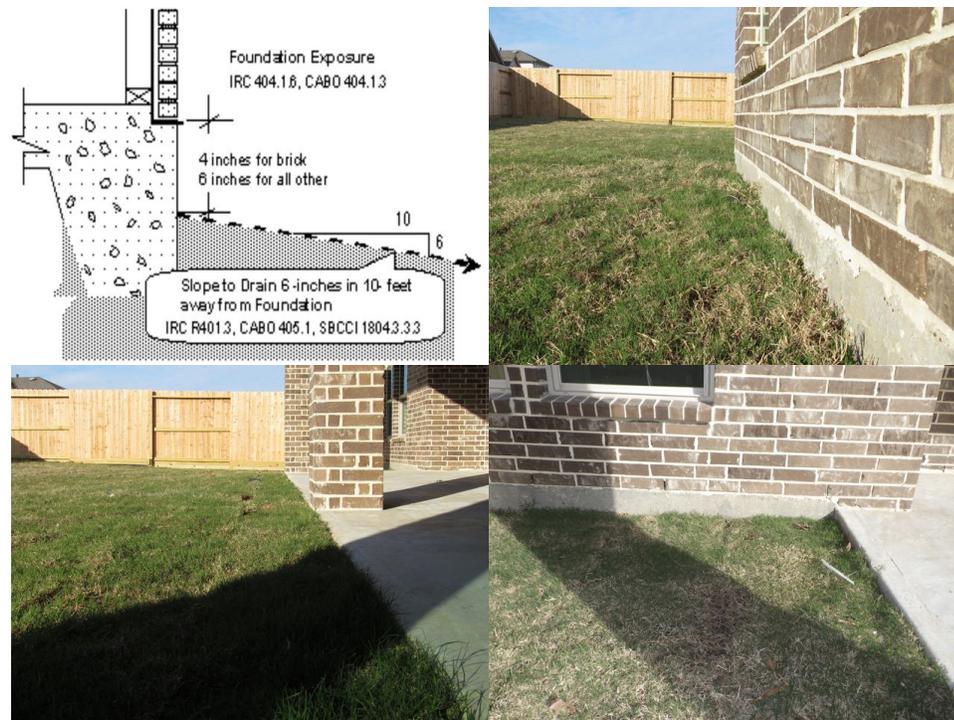
Soil grading had depressions or inadequate / negative slope in some rear areas and did not appear to properly direct runoff water away from foundation as required according to today's standards (6" drop in 10' Ref: IRC 401.3). This may promote water penetration, adversely affect the foundation and cause differential settlement. We recommend repair as necessary.

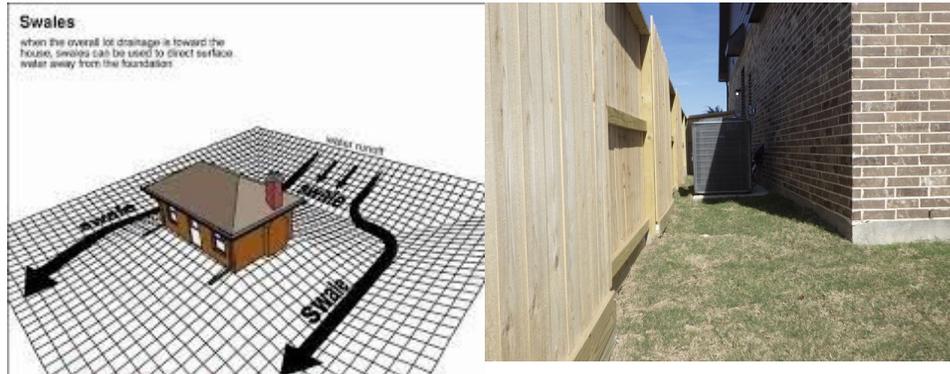
The drainage swale was not continuously sloped to street as required according to today's standards, may cause water ponding at rear of house. We recommend repair as necessary to promote proper drainage away from foundation and extend service life of fence.

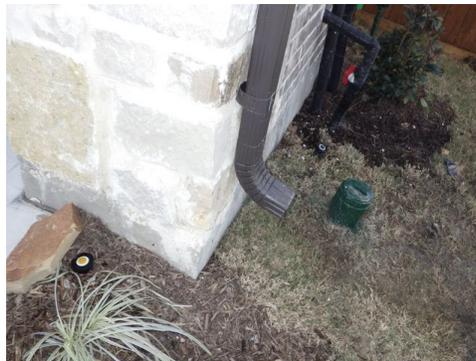
Runoff water from the roof gutters discharged next to the building. For improved foundation performance we recommend install splash blocks to direct runoff water sufficiently away from the building prevent erosion and saturation of the soil at foundation.

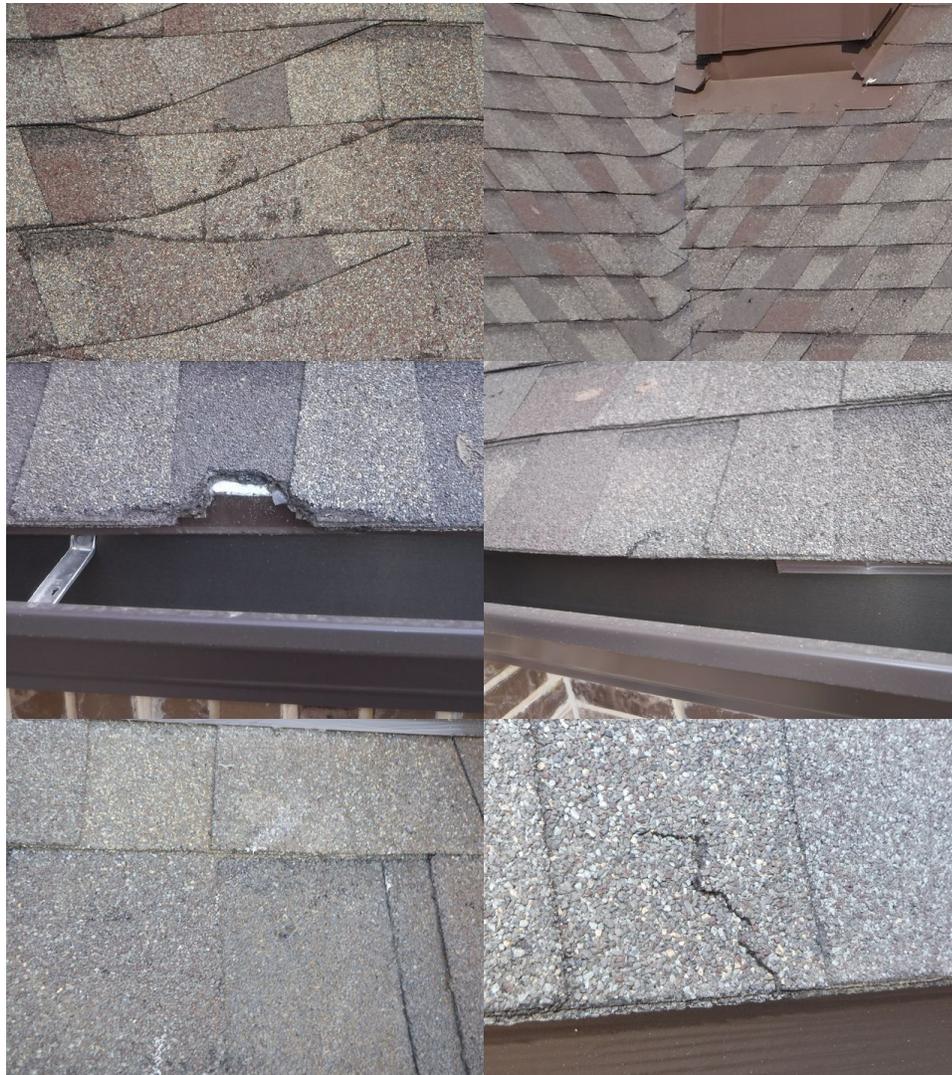
Observed shingles with tears and surface damage in some areas, likely due to foot traffic during construction.. (Photos are examples only and do not represent all instances of damage.) Shingles with UV protective mineral coating missing may wear out prematurely and damage may not be covered under warranty. We recommend further inspection by a specialist contractor and repair or replace as necessary.

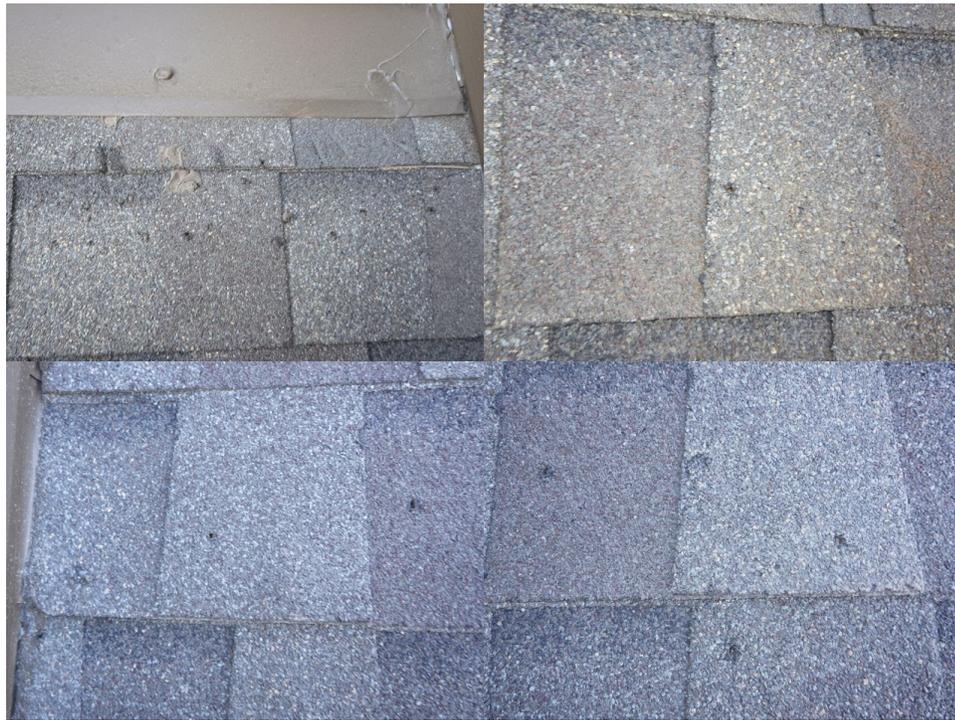
Observed multiple nail holes in shingles. These are likely from use of toe boards (lumber improperly nailed to roof surface to create walkway during construction). We recommend repair or replace as necessary to prevent water penetration.

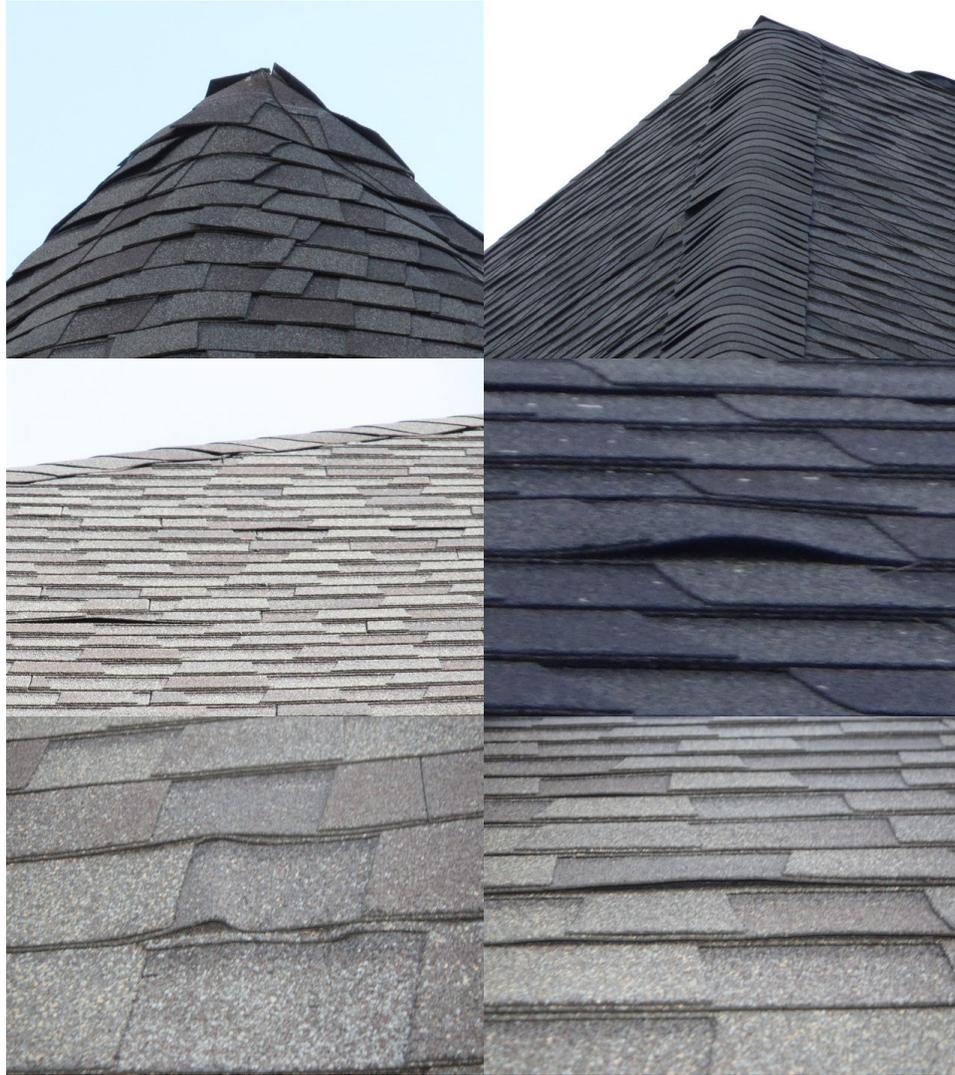
Observed shingles improperly installed, lifted/loose at lower edges in some areas. Loose shingles are prone to water penetration and more likely to be damaged in a windstorm. We recommend repair or replace as required according to manufacturer's requirements to prevent damage and water penetration. (The following example is from GAF installation instructions.)

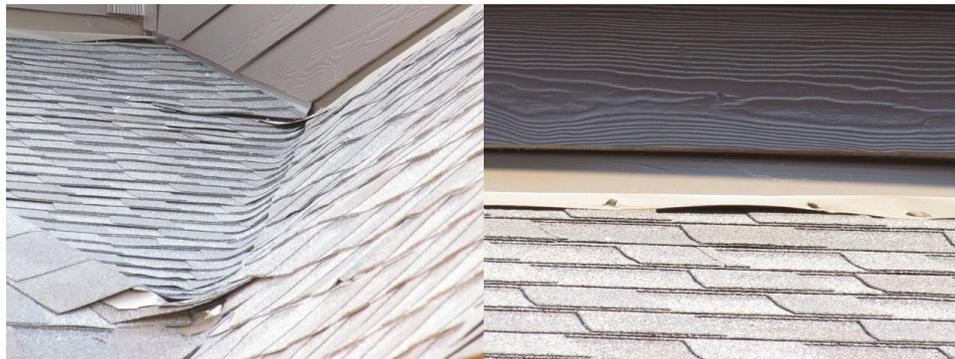
Lower edge of some flashings were lifted or not sealed down at rear. Wind driven rains can cause water penetration. We recommend repair / seal as necessary.

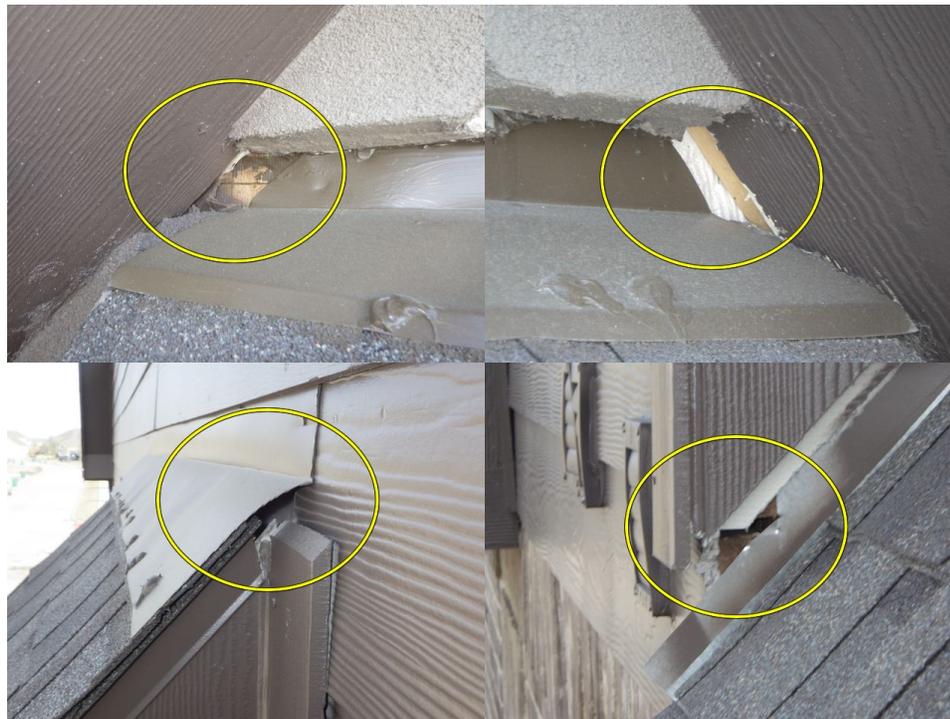
Flashings were improper in some areas where roof meets wall, leaving gaps that will promote water penetration. We recommend repair or replace as necessary.

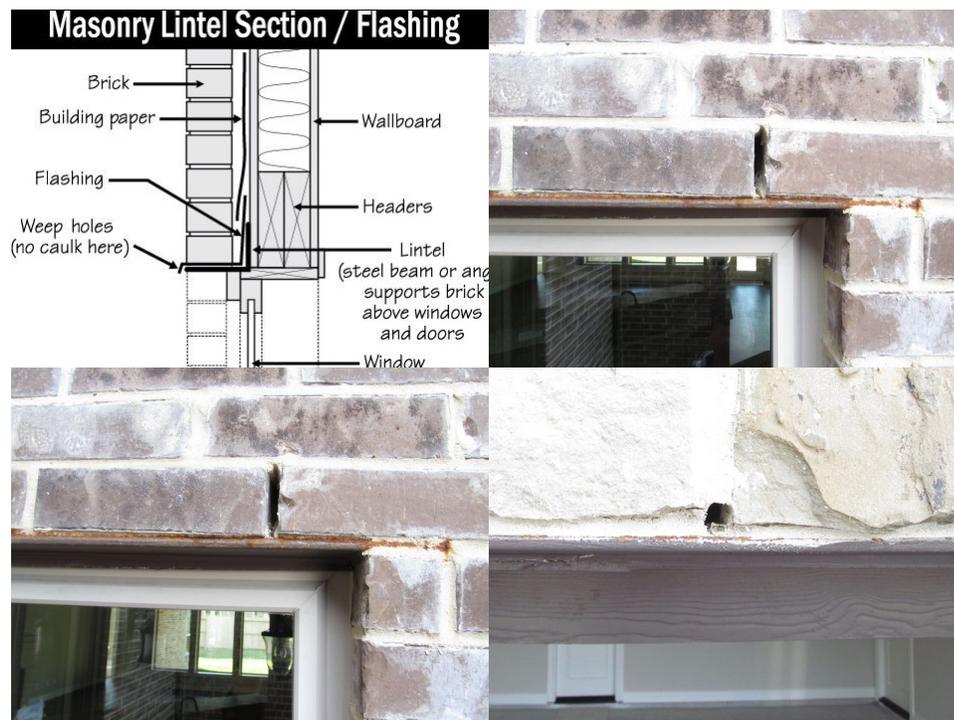
Flashing is required above steel lintels and below lowest brick course to shed moisture that may get inside wall and also minimize corrosion / deterioration of lintel (Ref IRC R703.8.5). Rust inhibiting paint is required prior to installation on all surfaces (Ref: IRC R703.8.3). No flashing was visible over garage doors and some windows with brick at top and lintels were observed to be corroded in one or more areas. We recommend further inspection by a specialist contractor and repair or replace as necessary.

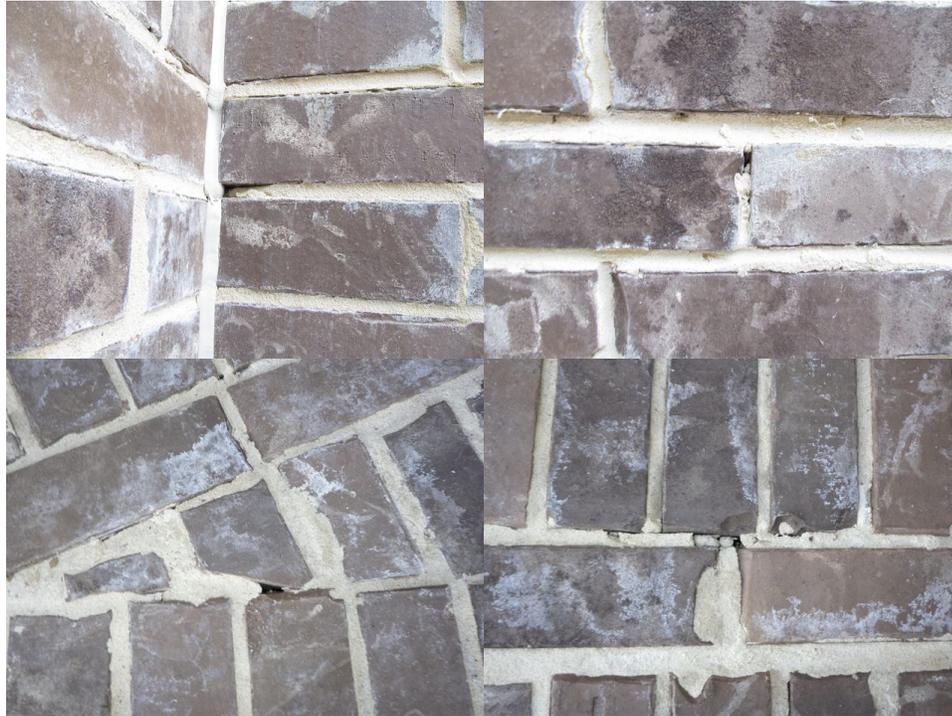
Mortar joints between brick ends was deficient in some areas leaving gaps or cracks. These gaps will promote water penetration. We recommend repair or replace as necessary.

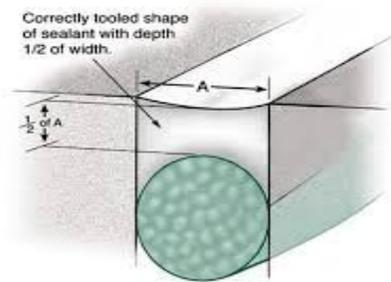
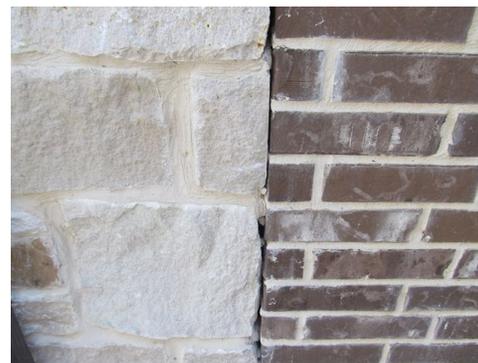
Caulking was observed to be missing from expansion joint(s) and / or inside corners of brick veneer in some areas. Ensure any mortar present in expansion joint is first removed before sealing with backer rod to allow movement.

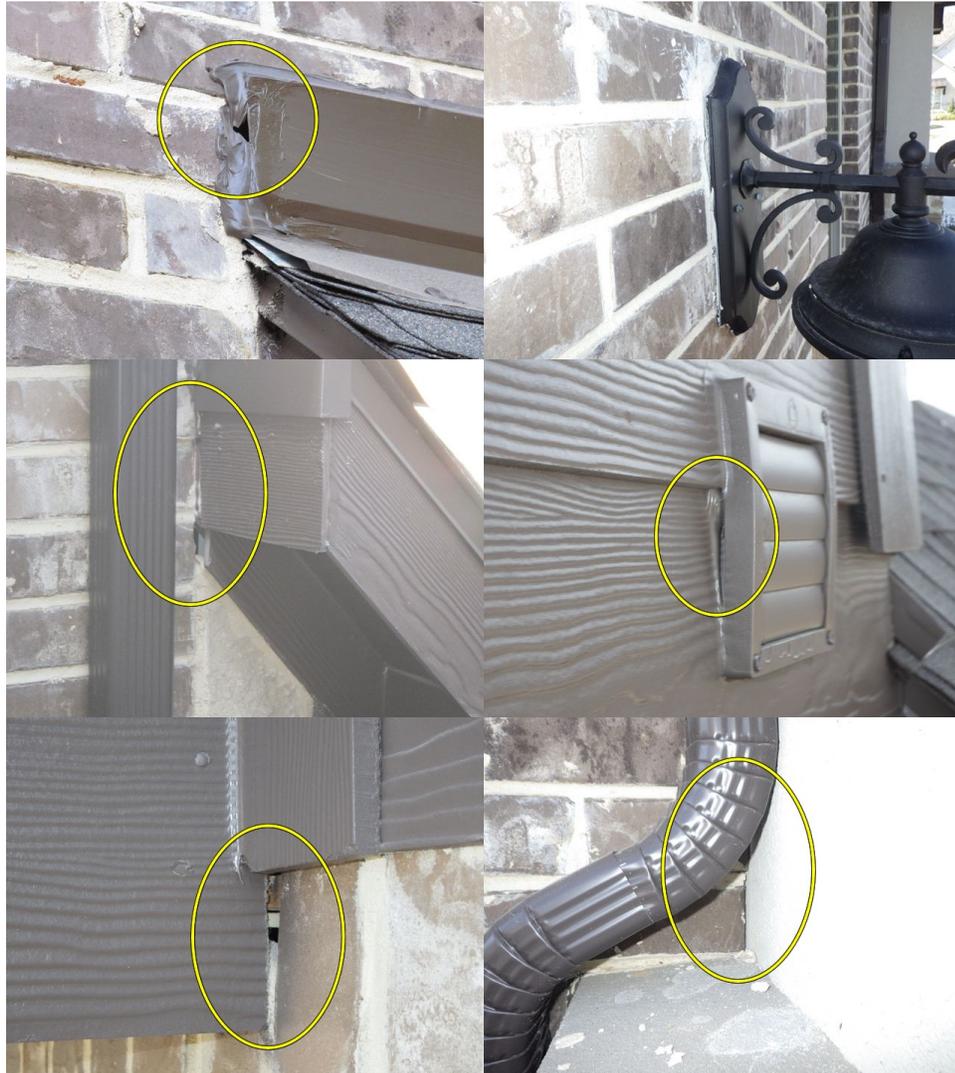
Observed caulking was missing or deficient around wall penetrations in some areas. We recommend all wall gaps for joints between cladding materials / vents / plumbing / electrical etc, be caulked to prevent water penetration.

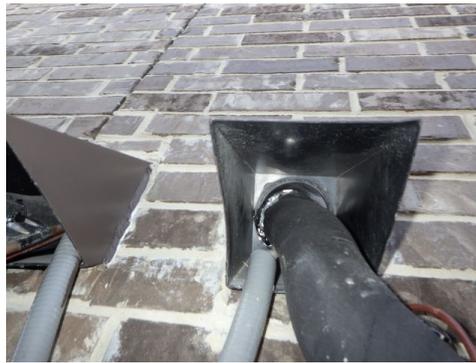
Observed gap in wall below flashing where air conditioner refrigerant / electric supply lines pass through exterior wall. We recommend install foam sealant and/or metal mesh to prevent rodent entry.

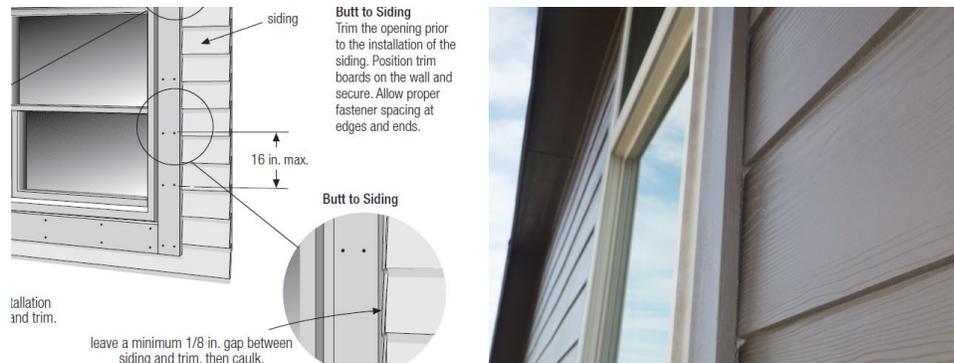
The cement board window trim appears to have been installed wrong, applied on top of siding leaving gaps. This may promote water penetration, pest entry and affect warranty. Typical installation instructions require siding to be cut to fit with ends flush and caulked against trim (diagram below is from James Hardie). We recommend further inspection by a qualified contractor and repair or replace as necessary.

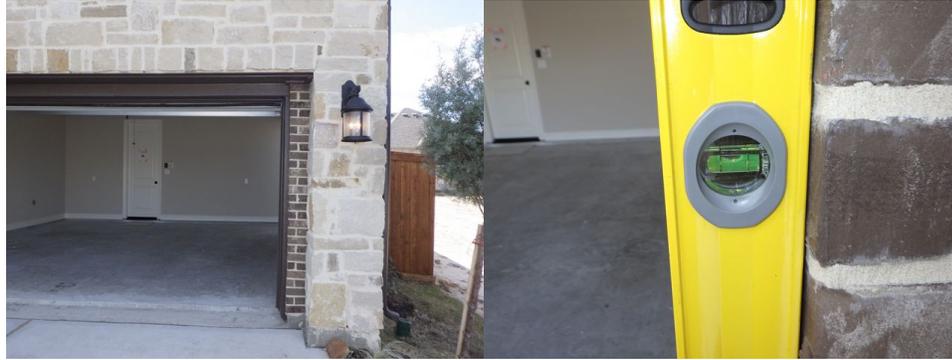
The wall at right side of right garage door did not appear square (vertical). This is

primarily a cosmetic condition. If this is a concern, we recommend further inspection by a specialist contractor and repair or replace as necessary.

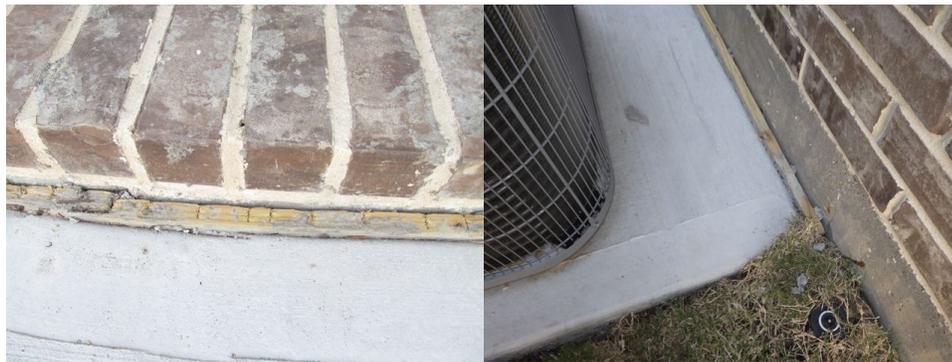
Wood form board(s) were observed against the foundation. These are left over from construction of foundation or adjacent flatwork and are considered a conducive condition for termites. We recommend remove any wood in contact with soil next to the house.

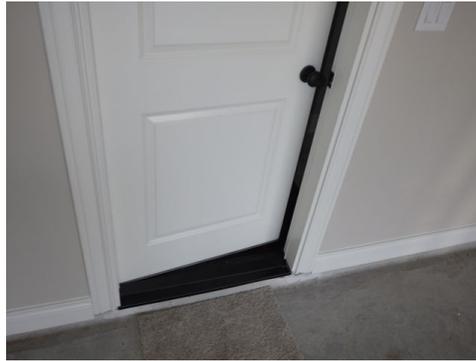
The right garage passage door self-closing mechanism did not close the door completely. We recommend the self-closing feature be repaired or replaced for safety in case of fire in the garage.

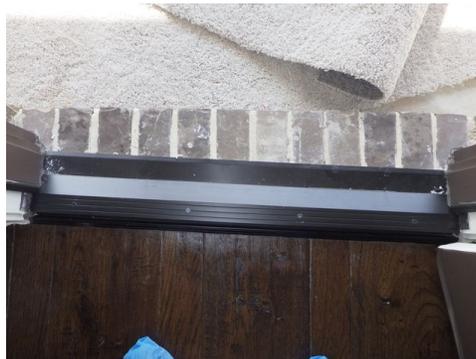
The back door did not appear square with exterior wall. This is primarily a cosmetic condition. If this is a concern, we recommend further inspection by a specialist contractor and repair or replace as necessary.

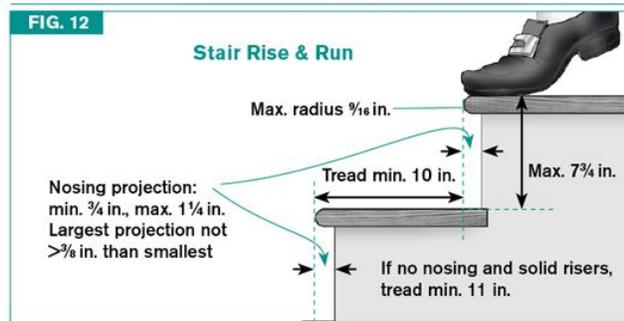
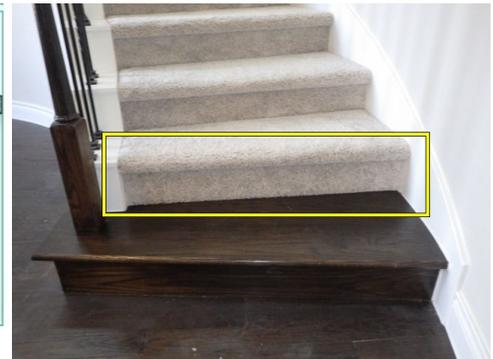
Observed inconsistent construction of stair tread heights, a possible tripping hazard (second step was noticeably taller). Current industry standard requires the greatest riser height within any flight of stairs shall not exceed the smallest by more than 3/8 inch. This may have been allowed at the time of construction, but for enhanced safety, we recommend use caution or alter according to today's standards if possible.

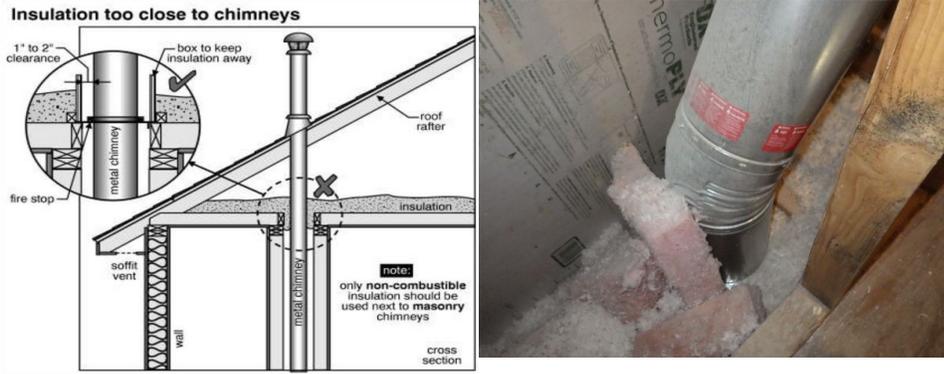
Insulation was observed to be improperly contacting fireplace vent in the attic according to today's standards (code) and as required according to manufacturer's recommendations (Ref: IRC G2426.4). We recommend repair as necessary.

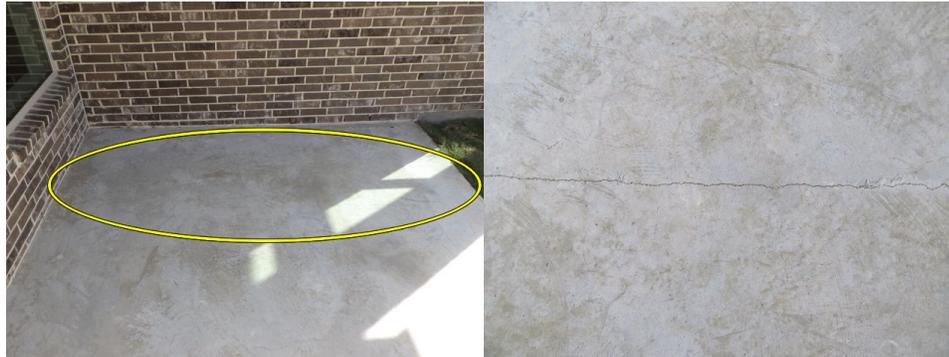
There was a crack from front to rear at the back patio (part of house foundation / slab). These can be caused by shrinkage during construction and/or foundation movement. These can be patched or painted for cosmetic reasons only. We recommend monitor for changes.

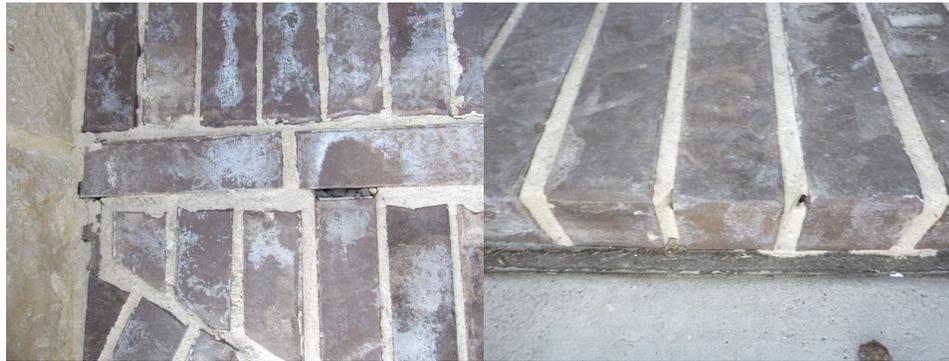
Mortar joints between brick ends is deficient in one or more areas leaving gaps or cracks. We recommend repair or replace as necessary.

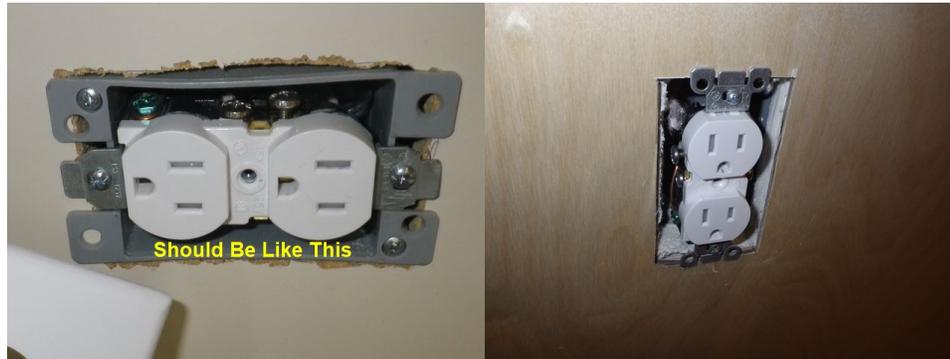
Observed junction box for refrigerator outlet in wood surface not flush mounted with no setback according to today's standards (Ref IRC 3907.3). We recommend install spark ring to reduce possible fire hazard.

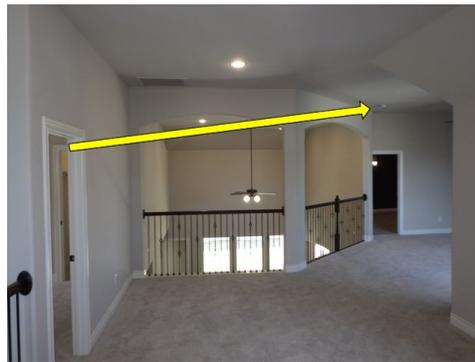
Smoke alarm was missing outside front bedroom upstairs (closest was about 25' away). We recommend alarms be installed "outside sleeping area in the immediate vicinity of the bedrooms" (Ref: IRC R314.3) .

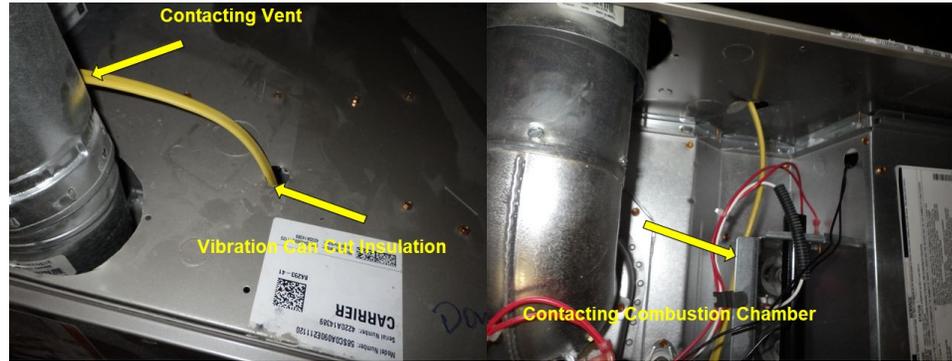
Electric power supply wiring at downstairs furnace was missing clamp / bushing, not secured to casing as required according to today's standards. Loose conductors can be a shock/fire hazard. We recommend repair as necessary to prevent damage / disconnection to wiring.

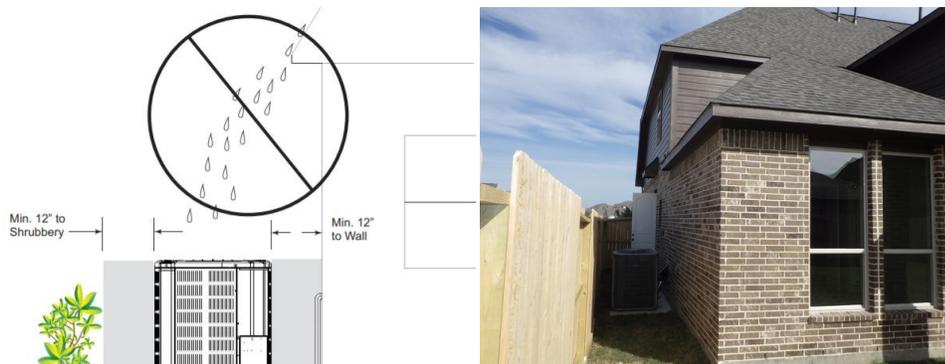
The air conditioner condensing unit was located below roof drip edge with no gutter. Manufacturers recommend against placing condensing unit where roof runoff drains directly into it. We recommend add gutter or relocate unit.

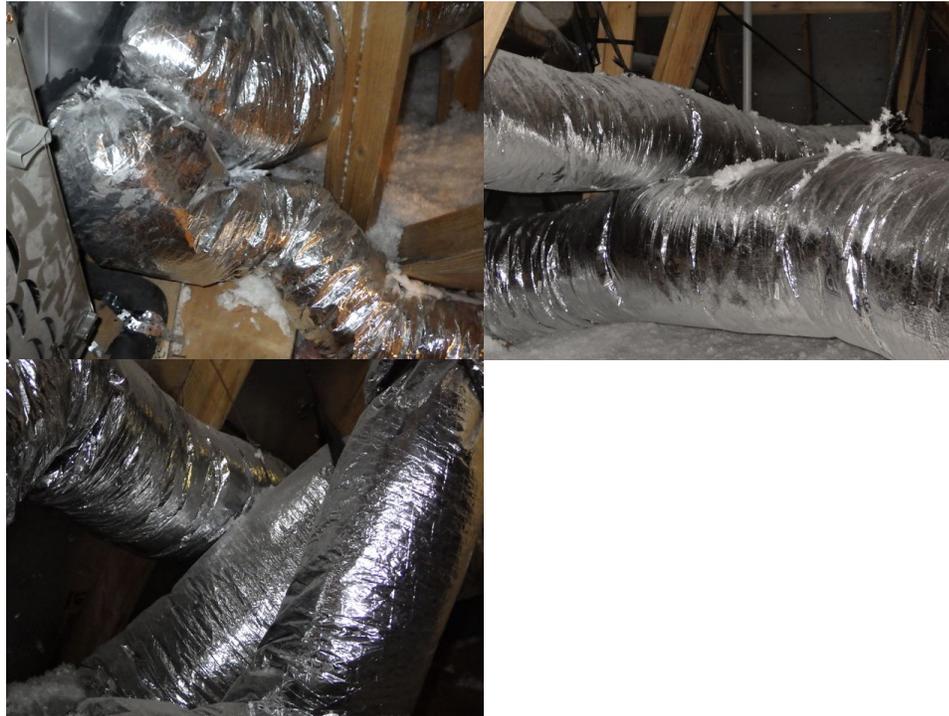
Observed several / multiple areas in attic where flex duct touch and are missing required 1" clearance from other ducts according to today's standards. This is required to prevent condensation between ducts that touch. We recommend maintenance as necessary.

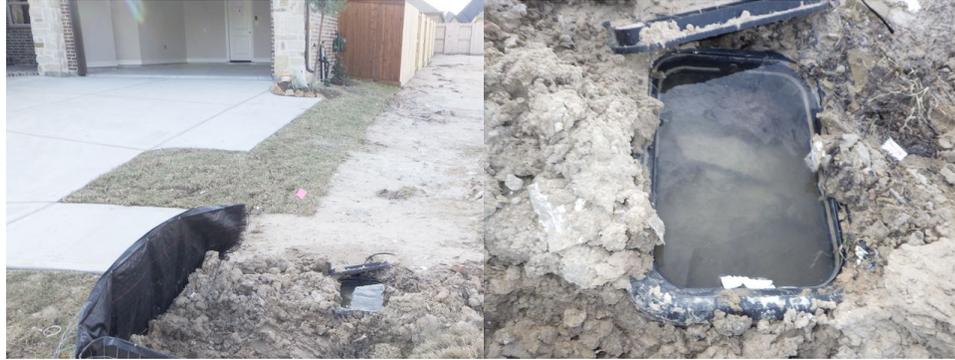
Possible leakage was observed at the water supply meter. We recommend further inspection by a licensed plumber and repair or replace as necessary.

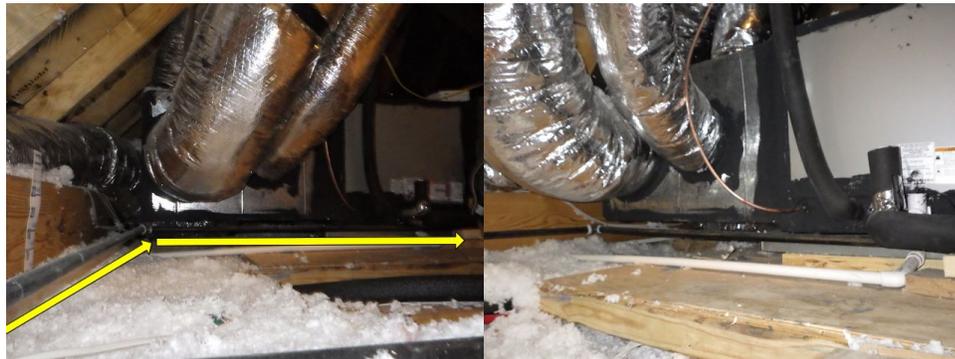
A long section of gas line in the attic (to downstairs furnace) was not adequately supported. We recommend that all pipe be supported in accordance with present building standards to prevent damage / leaks at joints.

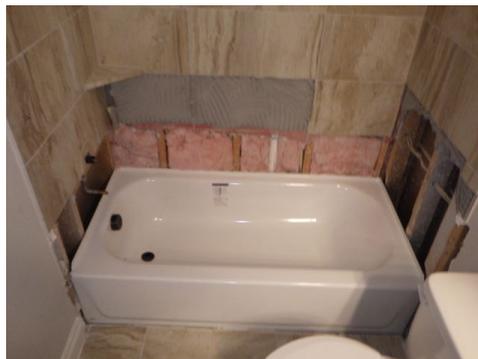
(work in progress) upstairs right tub/shower not checked / inspected.

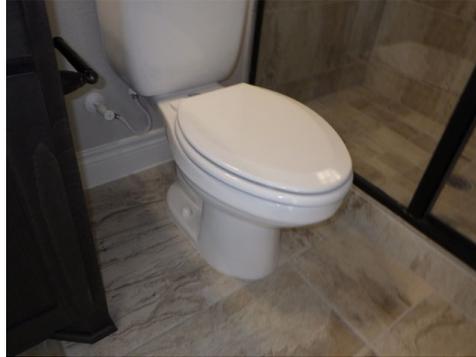
The downstairs right bathroom toilet was loose at the floor. We recommend toilet be secured to prevent movement and leakage.

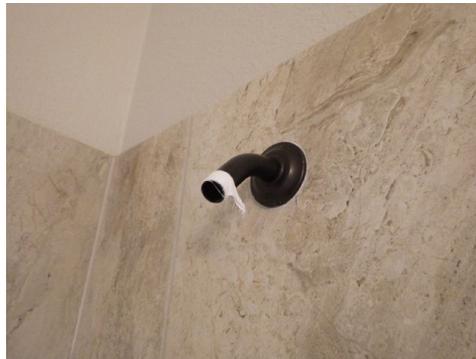
(work in progress) The shower heads were missing. We recommend they be installed.

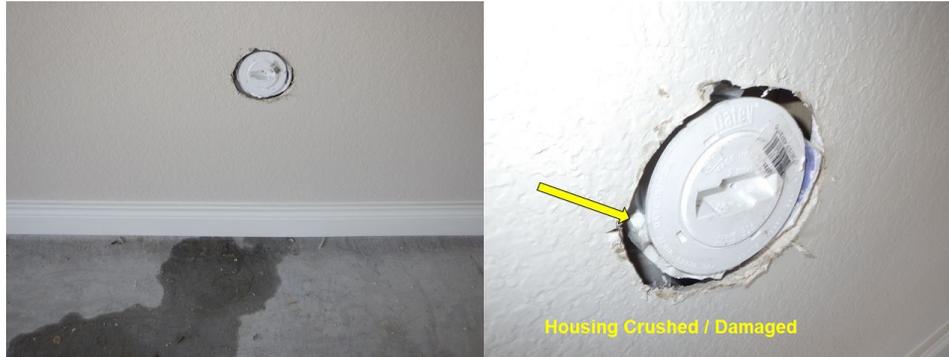
There was damage and leakage on floor/in wall observed at the garage cleanout for upstairs bathroom drains. We recommend further inspection by a licensed plumber and repair or replace as necessary.

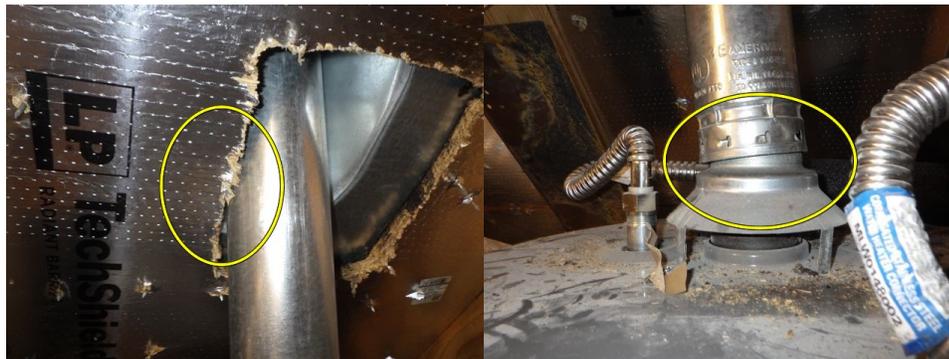
Observed water heater vent pipe was improperly installed, not seated on draft hood as required according to manufacturer's recommendations. This leaves a gap at connection to draft hood that may allow exhaust spillage into house, a carbon monoxide hazard. The vent was contacting wood framing and/or roof decking. This is a possible fire hazard. We recommend repair as necessary.

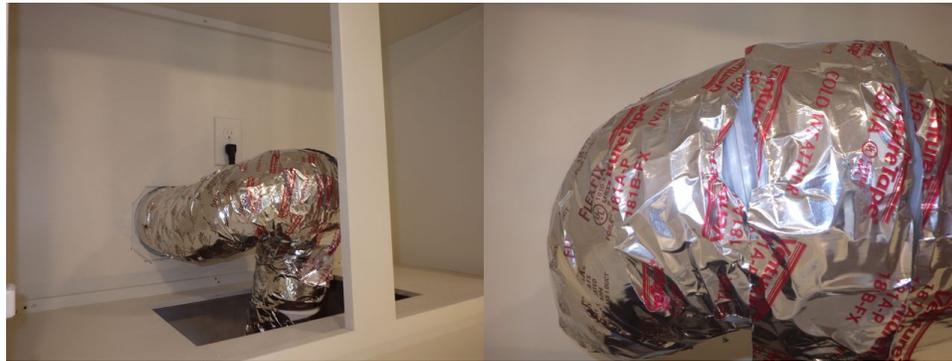
The non-metallic flexible duct visible at the kitchen exhaust fan is not an approved material and possible fire hazard. We recommend replacement with smooth walled galvanized steel as required according to today's standards (Ref IRC M1503.2).

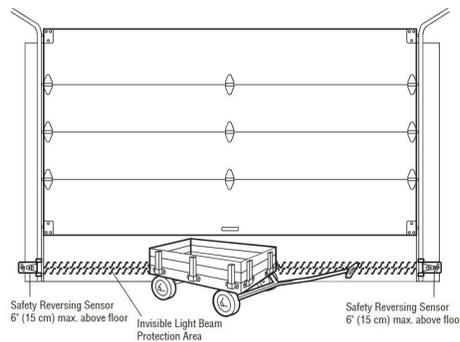
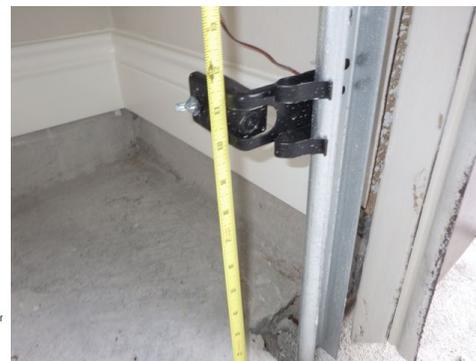
The garage door's infrared reversing beams were installed too high (more than 6") above the floor which decreases the devices effectiveness in preventing entrapment or injury. We recommend the beams be lowered to between four and six inches above the floor.

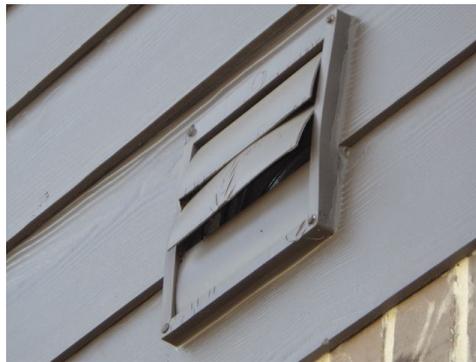
The dryer vent back draft damper did not close properly when not in use. We recommend it be repaired or replaced.
