20/20 PROPERTY INSPECTIONS

**23456 Woodstone
City, CA 926xx**

Prepared for: Mrs. Homeowner

190126 - 23456 Woodstone (mold).inspx

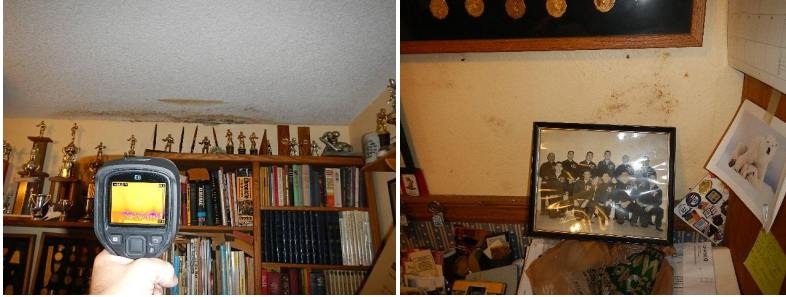
1. DEFECTIVE Walls: Painted Drywall Moisture stains/damage and mold like substance were observed [at the west wall and ceiling as shown. Also, personal items such as photos].

Elevated moisture levels detected with moisture meter [at the ceiling and wall.]. (HD)(RE)(PC).

[Suspect cause of moisture]: Roof related leak. More specifically, there has been a leak through a poorly installed valley flashing.

[Concealed Mold-like conditions may exist here.]
[Suspect Mold-like conditions exist here.]

Elevated mold spores and spores not found at the exterior were detected in this area. This indicates a mold problem exists in the air and the source likely originates from this area.

[A surface sample was not taken here. Appropriate precautions should be used when repairing the moisture damage as additional concealed mold may be revealed.
I advise that a professional mold remediator be employed to perform the remediation.]

The work area should be isolated with use of containment barriers. Negative air should be established with use of HEPA filtered negative air machines. Any moisture damaged surfaces that cannot be salvaged, such as gypsum board (aka Sheet rock, Drywall, etc.) should be removed and discarded, to at least 6 to 12 inches beyond where visible moisture damage ends, if practical.
Any water damaged and/or mold impacted structural materials that can be salvaged, should be properly HEPA vacuumed, scrubbed/cleaned, and then HEPA vacuumed again.
The entire work area should be HEPA vacuumed and wet wiped. HEPA air filtration should run for a minimum of 24 hours after the work is complete. If during removal additional mold sources/water damage

is noted, remediation/removal should continue until 12 past the last impacted area wherever feasible. The contained area should be inspected by 20/20 Advanced Property & Mold Inspections and if deemed acceptable the air should be tested to confirm that there is no detectable mold problem before restoring the finished surfaces.

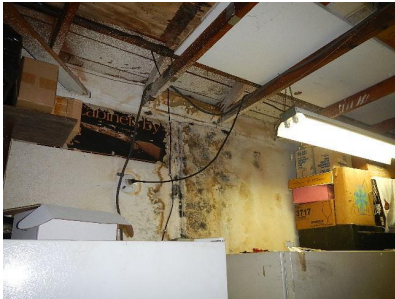
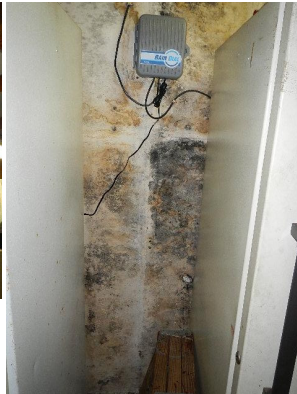
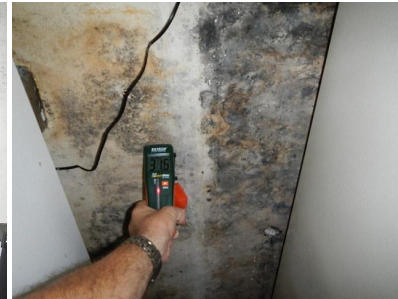
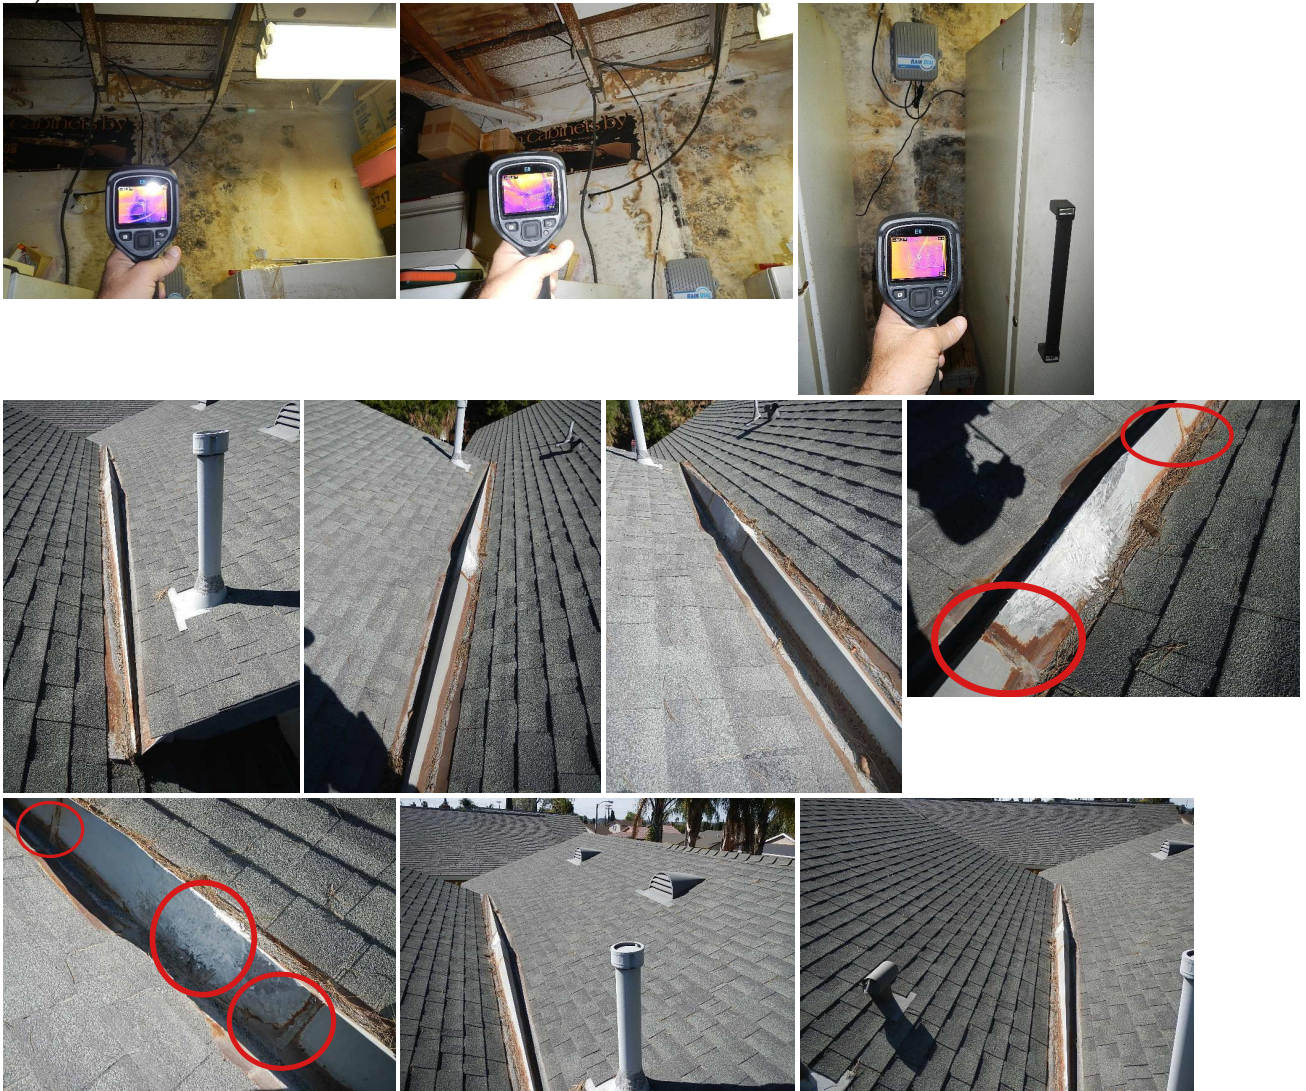
2. DEFECTIVE Walls: #1 Moisture stains/damage and mold like substance were observed [at the east wall of the garage and roof framing as shown.

Elevated moisture levels detected with moisture meter [at the wall and framing]. (HD)(RE)(PC).

[Suspect cause of moisture]: Roof related leak. More specifically, there has been a leak through a poorly installed valley flashing.

[Concealed Mold-like conditions may exist here.]

[Suspect Mold-like conditions exist here.]

Elevated mold spores and spores not found at the exterior were detected in this area. This indicates a mold problem exists in the air and the source likely originates from this area.

[A surface sample was not taken here at the east wall of the garage. Appropriate precautions should be used when repairing the moisture damage as additional concealed mold may be revealed. I advise that a professional mold remediator be employed to perform the remediation.]

The work area should be isolated with use of containment barriers. Negative air should be established with use of HEPA filtered negative air machines. Any moisture damaged surfaces that cannot be salvaged, such as gypsum board (aka Sheet rock, Drywall, etc.) should be removed and discarded, to at least 6 to 12 inches beyond where visible moisture damage ends, if practical.

Any water damaged and/or mold impacted structural materials that can be salvaged, should be properly HEPA vacuumed, scrubbed/cleaned, and then HEPA vacuumed again.

The entire work area should be HEPA vacuumed and wet wiped. HEPA air filtration should run for a minimum of 24 hours after the work is complete. If during removal additional mold sources/water damage is noted, remediation/removal should continue until 12 past the last impacted area wherever feasible. The contained area should be inspected by 20/20 Advanced Property & Mold Inspections and if deemed acceptable the air should be tested to confirm that there is no detectable mold problem before restoring the finished surfaces.

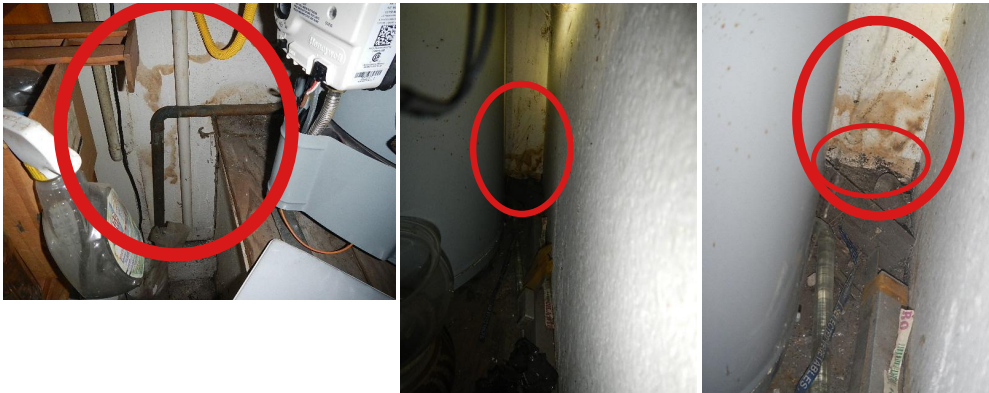
Walls: #2 Moisture stains/damage and mold like substance were observed [at the north wall at the water heater area.

No Elevated moisture levels detected with moisture meter. (HD)(RE)(PC).

[Suspect cause of moisture]: Past water heater related leak.

[Concealed Mold-like conditions may exist here.]

[Suspect Mold-like conditions exist here.]

The work area should be isolated with use of containment barriers. Negative air should be established with use of HEPA filtered negative air machines. Any moisture damaged surfaces that cannot be salvaged, such as gypsum board (aka Sheet rock, Drywall, etc.) should be removed and discarded, to at least 6 to 12 inches beyond where visible moisture damage ends, if practical.

Any water damaged and/or mold impacted structural materials that can be salvaged, should be properly HEPA vacuumed, scrubbed/cleaned, and then HEPA vacuumed again.

The entire work area should be HEPA vacuumed and wet wiped. HEPA air filtration should run for a minimum of 24 hours after the work is complete. If during removal additional mold sources/water damage is noted, remediation/removal should continue until 12 past the last impacted area wherever feasible. The contained area should be inspected by 20/20 Advanced Property & Mold Inspections and if deemed acceptable the air should be tested to confirm that there is no detectable mold problem before restoring the finished surfaces.

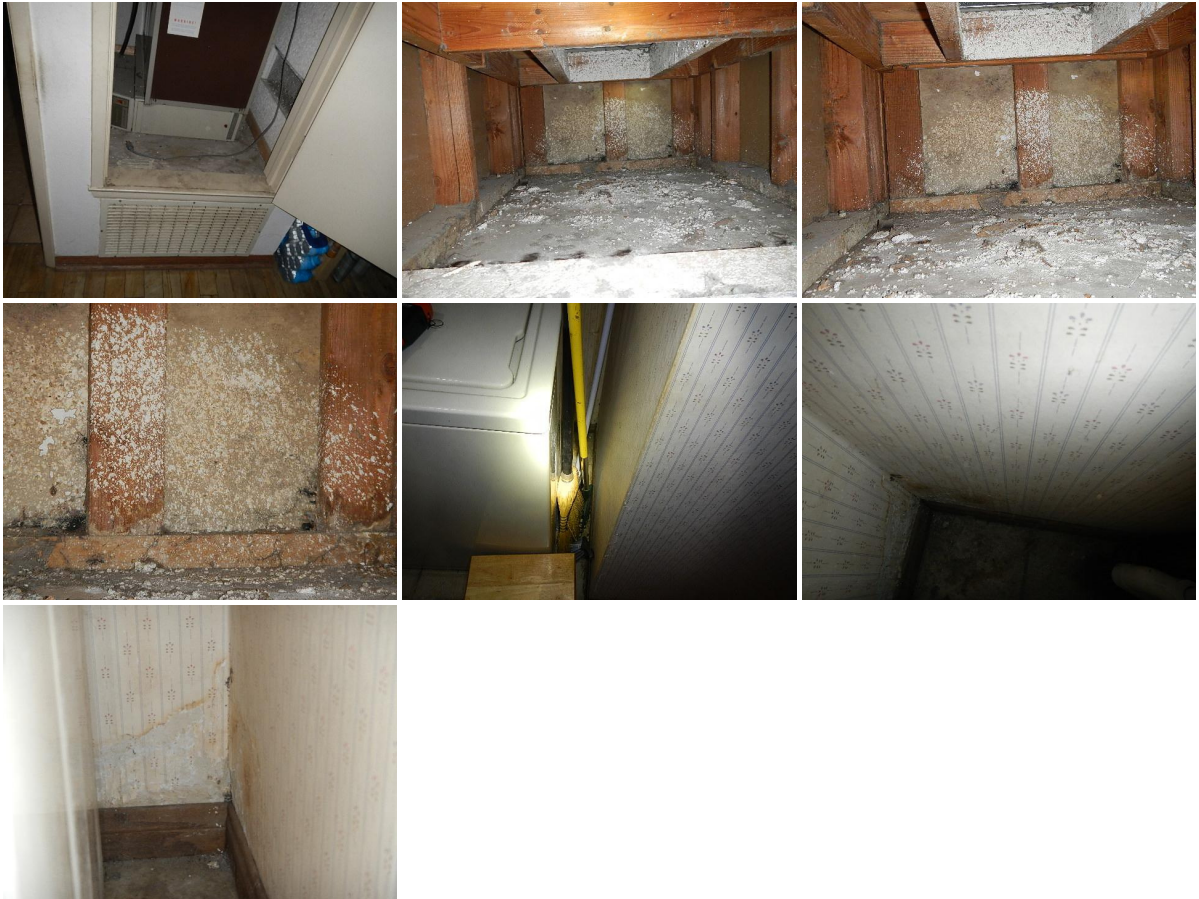
4. DEFECTIVE **Exposed Ductwork: #1** Moisture stains/damage and mold like substance were observed [at the west wall inside the HVAC return air plenum.].

No Elevated moisture levels detected with moisture meter []. (HD)(RE)(PC).

[Suspect cause of moisture]: Not determined. Possible spills or leaks in the laundry room at the other side of the wall.

[Concealed Mold-like conditions may exist here.]

[Suspect Mold-like conditions exist here.]

Elevated mold spores and spores not found at the exterior were detected in this area. This indicates a mold problem exists in the air and the source likely originates from this area.

The work area should be isolated with use of containment barriers. Negative air should be established with use of HEPA filtered negative air machines. Any moisture damaged surfaces that cannot be salvaged, such as gypsum board (aka Sheet rock, Drywall, etc.) should be removed and discarded, to at least 6 to 12 inches beyond where visible moisture damage ends, if practical.

Any water damaged and/or mold impacted structural materials that can be salvaged, should be properly HEPA vacuumed, scrubbed/cleaned, and then HEPA vacuumed again.

The entire work area should be HEPA vacuumed and wet wiped. HEPA air filtration should run for a minimum of 24 hours after the work is complete. If during removal additional mold sources/water damage is noted, remediation/removal should continue until 12 past the last impacted area wherever feasible. The contained area should be inspected by 20/20 Advanced Property & Mold Inspections and if deemed acceptable the air should be tested to confirm that there is no detectable mold problem before restoring the finished surfaces.

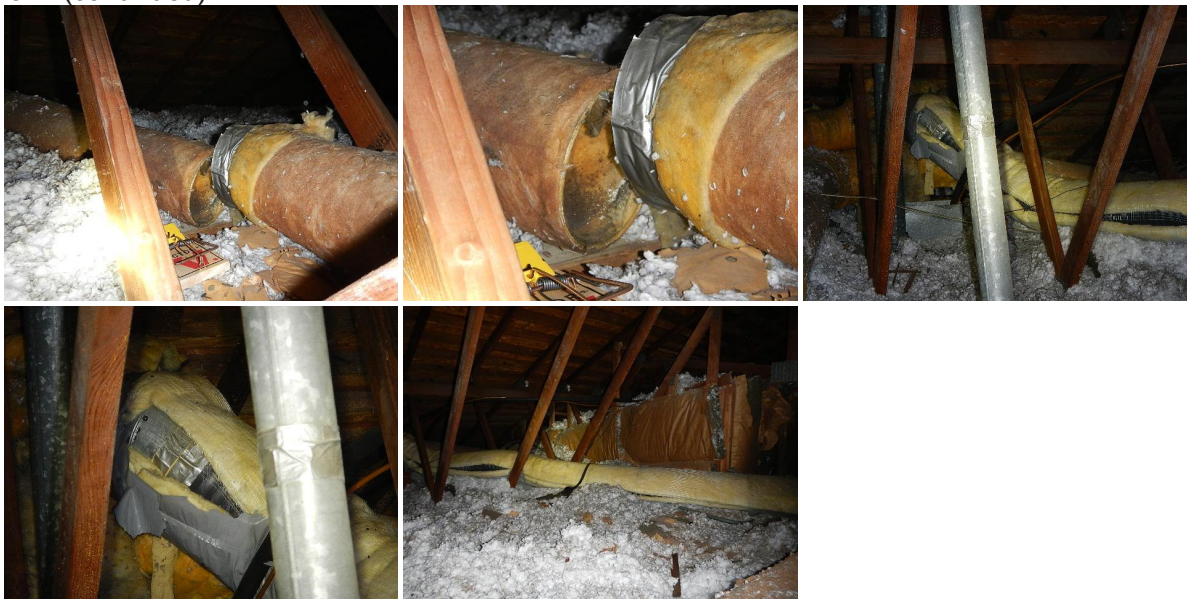
Exposed Ductwork: #2 A number of ducts in the attic were damaged. Mixed ducts are indication of repairs.

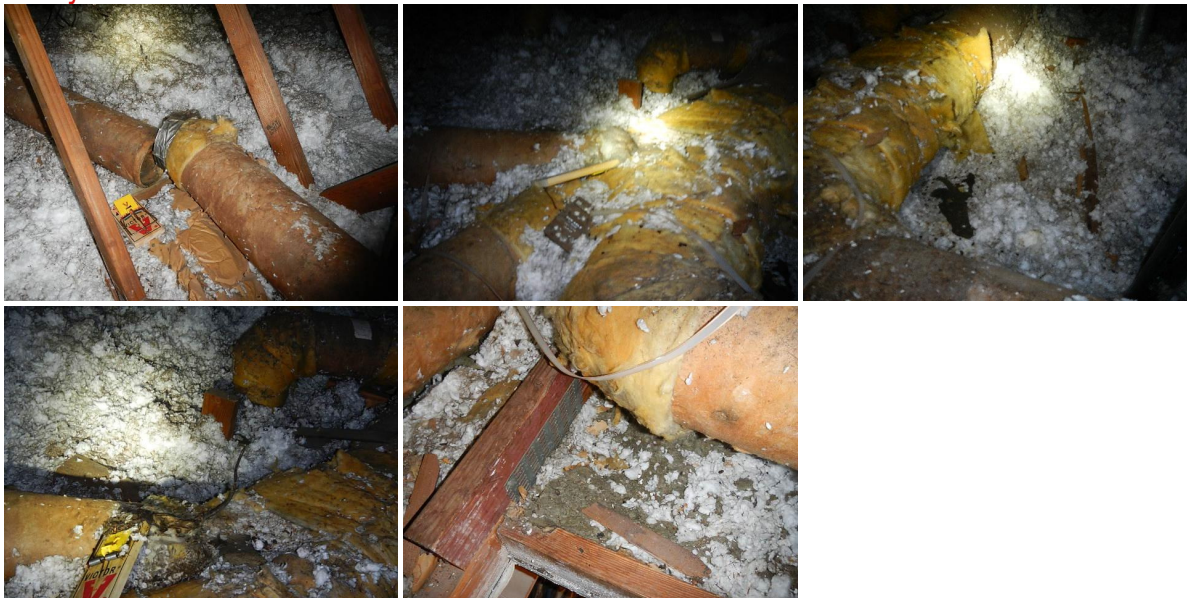
1. DEFECTIVE OTHER: I observed evidence of prior rodent activity [droppings] and [dead animal]. Advise evaluation by a qualified pest control operator. May warrant thorough, professional cleaning of the entire attic for health safety.
