20/20 PROPERTY INSPECTIONS

**XXX Lookout Dr.
Laguna Beach, CA 92651**

Prepared for: John Q. Homeowner

190316 - XXX Lookout Dr (mold).inspx

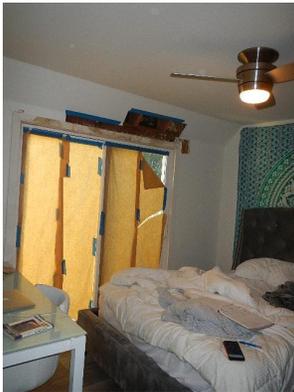
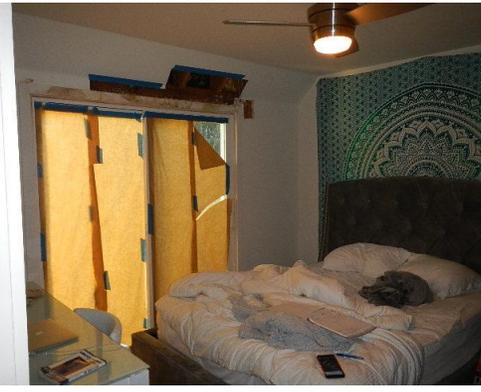
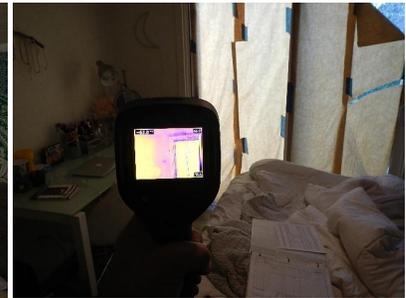
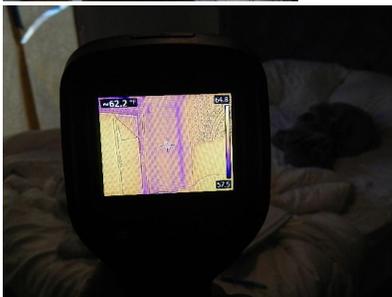
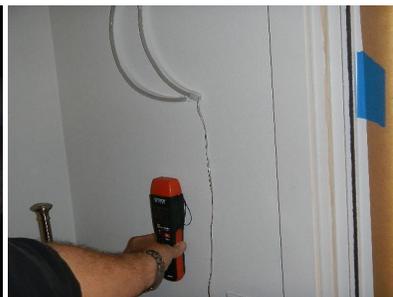
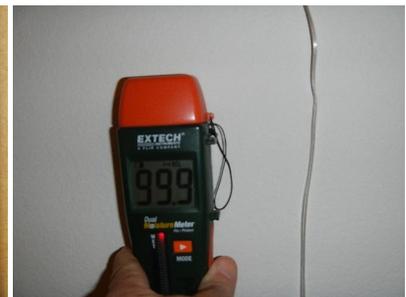
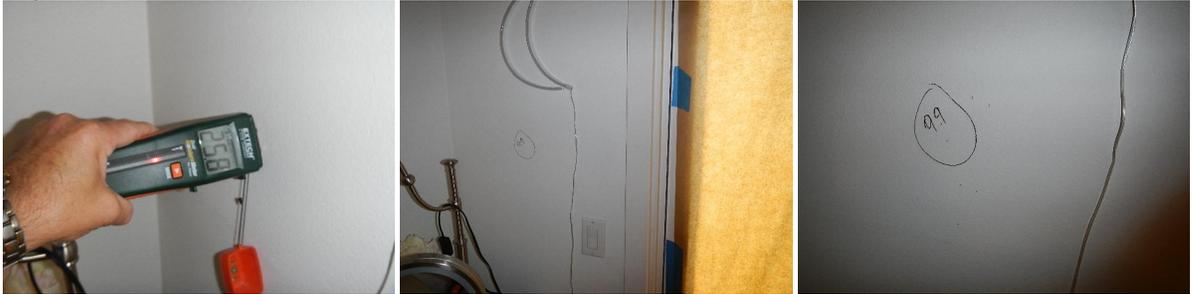
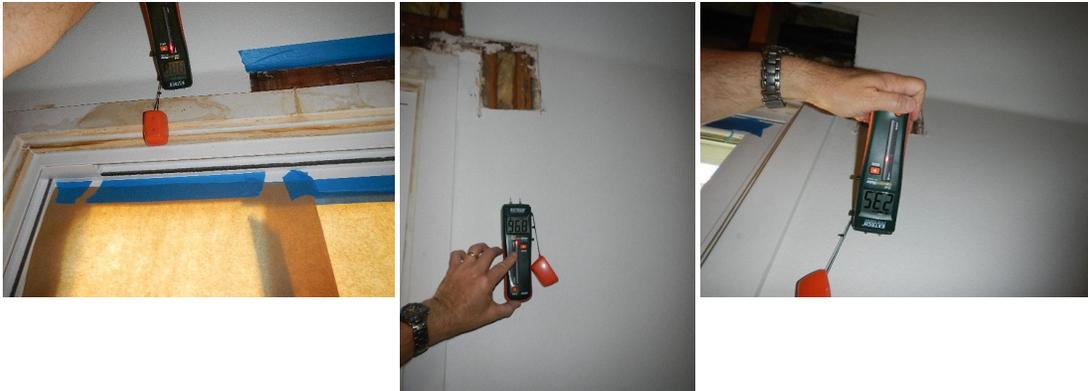
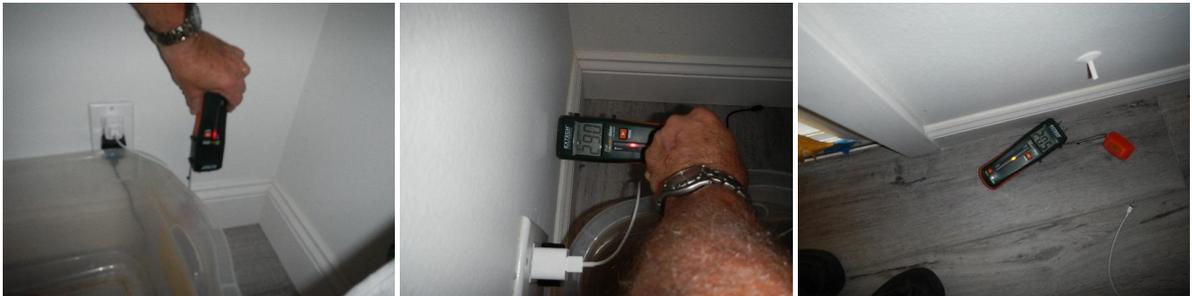
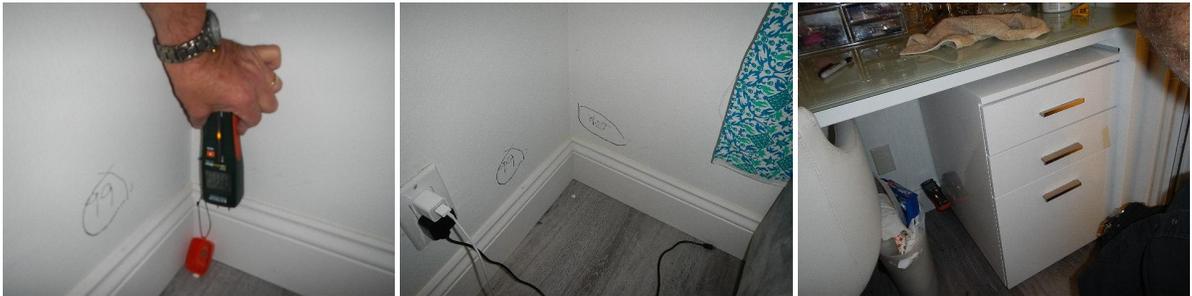
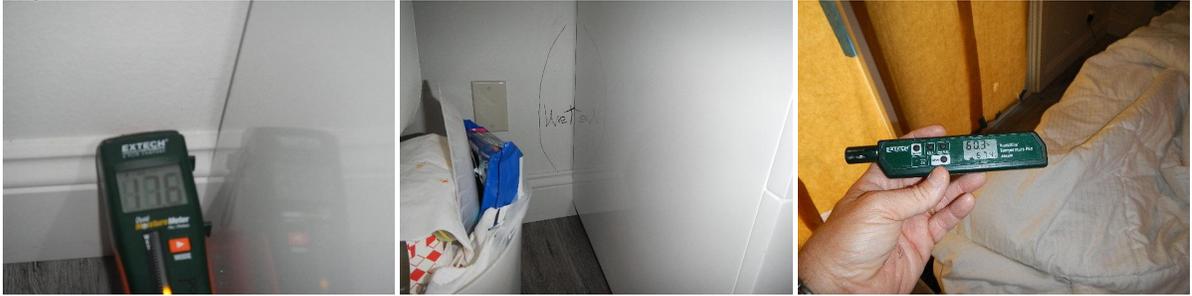
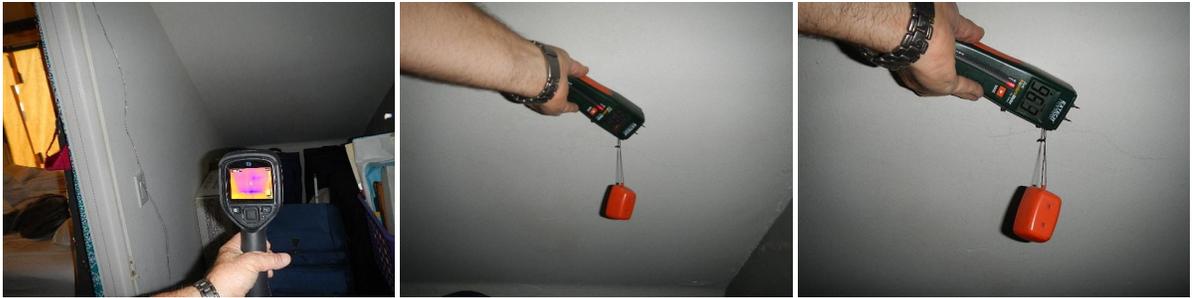
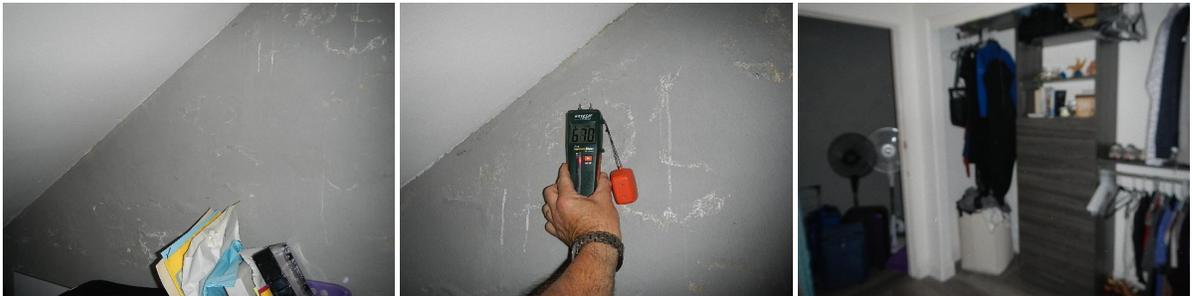
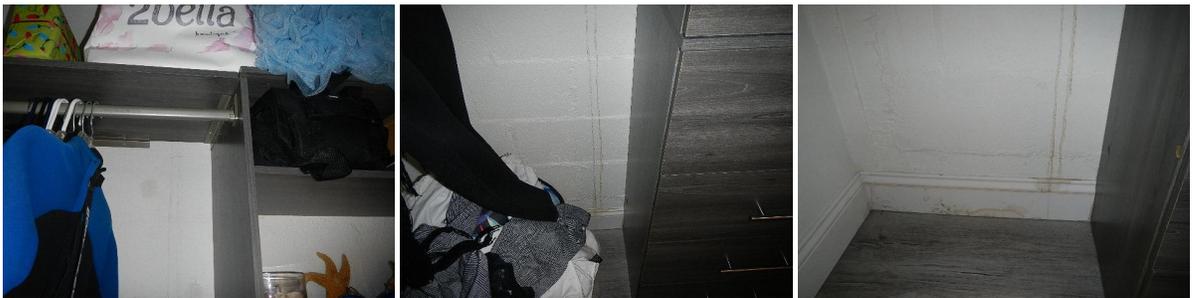
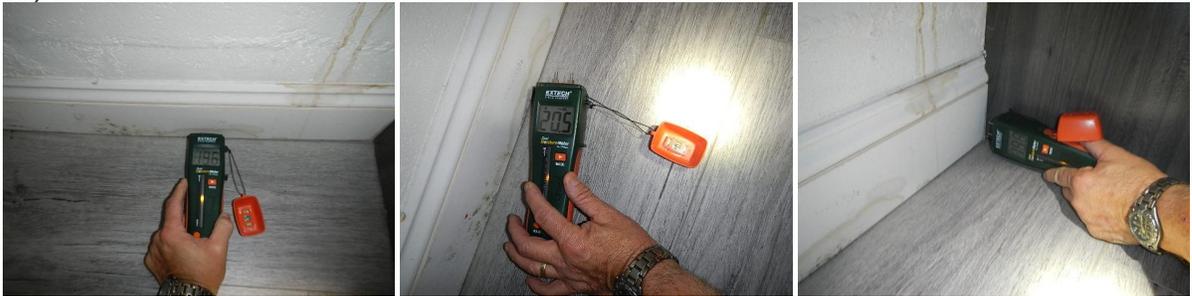
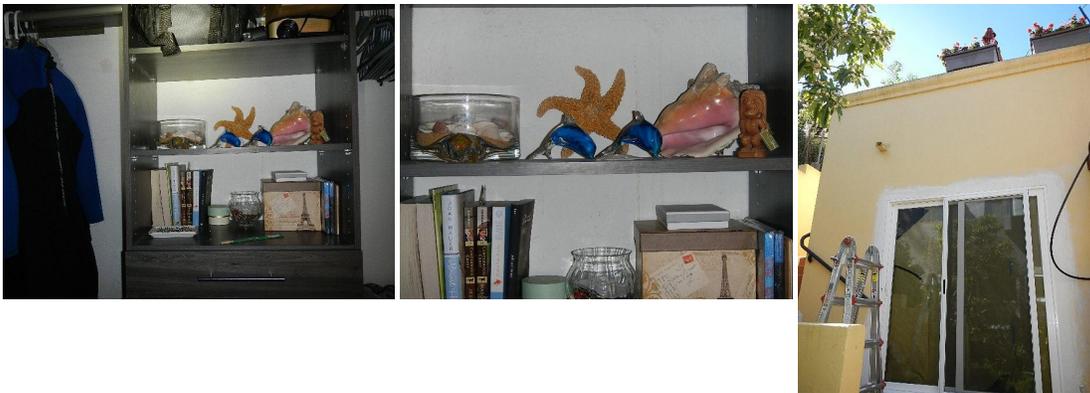
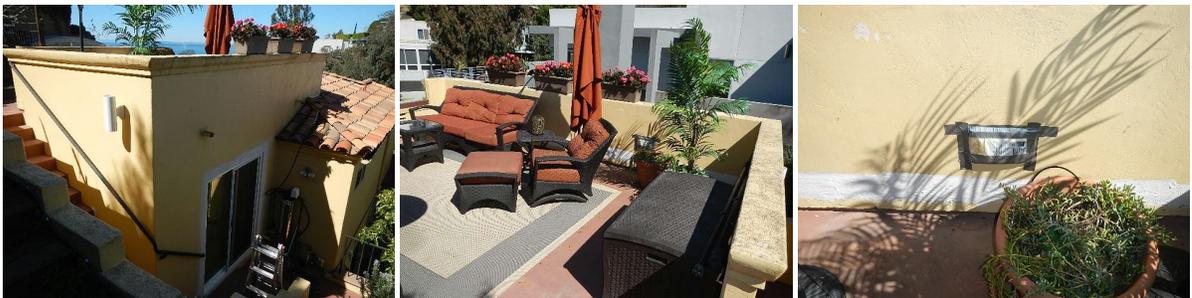
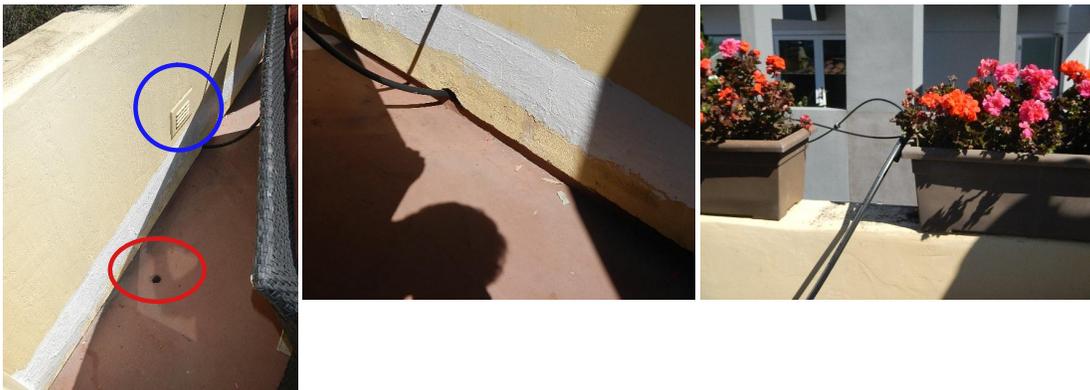
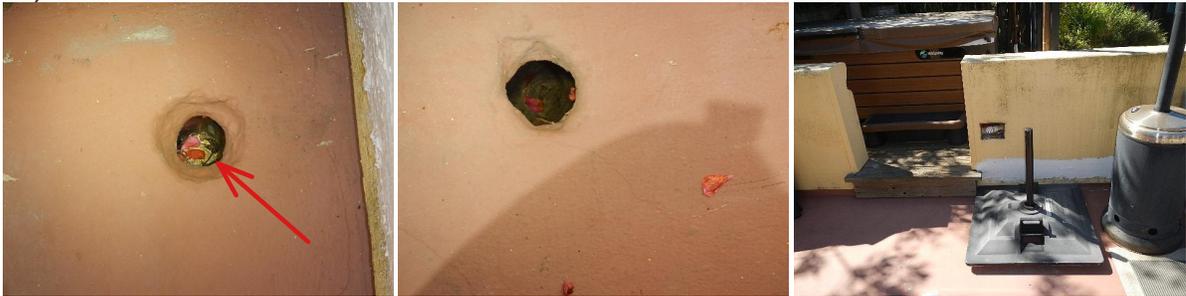
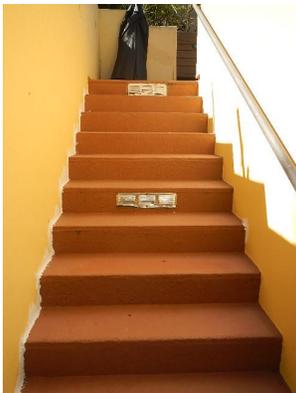
Walls: Painted Drywall The wall was broken open prior to my arrival for this inspection.

Moisture stains, extensive moisture and mold like substance were observed and detected at the SW side.

Mold like substance and moisture stains were observed at the NE wall. And moisture was detected with a moisture meter around virtually all the walls except a small area by the doorway at the east side because it is at the interior. Some floor areas seemed to be wet at the perimeter areas. It is likely that the moisture will spread to more areas as days go by without forced drying and remediation. (HD)(RE)(PC).

[Suspect cause of moisture]: Parapet walls at light sconces, electrical outlets at the roof deck structure above and also at the lights in the stair risers. Also, possibly deck surface drains leak at the roof deck penetrations. Possible leaks from the roof drain pipes themselves. Possible leaks at the tile roof to the south.

[Suspect Mold-like conditions exist at the SW wall as shown in the photos.

[Surface sampling is recommended here at the SW wall.]

The work area should be isolated with use of containment barriers. Negative air should be established with use of HEPA filtered negative air machines. All water damaged and/or mold impacted non-structural materials should be removed (drywall, baseboards, insulation, etc...). Any water damaged and/or mold impacted structural materials should be properly HEPA vacuumed, scrubbed/cleaned, and then HEPA vacuumed again. Entire work area should be HEPA vacuumed and wet wiped. HEPA air filtration should run for a minimum of 24 hours after the work is complete. If during removal additional mold sources/water damage is noted, remediation/removal should continue until 12" past the last impacted area wherever feasible.

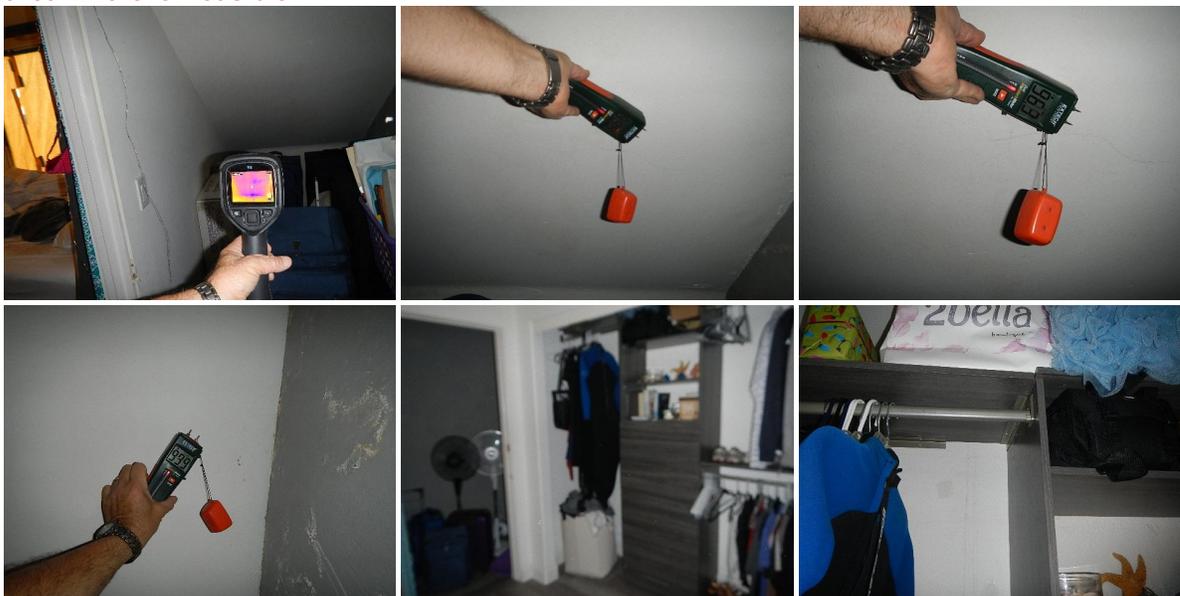
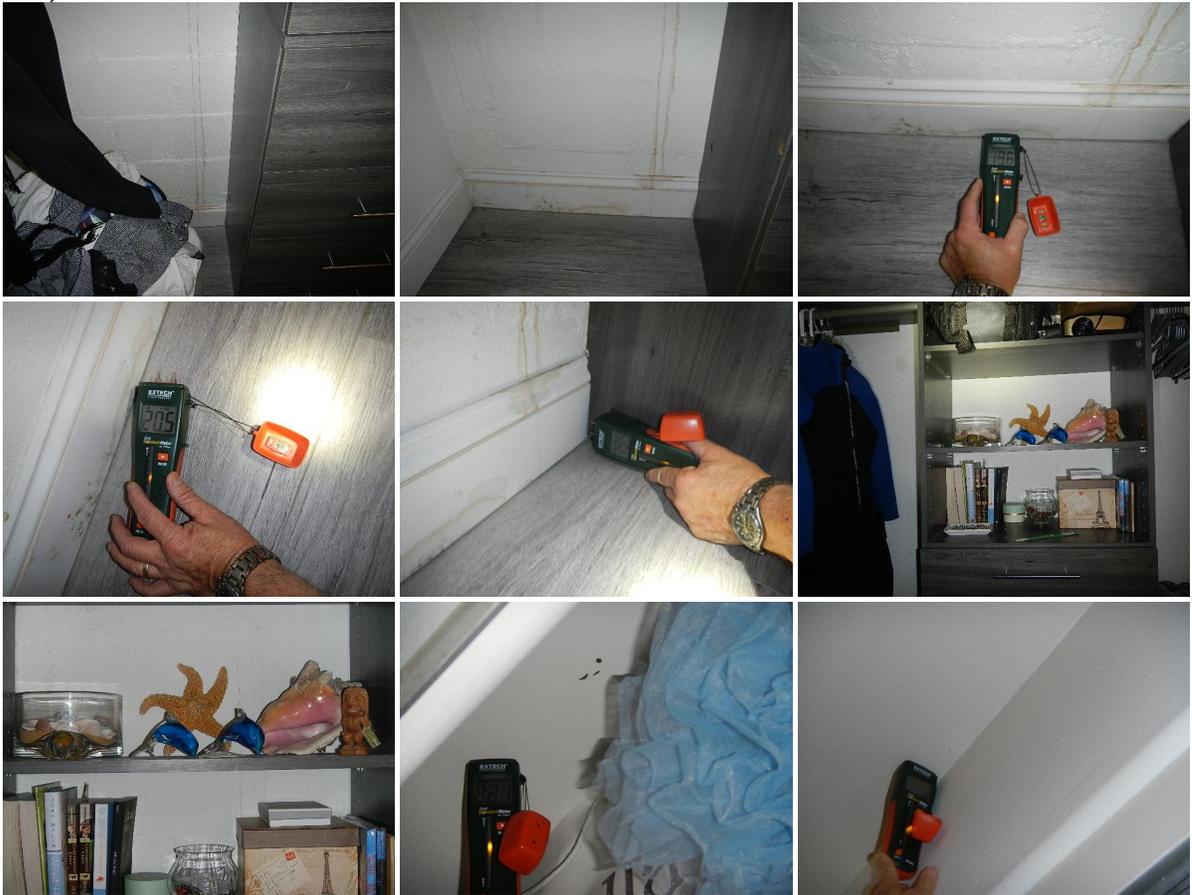
LOCATION: [Level 6 West Bedroom]:

Ceiling: Painted Drywall Some Moisture stains but extensive moisture was detected with a moisture meter across virtually the whole ceiling. Most of the perimeter of the ceiling except for maybe the SE at the side with the room door because it is at the interior. It is likely that the moisture will spread to more areas as days go by without forced drying and remediation. (HD)(RE)(PC).

[Suspect cause of moisture]: Parapet walls at light sconces, electrical outlets at the roof deck structure above and also at the lights in the stair risers. Also, possibly deck surface drains leak at the roof deck penetrations. Possible leaks from the roof drain pipes themselves. Once the ceiling and walls' gypsum board is removed the exact points of water entry should be revealed.

[Suspect Mold-like conditions likely exist at the back of the ceiling. By the time you receive this report it is possible that mold will be showing at the room side of the ceiling surface.]

Elevated mold spores and spores not found at the exterior were detected in this area. This indicates a mold problem exists in the air and the source likely originates from this area.

Mold Impacted and Water Damaged Materials. The air sample collected showed elevated airborne mold spore counts and mold growth was confirmed at the [Level 6 West Bedroom]. Additional hidden mold growth is possible. Work area should be isolated with use of containment barriers. Negative air should be established with use of HEPA filtered negative air machines. All water damaged and/or mold impacted non-structural materials should be removed (drywall, baseboards, insulation, etc...). Any water damaged and/or mold impacted structural materials should be properly HEPA vacuumed, scrubbed/cleaned, and then HEPA vacuumed again. Entire work area should be HEPA vacuumed and wet wiped. HEPA air filtration should run for a minimum of 24 hours after the work is complete. If during removal additional mold sources/water damage is noted, remediation/removal should continue until 12" past the last impacted area wherever feasible.

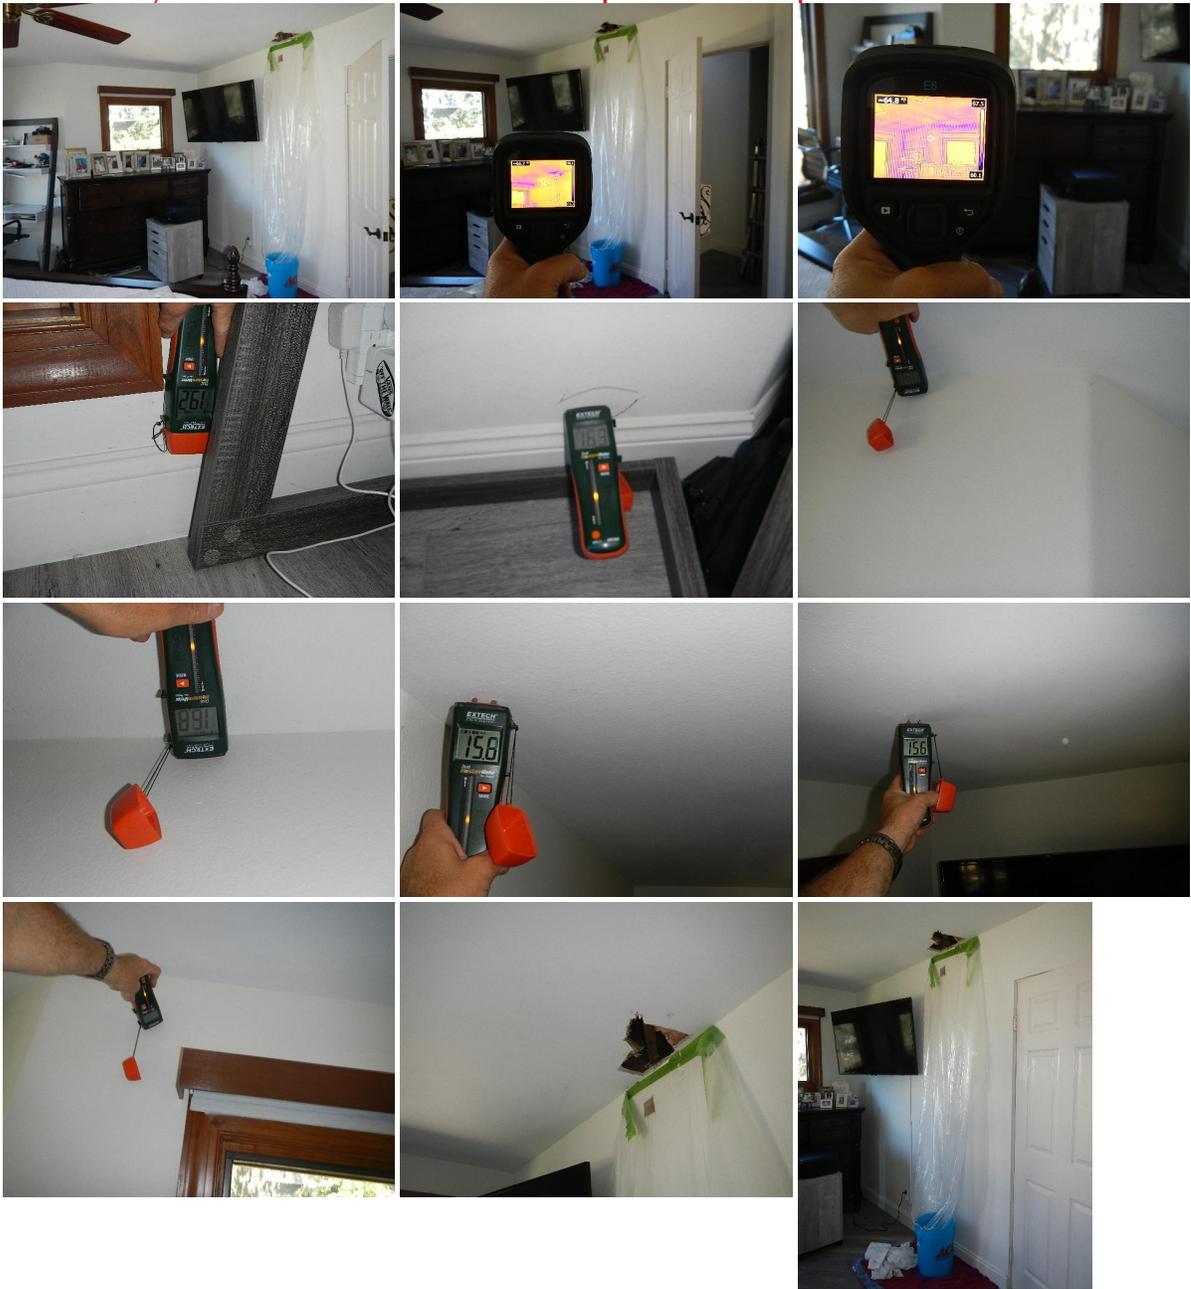
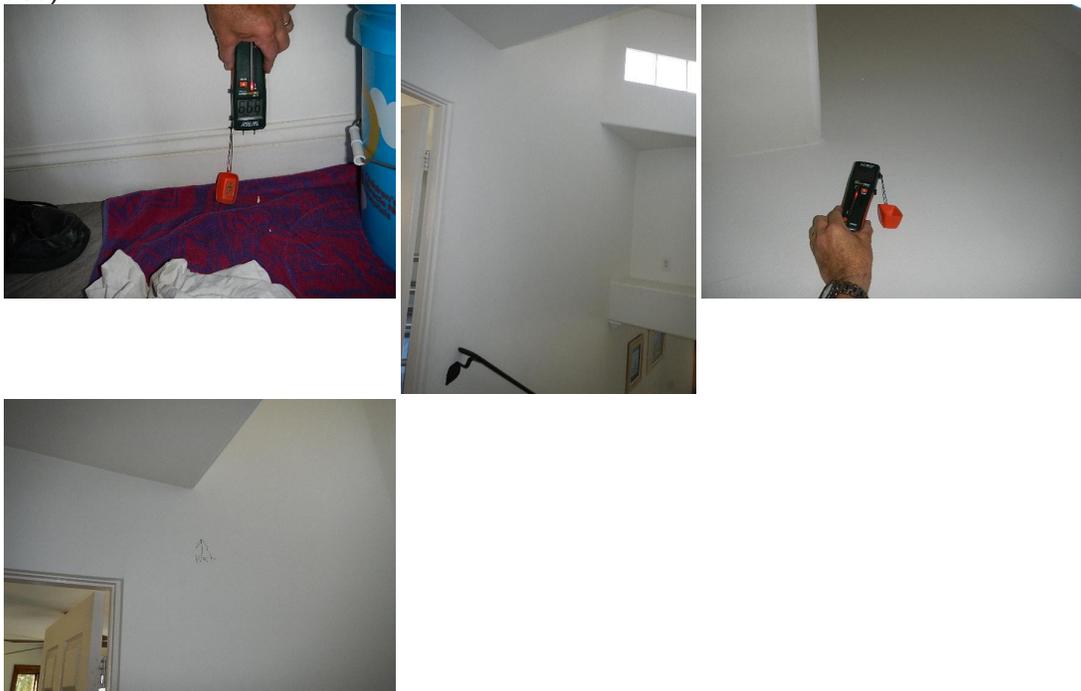
Level 5, SE, Master Bedroom

4. DEFECTIVE Ceiling: Painted Drywall The ceiling and wall were cut/broken open prior to my arrival for this inspection.

Moisture stains/damage and mold like substance were observed [at the west ceiling. (The following descriptions follow the general order of the photos):The southwest ceiling and walls were wet.
The SE corner wall was wet, low down.
The south wall was wet low down.
The south wall was wet high up.
The south ceiling was somewhat wet.
The south ceiling was wet.].
The west wall was wet low down.

Elevated moisture levels detected with moisture meter []. (HD)(RE)(PC).

[Suspect cause of moisture]: Roof related leaks.

[Suspect Mold-like conditions exist here at the master bedroom west ceiling.]

Mold Impacted and Water Damaged Materials. The air sample collected showed elevated airborne mold spore counts and mold growth was confirmed at the [Master bedroom walls and ceiling as indicated, this may extend into the flooring and even into the living space below. The water may keep migrating and it rained heavily again since this inspection.]. Additional hidden mold growth is possible. Work area should be isolated with use of containment barriers. Negative air should be established with use of HEPA filtered negative air machines. All water damaged and/or mold impacted non-structural materials should be removed (drywall, baseboards, insulation, etc...). Any water damaged and/or mold impacted structural materials should be properly HEPA vacuumed, scrubbed/cleaned, and then HEPA vacuumed again. Entire work area should be HEPA vacuumed and wet wiped. HEPA air filtration should run for a minimum of 24 hours after the work is complete. If during removal additional mold sources/water damage is noted, remediation/removal should continue until 12" past the last impacted area wherever feasible.

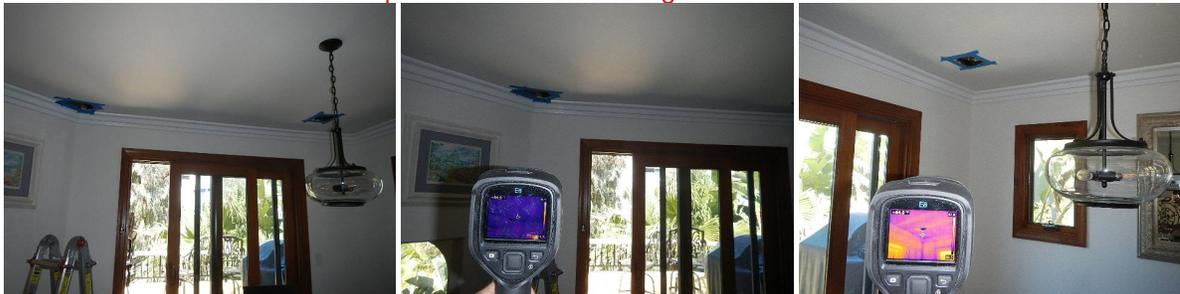
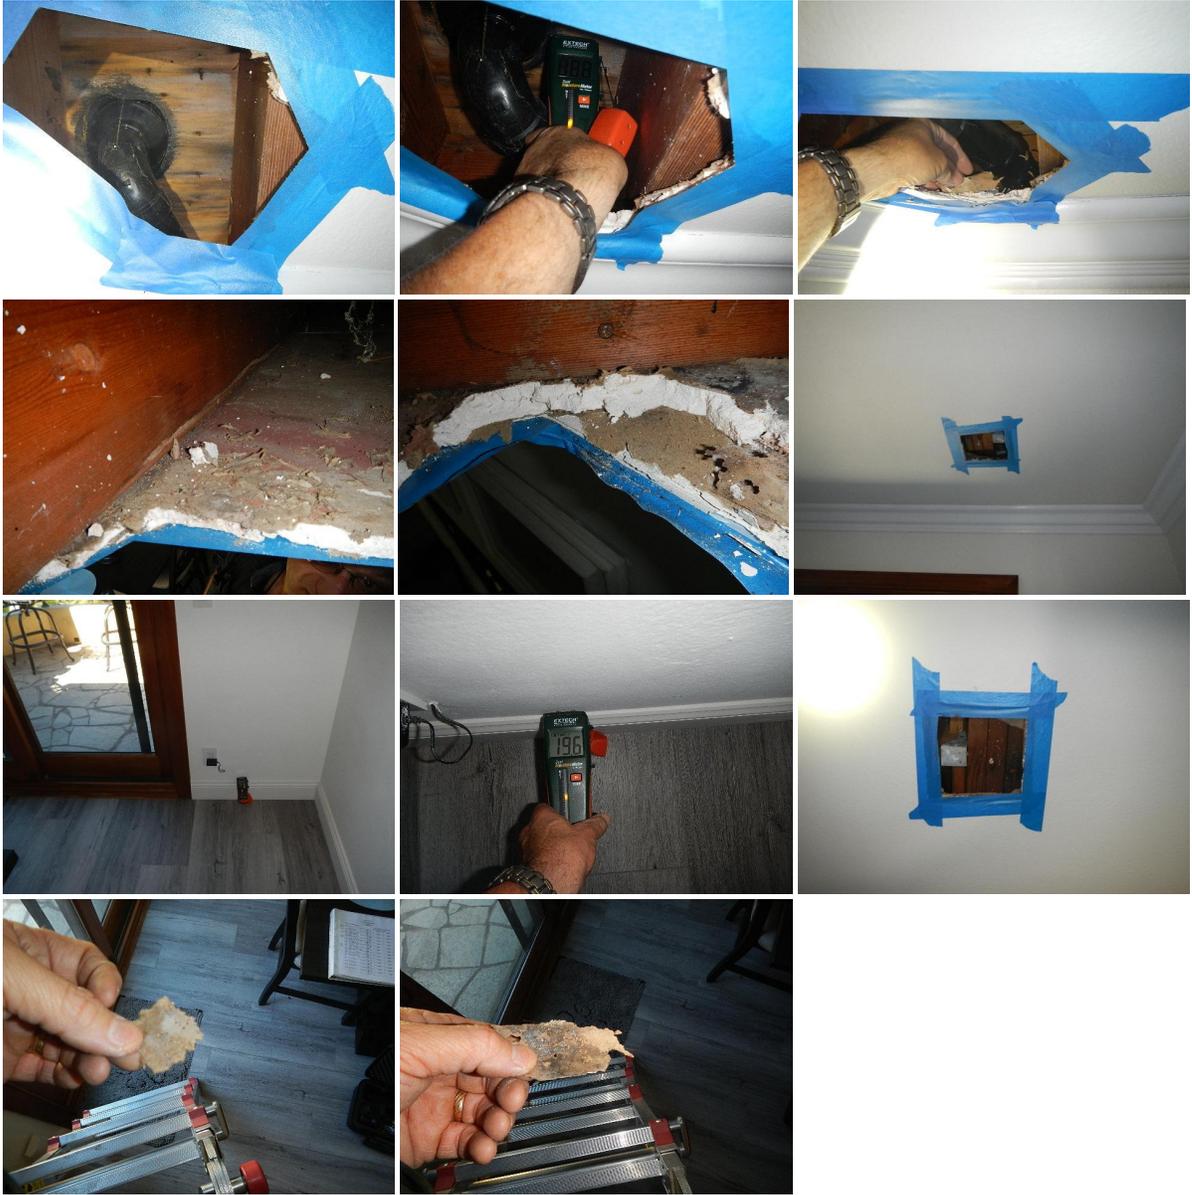
1. DEFECTIVE Ceiling: Painted Drywall The ceiling was broken open prior to my arrival for this inspection. Moisture stains/damage and mold like substance were observed [at the east ceiling.]. Particularly at photos 7,8,13,14. The S-SE wall was wet low down. See photos 10 and 11..

Elevated moisture levels detected with moisture meter [at the roof sheathing and at the S-SE wall down low.]. (HD)(RE)(PC).

[Suspect cause of moisture]: Roof related leaks, particularly around the roof drains at the flat roof.

[Concealed Mold-like conditions may exist here.]
[Suspect Mold-like conditions exist here at the ceiling.]

As a precaution, The work area should be isolated with use of containment barriers. Negative air should be established with use of HEPA filtered negative air machines. Any moisture damaged surfaces that cannot be salvaged, such as gypsum board (aka Sheet rock, Drywall, etc.) should be removed and discarded, to at least 6 to 12 inches beyond where visible moisture damage ends, if practical.

Any water damaged and/or mold impacted structural materials that can be salvaged, should be properly HEPA vacuumed, scrubbed/cleaned, and then HEPA vacuumed again.

The entire work area should be HEPA vacuumed and wet wiped. HEPA air filtration should run for a minimum of 24 hours after the work is complete. If during removal additional mold sources/water damage is noted, remediation/removal should continue until 12 past the last impacted area wherever feasible. The contained area should be inspected by 20/20 Property inspections and if deemed acceptable the air should be tested to confirm that there is no detectable mold problem before restoring the finished surfaces.

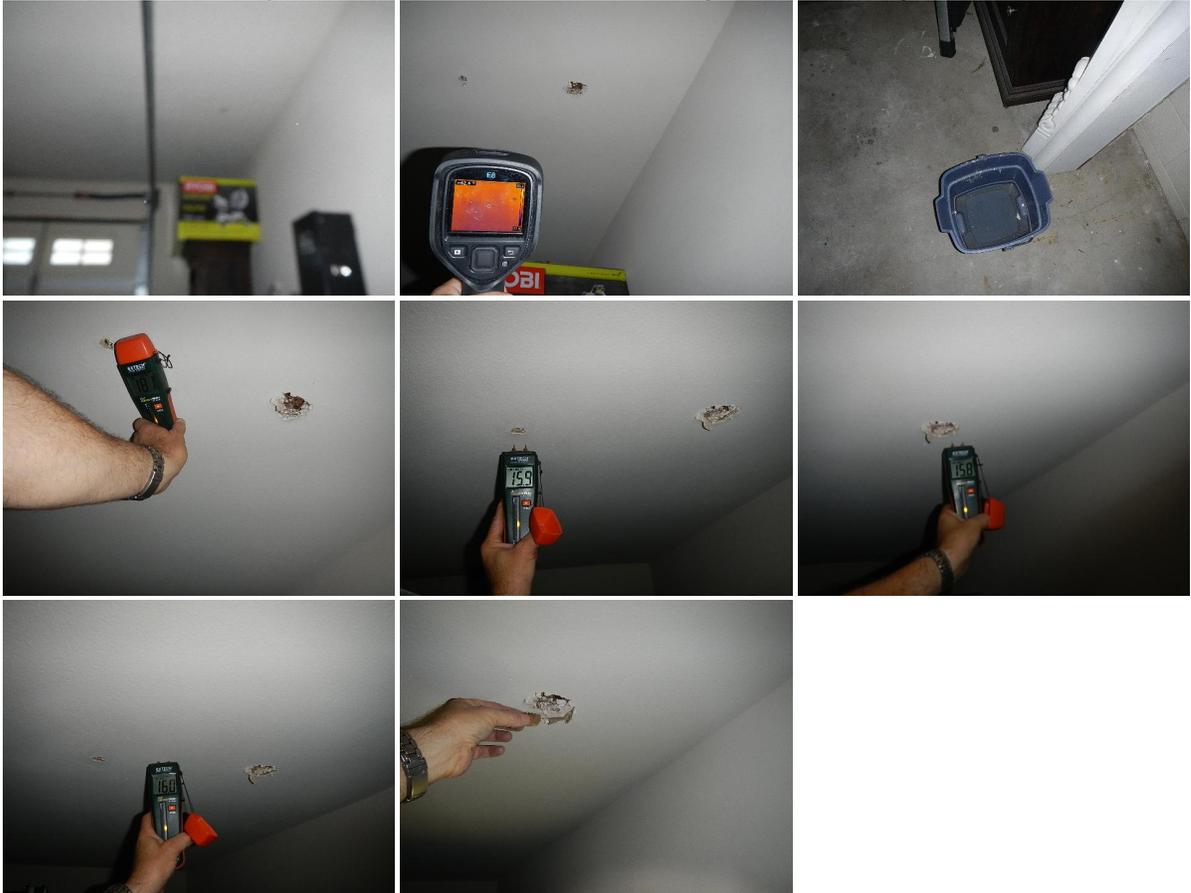
2. DEFECTIVE Ceiling: Moisture stains/damage and mold like substance were observed [at the ceiling, as shown.]. close of transaction, if applicable.

Elevated moisture levels detected with moisture meter []. (HD)(RE)(PC).

[Suspect cause of moisture]: Roof related leak.

[Suspect Mold-like conditions exist here.]

Hidden mold growth is possible. If mold is discovered, the work area should be isolated with use of containment barriers. Negative air should be established with use of HEPA filtered negative air machines. Any moisture damaged surfaces that cannot be salvaged, such as gypsum board (aka Sheet rock, Drywall, etc.) should be removed and discarded, to at least 6 to 12 inches beyond where visible moisture damage ends, if practical.
