# ***20/20 PROPERTY INSPECTIONS***

**52 Any Street  
City, CA 926XX**

**Prepared for: Michele and Jim Clients**

Inspection Date: **08/15/2019**

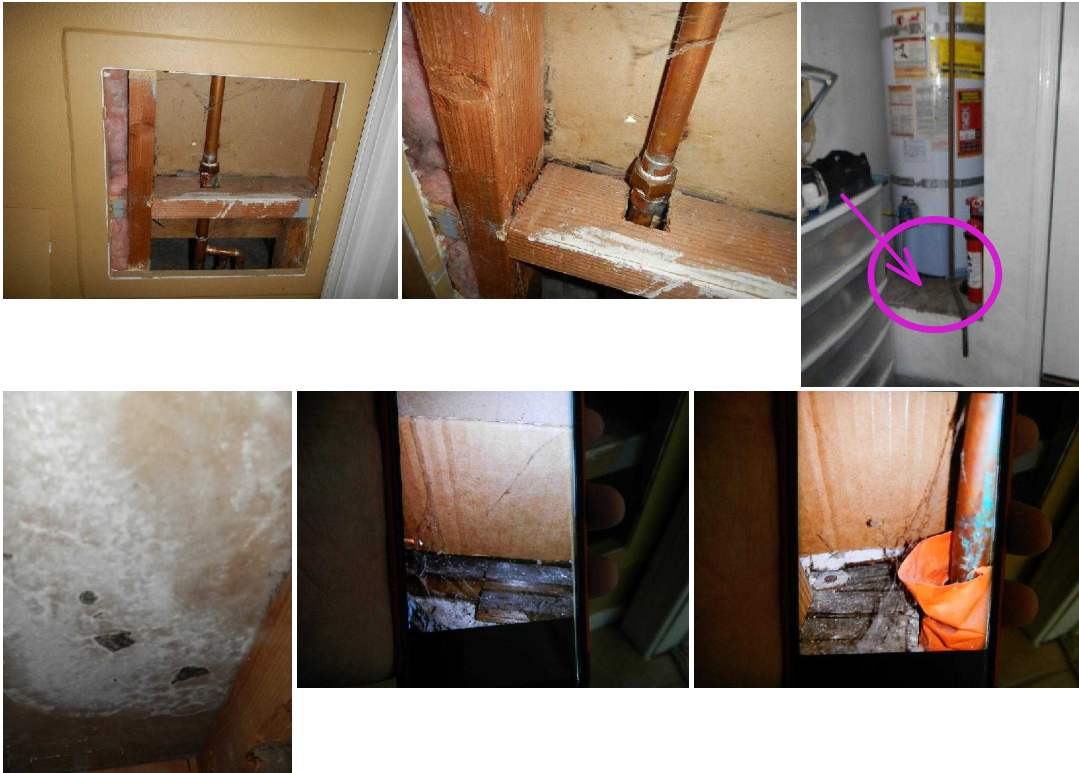
2. **DEFECTIVE** **Walls: Painted Drywall** Moisture stains/damage and mold like substance were observed [at the laundry room side of the SE wall of the garage. (Photos 1 and 2).  
Also, mold like substance was observed at the underside of the water heater platform.]. Photos 3 and 4. And moisture damage and possible mold at the the sill plate (framing at the base of the wall) (Photos 5 and 6).  
Ask owner about history of conditions.

- No Elevated moisture levels detected with moisture meter [ ]. (HD)(RE)(PC).
- [Suspect cause of moisture]: Past water heater related leak. It was also reported that there was a pinhole leak in a hot water pipe in the house. I was not told where the actual leak was discovered, but the pipe repair was made at the plumbing manifold in the common wall between the water heater platform and the laundry room.

Elevated mold spores and spores not found at the exterior were detected in this area. This indicates a mold problem exists in the air and the source likely originates from this area.

Hidden mold growth is possible. If mold is discovered, the work area should be isolated with use of containment barriers. Negative air should be established with use of HEPA filtered negative air machines. Any moisture damaged surfaces that cannot be salvaged, such as gypsum board (aka Sheet rock, Drywall, etc.) should be removed and discarded, to at least 6 to 12 inches beyond where visible moisture damage ends, if practical.

Any water damaged and/or mold impacted structural materials that can be salvaged, should be properly HEPA vacuumed, scrubbed/cleaned, and then HEPA vacuumed again.

The entire work area should be HEPA vacuumed and wet wiped. HEPA air filtration should run for a minimum of 24 hours after the work is complete. If during removal additional mold sources/water damage is noted, remediation/removal should continue until 12 past the last impacted area wherever feasible.

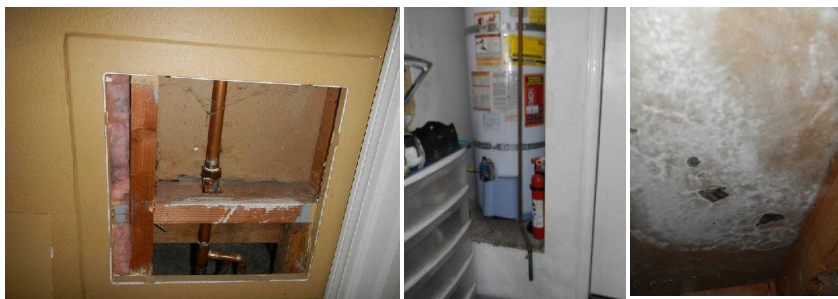
2. DEFECTIVE Walls: Painted Drywall (Partially repeated from the laundry room):  
Moisture stains/damage and mold like substance were observed [at the laundry room side of the SE wall of the garage. Also, mold like substance was observed at the underside of the water heater platform.].  
Ask owner about history of conditions.

See Laundry room wall comments.

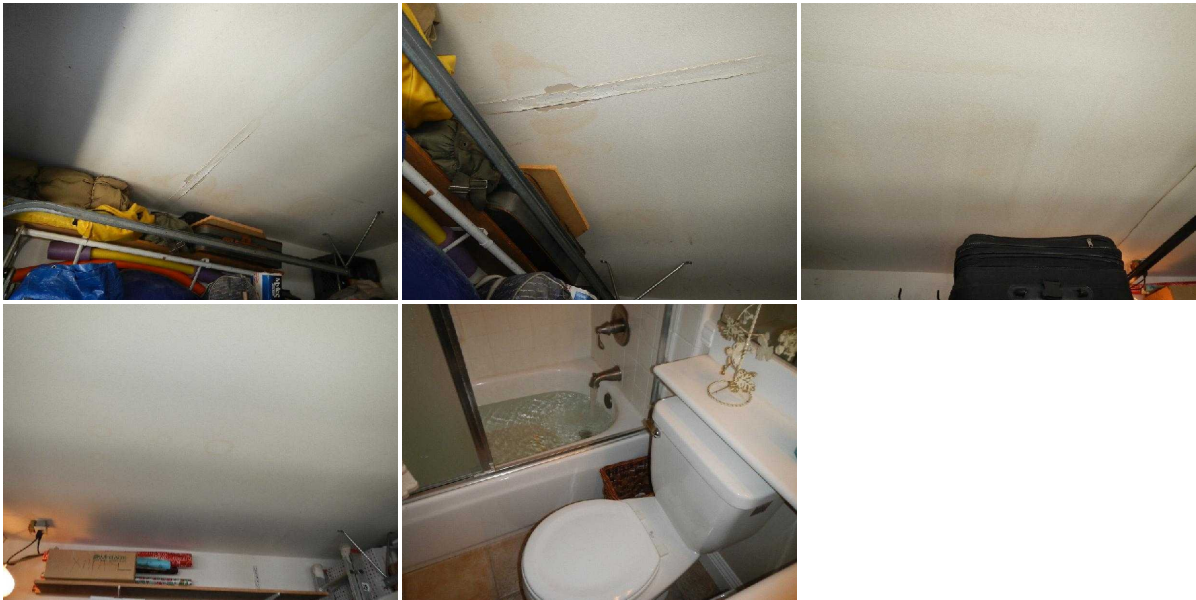
3. DEFECTIVE Ceiling: Painted Drywall Moisture stains/damage and were observed [at the ceiling, from left to right, across virtually the whole ceiling. The heaviest concentration of water damage was at the north corner area. ]. Ask owner about history of conditions.

[No] Elevated moisture levels detected with moisture meter [ ]. (HD)(RE)(PC).

[Suspect cause of moisture]: Reportedly a past leak from the overflow drain at the level 2 hall bathtub. (This seems to be the exact location by measurement).

Appropriate precautions should be used when repairing the moisture damage as concealed mold may be revealed.

I advise that a professional mold remediator be employed to perform the remediation (repair).]

Hidden mold growth is possible. If mold is discovered, the work area should be isolated with use of containment barriers. Negative air should be established with use of HEPA filtered negative air machines. Any moisture damaged surfaces that cannot be salvaged, such as gypsum board (aka Sheet rock, Drywall, etc.) should be removed and discarded, to at least 6 to 12 inches beyond where visible moisture damage ends, if practical.

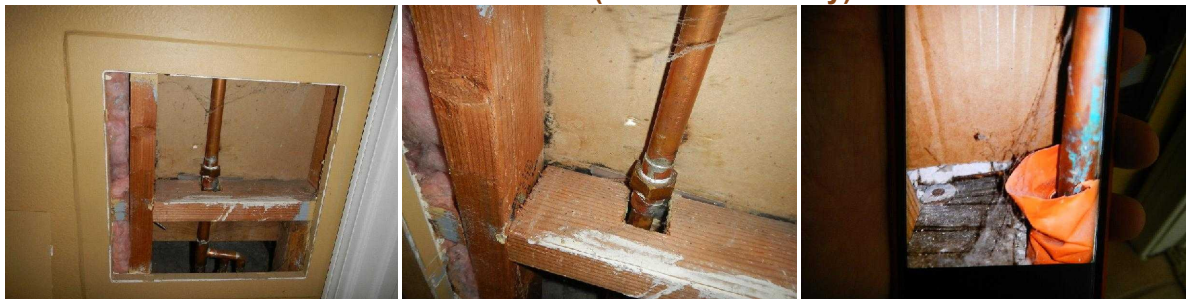
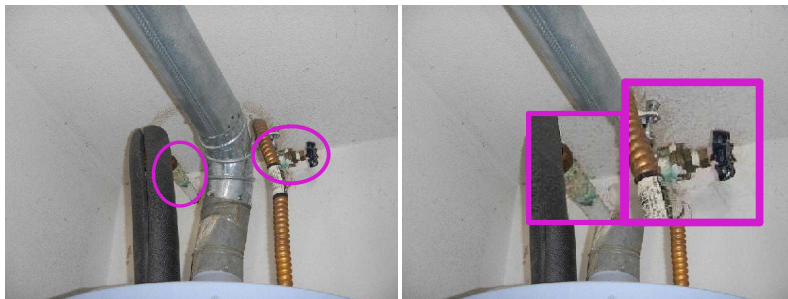
**1. NOT RATED** **Water Supply Distribution Pipes (as viewed):** \* See Note 1, above. *Copper type where visible.* \* See Note 1, above **a. There has been at least one reported water supply pipe leak. Be advised that that copper pipes have been known to fail with pin hole leaks as it starts to age and due to Chloramine additives from the water utility company and minerals from "hard" water. (AE)(PC).**

**\*\* I observed other problematic conditions regarding the copper plumbing:**  
**In the lower wall between the water heater and laundry room the there is excessive flux still on a water pipe. My visibility was extremely limited. (See photo 3).**  
**Also, there is calcification at the hot water pipe above the water heater and also at the cold water supply valve and sweated fitting. (Photos 4 and 5).**
