Buyer Buying

1234 Elm St
San Diego, California 91915

Tuesday
April 23, 2024

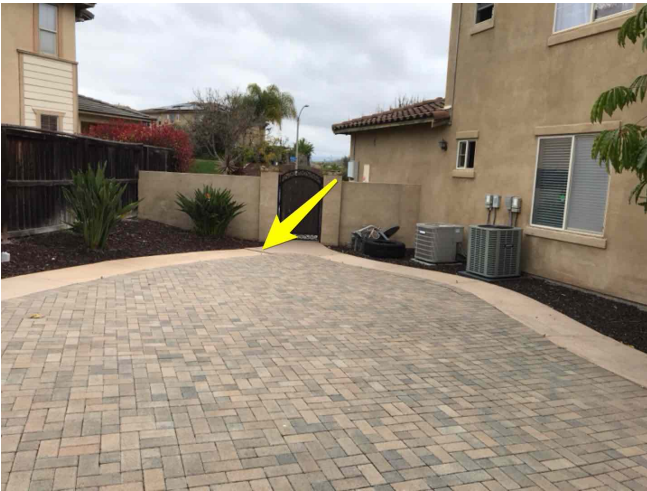
S 31: There is a trip hazard in the walkway at the right side exterior. We recommend it be patched or repaired to prevent injury.

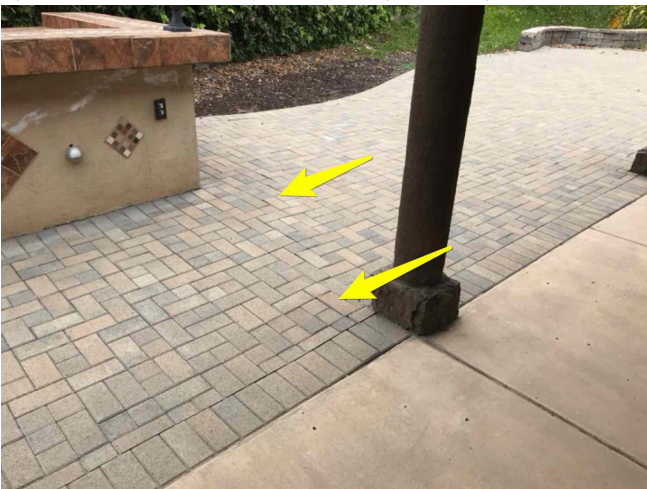
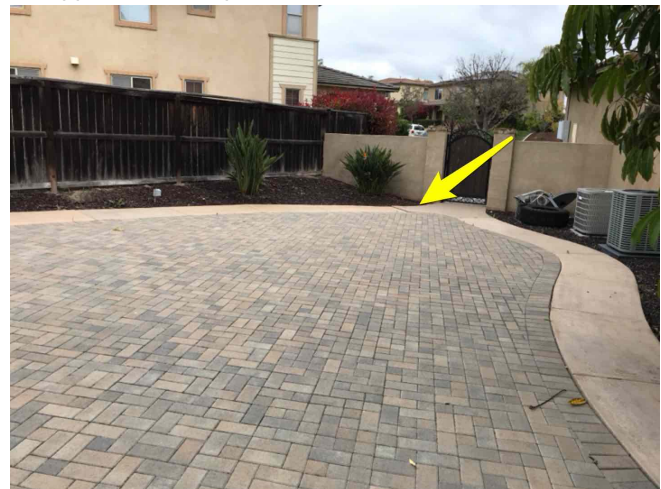
W 33: The paver patio has cracked and settled to the point that it might be considered aesthetically deficient. In our opinion, it is still serviceable and repair or replacement for a better appearance is optional.

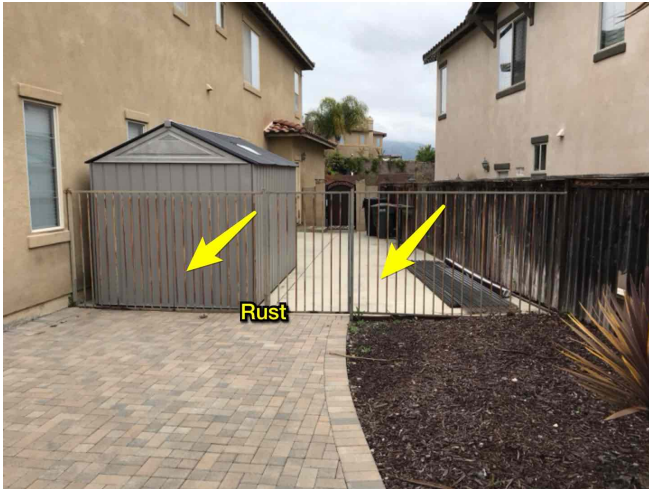
M 34: There is deterioration/damage to the fencing. We recommend the fencing be monitored and repaired and/or replaced as necessary.

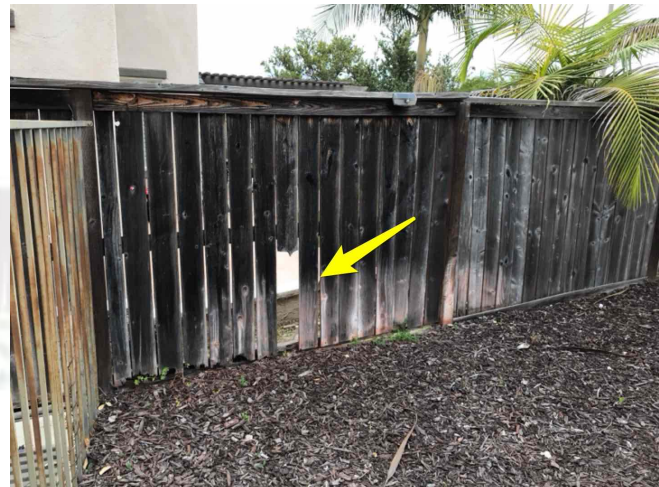
R 35: There is major damage to the fencing. We recommend the fencing be repaired and/or replaced.

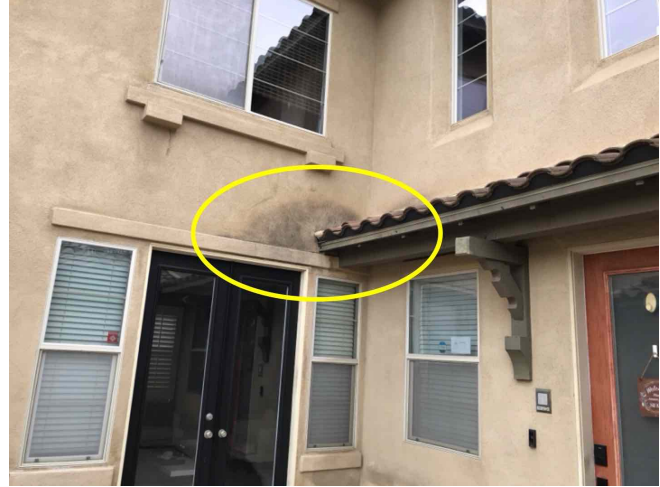
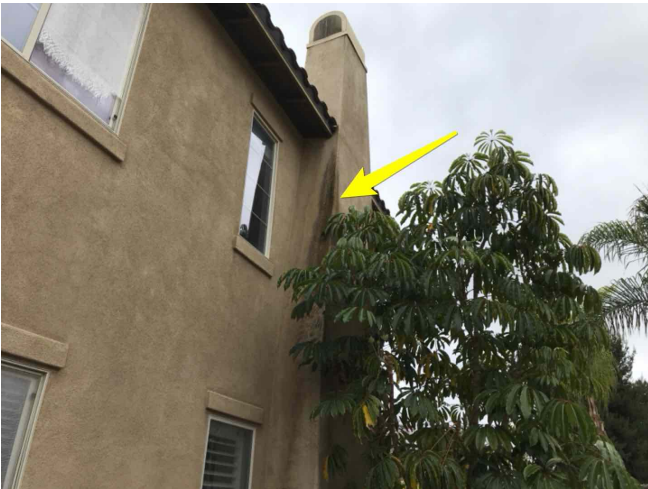
W 38: There is water staining to the exterior stucco. The gutters, flashing, exterior drainage and sprinkler system should be serviced to prevent future staining.

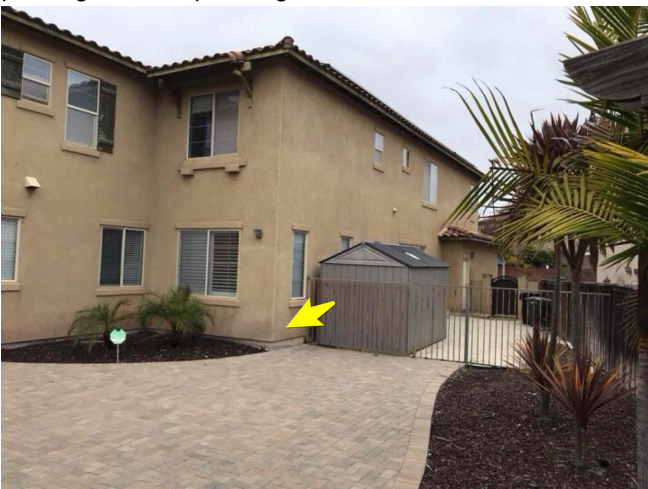
R 39: There are moderate sized cracks in the stucco that should be patched and sealed as part of preparation for the next painting. Flexible patching materials are recommended rather than rigid cementitious patching compounds.

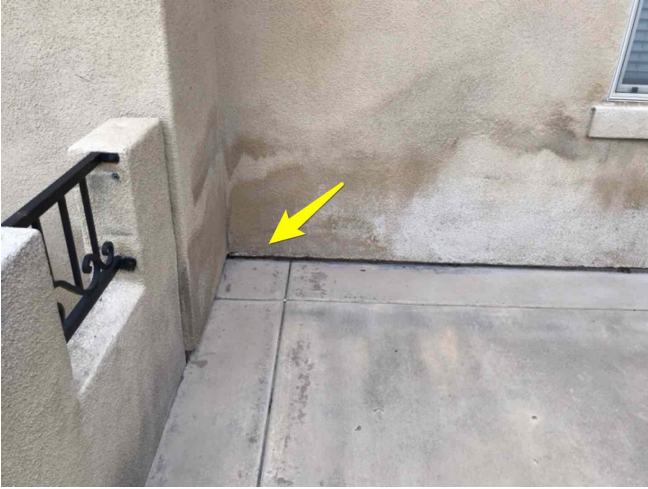
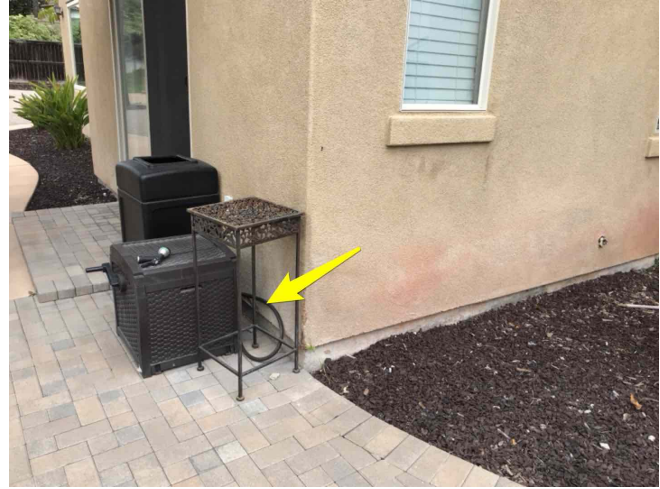
R 40: Sections of the stucco are stained/cracked and/or deteriorated. We recommend the stucco be patched, repaired or replaced.

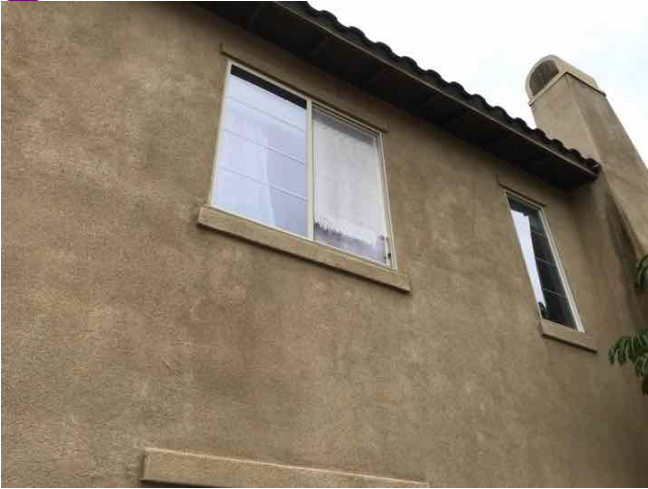
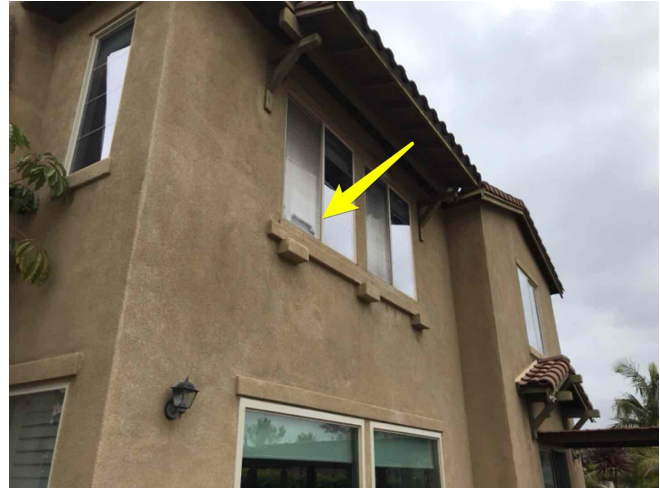
M 45: There are one or more damaged or torn screen(s) that should be repaired or replaced.

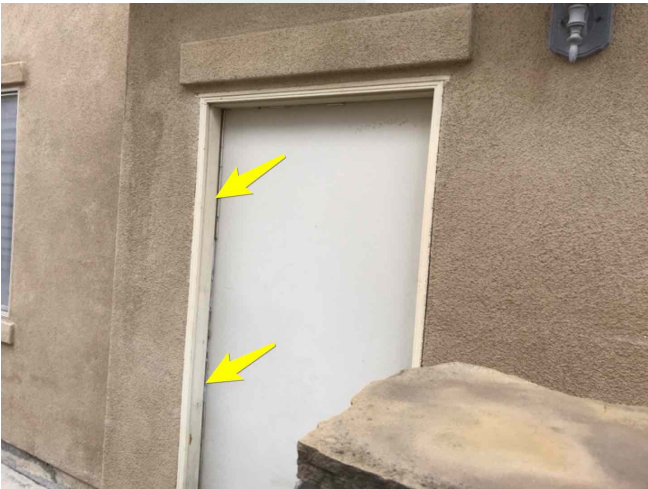
M 47: The weatherstripping is generally in poor condition and will not be effective. To conserve energy and lower the utility bills, we recommend all deficient weatherstripping be repaired or replaced.

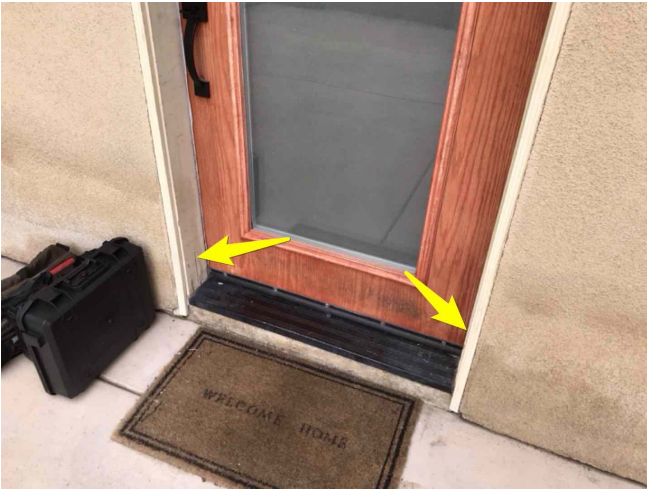
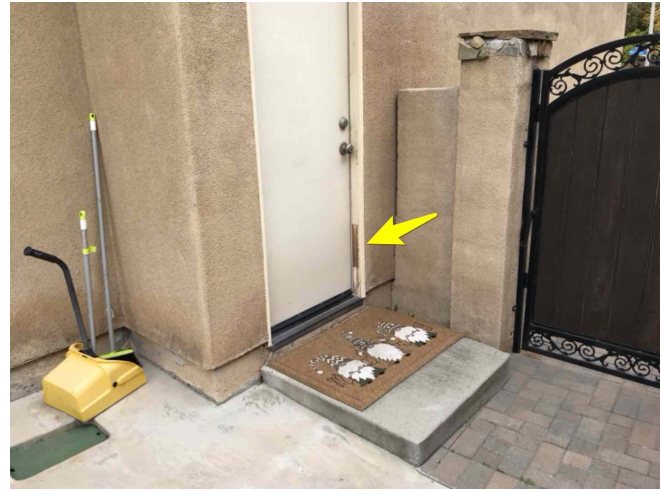
M 49: The trim shows routine wear but appears to be properly installed and in serviceable condition. We advise routine maintenance to ensure maximum service life.

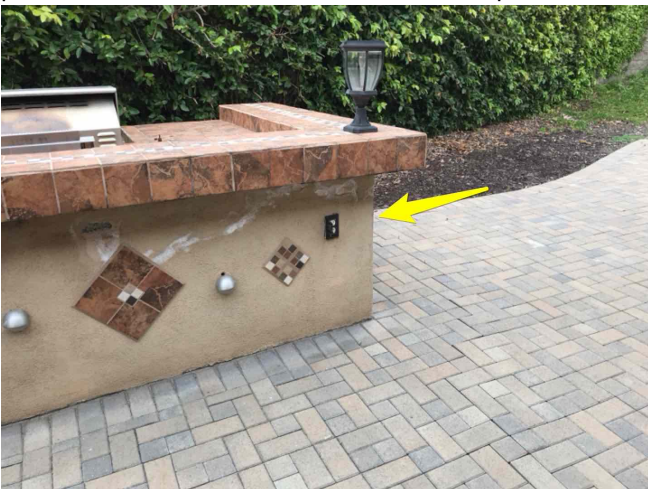
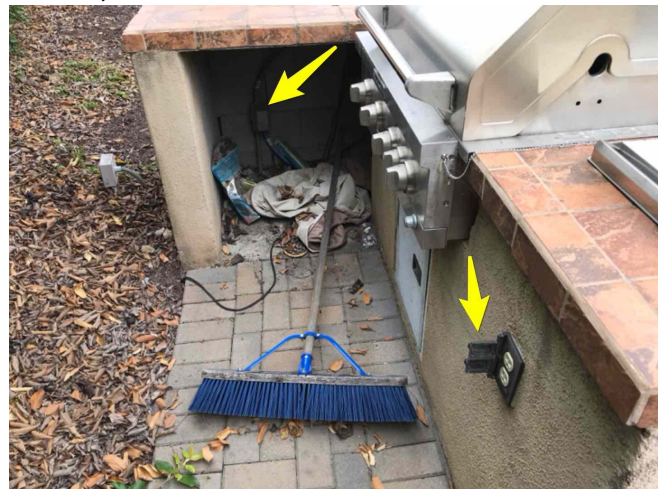
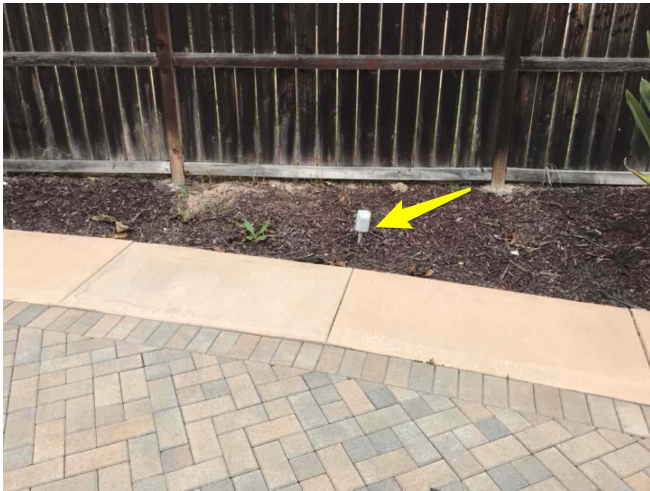
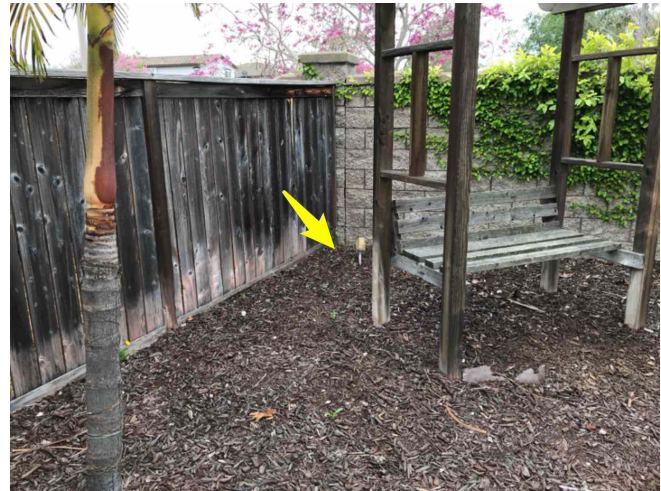
R 63: Several receptacles on the exterior are not working. We suspect a 'dead' circuit, but could not locate a specific problem. We recommend the circuit and receptacles be checked and repaired.

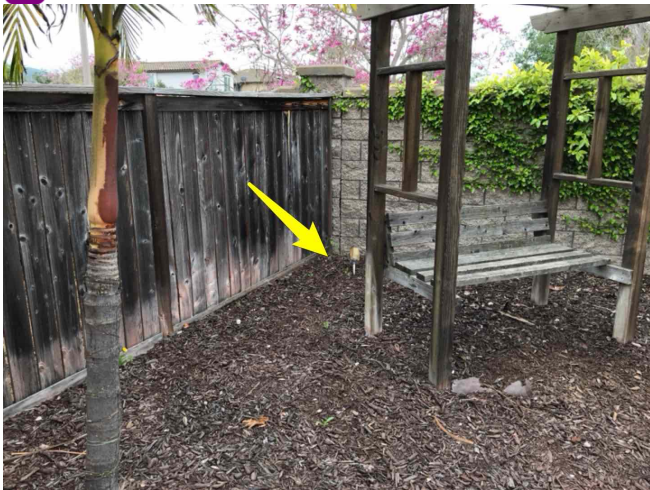
M 64: A receptacle at the rear of the property is loose. For maximum safety we recommend that it be resecured.

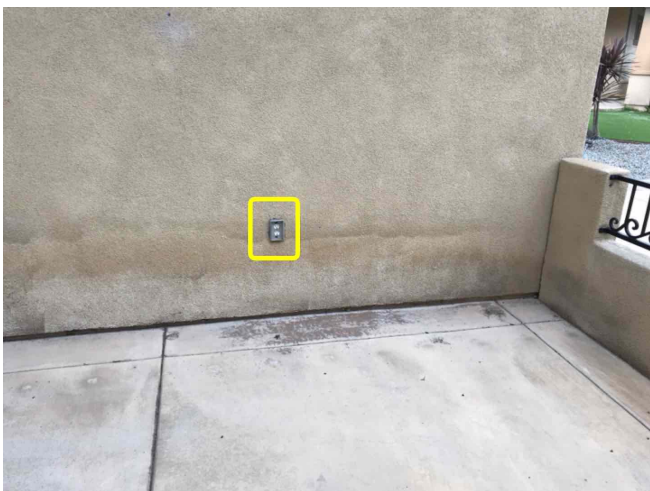
R 65: A receptacle cover plate at the front is damaged. We recommend it be replaced during the course of normal maintenance.

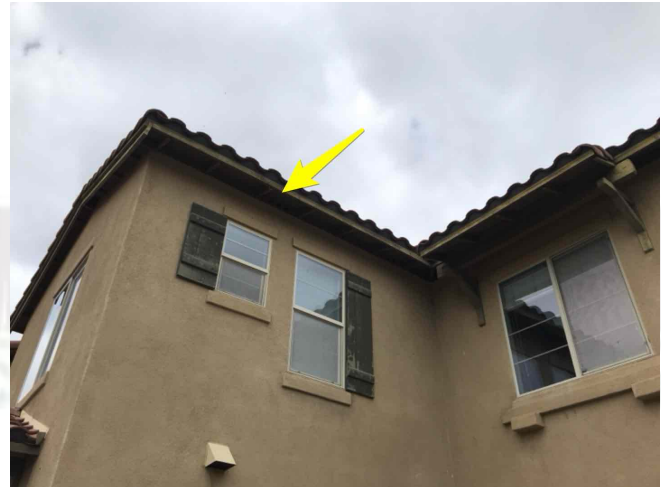
S 73: There is an active bee hive at the eaves. We recommend this hive be removed by a professional beekeeper. Inspection was limited because of this condition.

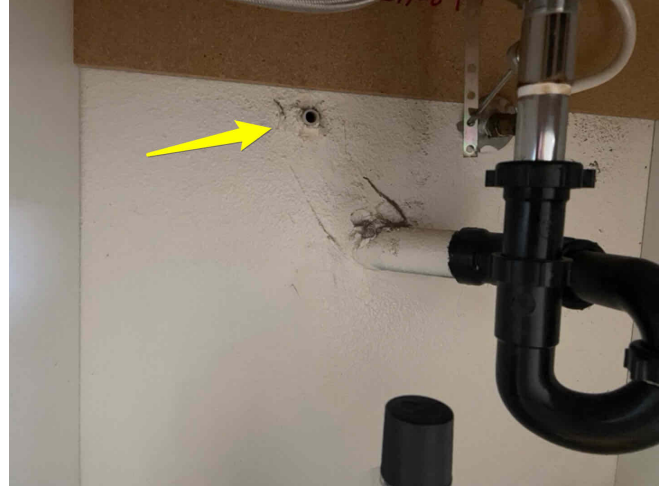
154: There are signs of repairs made to the plumbing supply system. It's advised that the seller be questioned about the scope of the repairs.

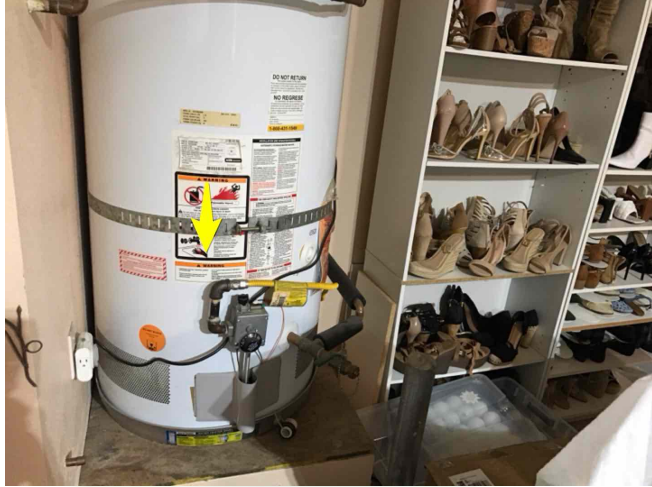
U 182: The fuel piping does not include a 'T' extension to collect condensation and debris, as is considered good practice. In the course of future upgrading or repair, a 'drip leg' should be added to the gas piping just ahead of the connector.

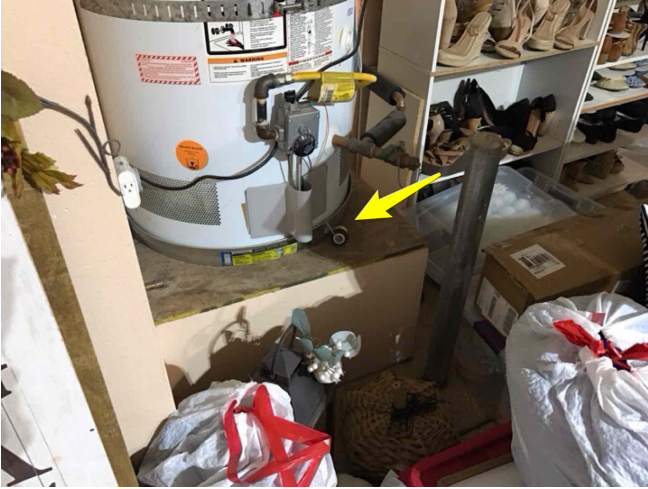
U 189: The water heater has a drain pan installed without an overflow pipe installed to a termination that will not cause moisture intrusion or damage.

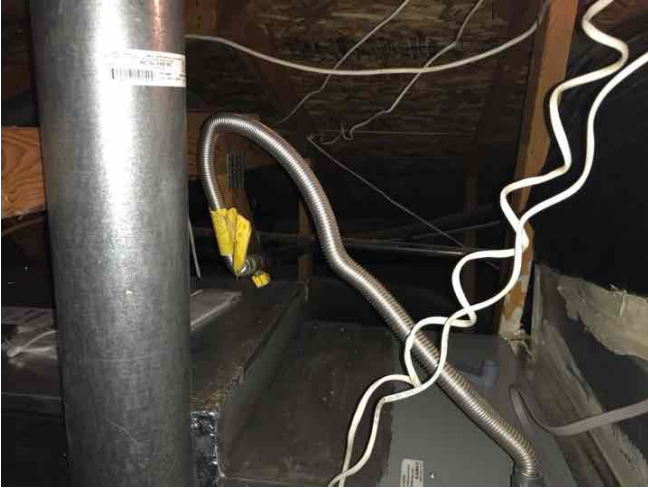
U 203: The fuel piping does not include a drip leg extension to collect condensation and debris. It is advised that a 'drip leg' be added to the gas piping just ahead of the connector.

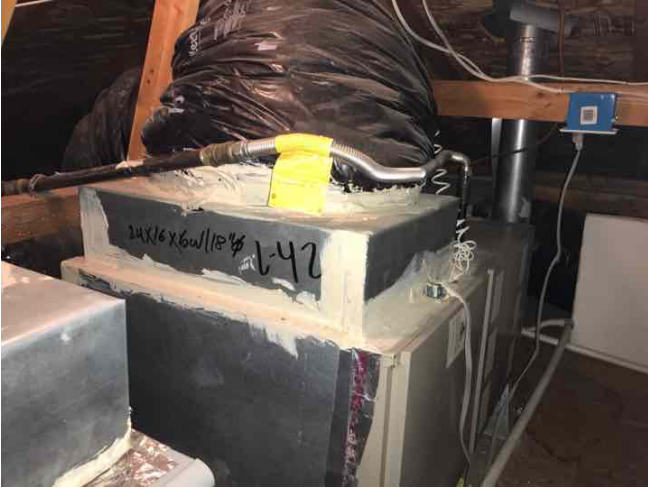
U 228: The fuel piping does not include a drip leg extension to collect condensation and debris. It is advised that a 'drip leg' be added to the gas piping just ahead of the connector.

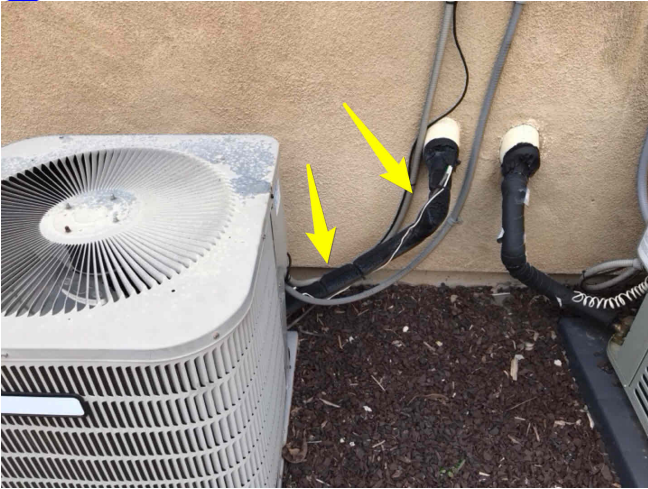
U 287: The refrigerant lines at the Air conditioning condenser should be wrapped with a UV tape to prevent deterioration.

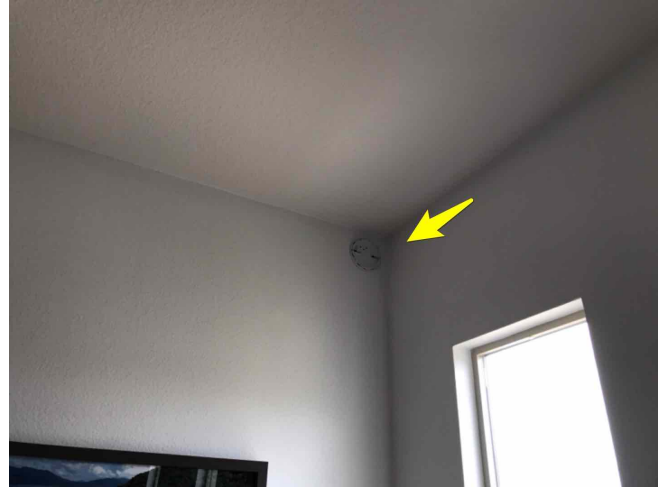
S 366: The smoke detector has been removed and needs to be replaced.

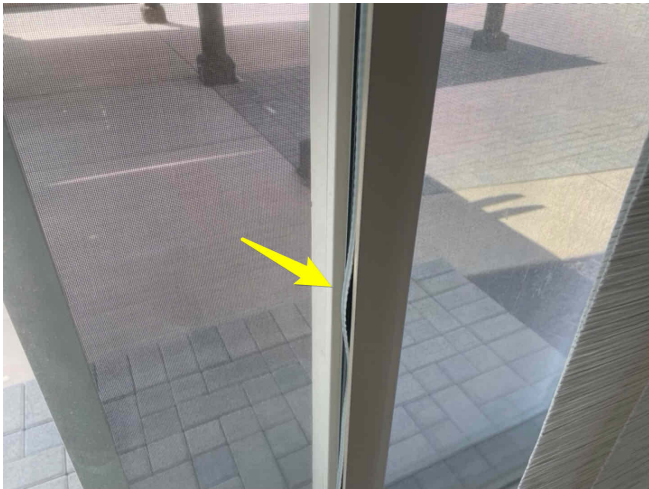
W 383: The window seal is bulging this can lead to a potential failure of the windows thermal seal, which would result in fogging of the window pane.

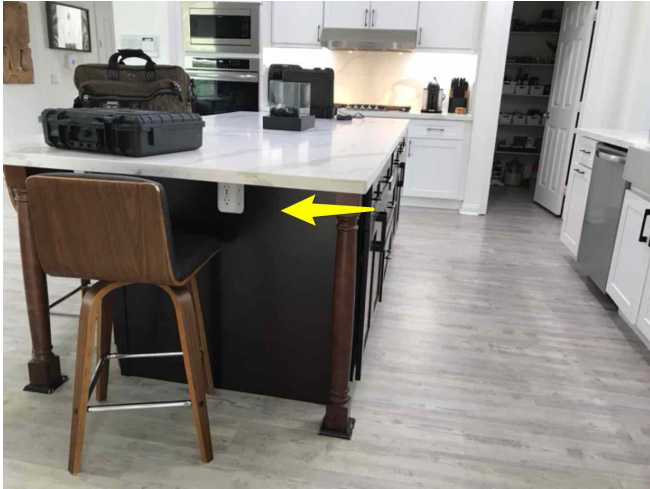
U 403: GFCI protection was not found at all countertop receptacles even though this was not mandatory at the time of construction. We recommend upgrading in compliance with current standards.

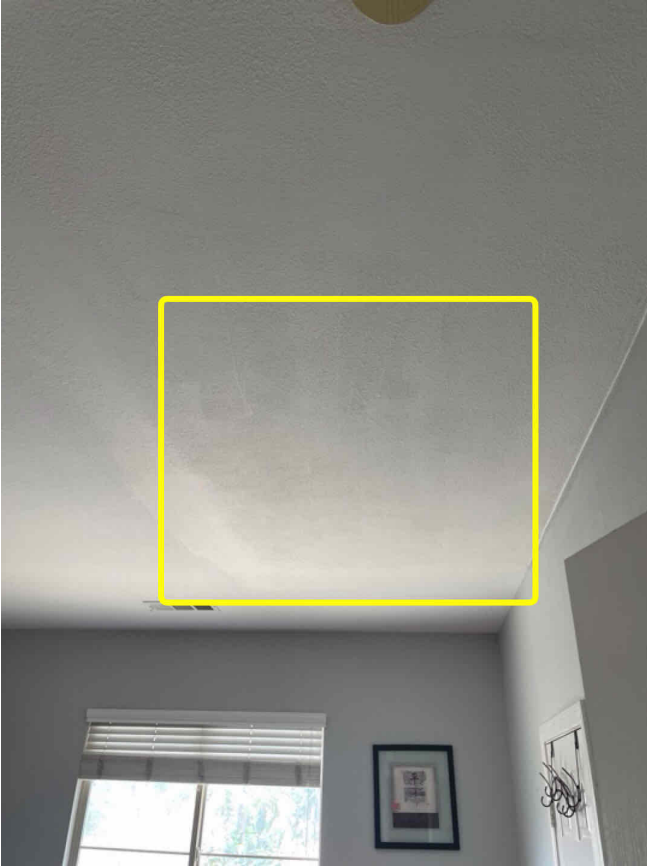
429: There is evidence of patching to the ceiling. It is advised that further inquiry be made regarding this condition.

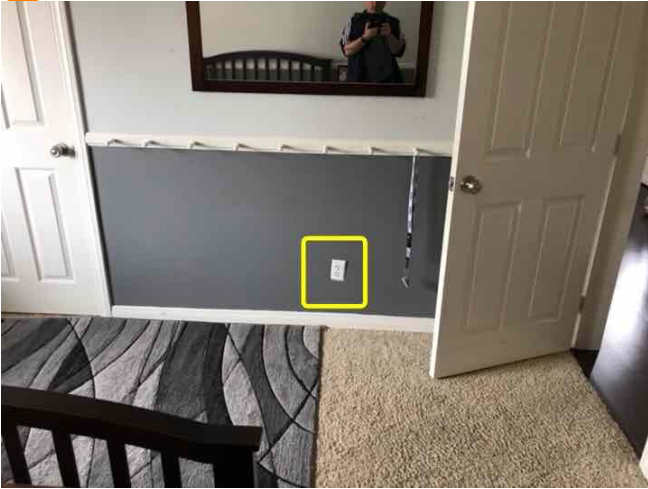
R 435: A receptacle located at bedroom is loose. For maximum safety we recommend that it be tightened.

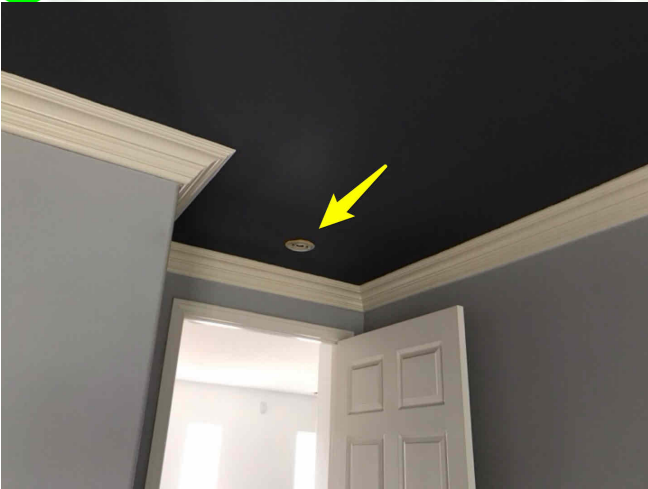
S 447: The smoke detector has been removed or is missing and needs to be installed.

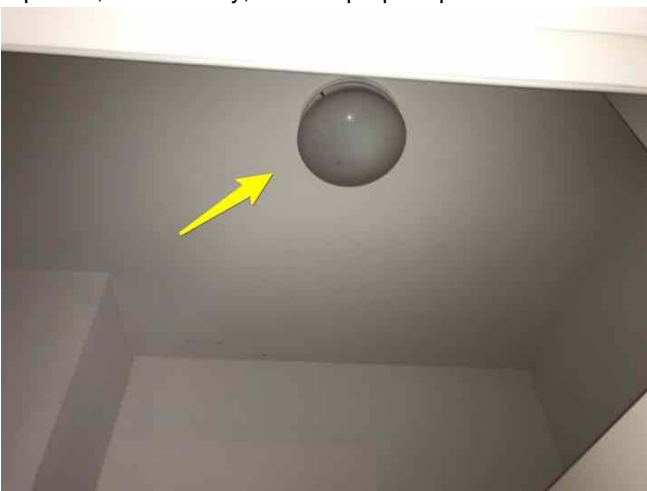
M 457: The closet light is not working. The bulb may have burned out. We recommend that the bulb be tested and replaced, if necessary, and the proper operation of the fixture be verified.

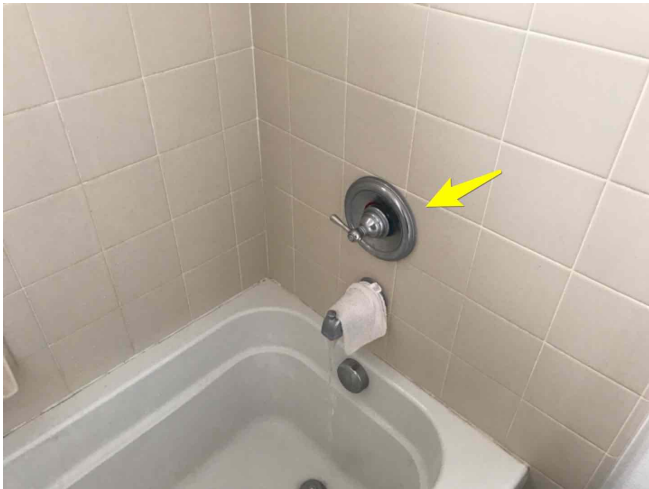
R 489: The faucet for the shower has low flow on the hot side when fully turned on this is most likely a sign of a valve cartridge failing, further evaluation by a plumber is suggested.

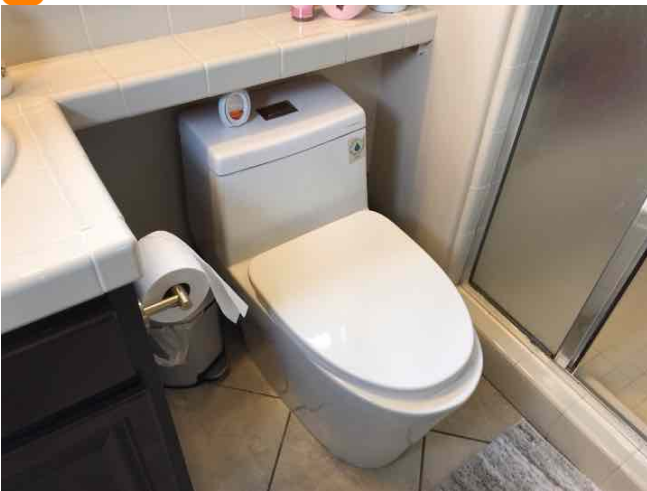
R 512: The toilet doesn't flush. We recommend that it be repaired.

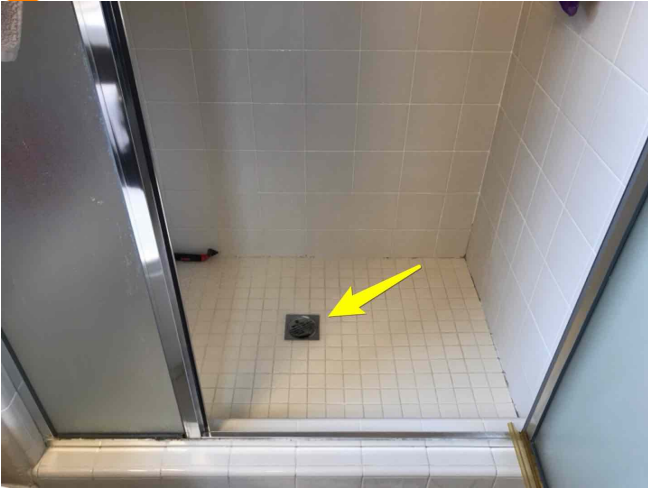
R 516: The shower drain cover is loose or damaged and needs to be repaired or replaced.

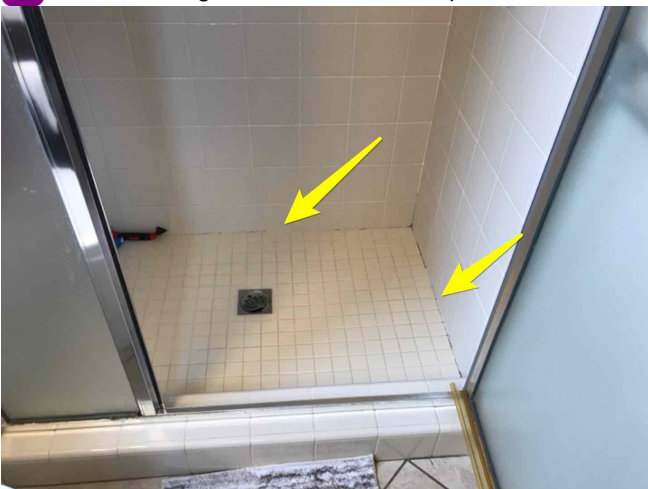
M 521: Caulking needed at shower to prevent moisture intrusion or damage.

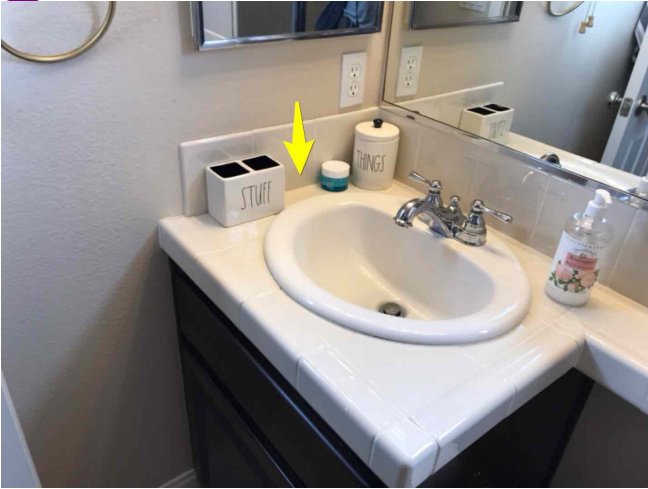
M 522: Caulking needed at backsplash to prevent moisture intrusion or damage.

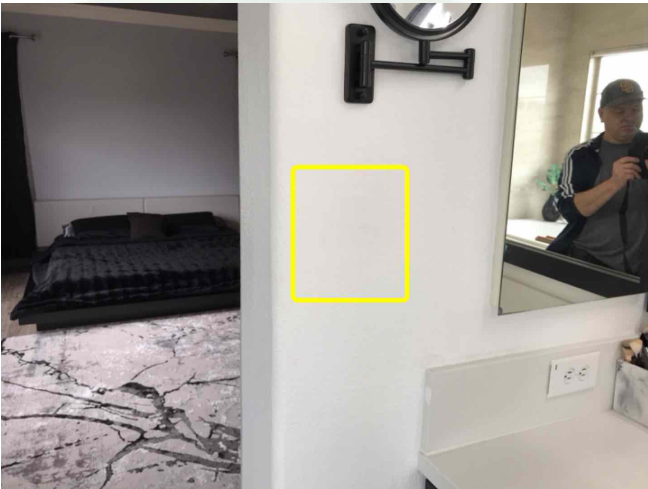
524: There is evidence of patching to the wall. It is advised that further inquiry be made regarding this condition.

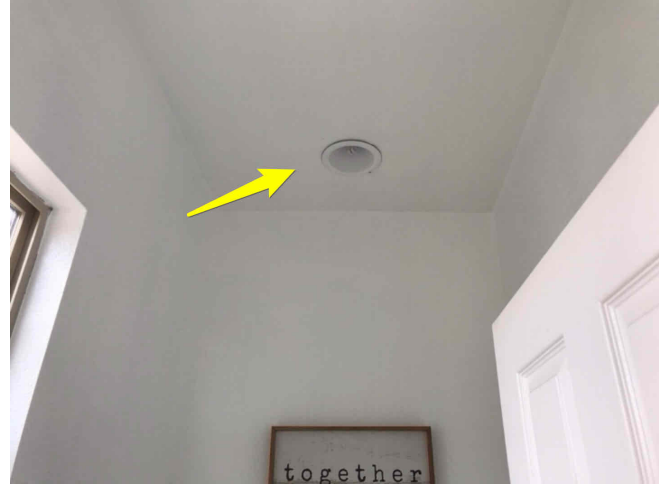
M 542: The light is not working. The bulb may have burned out. We recommend that the bulb be tested and replaced, if necessary, and the proper operation of the fixture be verified.

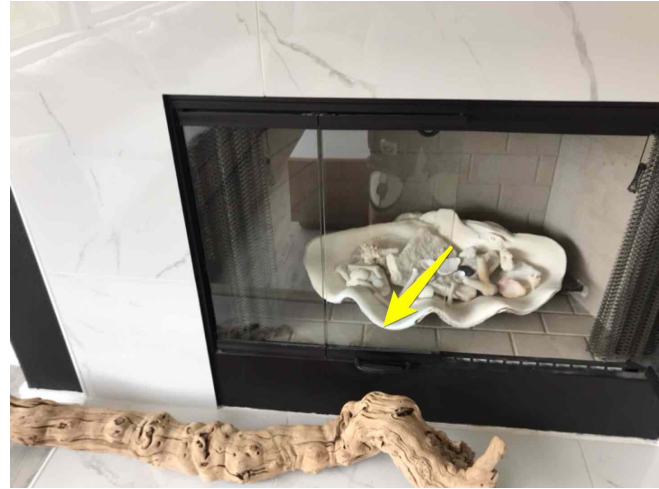
M 554: The fireplace glass doors off track and have a damaged handle and need service or repair.

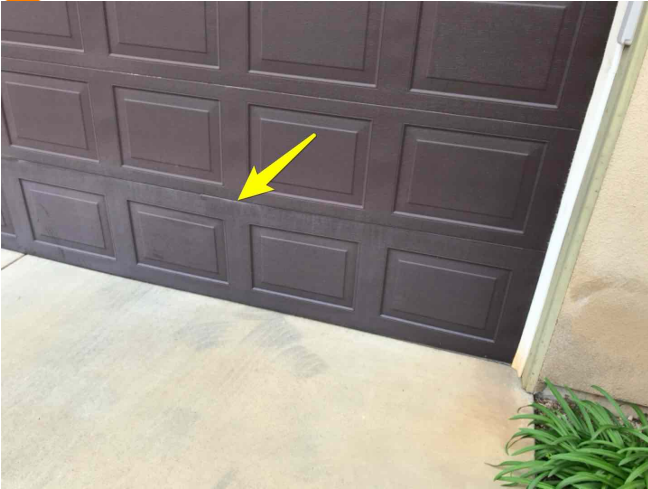
R 575: The garage door is damaged. We recommend it be repaired or replaced.
