Home Inspection Report

Prepared For Joe and Jane Homeowner
11/21/2021

123 Main St
Anywhere, OR

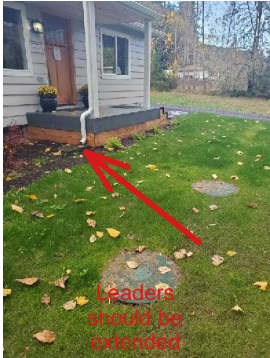
1. Leader/Extension: Leaders do not extend 6 feet beyond the foundation perimeter. This can cause water damage to foundation. Recommend extend all leaders as needed to at least 6 feet beyond foundation.

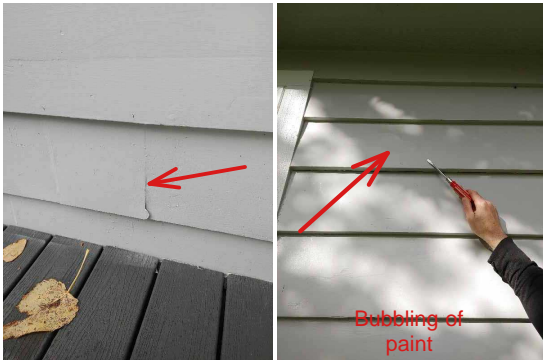
2. Trim: Wood - Additional area of bubbling of paint, indicating likely underlying moisture damage. Recommend scraping paint to evaluate and repair/replace siding as needed. Also, there is an area of thin painted metal covering what was presumably a prior vent for a dryer. Recommend qualified contractor evaluate this repair to make sure it will prevent water and rodent intrusion.

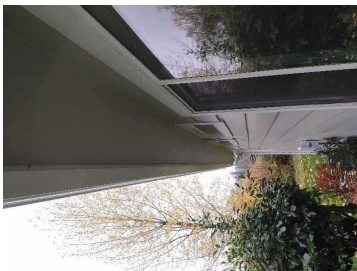
3. Soffits: Wood - No soffit or eave vents noted around entire house. The only attic ventilation are roof vents.

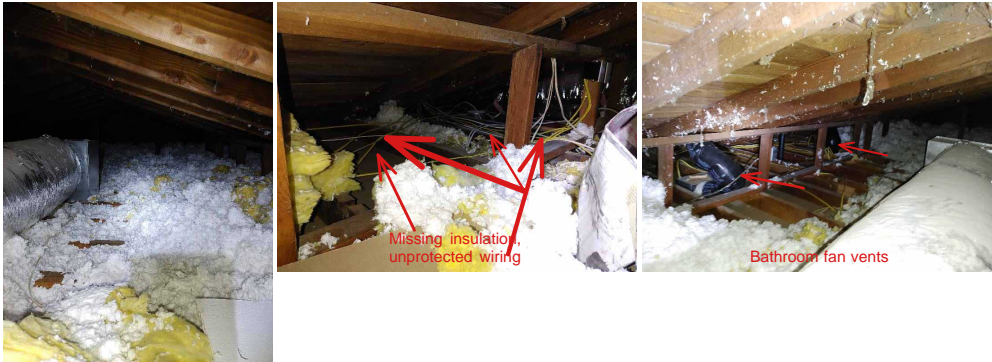
5. Pantry Attic Insulation: Blown in - Insufficient insulation present, Recommend additional insulation be installed. In addition, most of the wiring is unprotected and running over the tops of joists. This subjects them to damage which could cause electrical shorts and/or a fire. Recommend qualified electrician to route wires properly.

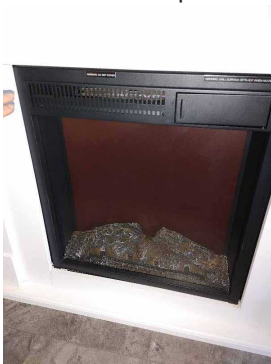
6. Living Room Fireplace Freestanding Stove: Installation may not meet standards for fire safety. Electric fireplace is not secured, but client and realtor indicated this was placed just as part of showing the home. If unit is to remain, recommend qualified contractor to install unit properly and make sure wiring is sufficient for unit needs.

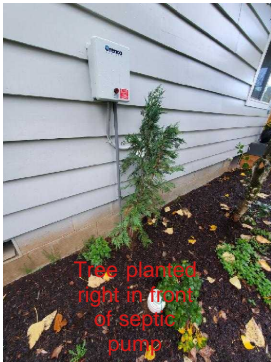
1. Vegetation: Trees, Shrubs - Tree planted in front of septic pump, the roots may damage both the septic pump and the foundation of the home. Recommend removal of tree.

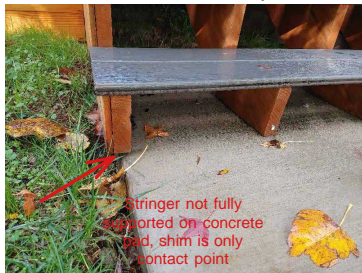
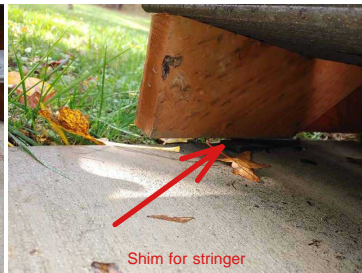
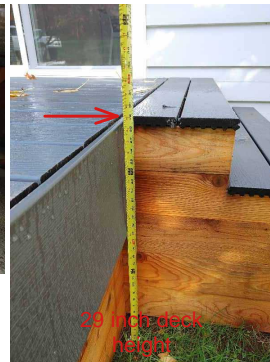
2. Deck: Composite wood deck material, appears new - Railings should be installed for any deck >30" above ground, or for any stairway >3 steps. This deck is 29" above ground, but does have 4 steps. Recommend installation of railing along steps and deck, especially with small child at home. And while one of the stair stringers is not supported by the concrete pad, there are 3 additional stringers that should provide enough stability. However, it is recommended to monitor the unsupported edge for undo stress or shifting. Consider consulting a qualified contractor to repair either the concrete pad to make it of sufficient width, or to repair the stairs to have them fit within the concrete pad.

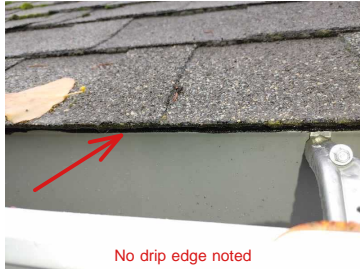
3. Edge Flashing Edge flashing protects the underlying roof substrate from water damage. Absent or missing flashing can shorten the life expectancy of the roof and cause significant water damage. Edge flashing was not observed at time of inspection. Recommend a qualified roofing contractor evaluate and repair as needed.

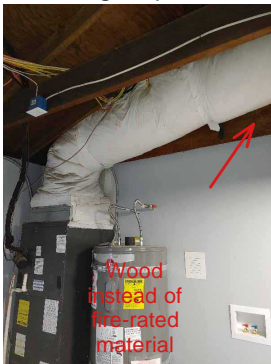
4. Attached Garage Walls: Exposed framing, Painted drywall - Unable to determine if existing wall covering in garage is fire rated. In addition, the upper wall, where ducting and wiring enter the attic space over the living areas, is composed of wood which is not fire rated. Recommend a qualified contractor evaluate and replace with a fire-rated covering to protect the living areas from any fire in the attached garage.

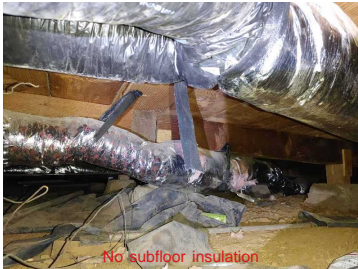
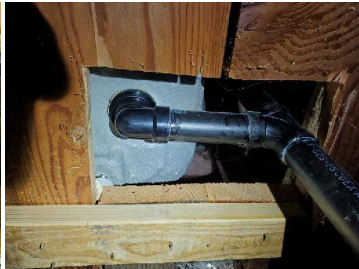
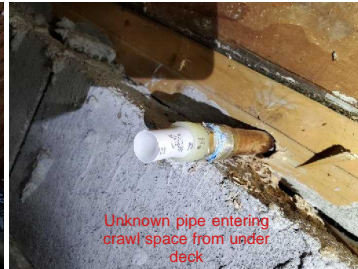
5. Next to front steps Crawl Space Moisture Barrier: Plastic moisture or vapor barrier torn, No moisture or vapor barrier present in multiple locations. This can allow ground moisture to enter the crawl space and then damage the wood members of the house, including mold growth and insect infestation. A qualified contractor is recommended to evaluate and estimate repairs

6. Next to front steps Crawl Space Insulation: None - Insulation missing, recommend qualified contractor install recommended insulation under subfloor. Also, area in picture shows drain for bathroom fixture (presumably the tub) with insufficient enclosure and with no P-trap. The former could easily allow rodents and larger animals to invade the living space. Recommend evaluation and repair by qualified contractor. The latter can allow sewer gases to enter the living space. Recommend evaluation and repair by qualified plumber.

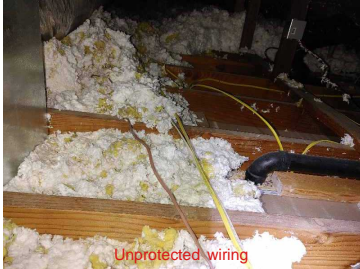
7. Pantry Attic Wiring/Lighting: Improper routing of attic wiring. Wiring unprotected, running over joists.

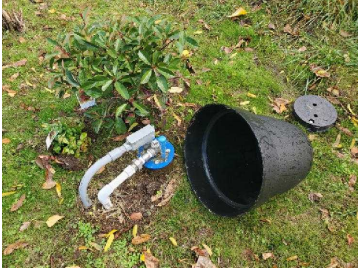
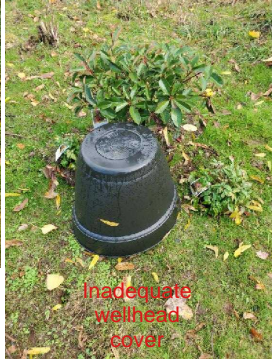
Water Source: Well How Verified: Multiple Listing Service, Visual Inspection, Recommend a qualified contractor evaluate and replace well head cover.

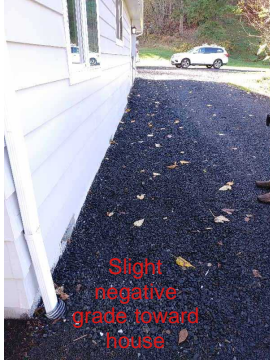
Acceptable Grading: Flat, Minor slope, Negative slope - Improper soil slope towards foundation on west side along driveway, recommend improving grade to avoid water draining towards foundation

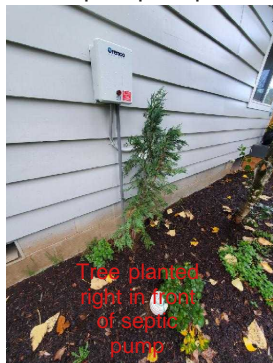
Acceptable, Defective Vegetation: Trees, Shrubs - Tree planted in front of septic pump, the roots may damage both the septic pump and the foundation of the home. Recommend removal of tree.

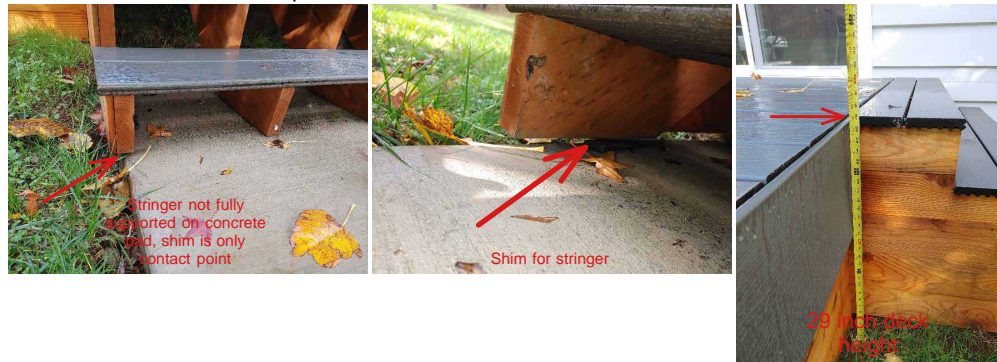
Acceptable, Defective Deck: Composite wood deck material, appears new - Railings should be installed for any deck >30" above ground, or for any stairway >3 steps. This deck is 29" above ground, but does have 4 steps. Recommend installation of railing along steps and deck, especially with small child at home. And while one of the stair stringers is not supported by the concrete pad, there are 3 additional stringers that should provide enough stability. However, it is recommended to monitor the unsupported edge for undo stress or shifting. Consider consulting a qualified contractor to repair either the concrete pad to make it of sufficient width, or to repair the stairs to have them fit within the concrete pad.

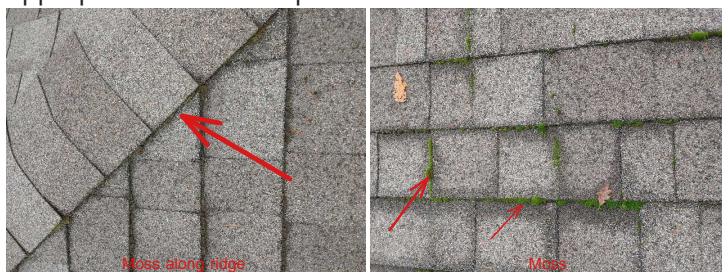
Acceptable Material: Asphalt shingle - Moss growth noted at various locations on roof. Moss can damage the roofing material, causing premature aging of the roof and allowing water penetration of the house., Recommend complete moss removal by a qualified contractor, and then evaluation of the underlying roof material for signs of damage. Estimated shingle age is 10-15 years, and asphalt shingles have a typical lifespan of 20-30 years. At least yearly inspection of shingles is recommended to determine appropriate time for replacement.

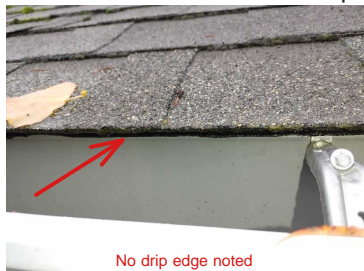
Not Present, Defective Edge Flashing Edge flashing protects the underlying roof substrate from water damage. Absent or missing flashing can shorten the life expectancy of the roof and cause significant water damage. Edge flashing was not observed at time of inspection. Recommend a qualified roofing contractor evaluate and repair as needed.

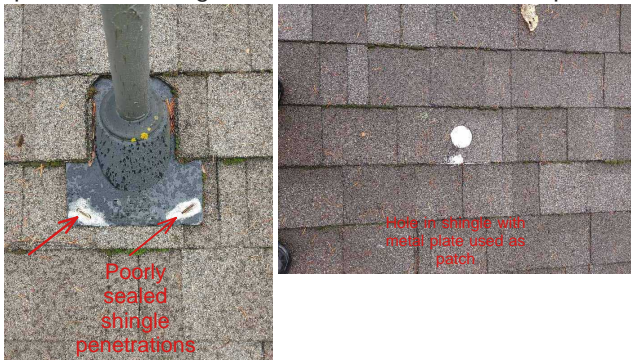
Plumbing Vents: Galvanized, PVC - An area of presumed prior vent penetration has been repaired with metal plate inserted under shingle. This is not a typical or recommended repair method. Recommend a qualified roofing contractor evaluate and repair/replace as needed.

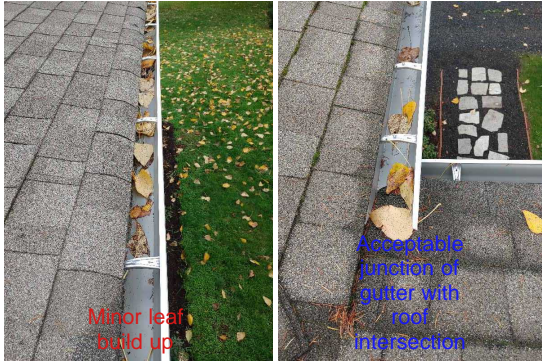
Acceptable Gutters: Aluminum - Minimal to moderate leaf buildup in gutters, typical for this time of year. Recommend at least once per year cleaning of gutters to maintain water flow and prevent roof and structural damage.

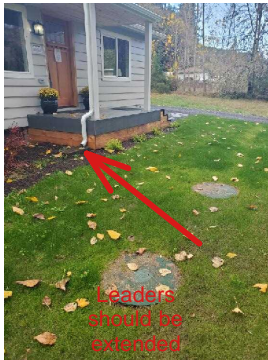
Acceptable
Marginal Downspouts: Aluminum
Leader/Extension: Leaders do not extend 6 feet beyond the foundation perimeter. This can cause water damage to foundation. Recommend extend all leaders as needed to at least 6 feet beyond foundation.

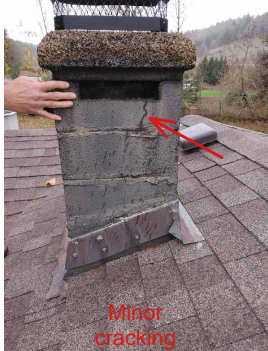
East Chimney

Acceptable Chimney: Block - Stair step cracks (minor) in chimney, A qualified contractor is recommended to evaluate and estimate repairs

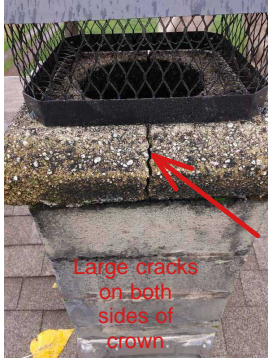
Acceptable Flue/Flue Cap: Concrete, Clay - A qualified contractor is recommended to evaluate and estimate repairs of crown. Chimney lining could not be inspected due to rain cap.

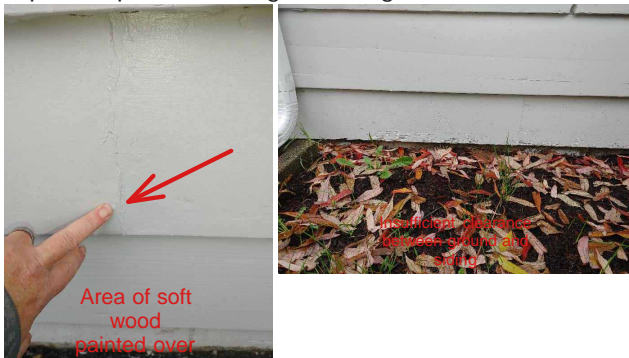
Acceptable Type: Wood - Numerous areas noted of painted siding with bubbling and/or soft wood indicating underlying moisture damage. Recommend scraping paint in these areas to fully evaluate and repair/replace damaged siding areas as needed.

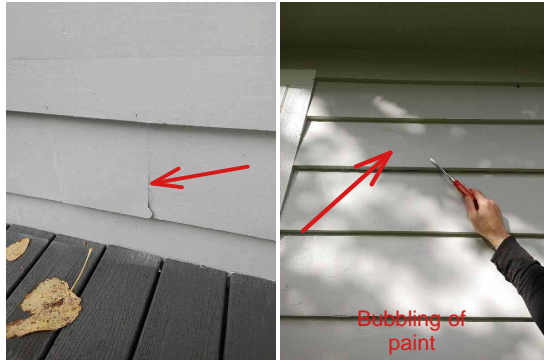
Acceptable, Marginal Trim: Wood - Additional area of bubbling of paint, indicating likely underlying moisture damage. Recommend scraping paint to evaluate and repair/replace siding as needed. Also, there is an area of thin painted metal covering what was presumably a prior vent for a dryer. Recommend qualified contractor evaluate this repair to make sure it will prevent water and rodent intrusion.

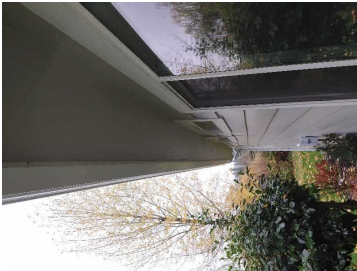
Soffits: Wood - No soffit or eave vents noted around entire house. The only attic ventilation are roof vents.

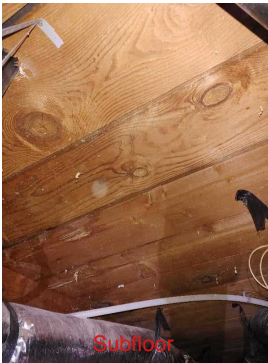
Acceptable Floor/Slab: Dimensional wood
Acceptable Stairs/Handrails: Wood stairs with wood handrails - Handrails missing at front steps. One handrail only at back deck steps. Recommend adding handrail for front steps, and railing at back deck as discussed earlier.

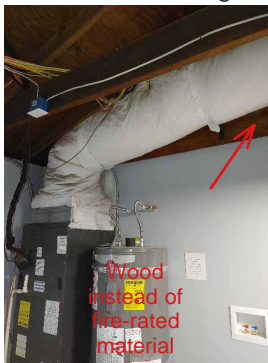
Defective Walls: Exposed framing, Painted drywall - Unable to determine if existing wall covering in garage is fire rated. In addition, the upper wall, where ducting and wiring enter the attic space over the living areas, is composed of wood which is not fire rated. Recommend a qualified contractor evaluate and replace with a fire-rated covering to protect the living areas from any fire in the attached garage.

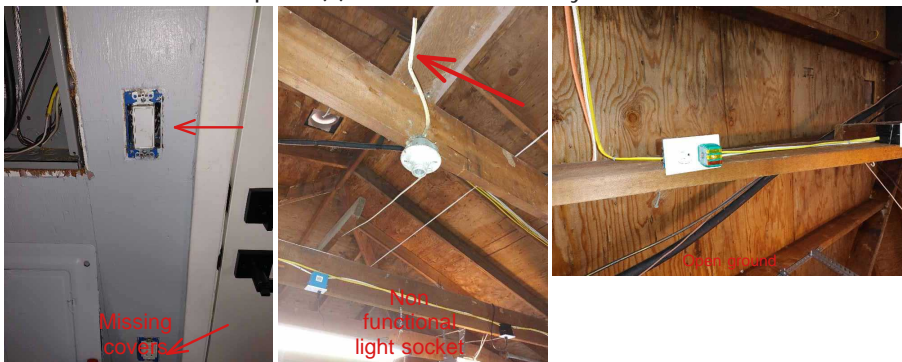
Acceptable Electrical: 110 VAC GFCI, 220 VAC - Open or missing ground on 6 outlets along circuit for overhead lights. A licensed electrician is recommended to evaluate and estimate repairs. Install missing outlet/switch cover plate(s), as this is a safety hazard.

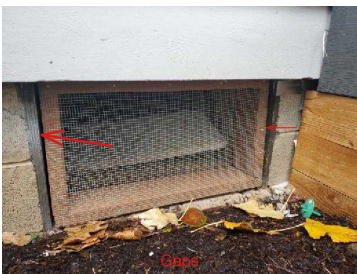
Acceptable Access: Wood door - Access panel does not seal opening completely which may allow easy access for rodents. Recommend evaluation and repair. In addition, there is a large amount of construction/renovation debris in the crawl space, which could create habitat for pests/rodents/insects. Recommend removal of all debris and replacement of moisture barrier (as described below).

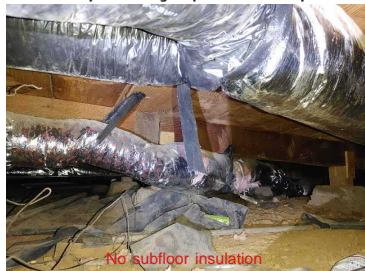
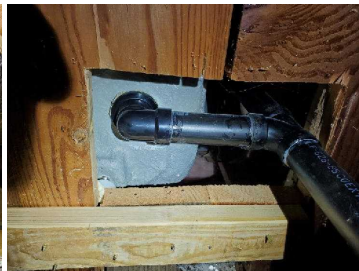
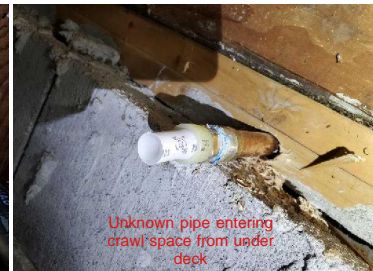
Defective Moisture Barrier: Plastic moisture or vapor barrier torn, No moisture or vapor barrier present in multiple locations. This can allow ground moisture to enter the crawl space and then damage the wood members of the house, including mold growth and insect infestation. A qualified contractor is recommended to evaluate and estimate repairs

Not Present, Defective Insulation: None - Insulation missing, recommend qualified contractor install recommended insulation under subfloor. Also, area in picture shows drain for bathroom fixture (presumably the tub) with insufficient enclosure and with no P-trap. The former could easily allow rodents and larger animals to invade the living space. Recommend evaluation and repair by qualified contractor. The latter can allow sewer gases to enter the living space. Recommend evaluation and repair by qualified plumber.

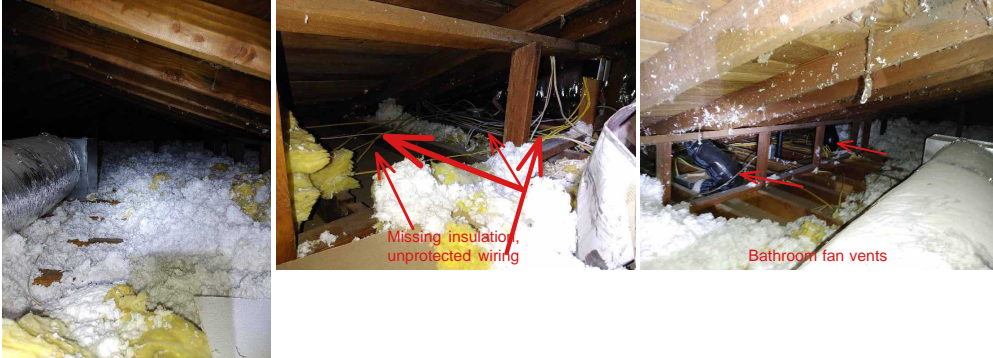
Marginal Insulation: Blown in - Insufficient insulation present, Recommend additional insulation be installed. In addition, most of the wiring is unprotected and running over the tops of joists. This subjects them to damage which could cause electrical shorts and/or a fire. Recommend qualified electrician to route wires properly.

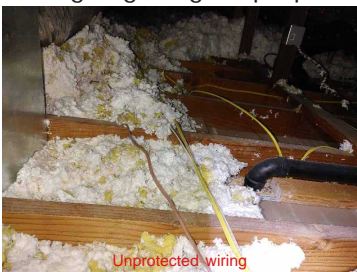
Defective Wiring/Lighting: Improper routing of attic wiring. Wiring unprotected, running over joists.

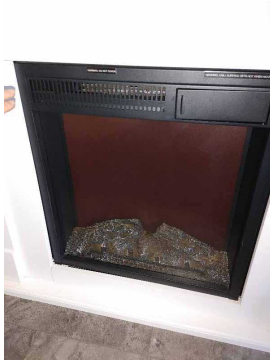
Marginal Freestanding Stove: Installation may not meet standards for fire safety. Electric fireplace is not secured, but client and realtor indicated this was placed just as part of showing the home. If unit is to remain, recommend qualified contractor to install unit properly and make sure wiring is sufficient for unit needs.

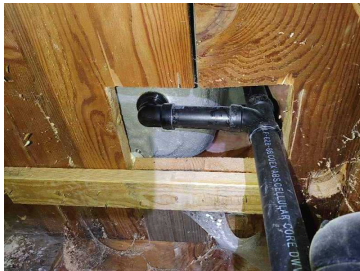
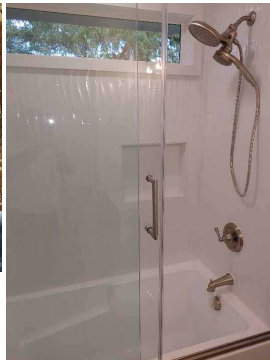
Acceptable Faucets/Traps: Low pressure or flow rate at faucet, further review and/or repair is indicated
Acceptable, Defective Tub/Surround: Fiberglass tub and fiberglass surround

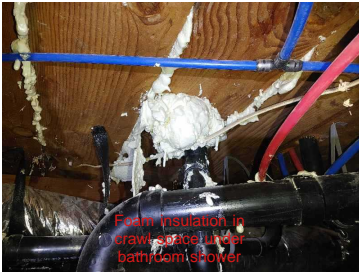
Acceptable Faucets/Traps: Low pressure or flow rate at faucet, further review and/or repair is indicated
Not Present Tub/Surround:

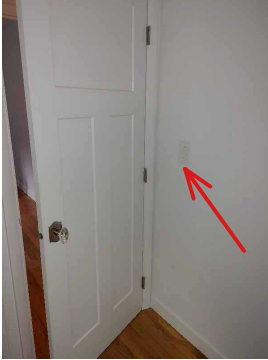
Acceptable Electrical: 110 VAC - Open or missing ground, A licensed electrician is recommended to evaluate and estimate repairs. Also the light switch is behind the door, which is inconvenient. Consider having a qualified electrician relocate this switch.

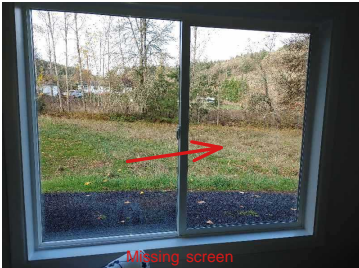
Acceptable Windows: Vinyl slider - Screens missing from multiple windows throughout house

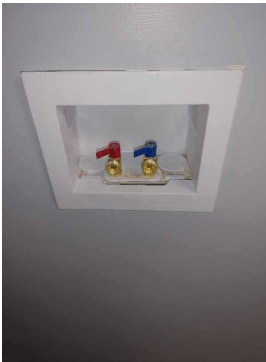
Garage Laundry Room/Area	
Not Present	Closet:
Acceptable	Ceiling: Exposed framing
Defective	Walls: Painted drywall - Unable to determine if existing wall covering in garage is fire rated. In addition, top of wall is wood, where HVAC and electrical enters attic above living space, and this is not fire rated. Recommend evaluation and repair by qualified contractor.
Acceptable	Floor: Poured concrete
Acceptable	Doors: Metal exterior
Acceptable	Windows: Vinyl slider
Acceptable	Electrical: 110 VAC GFCI, 220 VAC - Washer outlet is not on a dedicated circuit. This may cause frequent "tripping" of the circuit when the washer is running, depending on what other items are sharing the circuit. Recommend qualified electrician evaluate and repair as needed.
Not Present	Smoke Detector:
Not Present	HVAC Source:
Not Present	Laundry Tub:
Not Present	Laundry Tub Drain:
Acceptable	Washer Hose Bib: Ball valves

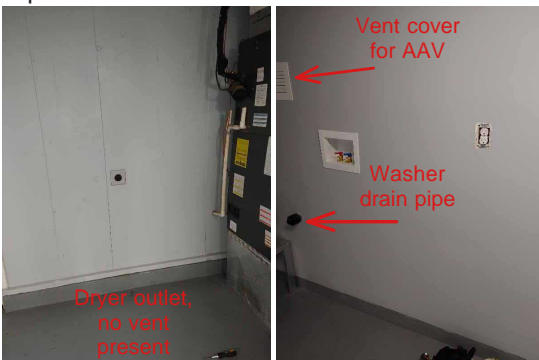
Acceptable	Washer and Dryer Electrical: 110-240 VAC - Covers missing from all electrical boxes in garage, replacement recommended as this is a safety issue.
------------	---
