# Lead Cable Investigation

June 30, 2023

**Prepared for:**

Marine Taxonomic Services, Ltd.  
Below the Blue 501(c)3

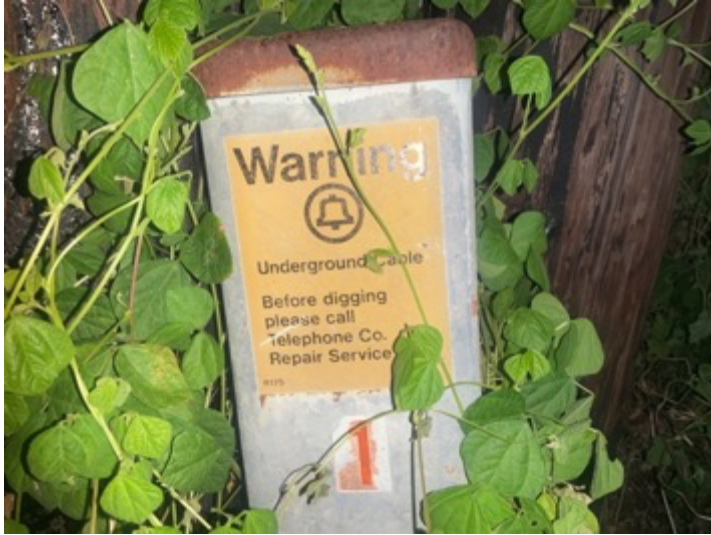
(A) Bell Systems sign for underground Telephone Cables. BL 2.1. Labadieville, Louisiana. June 2022.

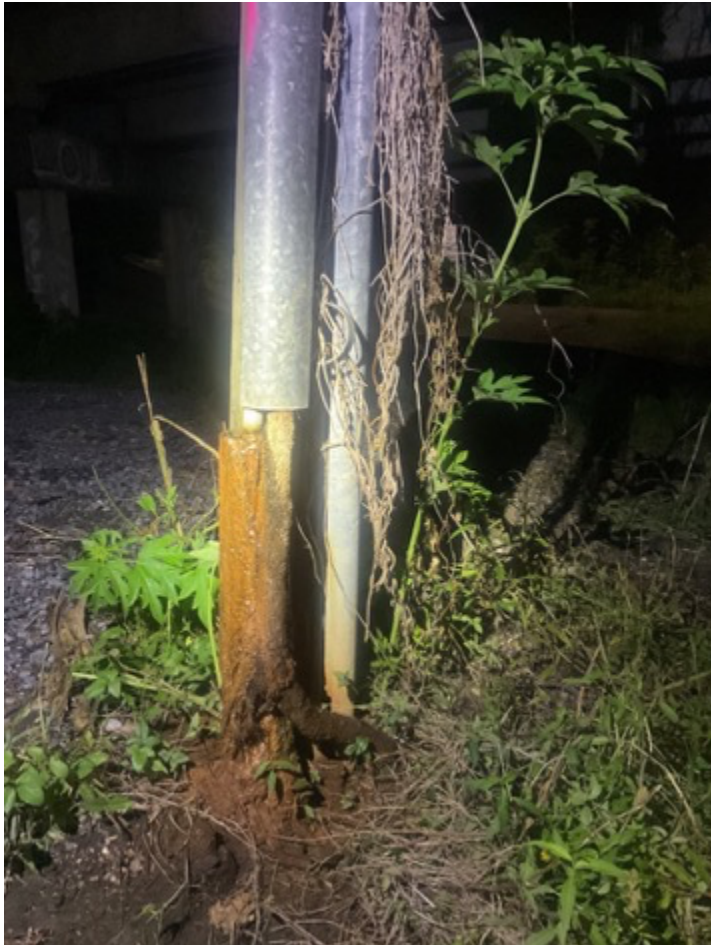
(B) Old telephone pole with cable guard and old conduit where a cable would have been. There is currently corrugated plastic hose behind the guard and in the steel pipe, but no visible cable. BL 2.2. Labadieville, Louisiana. June 2022.

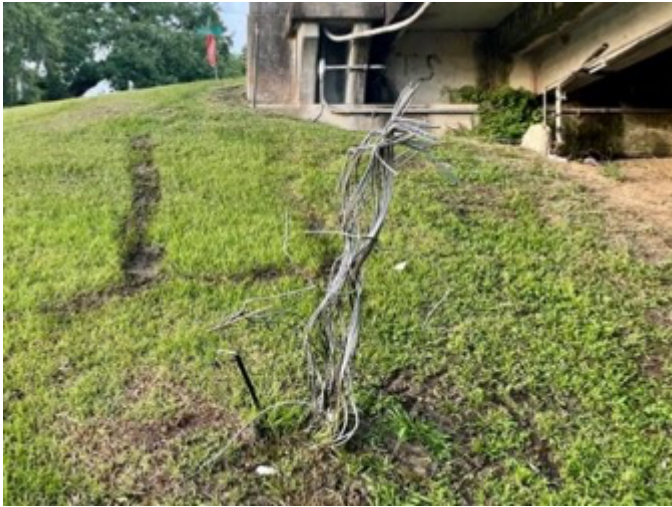
(C) Remnants of bare lead sheathed cable and steel wire below the Bridge Street Bridge. BT 1.1. June 2022, New Iberia, Louisiana.

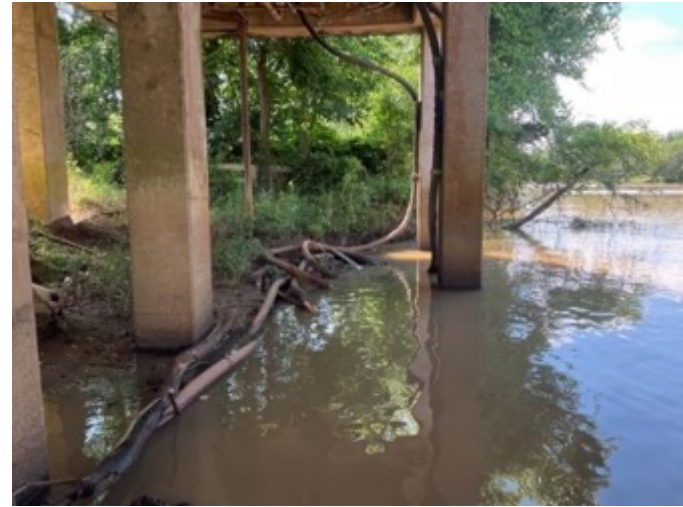
(E) Rd. 320 southeast of New Iberia, LA. Cluster of lead sheathed cables under the Oliver Bridge. BT 17.1. June 2022, New Iberia, Louisiana.

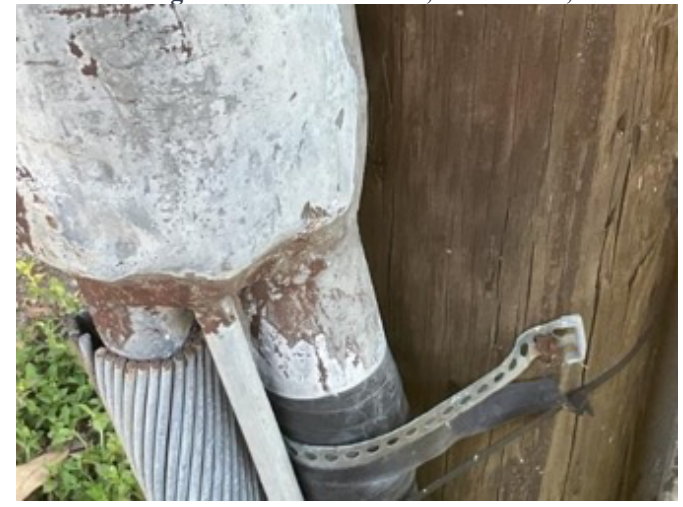
(F) Up close photo of bare lead sheathed cables coming from the bottom of a lead splice box (upper left corner of photo). BT 24.1. June 2022, St. Martinville, Louisiana.

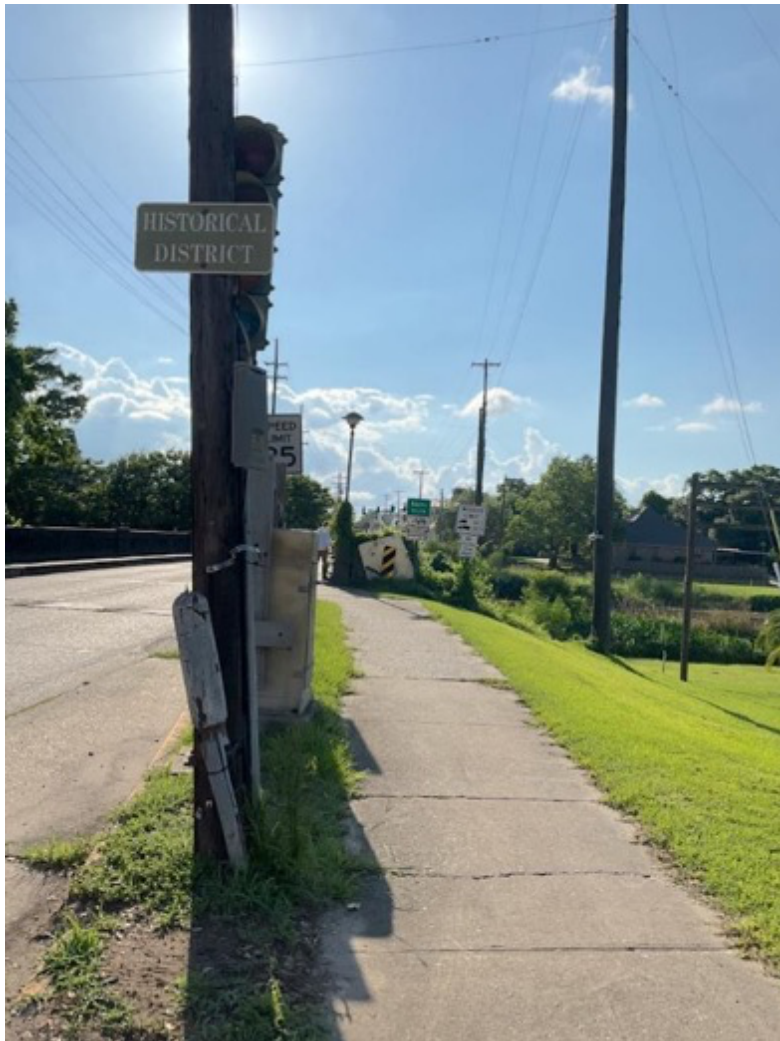
**(G)** Bare lead sheathed cables going into a lead splice box near the sidewalk leading into the Historical District. BT 24.1. June 2022, St Martinville, Louisiana.

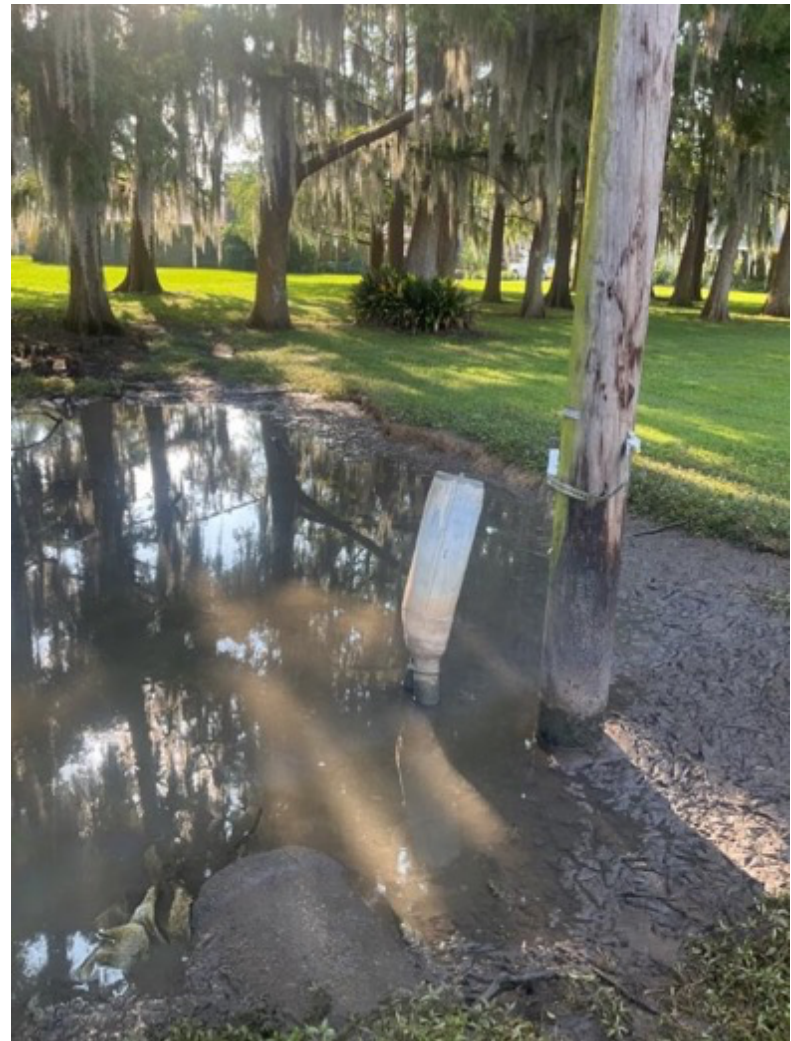
**(H)** Exposed lead splice box with attached cables and drainage into the Bayou Teche. BT 26.2. June 2022, Franklin, Louisiana.

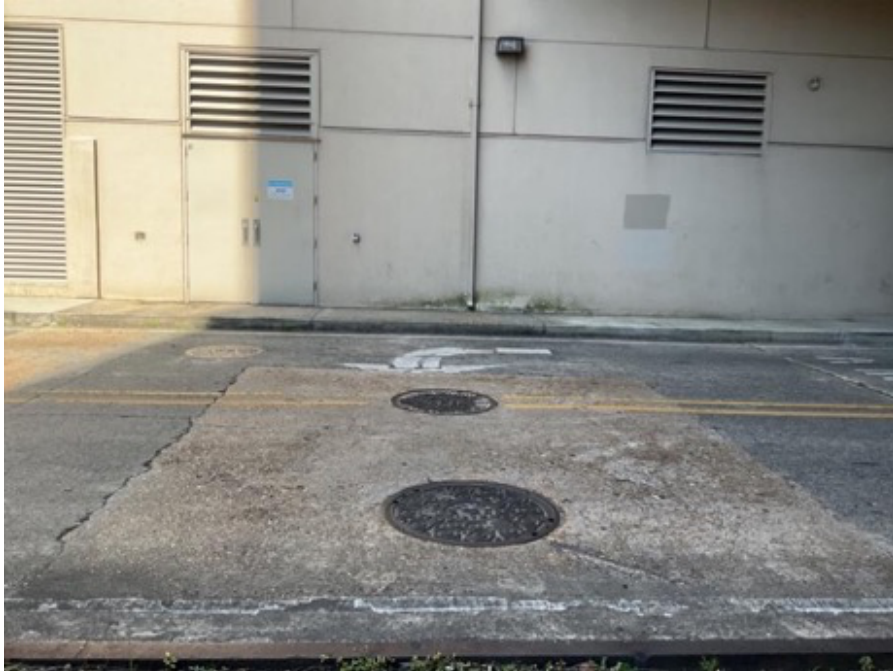
**(I) New Orleans, LA. MISS 2.1 with Bell Systems manholes, vault, and Utility Building. This is a likely hub and splice area for cables, both old and new. June 2022.**

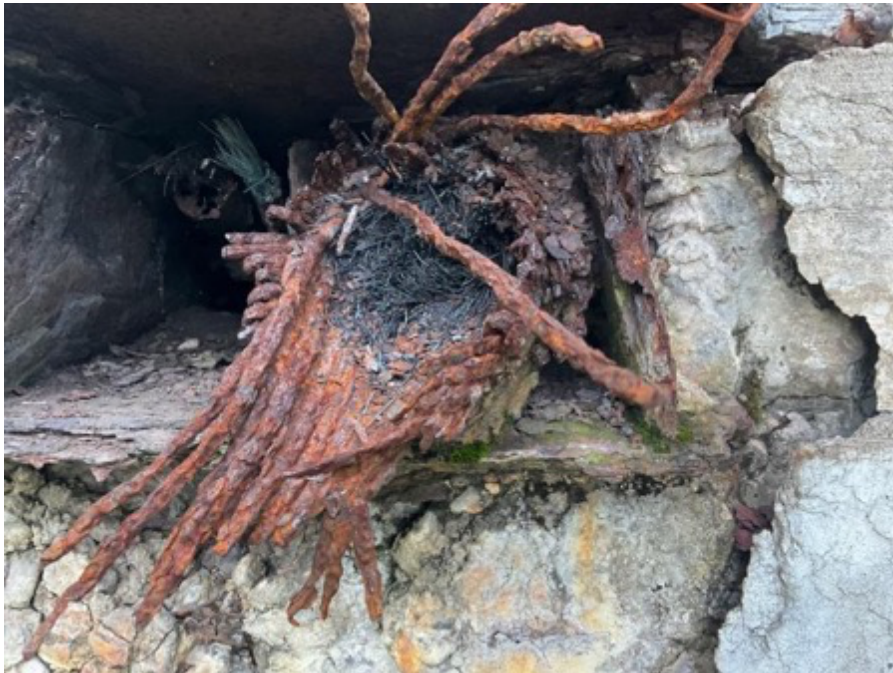
**(J) New Orleans, LA. MISS 3.1. is an abandoned collection of cables.**

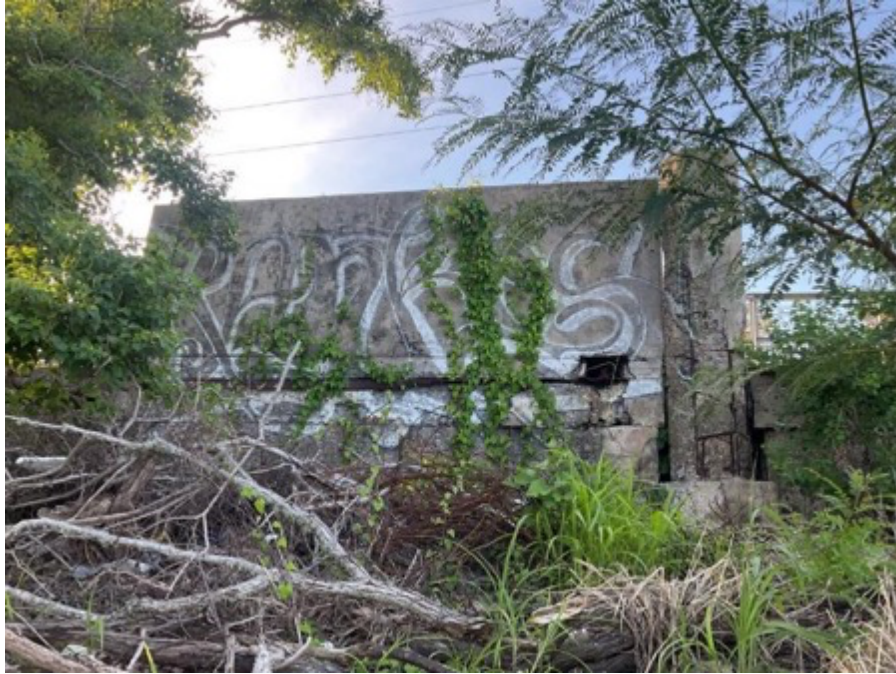
**(K)** New Orleans, LA. MISS 3.1. The small rectangle on the left is the passthrough for utility cables. June 2022.

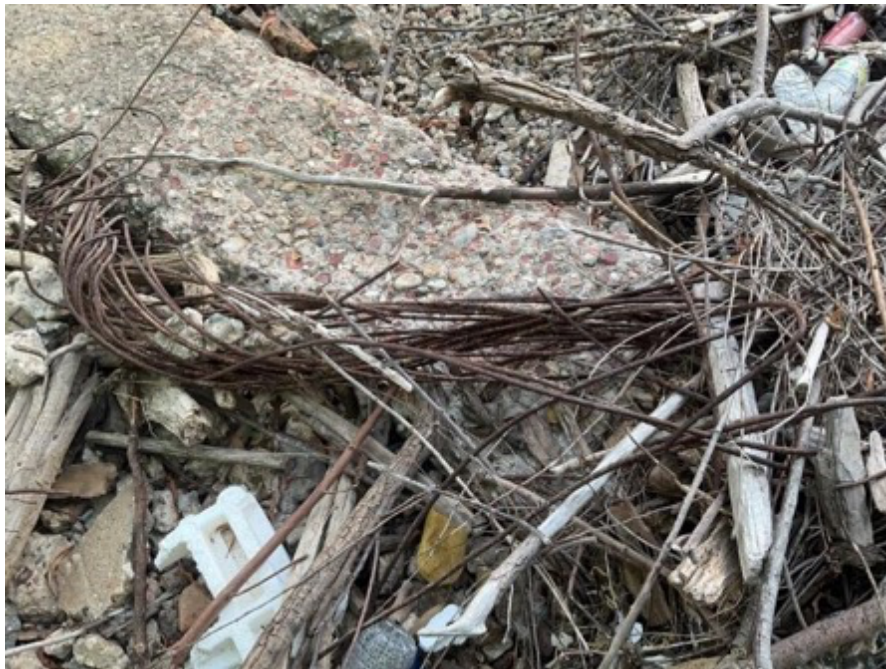
**(L)** New Orleans, LA. MISS 3.1. Remnants of outer steel wire from a lead sheathed cable. Evidence that parts of the cable may have been scrapped for money. Locals told us that that was done to these cables.

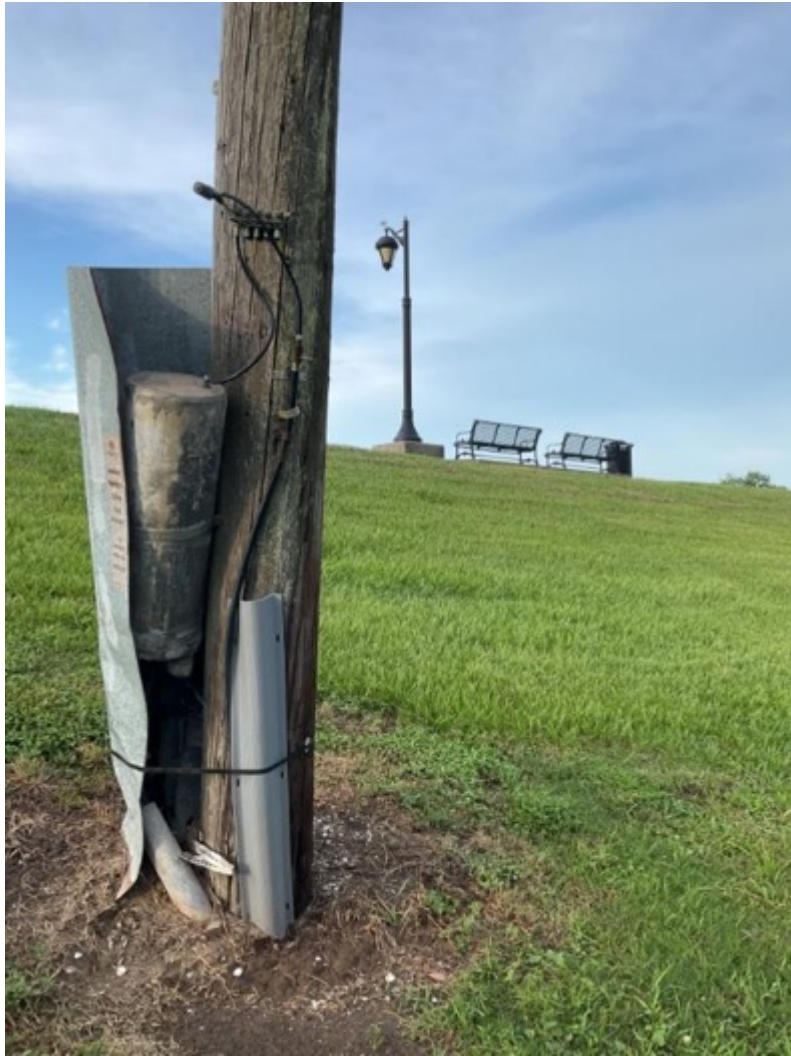
**(M) Donaldsonville, LA. Location MISS 12.1. Exposed leaded splice box that appears to still be connected to an air test line. See photo (L) for the abandoned cable just the other side of the splice box. June 2022,**

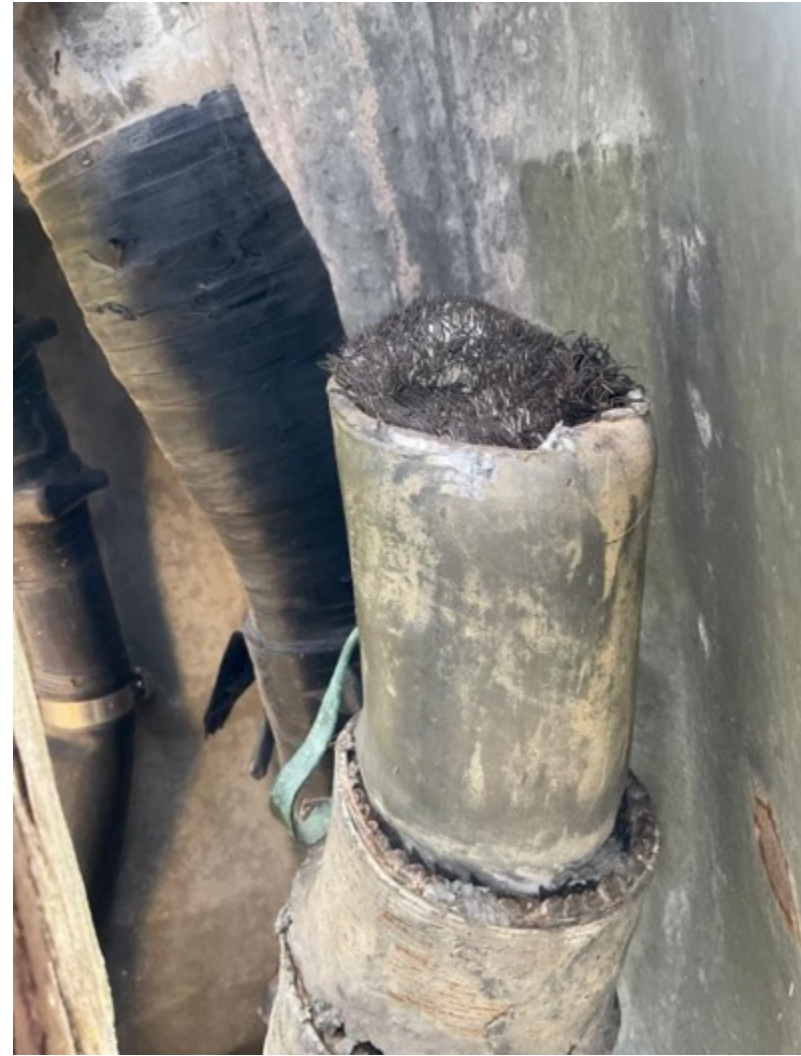
**(N) Donaldsonville, LA. Location MISS 12.1. Close up of lead sheathed cable next to lead splice box seen in (K). June 2022.**

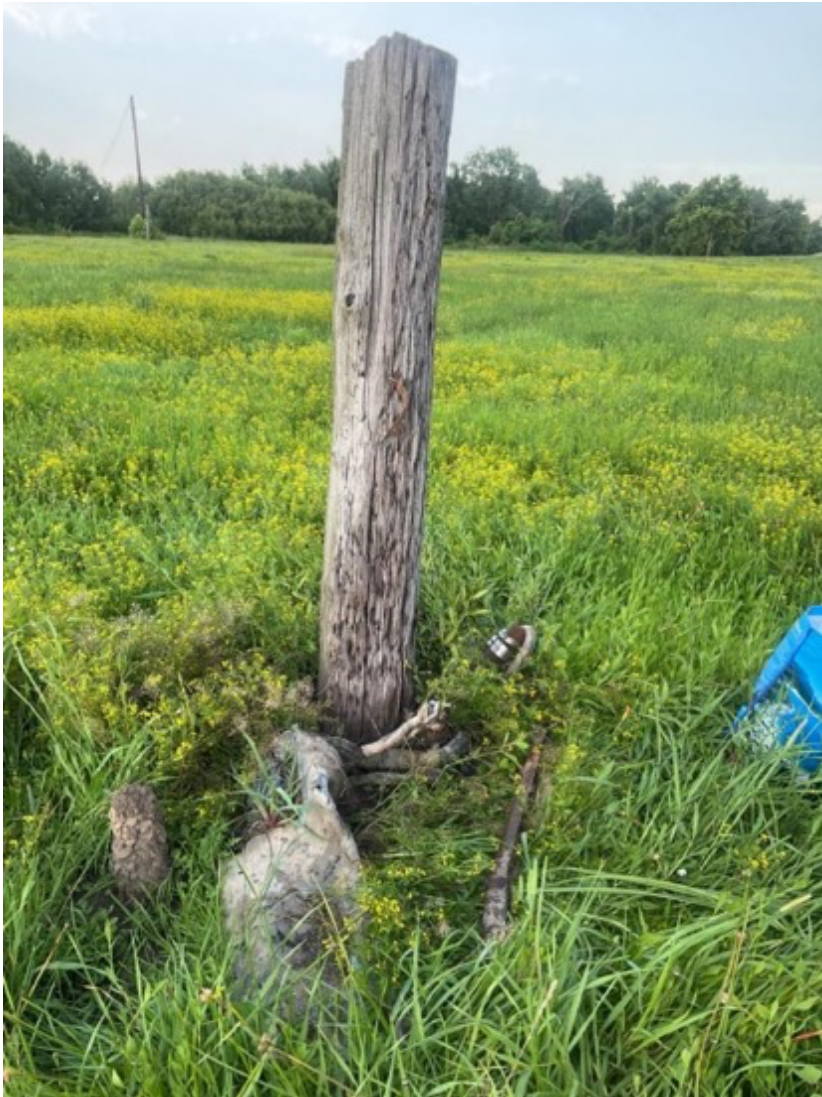
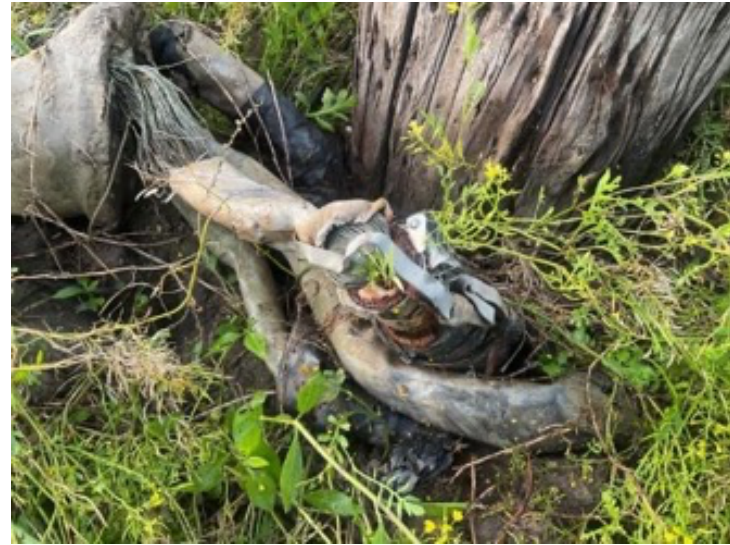
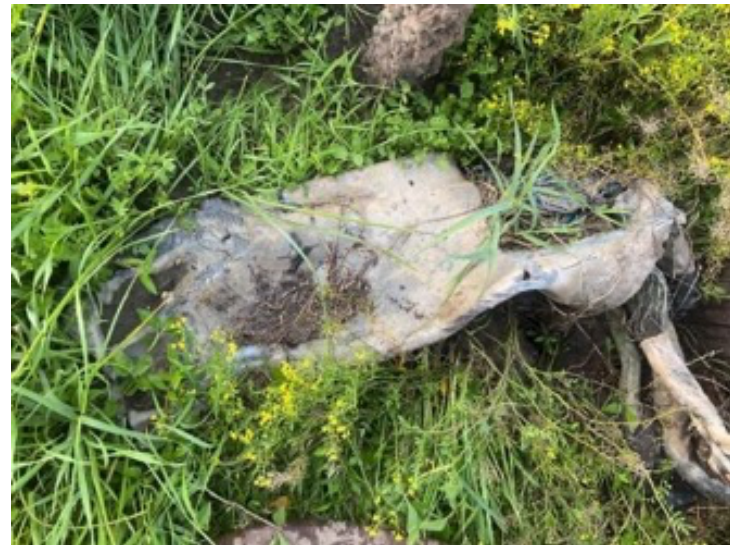
**Figure 9 Photos. Louisiana continued. Damaged and abandoned leaded splice box and collection of five lead sheathed cables. MISS 12.3. June 2022, Donaldsonville, Louisiana.**

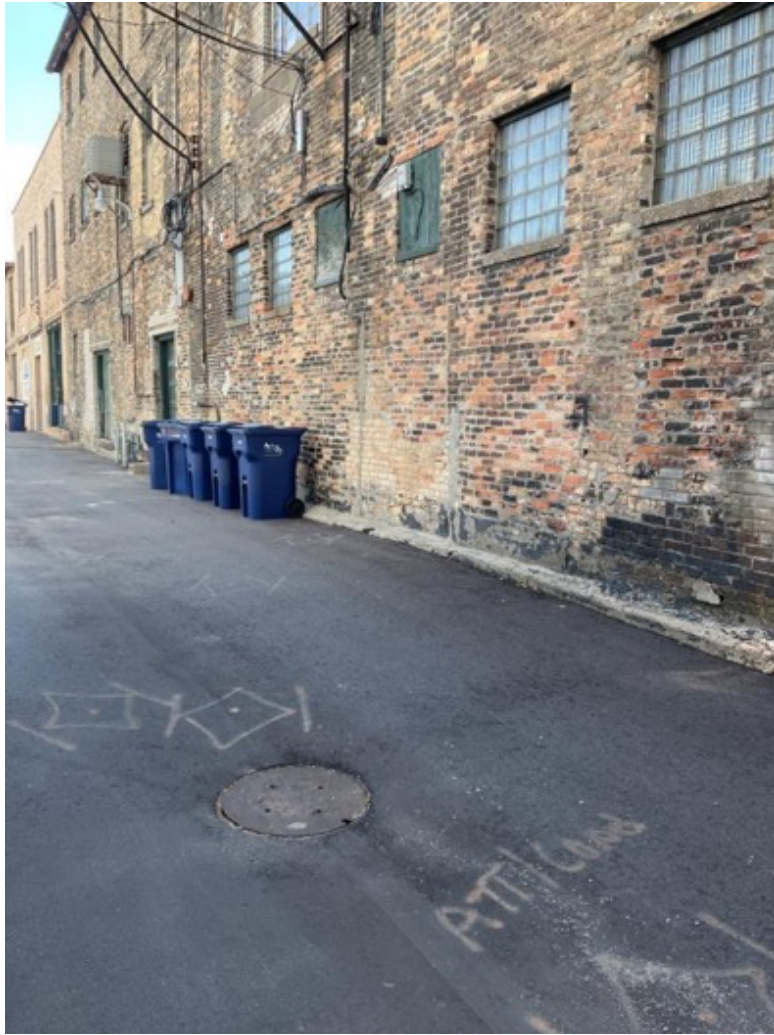
(A) Paint Markings indicating an AT&T service corridor. The lead sheathed test line follows these markings along the brick building shown above. LH 2.2. July 2022, Bay City, MI.

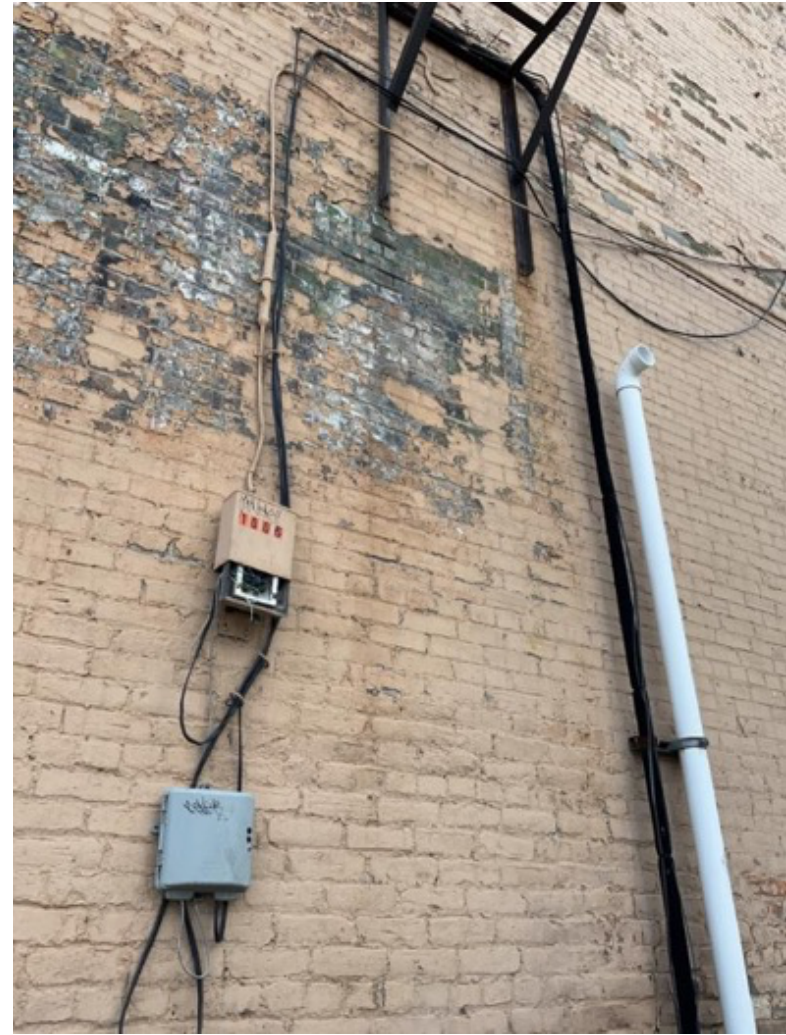
(B) End of the lead sheathed test line shown in (A). LH 2.3. July 2022, Bay City, MI.

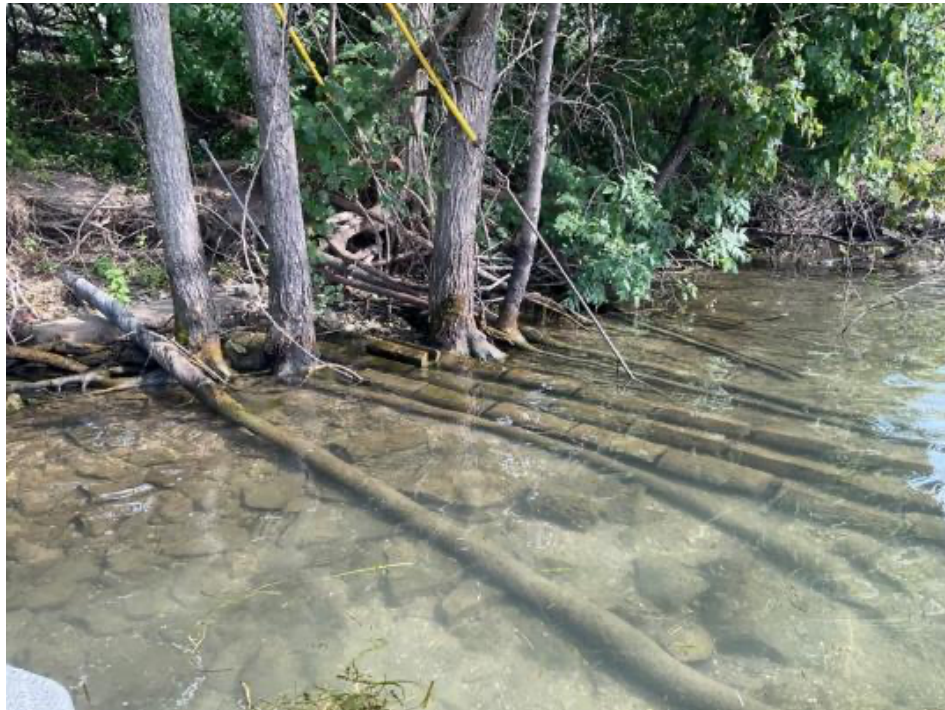
**(C) Seven lead sheathed cables in the Detroit River. DR 1. July 2022, Trenton, MI.**

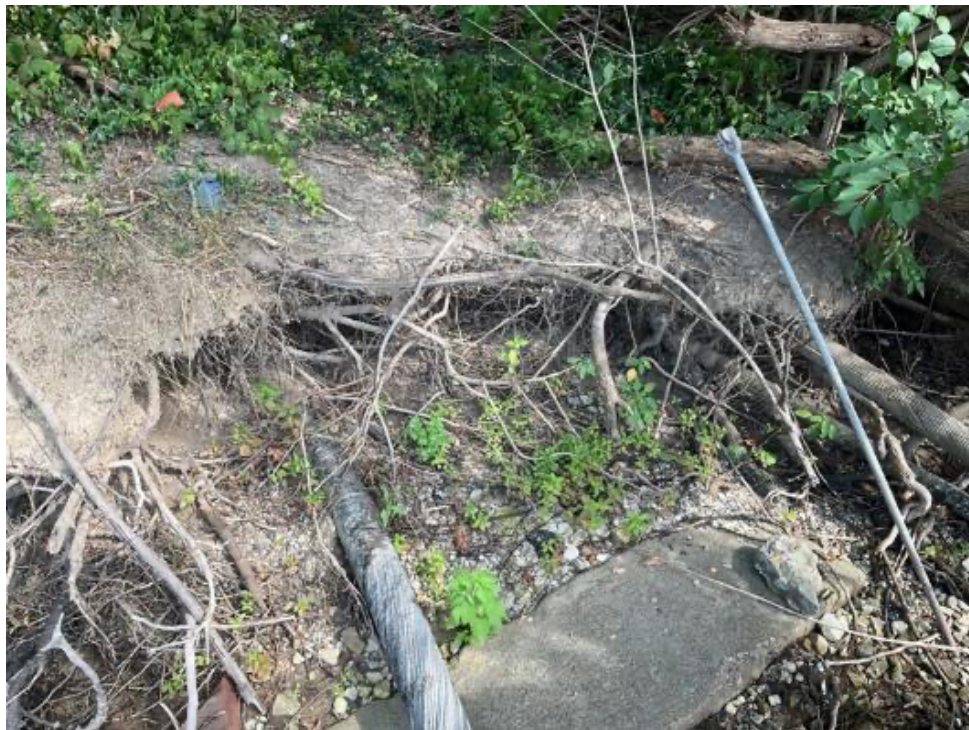
**(D) Lead sheathed cables from (C) continuing past the tree line. They are buried in the ground and run up the hill to a Bell Systems manhole. DR 1. July 2022, Trenton, MI.**

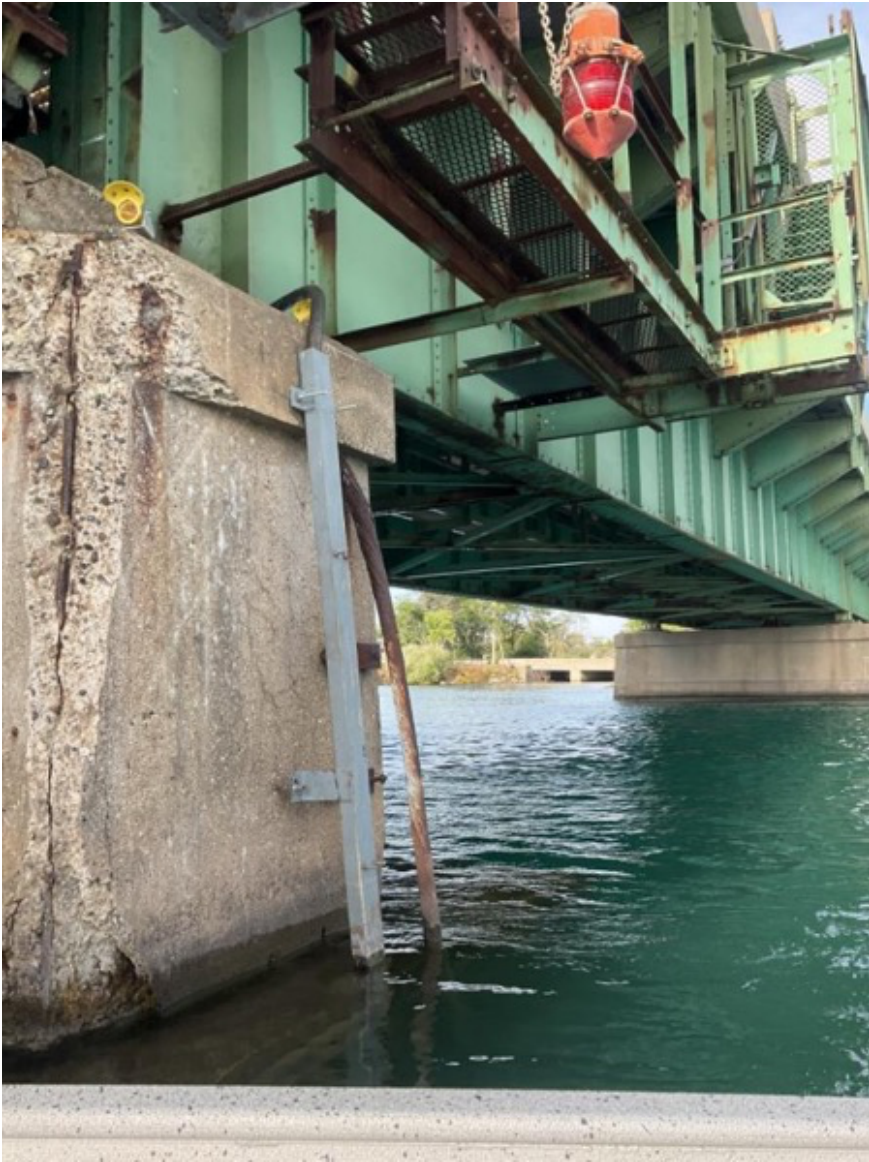
(E) Lead sheathed cable along the Grosse Ile Parkway Bridge. The cable runs through the concrete and is cut just above the ledge. DR 2. Grosse Ile Township, MI

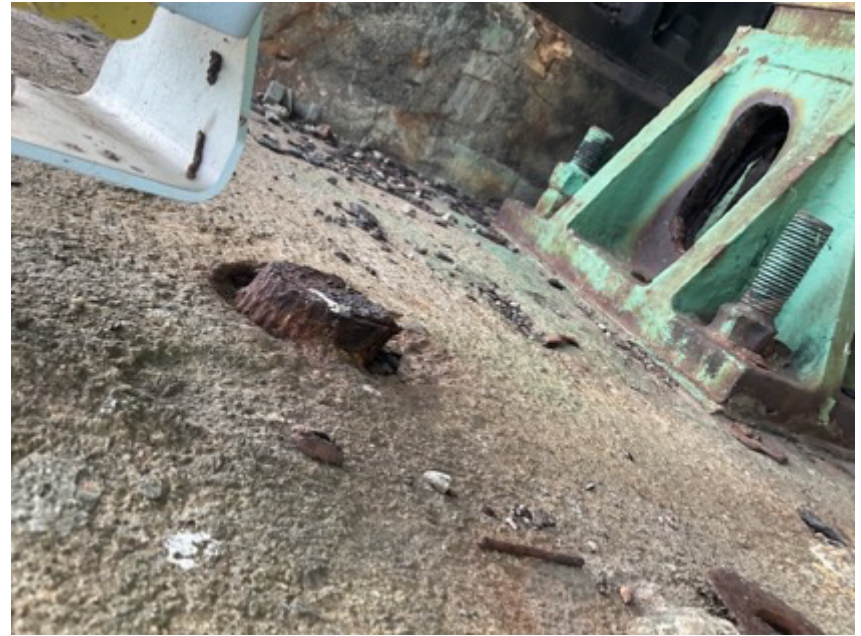
(F) Cut lead sheathed cable, referenced in (E). DR 2. Grosse Ile Township, MI.

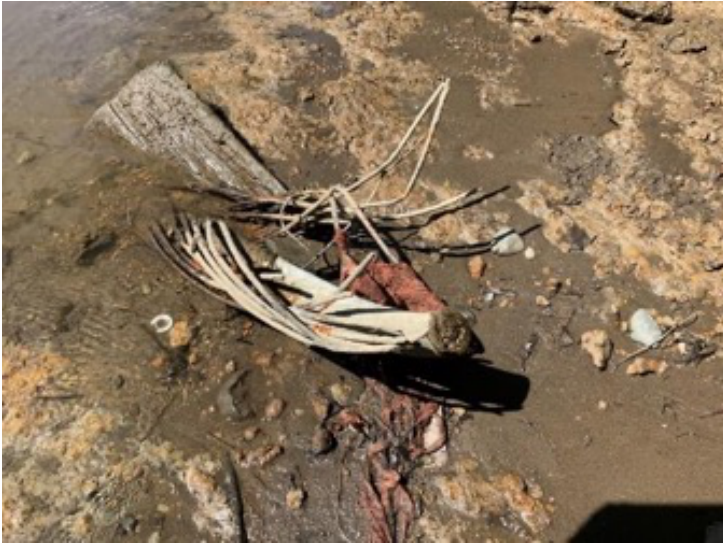
(A) Abandoned lead sheathed cable near Ross Island. WR 1. August 2022, Portland, Oregon.

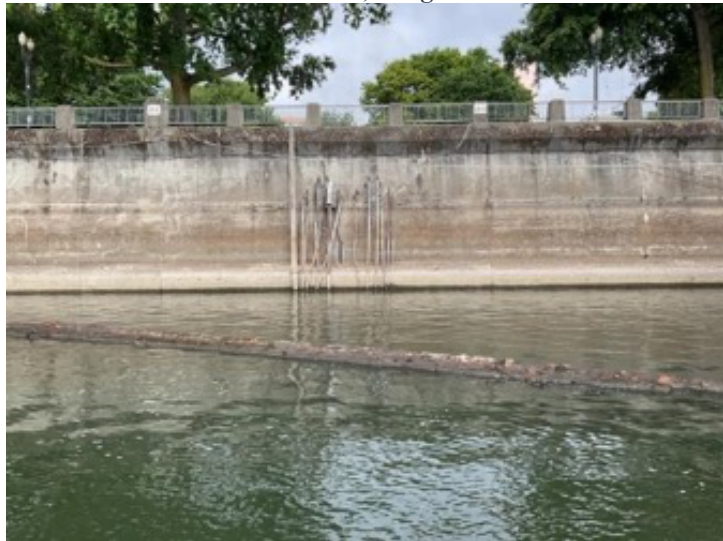
(B) Eleven cables near Maritime Museum and Waterfront Park. WR 2.2. August 2022, Portland, Oregon.

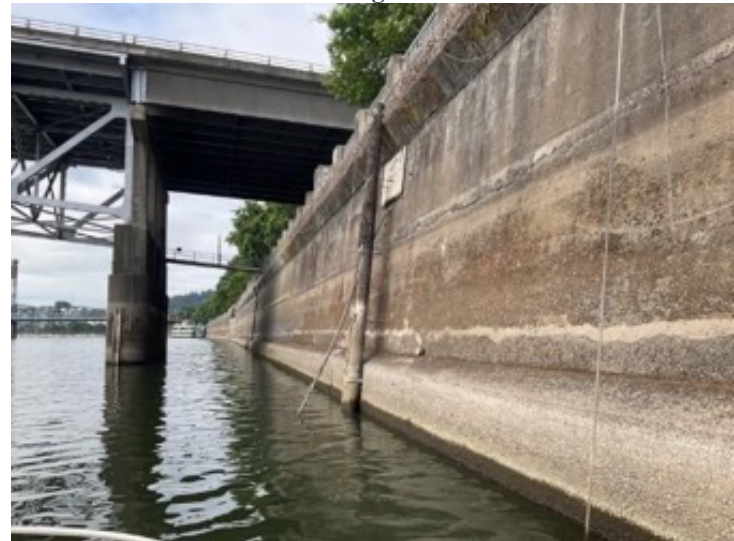
(D) Smaller lead sheathed cable below Western Union Telecom Co. Sign. WR 3. August 2022, Portland, Oregon.

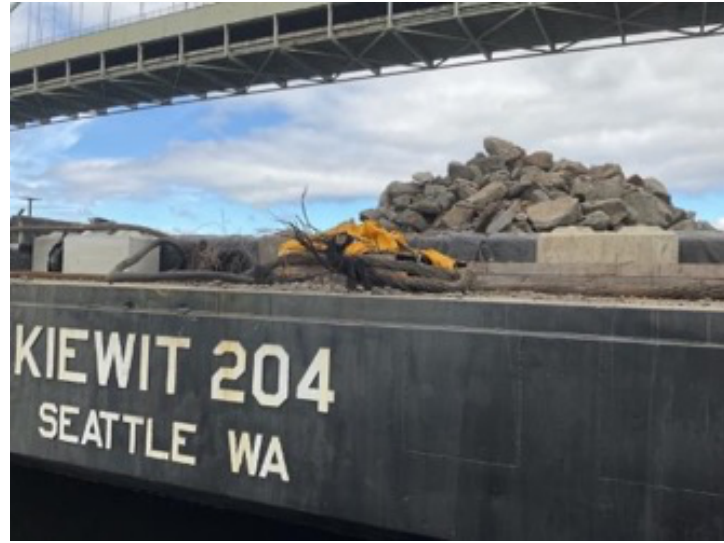
(G) Active construction site. Lead sheathed cable. Kiewit 204. WR 8. August 2022, Portland, Oregon.

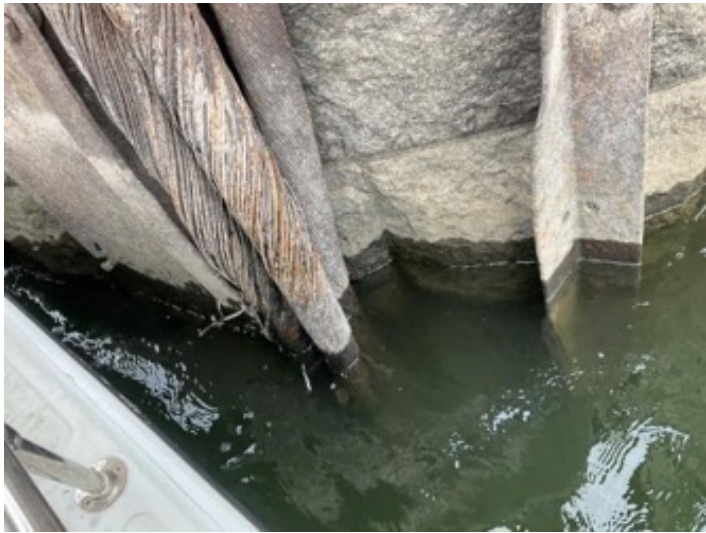
There were seven locations along the Willamette River in Oregon. Nine points of interest were recorded along the Willamette River containing visible lead sheathed submarine cables in varied conditions. At low tide, with lower river levels, WR 1 can be seen on the shoreline protruding from the riverbed. This is a cut and abandoned lead sheathed cable on the east bank of the Willamette River near Ross Island (Figure 13(A)). Our team spoke with a homeless man living on a nearby boat who mentioned the cables being visible at different times during the year. The same location had a newer cut telecommunications cable which also had a thin lead sheathing. Near the Oregon Maritime Museum and Waterfront Park Trail, WR 2.2 contains eleven lead sheathed cables protruding from the wall and running into the Willamette River. The associated site WR 2, just over the railing has five Bell Systems manholes and what appears to be a large access vault (Figure 13(B-C)). Site WR 3 had a much older and smaller lead sheathed cable running just below an old wooden, Western Union Telecom Co. Sign just below the Morrison Bridge (Figure 13(D)). Underneath the West Burnside Bridge, site WR 5.1 had four lead sheathed cables that went submarine where the bridge opens. At the North Steel Bridge, point of interest, WR 6, is a collection of four lead sheathed cables that were observed chained up to the concrete footings, until going inside the footings near the street (Figure 14(E)). These were not visible at the southwest end of the bridge, which is also the northernmost end of Portland's Waterfront Park Trail and Greenway. As such, these cables are likely hidden within the new development. The NW Broadway Bridge, at point WR 7, contained a collection of six lead sheathed cables. These cables go submarine at the point the bridge opens. Some of these cables have been struck and damaged

by, passing boats, or floating debris in the river (Figure 14(F)). The final screened location WR 8, was an active construction site along the waterfront. There was limited access to the point of interest provided by the WSJ, however, the team observed a coiled-up, lead sheathed cable on the barge. After a brief discussion with the foreman, it was learned that this cable may have been pulled from the Abernathy Bridge south of Ross Island. This was not a location the team had time to investigate during this trip (Figure 14(G-H)).

(F) NW Broadway Bridge cables. WR 7. August 2022, Portland, Oregon.

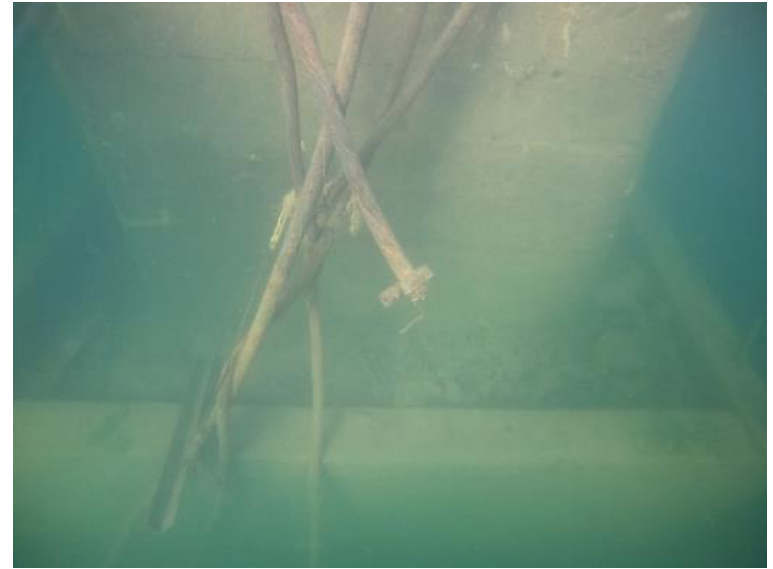
(B) Photo. Lead sheathed cables just below the surface. Site LP 4.1. August 2022, Lake Pend Oreille, ID.

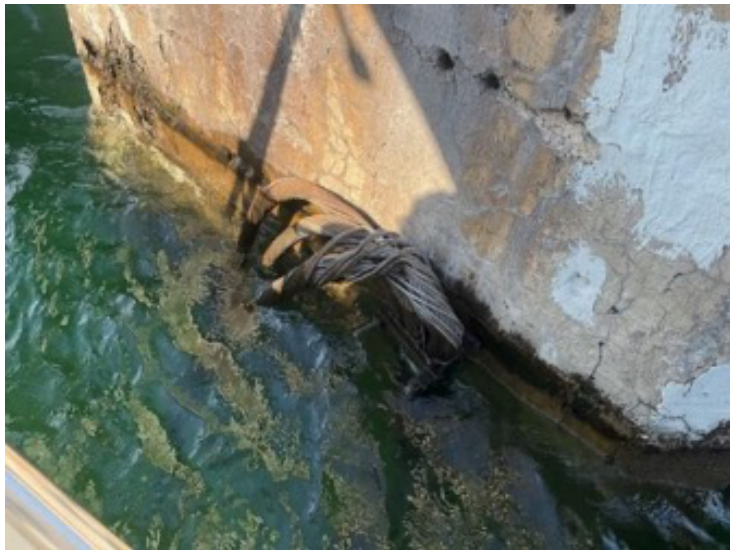
(C) Lead sheathed cables cut and hanging from bridge. Site LP 4.1. August 2022, Lake Pend Oreille, ID.

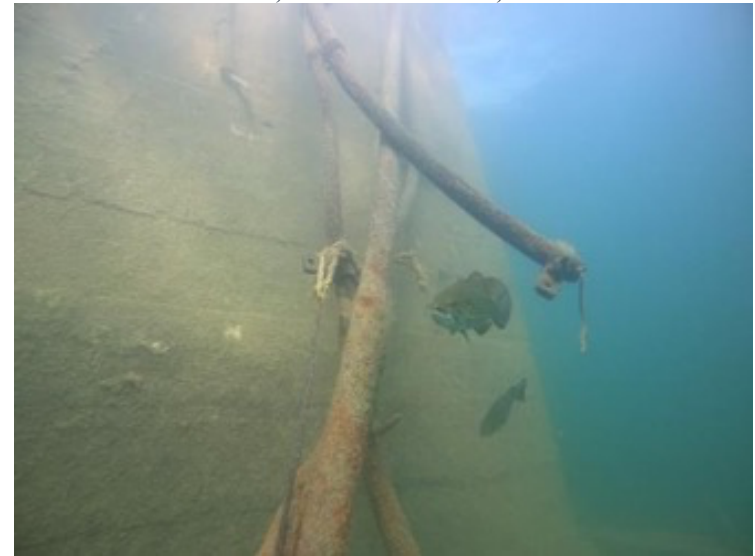
(D) Bare lead (upper-left). Cut end, near fish (mid-right). Site LP 4.1. August 2022, Lake Pend Oreille, ID.

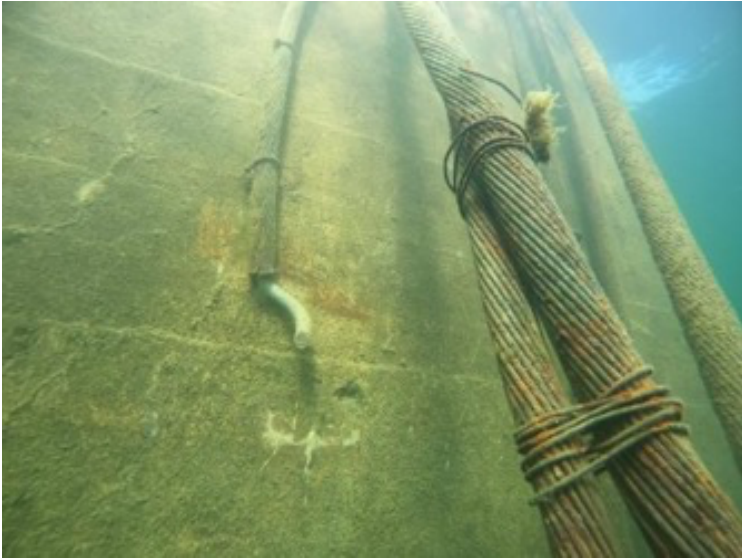
(E) Close up of small, cut, bare lead sheathed cable underwater. Site LP 4.1. August 2022, Lake Pend Oreille, ID.

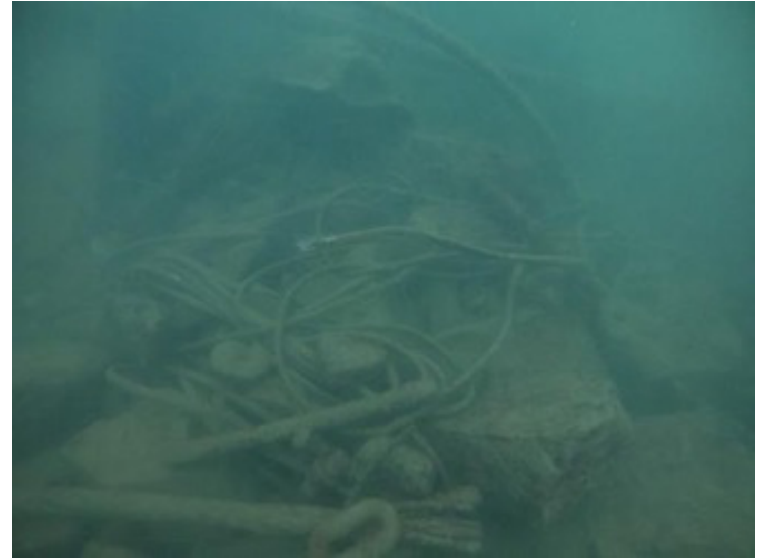
(F) Lead sheathed cables abandoned and coiled below the surface. Site LP 4.1. August 2022, Lake Pend Oreille, ID.

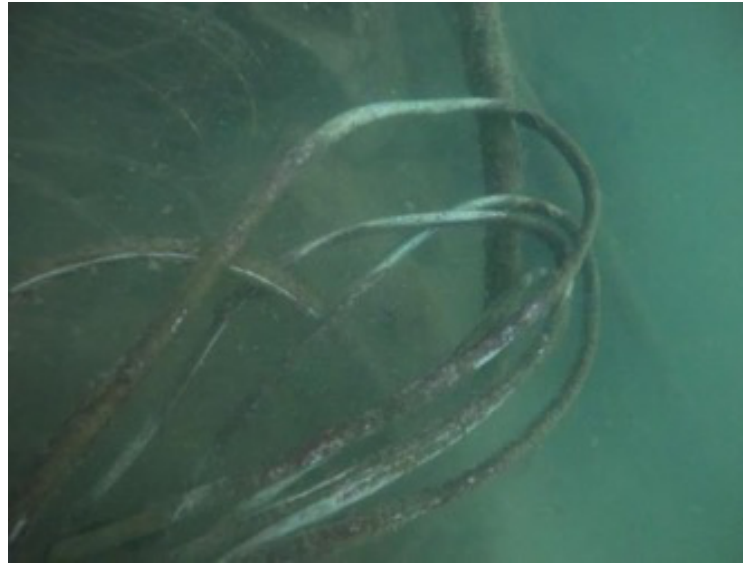
(G) Close up of bare lead from abandoned cables. Site LP 4.1. August 2022, Lake Pend Oreille, ID.

Overall, our findings in Idaho showed few visible lead sheathed cables with a high potential of buried cables in areas where signs and Bell Systems manholes were observed. The cables found off the old railroad bridge have been cut and left near the base of the bridge. They are clearly abandoned and should be removed. Further investigation into the status of these cables and how to move forward with the next steps of removing the remnants is suggested.

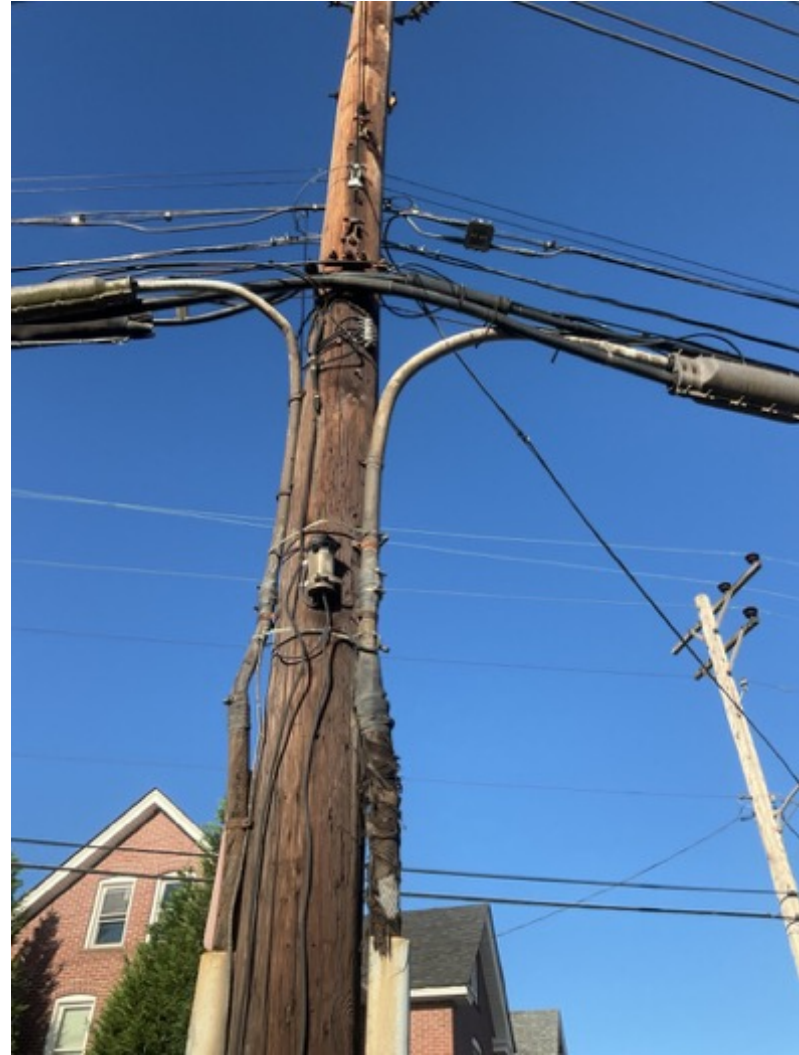
**(C) Close up of lead sheathed cable and splice boxes referenced in (A). October 2022. Natrona, Pennsylvania.**

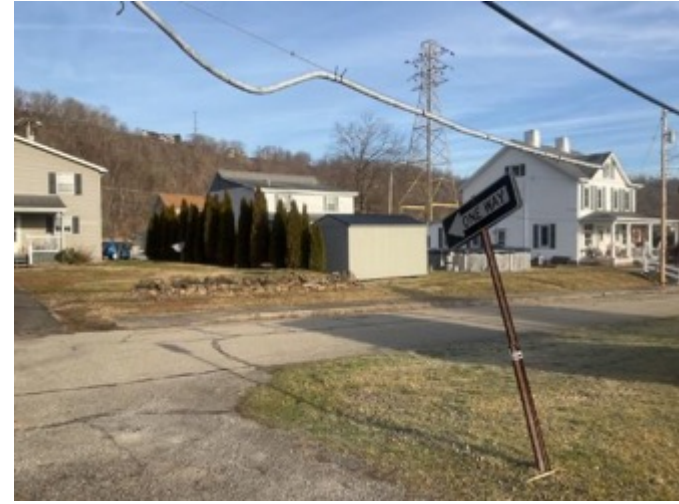
(F) CT11. Overhead lead sheathed cable running through a residential area near the end of town. February 2023. Coal Center, Pennsylvania.

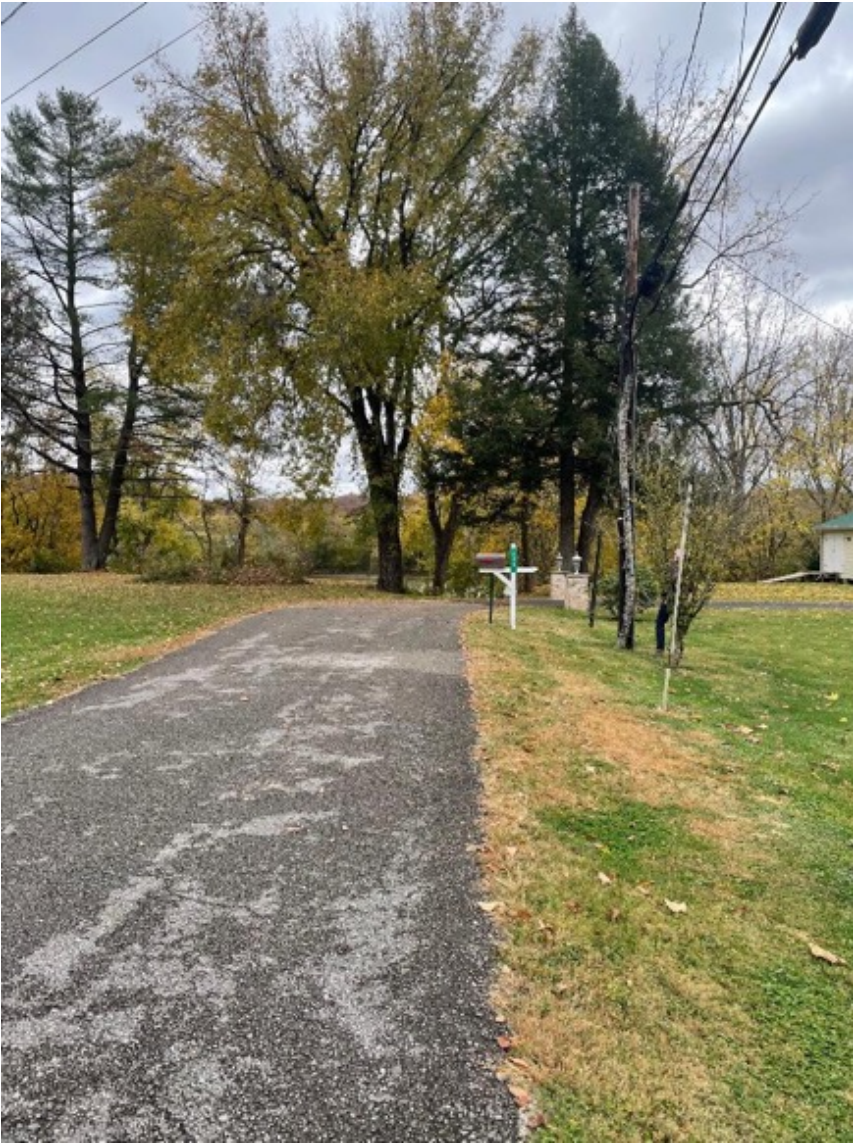
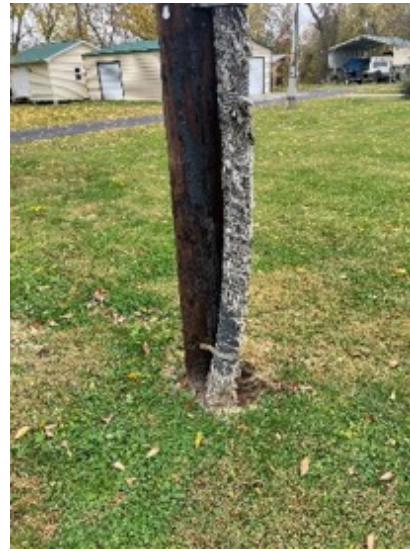
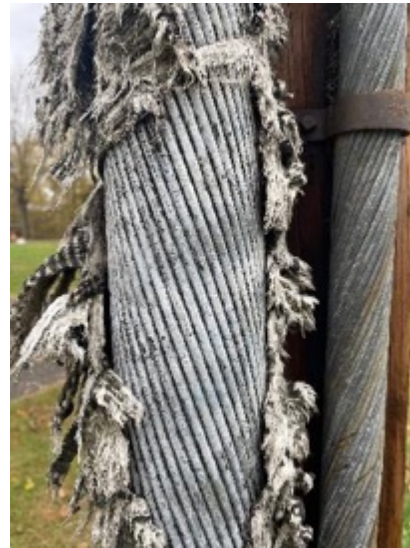
**Figure 19. Photos taken in West Virginia. Site for the Old Pliny Ferry Crossing at Frasier's Bottom. Two bare lead sheathed cables were observed at the end of Ferry Lane. KR 1.3. October 2022, Pliny, West Virginia.**
