# Lead Cable Investigation

June 30, 2023

**Prepared for:**

Marine Taxonomic Services, Ltd.  
Below the Blue 501(c)3

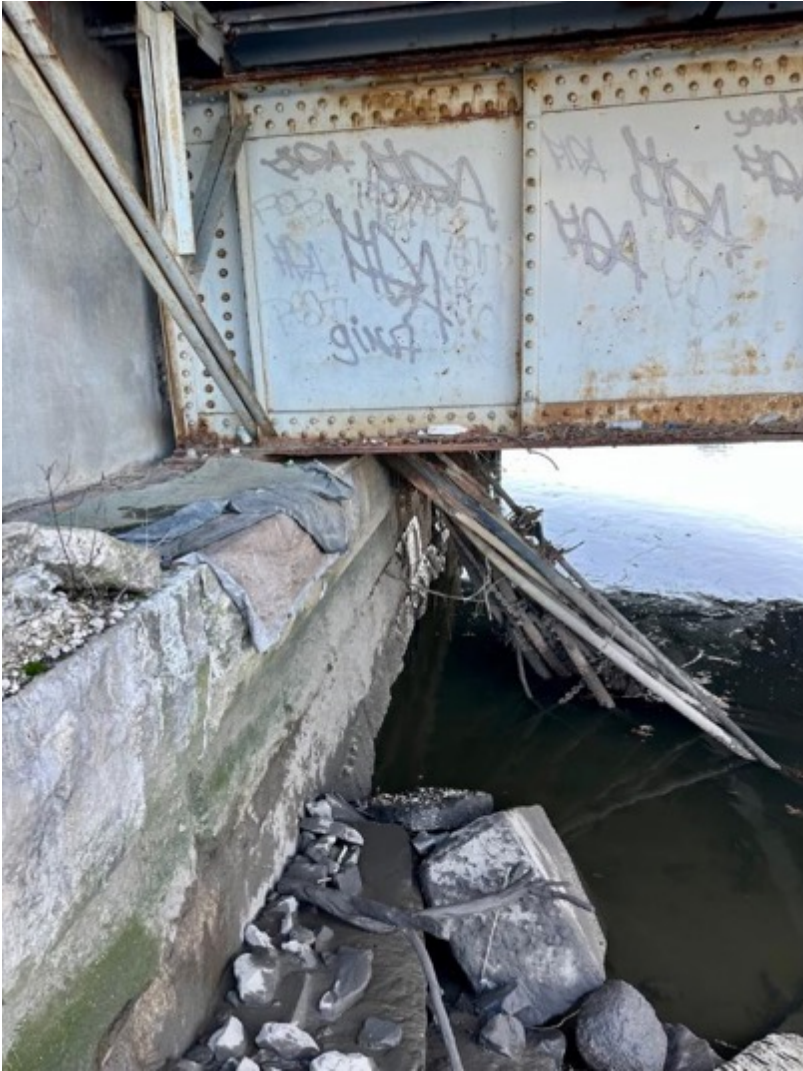
**(H)** Evidence of homeless sleeping next to these cables along the Passaic River. Passaic 2. January 2023, Harrison/University Heights, New Jersey.

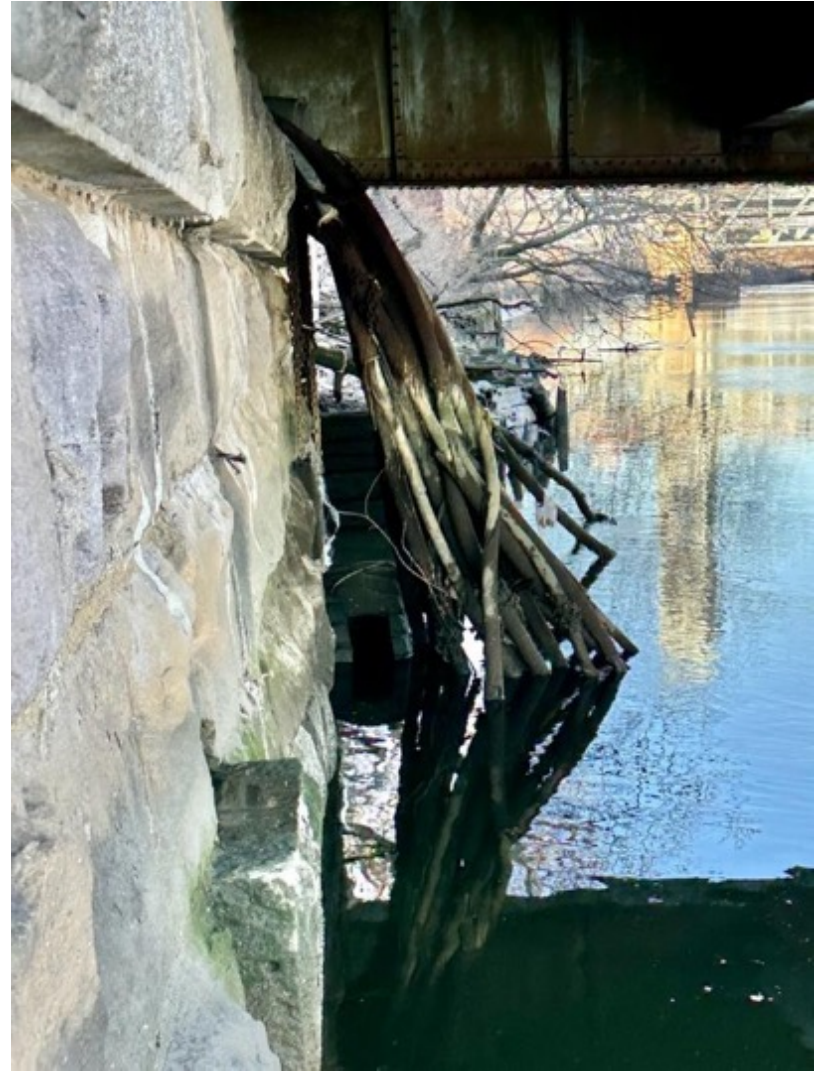
**(I)** Cable location with twenty lead sheathed cables underneath the Bridge Street Bridge (Harrison Ave.). Passaic 2.1 January 2023. Harrison/University Heights, New Jersey.

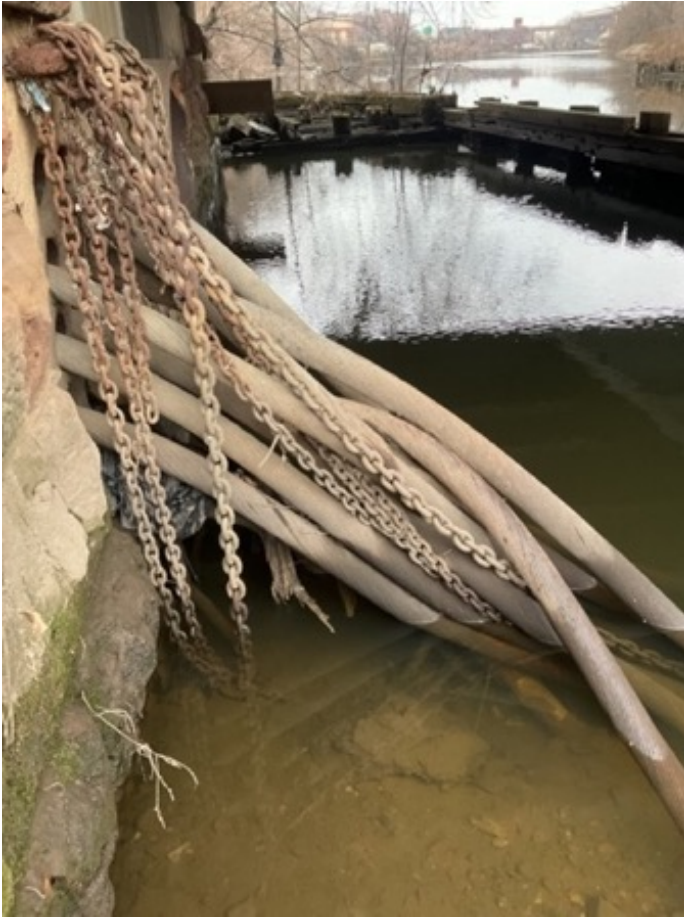
**(J)** Part of a complex site containing twenty-one cables near Washington Crossing State Park along the Passaic River. Passaic 5.10. January 2023. New Jersey.

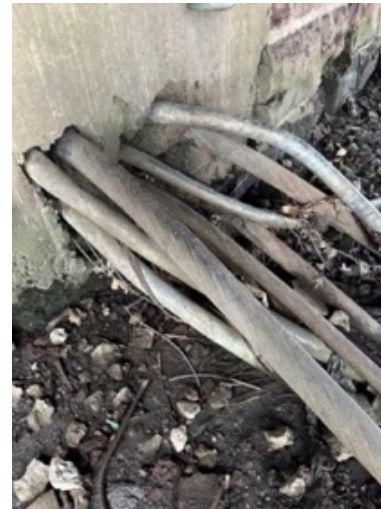
**(L)** Part of an eleven-cable location found near Wall Street Bridge, between Garfield and Wallington. Passaic 8. January 2023. New Jersey.

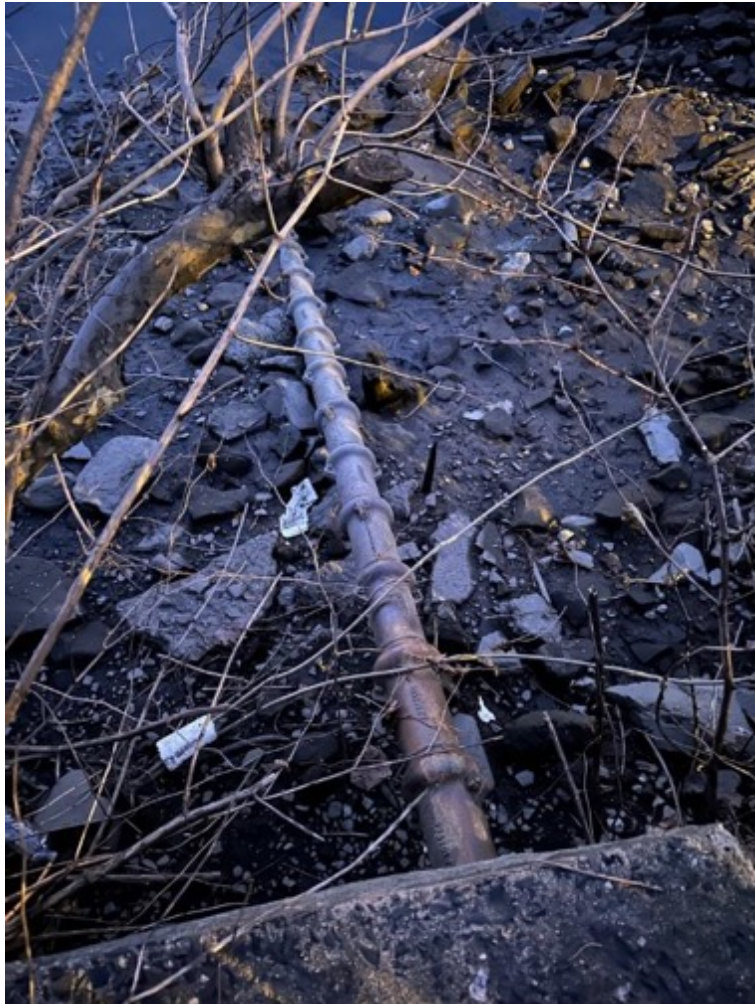
**(A)** Armored cable approximately fifteen feet from the water's edge. Passaic 3. January 2023, Belleville, New Jersey.

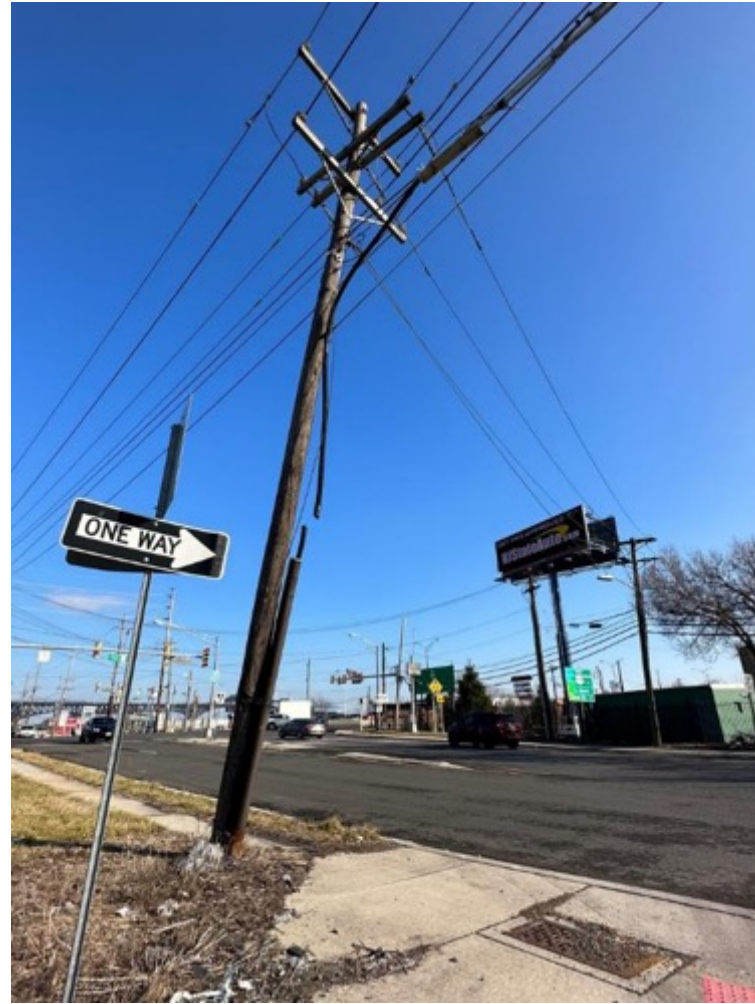
**(B)** Overhead cut, lead sheathed cables in the South Kearny area. There are two cables that run approximately 0.4 miles. South Kearny End A. January 2023, Kearny, New Jersey.

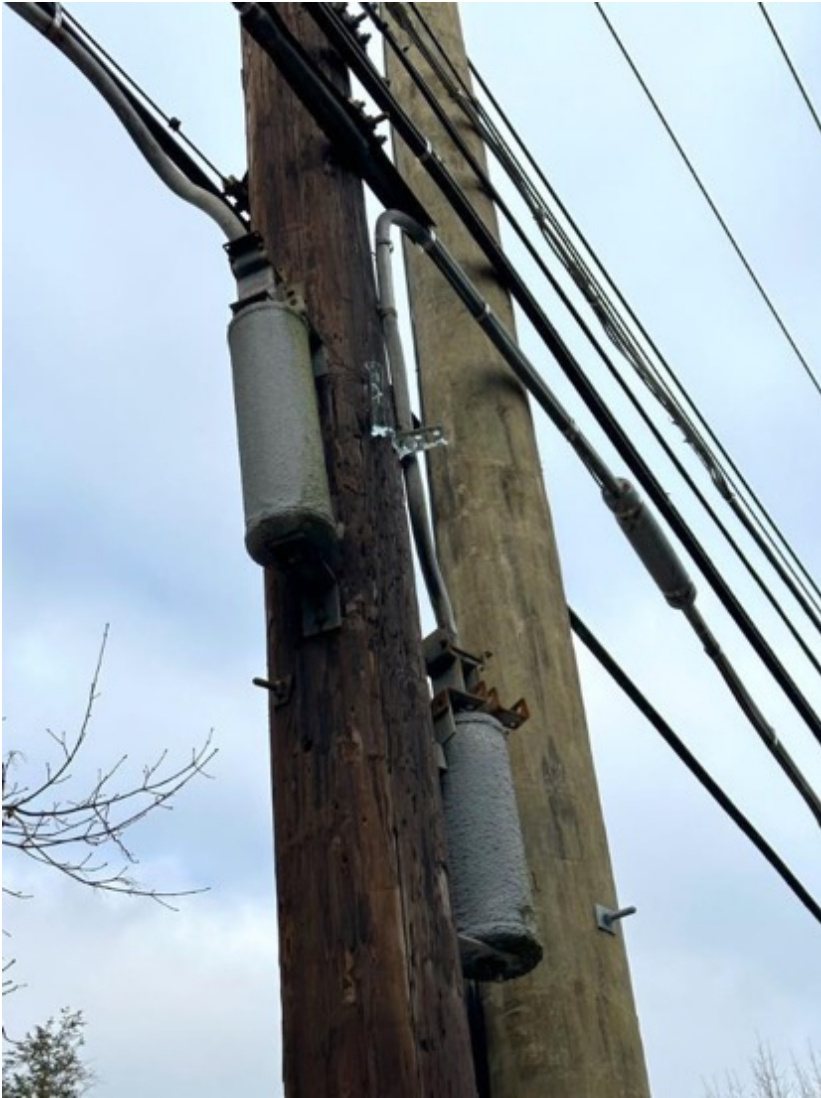
(A) Close up of telephone poles with overhead lead sheathed cable and leaded splice boxes. January 2023. Highland Falls, New York.

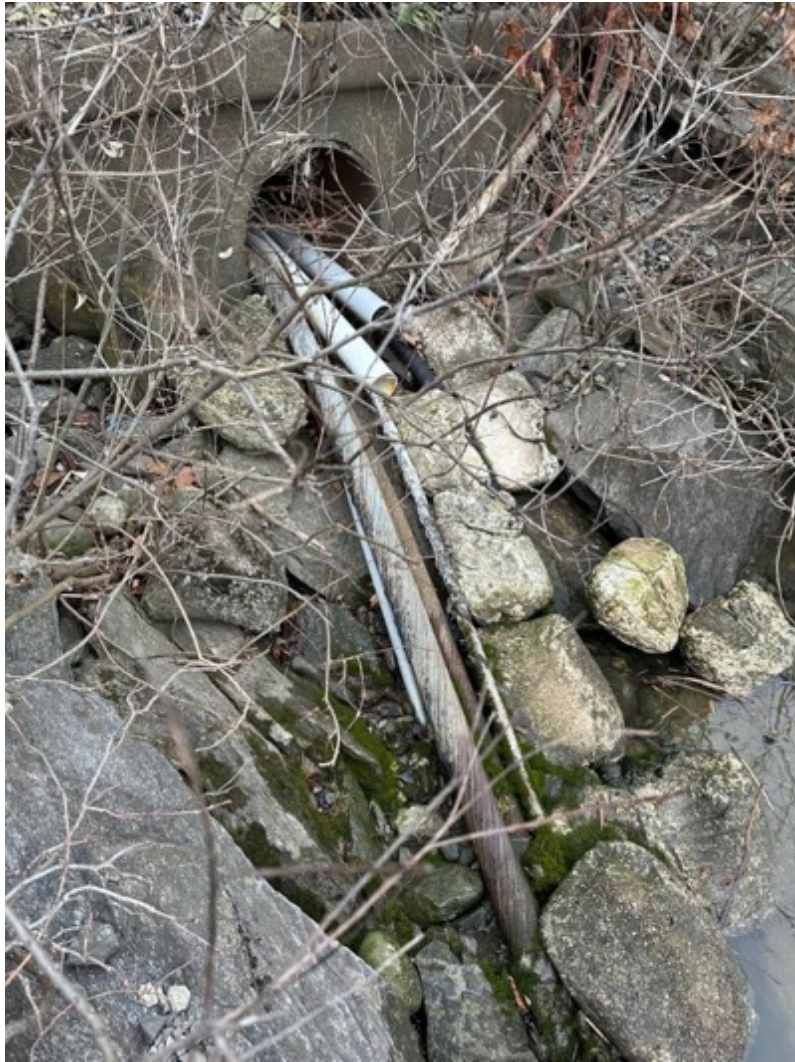
**(D)** Cables run under the road and into the Hudson River near the Mid-Hudson Bridge at Point of Interest: Hudson 3.1. January 2023. Highland, New York.

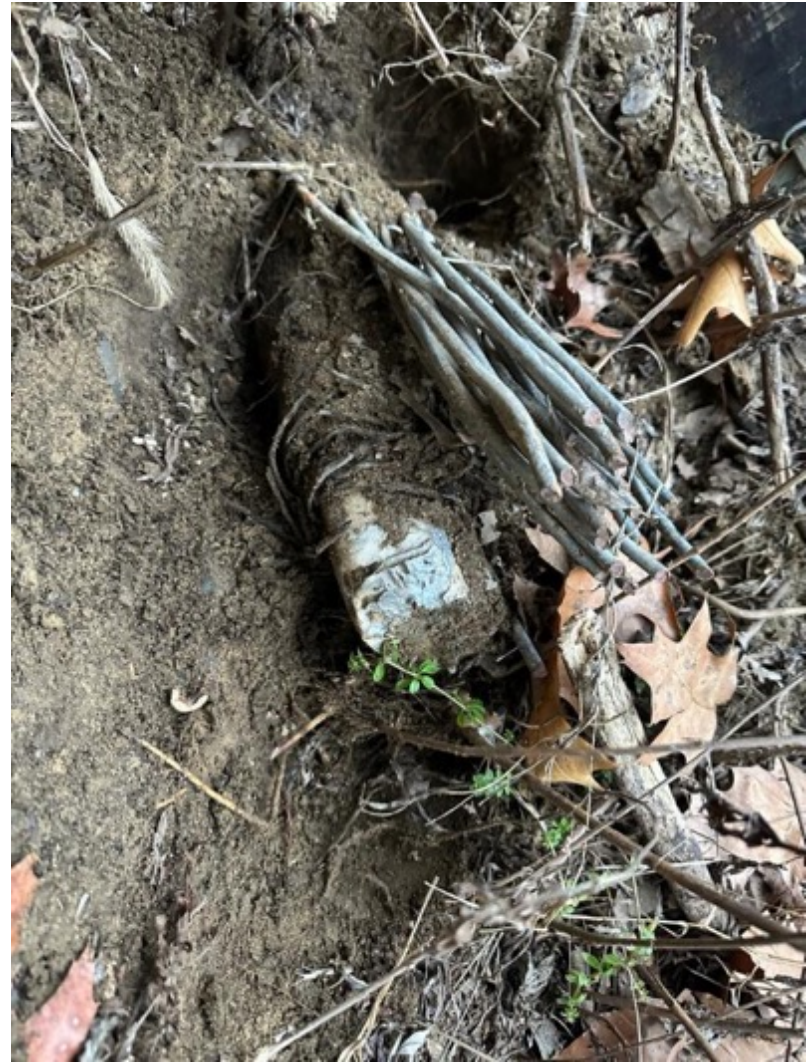
**(E)** Severed cable and steel wire at the base of an old telephone pole, across from those shown in (D). Point if Interest: Hudson 3.4. January 2023. Highland, New York.

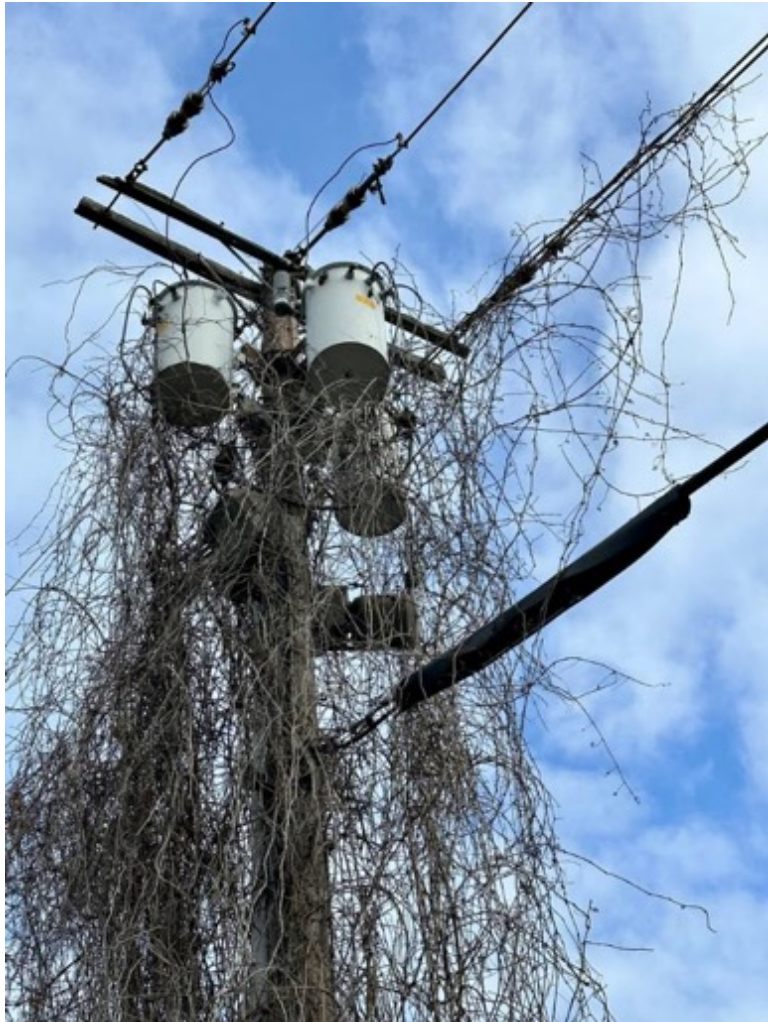
**(F) “Squirrel Guard” tied around an exposed area of lead sheathed cable. Point of Interest: Newburgh 1. January 2023, Newbury, New York.**

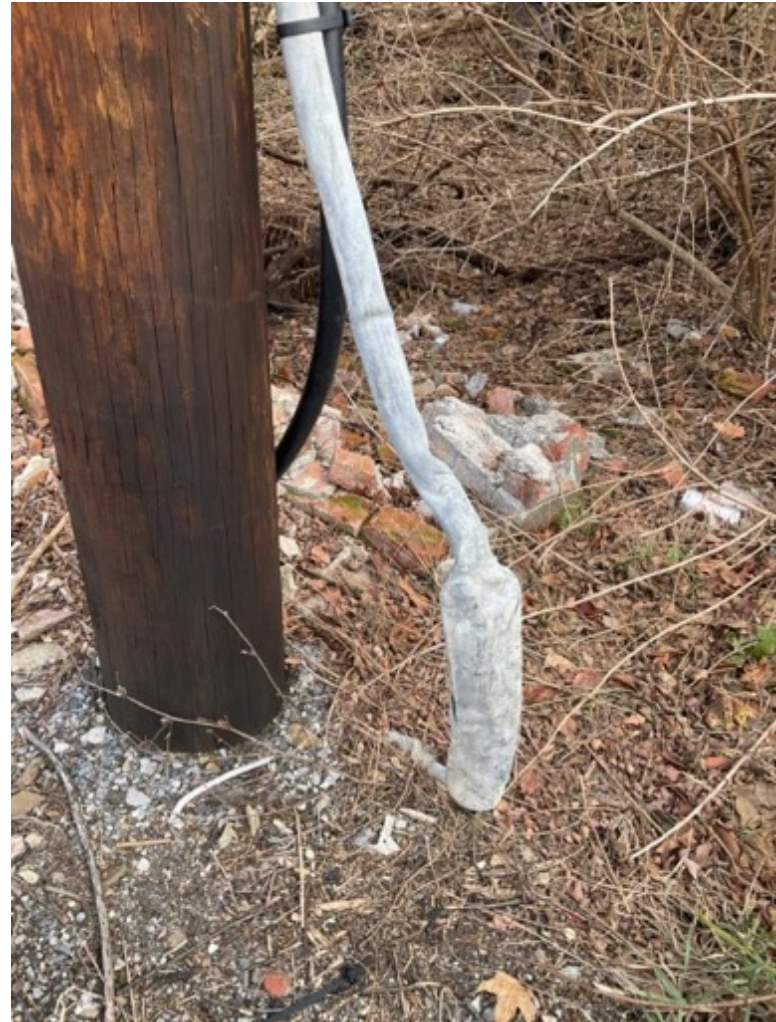
**(G) Damaged lead cable and splice box at the base of an old telephone pole. Point of Interest: New Windsor 1. January 2023, New Windsor, New York.**

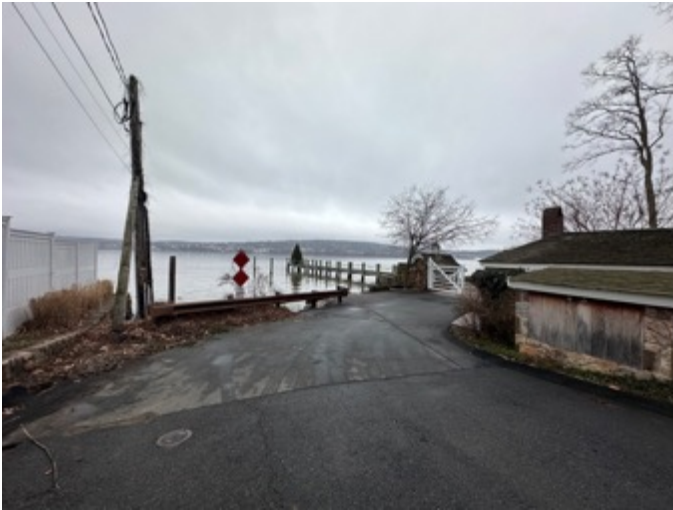
**(H) Abandoned 5" lead sheathed cable along the Hudson River. January 2023, Palisades, New York.**

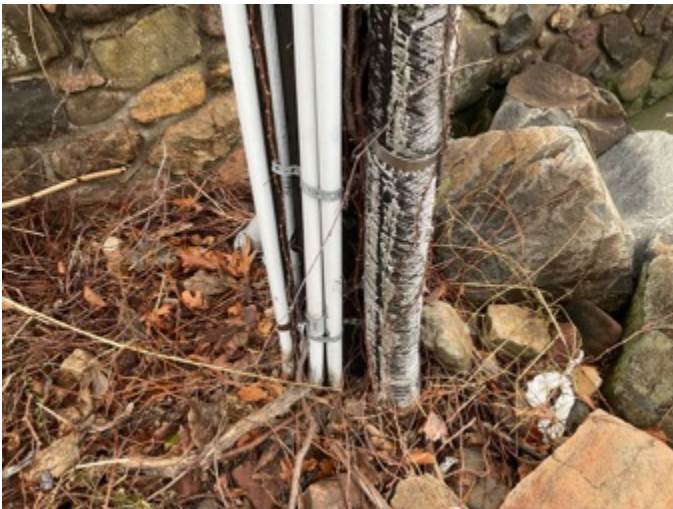
**(I) Close up of abandoned 5" lead sheathed cable along the Hudson River. January 2023, Palisades, New York.**

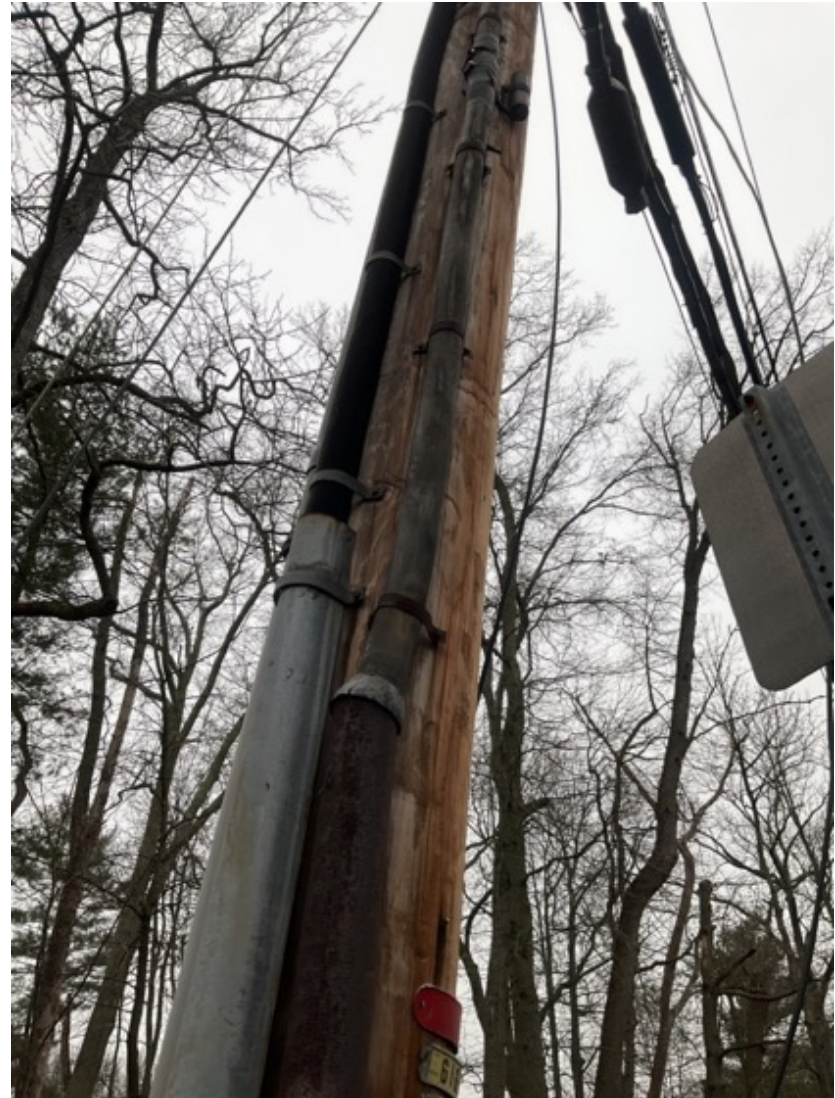
**(J) Bare lead sheathed cable running up telephone pole in the Palisades. January 2023, Palisades, New York.**

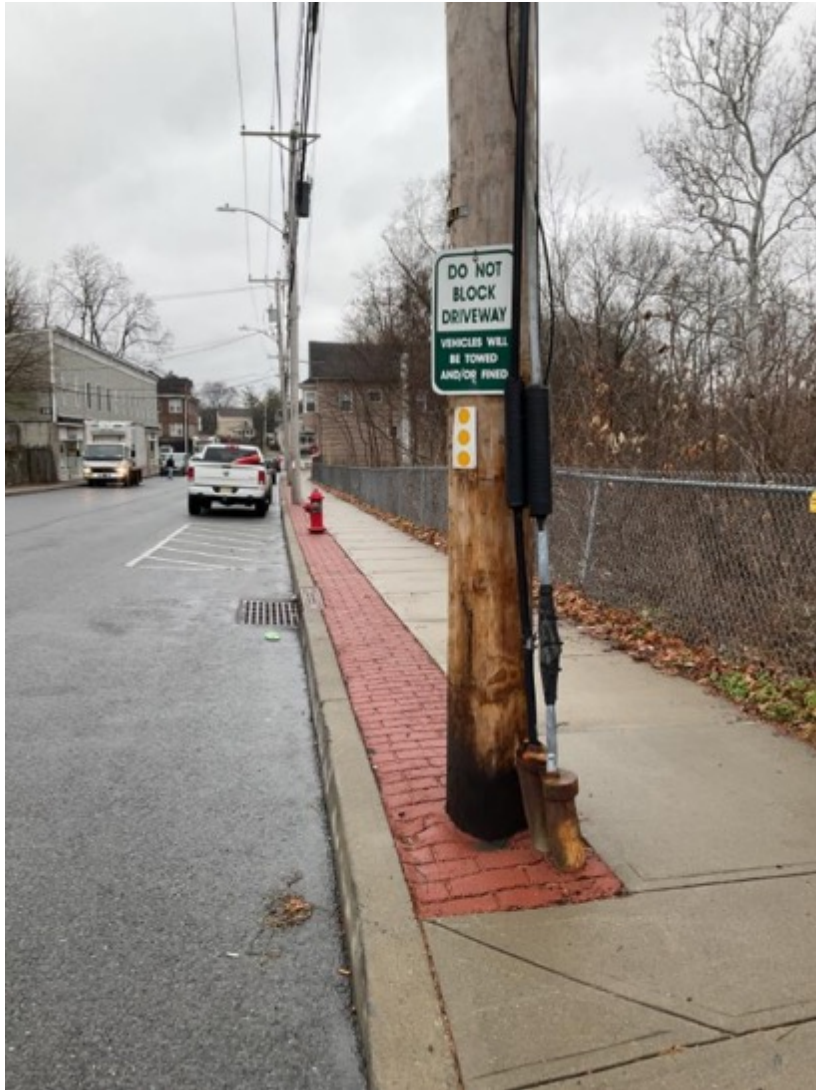
**(K) Damaged lead sheathed cable at the base of a telephone in Wappingers Falls. Point of Interest: Wappingers Falls 3. January 2023, Wappingers Falls, New York.**

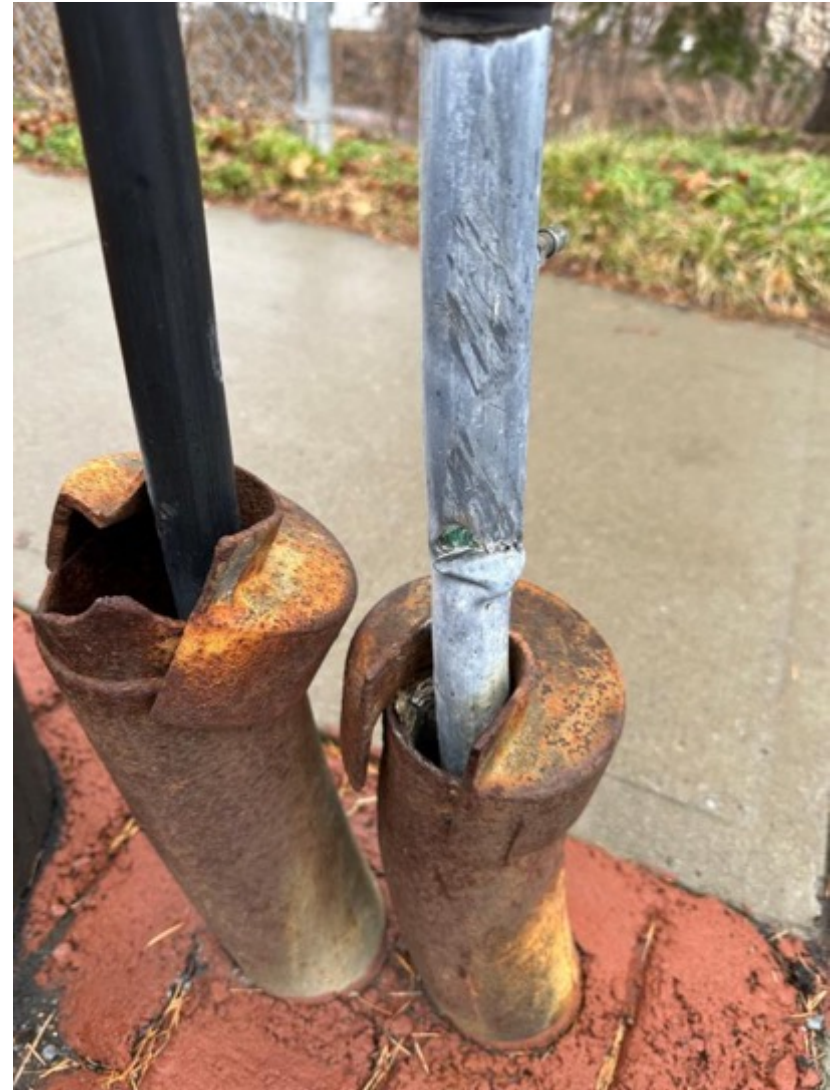
**(L) Close up of damaged lead sheathed cable shown in (K). Wappingers Falls 3. January 2023, Wappingers Falls, New York.**

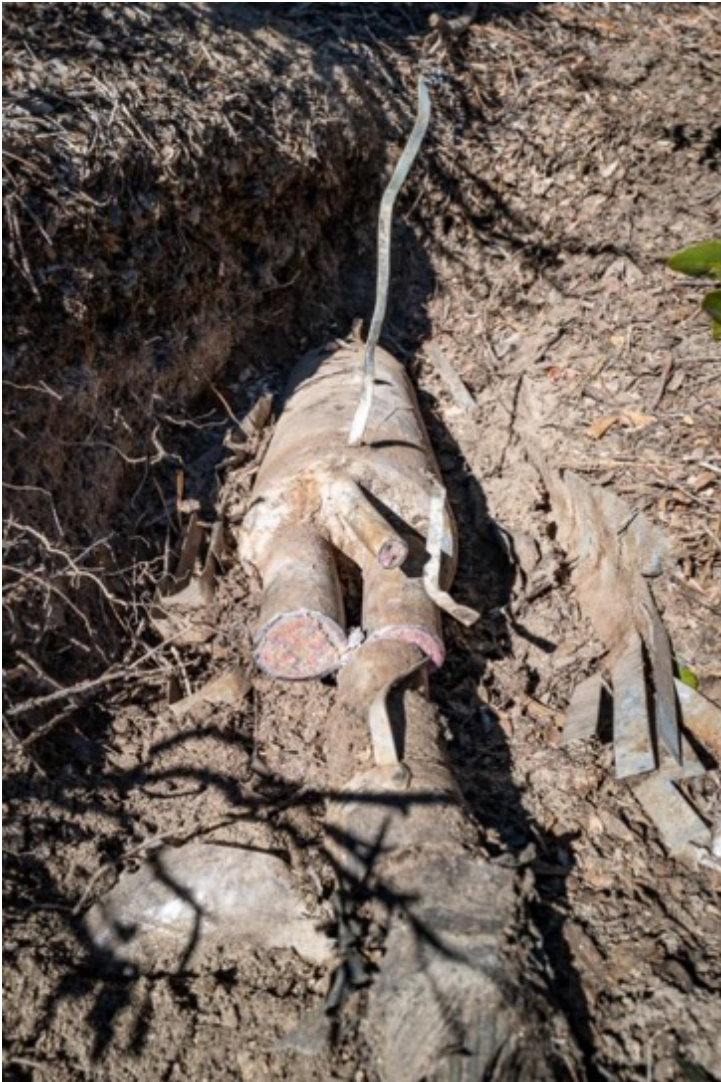
(A) Severed lead sheathed cables, and lead splice box on land. This photo was during a site visit with AT&T in January 2021.

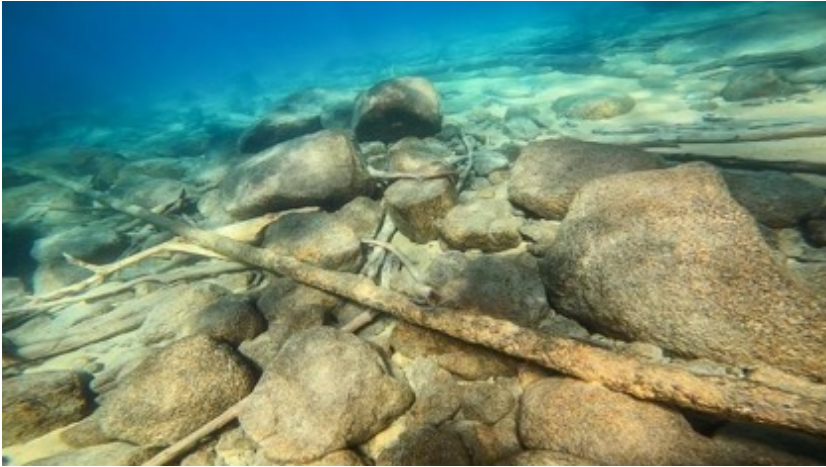
**(D)** Lead sheathed cable laying among boulders on the lake bottom. April/March 2022. Lake Tahoe, California.

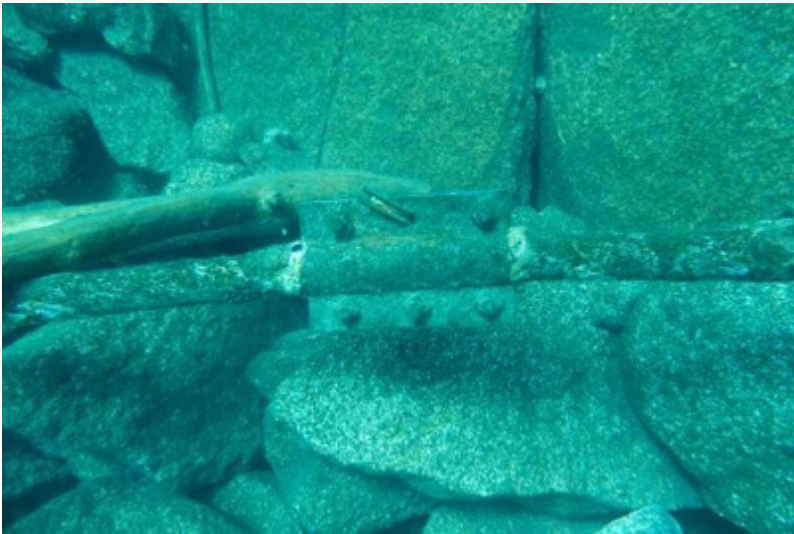
**(E)** Part of a broken anchor on the cable near Rubicon. April/March 2022. Lake Tahoe, California.

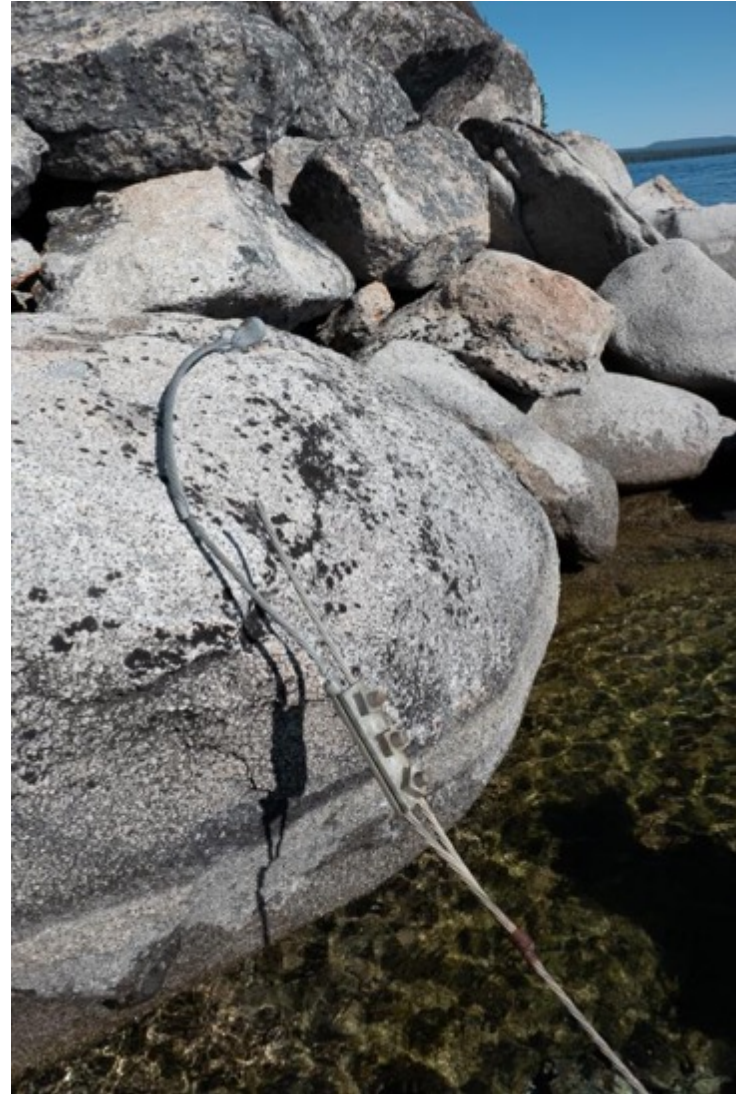
**(F)** Broken cable anchor on land near Rubicon. April/March 2022. Lake Tahoe, California.

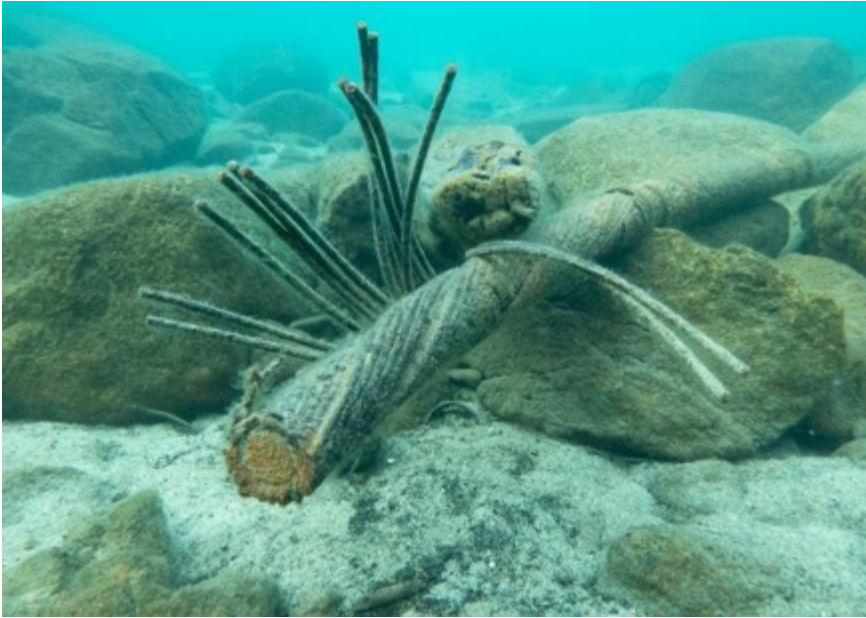
**(G) Severed end of 1920's cable in Emerald Bay. May 2021, Emerald Bay - Lake Tahoe, California.**

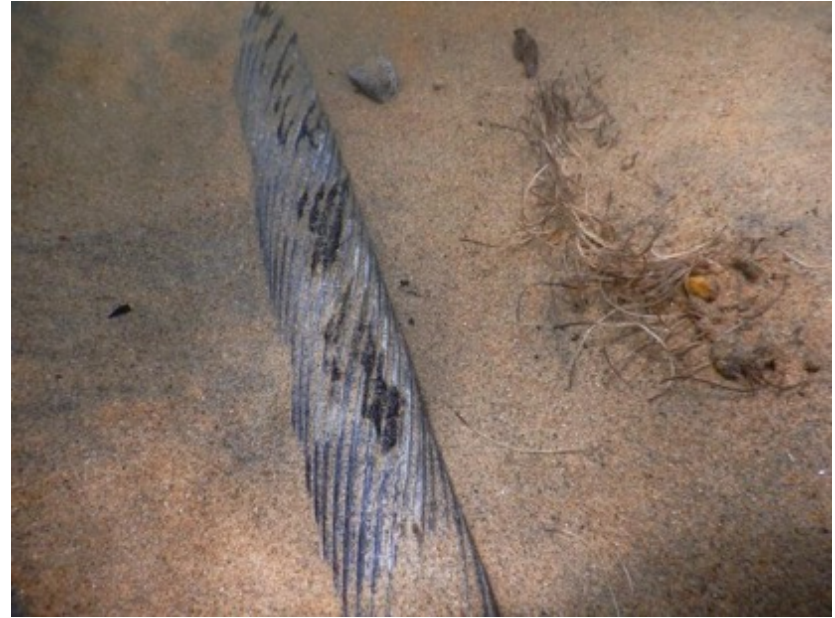
**(H) 1920's lead sheathed cable resting on the lake bottom in Emerald Bay. May 2021, Emerald Bay - Lake Tahoe, California.**
