## RETROFIT ASSESSMENT REPORT

### PROPERTY SUMMARY

The property is a detached, first floor maisonette above an unheated space. It is of traditional, solid wall construction with brick extensions to the rear and right elevations. Neither extension has loft / roof insulation while the main property has 100mm of loft insulation. Internally the property is in average condition with some areas of damp and mould present.

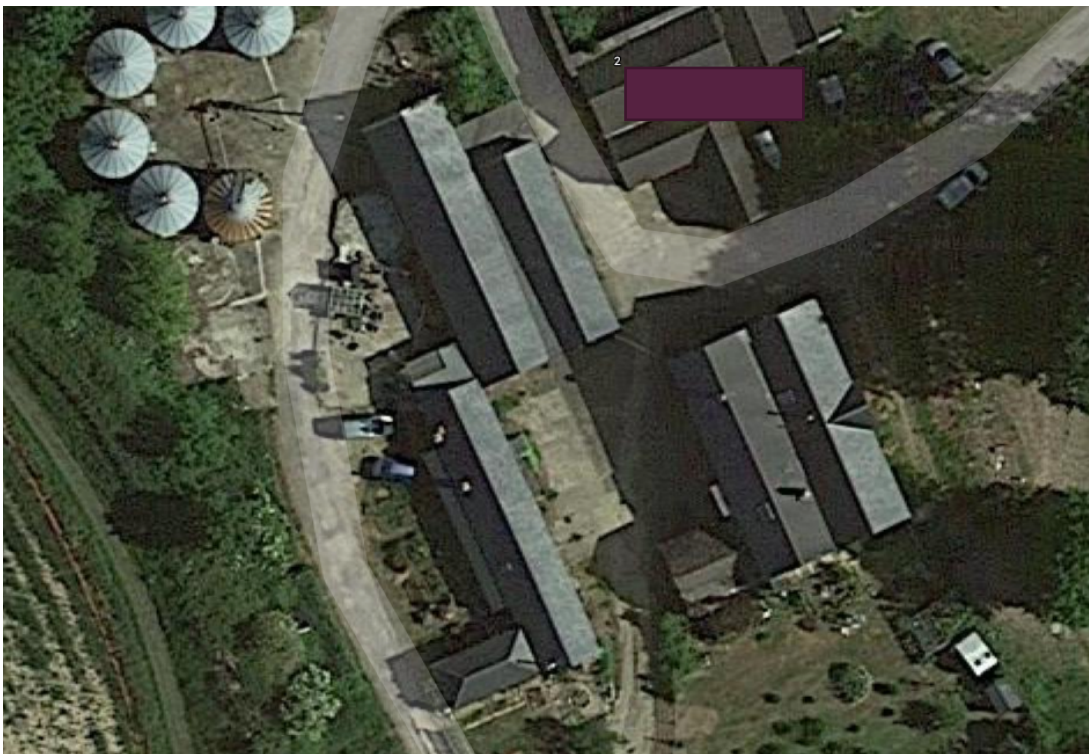
## ORIENTATION OF ROOF

The property faces East North East so is not ideally suited to Solar PV.
