# LEVEL 2 REPLACEMENT RESERVE REPORT FY 2022 CHARLESTOWNE VILLAGE

## CHARLESTOWNE VILLAGE

GREENBELT, MARYLAND

December 28, 2021

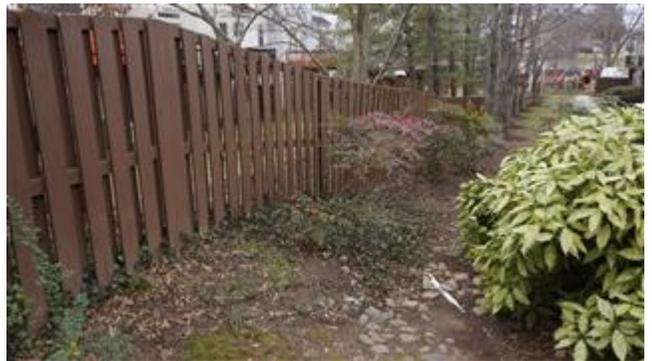
The wood board-on-board fencing is located along portions of the southwest property line, around the play area, at the trash enclosures at each of the 15 buildings, and at privacy fences at certain individual townhouse units. The condition of these various fences varies from good to poor, with rotten components, loose fence posts, and out of plumb sections of fencing noted

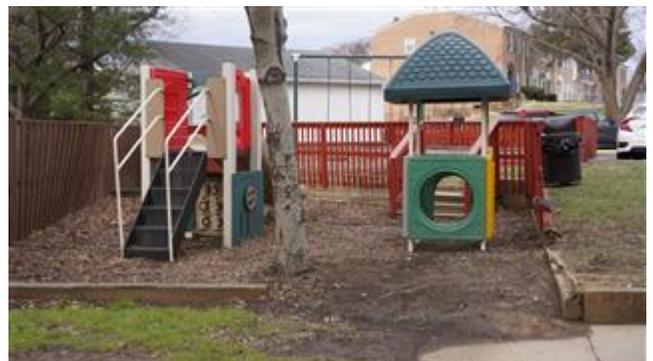
There is a metal picnic table and a metal bench located at the Tot Lot, both of which are in good serviceable condition. Two wood picnic tables located elsewhere are in poor condition and need to be replaced.

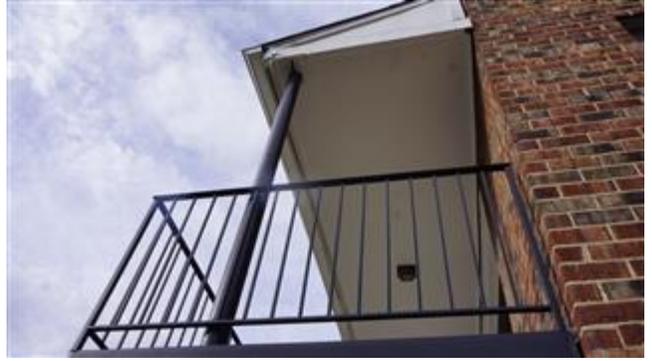
We noted no major defects which appear to be significant, although cracking in the concrete decks near support structures, cracks in supporting brick masonry, and spalling of brick at balcony bearing locations is noted. These defects should be closely monitored to determine if any of these conditions worsen over time.

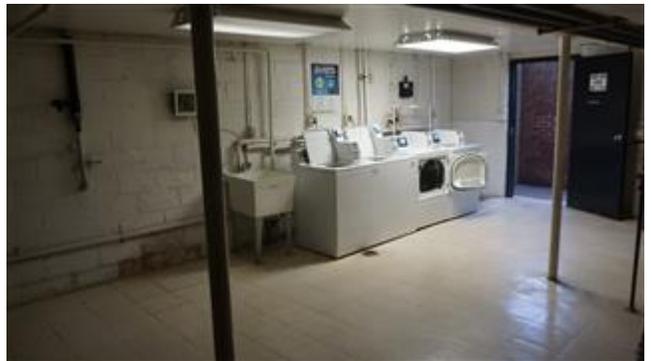
The condition of these light fixtures ranges from good to poor, as some fixtures appear to be newer or have been retrofitted with LED luminaries while others are in poor condition with inoperative luminaries and stained diffusers noted.

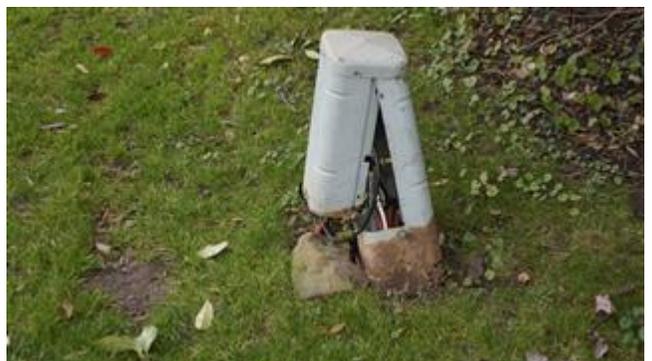
**Finally, certain observed utility conditions of concern include missing covers at communication systems boxes within the building common areas as well as at outside yard areas. It is recommended that these be repaired to avoid any possible hazardous conditions.**

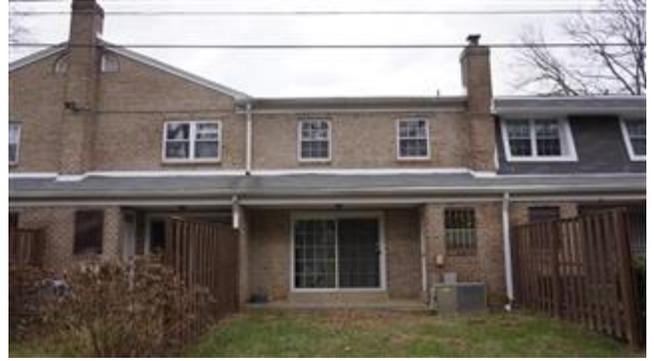
There are roof areas that have become discolored where downspouts from upper roof surfaces discharge onto lower roof surfaces. Although this is unsightly, the performance of the roof surface itself does not appear to be compromised. Organic growth noted on some lower roof surface areas, if not checked, may result in accelerated degradation of these surfaces. Finally, areas are noted where sheet metal counter flashing is excessively deflected from the adjacent roof surface which may allow for the intrusion of water into the roof surface and adjacent wall area.

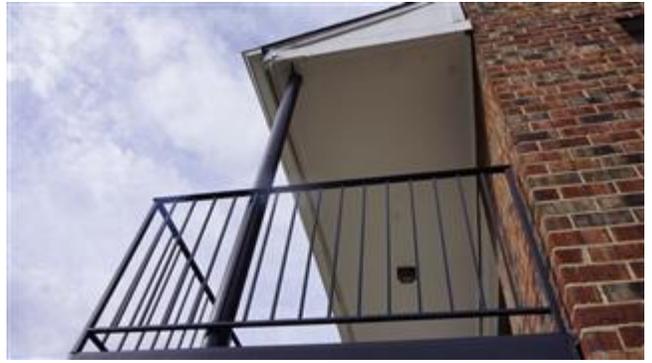
We noted no major defects which appear to be significant, although cracking in the concrete decks near support structures, cracks in supporting brick masonry, and spalling of brick at balcony bearing locations is noted. These defects should be closely monitored to determine if any of these conditions worsen over time.

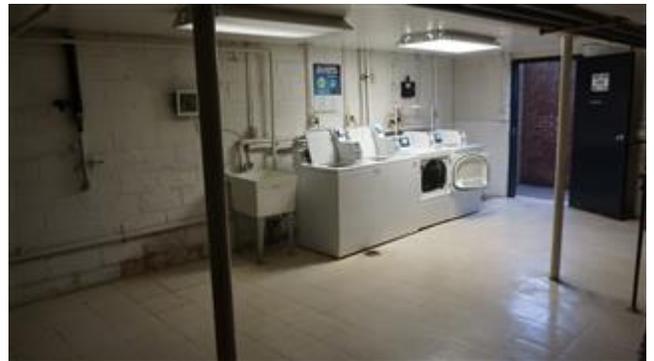
The condition of these light fixtures ranges from good to poor, as some fixtures appear to be newer or have been retrofitted with LED luminaires while others are in poor condition with inoperative luminaires and stained diffusers noted.
