## Southern Home Consultants, Inc.

### 4-Point Insurance Inspection Report

**Inspection #:** 010424DW2. **Date:** 01/04/2024. **Policy Number:** \_\_\_\_\_

**Address:** 1215 Alligator Dr. **City:** Alligator Point, FL 32346.

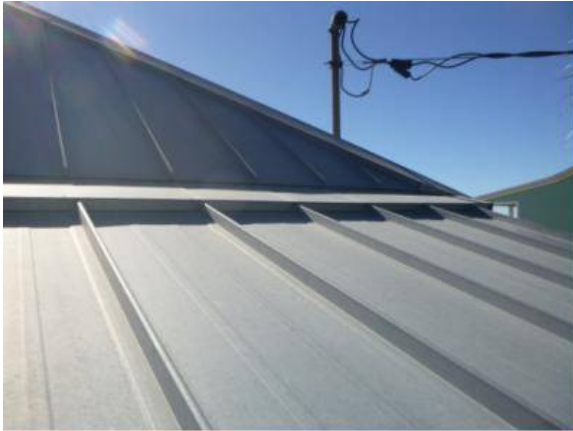
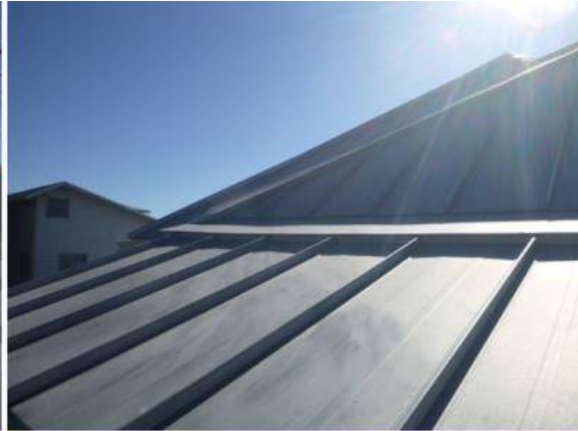
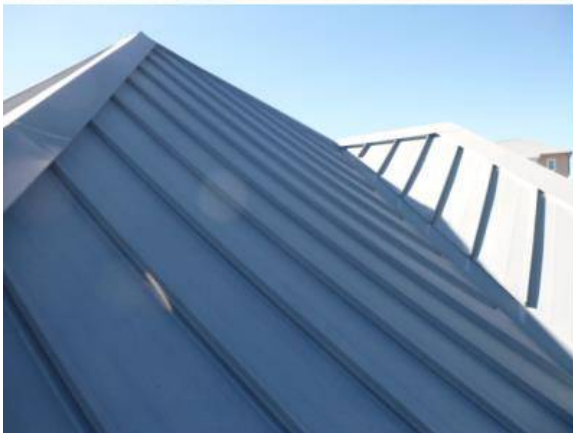
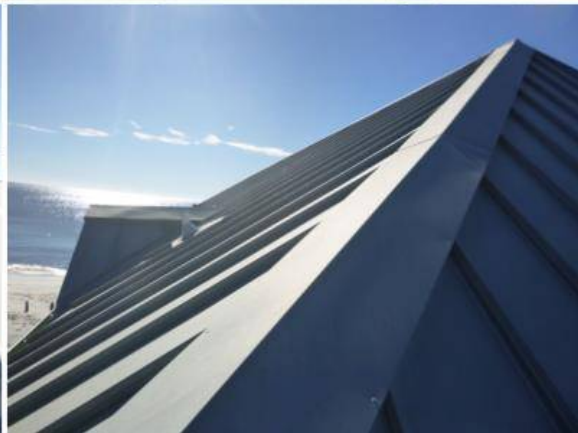
ROOF:

**Style:** Hip, Shed, Combination **Covering type:** Metal **Estimated age:** 2005 Stated by: Owner **Leaks:** No

**Visible roof damage noted:** No **Condition of roof:** Appears serviceable/within useful life **Remaining Life:** 20 plus years

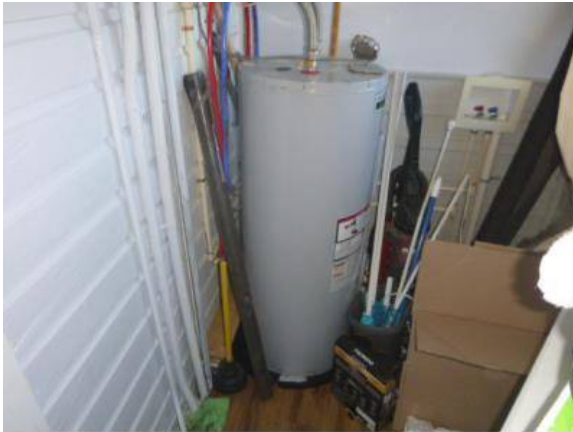
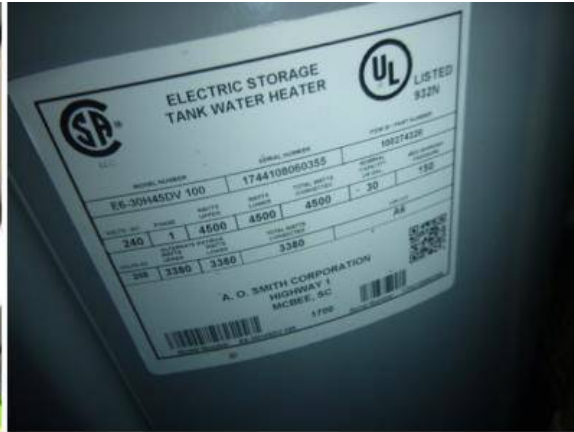
WATER HEATER:

**Location of water heater:** Utility room **Age of water heater:** 2017

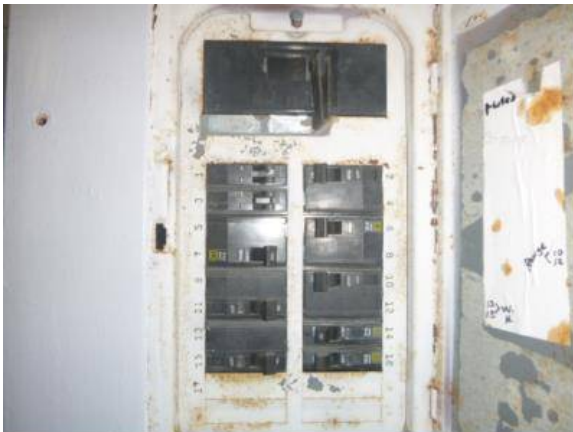
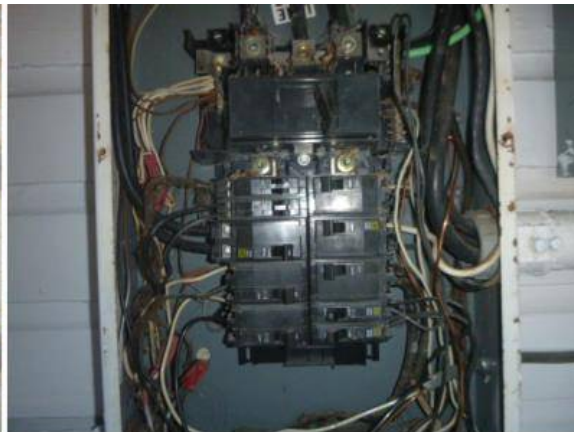
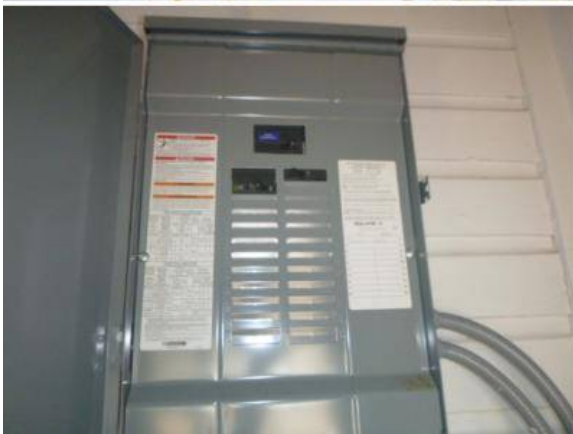
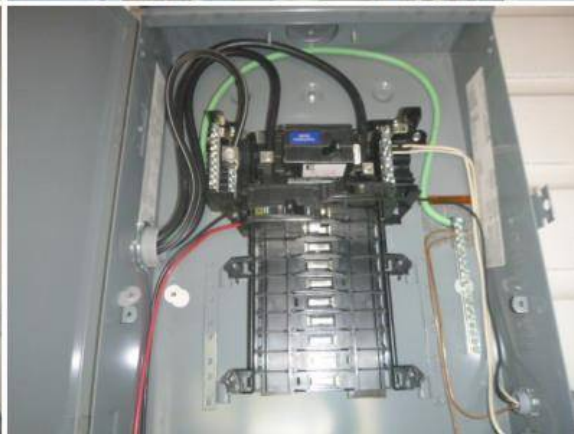
ELECTRICAL PANELS:

**- Multiple wires are connected to a single lug on a circuit breaker in the electrical panel where only one wire should be connected.**

**Refrigerator is plugged into a non-grounded receptacle. Shock hazard exist.**

*There are numerous three prong type outlets that are not properly grounded. These outlets should be properly grounded or returned to two pronged type by a licensed electrician.*

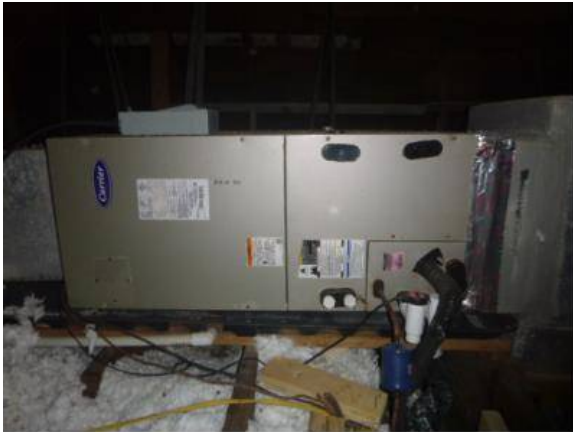
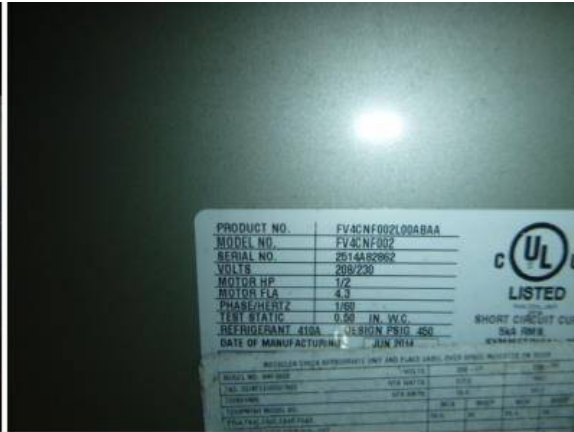
**HEATING - AIR CONDITIONING**  
**HEATING SYSTEM DESCRIPTION:**

**Heat system condition:** Heating system appeared serviceable at time of inspection

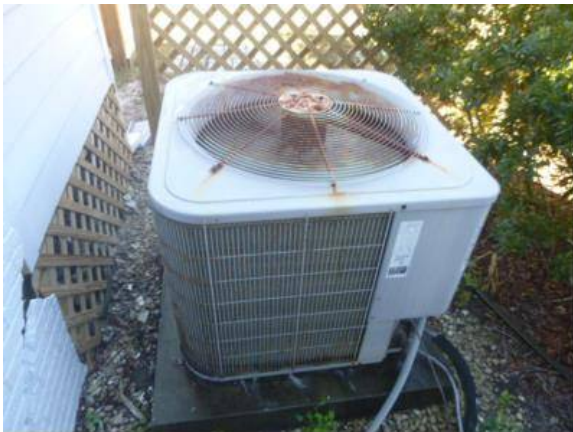
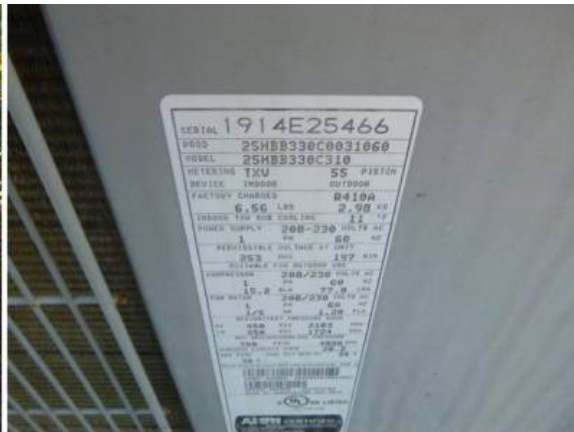
**AIR CONDITIONING:**

**Cooling system condition:** Appears serviceable
