# Property Inspection Report

**Inspection Date: 01/04/2024.**

**Report #: 010424DW2.**

**1215 Alligator Dr.  
Alligator Point, FL 32346.**

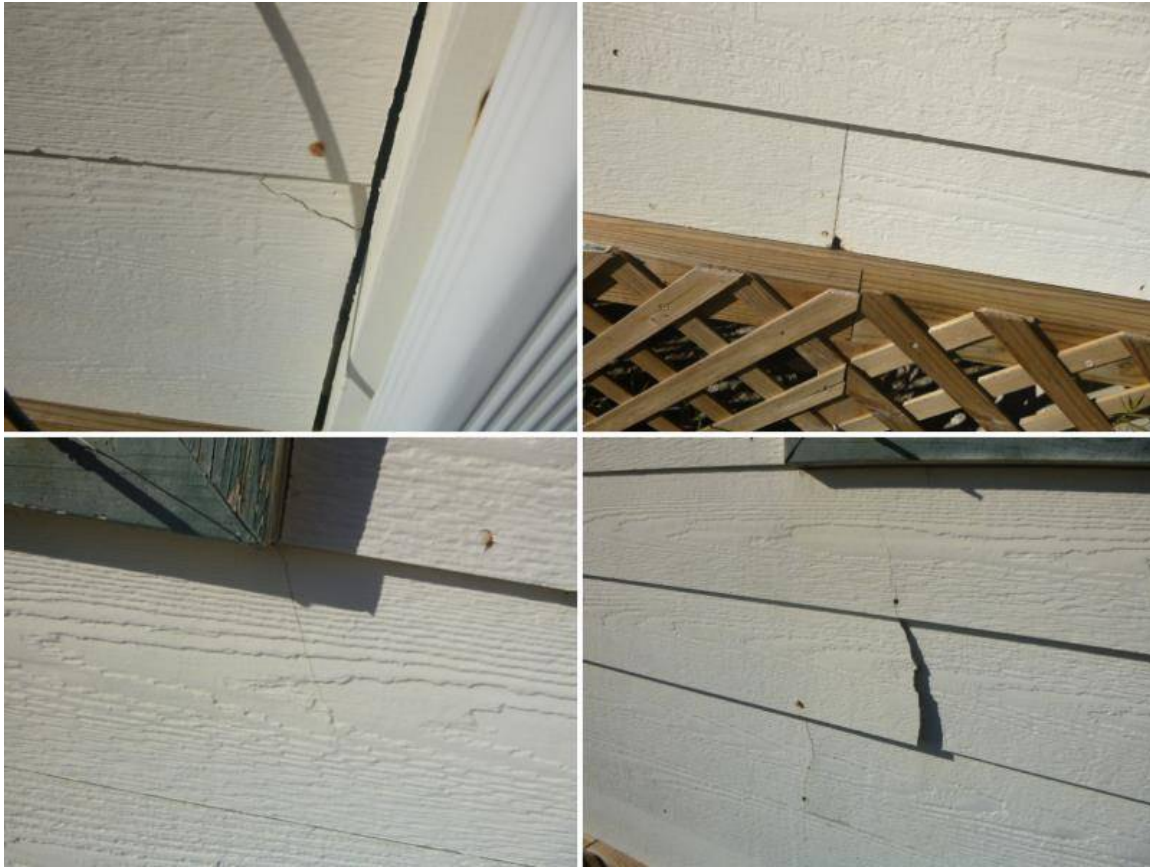
4. Cracked/damaged siding noted on the left side yard siding, recommend repairs to prevent further damage/deterioration.

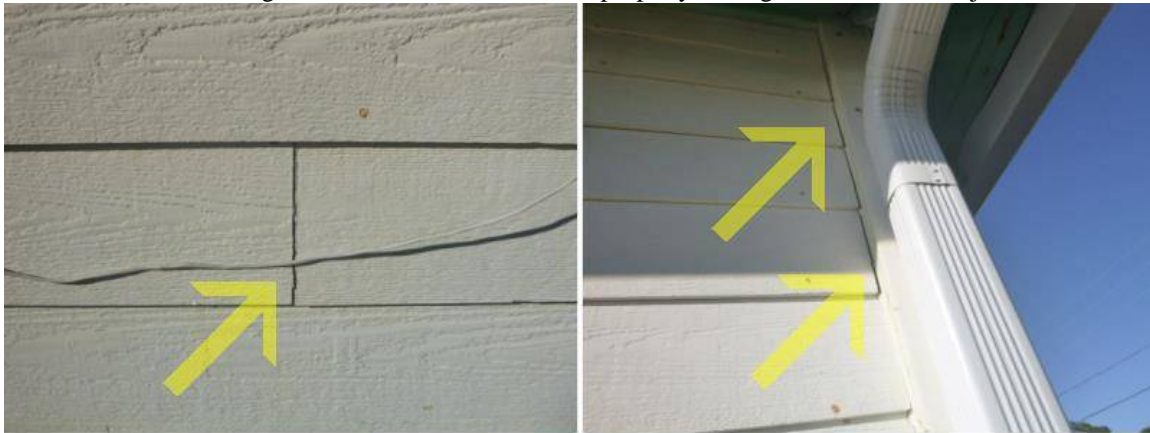
5. Some or all of the exterior siding is "Hardee Plank" fibrous siding. The vertical joints do not appear to be properly sealed. Manufacturers specifications require either flashing or caulk on all vertical joints. The joints either lack this treatment or the caulking is deteriorated. Recommend properly sealing all of the vertical joints.

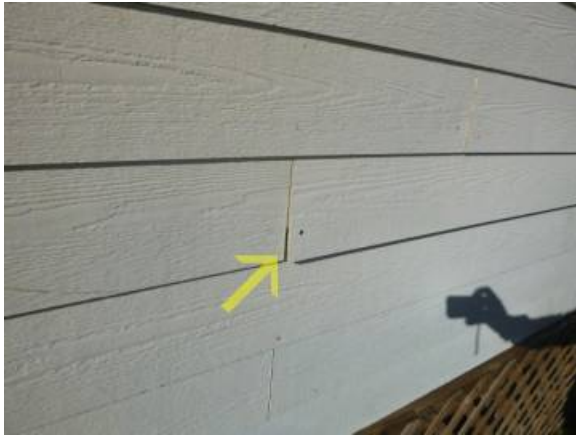
6. Loose/popped siding noted on the left side yard, recommend securing and sealing as needed.

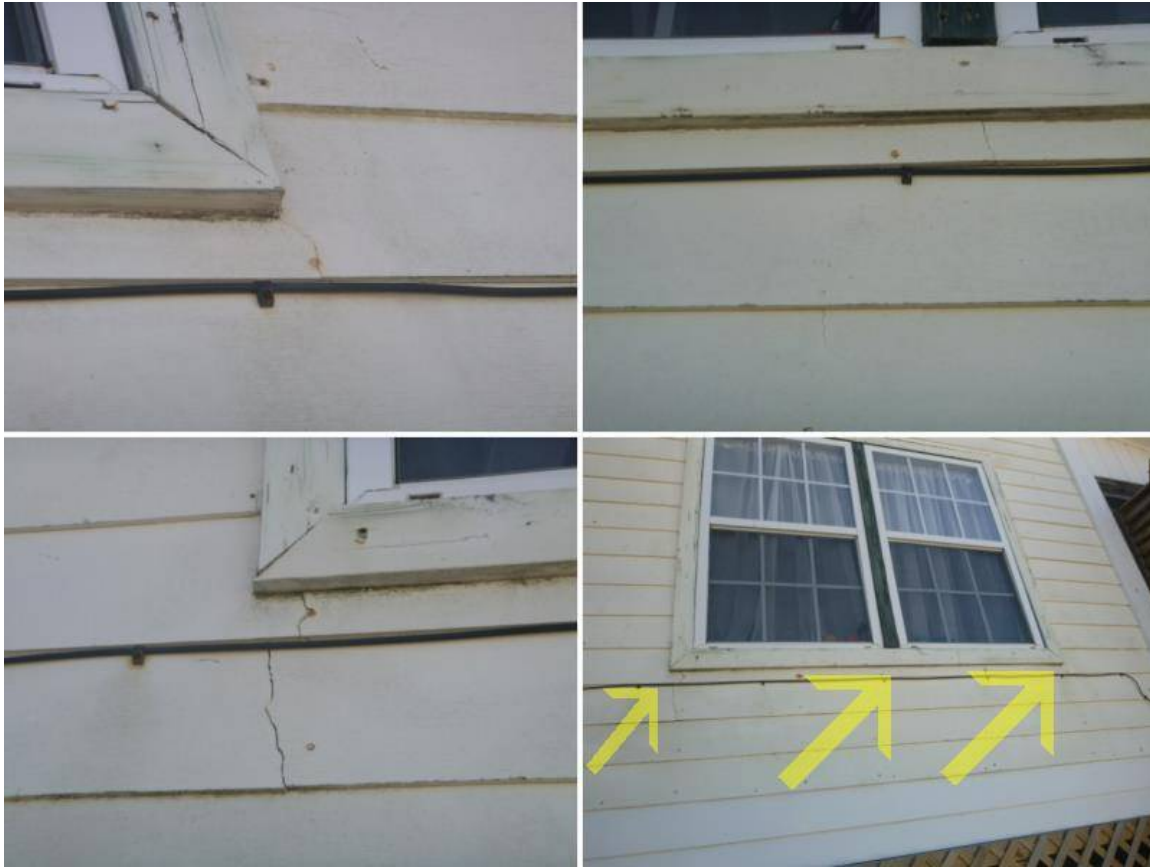
9. Cracked/damaged siding noted on the right side yard siding, recommend repairs to prevent further damage/deterioration.

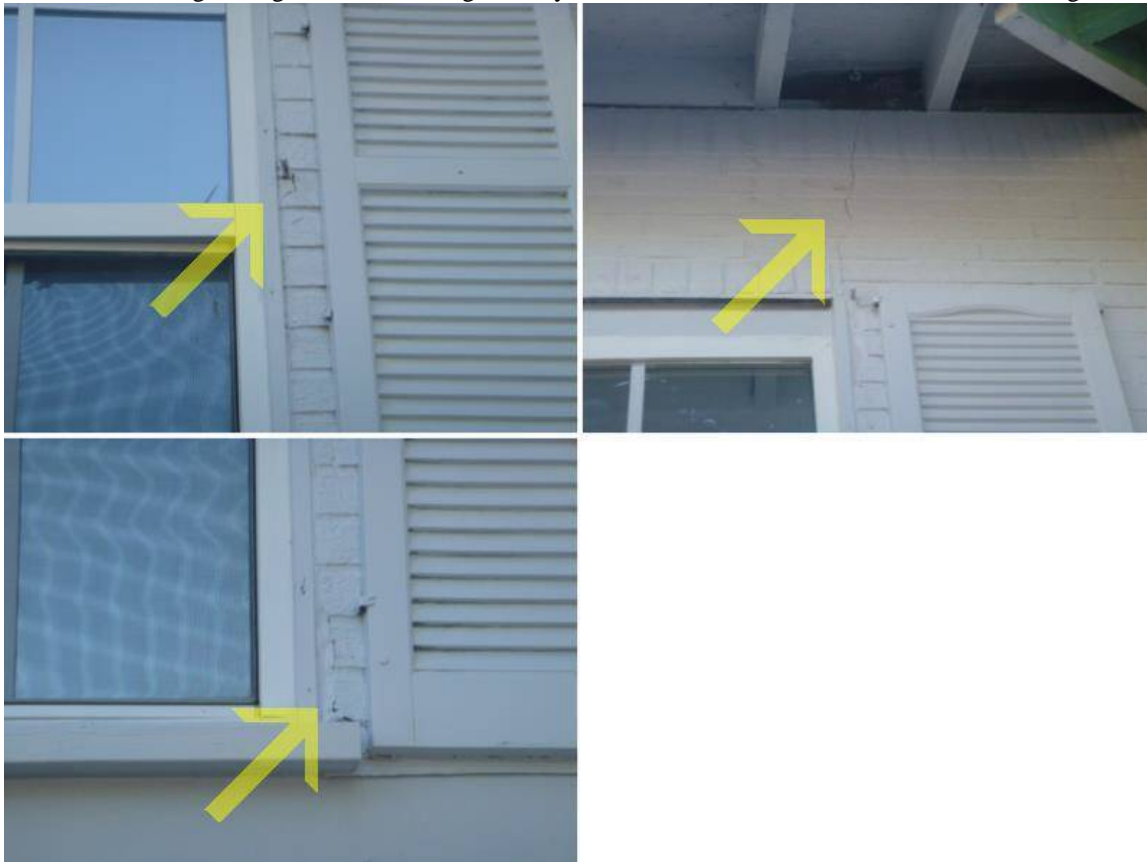
10. Some cracking/damage noted on the right side yard stucco wall at window. Recommend sealing cracks as needed.

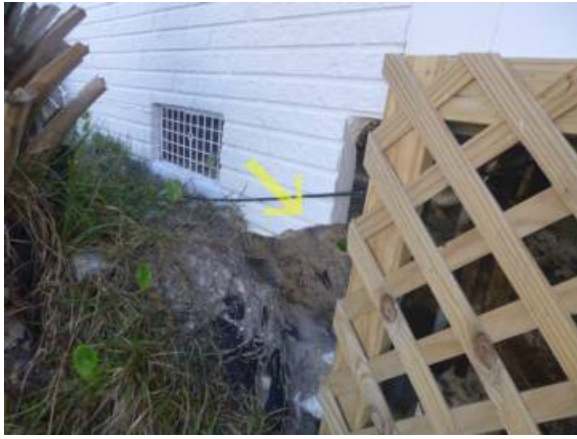
11. Damaged/missing stucco noted on the right side yard.

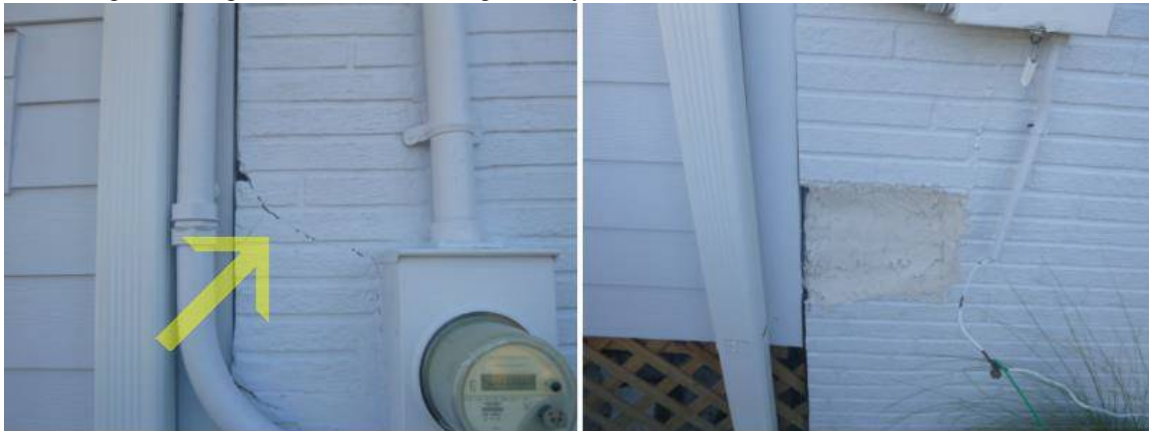
13. Damaged/missing stucco noted on the right side yard.

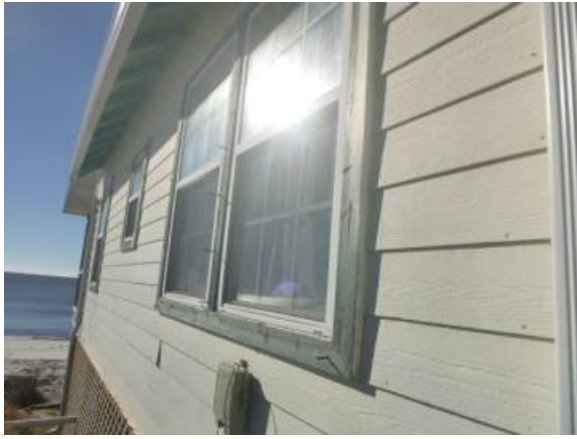
14. The paint and finish on the exterior window trim is missing/deteriorated on the left side yard.

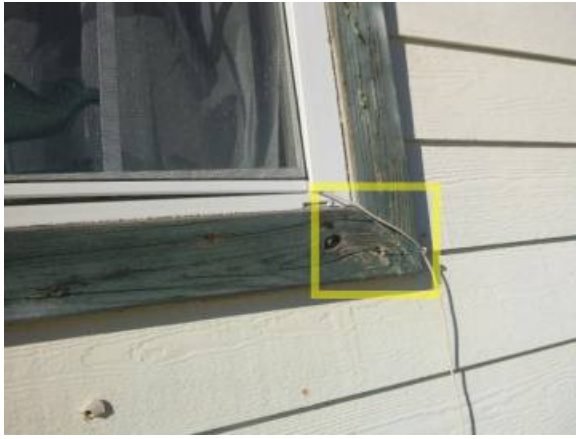
17. Wood rot noted on the exterior trim: left side yard window trim.

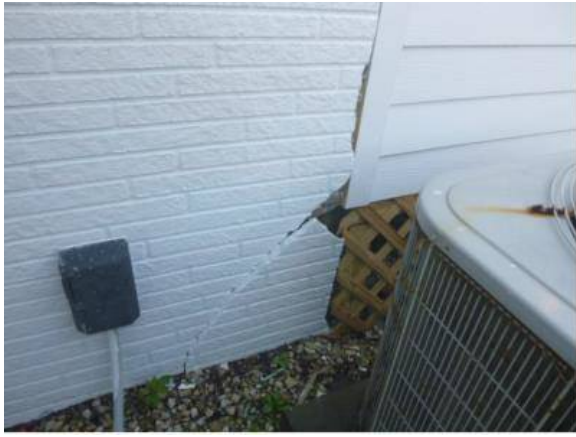
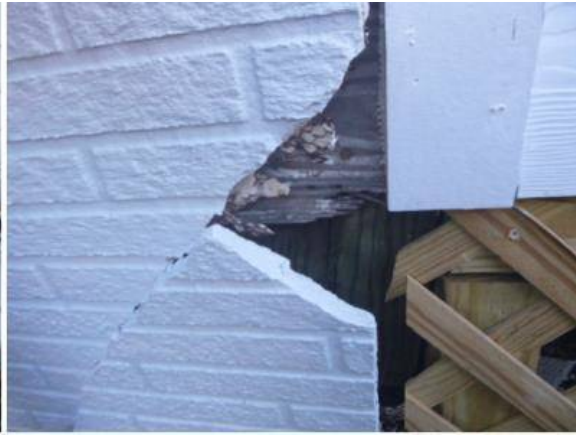
20. Cracked/damaged siding noted in the AC area and the exposed wood wall sheathing has wood rot. Recommend repairs by a licensed contractor.

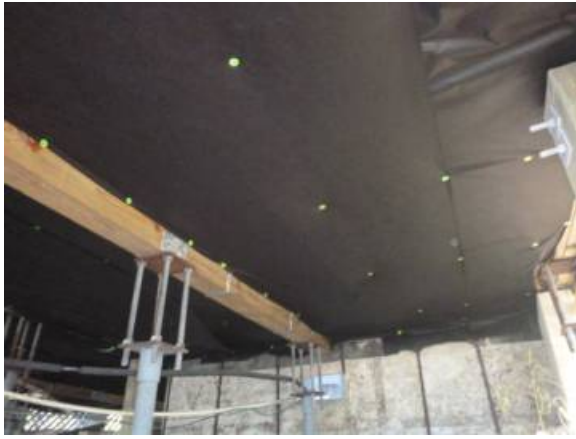
23. Crawl space ceiling felt restricted full view of the floor framing members and sub floor. Inspection was limited.

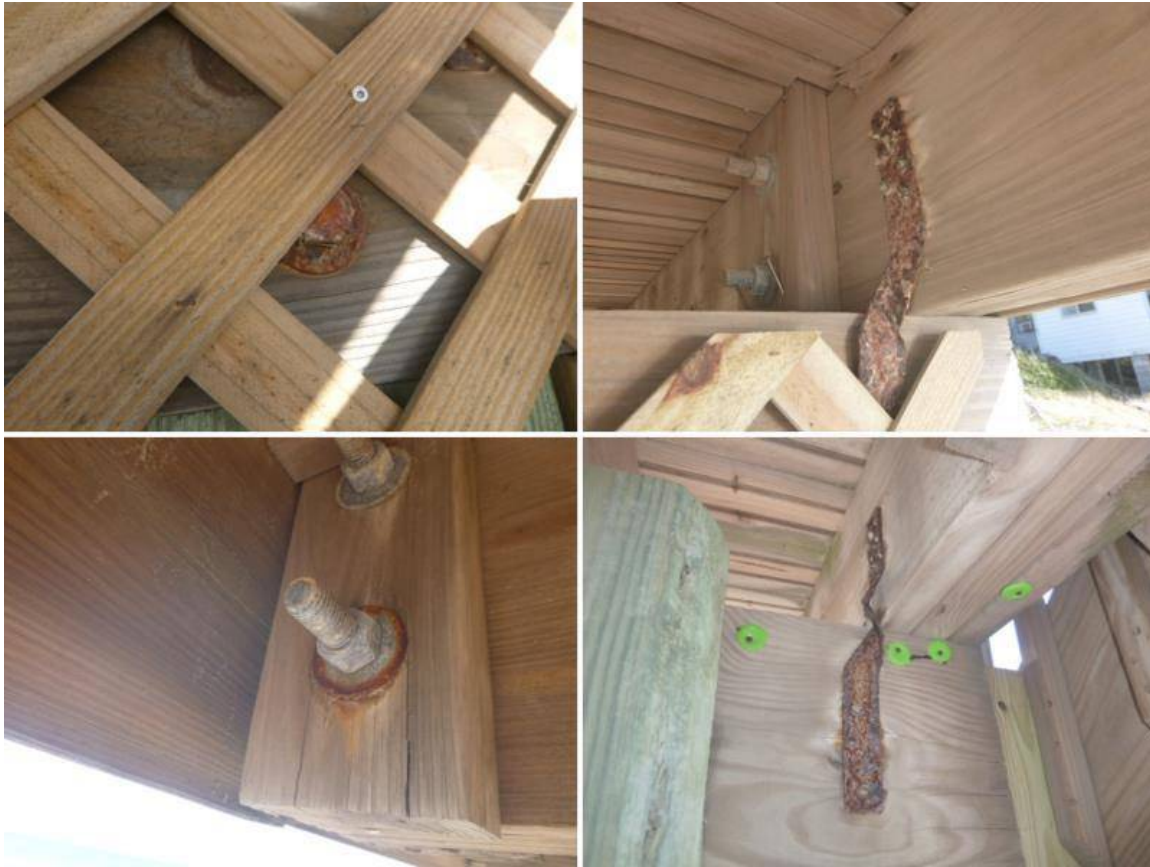
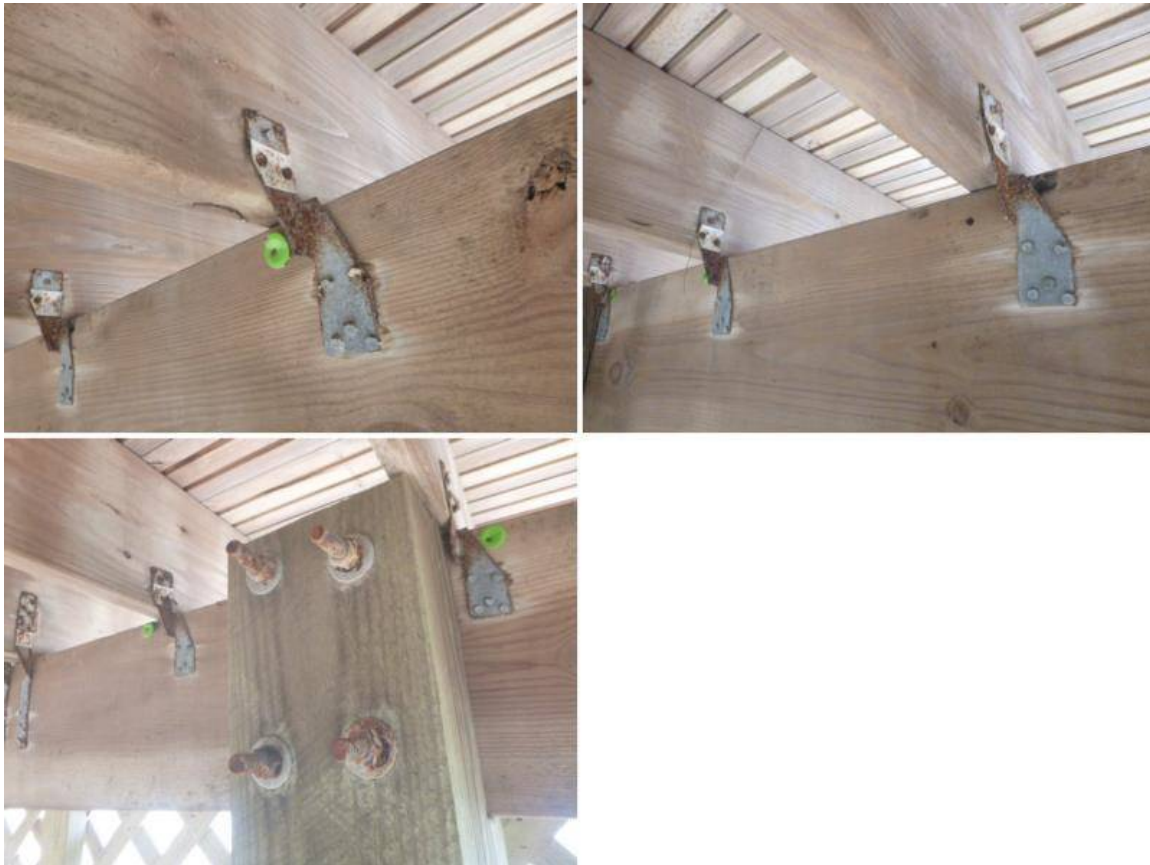
25. Various hurricane clips and framing fasteners below the home have rust/corrosion damage, recommend further evaluations by a licensed foundation specialist.

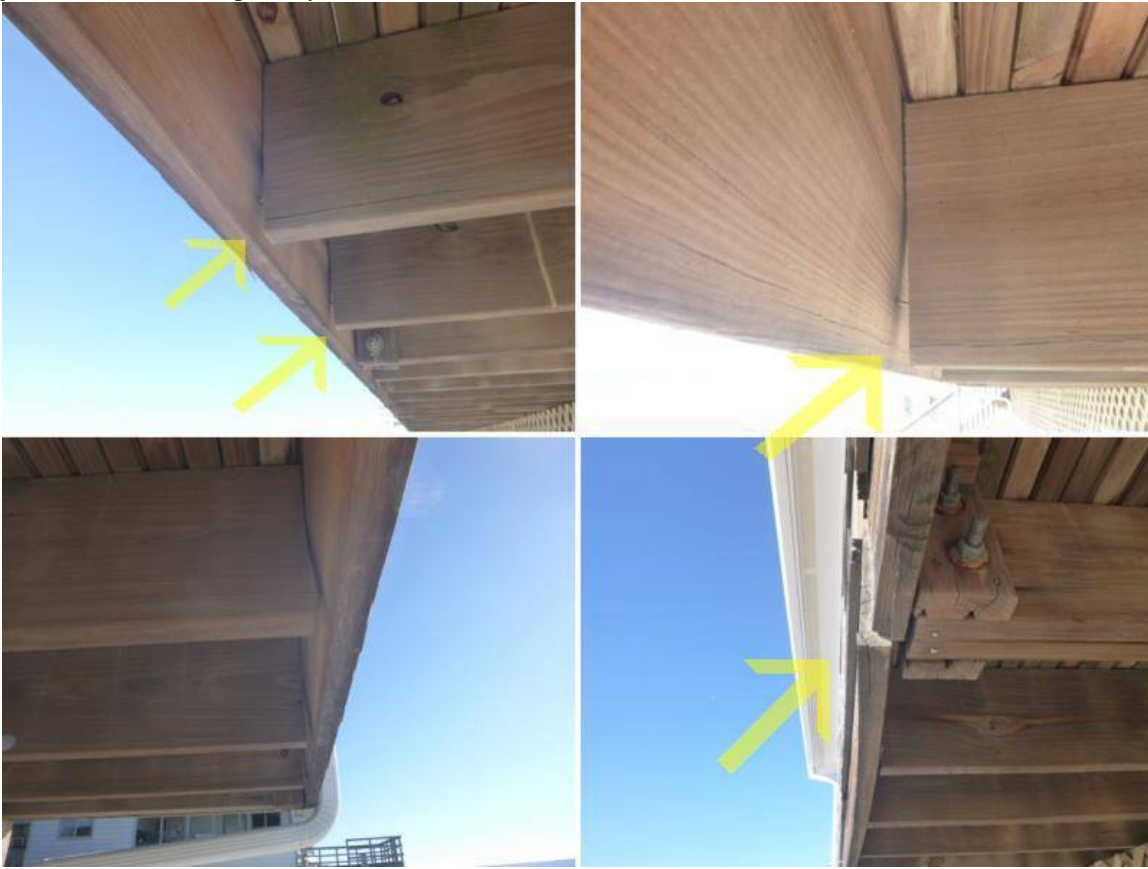
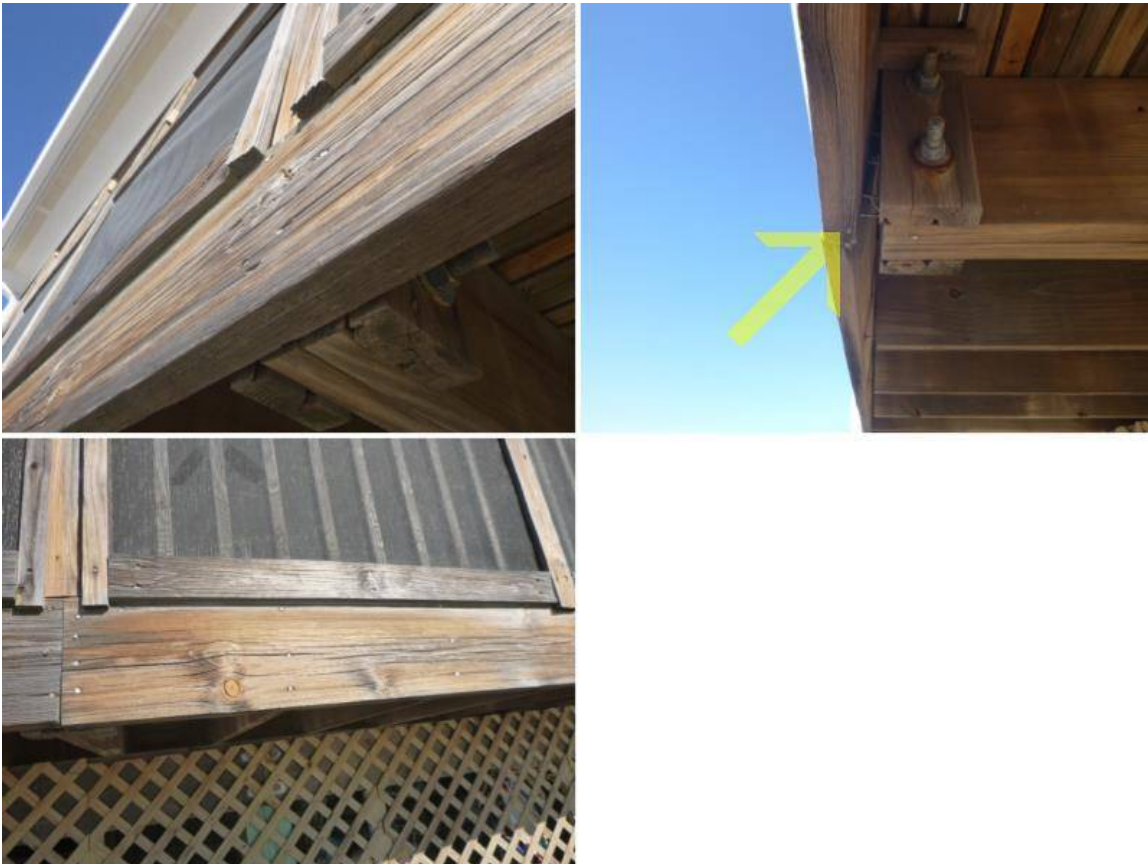
27. The rear screen porch outer band joist has some warping/deterioration, popped fasteners and separation from deck

joists. Recommend repairs by a licensed contractor.

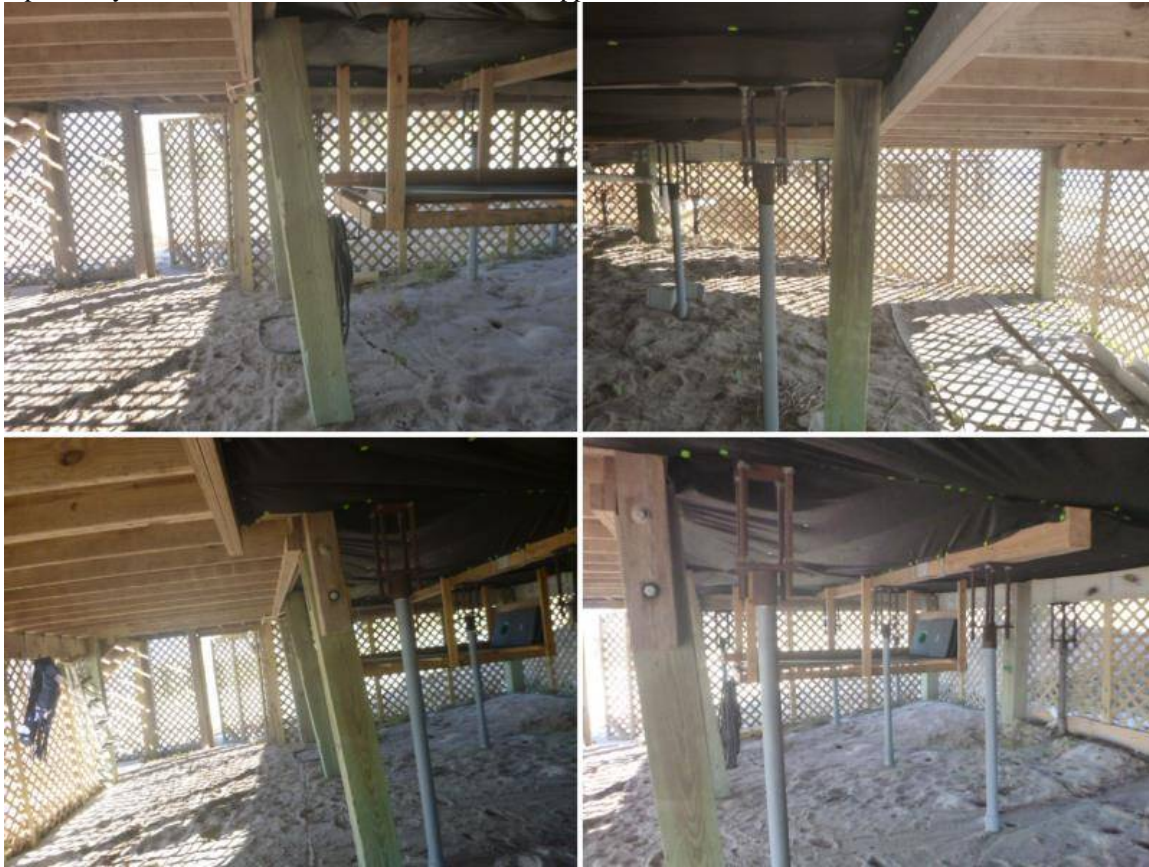
29. The rear foundation piers appear to have shifted and are not longer fully vertical. The foundation appears to have been repaired by the addition of new beams and metal supports.

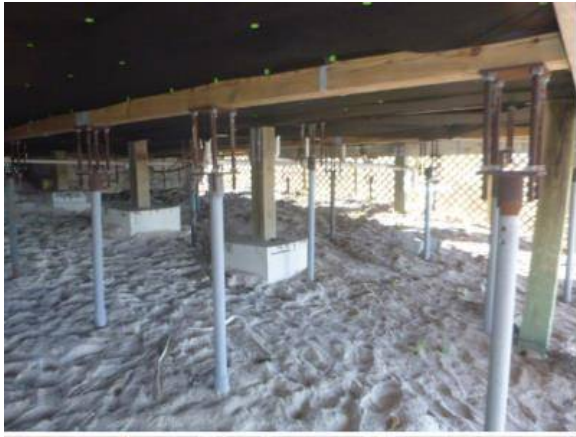
30. Same: Added metal supports appear to have some rust/corrosion. Recommend consulting foundation company who installed the supports on repairs/recommendations on corrosion since installation.

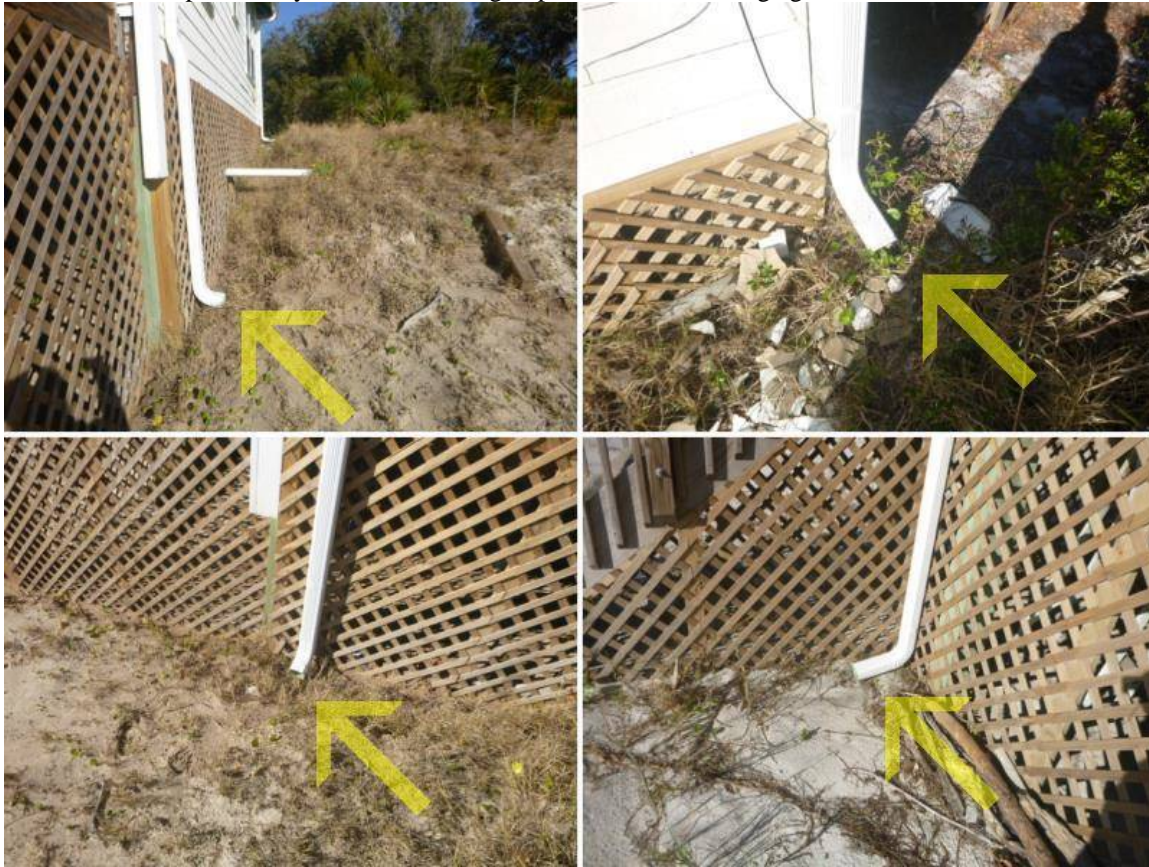
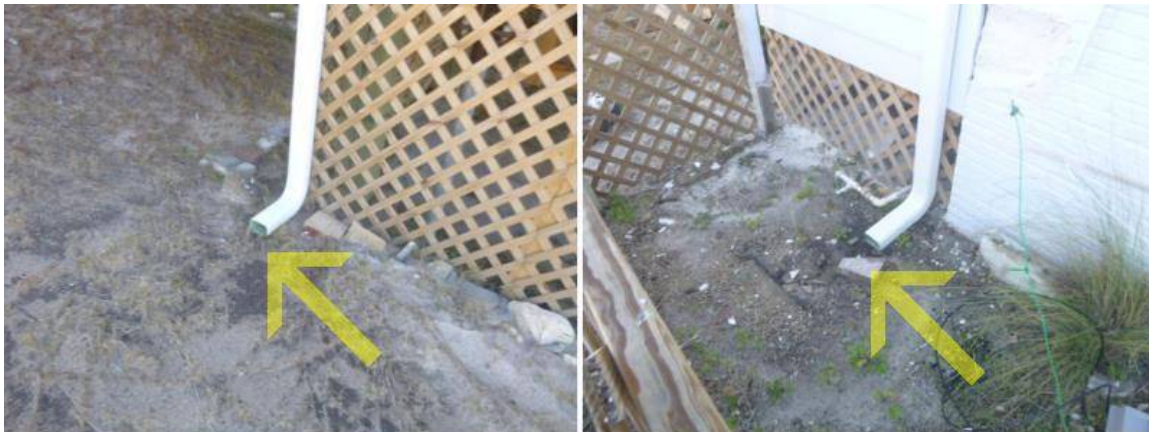
33. Route downspouts away from the building to prevent water settling against the foundation.

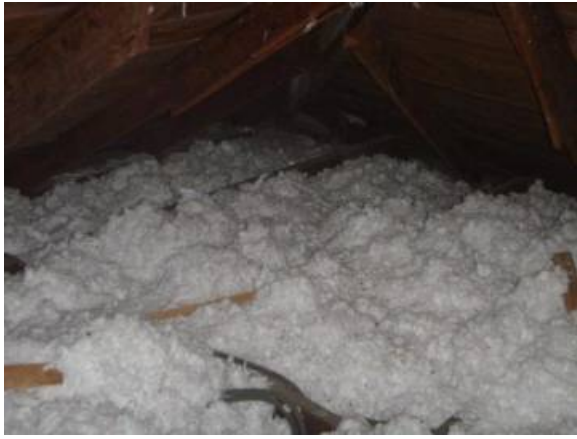
35. Evidence of prior rodent activity was noted. Recommend having a licensed pest control company evaluate rodent activity and entry points and treat/repair as needed.

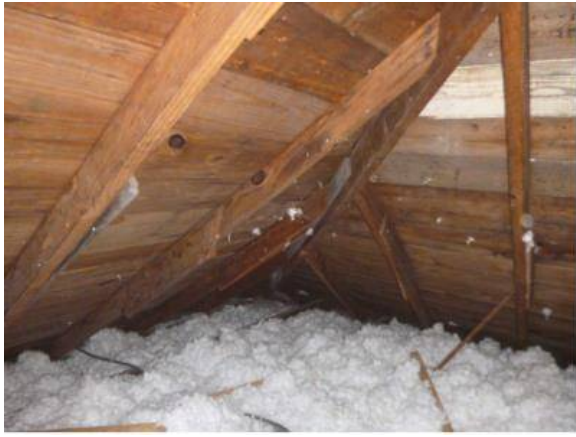
37. Some hip ridges appears to have slight sags from missing or damaged bracing. Recommend further evaluations by a licensed contractor.

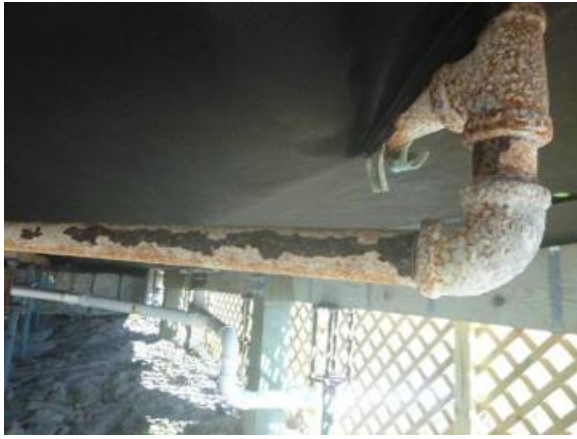
39. Rust/corrosion damage noted on exposed galvanized steel piping, recommend further evaluations and repairs by a licensed plumber.

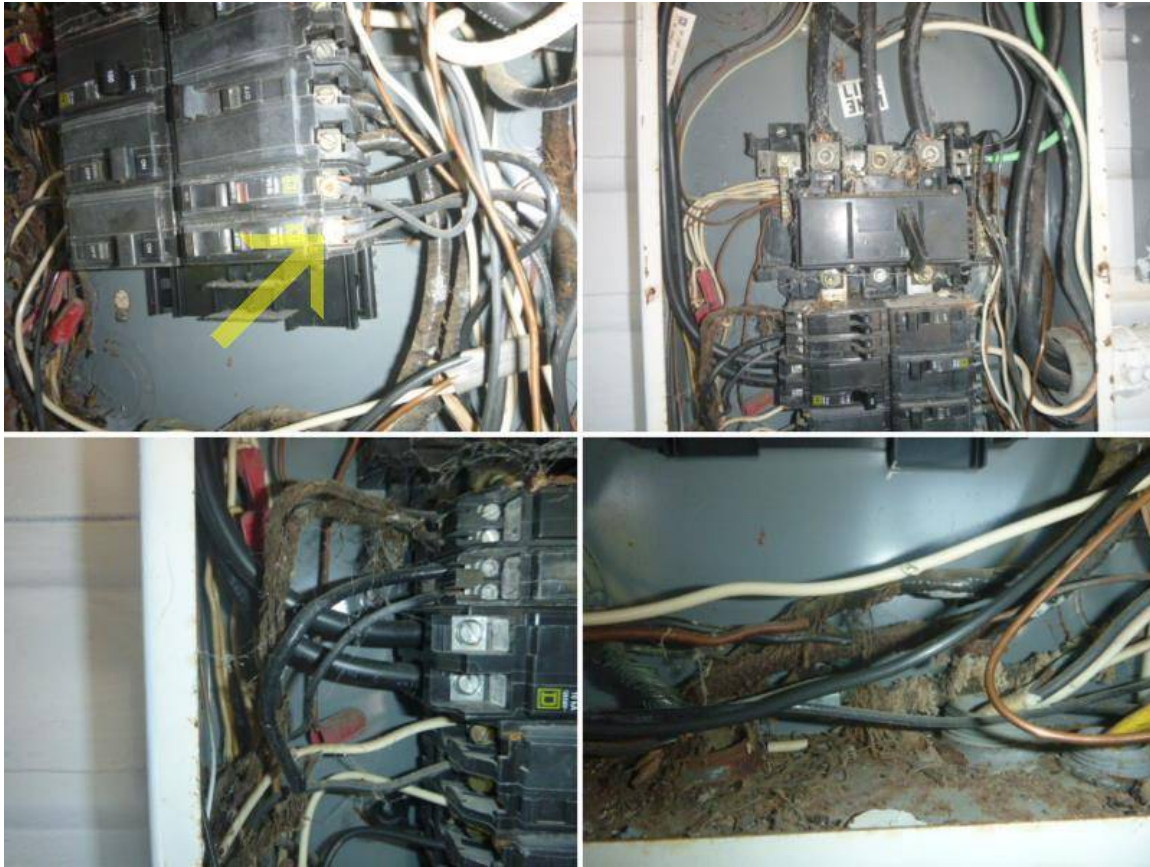
46. The following problems were noted at the electrical panel:

- Multiple wires are connected to a single lug on a circuit breaker in the electrical panel where only one wire should be connected.
- Recommend having the interior of the panel cleaned of all debris.
- The type of wiring noted appears to be copper wire wrapped with rubber or similar insulation in direct contact with the wiring with an exterior cloth material that is not in direct contact with the wire. Recommend inquiring with insurance company and electrician as to if this type of wiring is acceptable. This type of wiring was common practice for some time. Recommend further evaluations and repairs by a licensed electrician.

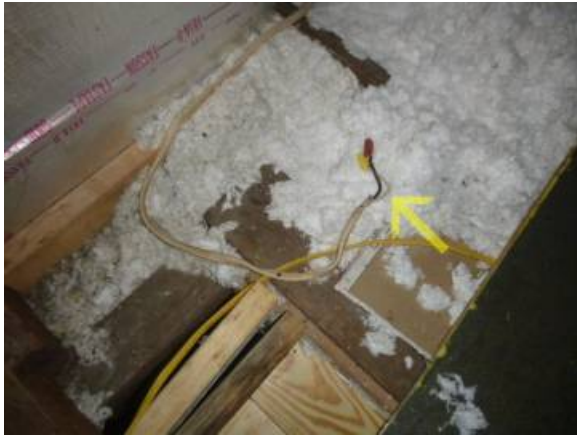
52. Recommend adding the wire splice near the attic entry to a covered junction box as needed.

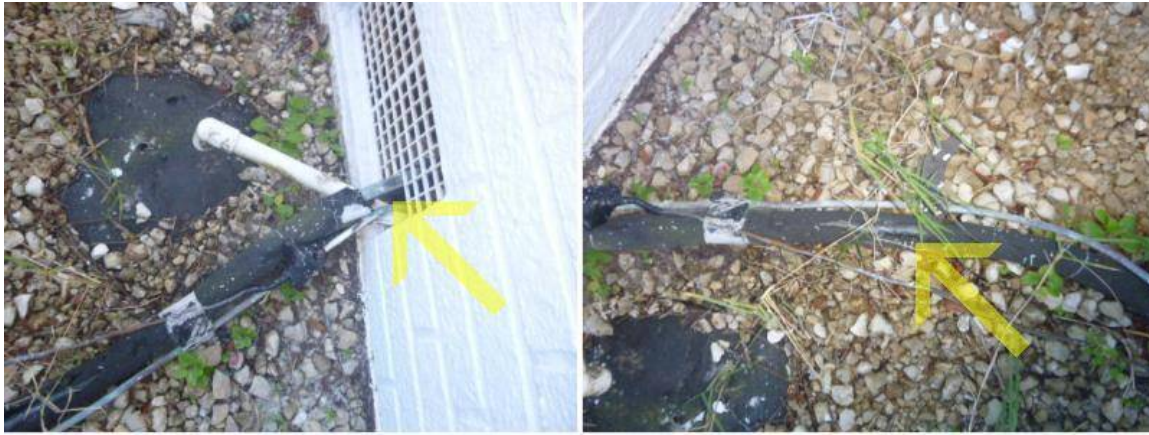
55. Freon line insulation at the outside HVAC condensing unit is deteriorated or missing.

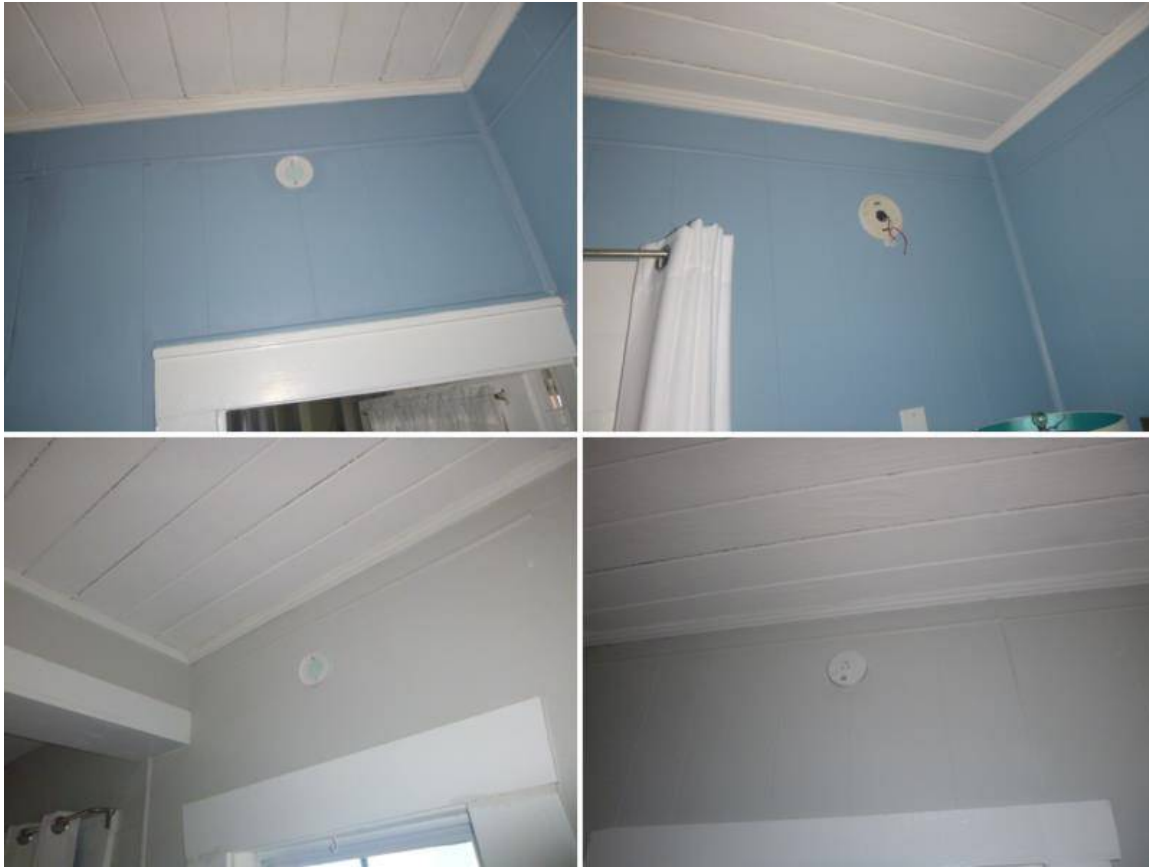
66. Missing/inoperable smoke detectors noted, recommend installing smoke detectors in all necessary locations.

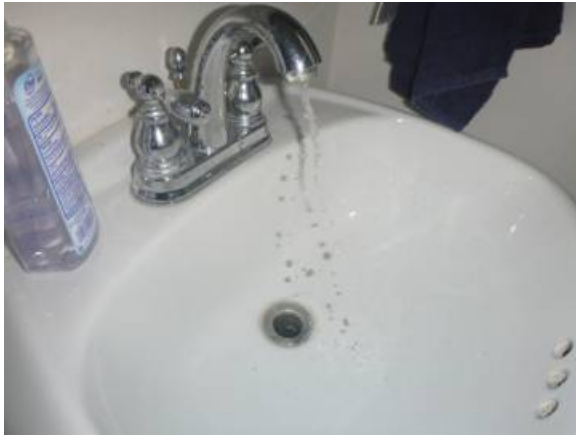
69. The following problems were noted at the sink: drain stopper is missing at sink and the aerator appears clogged.

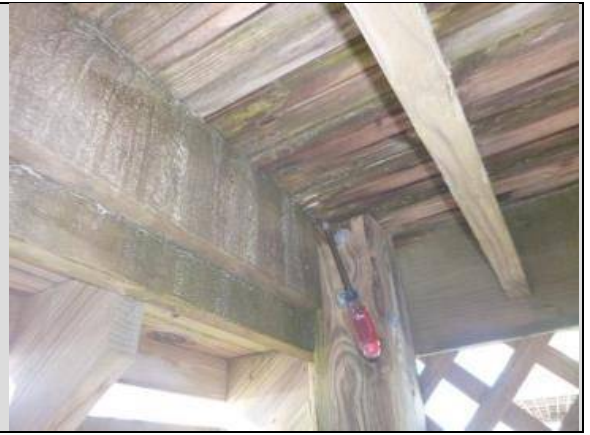
*Minor wood rot noted below the rear porch entry steps upper landing.*

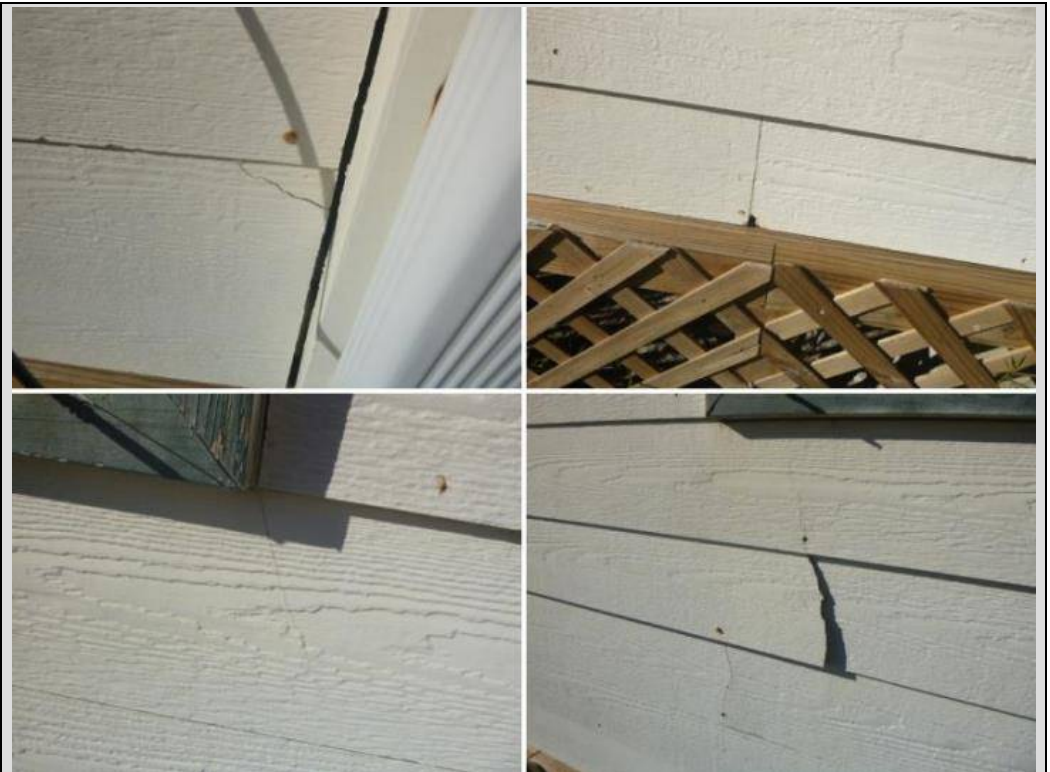
**Cracked/damaged siding noted on the left side yard siding, recommend repairs to prevent further damage/deterioration.**

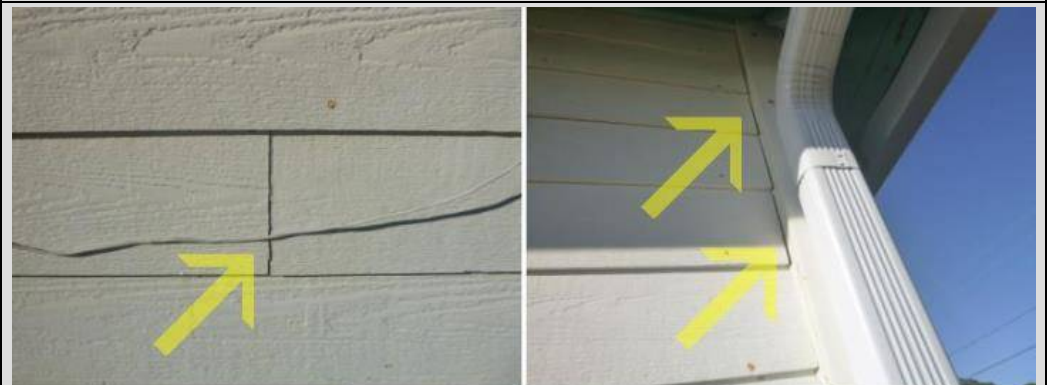
**Some or all of the exterior siding is "Hardee Plank" fibrous siding. The vertical joints do not appear to be properly sealed. Manufacturers specifications require either flashing or caulk on all vertical joints. The joints either lack this treatment or the caulking is deteriorated. Recommend properly sealing all of the vertical joints.**

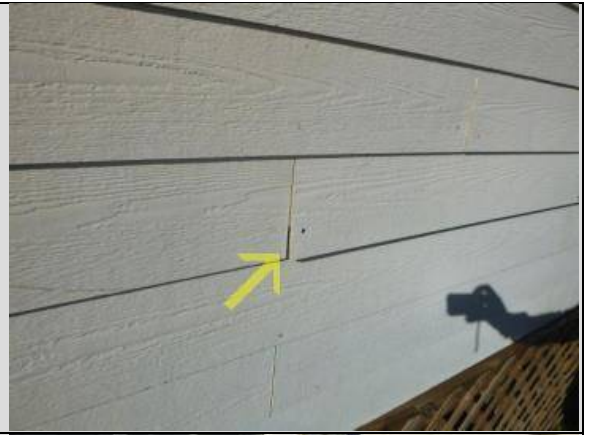
***Loose/popped siding noted on the left side yard, recommend securing and sealing as needed.***

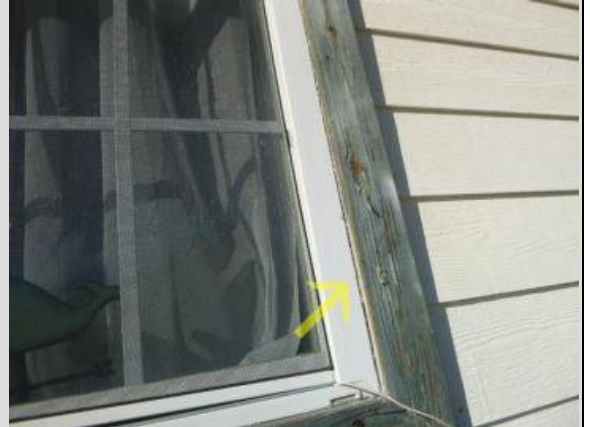
***Recommend sealing the transition from the trim to the windows.***

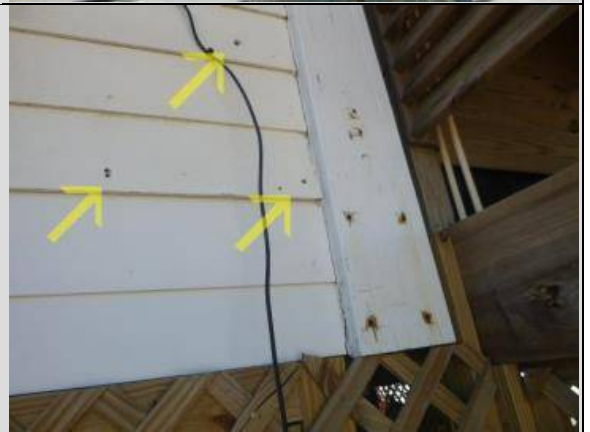
***Recommend sealing holes noted in the siding as needed.***

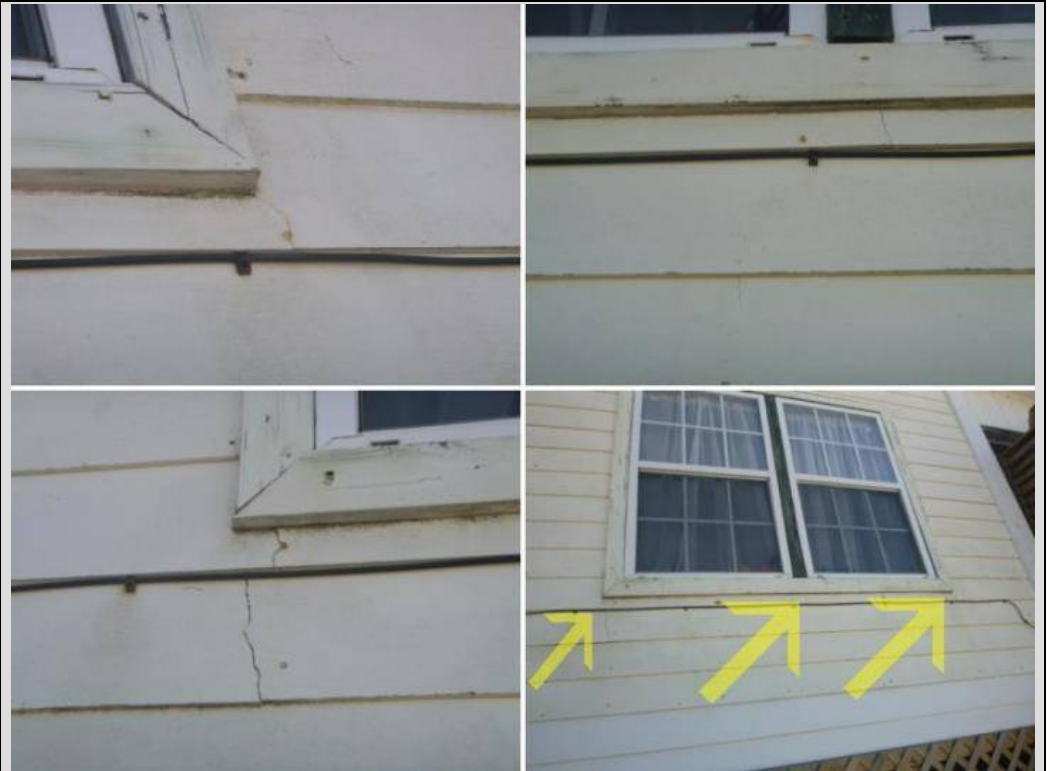
**Cracked/damaged siding noted on the right side yard siding, recommend repairs to prevent further damage/deterioration.**

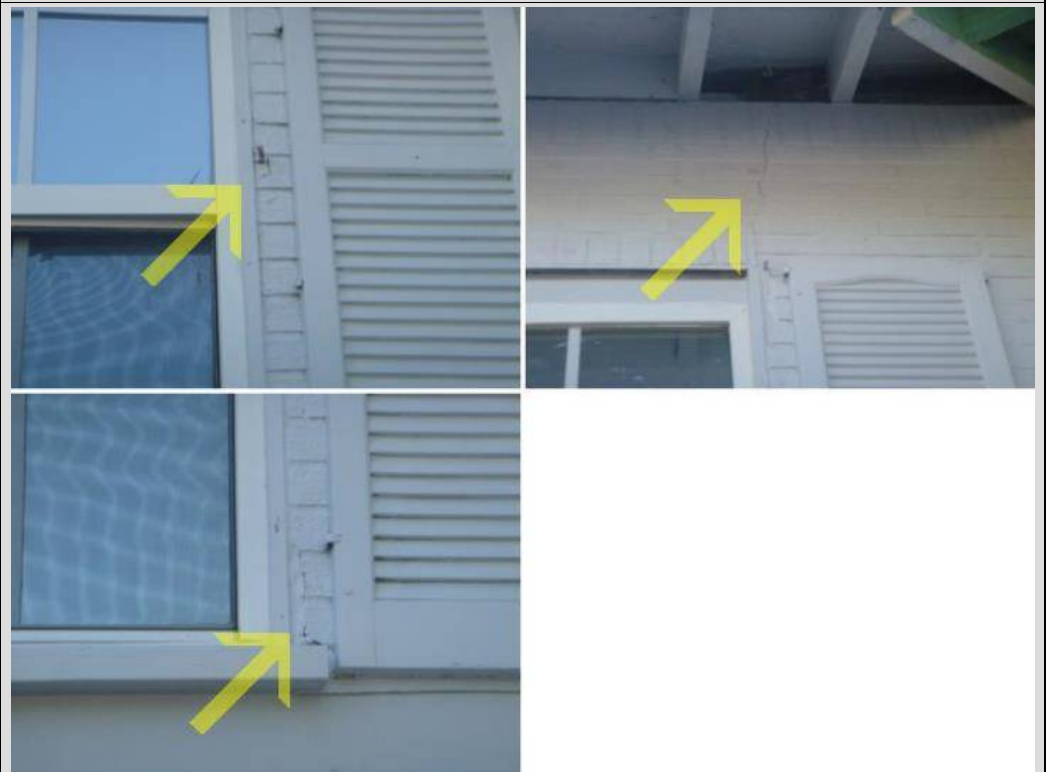
**Some cracking/damage noted on the right side yard stucco wall at window. Recommend sealing cracks as needed.**

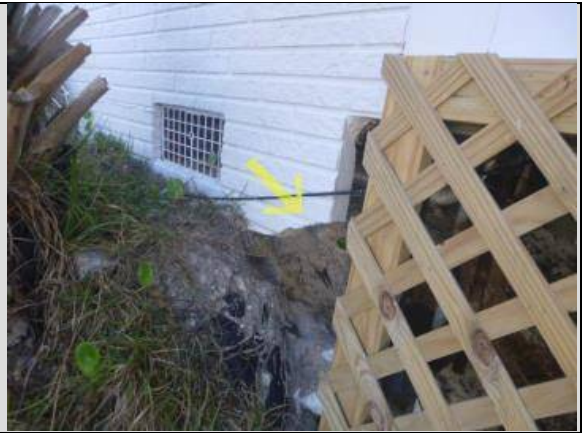
*Damaged/missing stucco noted on the right side yard.*

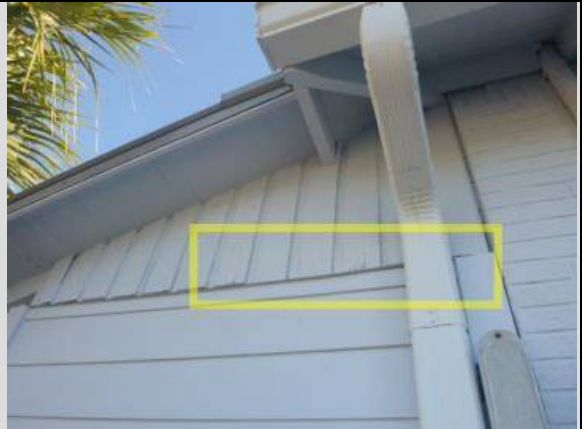
*Wood rot noted on exterior siding: right side yard front upper siding.*

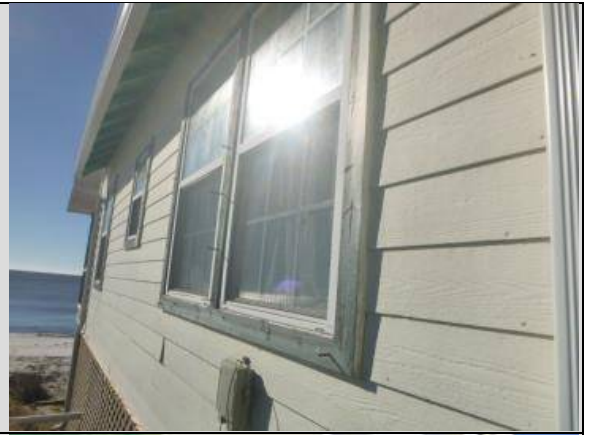
*The paint and finish on the exterior window trim is missing/deteriorated on the left side yard.*

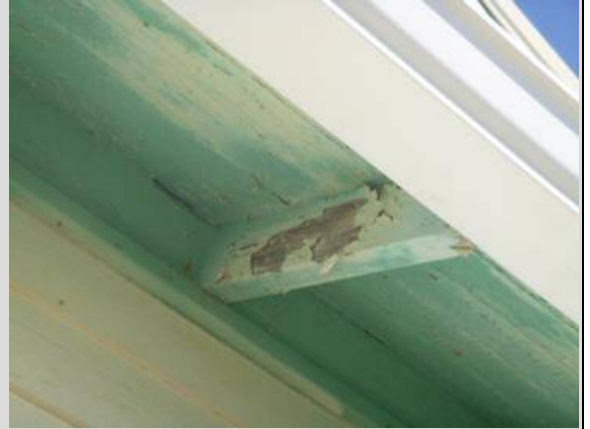
*Paint on exterior trim is deteriorated and peeling in various areas. Home was built prior to 1978. Care should be taken to insure that all lead base paint safety practices required by the Environmental Protection Agency are followed. Testing for the presence of lead base paint is beyond the scope of this inspection. Recommend a full lead base paint inspection be performed prior to any disturbance of painted surfaces.*

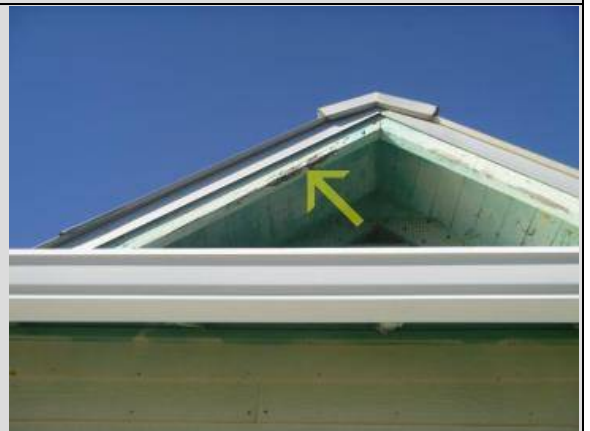
*Wood rot noted on the exterior trim: left side yard upper gable end fascia framing.*

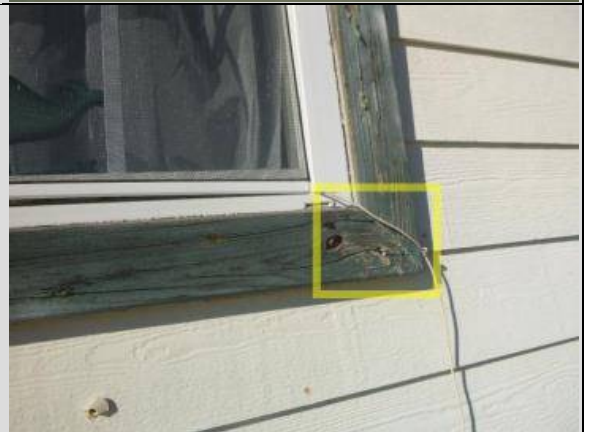
*Wood rot noted on the exterior trim: left side yard window trim.*
