# Property Inspection Report

**Inspection Date: 01/04/2024.**

**Report #: 010424DW2.**

**1215 Alligator Dr.  
Alligator Point, FL 32346.**

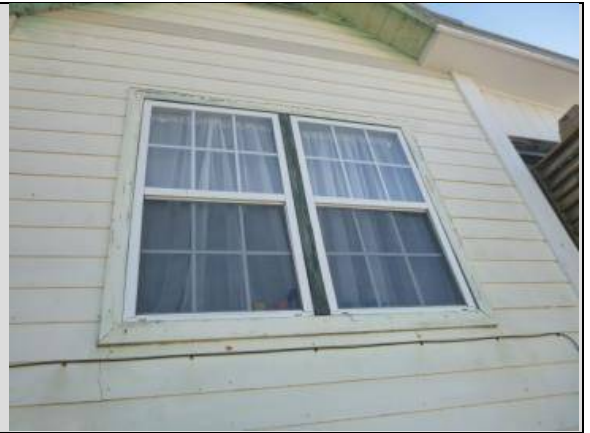
*The paint and finish on the exterior window trim is missing/deteriorated on the right side yard.*

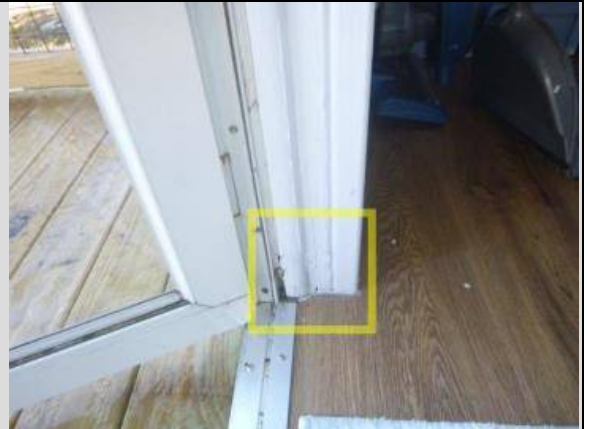
*Wood rot noted on the exterior trim: front storm door entry frame/jamb.*

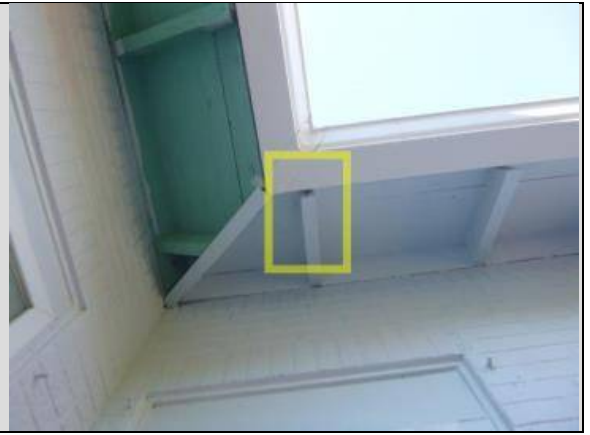
**Wood rot/possible WDO damage noted on the rafter tail above the AC areas.**

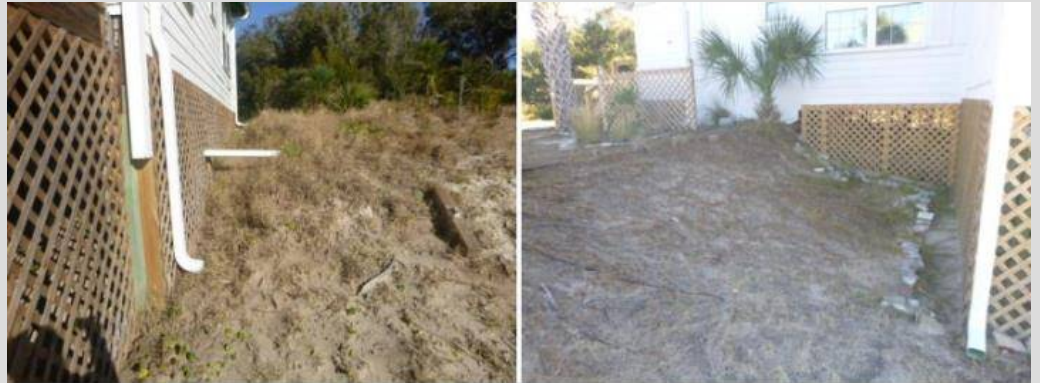
**The grade along the foundation is improperly sloped toward the structure at the front and both sides of the house. Recommend re-grading to establish proper water flow away from the structure. Moisture intrusion and evidence of water flowing under the house noted.**

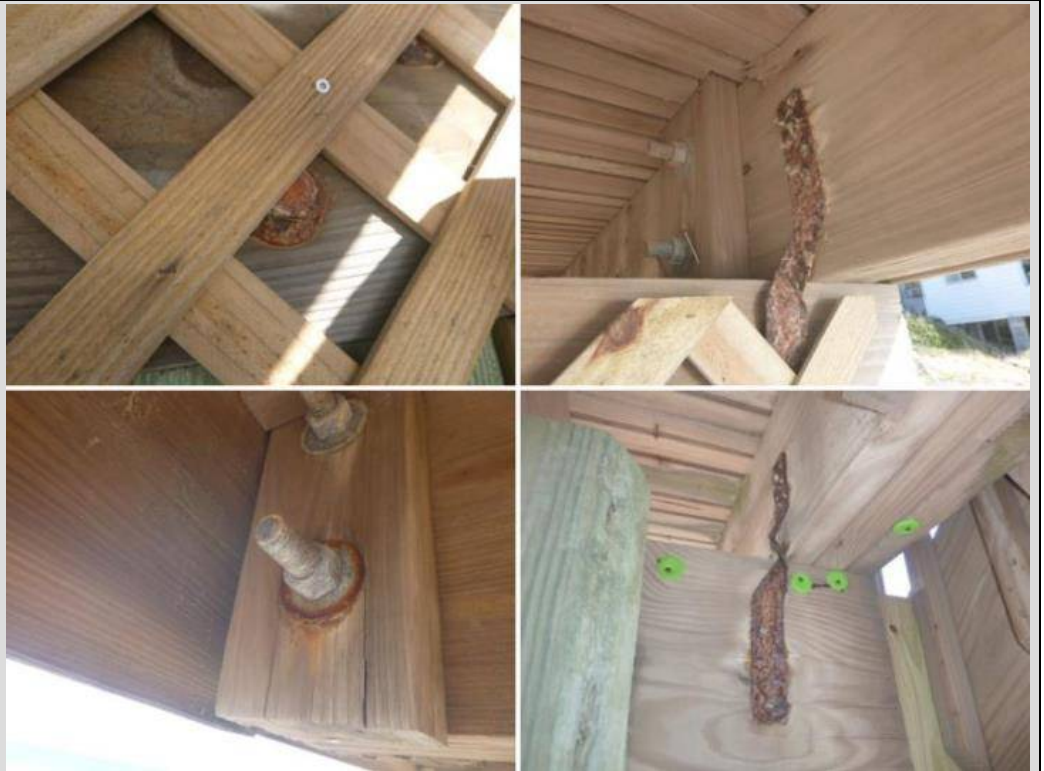
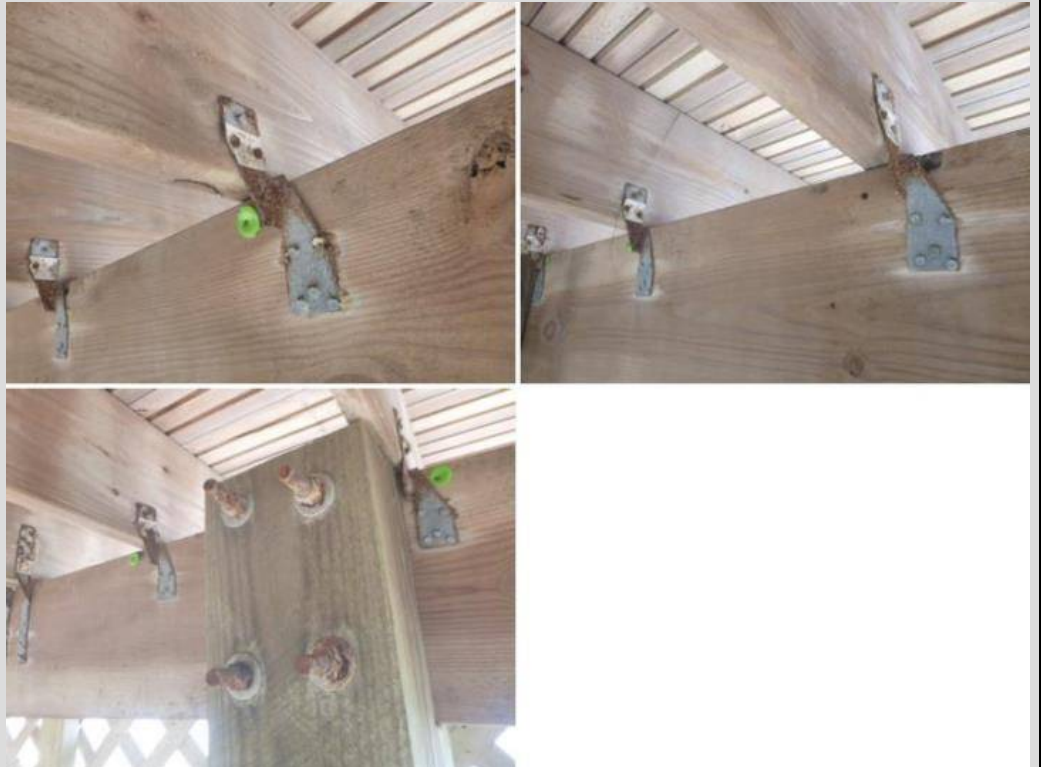
*Various hurricane clips and framing fasteners below the home have rust/corrosion damage, recommend further evaluations by a licensed foundation specialist.*

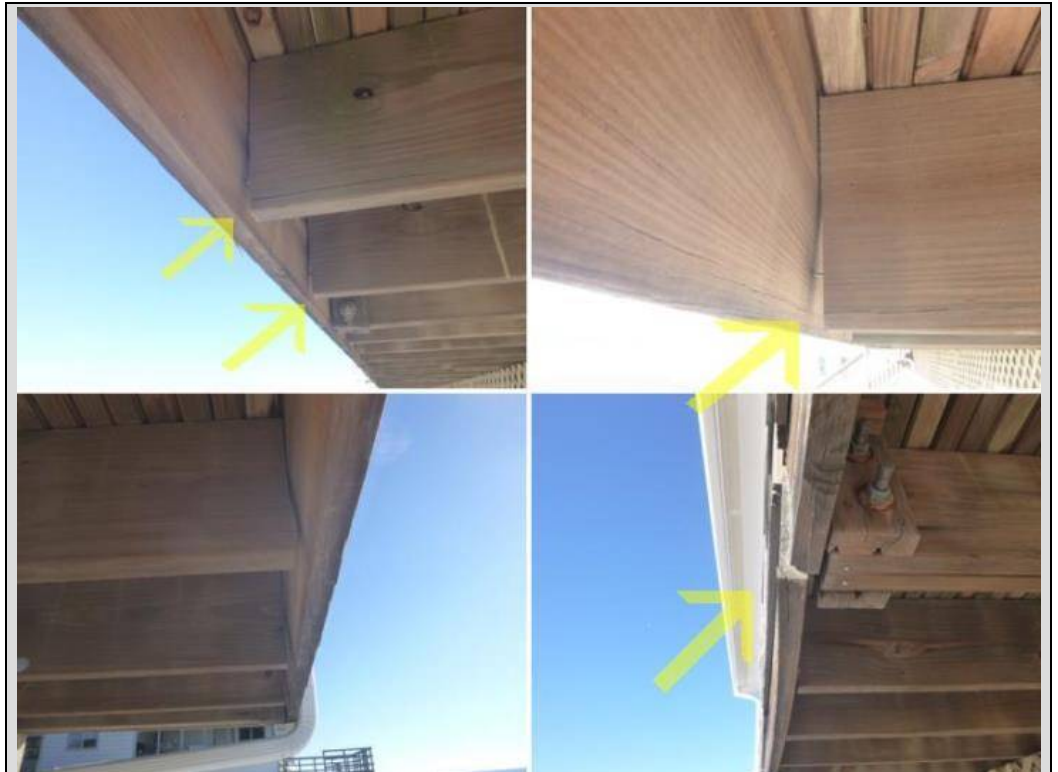
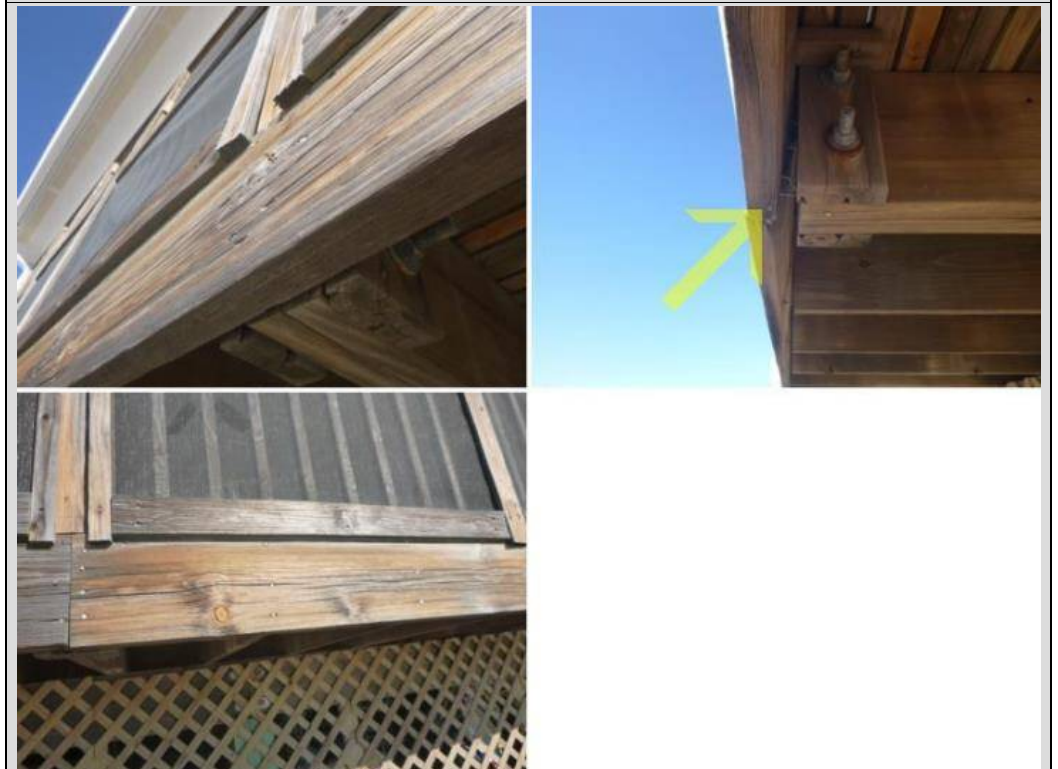
*The rear screen porch outer band joist has some warping/deterioration, popped fasteners and separation from deck joists. Recommend repairs by a licensed contractor.*

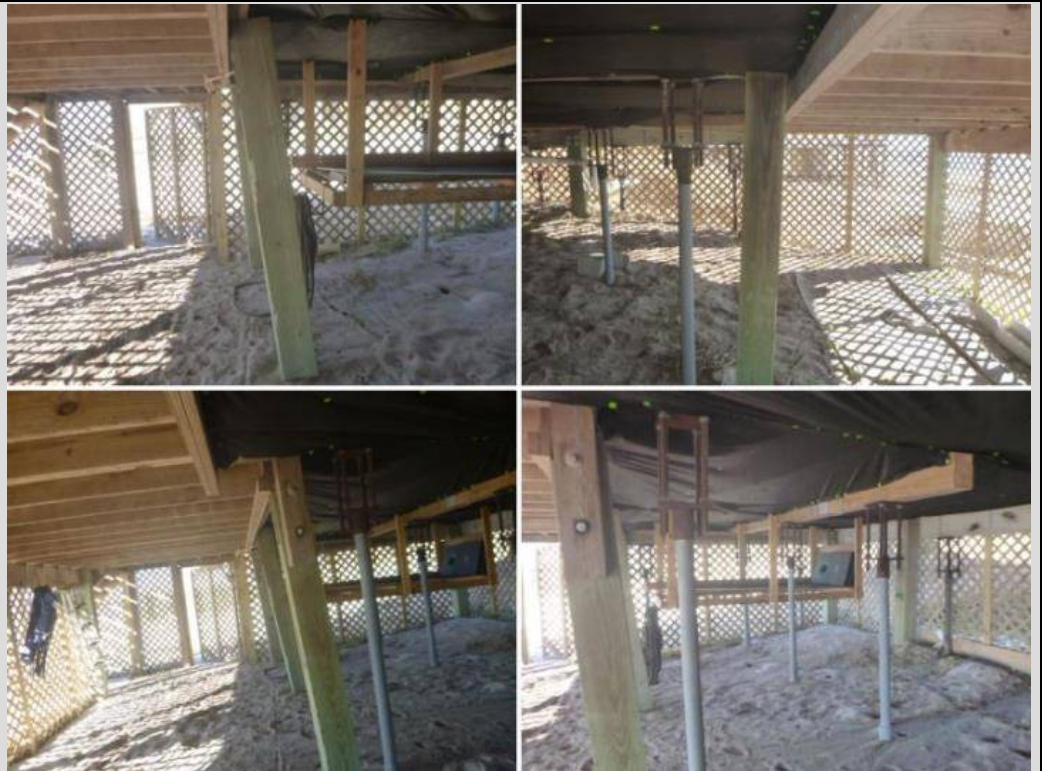
*The rear foundation piers appear to have shifted and are not longer fully vertical. The foundation appears to have been repaired by the addition of new beams and metal supports.*

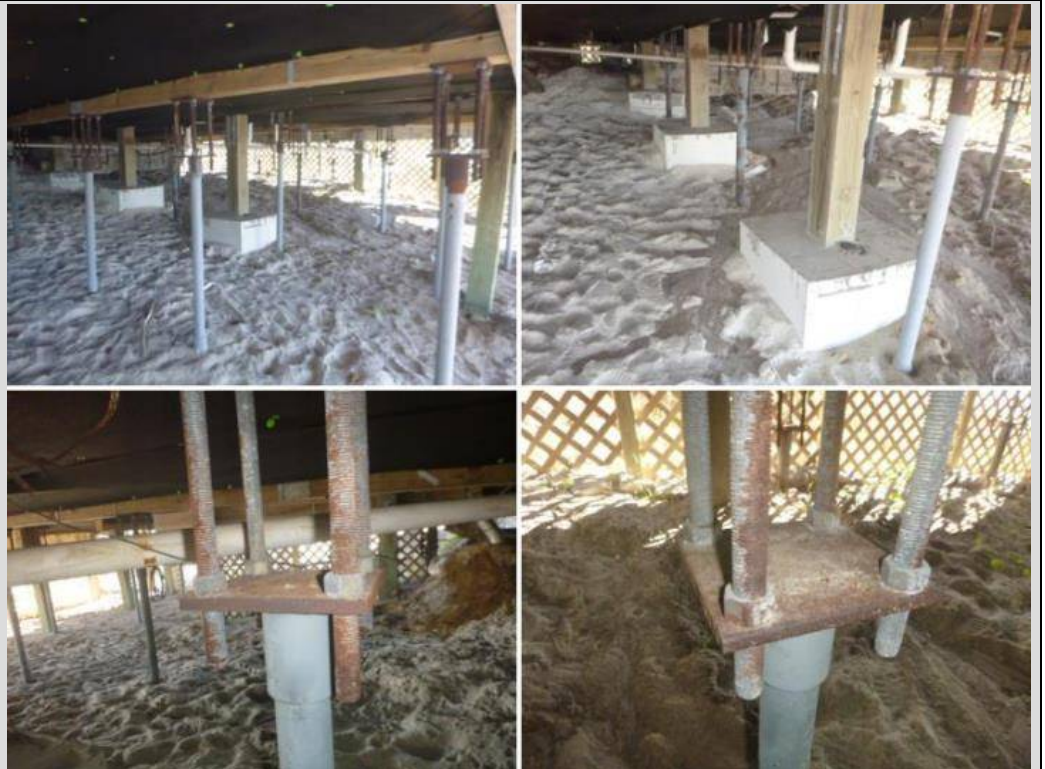
*Same: Added metal supports appear to have some rust/corrosion. Recommend consulting foundation company who installed the supports on repairs/recommendations on corrosion since installation.*

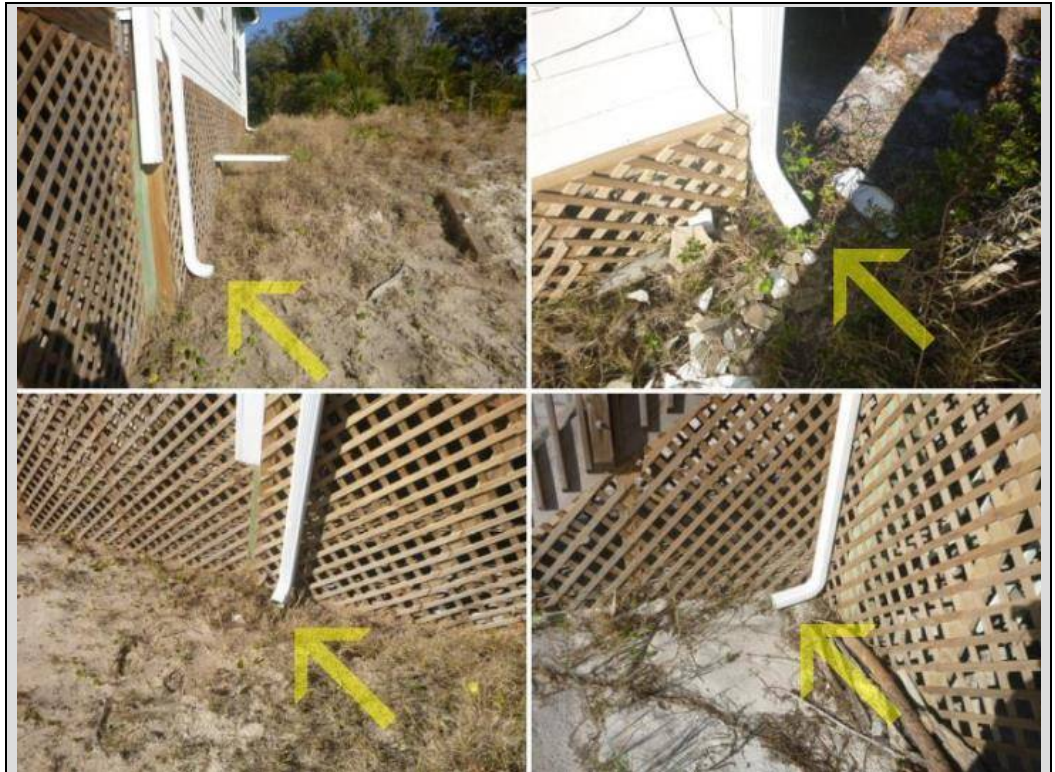
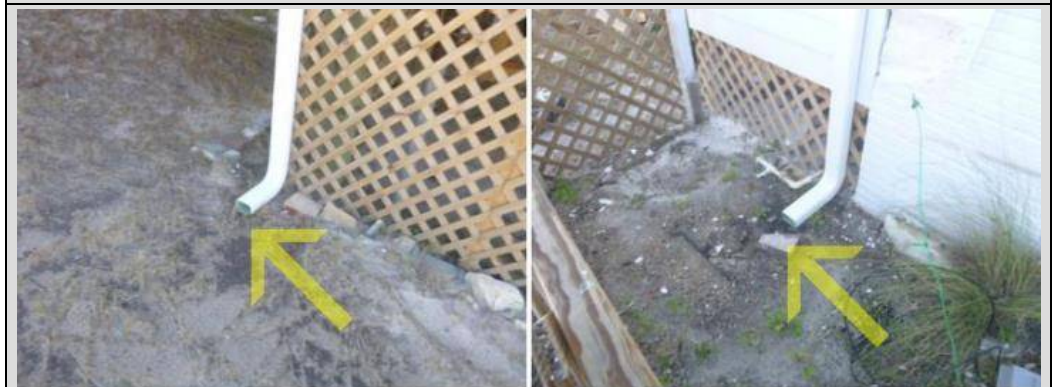
*Route downspouts away from the building to prevent water settling against the foundation.*

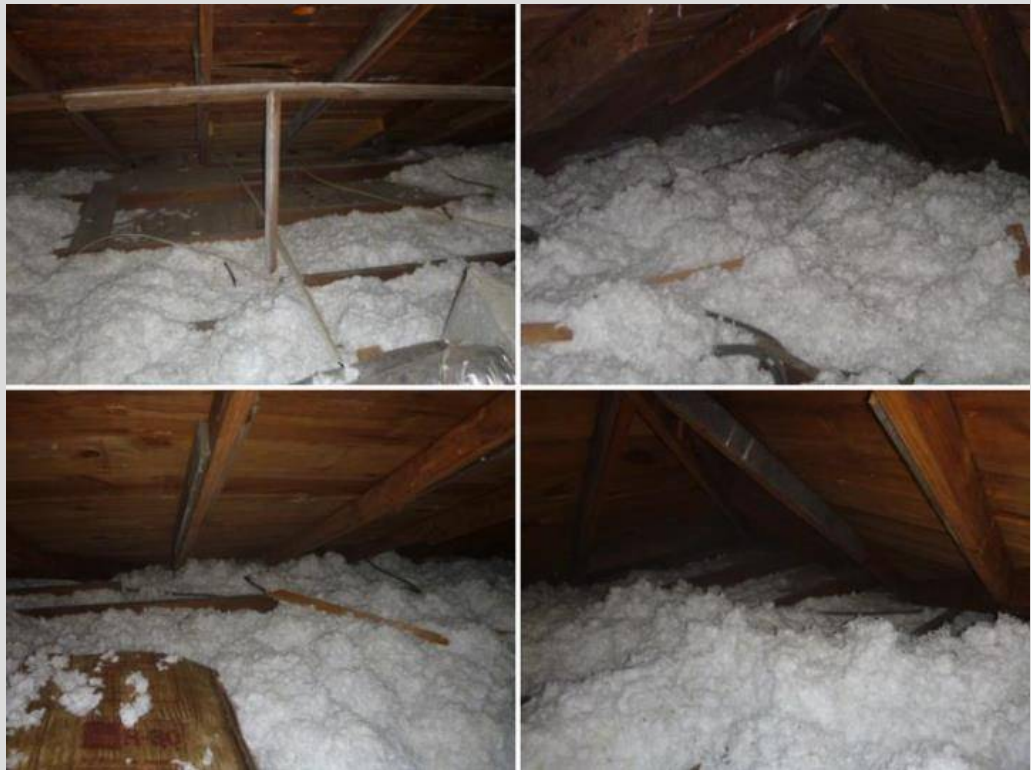
*Insulation is somewhat disturbed/compacted and the true R-factor at this point in time may be substantially less than that originally installed. Installation of additional insulation is recommended.*

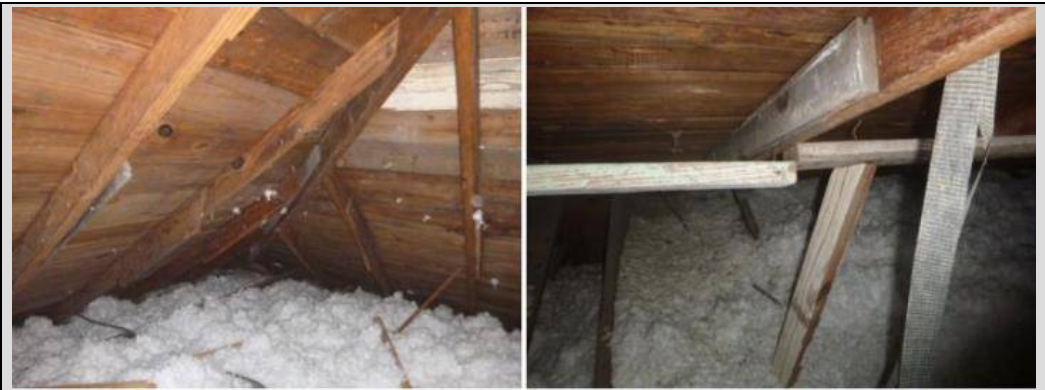
Some hip ridges appears to have slight sags from missing or damaged bracing. Recommend further evaluations by a licensed contractor.

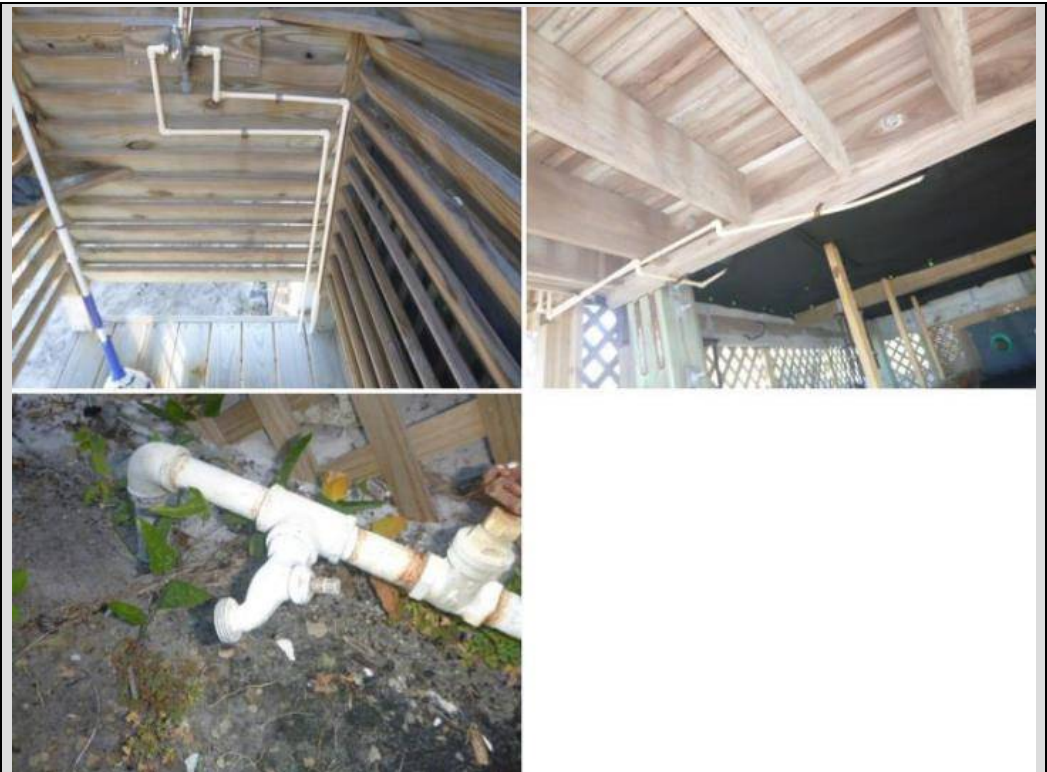
*Recommend insulating all exterior exposed piping to prevent freeze damage.*

*Rust/corrosion damage noted on exposed galvanized steel piping, recommend further evaluations and repairs by a licensed plumber.*

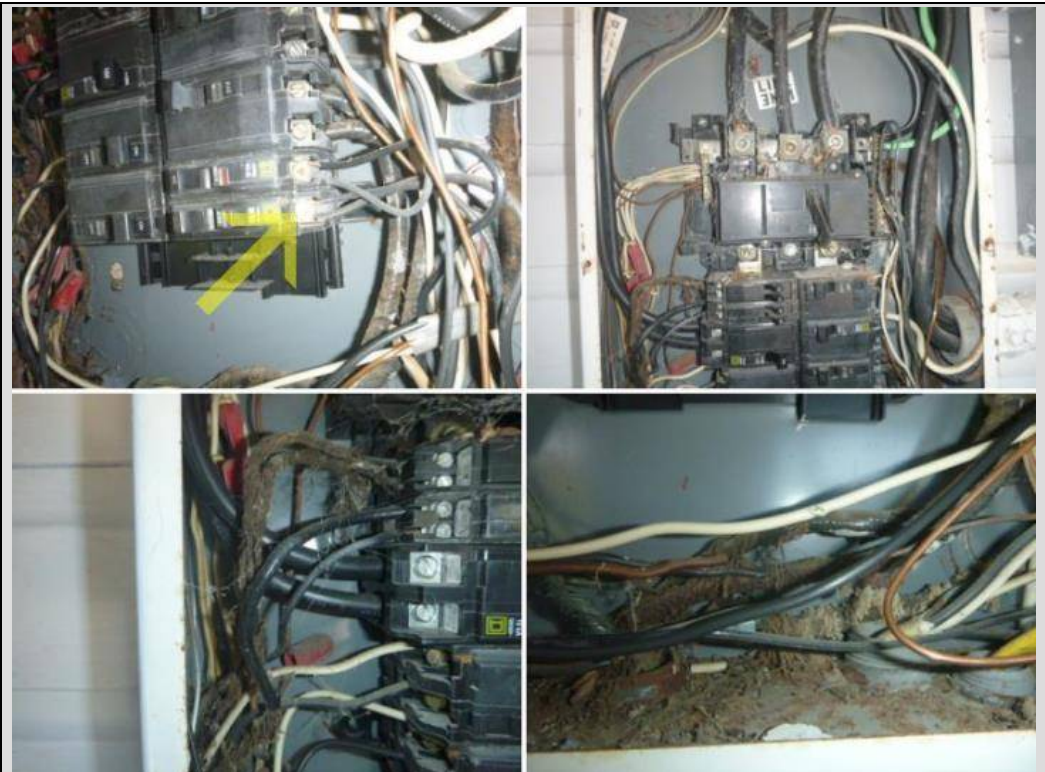
*The following problems were noted at the electrical panel:*

- Multiple wires are connected to a single lug on a circuit breaker in the electrical panel where only one wire should be connected.
- Recommend having the interior of the panel cleaned of all debris.
- The type of wiring noted appears to be copper wire wrapped with rubber or similar insulation in direct contact with the wiring with an exterior cloth material that is not in direct contact with the wire. Recommend inquiring with insurance company and electrician as to if this type of wiring is acceptable. This type of wiring was common practice for some time

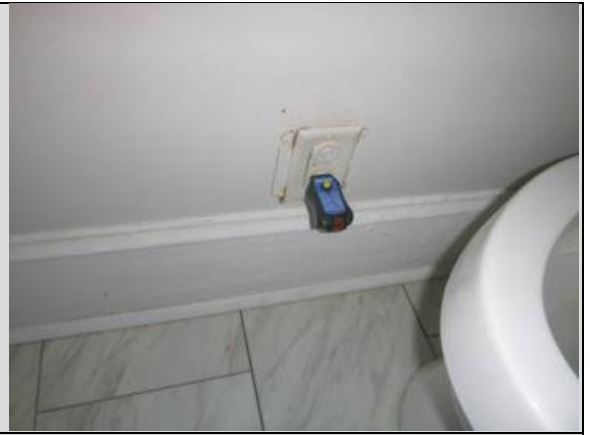
**Electrical outlet(s) had no power:  
jack and jill bathroom GFCI outlet.**

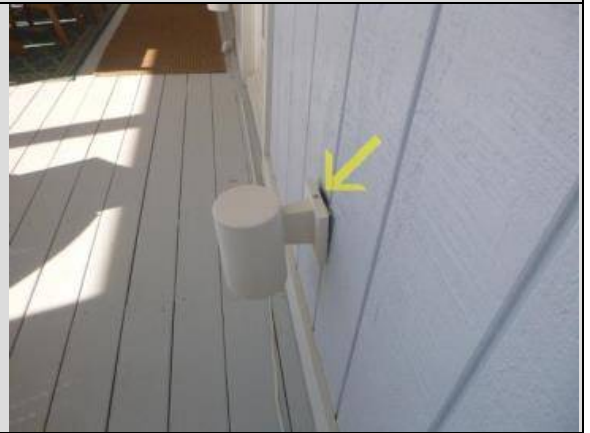
**Loose light fixture noted at the rear screen porch.**

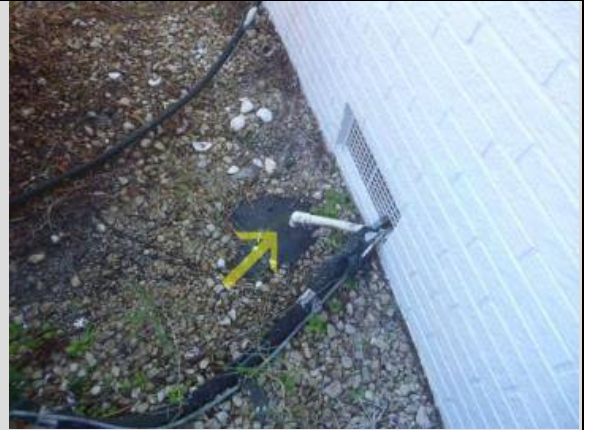
**Recommend extending the condensation line away from the foundation.**

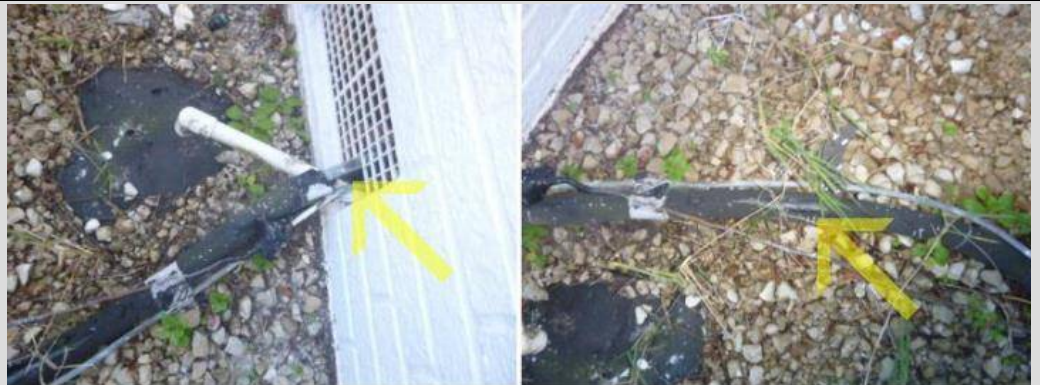
**Freon line insulation at the outside HVAC condensing unit is deteriorated or missing.**

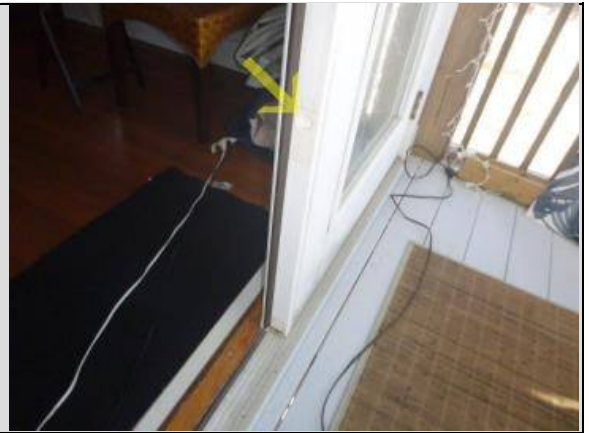
*The right hall bedroom french  
secondary door lower pin is  
inoperable.*

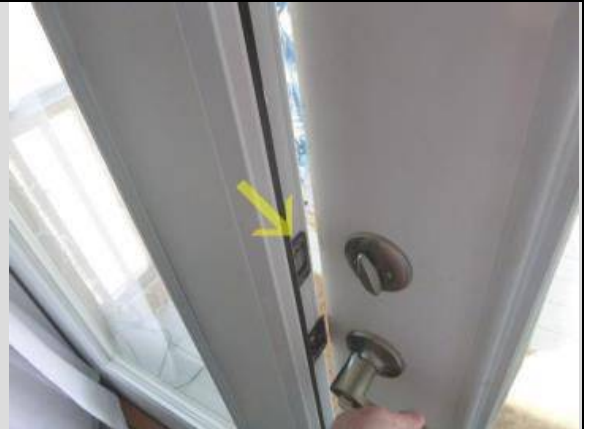
*The right hall bedroom french  
secondary door dead bolt is  
inoperable.*

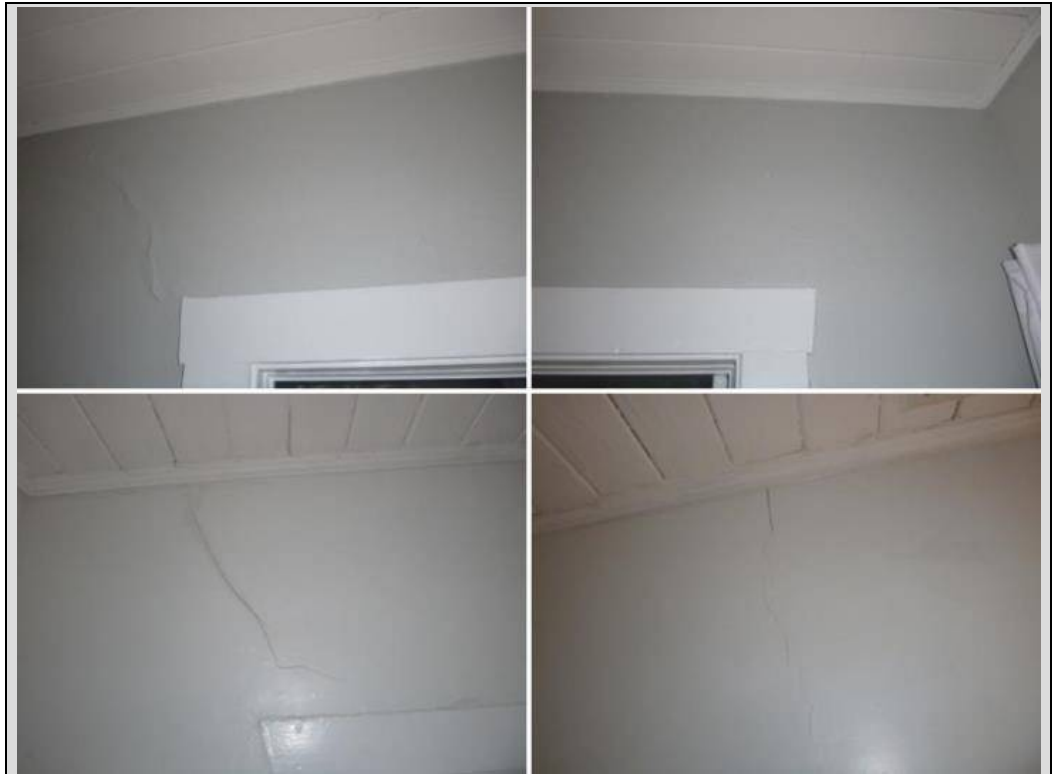
There are multiple cracks noted on interior wall, recent foundation repairs noted.
