Property Inspection Report

Southern Home Consultants, Inc.

Report #: 082021WO6.

**1215 Alligator Drive.
Alligator Point, FL 32346.**

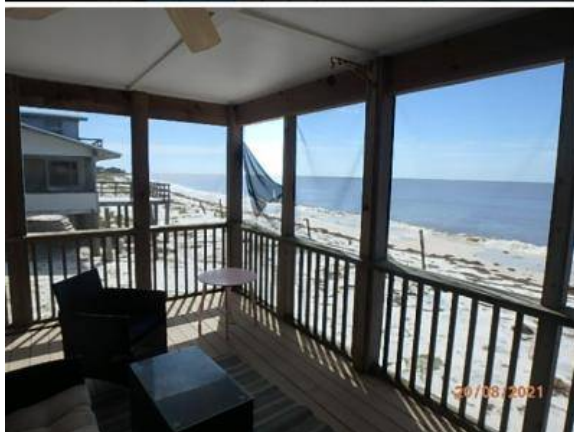
3. Various areas of damaged screening noted at the South side porch / deck area.

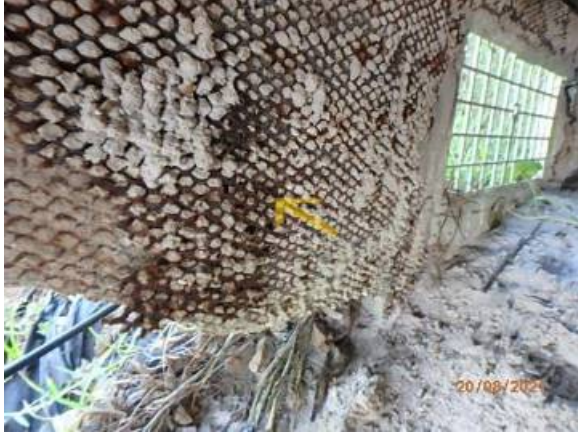
4. Various areas of cracking and damage noted to the stucco siding. Stucco appears to be improperly installed at transition locations allowing moisture intrusion behind the stucco. Possible concealed damage. See notes below for noted areas of cracking and damage. Recommend full evaluation and repairs as needed by a licensed contractor and stucco contractor.

5. Exposed wire mesh is rusting and swelling causing damage to the stucco.

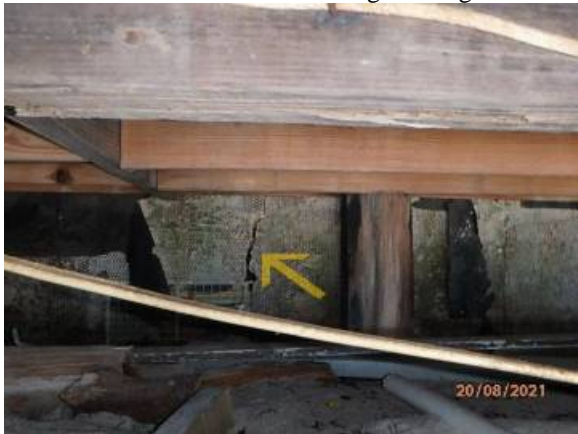
6. Various areas of visible cracking / damage to stucco siding below the finish floor level visible from under the house.

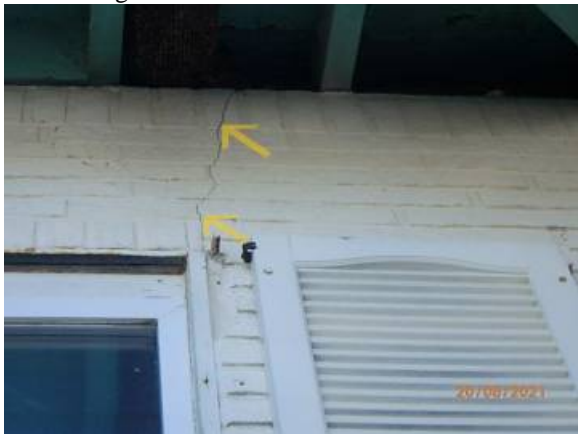
7. Cracking on West side.

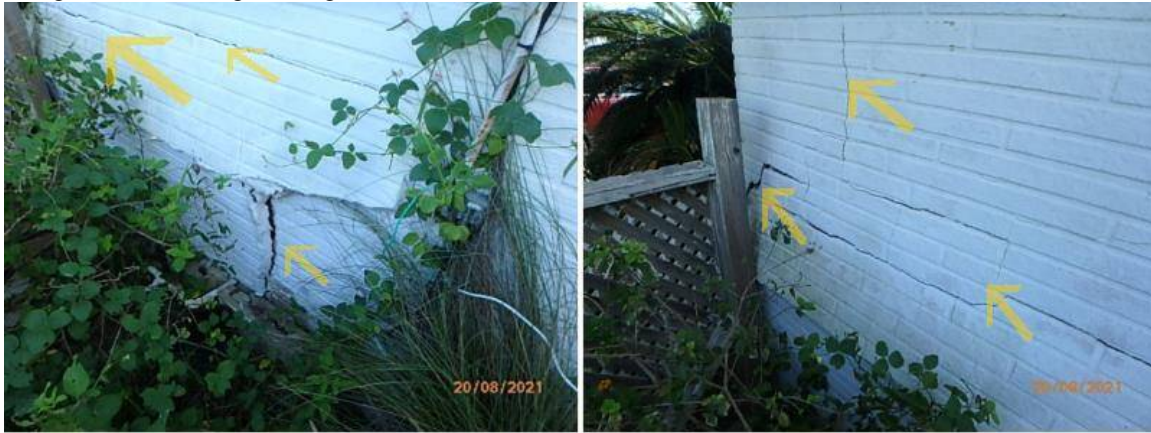
8. Significant cracking / damage to stucco from settlement at the West side near the front NW corner.

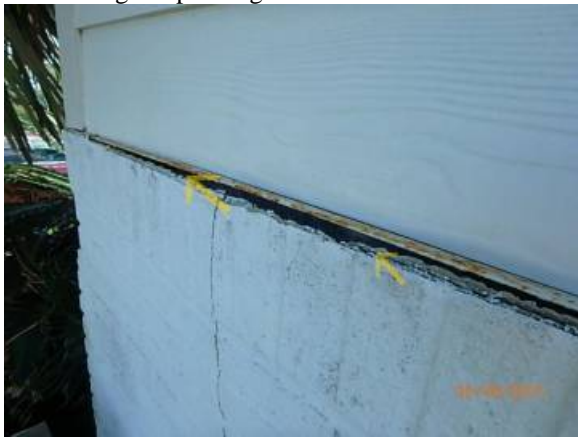
9. Cracking a separating stucco noted. Moisture intrusion is occurring behind the stucco finish. Possible concealed damage.

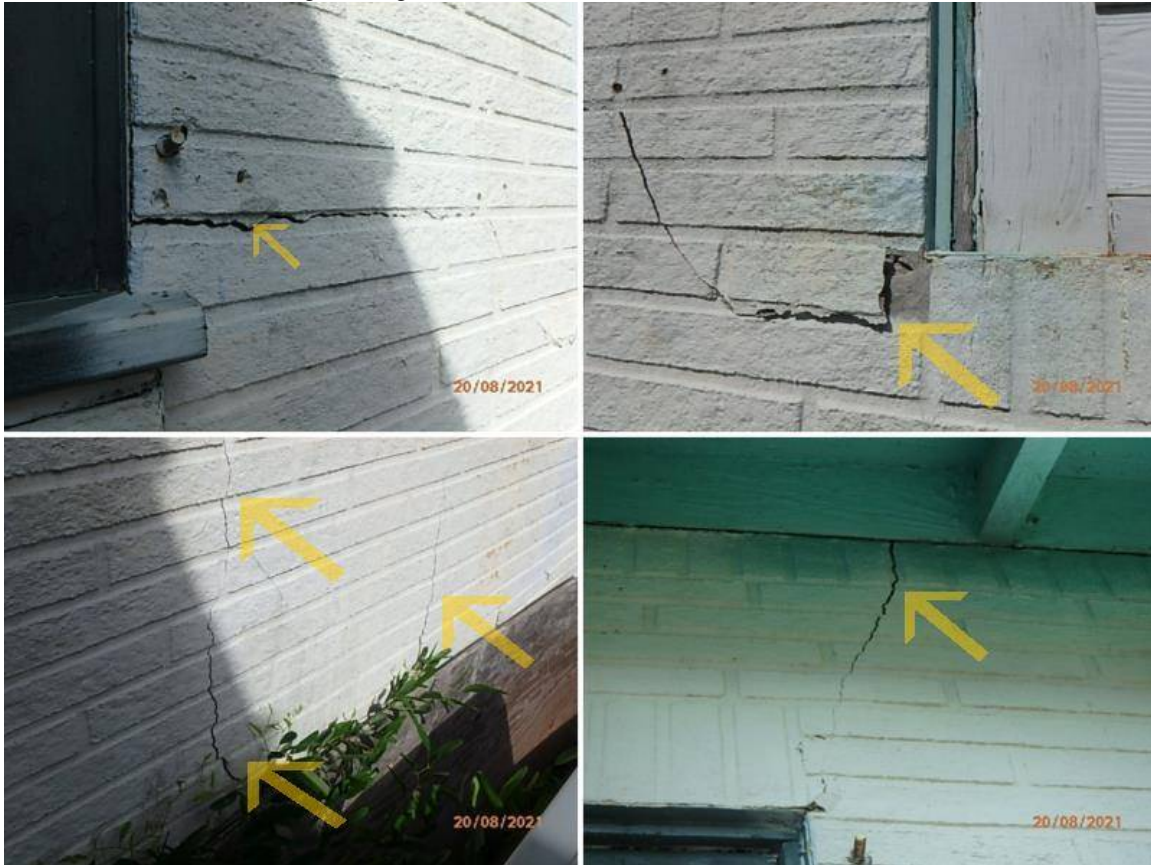
10. Various areas of cracking / damage to stucco at the East side near the front NE corner.

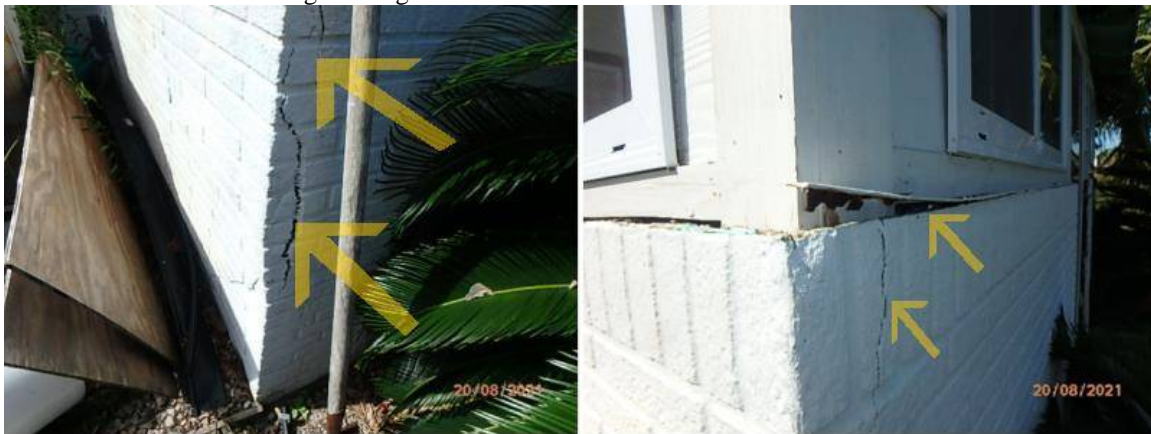
11. Various areas of cracking / damage to stucco at the East side near the front NE corner.

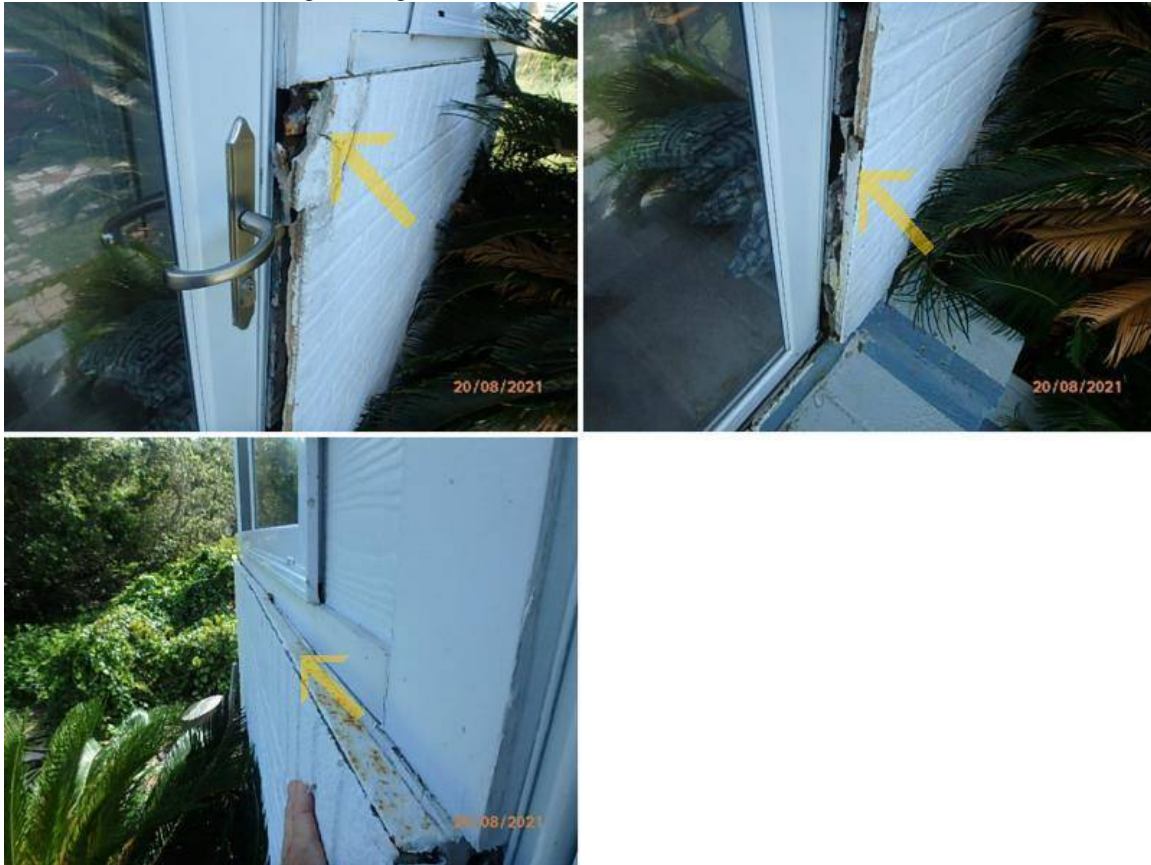
12. Various areas of cracking / damage to stucco at the North side.

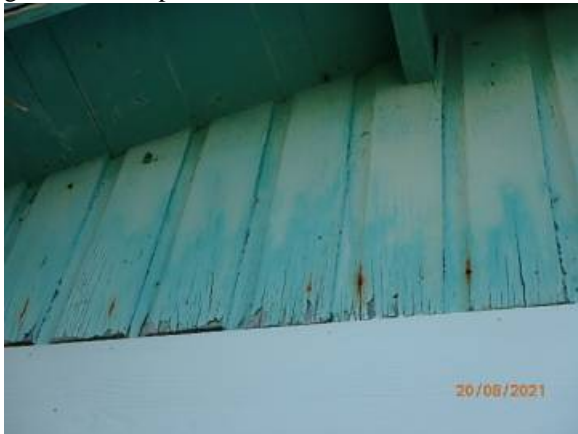
13. The exterior paint is deteriorated and peeling in various locations. The house was built prior to 1978 which brings strict guidelines for paint surface disturbance.

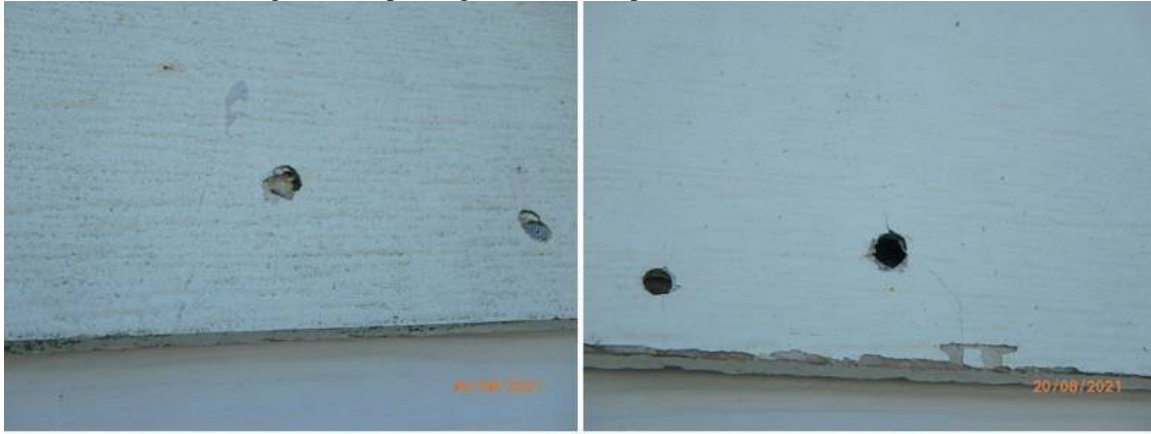
14. Various holes / damage in the lap siding material from pulled out nails.

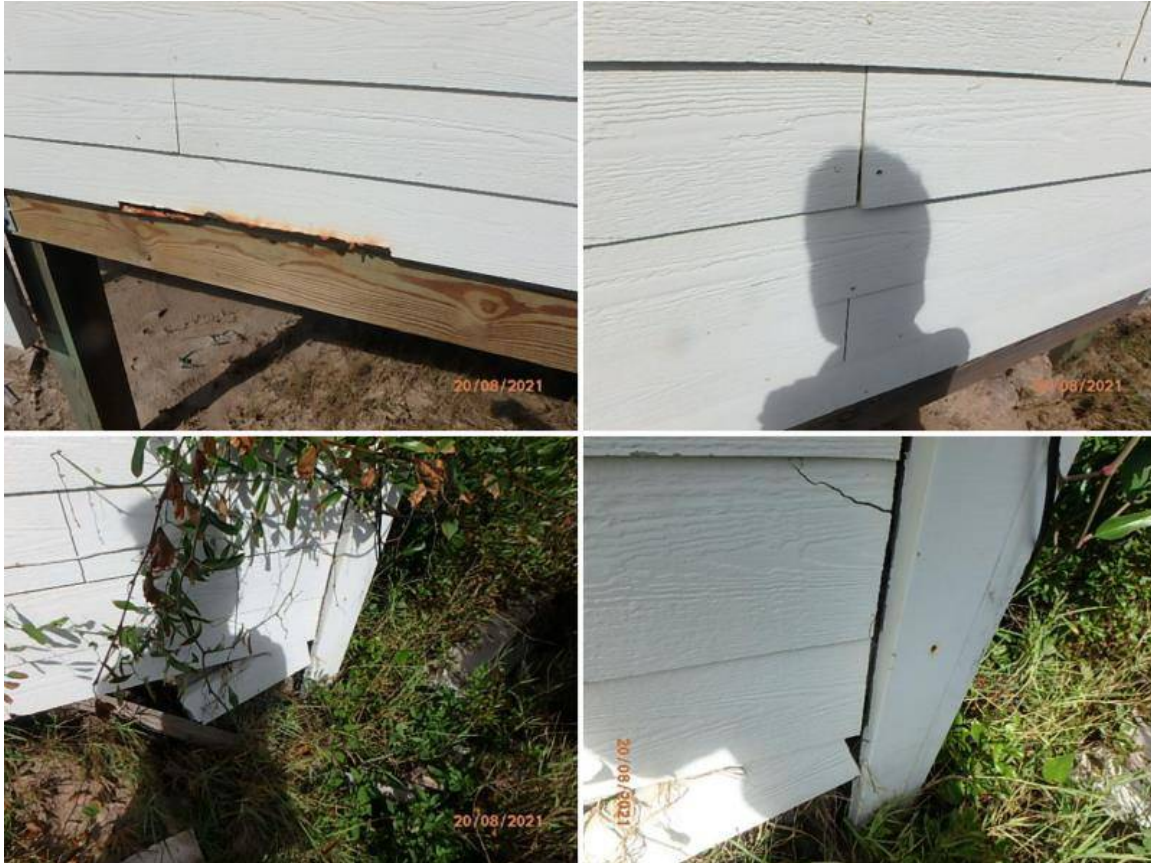
15. Various areas of damage noted to the siding on the East side of the house.

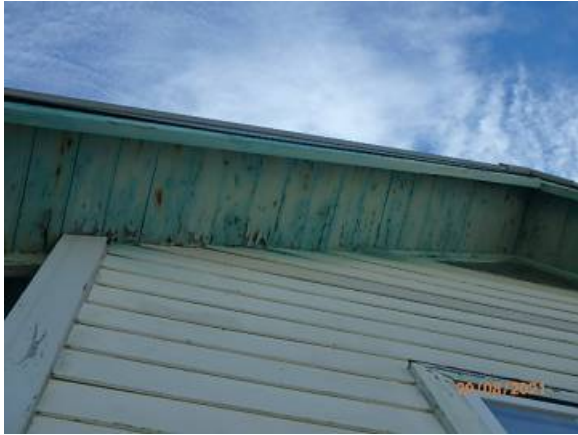
16. Paint on exterior trim is deteriorated and peeling in various areas. Home was built prior to 1978. Care should be taken to insure that all lead base paint safety practices required by the Environmental Protection Agency are followed. Testing for the presence of lead base paint is beyond the scope of this inspection. Recommend a full lead base paint inspection be performed prior to any disturbance of painted surfaces.

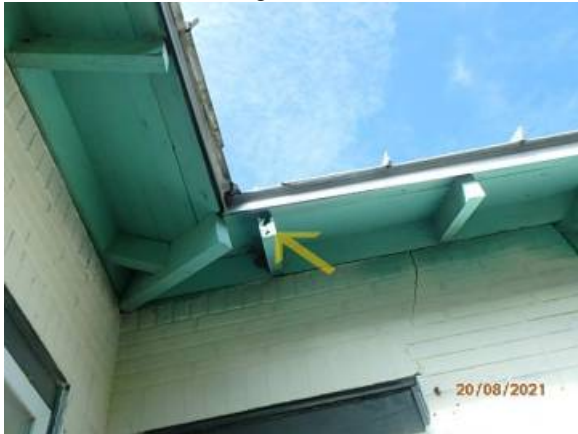
17. Wood rot and damage noted at the rafter tail end at the north side of the house.

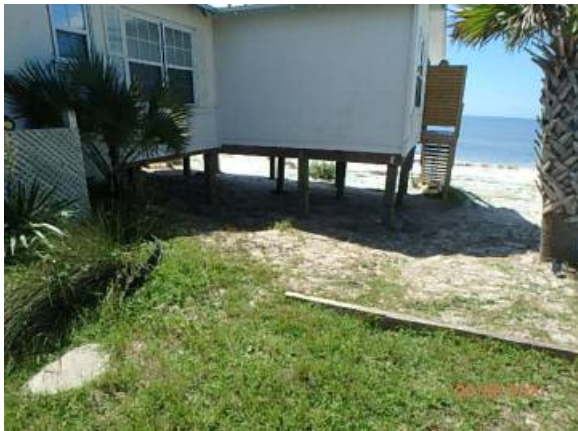
18. The grade along the foundation is improperly sloped toward the structure at the North side of the house. Recommend re-grading to establish proper water flow away from the structure. Moisture intrusion and evidence of water flowing under the house noted.

19. Areas of erosion noted around the house from run-off and storm surge.

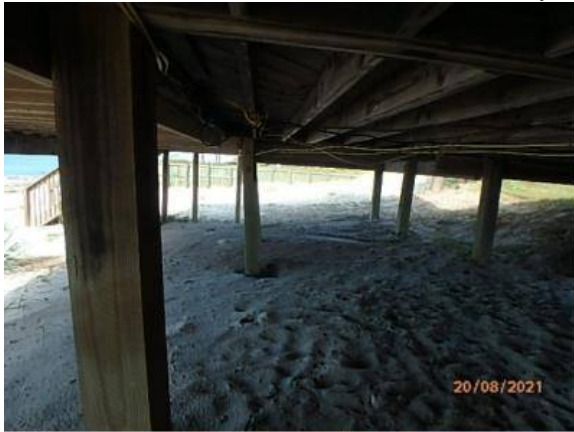
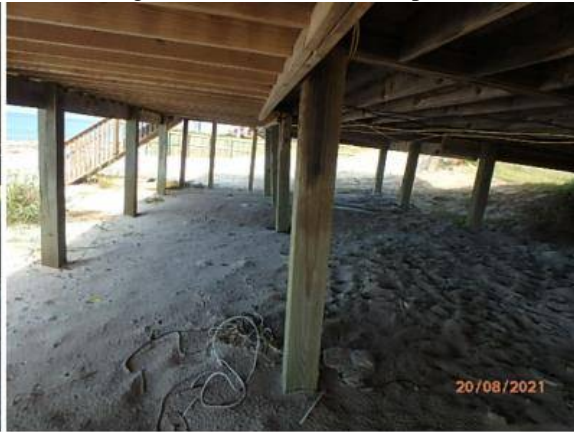
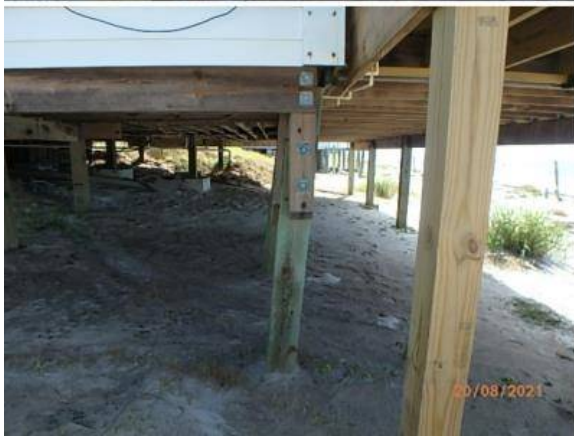
20. Various leaning wood piers / supports noted. Settlement / shifting appears to have occurred. Excessive soil wash-out noted under the structure. Recommend full evaluation by a structural engineer and/or foundation specialist.

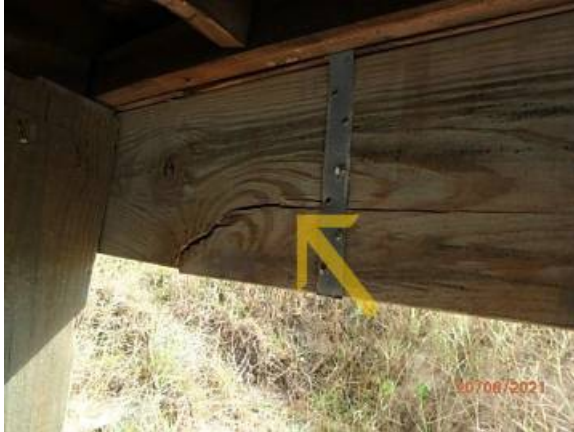
21. Damaged / cracked wood beam noted at the East side under the bathroom area.

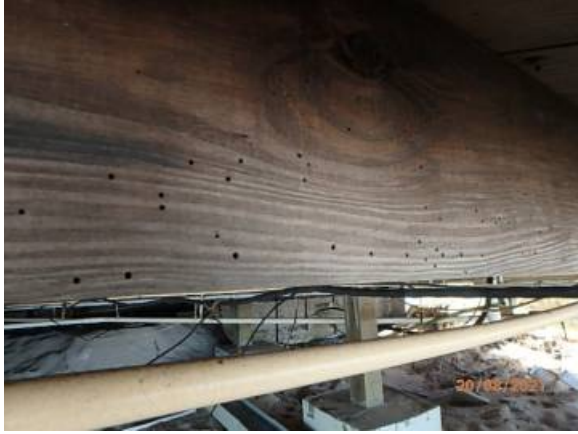
23. Evidence of what appears to be "Powder Post Beetle" damage noted at the wood framing under the house. Recommend further evaluation by a licensed exterminator.

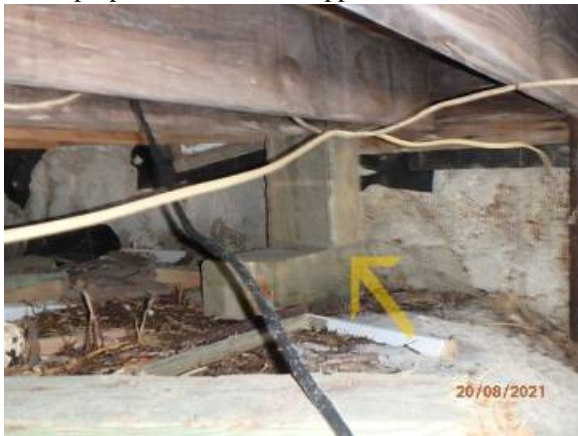
24. Improper / added wood supports noted under the house. Wood to ground contact noted.

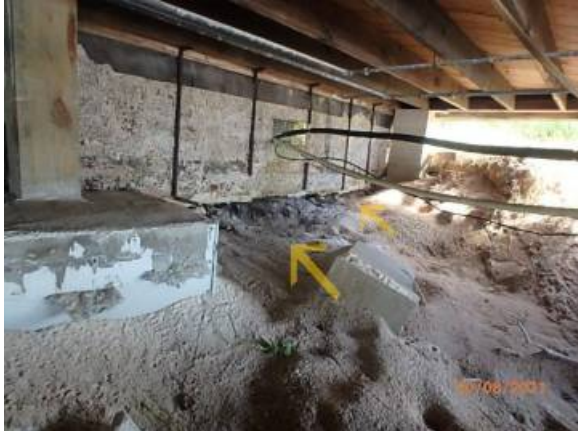
25. Evidence of excessive moisture / water intrusion under house noted. It appears that water from the "Gulf" washes under the house during large storm events or high surge events.

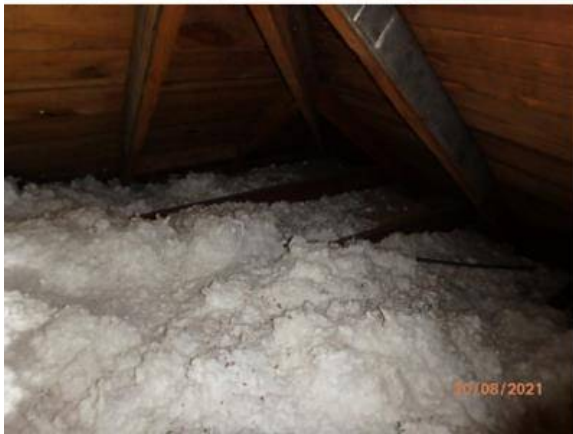
26. Insulation is disturbed resulting in poor coverage in various locations. Recommend installing additional insulation.

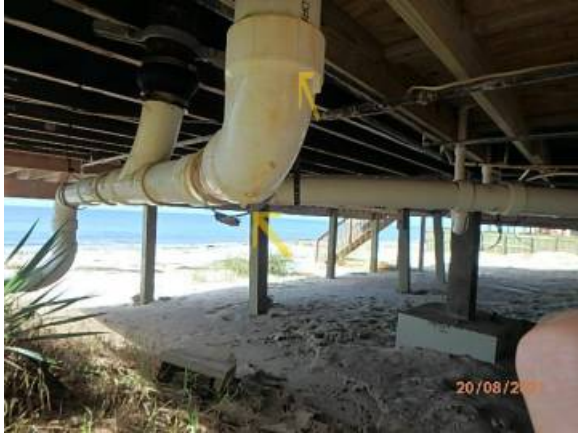
28. Leakage noted from the PVC waste line under be between bedroom bathroom area.

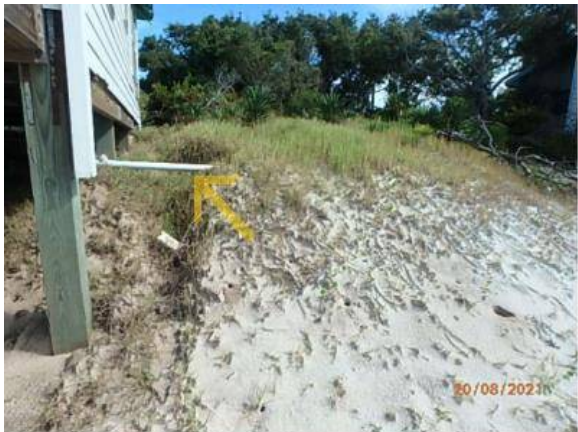
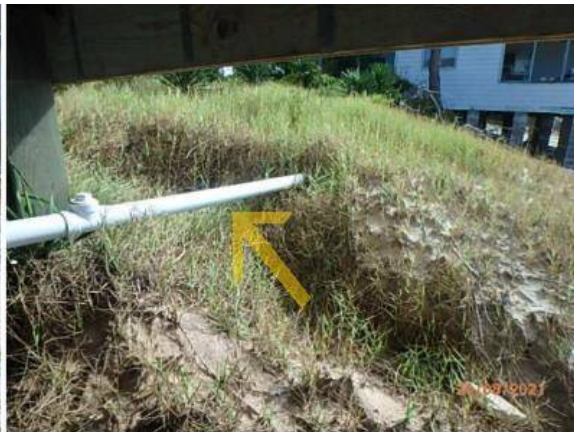
29. The earth / dirt around the septic system is washed out in various locations. The main waste line is exposed. Recommend full evaluation and repairs as needed by licensed septic tank professional. Septic systems can only be properly evaluated by pumping and examining the tank. This should be done by a licensed septic tank installer. State law dictates that all septic system inspections be performed by a licensed septic tank installer. Periodic pumping of the system is part of normal maintenance.

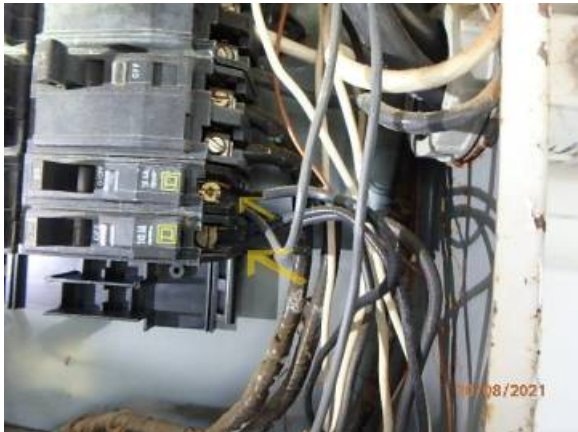
30. Multiple wires are connected to a single lug on a circuit breaker (2 locations) in the electrical panel where only one wire should be connected.

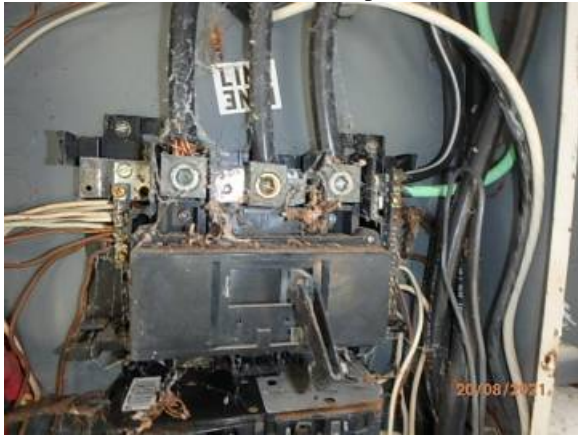
31. Excessive debris noted inside panel. Recommend having panel cleaned / serviced by a licensed electrician.

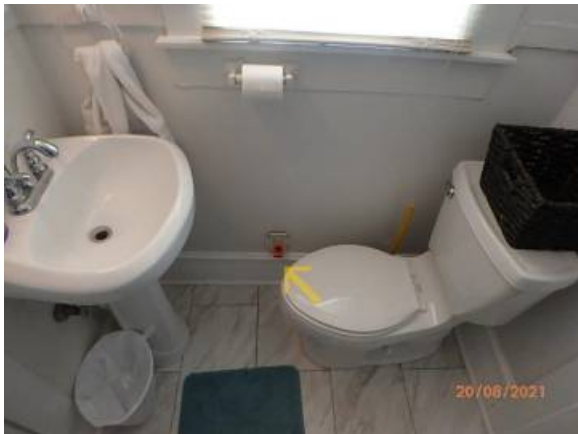
33. The electrical outlet in the between bedrooms bathroom did not have power at time of inspection.

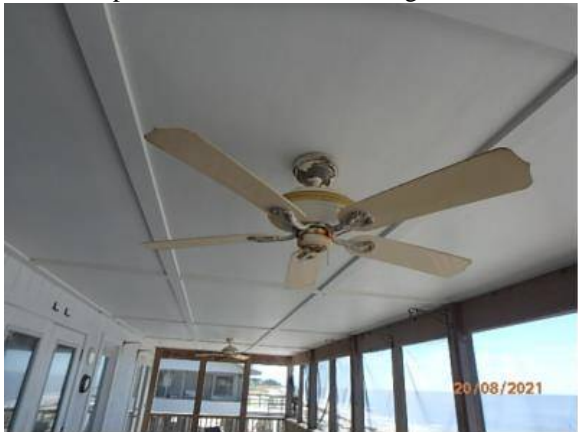
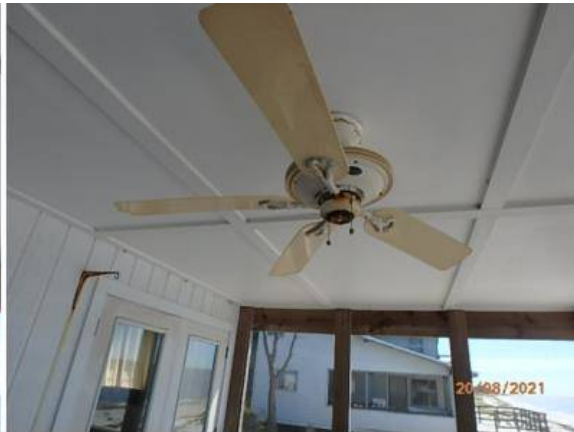
34. South porch fan fixtures are damaged.

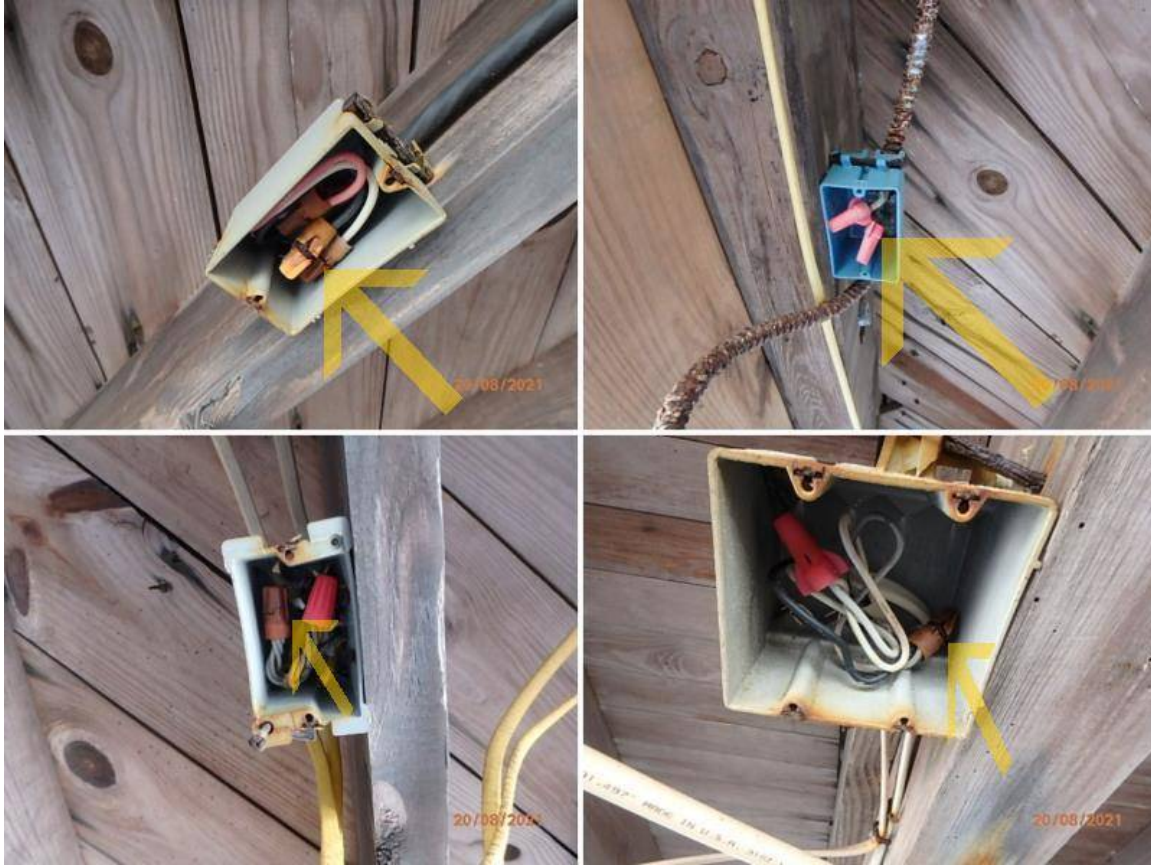
35. Various uncapped junction boxes noted under the house. Exposed connections noted with areas of rust / damage to the "Wire nuts".

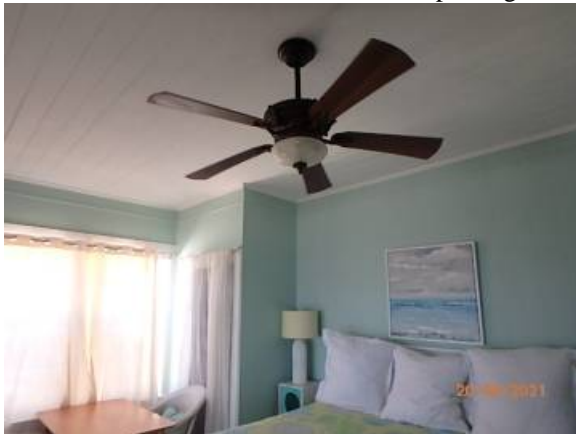
36. Master bedroom fan fixture is slow spinning and the light is not operational.

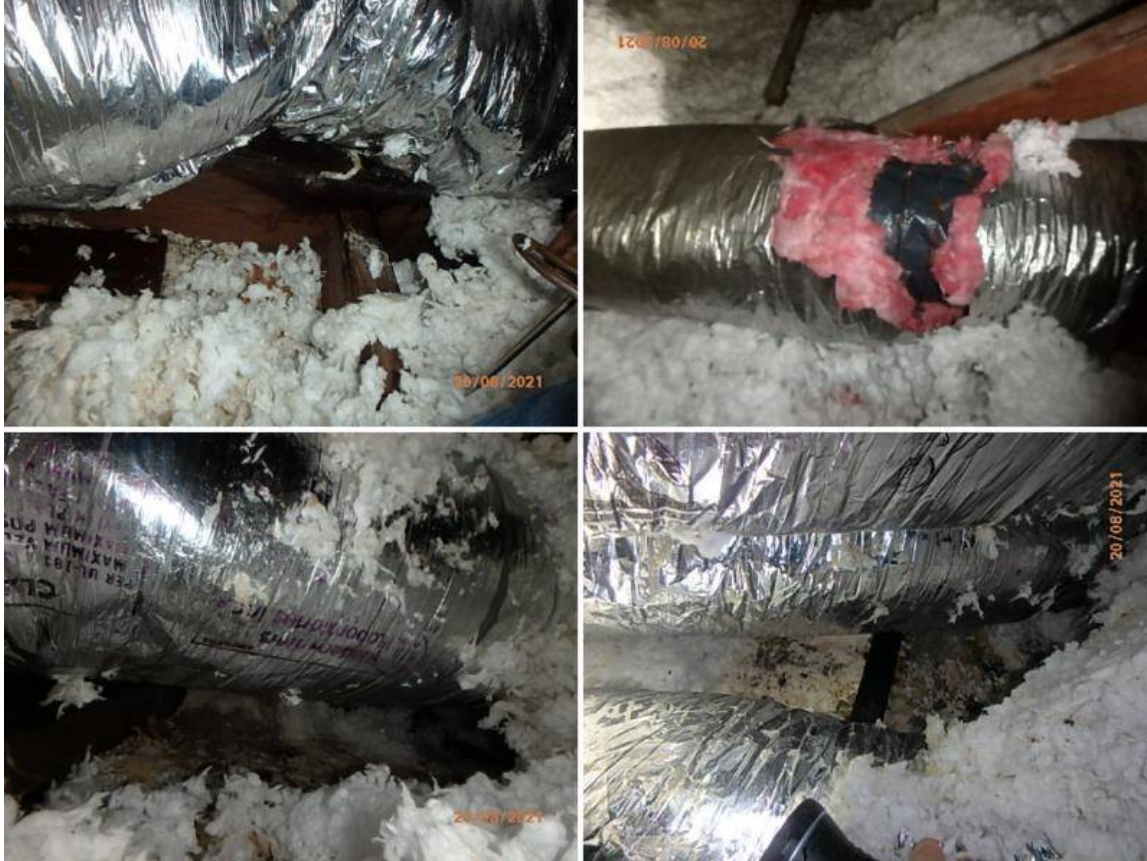
37. Various areas of damp or wet HVAC ductwork noted in the attic area. Ductwork saturation is dripping to the insulation and ceilings below causing moisture damage and areas of mildew and mold growth.

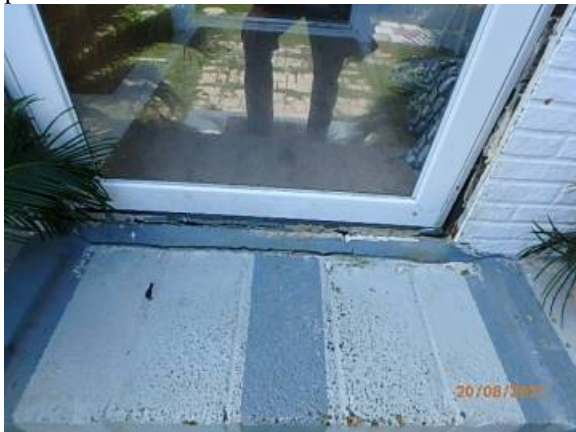
38. Visible rot / damage noted under the North side entry door. Possible concealed damage. View / inspection under this portion of the house was limited due to low head room.

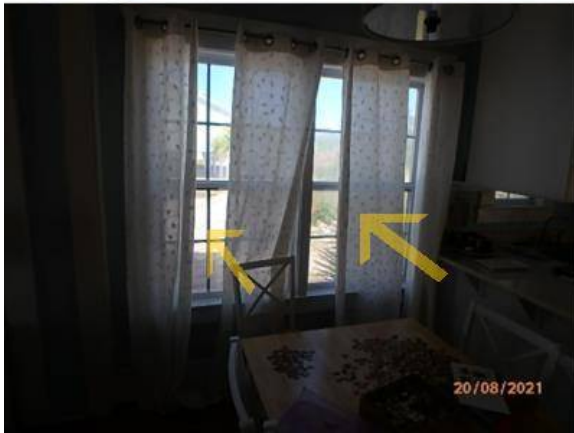
43. Windows will not stay open in the following locations: master bedroom windows, dining area windows. Windows do not stay in track properly.

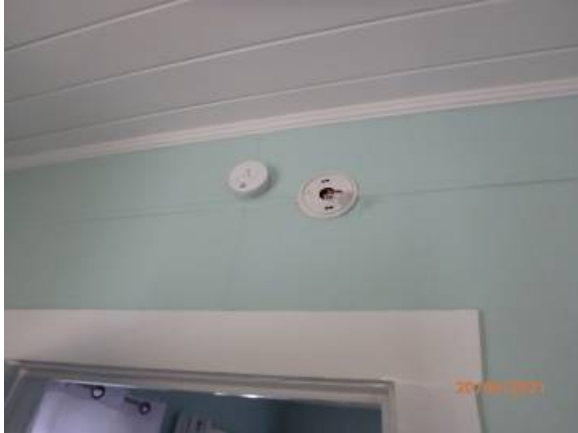
48. Missing smoke detector.

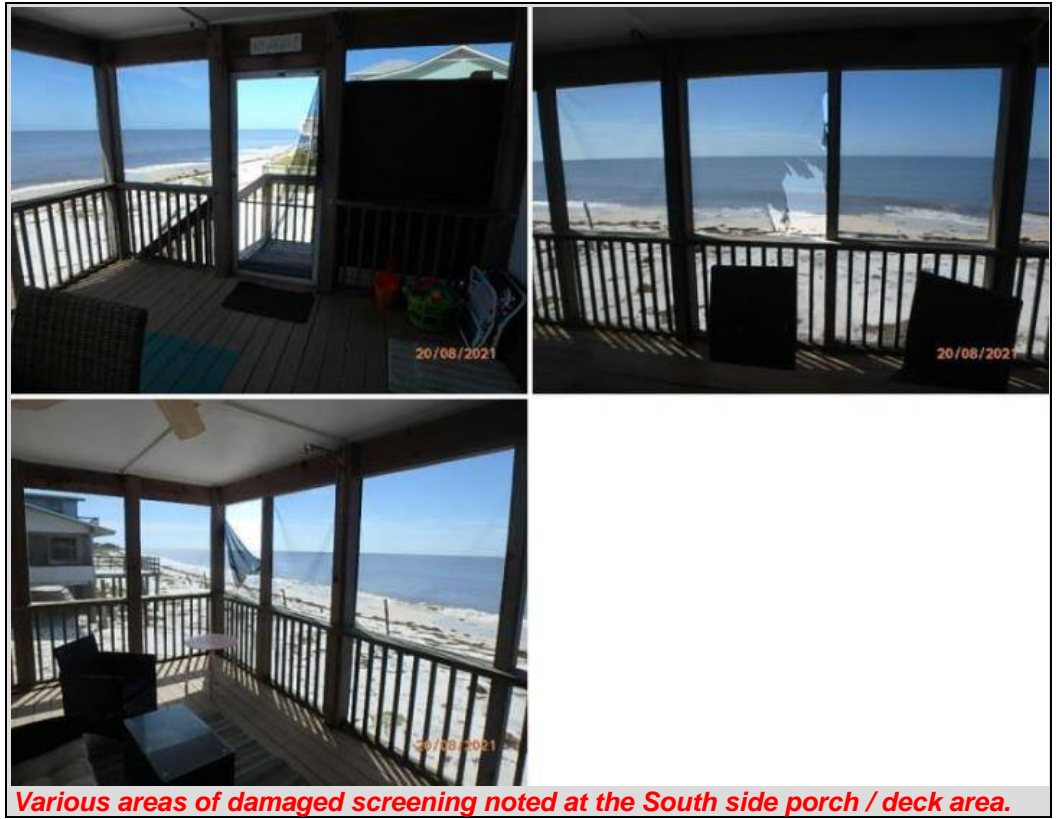
Various areas of damaged screening noted at the South side porch / deck area.

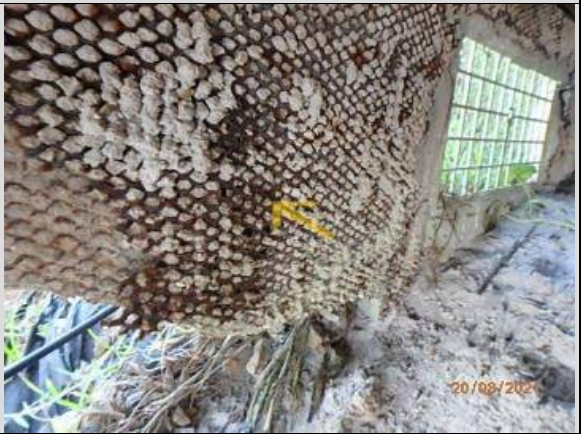
TYPE OF WALL	Wood Frame.
CONSTRUCTION:	Wood siding, Aluminum siding, Conventional type stucco. Fibrous siding.
WALL COVERING	
MATERIAL:	
CONDITION:	<p>Various areas of cracking and damage noted to the stucco siding. Stucco appears to be improperly installed at transition locations allowing moisture intrusion behind the stucco. Possible concealed damage. See notes below for noted areas of cracking and damage. Recommend full evaluation and repairs as needed by a licensed contractor and stucco contractor.</p> <p>Exposed wire mesh is rusting and swelling causing damage to the stucco.</p>

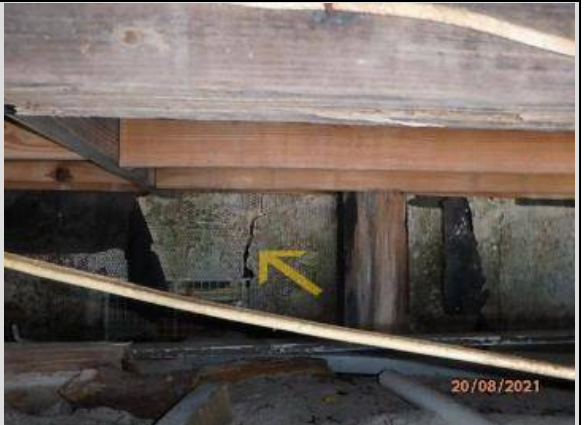
<p>Various areas of visible cracking / damage to stucco siding below the finish floor level visible from under the house.</p>

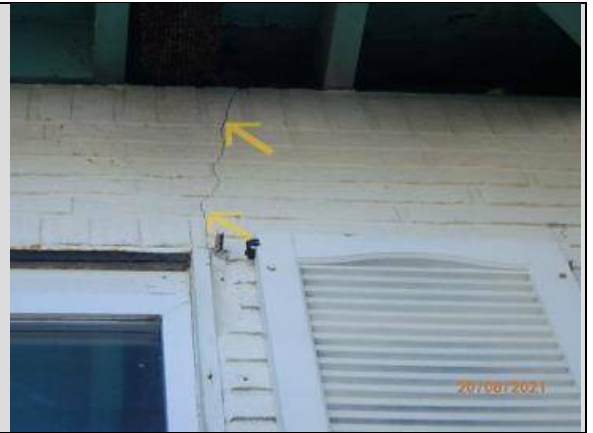
Cracking on West side.

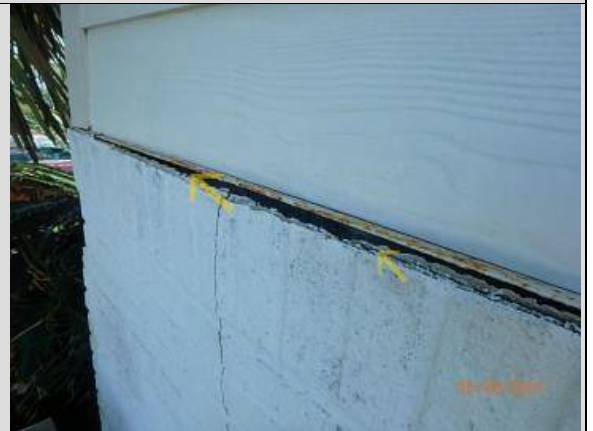
Cracking a separating stucco noted. Moisture intrusion is occurring behind the stucco finish. Possible concealed damage.

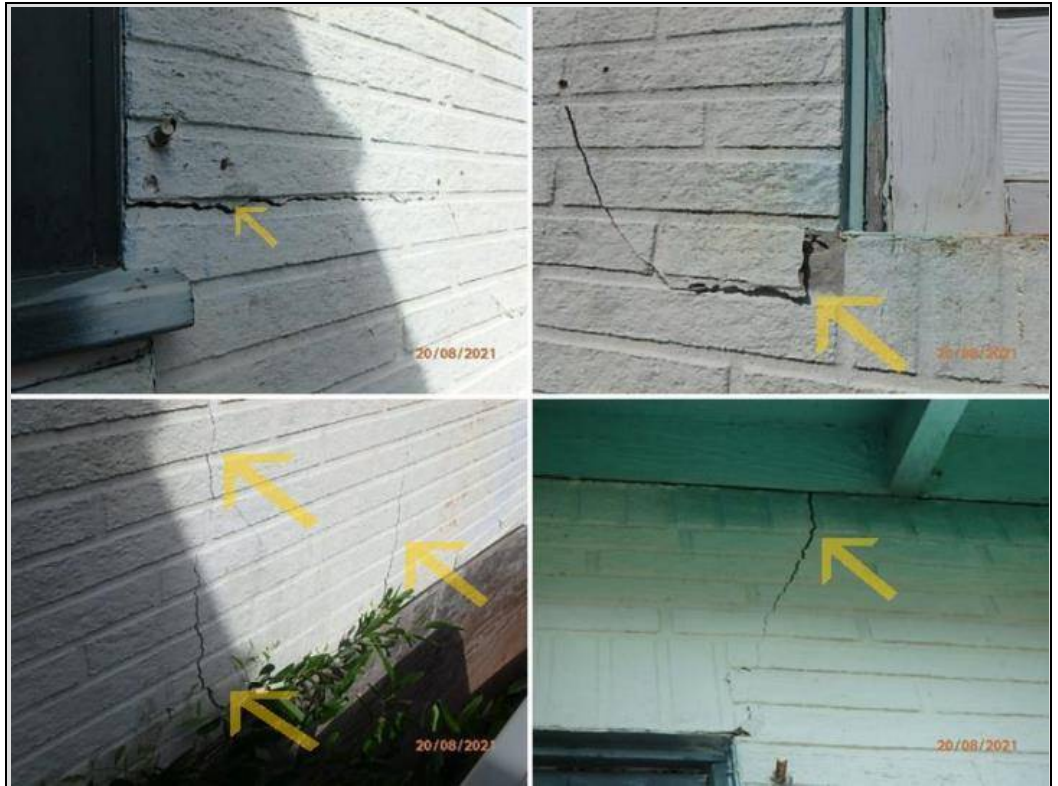
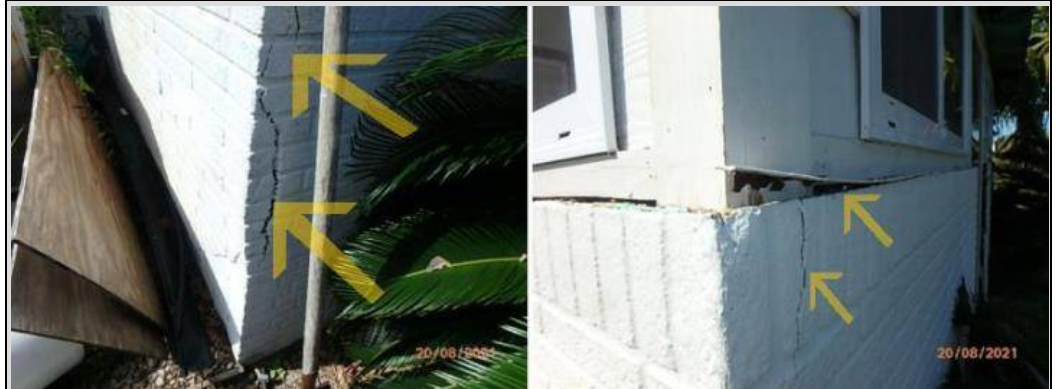
Various areas of cracking / damage to stucco at the East side near the front NE corner.

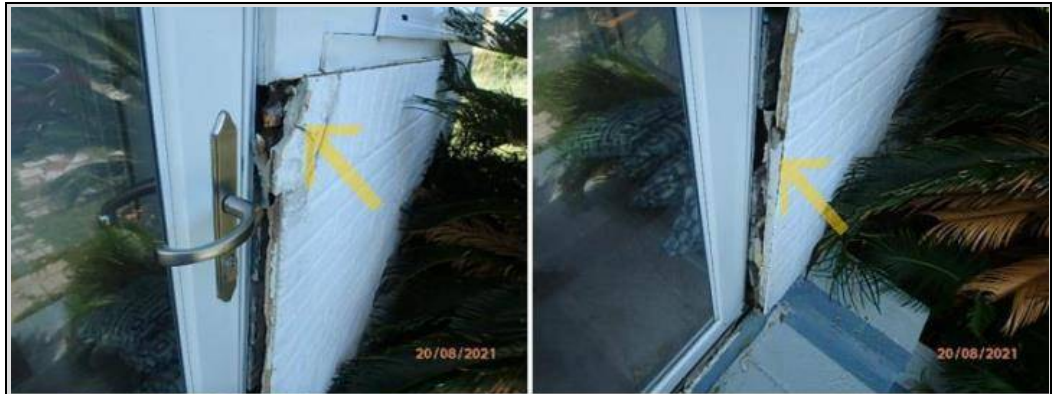
Various areas of cracking / damage to stucco at the East side near the front NE corner.

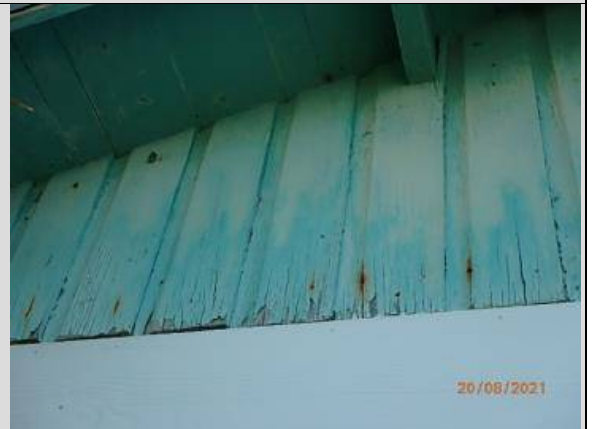
The exterior paint is deteriorated and peeling in various locations. The house was built prior to 1978 which brings strict guidelines for paint surface disturbance.

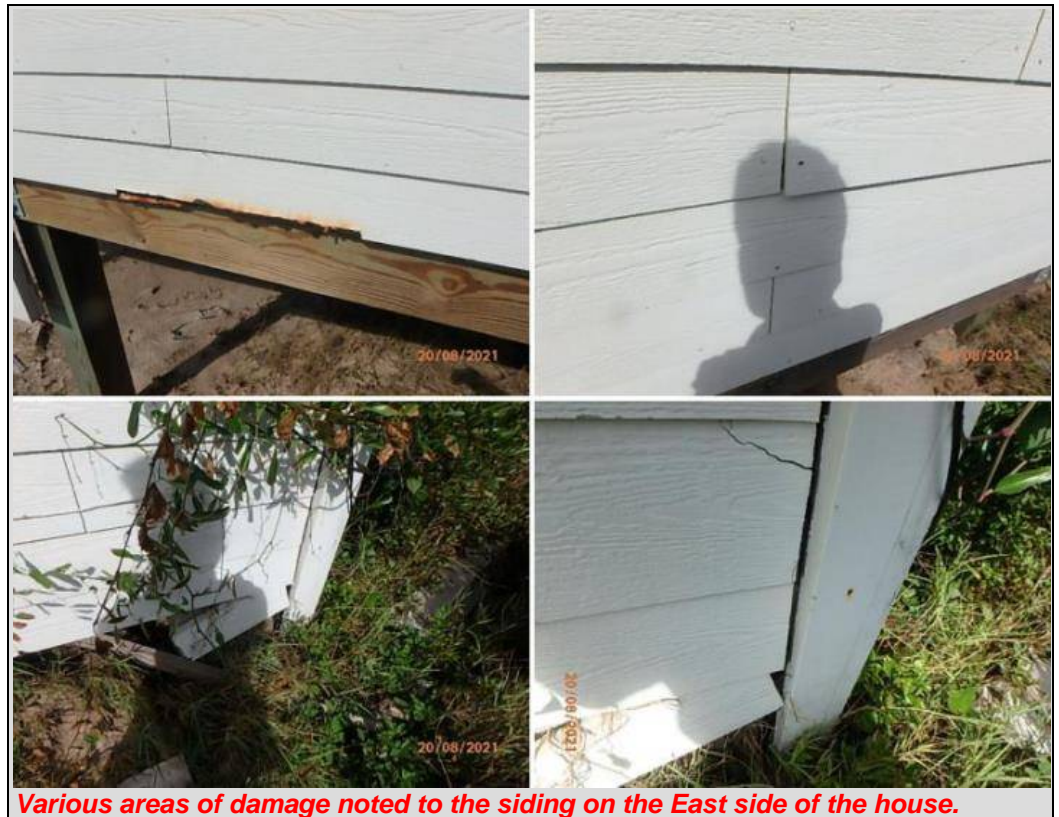
Various holes / damage in the lap siding material from pulled out nails.

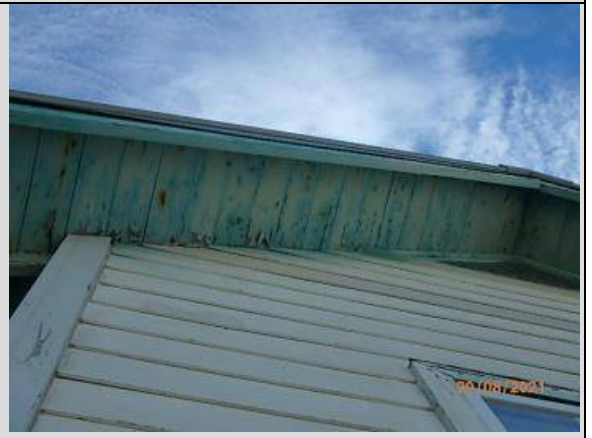
Paint on exterior trim is deteriorated and peeling in various areas. Home was built prior to 1978. Care should be taken to insure that all lead base paint safety practices required by the Environmental Protection Agency are followed. Testing for the presence of lead base paint is beyond the scope of this inspection. Recommend a full lead base paint inspection be performed prior to any disturbance of painted surfaces.

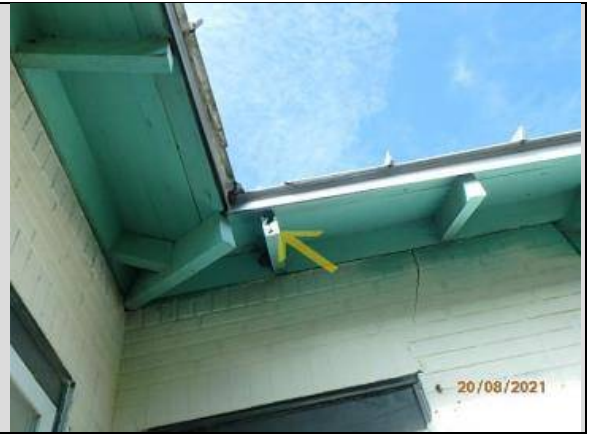
***Wood rot and damage noted at the
rafter tail end at the north side of
the house.***

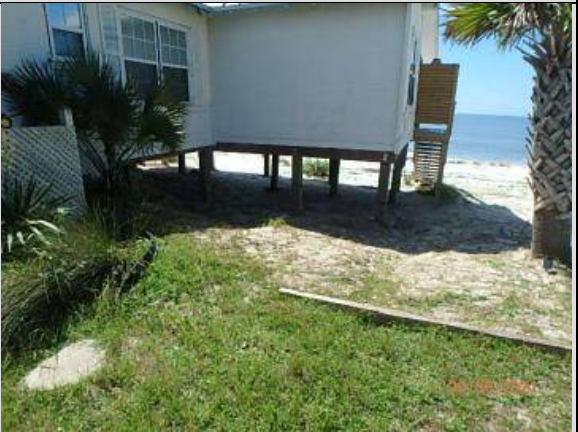
SITE:	Moderate.
CONDITION:	<i>The grade along the foundation is improperly sloped toward the structure at the North side of the house. Recommend re-grading to establish proper water flow away from the structure. Moisture intrusion and evidence of water flowing under the house noted.</i>
OTHER OBSERVATIONS:	<i>Areas of erosion noted around the house from run-off and storm surge.</i> <div>

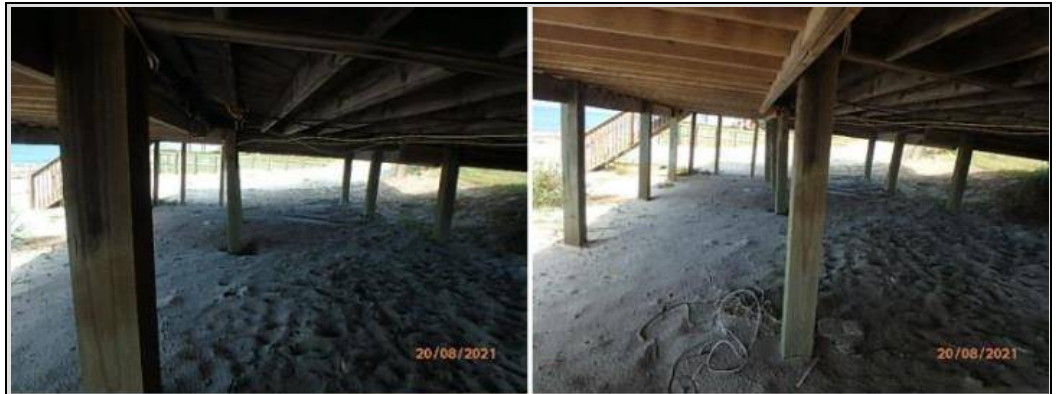
Various leaning wood piers / supports noted. Settlement / shifting appears to have occurred. Excessive soil wash-out noted under the structure. Recommend full evaluation by a structural engineer and/or foundation specialist.

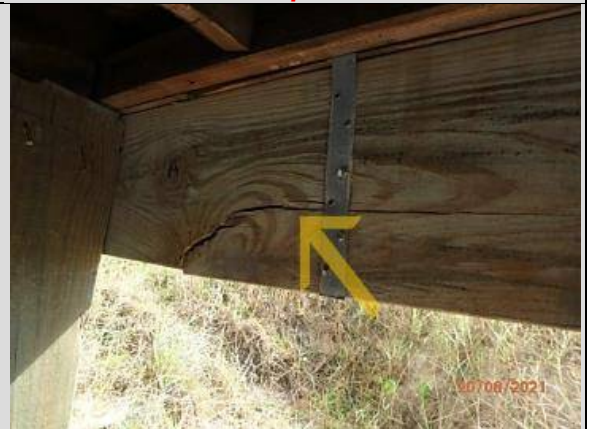
Damaged / cracked wood beam noted at the East side under the bathroom area.

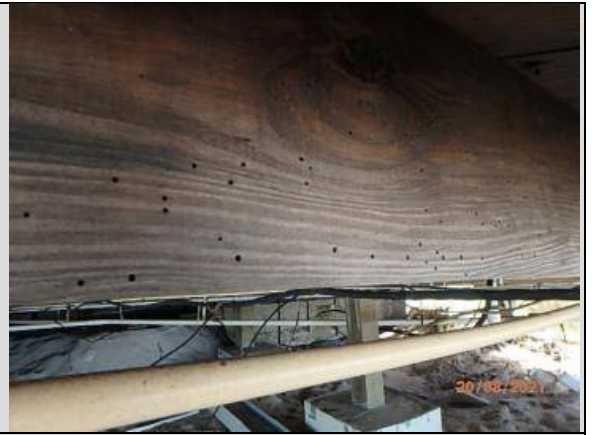
Evidence of what appears to be "Powder Post Beetle" damage noted at the wood framing under the house. Recommend further evaluation by a licensed exterminator.

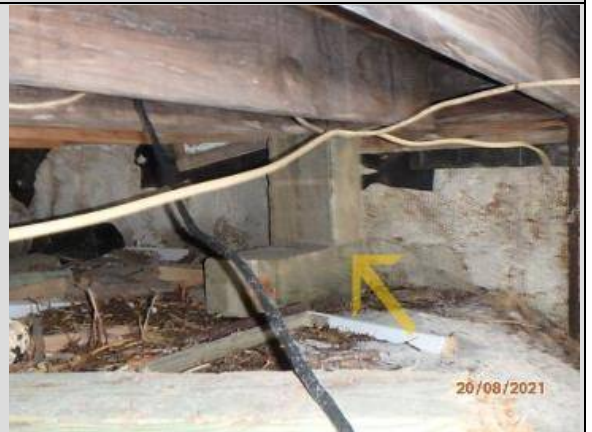
Improper / added wood supports noted under the house. Wood to ground contact noted.

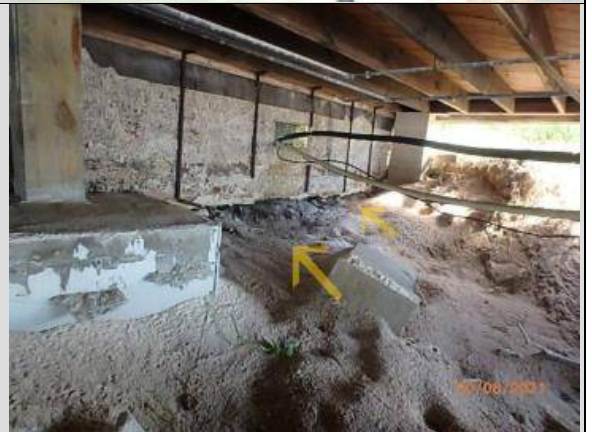
Evidence of excessive moisture / water intrusion under house noted. It appears that water from the "Gulf" washes under the house during large storm events or high surge events.

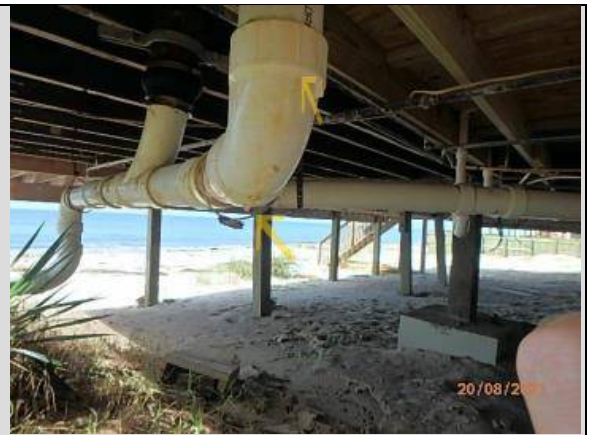
Leakage noted from the PVC waste line under be between bedroom bathroom area.
