Property Inspection Report

Southern Home Consultants, Inc.

Report #: 082021WO6.

**1215 Alligator Drive.
Alligator Point, FL 32346.**

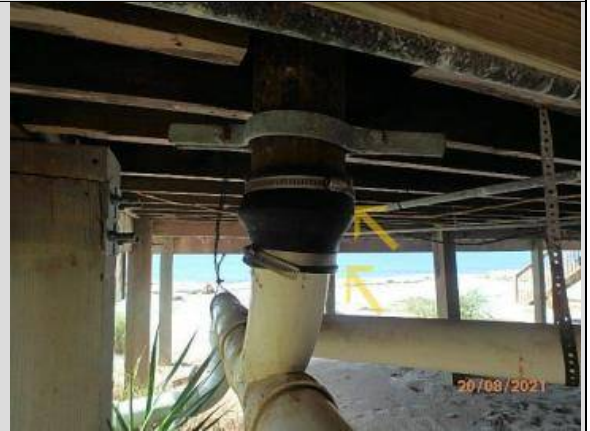
Improper waste line plumbing connection noted under the East bathroom.

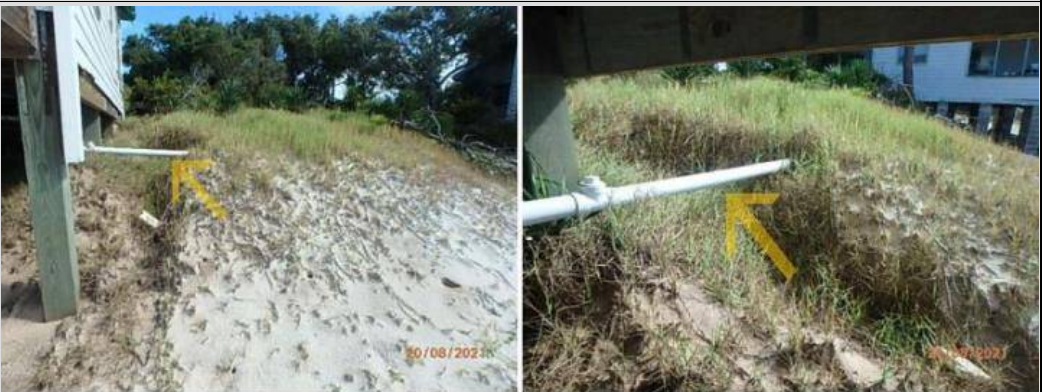
The earth / dirt around the septic system is washed out in various locations. The main waste line is exposed. Recommend full evaluation and repairs as needed my licensed septic tank professional. Septic systems can only be properly evaluated by pumping and examining the tank. This should be done by a licensed septic tank installer. State law dictates that all septic system inspections be performed by a licensed septic tank installer. Periodic pumping of the system is part of normal maintenance.

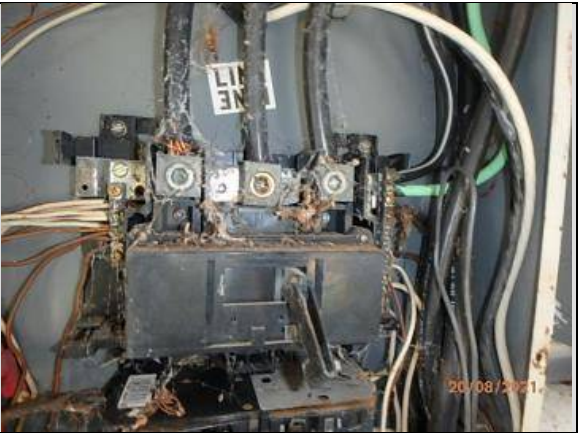
Excessive debris noted inside panel. Recommend having panel cleaned / serviced by a licensed electrician.

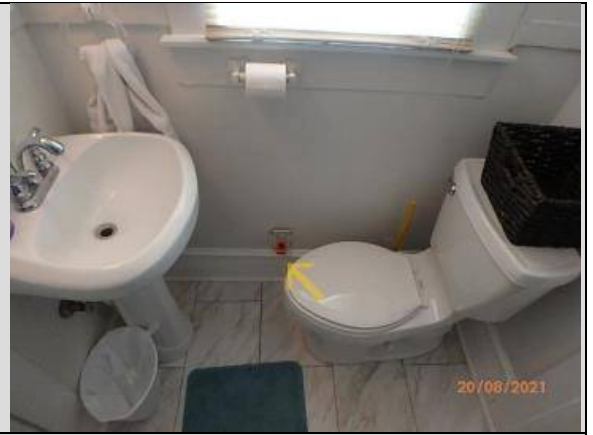
The electrical outlet in the between bedrooms bathroom did not have power at time of inspection.

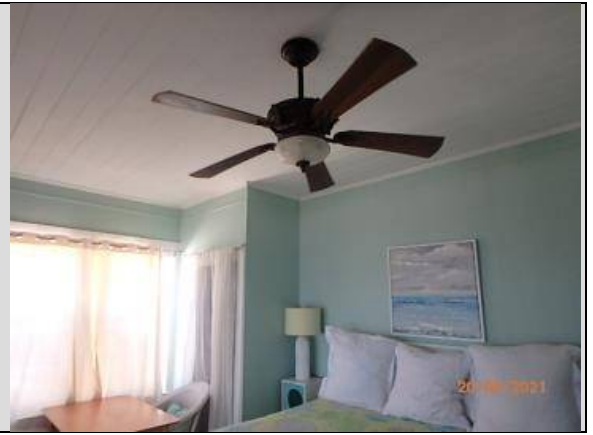
Master bedroom fan fixture is slow spinning and the light is not operational.

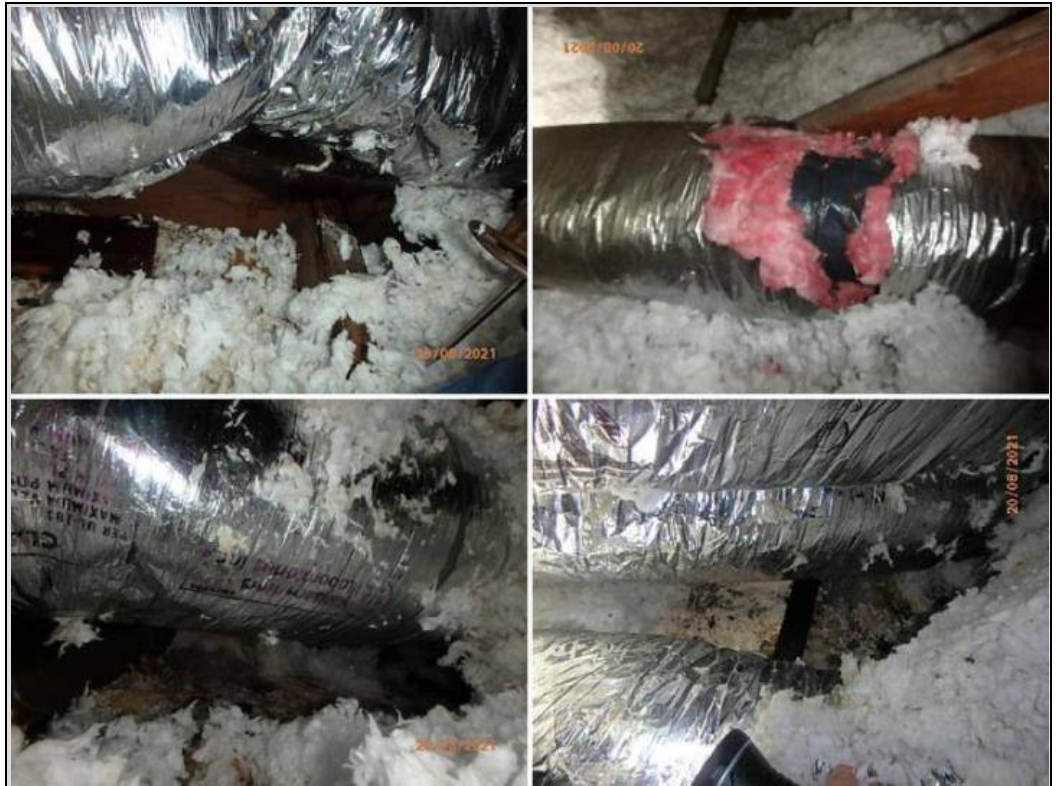
Various areas of damp or wet HVAC ductwork noted in the attic area. Ductwork saturation is dripping to the insulation and ceilings below causing moisture damage and areas of mildew and mold growth.

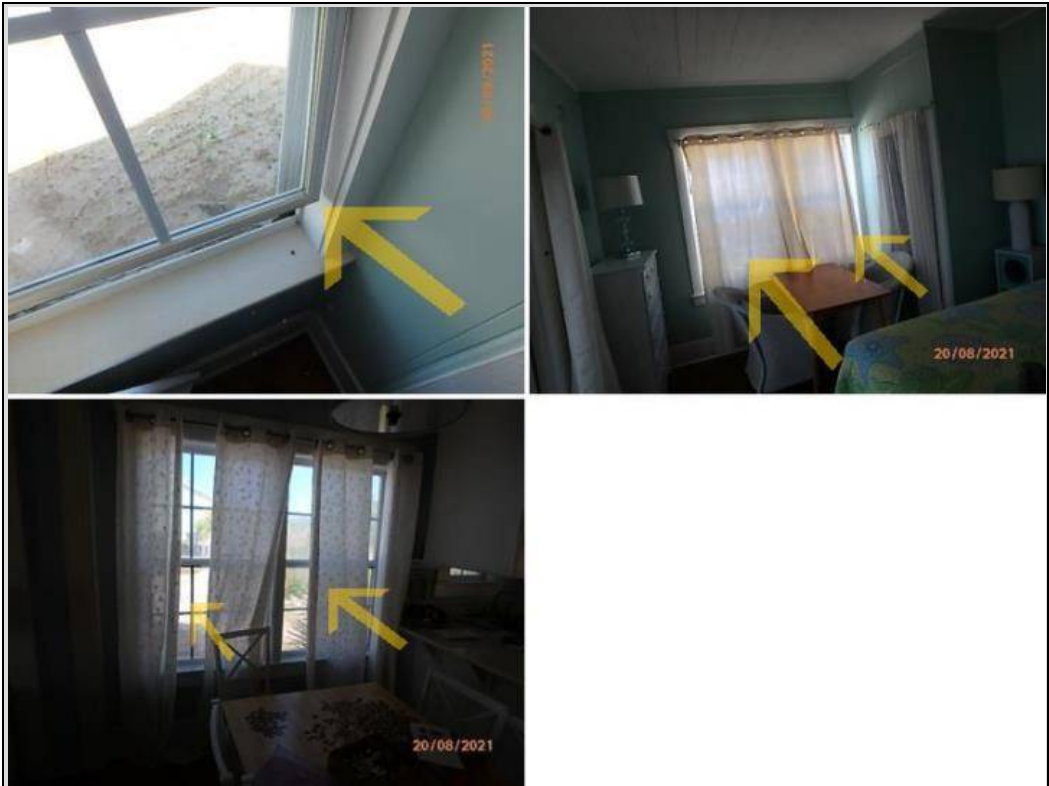
Insulated glass.
*Windows fogged at the following locations: NE Bedroom North window, dining room window closest to kitchen,
(Please note: Fogged windows can sometimes not be seen due to climate conditions. If some windows are noted fogged it is not to be concluded that all fogged windows are identified. Every attempt has been made to note all visible windows that are fogged. Client may want to have windows further evaluated by a window specialist).*

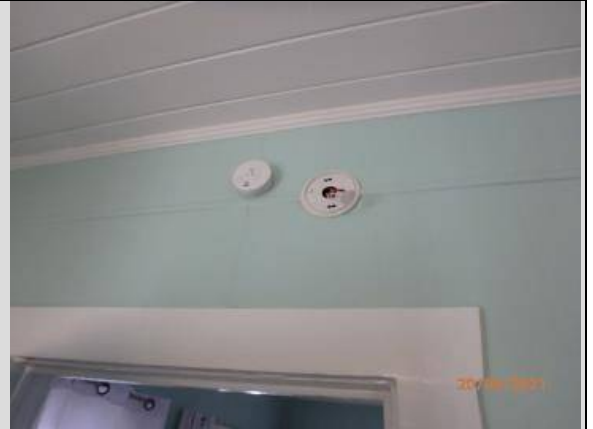
Missing smoke detector.

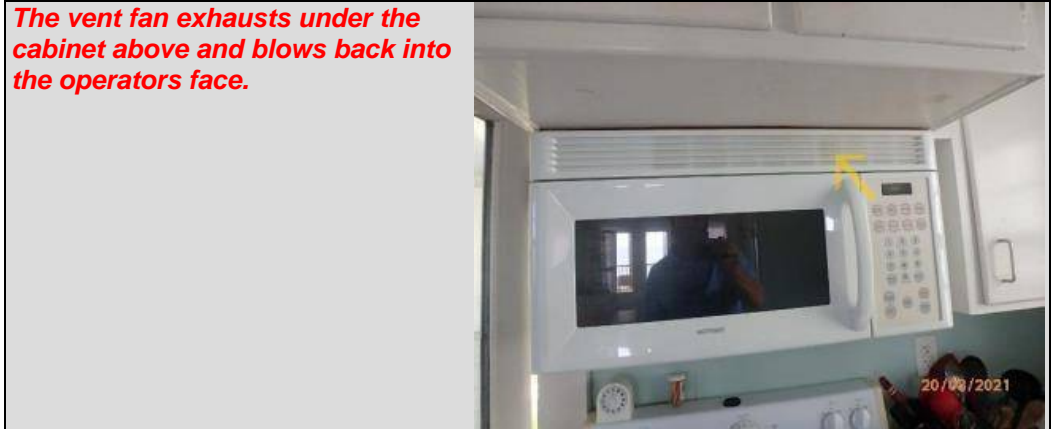
The vent fan exhausts under the cabinet above and blows back into the operators face.
