# Roof Takeoff Pictures with Core, Details, and Overviews - Report #12345

**ABC Company**

123 Main ST, Anytown, TBD

Dec/1/2023, 8:24pm UTC

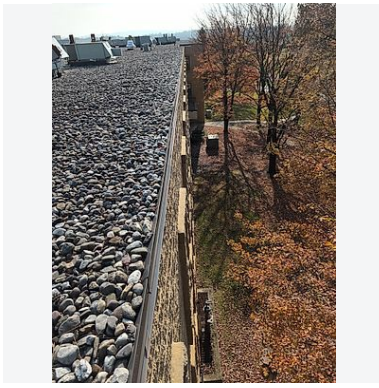
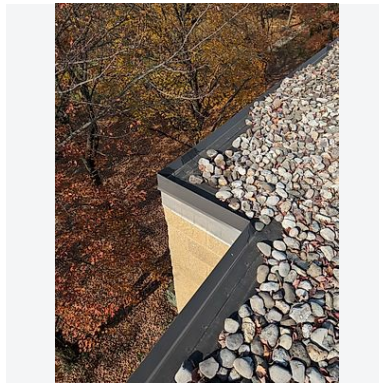
### ✓ A - Gravel Stop

5" overall face gravel stop with additional 6" fascia below.

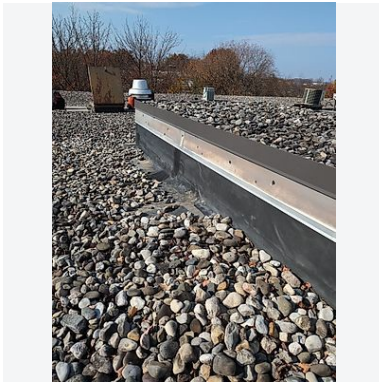
✓ **B - 28" External Wall and wall flash with Gravel Stop (Same as "A")**

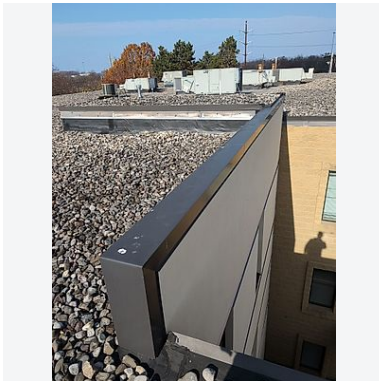
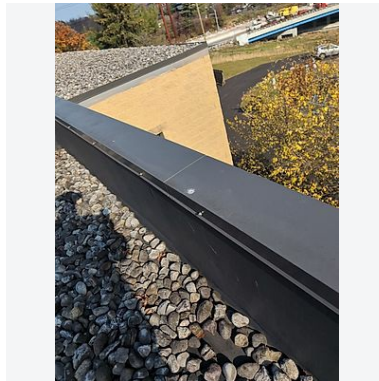
✓ **C - 24" External Wall and wall flash with metal coping**

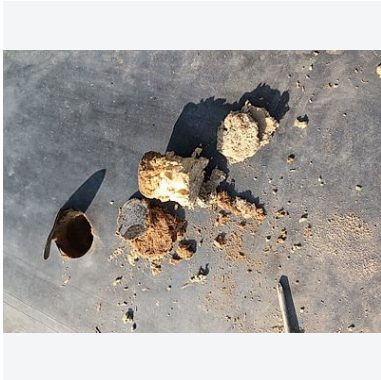
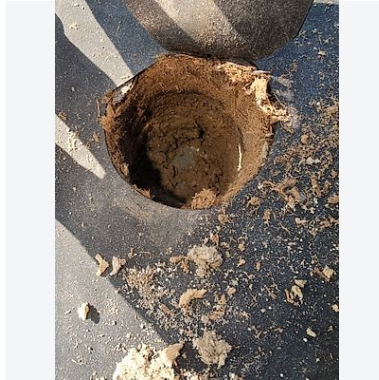
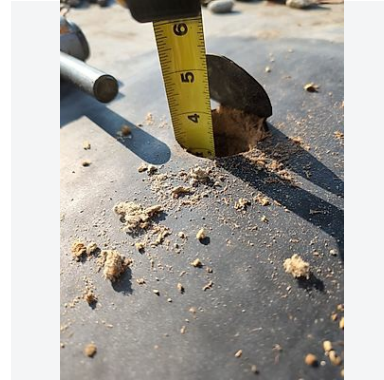
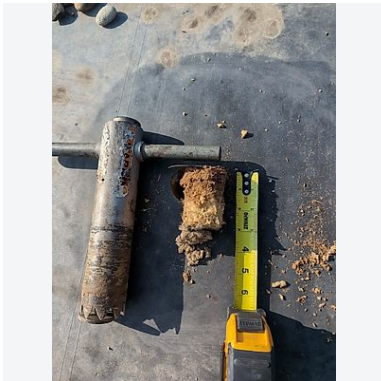
Roof Core:  
Steel Decking

0.75" Perlite Insulation  
2.0" Polyisocyanurate Insulation  
0.75" Fiberboard Insulation/Coverboard  
60mil EPDM - Loose Laid  
Ballast / River Rock (No Protective Matting)

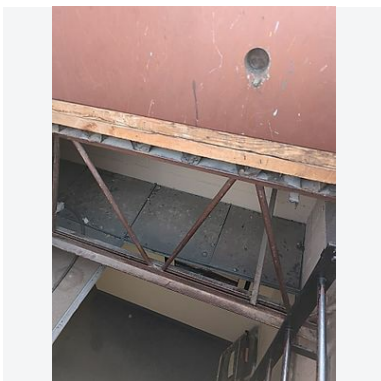
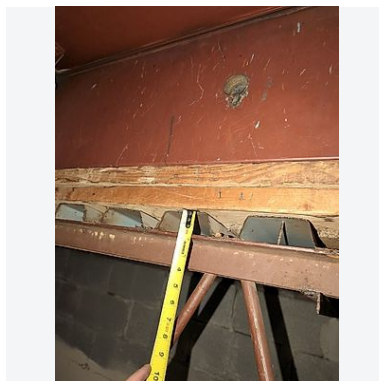
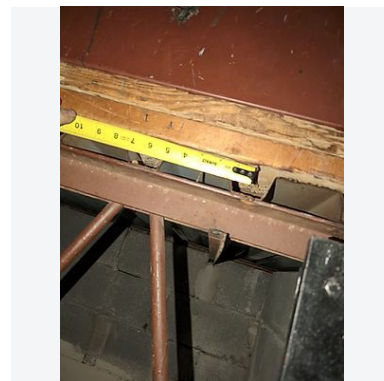
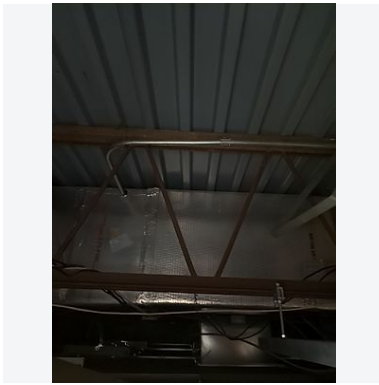
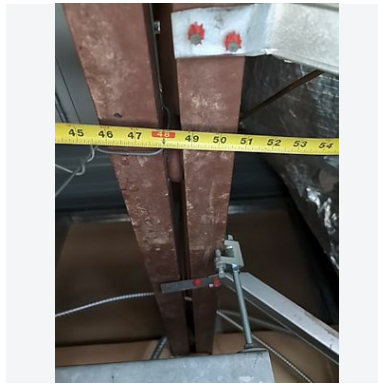
### ✓ Steel Deck

"B" Style decking. Ribs are 6" on center and 1.5" in depth from top to bottom. Purlin spacing is 4' on center.

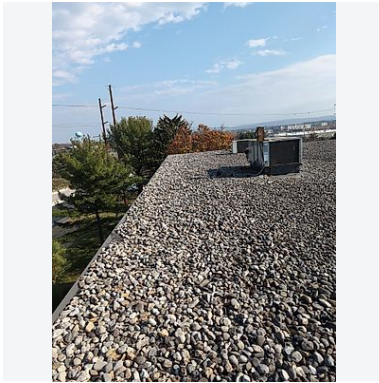
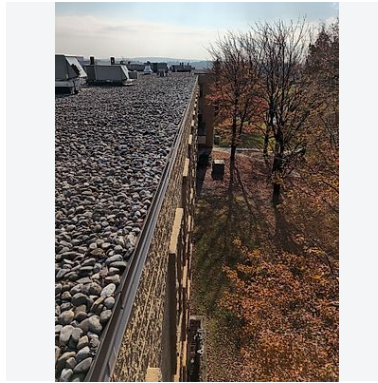
### ✓ Safety

No sufficient wall heights for safety. Taller building in windy corridor near highway.

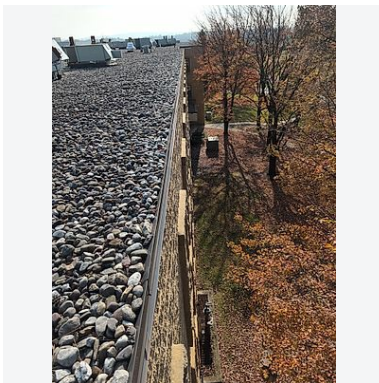
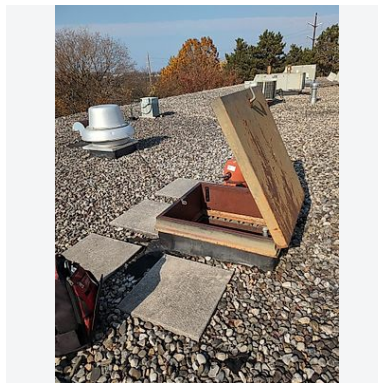
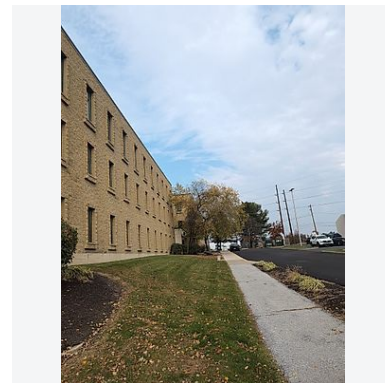
### ✓ Access and Load

Internal Hatch located at the top of the stairwell inside the building. Approximately 35-40 feet high. Load possible from East and South only due to vegetation and limited roadways.
