# YOUR INSPECTION REPORT

1234 Main street  
Calgary, AB

Sunday, February 18, 2018

RE: Report No. 1016  
1234 Main street  
Calgary, AB

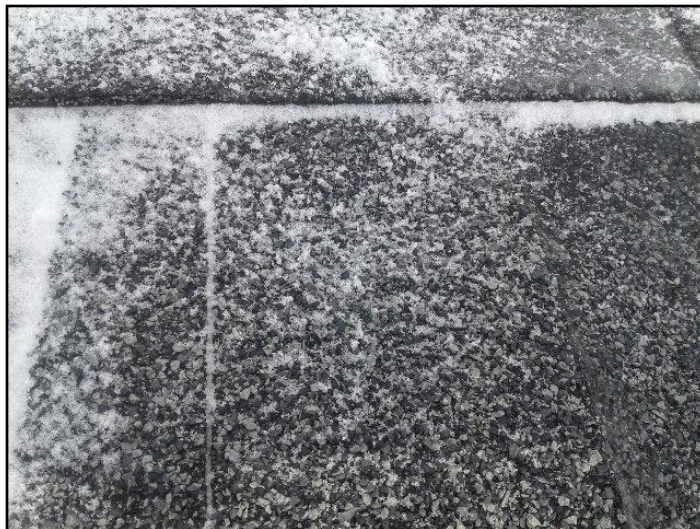
2. Snow/ice/frost

limited inspection of asphalt shingles due to excess snow and ice on roof surface

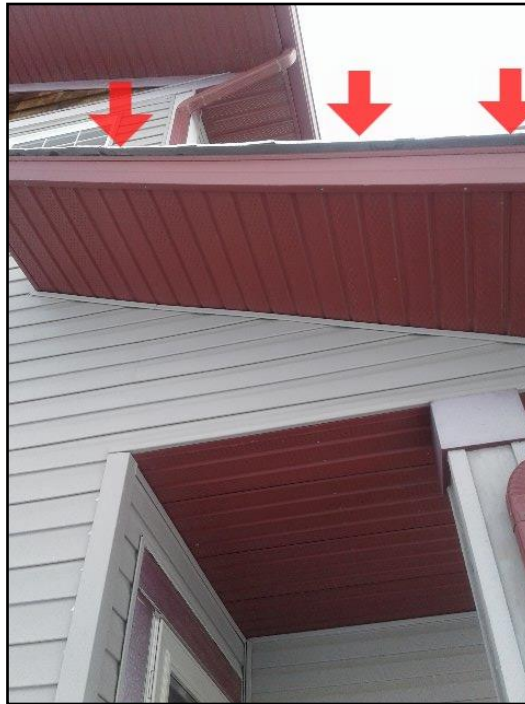
3.

**1. Condition:** • Shingles have not been cut back from gutters and rain water might overshoot the gutter system causing moisture around foundation. Have a qualified roofer inspect and provide recommendations. This condition was observed throughout the exterior roof system of the house.

**Implication(s):** Excess moisture might overflow the gutter system causing moisture to enter the foundations at various locations.

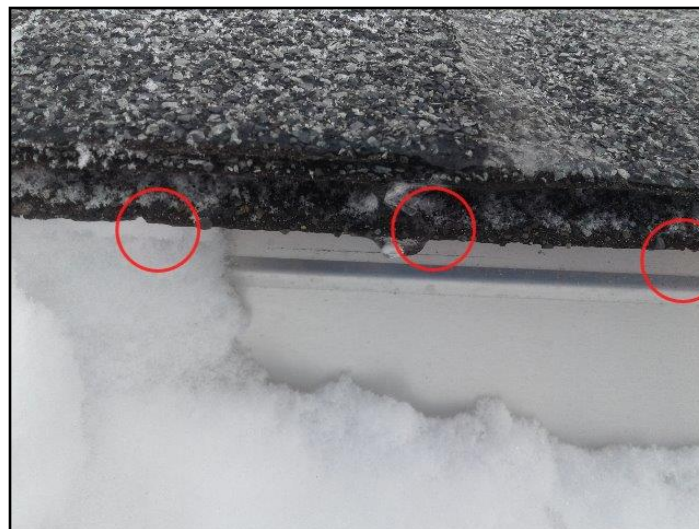
4. Missing

Repair roof drip edge missing on front roof over the garage. Have a qualified roofer check to see if missing throughout the rest of the home and repair

**Implication(s):** Chance of water damage to contents, finishes and/or structure

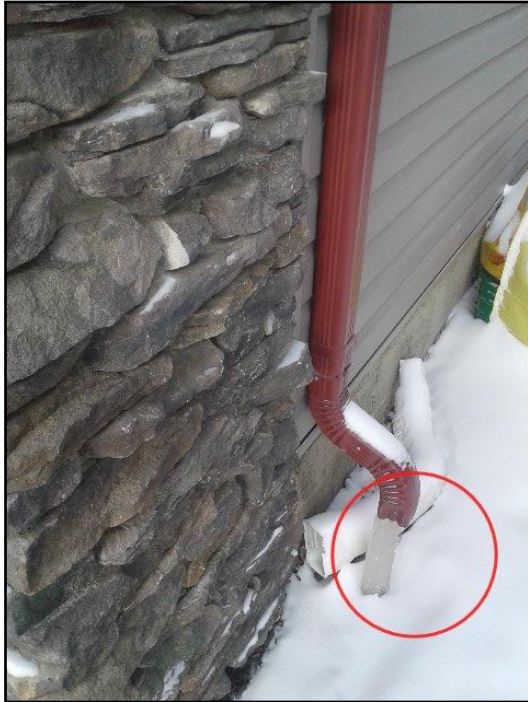
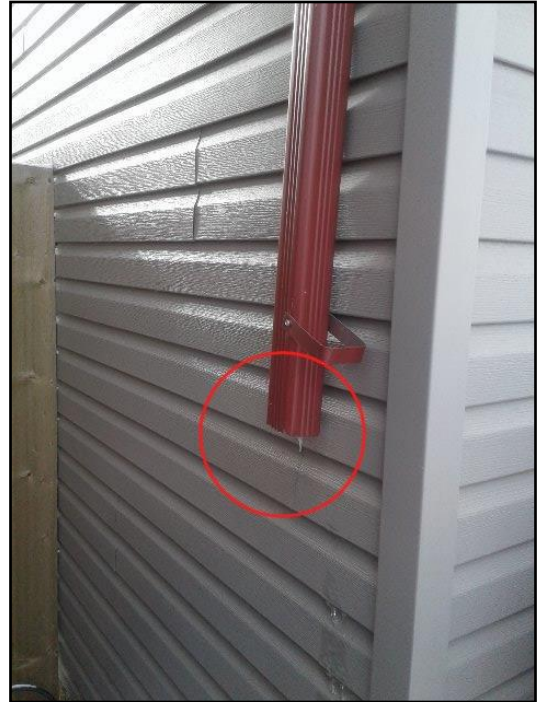
Downspouts are missing from the residence. Repair so that the downspouts are directing water at least 6 ft from the residence.

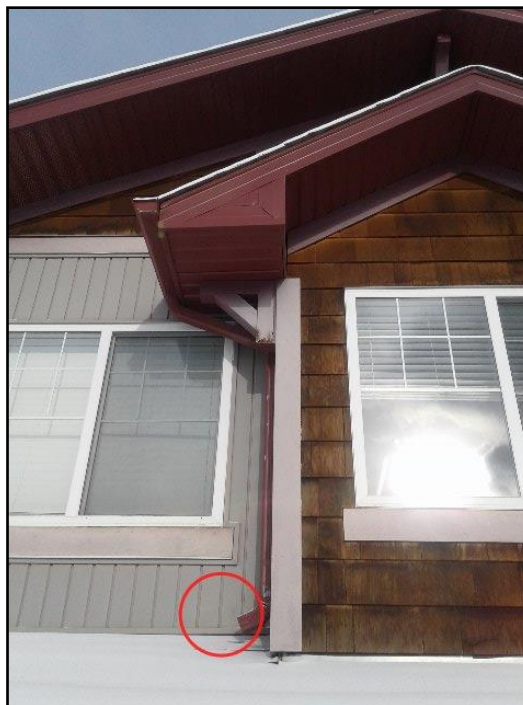
7. Discharge onto roofs

Downspouts are discharging onto roof. recommend placing another elbow and a run so it flows with the slope of the roof versus against the slope.

**Implication(s):** Chance of water damage to contents, finishes and/or structure

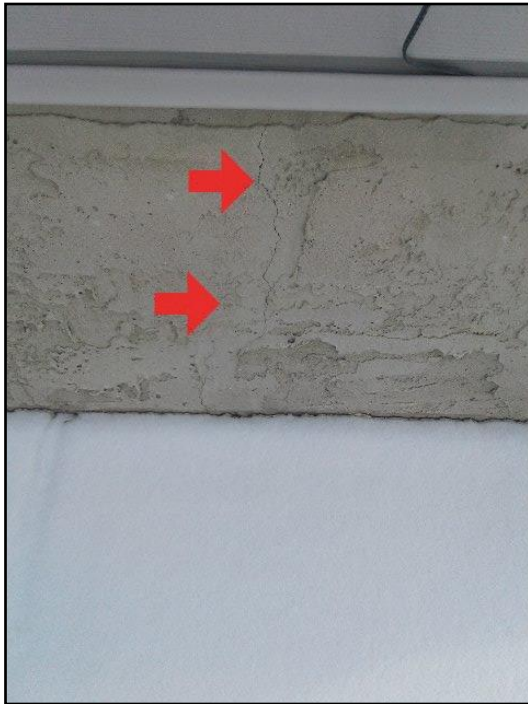
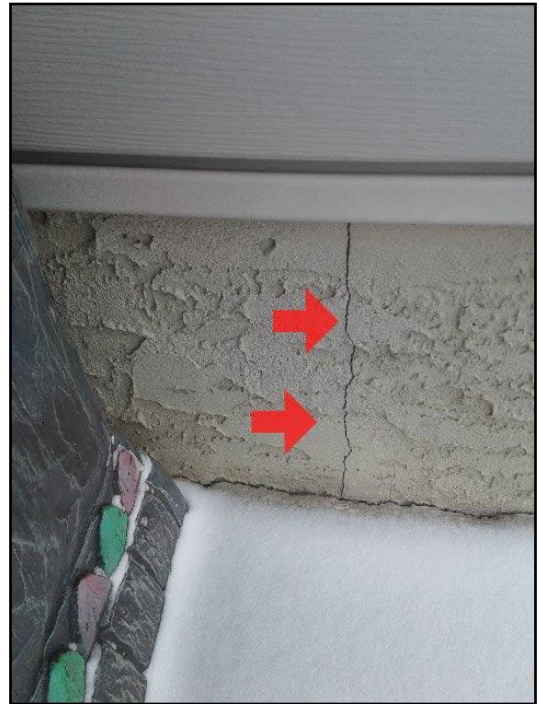
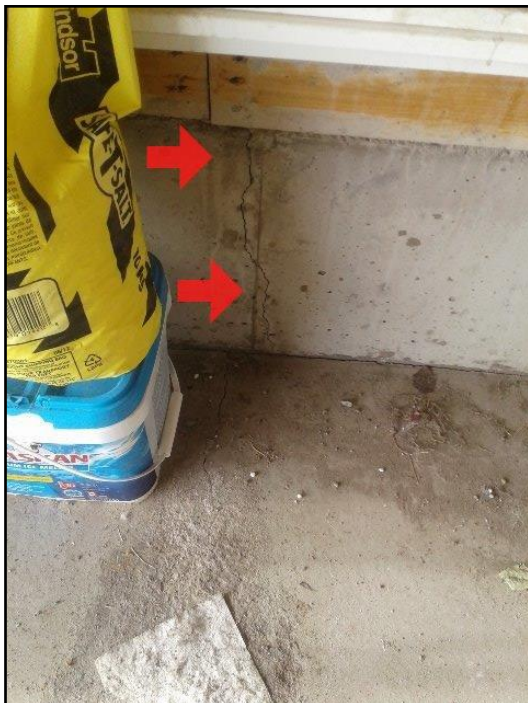
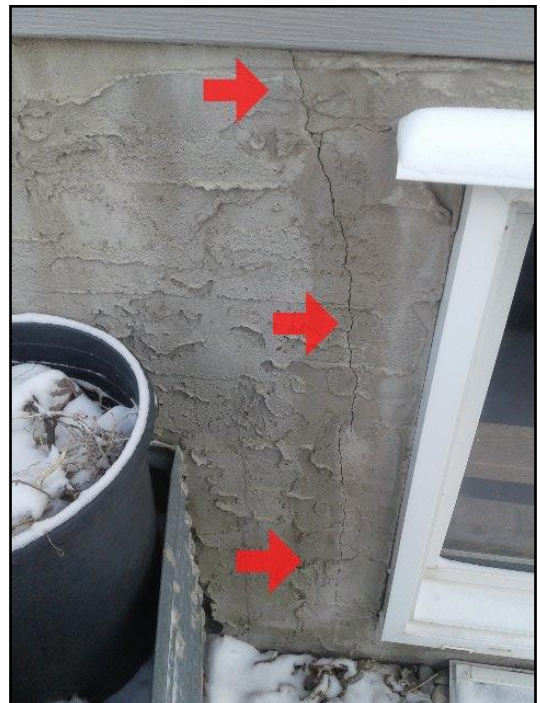
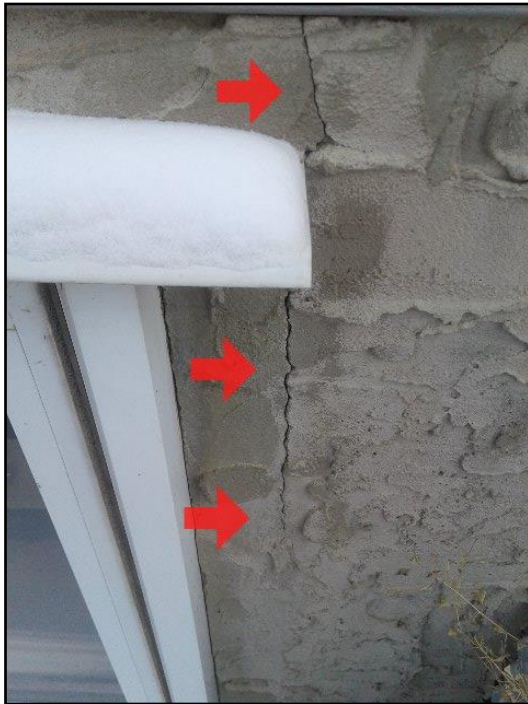
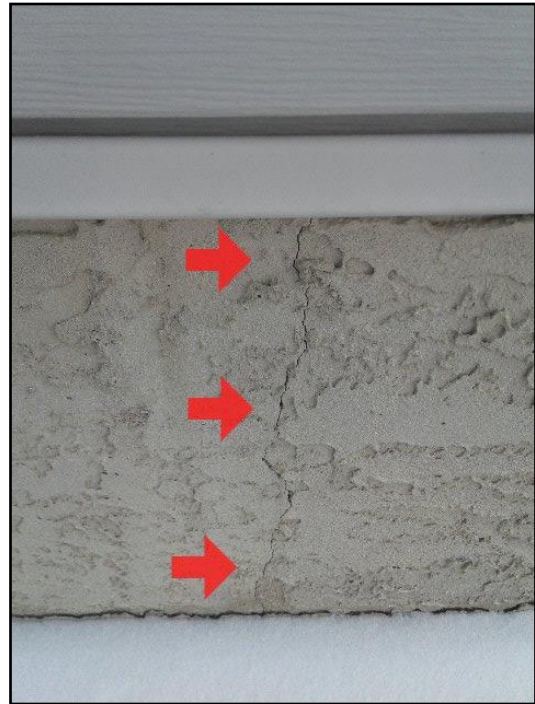
8. Condition: • [Cracked](#)

All cracks around the foundation should be sealed with a concrete adhesive sealant in order to prevent moisture intrusion.

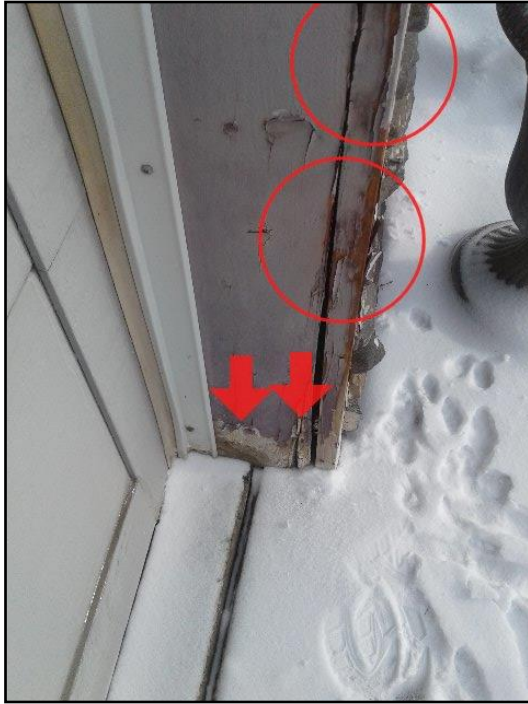
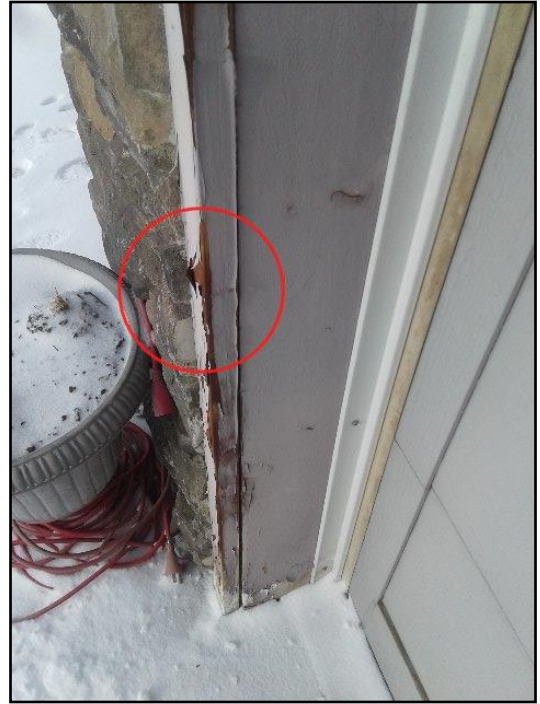
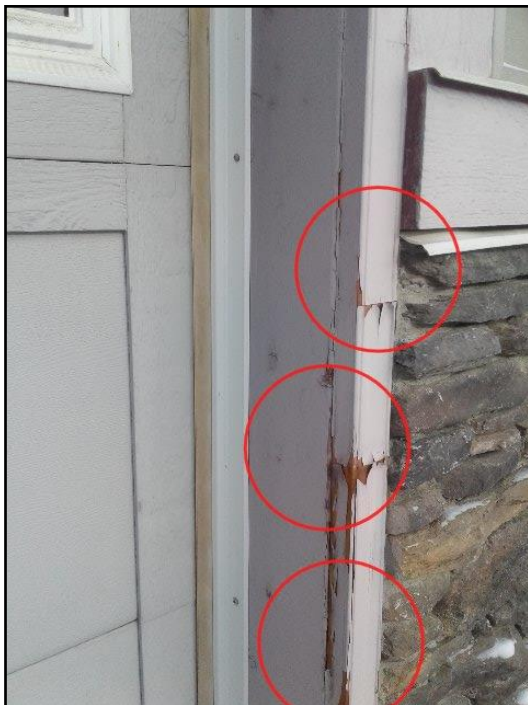
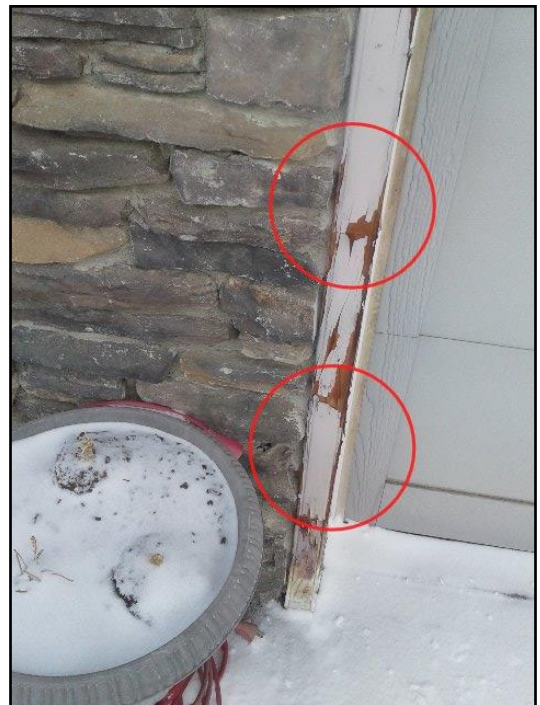
### **9. Condition:** • [Paint or stain needed](#)

Deferred maintenance. Paint to prevent damage to wood material

**Implication(s):** Material deterioration | Chance of damage to finishes and structure

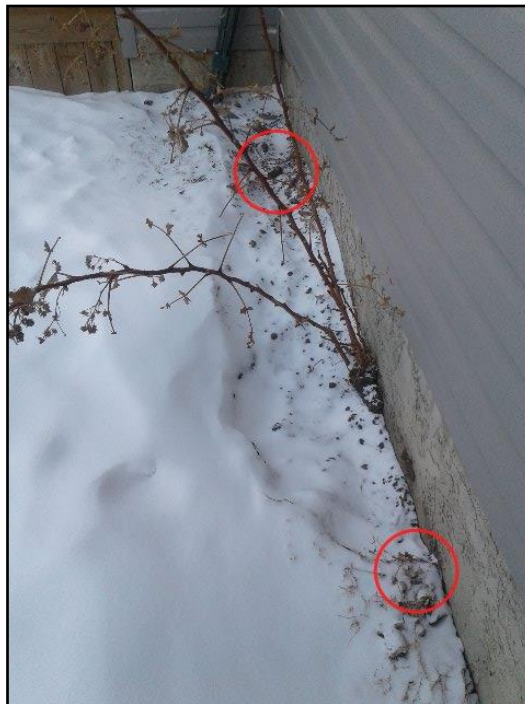
19. Improper slope or drainage

10. Condition: • [Improper slope or drainage](#)

**Implication(s):** Chance of water damage to contents, finishes and/or structure

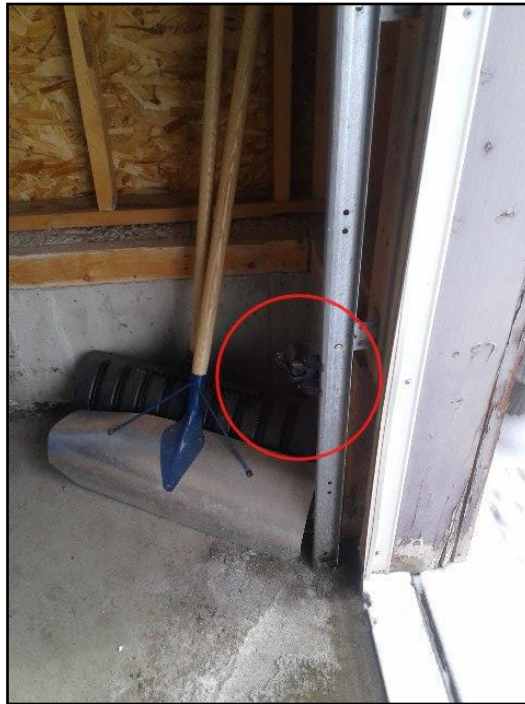
20. Sensors poorly located

11. Condition: • Sensors poorly located

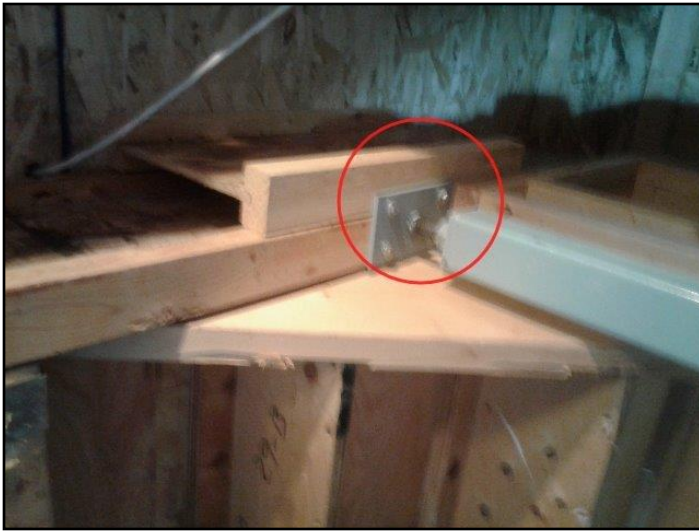
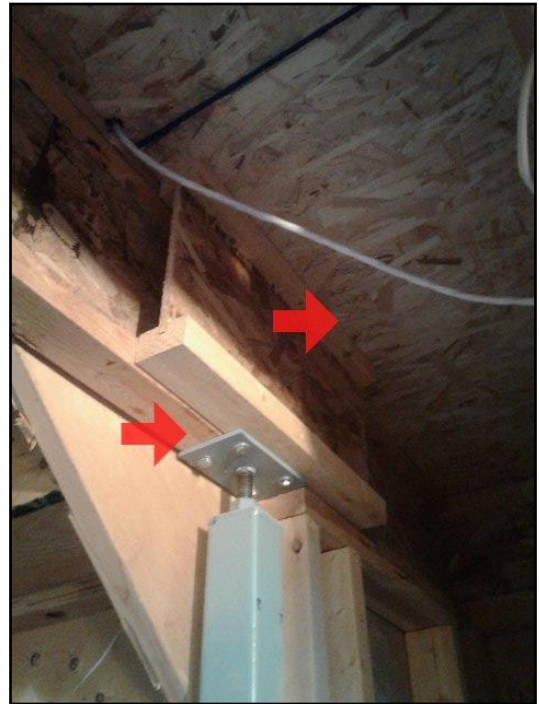
**13. Condition:** • [Weak connection to joists](#)

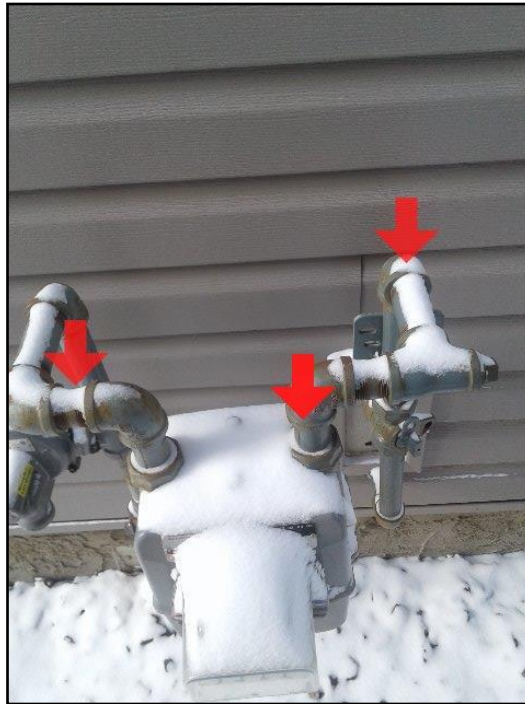
24. Rust

**14. Condition:** • [Rust](#)

Deferred maintenance. Paint gas meter as rust is starting to show

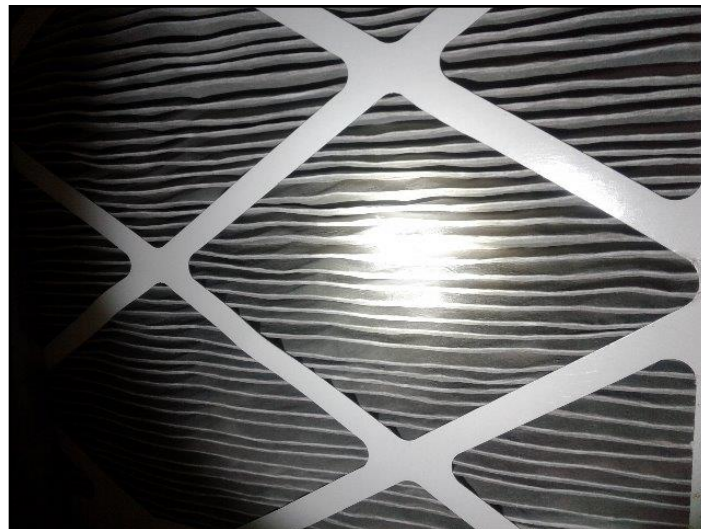
25. Dirty

15. Condition: • [Dirty](#)

Dirty air filter. Replace as soon as possible also suggest a furnace cleaning since the last one was completed in 2007

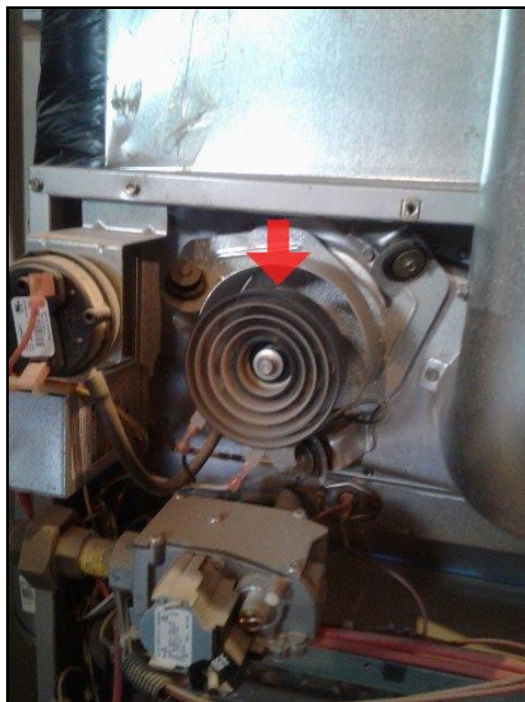
26. Induced draft fan problems

### 16. Condition: • [Induced draft fan problems](#)

**Implication(s):** Hazardous combustion products entering home | Equipment inoperative | Equipment not operating properly

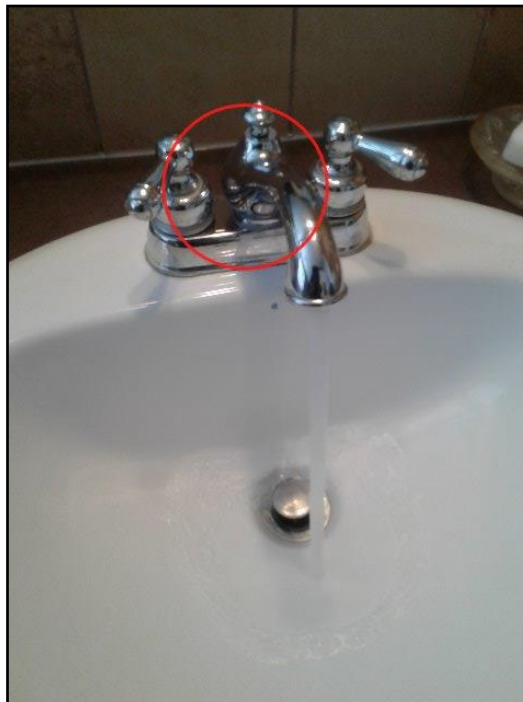
**28.** *Drip, leak*

**19. Condition:** • [Drip, leak](#)

Active water leak discovered in hallway bathroom. Repair with a qualified plumber. Moisture on the bottom of cabinet floor plus actual dripping from hot and cold piping.

**Implication(s):** Chance of water damage to contents, finishes and/or structure

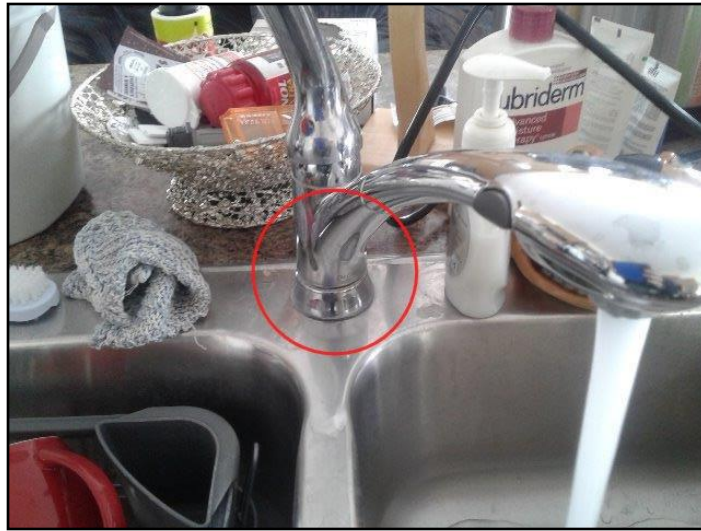
29. Loose

**20. Condition:** • [Loose](#)

At time of inspection kitchen faucet was very loose. Re-tighten so that the faucet does not fail.

**Implication(s):** Equipment failure

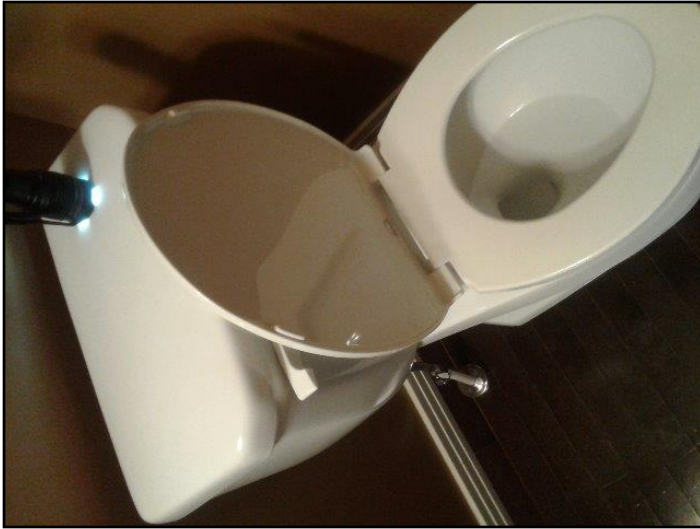
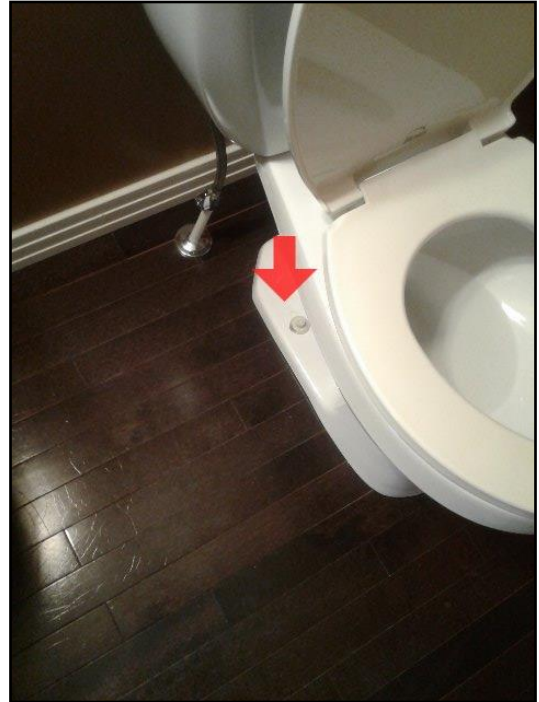
21. Condition: • [Loose](#)

Toilet is loose to the floor retighten floor nuts and suggest that the wax seal be replaced also. No active moisture leakage at time of inspection

**Implication(s):** Sewage entering the building | Chance of water damage to contents, finishes and/or structure

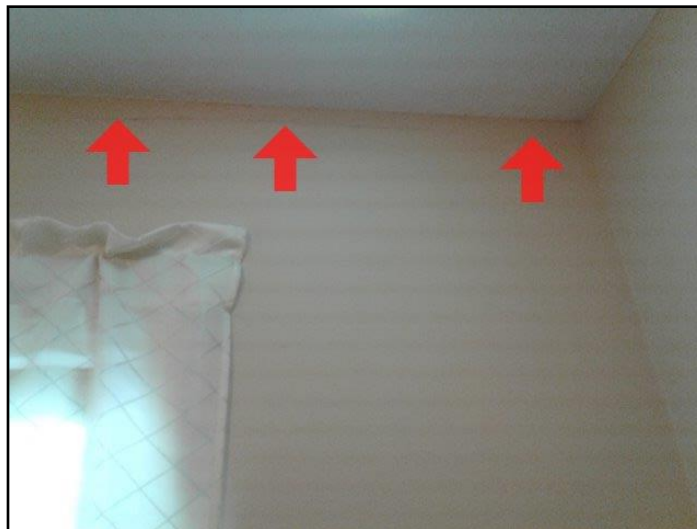
33. Poor joints

#### 22. Condition: • [Poor joints](#)

**Implication(s):** Damage or physical injury due to falling materials

Repair with drywall patch cement and repaint

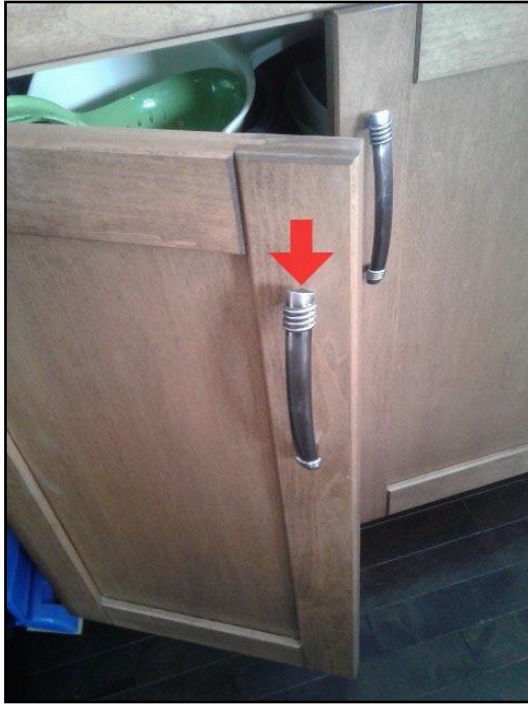
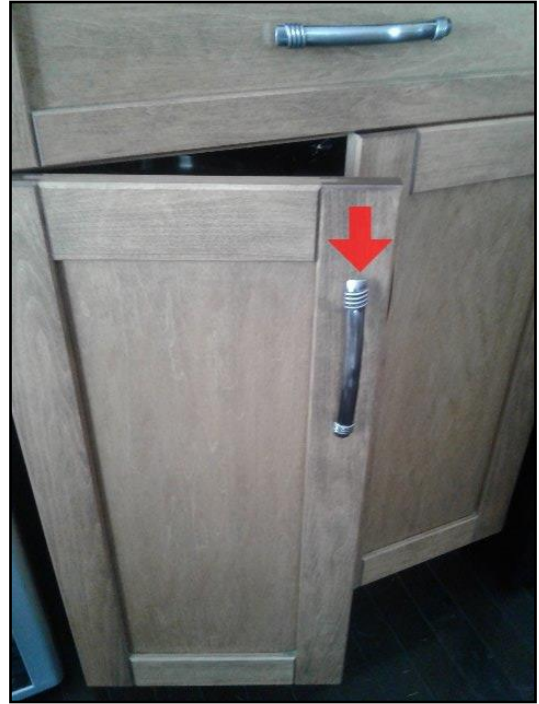
#### 23. Condition: • [Pieces missing or loose](#)

When the kitchen was inspected the handles on the two cabinet fronts were loose. Tighten handles to repair.

**Implication(s):** Damage or physical injury due to falling materials

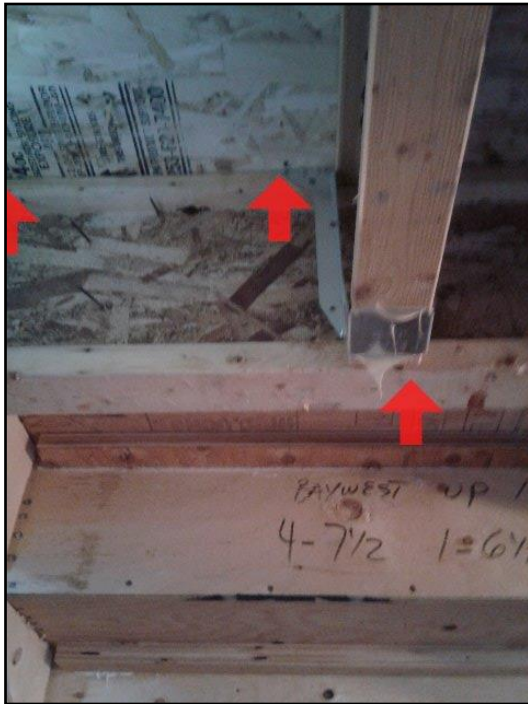
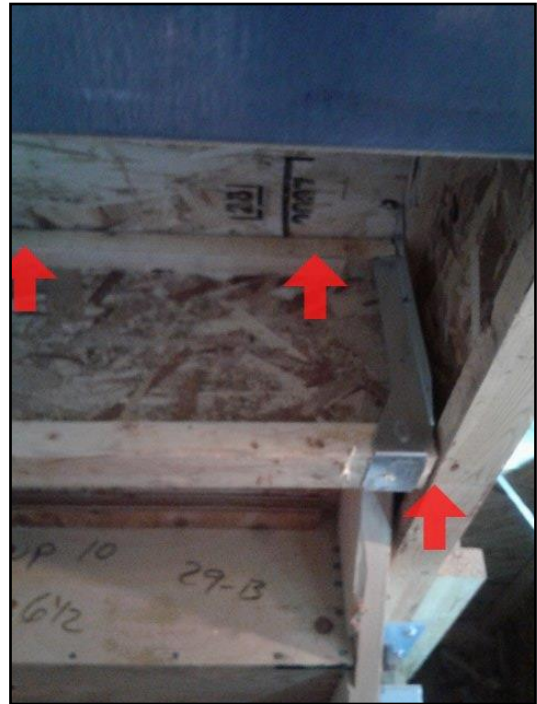
**24. Condition:** • When I inspected the basement staircase the top stair riser is not securely attached to the staircase. A certified contractor needs to provide a repair so that the top stair is secured to the staircase.

**Implication(s):** At the time of inspection the staircase is very stable but over time this could deteriorate and could be a potential fall hazard

**Task:** Repair or replace Further evaluation Consult qualified professional

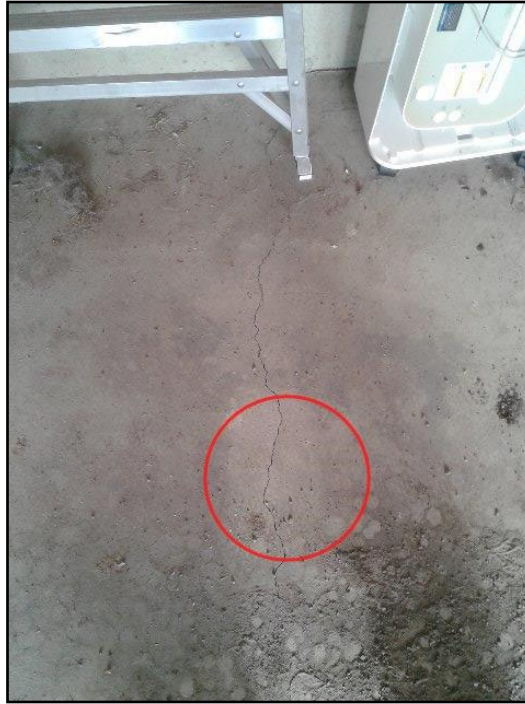
38. Cracked

### 25. Condition: • [Cracked](#)

When I inspected the garage a small crack was noticed. Continue to monitor and if it gets wider or is causing an uneven floor repair with concrete patch cement.

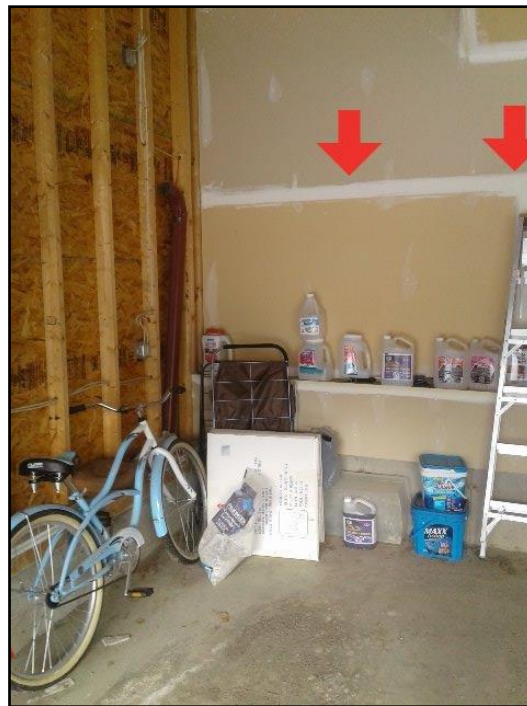
39. Not fireproof

26. Condition: • [Not fireproof](#)

**Implication(s):** Fire hazard
