## **RV Inspection Report**

**Inspection Date:** 4/29/2021

**RV Model: 2018 George Town Forest River GT5 36B5**

**Blue Line Mobile RV Service**

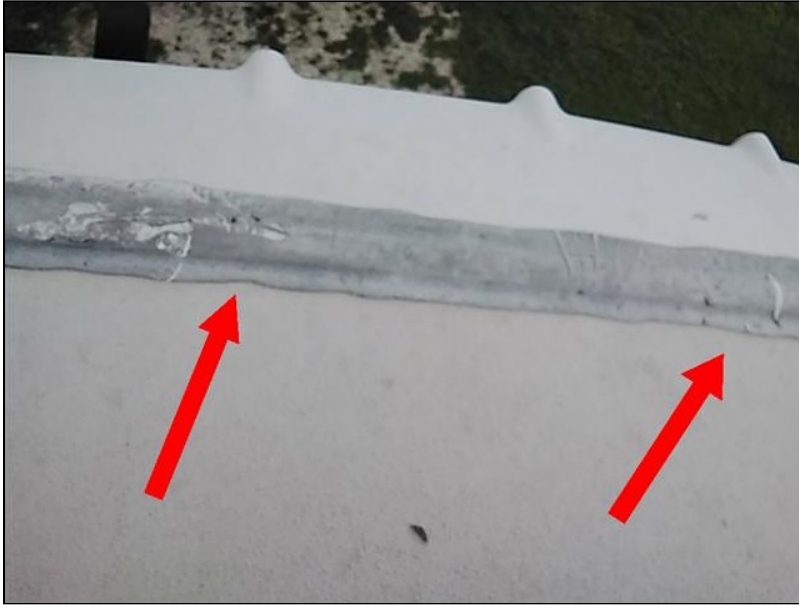
rear cap sealant

Inspector found several small holes in the rear cap sealant. These small holes could allow water to enter the vehicle and inspector would recommend that these be repaired by qualified RV technician.

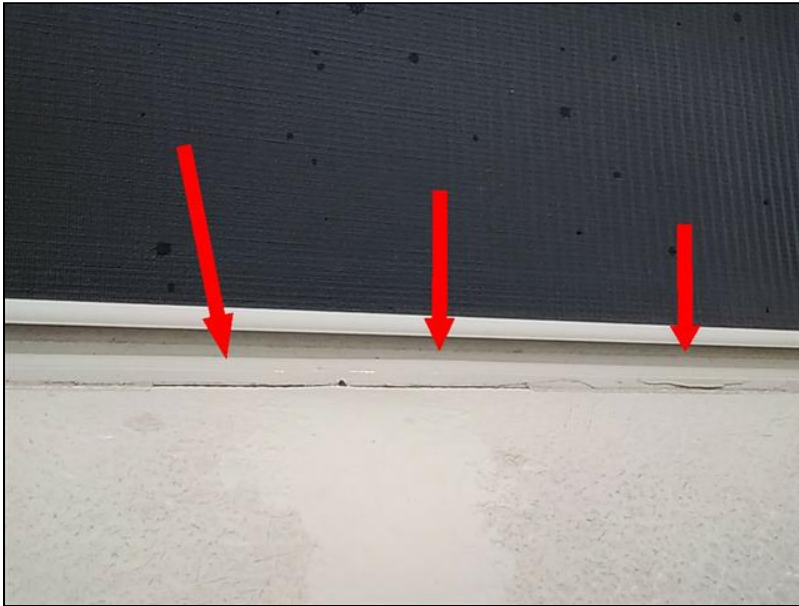
streetside gutter trim rail

Inspector observed cracks in the streetside gutter sealants above the rear awning. These cracks could allow moisture to enter the vehicle and inspector would recommend that this be repaired by qualified RV technician.

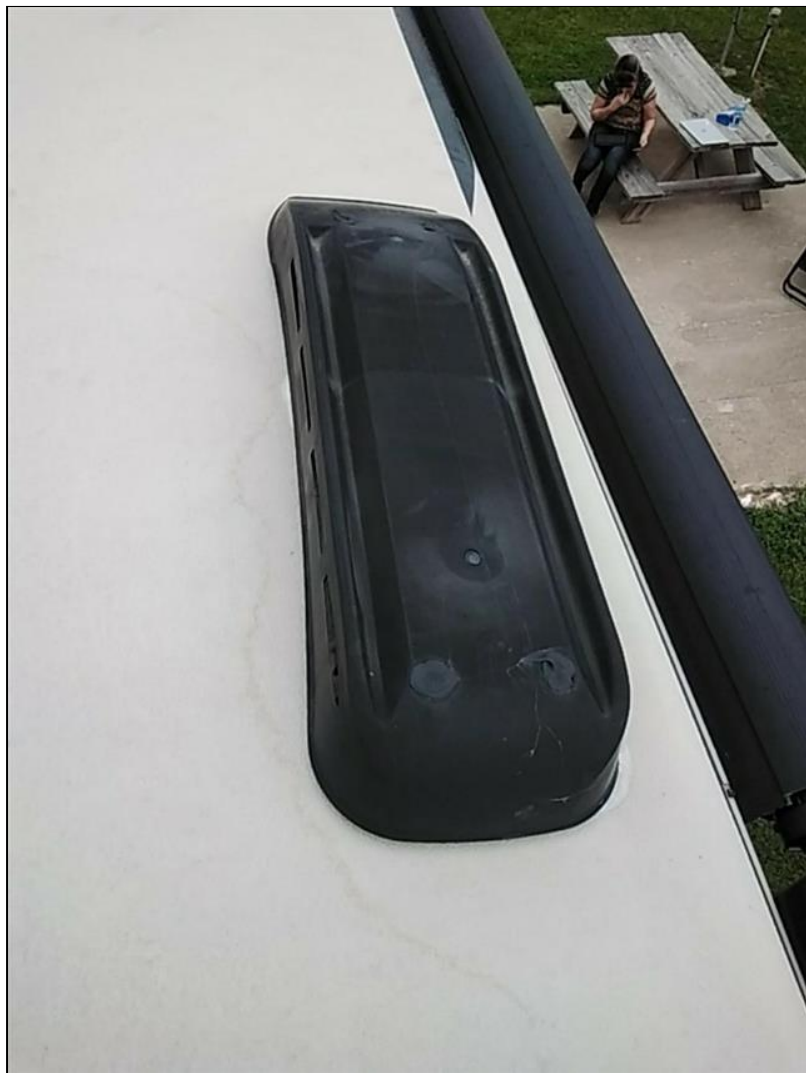
Inspector noticed that refrigerator vent cover was faded from UV exposure..

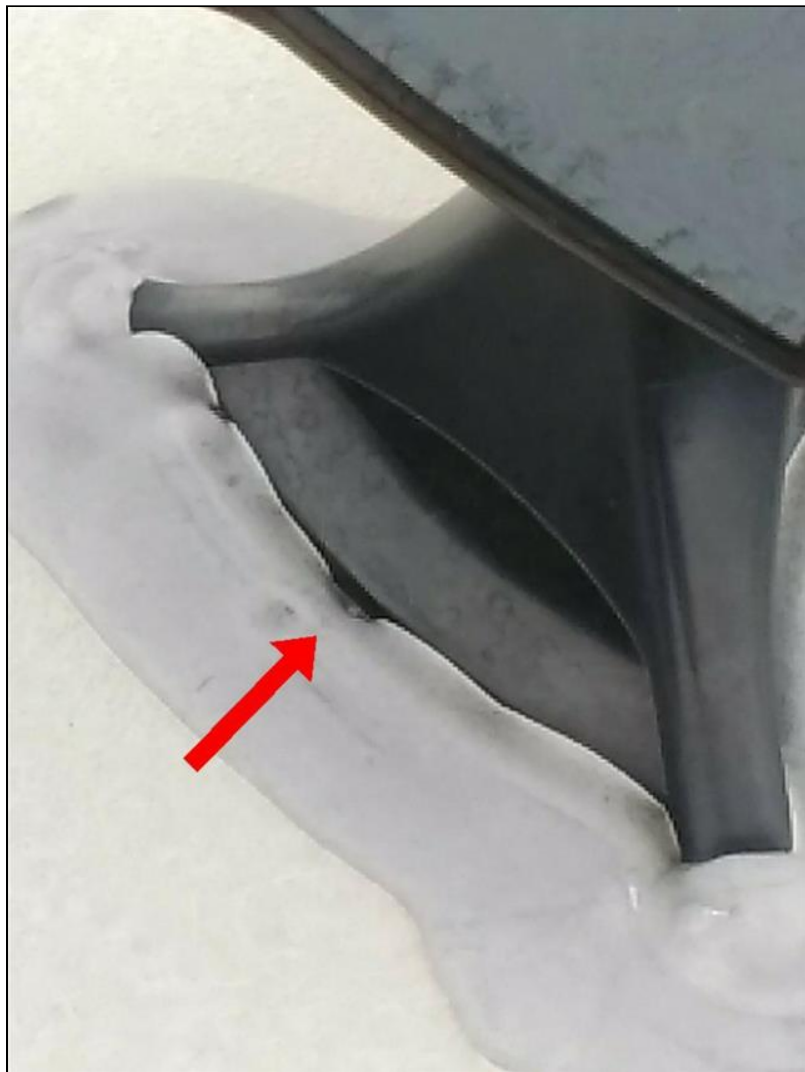
RV Antenna

Inspector observed that on the rear side of the King TV antenna, there was a small pocket in the sealant that could allow water to accumulate and penetrate into the RV. Inspector would recommend that this be repaired by a qualified RV technician.

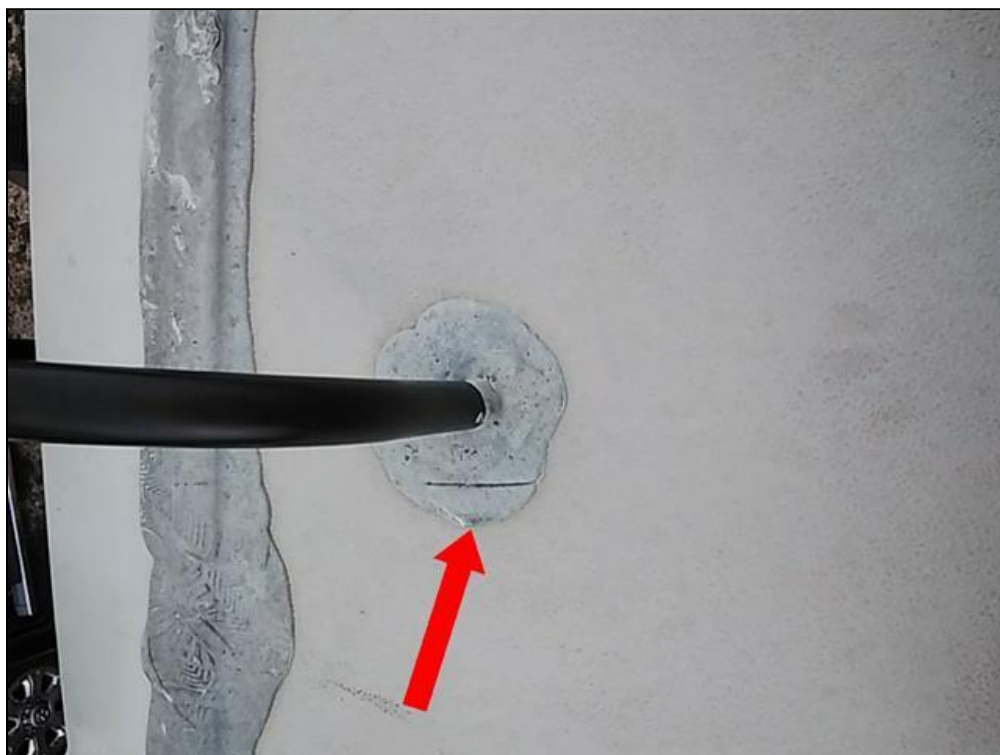
Ladder connection at roof

Inspector observed a crack in the sealant where the ladder connects to the roof. This is a possible area for water penetration and should be repaired by qualified RV technician.

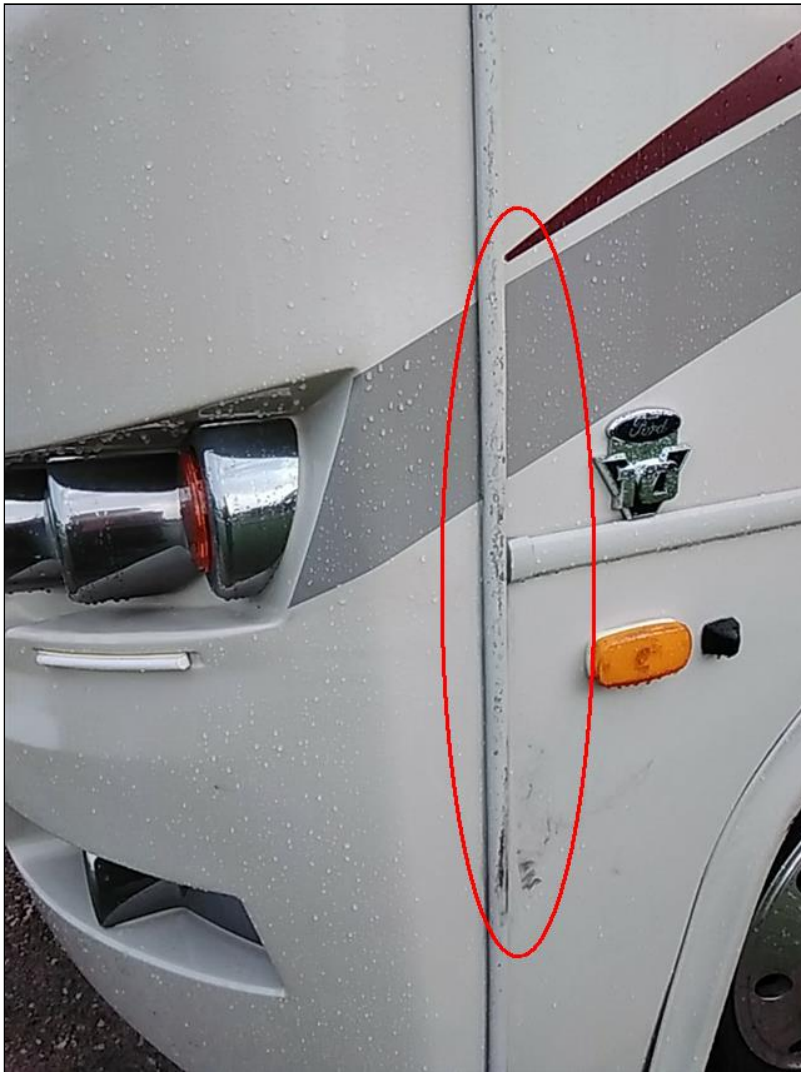
streetside front corner

Front cap trim connection points have chips in the paint.

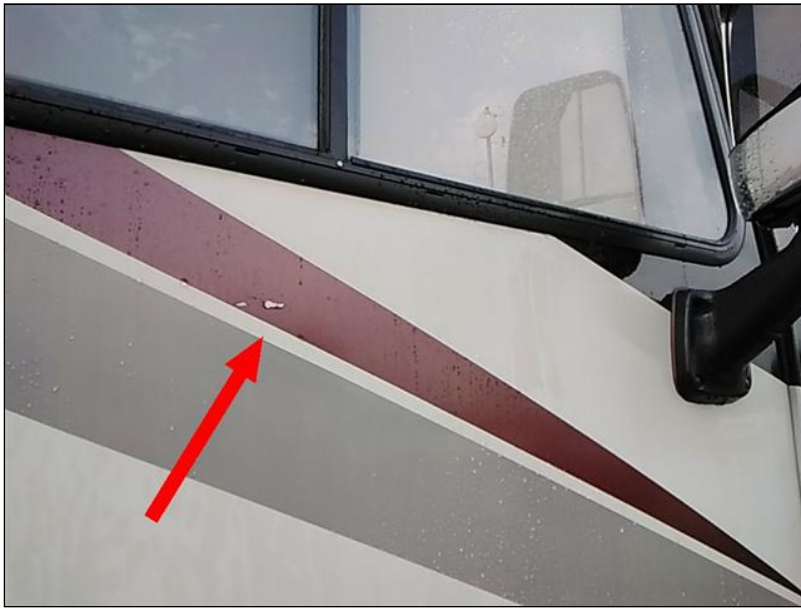
passenger side front

Inspector found damage to the curbside decal next to where the front passenger sits.

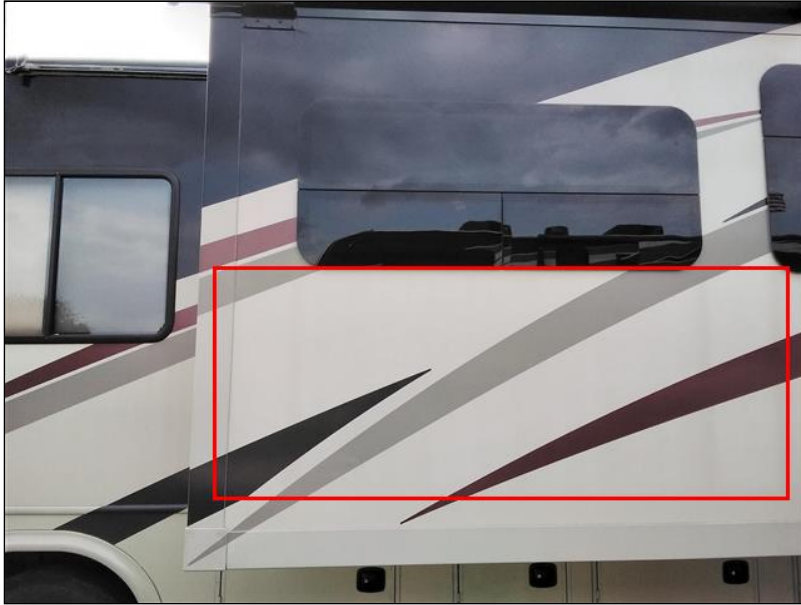
front streetside slide

Inspector observed on the streetside sidewall, there were areas of UV damage/oxidation on the main slide behind the driver seat.

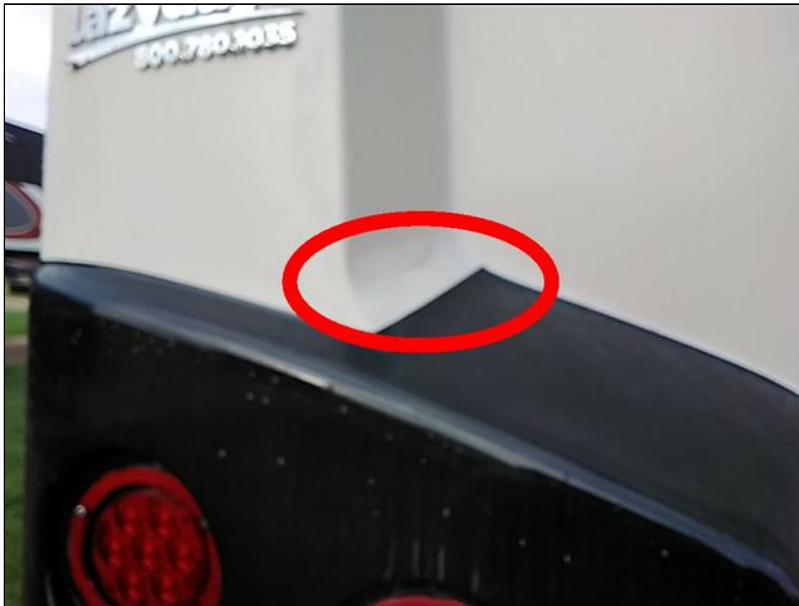
rear cap corner

Inspector noted some UV fading/oxidation on the driver side rear corner above the tail lights.

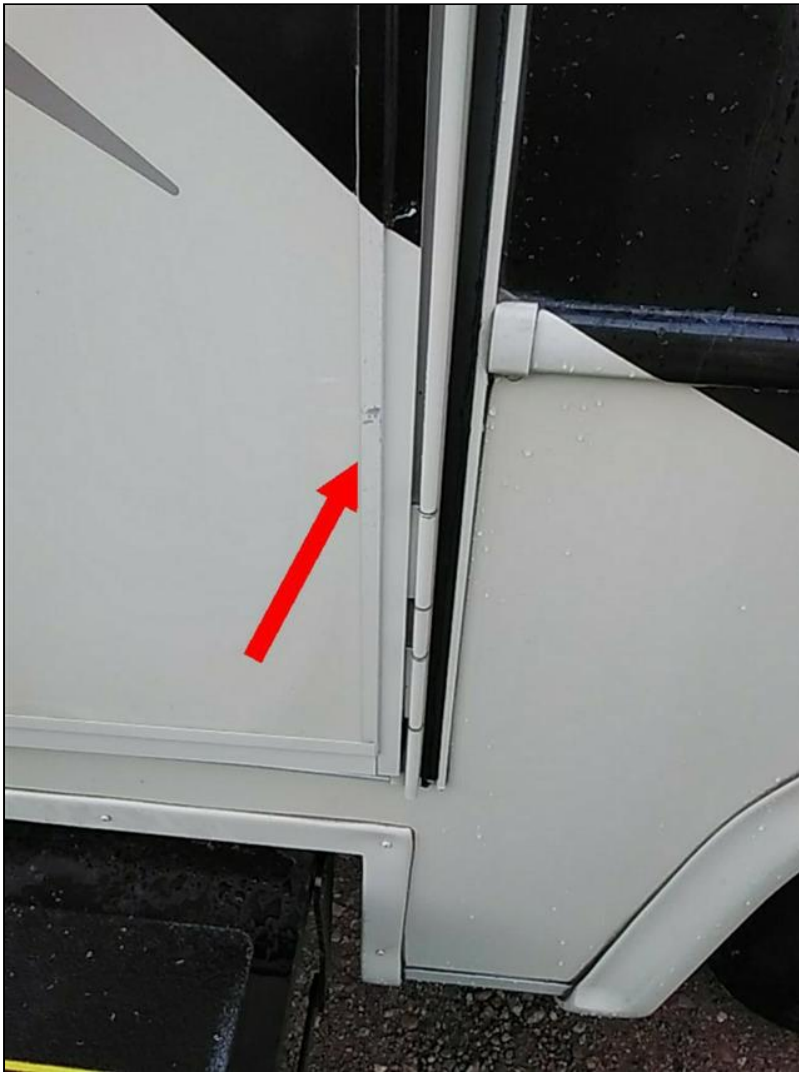
main access door

Inspector observed damage to the lower right corner of the main access door, a chip in the painted trim

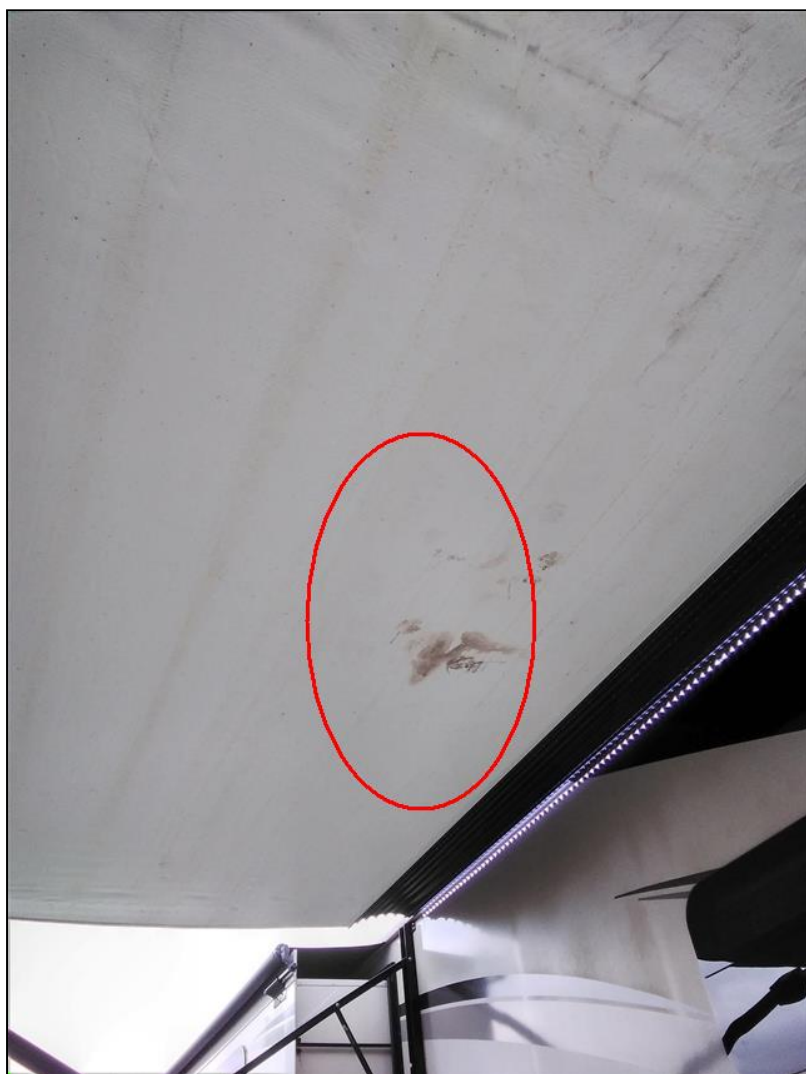
underside of awning

Fabric on the topside was clean with no tears. The underside had some black marks.

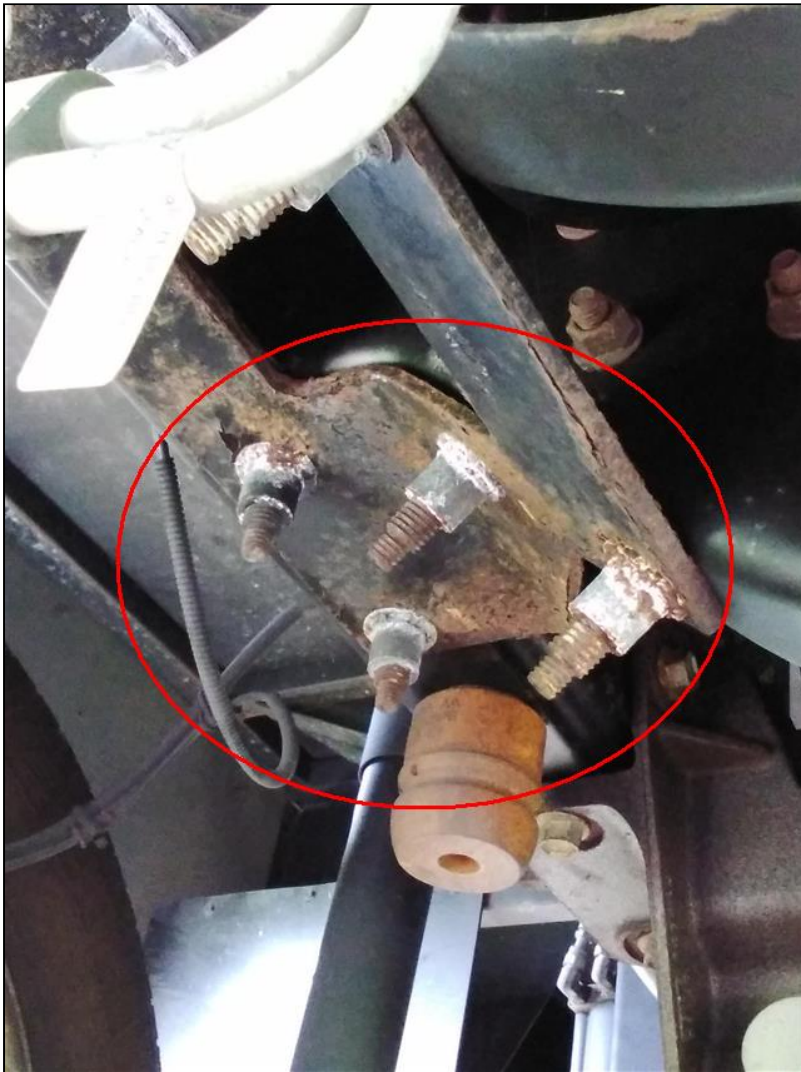
The inspector found some rust on cross member under the engine, on the curbside.

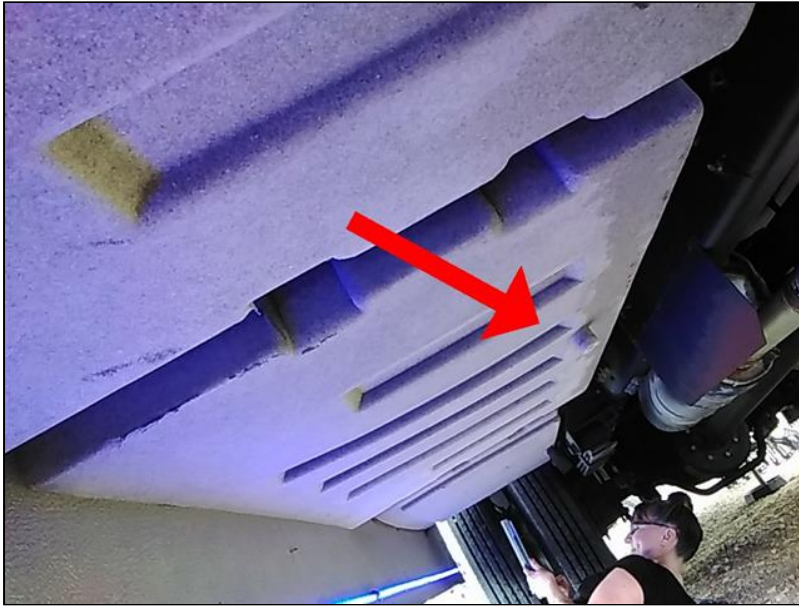
Curbside storage compartment

The inspector found that a rubber one way seal that keeps water out of the basement storage compartment was missing. This compartment is on the curbside, two compartments forward of the rear drive tires. The lack of this seal could allow water to enter the compartment,

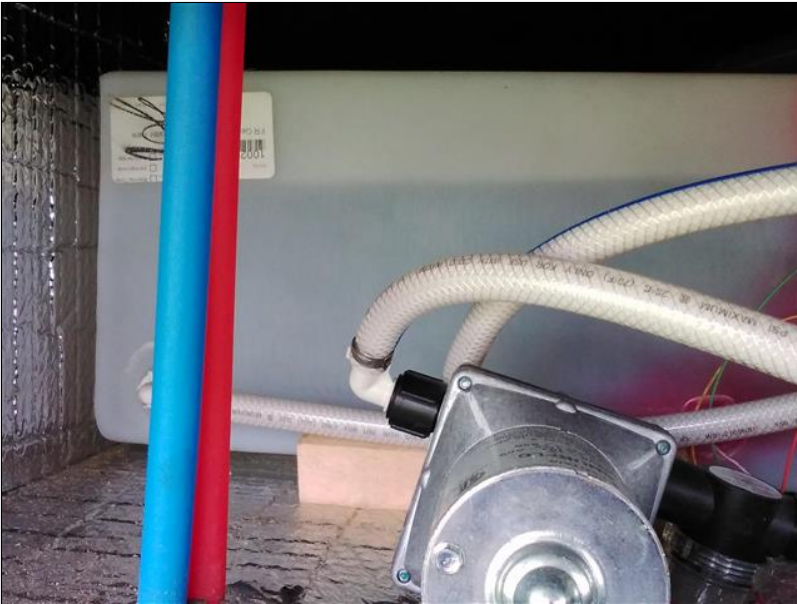
(1) Inspector observed water damage in water pump cabinet in the curbside compartment. Water has caused the floor board to warp and pump now sits at an angle. Owner advised that he had a leak at the strainer and it caused the warped floor in that compartment. .

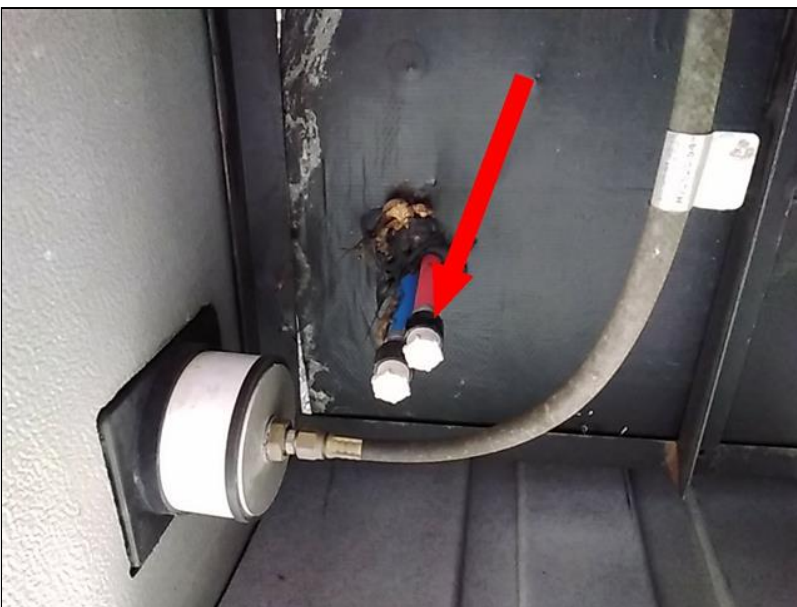
(2) Inspector found a small leak in the rear low point drain, on the red (hot) water line. This low point drain is located toward the rear curbside of the vehicle, behind the rear drive tires.

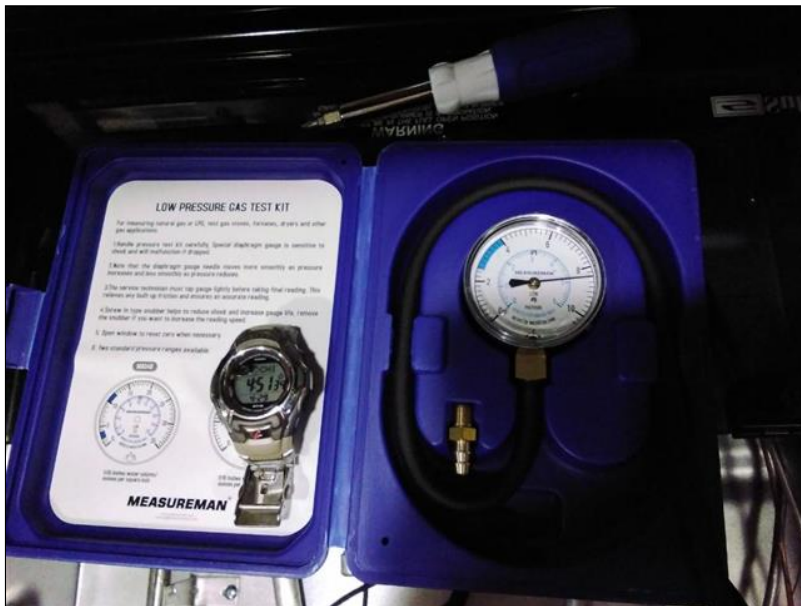
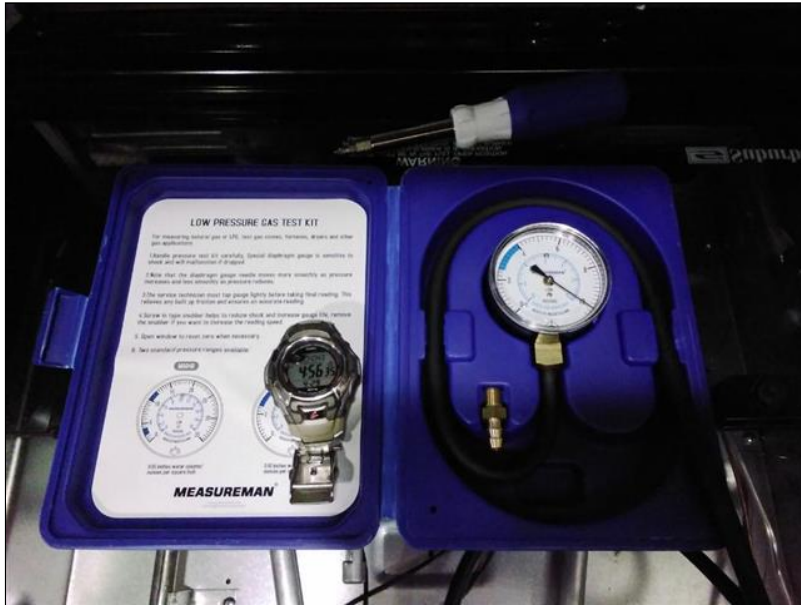
Inspector found that during the LP leak test, the pressure actually increased from 8 inches of water column to 9 inches of water column, possibly indicating that the shut-off valve is not working properly. Inspector would recommended that this shut off valve be further evaluated and repaired by a qualified RV technician before the unit is occupied or driven from its current location.

**+** Inspector found that during the LP leak test, the pressure actually increased from 8 inches of water column to 9 inches of water column, possibly indicating that the shut-off valve is not working properly. Inspector would recommended that this shut off valve be further evaluated and repaired by a qualified RV technician before the unit is occupied or driven from its current location.

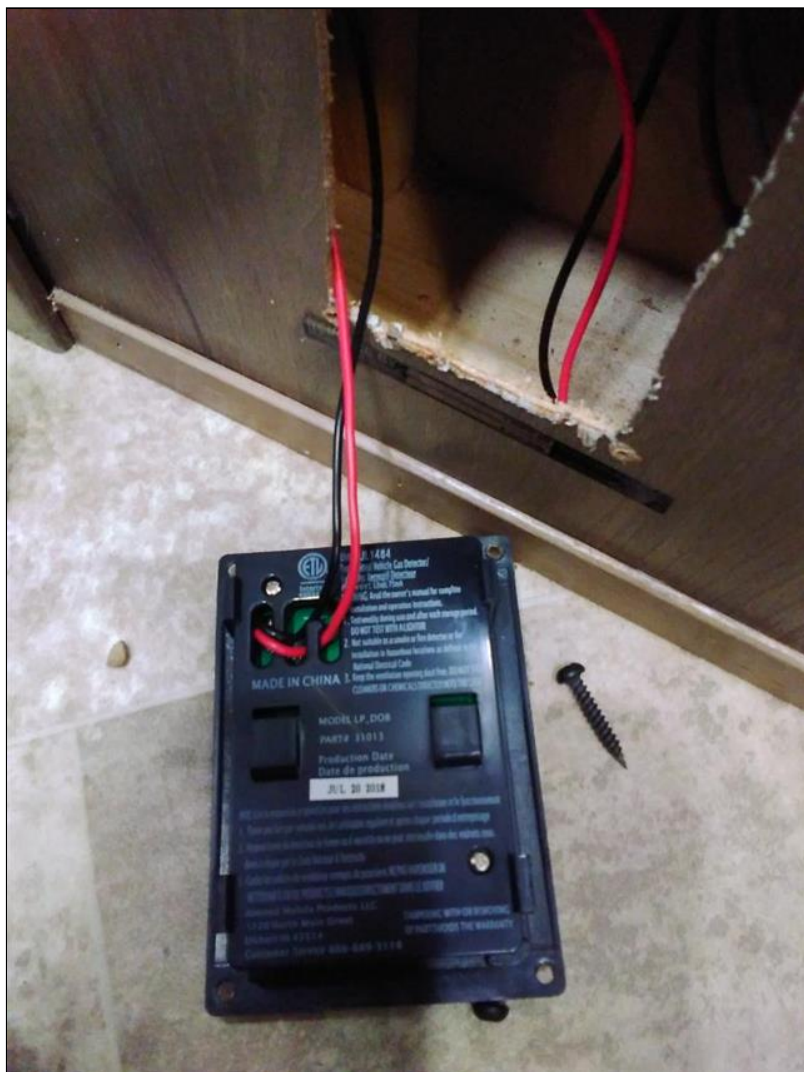
LP Detector

LP detector failed to alarm during test with butane lighter. Inspector would recommend that this unit be replaced by a qualified RV technician prior to it being occupied.

**+** LP detector failed to alarm during test with butane lighter. Inspector would recommend that this unit be replaced by a qualified RV technician prior to it being occupied.

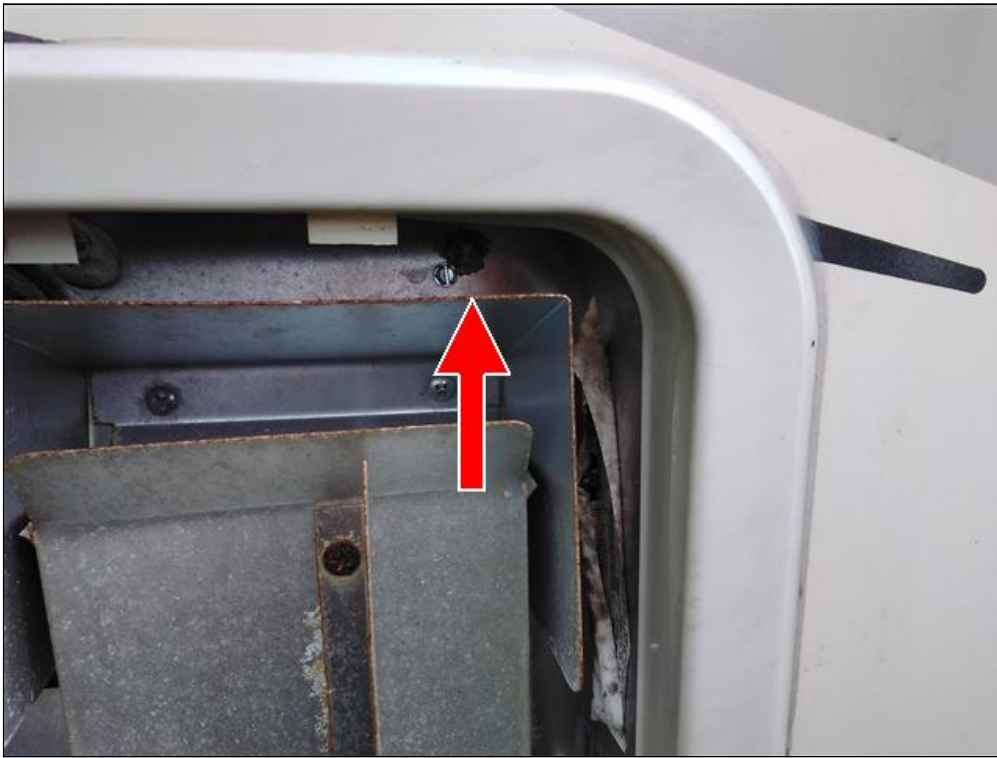
front water heater

The inspector found the beginnings of a wasps nest being built above the water heater exhaust.

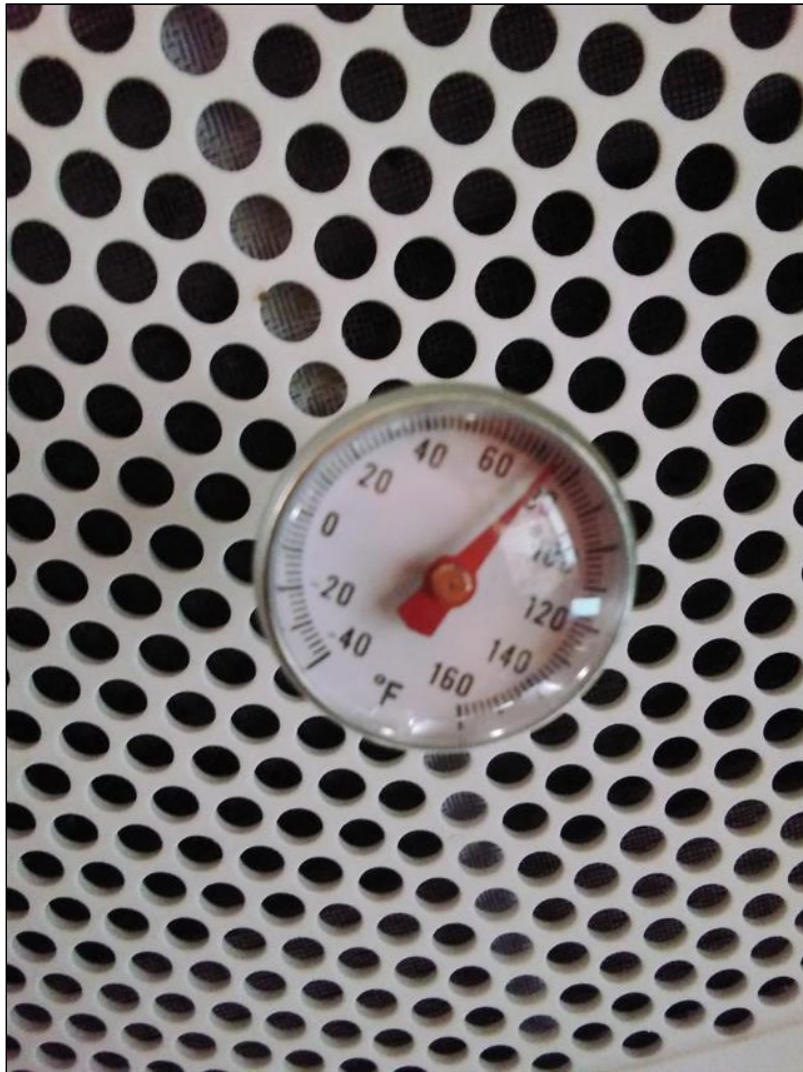
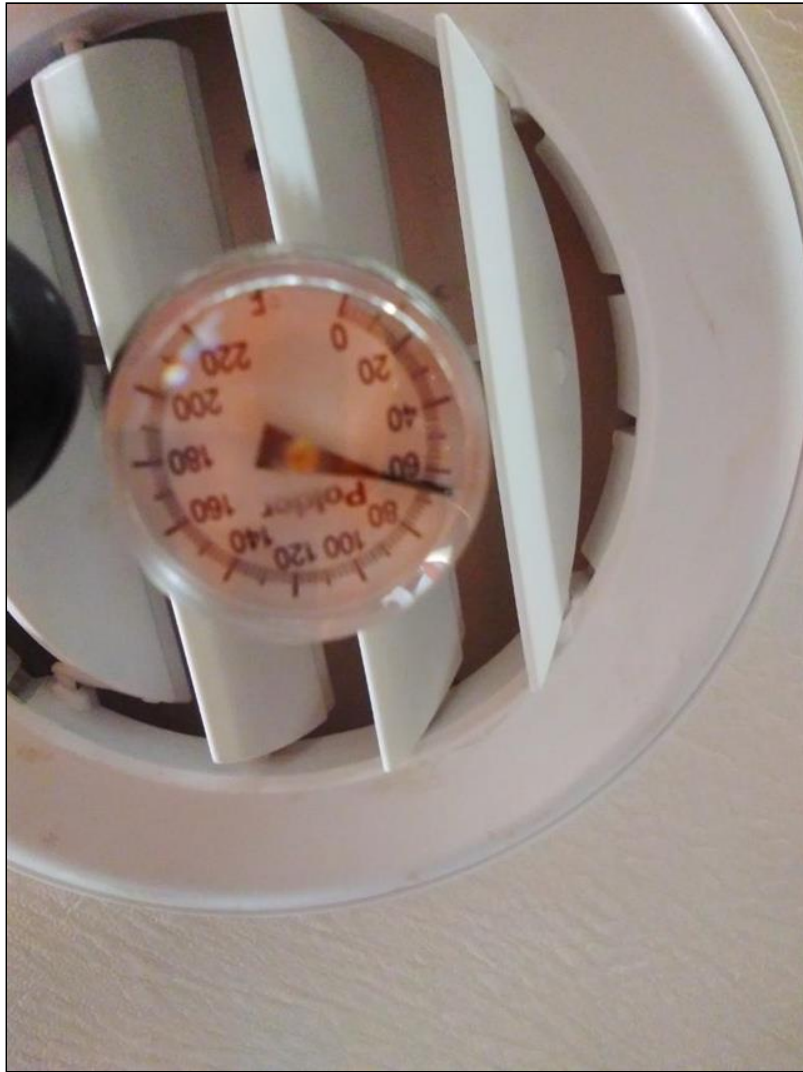
Delta test readings was only 8 degrees and should be repaired by qualified by qualified RV technician.

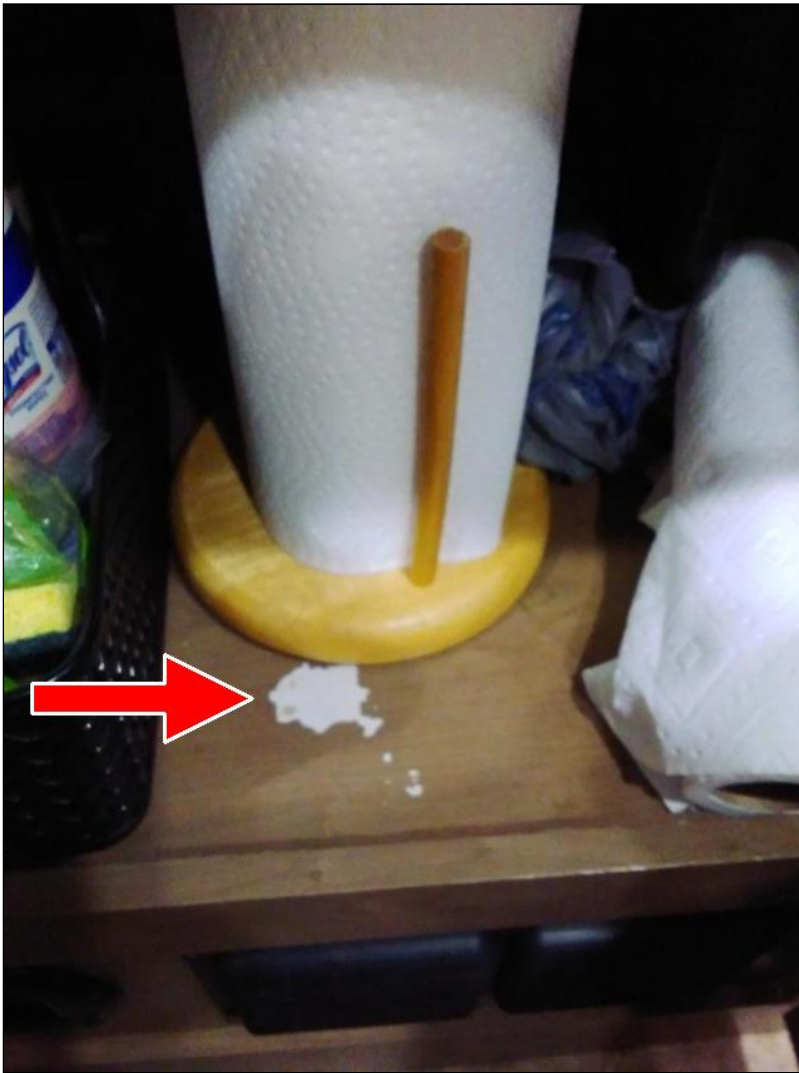
under kitchen sink

Inspector observed damage under the kitchen sink, where the RV cabinet wood covering peeled away from the shelf, causing a 2 inch diameter spot on the shelf that appears white in color.
