RV Inspection Report

2018 Cruiser RV, Stryker, ST-2916, Athens, Texas 75751

Inspection Date: 4/22/2021

Blue Line Mobile RV Service

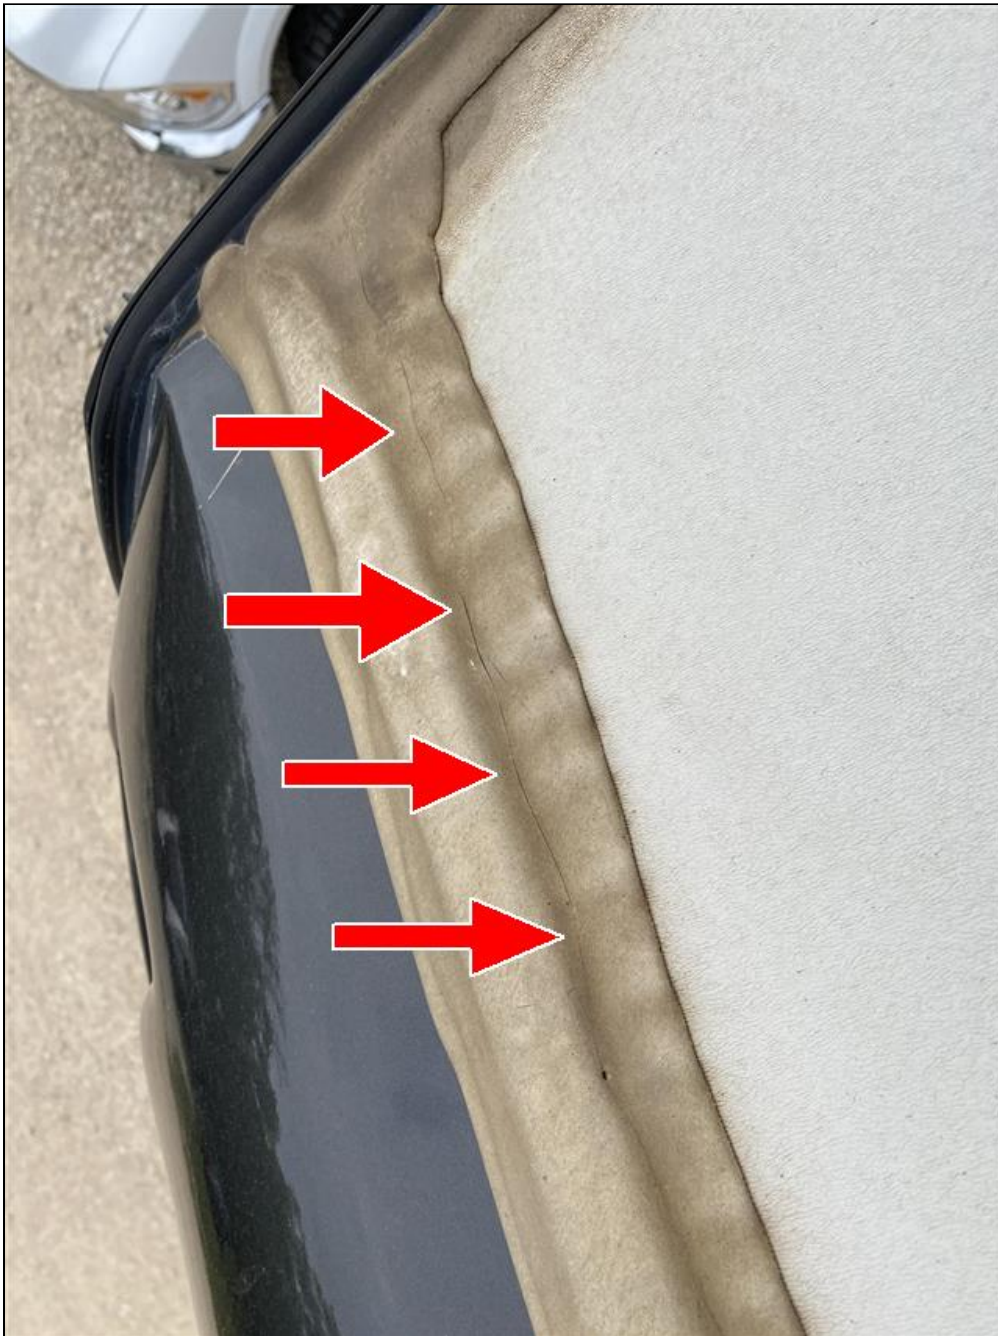
Front cap seal, curb side

Inspector found several areas of possible water intrusion in the front cap seal. Recommend seal be evaluated by qualified RV technician for repair.

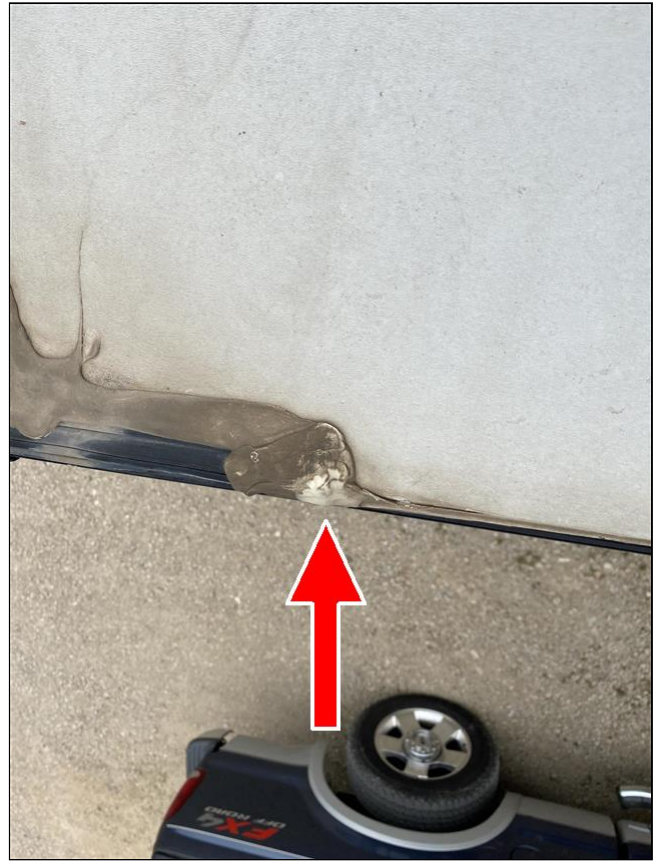
Peeling sealant on street side front cap seal

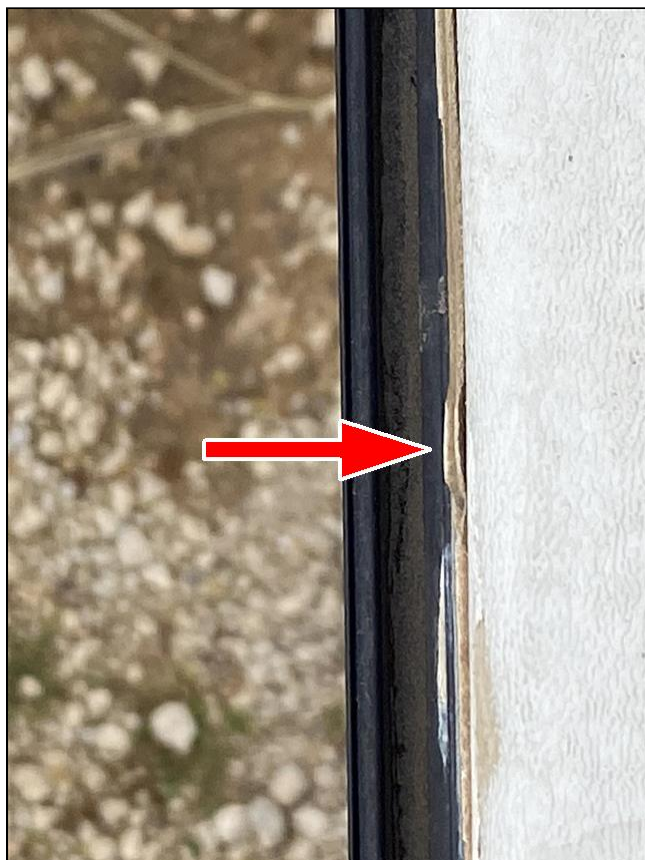
rear curbside gutter

\$ Inspector found sealant crack long the curbside gutter/trim rail in two locations at the rear side of the vehicle, where water can possibly enter the vehicle. Recommend that this trim rail be resealed by qualified RV technician.

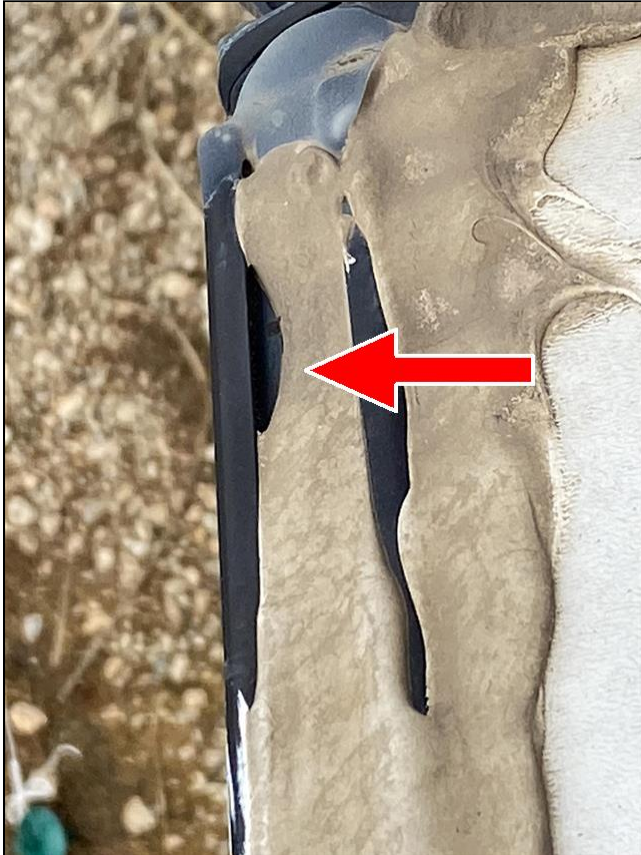
Streetside rear cap seal

Inspector found two areas, streetside rear, where sealant has a visible void in sealant and where water can possibly enter. Recommend that the rear cap seal be resealed by qualified RV technician.

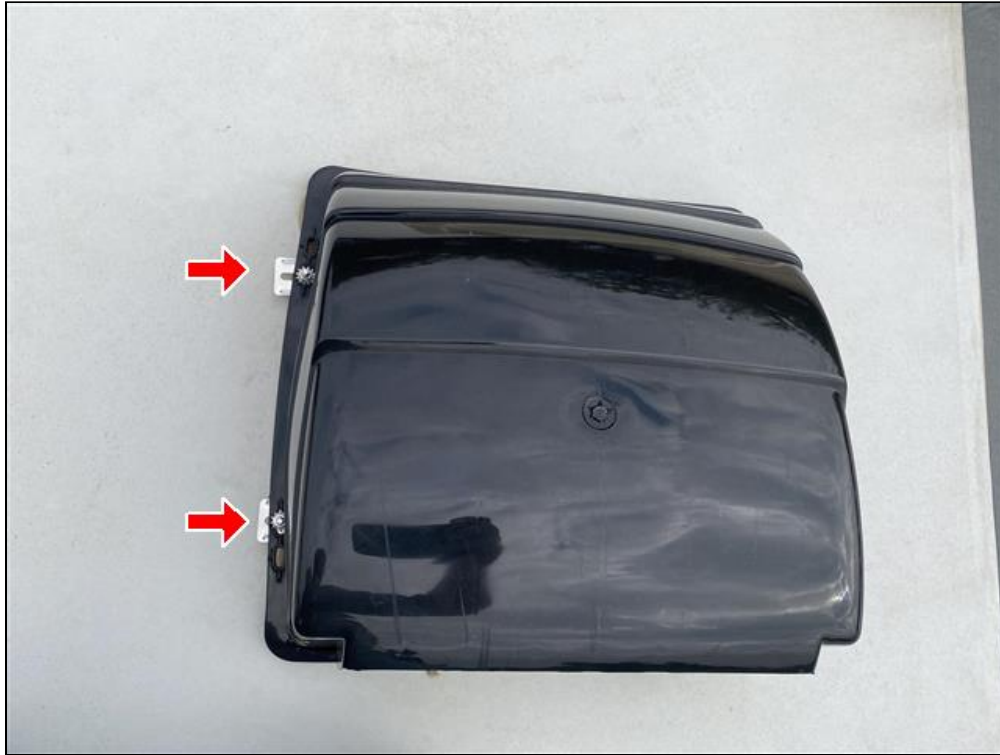
\$ Inspector found that one vent was accessible and was inspected by removing the vent cover. The second vent cover was bolted down and was not inspected. Recommend that the vent cover that inspector was not inspected, be removed and inspected by qualified RV technician for sealant cracks, failures or areas of possible water intrusion.

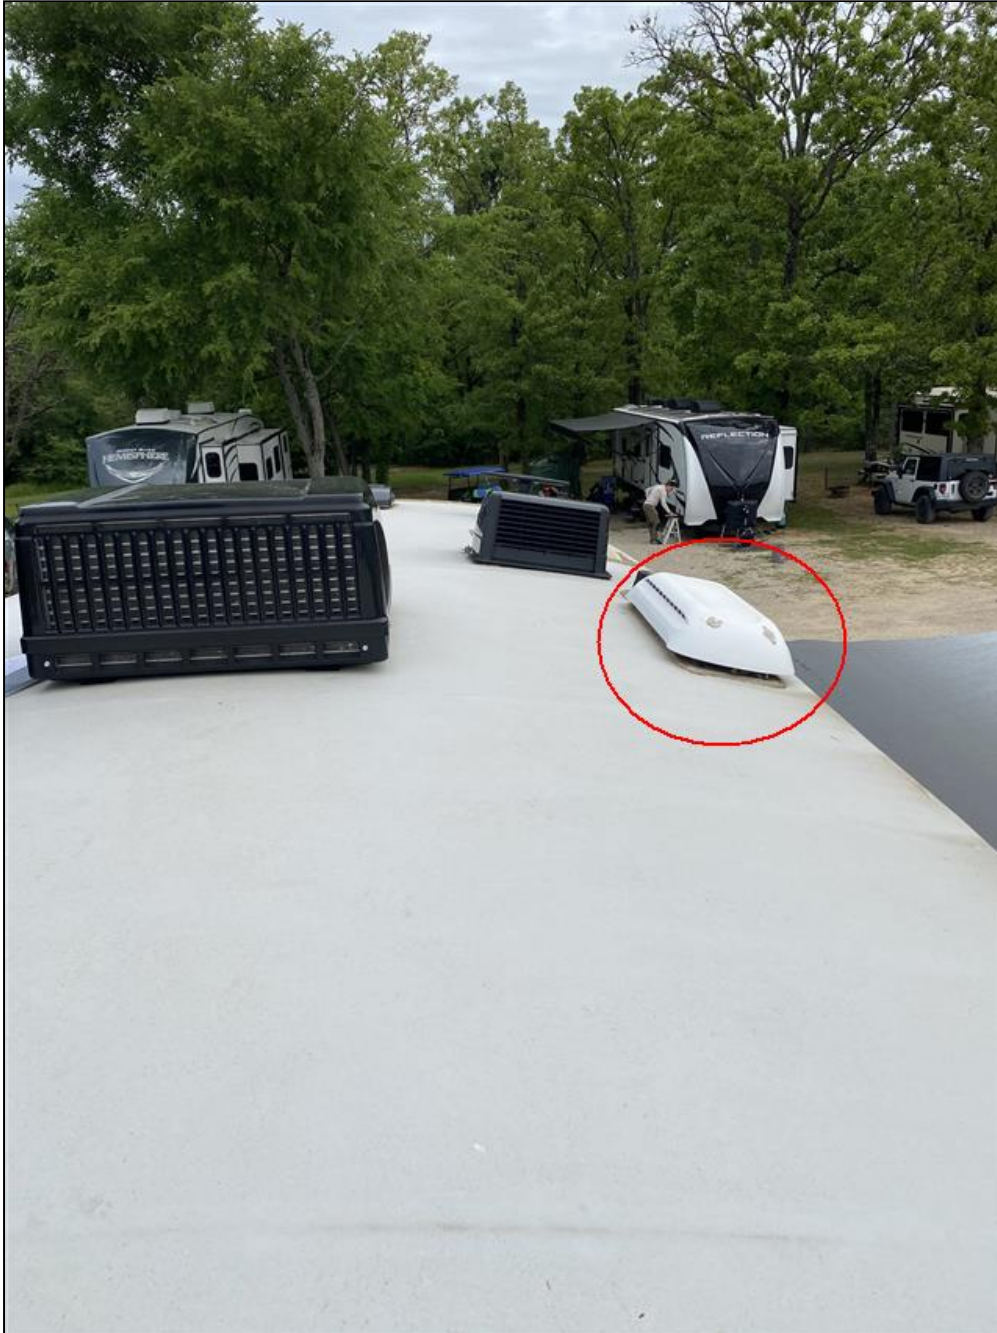
Inspector found that refrigerator vent cover was acceptable, but was white in color. All other covers and caps were black in color.

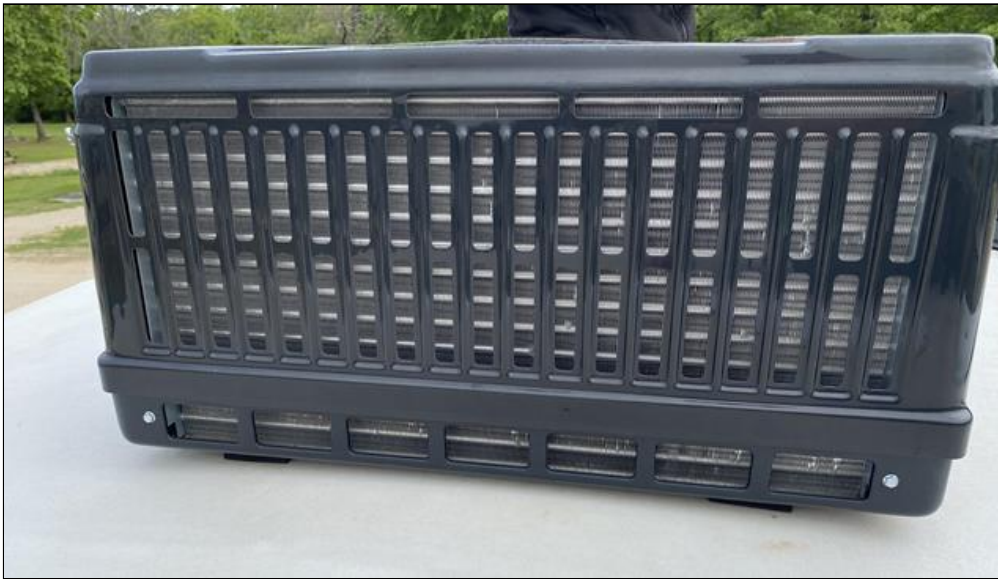
AC Coils - rear view

Inspector found that the rear coil on the AC unit to have few bent fins on the coils and coils were clean.

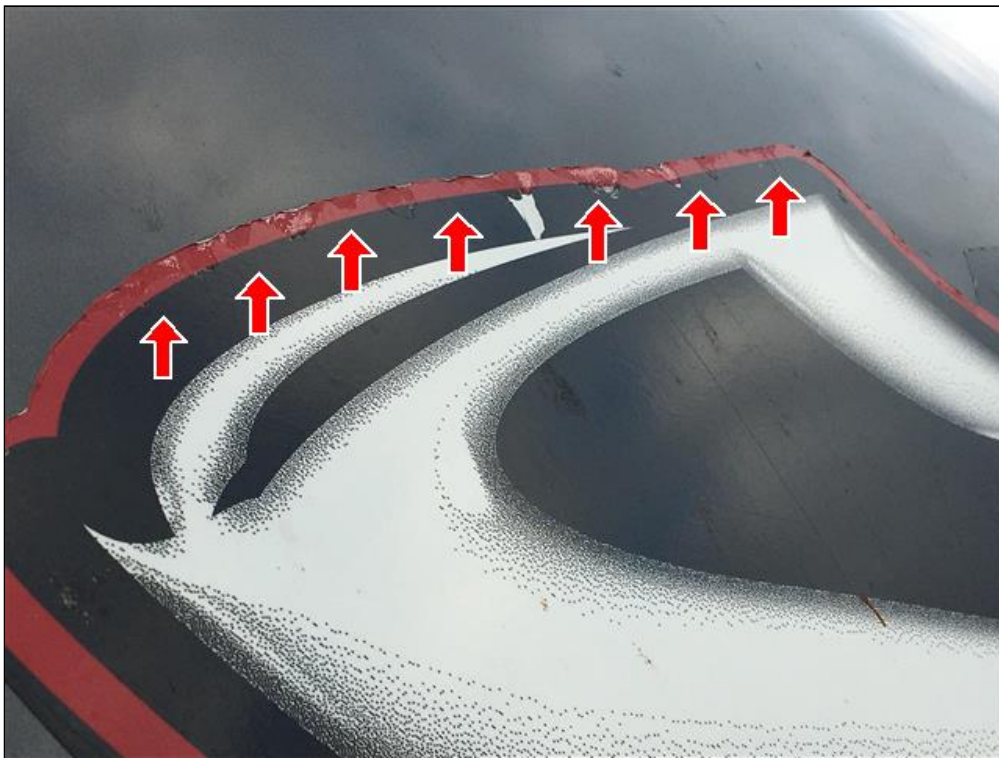
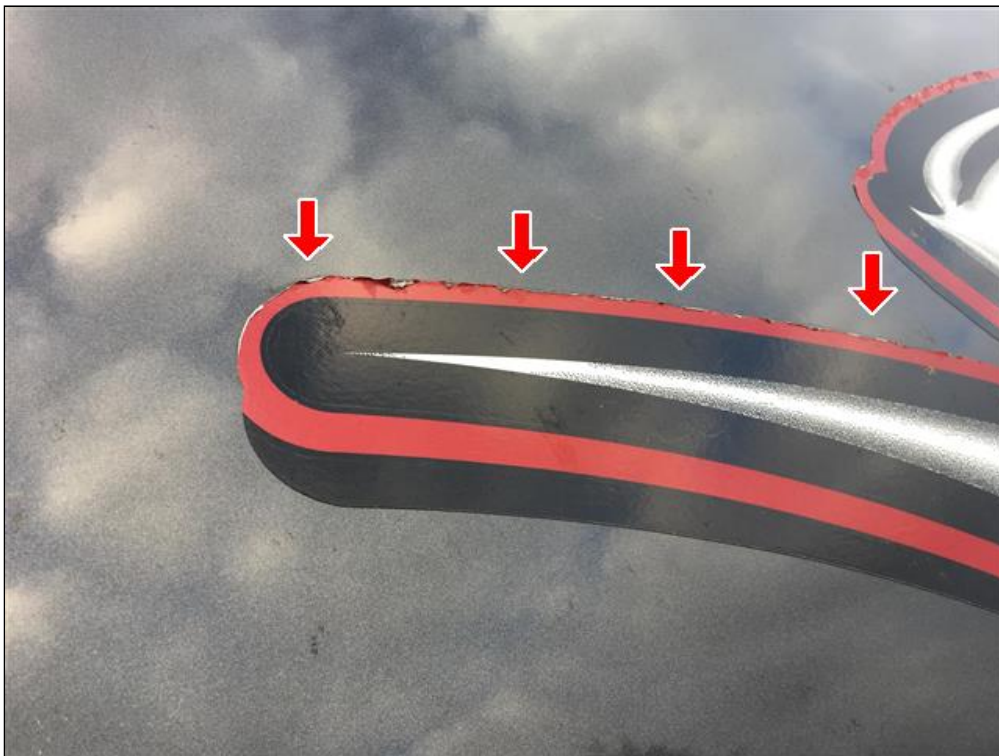
Front Cap Emblem

Inspector found that the front cap emblem was peeling away on upper section of the decal.

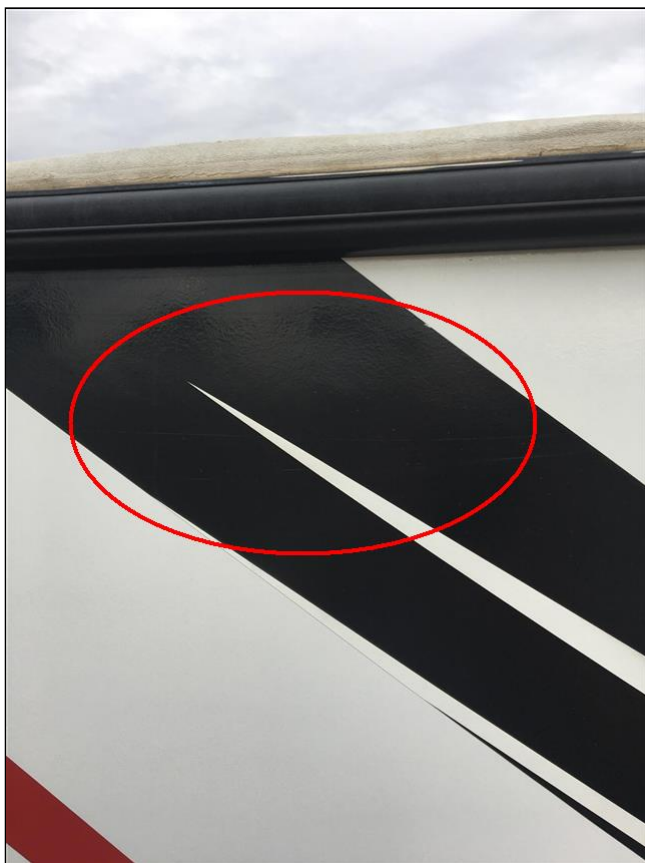
(1) Inspector found some surfaces scratching on the upper decals.

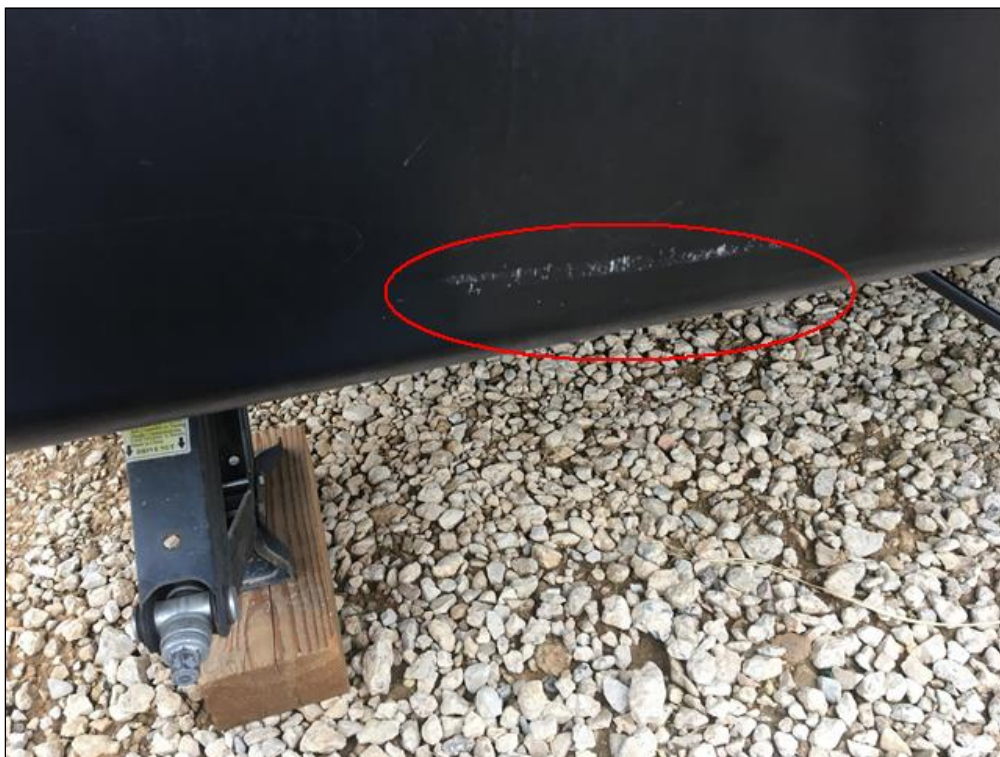
paint damage

(2) scraping along lower rear painted metal surface, above rear stabilizing jack.

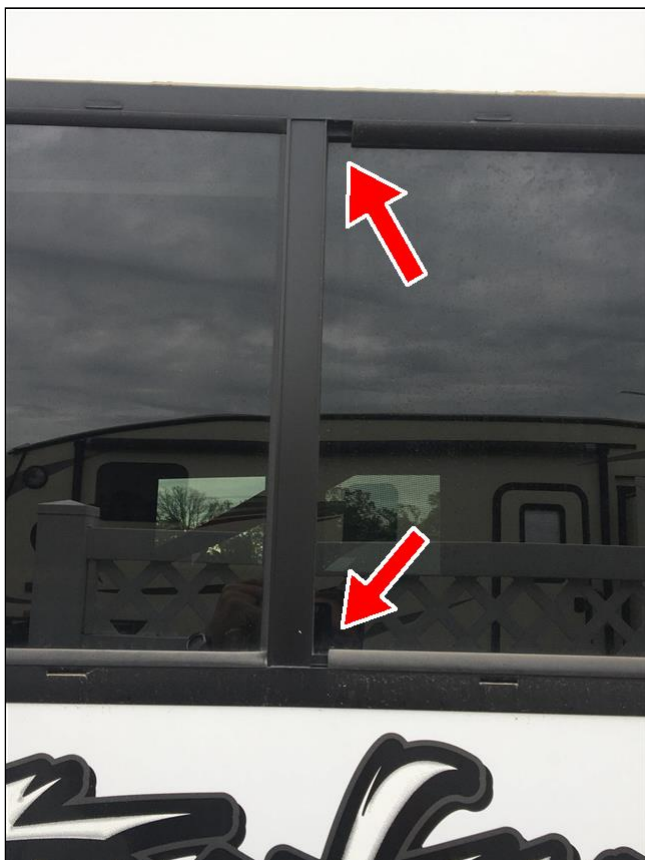
Curbside bay window

\$ Inspector found window trim on the exterior windows to be short, possibly not sealing the window and has a possibility of allowing water intrusion. Recommend that these windows be repaired by qualified RV technician.

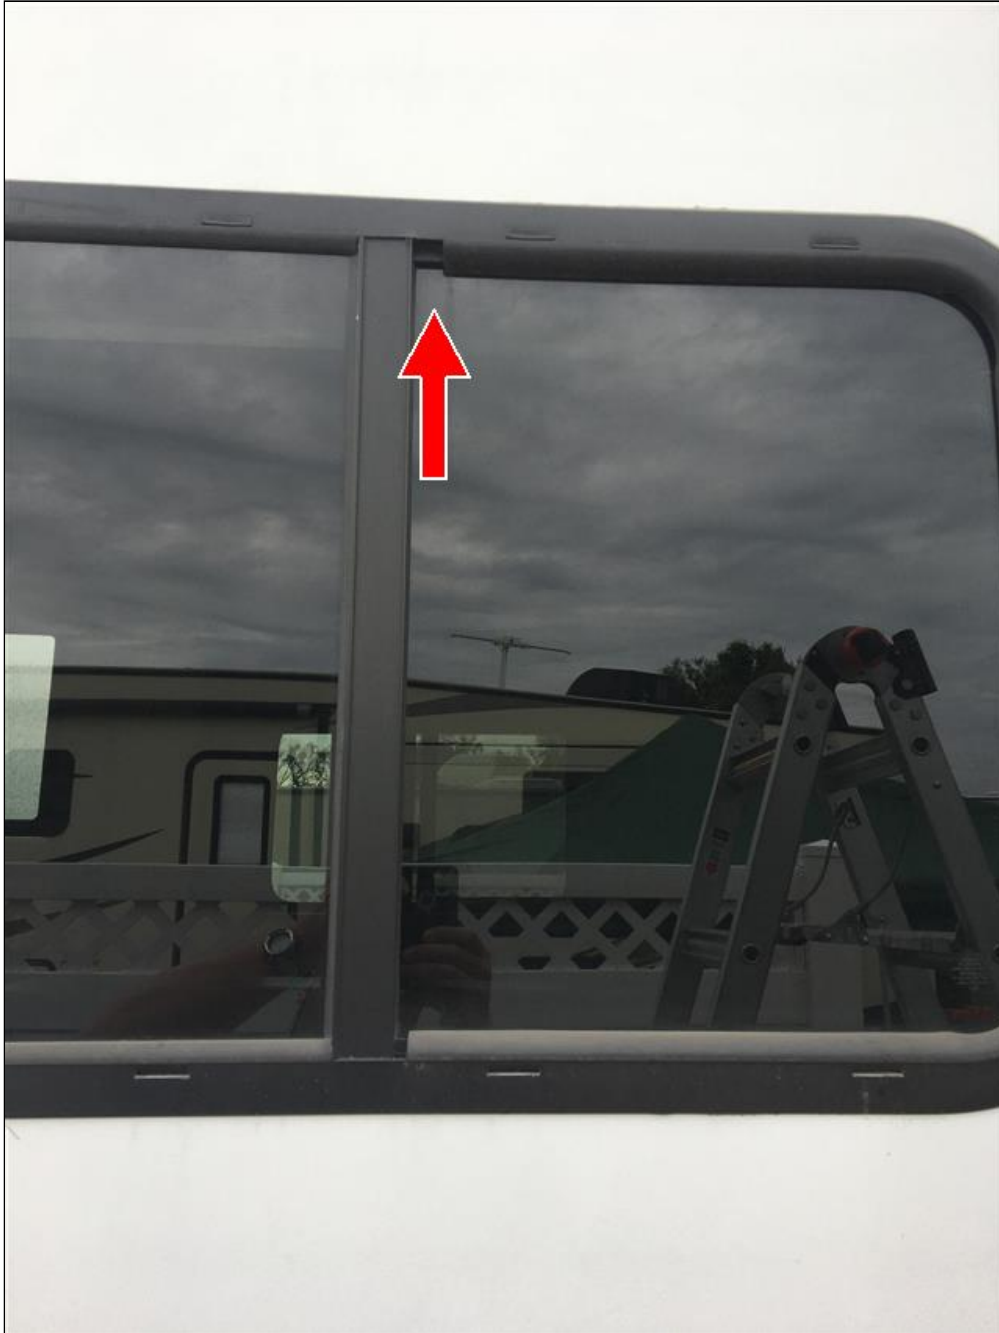
kitchen window

Inspector found that the window trim moulding did not completely seal the windows, making this a possibly water intrusion point. Recommend that this be repaired by qualified RV technician.

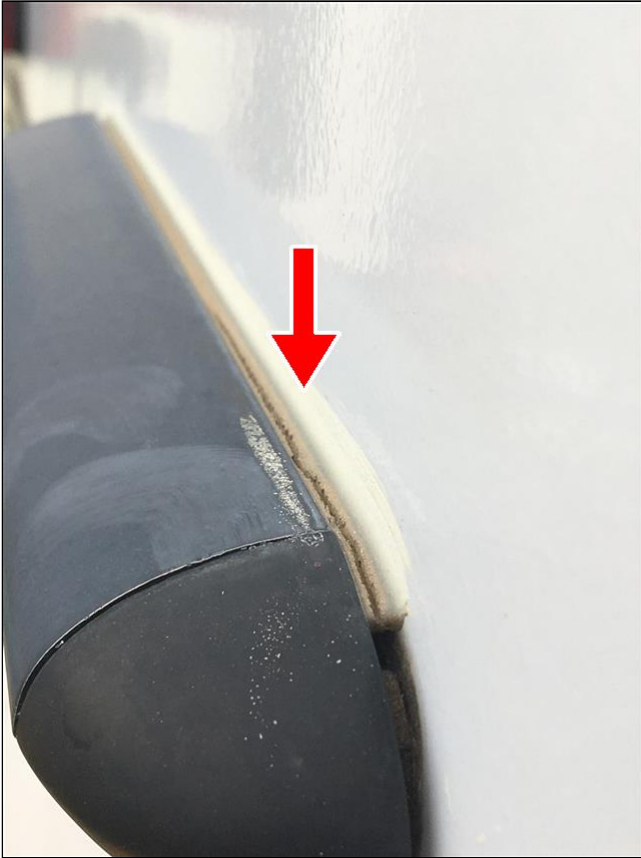
streetside upper rear light

\$ (1) Inspector found that the sealant on the upper rear flood light was cracked, making this a possibly point of water intrusion. Recommend that this be repaired by qualified RV technician.

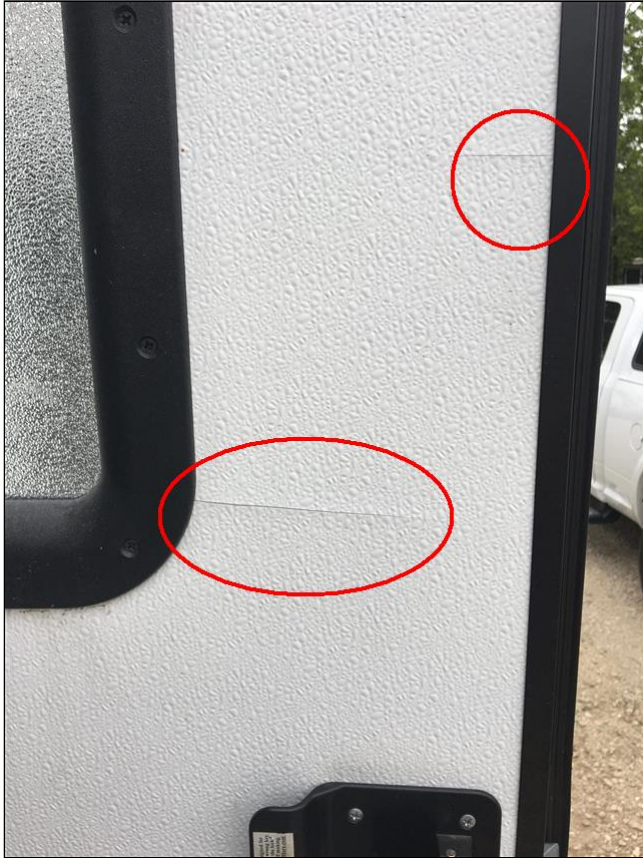
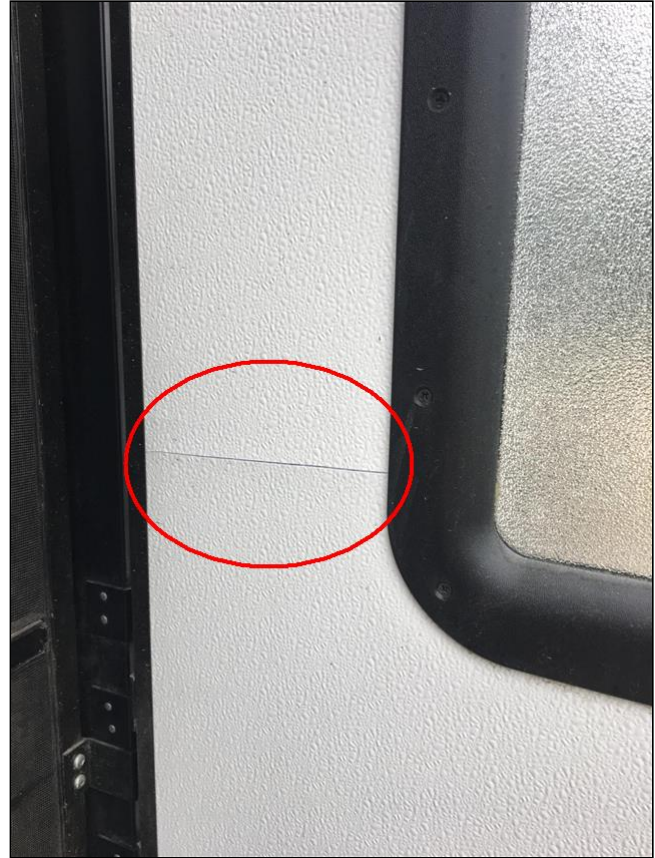
Cracks on interior main door

(1) Inspector found several cracks on the inside of the main door. Main door also did not pick up the screen door, unless the door was closed hard.

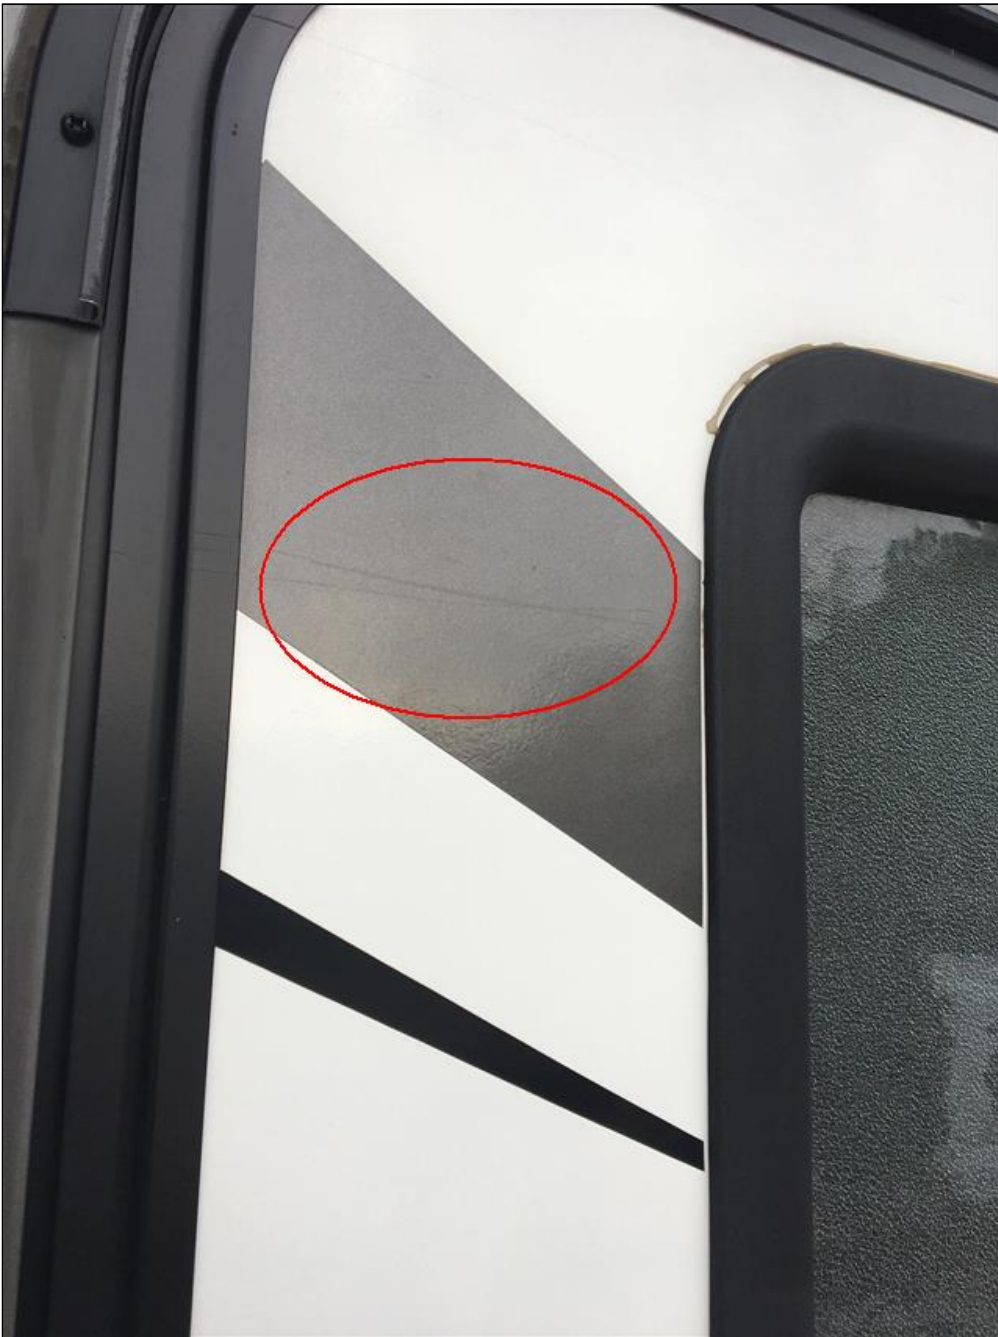
Upper main door entry door

(2) Inspector found decals scratched on upper section of the main door.

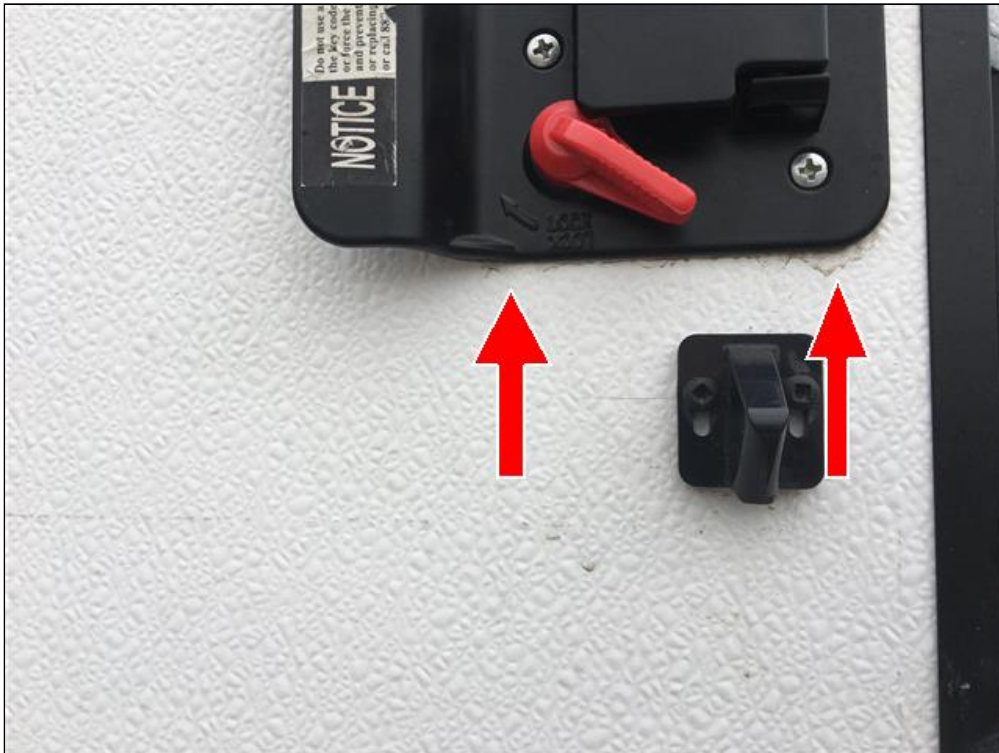
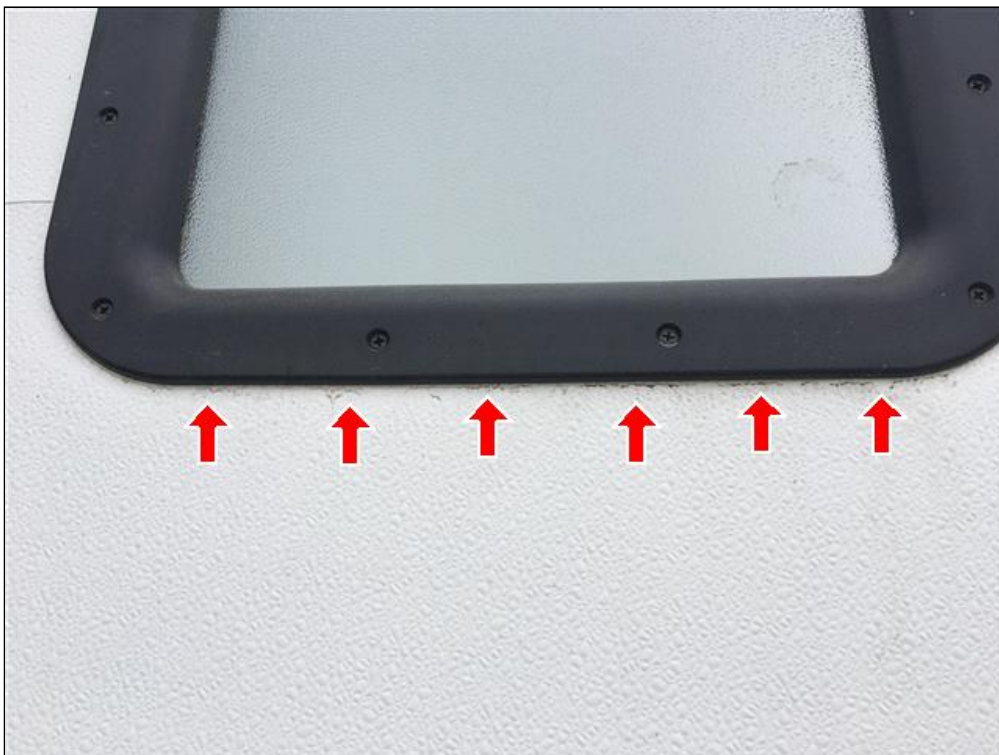
Interior main door entry

(3) Inspector observed what appears to be dried water marks on the inside of the main door, below the window and door handle, possibly indicating a water intrusion. Recommend that this be repaired by qualified RV technician.

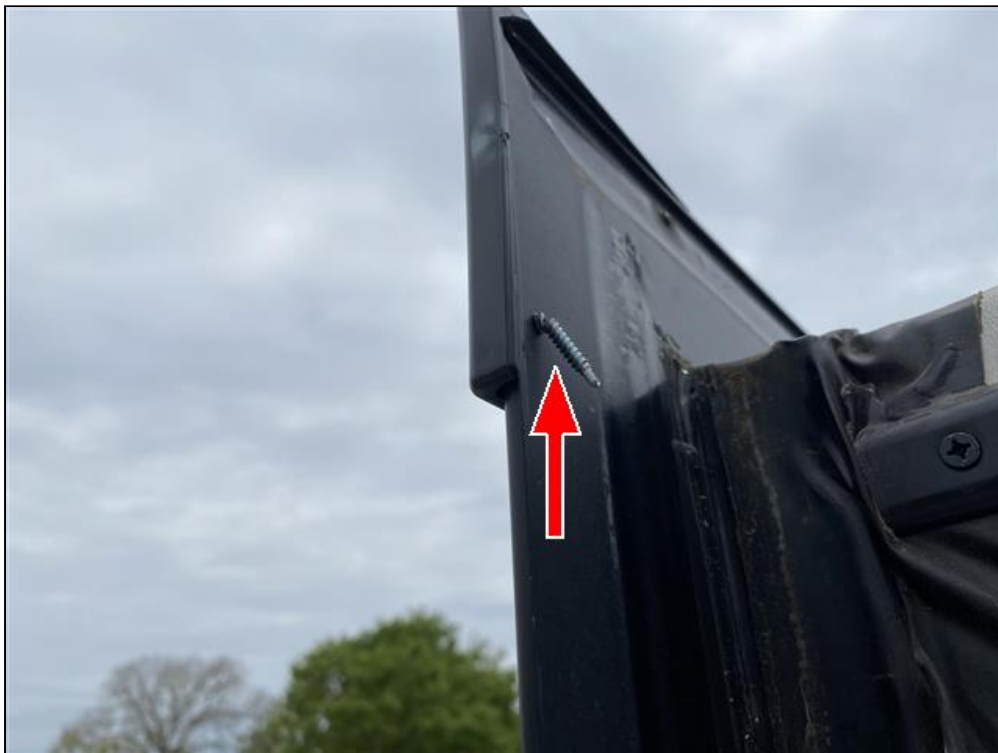
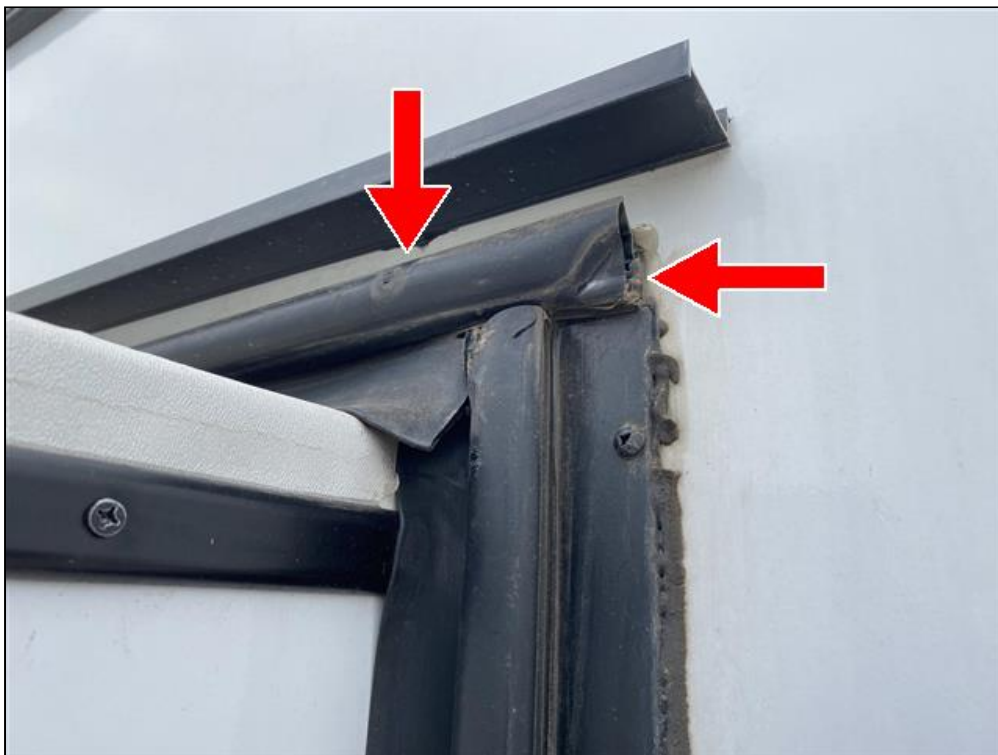
Rear upper corner of slide

Inspector found a long screw protruding through the T-molding on the upper rear of the slide. Recommend that this be repaired by qualified RV technician.

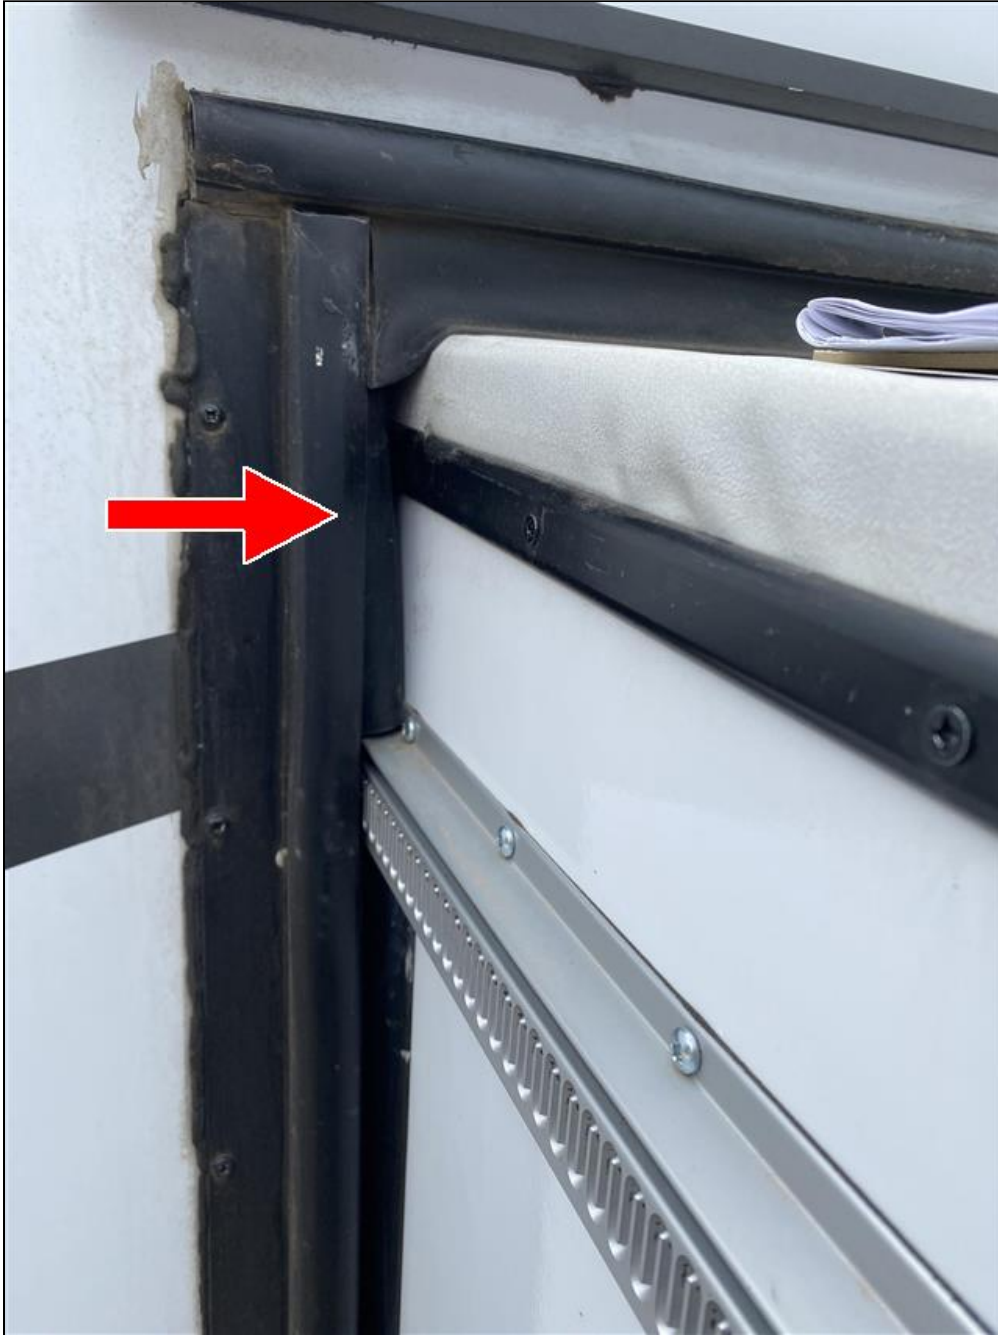
upper front corner of slide

Inspector found that upper front seal of slide did not deploy properly when slide extended, which could be a possible point of water intrusion. Recommend that this be evaluated and repaired by qualified RV technician.

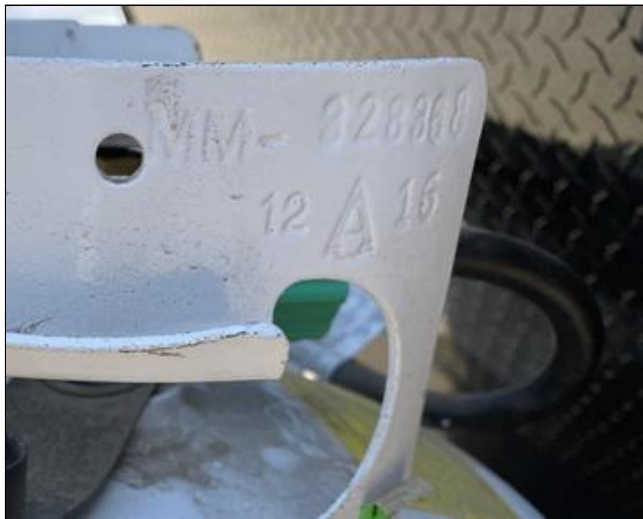
streetside tank

- +** (1) Inspector found that when opening the propane access port on the top of the cover, inspector could clearly smell the odor of propane. Recommend that regulator and hoses be further evaluated and repaired by qualified RV repair technician before the unit is moved or occupied.

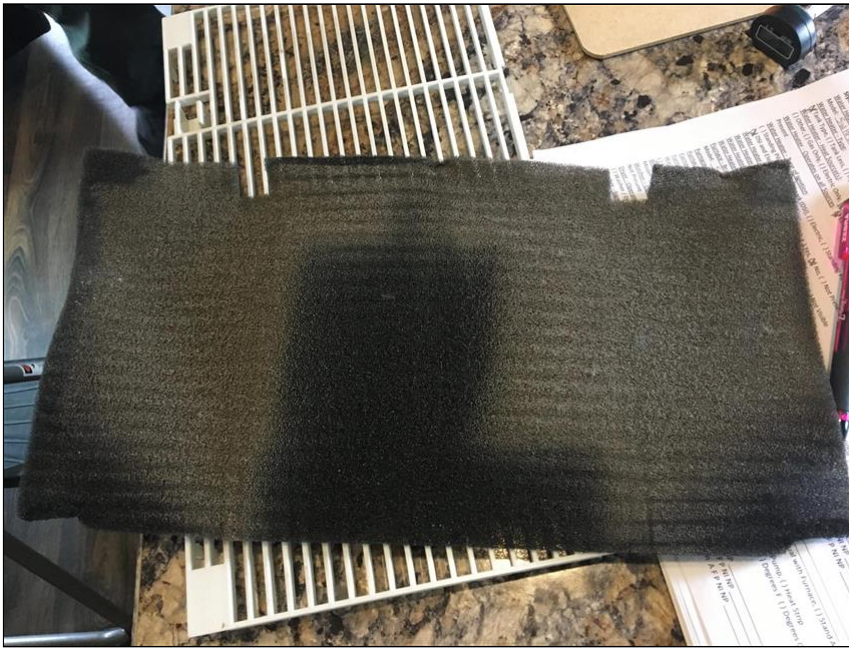
dirty air filter

Dirty filter when owner removed it for inspector

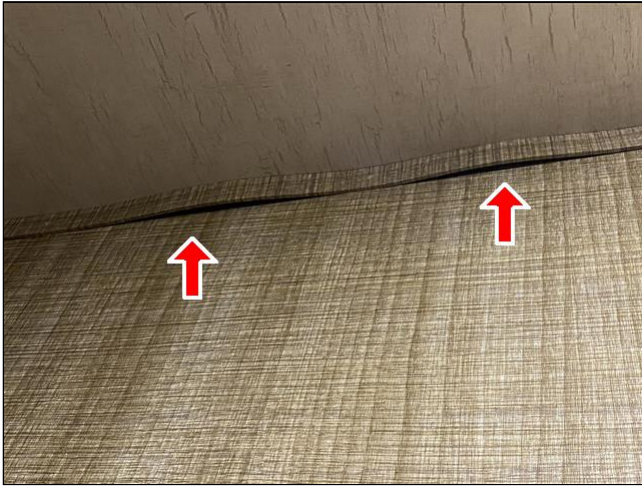
Kitchen Pantry wall

(1) Inspector found trim was not laying flat against wall at ceiling, above and opposite kitchen pantry

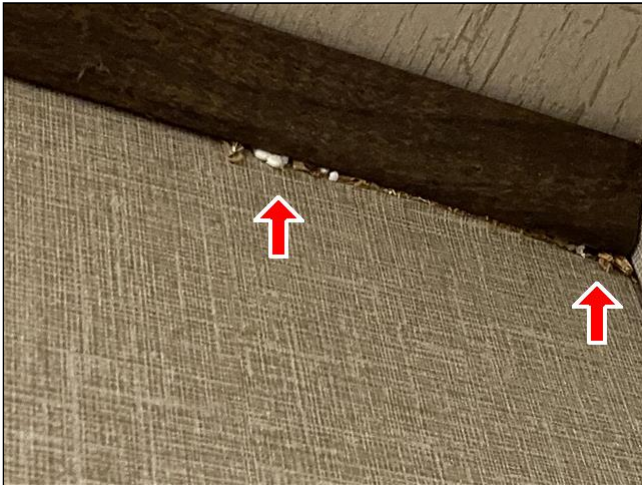
(2) Foam showing through on wall in kitchen, next to bedroom room, above pantry

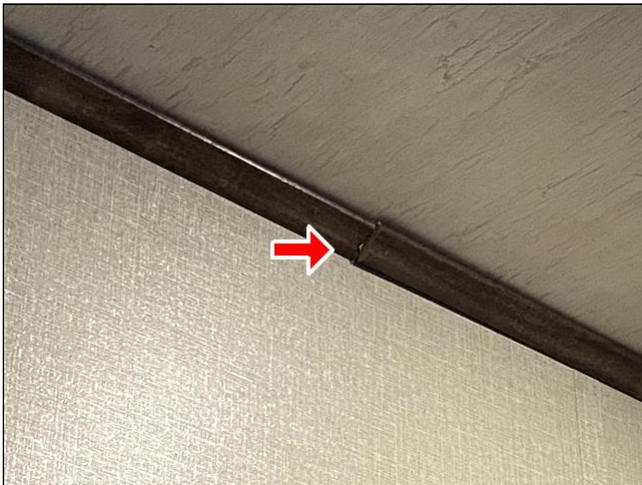
(3) Inspector found trim not flush against other butt joint of other trim.

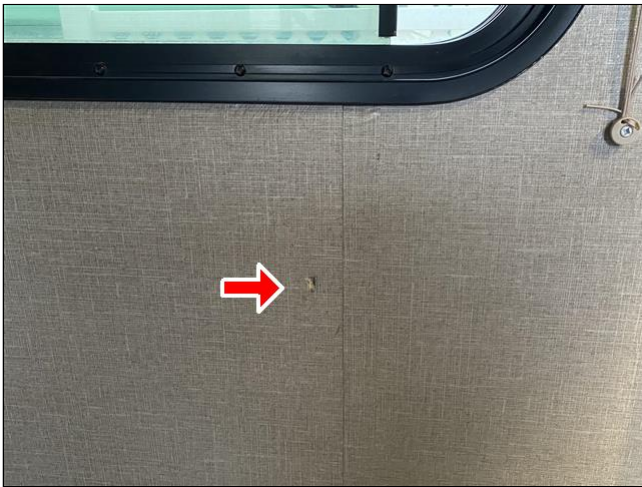
hole in wall

INSpector found a small hole in the wall on the streetside, below rear window in dinette area

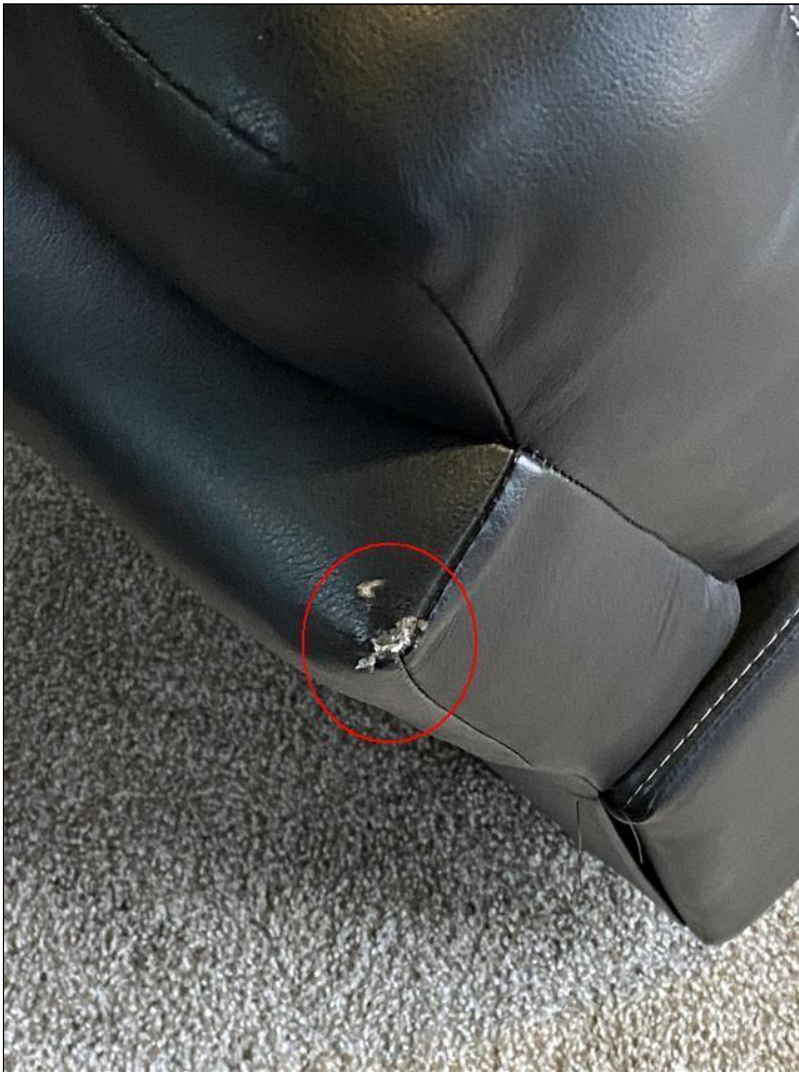
damaged chair

Fabric tears on chair rear corner

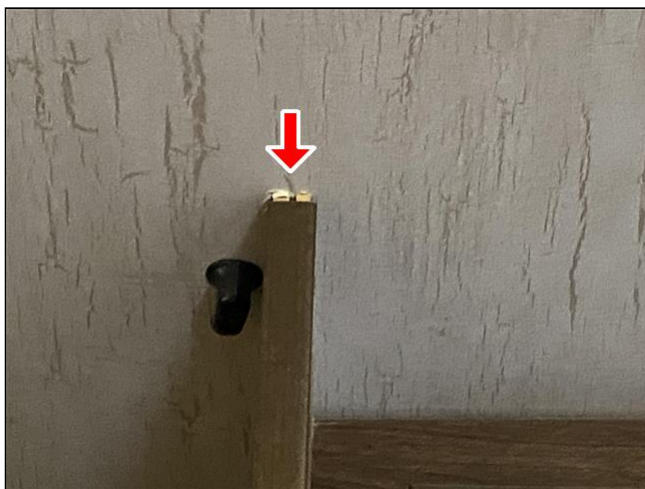
Cabinet trim

(5) Main entry door upper cabinet, trim does not continue to ceiling

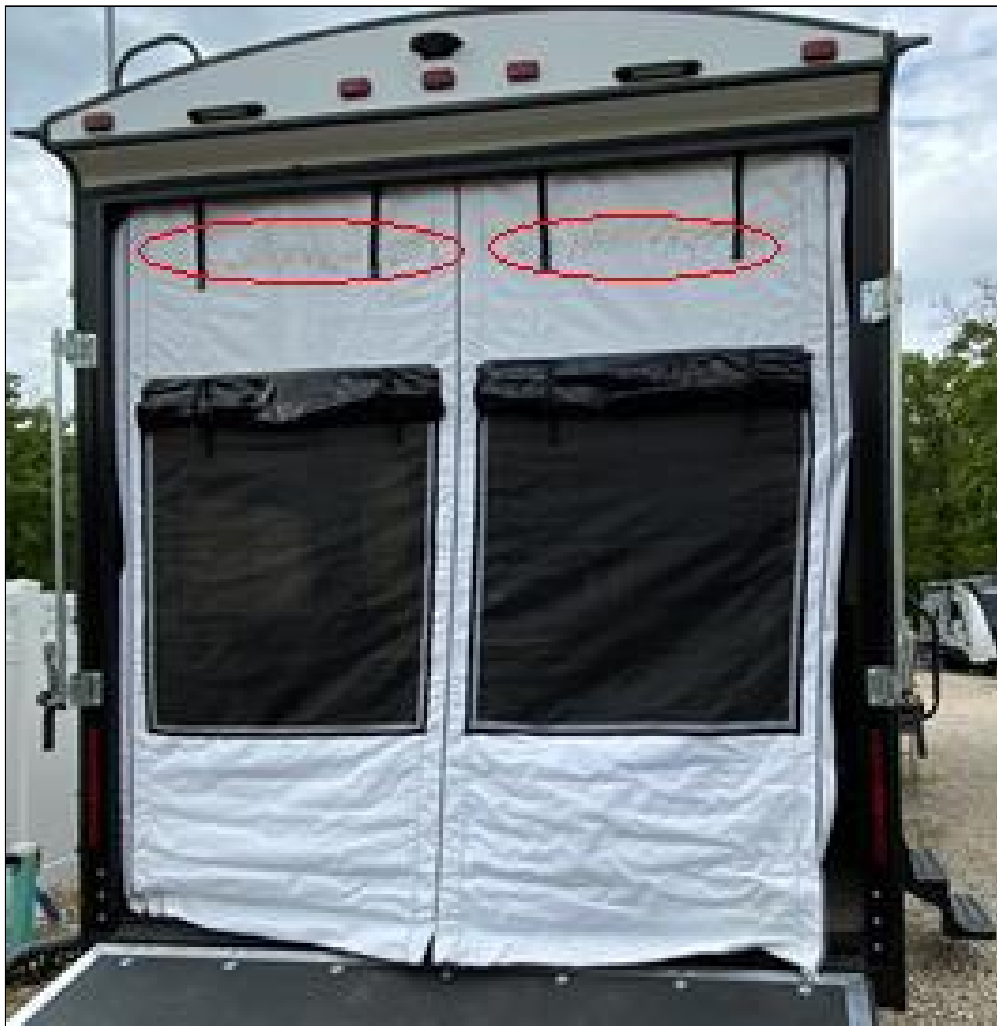
rear screen

Inspector found areas of wear, but no visible holes
