Report of Marine Survey

"Sample 2002 Sea Ray 340"

"2002 Sea Ray 340 w twin Mercury 8.1S Horizon engines"

August 21, 2020

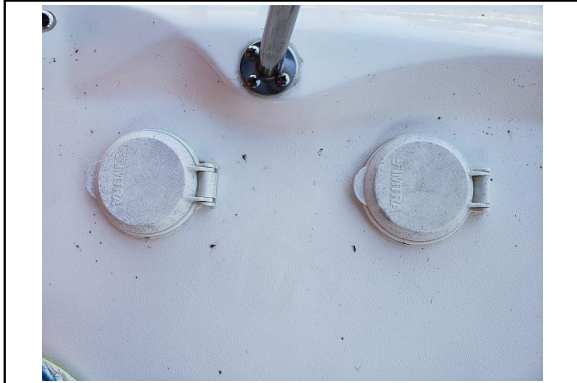
The remote's cover plates are beginning to waste. At this time, they appear to be sound but it is self evident that the sun has taken a toll on their structural strength.

Anchor Remote Controls

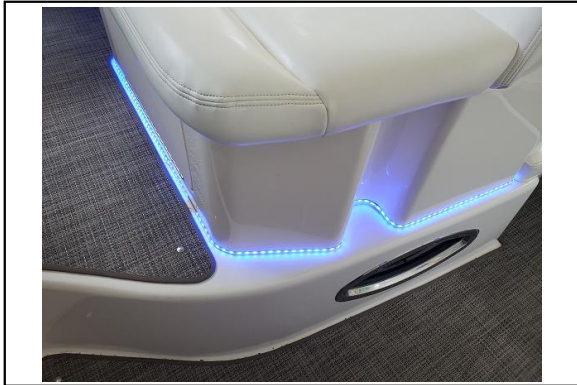
The cockpit has flat wiring running around some of it's sole's exterior and the captain - navigator's area. This wiring provides blue light when triggered by a rocker switch at the far starboard edge of the helm station. A portion of this wiring no longer provides blue light and has pulled away from the cockpit sole's bulwark.

Lighting Cockpit Sole Blue Lights

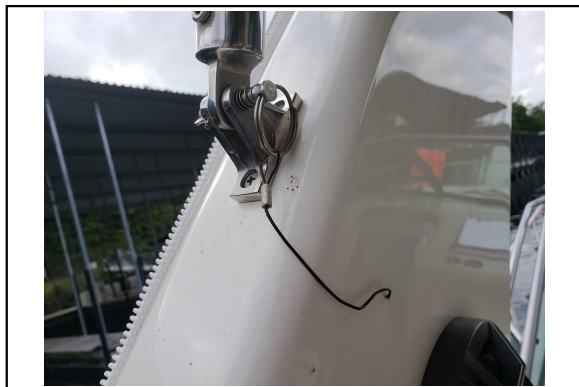
BIMINI: A light brown bimini top extends forward and aft of the radar arch. It's support structures were solid and in serviceable condition. The canvas portion at the aft port side shows sign of having been repaired by virtue of an area approximately six inches square which shows extensive stitching. A ring that holds a pin in the bimini's support structure has lost it's attachment wire. The attachment wire prevents the ring from being lost overboard. Replace this to maintain value and aid in the boats appearance.

Bimini Top Pin Wire Loose

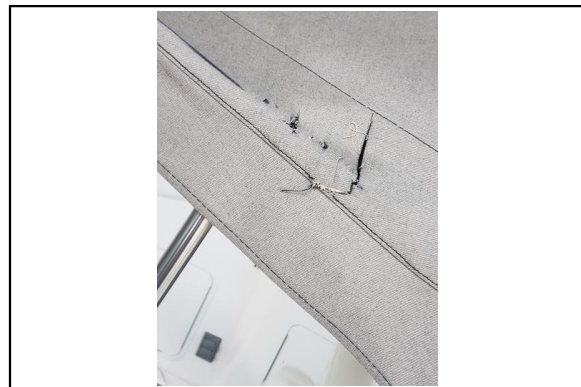
Bimini Top Stitched Repair

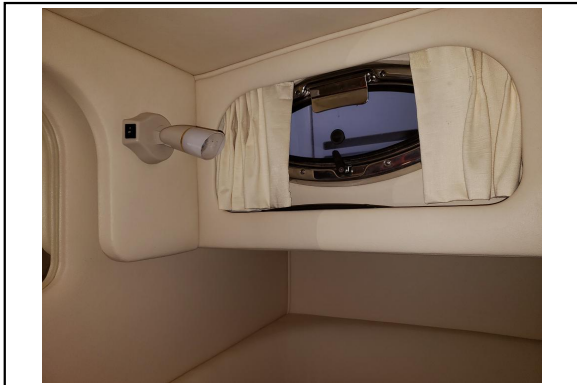
LIGHTS POWERED ON: Lights powered on throughout the vessel with the exception of the aft port light in the aft berth.

Light did not Power On

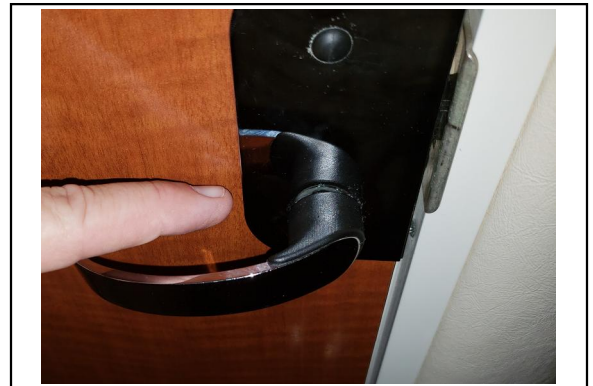
The door handle to the head is slightly loose.

[C.2] The door handle to the head is slightly loose.

Head Door Handle Loose

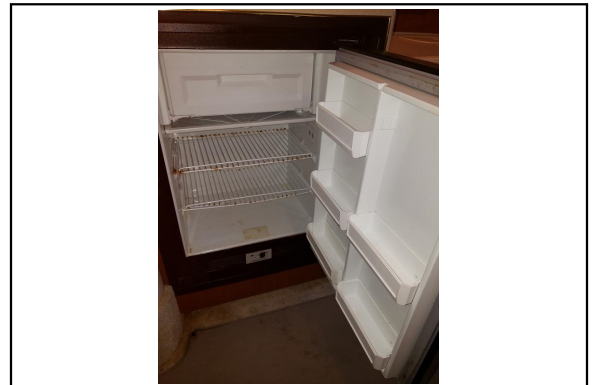
GALLEY INFORMATION: The galley sits on the port side of the cabin. It features a Sylvania microwave, a 2 burner Kenyon electric stove, a Norcold refrigerator / freezer and a single basin molded sink faucet, a Black & Decker coffee maker and Corian countertop. The sink's drain collar is corroded from what appears to be hard water staining. The refrigerator's vinyl coated shelves are somewhat corroded and should be replaced to maintain value.

Galley Norcold Refrigerator Grates are

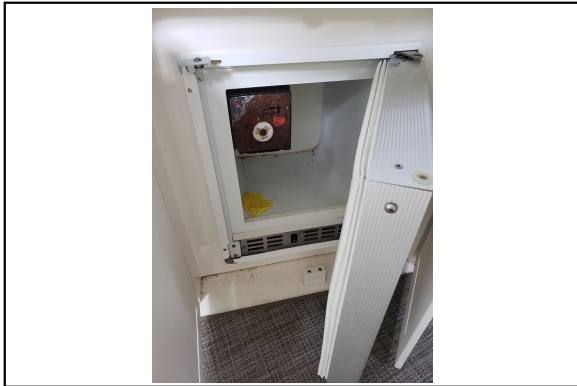
The cockpit's miniature galley has a single basin sink with faucet, a fiberglass countertop and a non-functioning ice maker.

Cockpit Galley Ice Maker Does Not Work

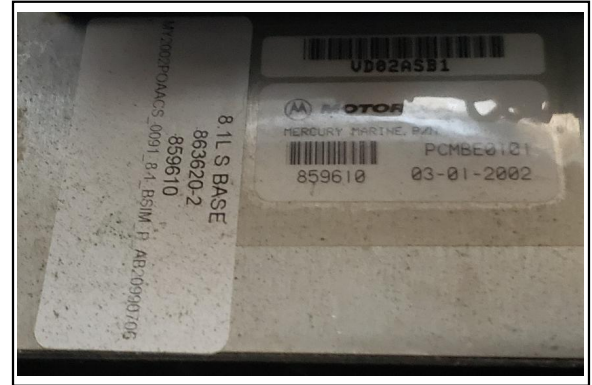
The serial number information is missing from the plastic cowling that is present on each engine.

Engine Info Starboard not Serial Number

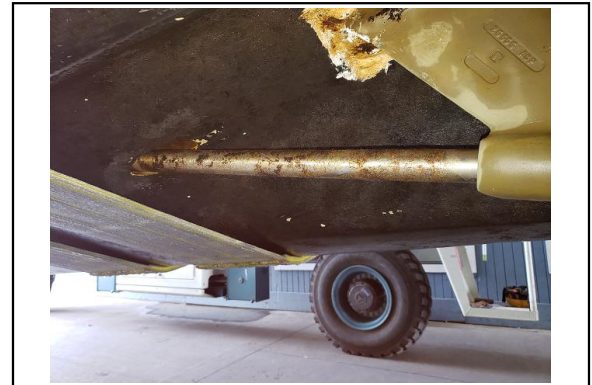
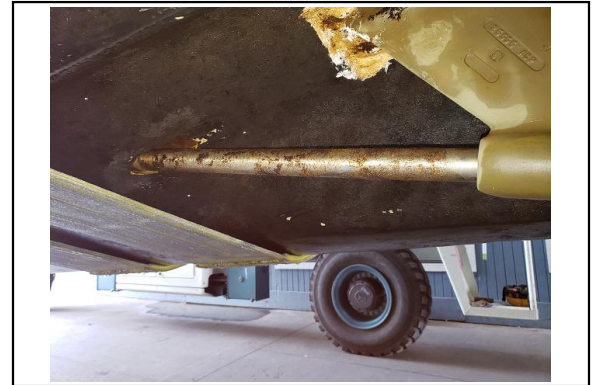
The prop shafts do not have sacrificial anodes attached.

Bottom Prop Shaft no Anodes

[A.3] The propeller shafts and rudders are not protected against stray current electricity nor against galvanic corrosion.

The propeller shafts and rudders are not protected against stray current electricity nor against galvanic corrosion.

Add sacrificial anodes appropriate to the type of water you're going to use the boat in. Remove the existing anodes on the trim tabs and replace them with the type of metal you need for your area. (presuming they are not correct already)

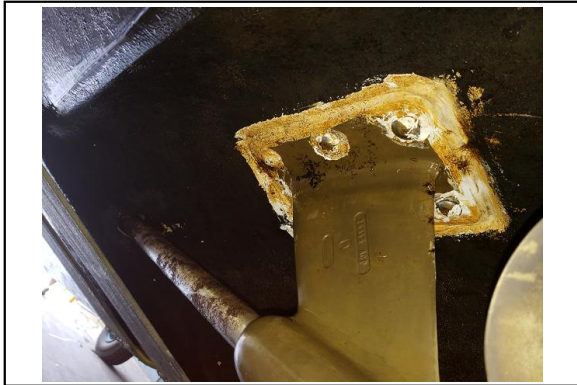
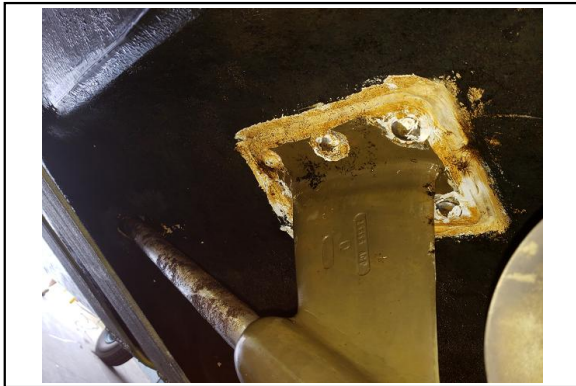
Some standing water was observed in the port side of the area. I did not find an explanation for the standing water until the vessel was hauled out. See that section of the report, which shows the propeller shaft strut photograph.

[A.1] The port propeller strut appears to have been removed and replaced recently. It seems likely that this strut is the source of the water in the port side of the engine compartment.

Bottom Prop Strut has had Maintenance

The port side propeller shaft strut appeared to have under gone recent maintenance and the silicone used to seal the unit to the hull appears to be improperly selected.

The port propeller strut appears to have been removed and replaced recently. It seems likely that this strut is the source of the water in the port side of the engine compartment.

Investigate, replace & renew as necessary. If you can learn whom did this work, they may provide some sort of warranty.

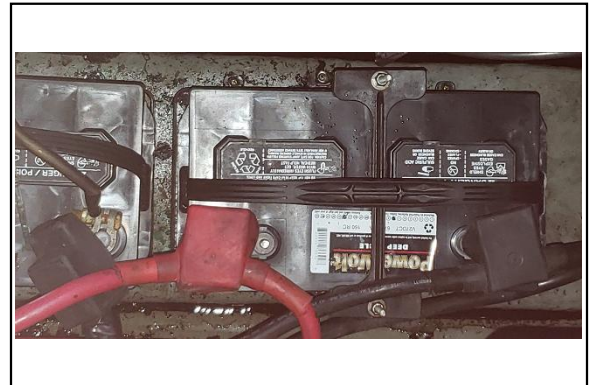
Battery + Terminals not Covered (2)

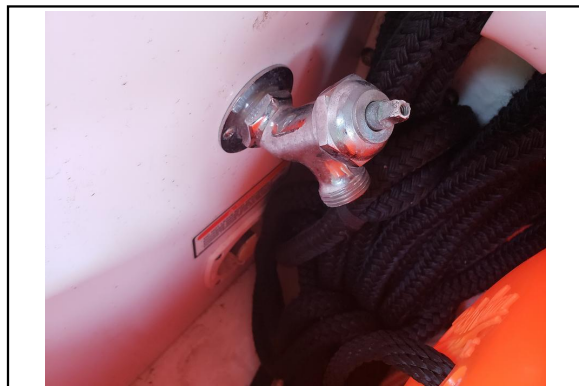
There is a water spigot at the swim platform located inside the aft storage tank on the port side. This faucet is missing its turn handle.

[C.3] The water spigot at the aft storage compartment is missing its turn handle.

Water City Handle Missing

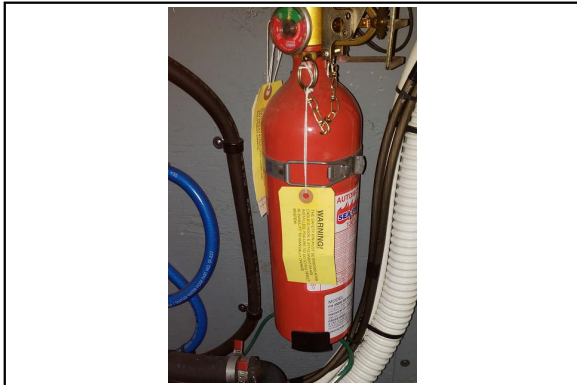
[A.4] The fire extinguishers do not have signed inspection cards and the hand held extinguishers are not held in place in marine style brackets.

Fire Extinguisher Engine Halon 1301

It is recommended that fire extinguishers be inspected annually and that a signature card be attached. Being in the green indicates that there is sufficient air pressure, it does not guarantee sufficient suppressant in the cylinder. It also does not guarantee that the suppressant in the cylinder is loose enough to be blown out of the cylinder.

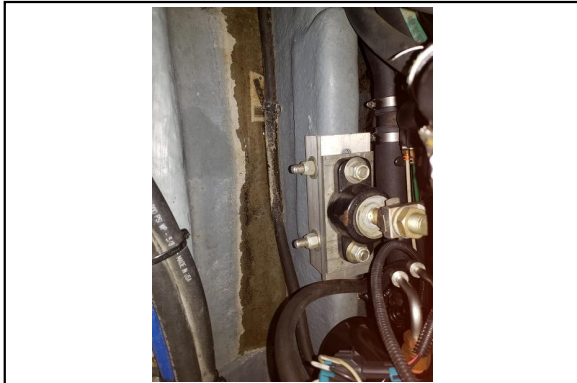
Bilge Water Standing

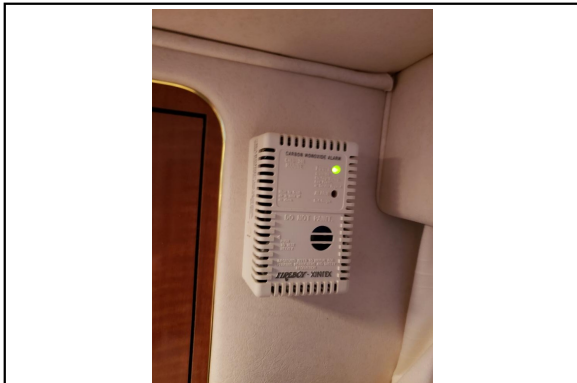
* **CARBON MONOXIDE DETECTORS:** The carbon monoxide detector powered on but appears to be originally installed equipment.

[A.5] Carbon monoxide detector appears to be originally installed equipment which makes it 17 years old

Carbon Monoxide Detector Powers On

Carbon monoxide detector manufacturers recommend replacing their units every 5 - 8 years.
