**"2002 Sea Ray 340 w twin Mercury 8.1S Horizon engines"**  
***"Quinn-Tes-Sen-Tial"***

## **Report of Marine Survey**

Conducted by  
Brad Bolz

10-10-2018

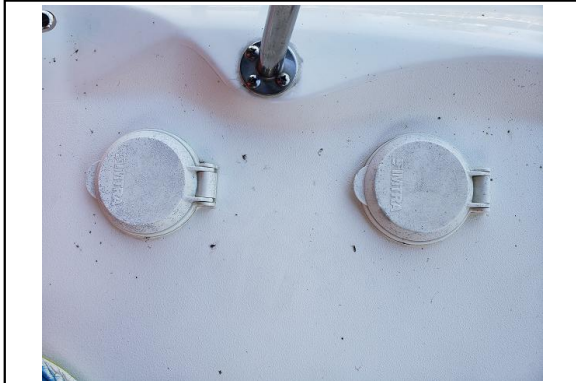
The remote's cover plates are beginning to waste. At this time, they appear to be sound but it is self evident that the sun has taken a toll on their structural strength.

**Anchor Remote Controls**

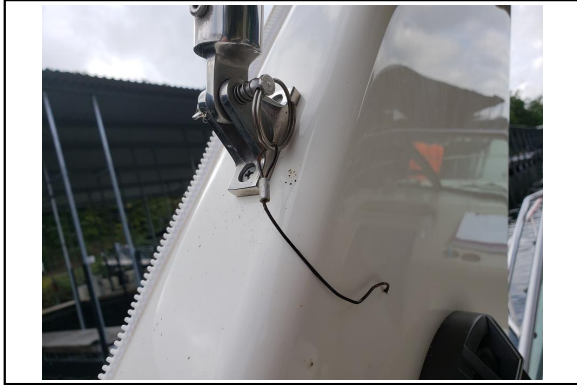
**BIMINI:** A light brown bimini top extends forward and aft of the radar arch. It's support structures were solid and in serviceable condition. The canvas portion at the aft port side shows sign of having been repaired by virtue of an area approximately six inches square which shows extensive stitching. A ring that holds a pin in the bimini's support structure has lost it's attachment wire. The attachment wire prevents the ring from being lost overboard. Replace this to maintain value and aid in the boats appearance.

**Bimini Top Pin Wire Loose**

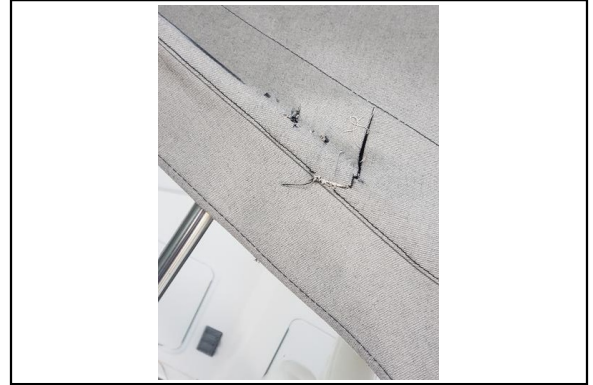
**Bimini Top Stitched Repair**

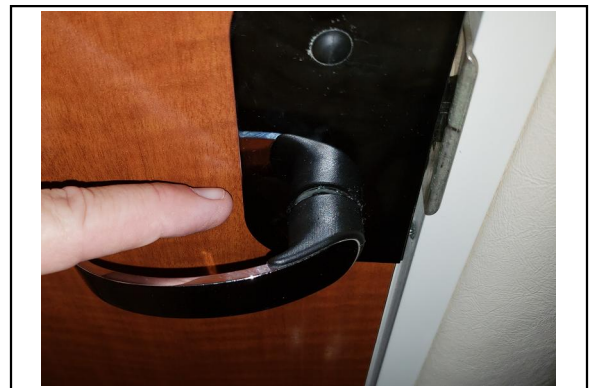
The door handle to the head is slightly loose.

**Head Door Handle Loose**

*Replace or renew.*

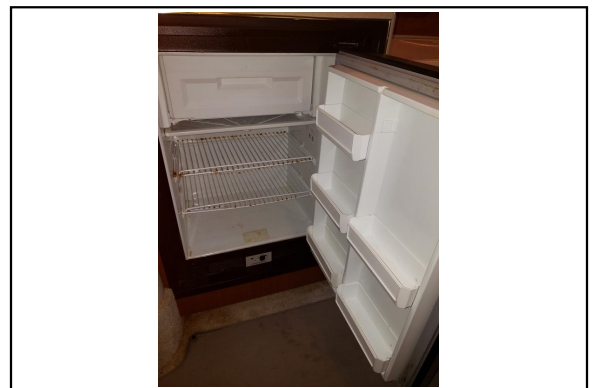
**GALLEY INFORMATION:** The galley sits on the port side of the cabin. It features a Sylvania microwave, a 2 burner Kenyon electric stove, a Norcold refrigerator / freezer and a single basin molded sink faucet, a Black & Decker coffee maker and Corian countertop. The sink's drain collar is corroded from what appears to be hard water staining. The refrigerator's vinyl coated shelves are somewhat corroded and should be replaced to maintain value.

**Galley Norcold Refrigerator Grates are**

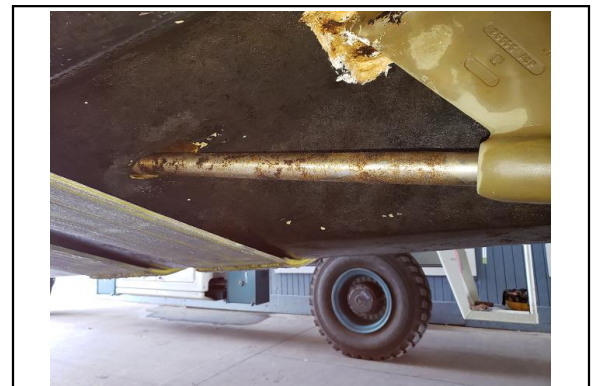
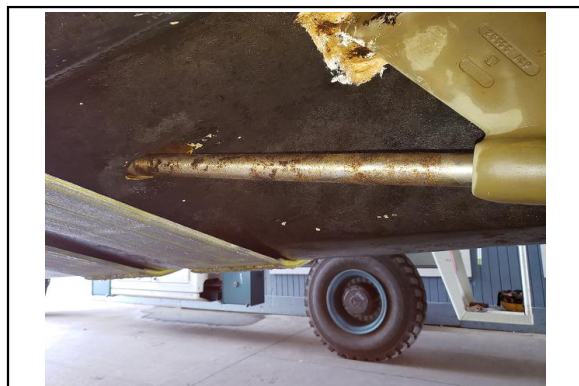
[A.2] The prop shafts do not have sacrificial anodes attached.

Bottom Prop Shaft no Anodes

**[A.4]** The propeller shafts and rudders are not protected against stray current electricity nor against galvanic corrosion.

<b>A.4 (PAGE 19) ZINC (HULL ZINC):</b> <b>The propeller shafts and rudders are not protected against stray current electricity nor against galvanic corrosion.</b>	<i>Add sacrificial anodes appropriate to the type of water you're going to use the boat in. Remove the existing anodes on the trim tabs and replace them with the type of metal you need for your area. (presuming they are not correct already)</i>

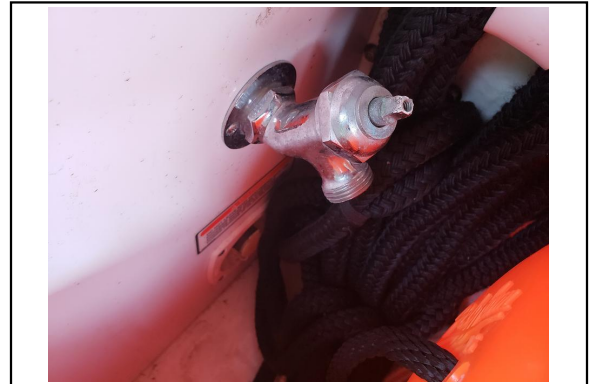
[C.3] The water spigot at the aft storage compartment is missing its turn handle.

Water City Handle Missing

*Replace.*

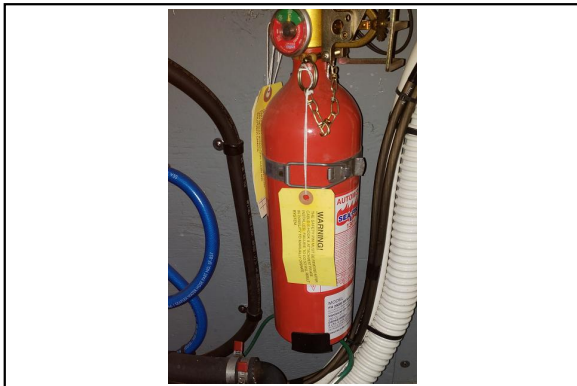
**[A.5]** The fire extinguishers do not have signed inspection cards and the hand held extinguishers are not held in place in marine style brackets.

Fire Extinguisher Engine Halon 1301

*It is recommended that fire extinguishers be inspected annually and that a signature card be attached. Being in the green indicates that there is sufficient air pressure, it does not guarantee sufficient suppressant in the cylinder. It also does not guarantee that the suppressant in the cylinder is loose enough to be blown out of the cylinder.*

*Even with newly purchased extinguishers, it is recommended that you take them to someone that can inspect them and weigh them to assure there is a proper amount of suppressant. They need to be properly attached per NFPA 10 and USCG requirements. Coast Guard Approved extinguishers are hand-portable, either B-I or B-II classification and have a specific marine type mounting bracket. It is recommended the extinguishers be mounted in a readily accessible position. Minimums of a 5 B:C U/L rating and 2lbs. of dry chemical, 2 1/2 lbs. of Halon or 5 lbs. of CO2 are necessary to meet the requirements for a Coast Guard B classification. All extinguishers must be "restrained" in mounting brackets of the marine or motor vehicle type which have been subjected to the same rigid salt spray and vibration tests as the extinguishers (wall type brackets are not acceptable). A Marine Bracket must be used when mounting a fire extinguisher for marine use.*

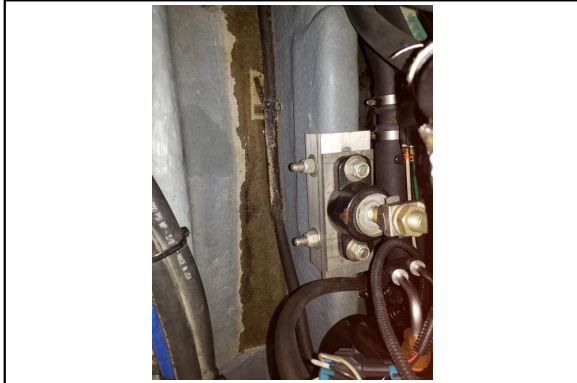
Some standing water was observed in the port side of the area. I did not find an explanation for the standing water until the vessel was hauled out. See that section of the report, which shows the propeller shaft strut photograph.

**Bilge Water Standing**

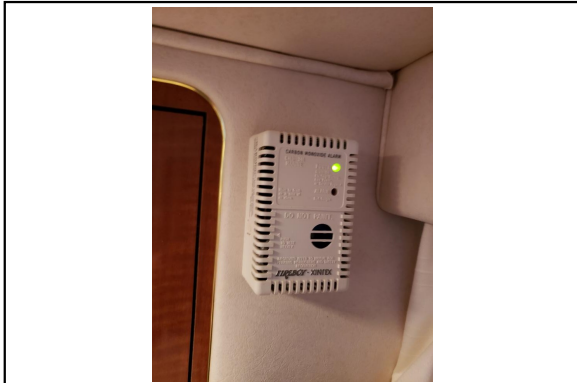
**[A.6]** Carbon monoxide detector appears to be originally installed equipment.

**Carbon Monoxide Detector Powers On**

*Carbon monoxide detector manufacturers recommend replacing their units every 5 - 8 years.*

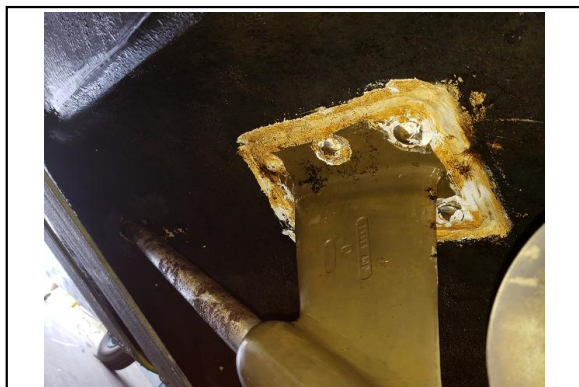
[A.1] The port propeller strut appears to have been removed and replaced recently. It seems likely that this strut is the source of the water in the port side of the engine compartment.

Bottom Prop Strut has had Maintenance

The port side propeller shaft strut appeared to have under gone recent maintenance and the silicone used to seal the unit to the hull appears to be improperly selected.

FINDINGS	RECOMMENDATIONS
<b>A.1 (PAGE 12) PROP SHAFTS:</b> <b>The port propeller strut appears to have been removed and replaced recently. It seems likely that this strut is the source of the water in the port side of the engine compartment.</b>	<i>Investigate, replace &amp; renew as necessary. If you can learn whom did this work, they may provide some sort of warranty.</i>
<b>A.2 (PAGE 12) PROP SHAFTS:</b> <b>The prop shafts do not have sacrificial anodes attached.</b>	<i>Add protective anodes to the prop shafts to guard against stray electrical currents and galvanic corrosion.</i>
<b>A.3 (PAGE 13) BATTERIES:</b> <b>The batteries positive terminals are not fully covered to prevent accidental shorts.</b>	<i>ABYC E-11 requires any continuously energized part to be physically protected with boots, an enclosure or some other cover. These are usually at the batteries and the connections in the starting circuit. Whether it's a positive battery terminal or the positive starter post, if it's not protected by overcurrent protection (breaker or fuse), then it needs a boot or enclosure.</i>
