**Vistas Condominium**

2025 Structural Integrity Reserve Study

SOCOTEC Consulting, Inc

November 13, 2024

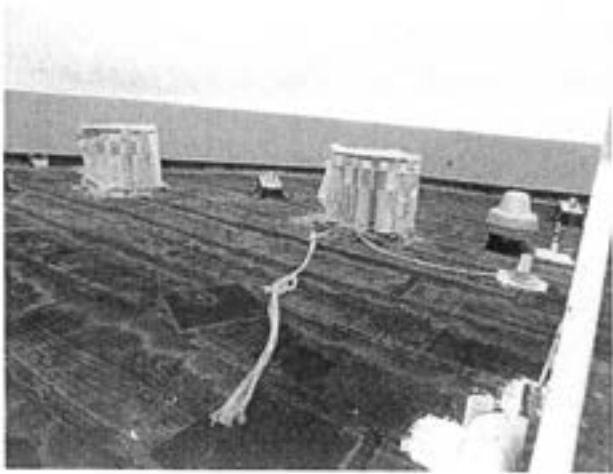
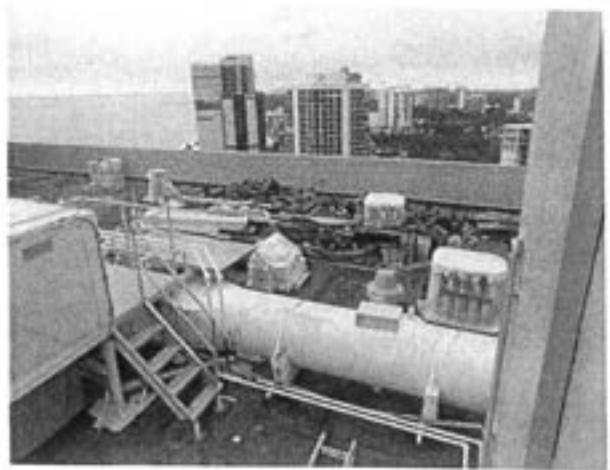
### 1 - Tower Main Roof - Mod. Bit. Replacement

Tower Main Roof - Modified Bitumen Replacement - The roofing system over the main residential tower is covered by a Siplast granule-surfaced SBS-Modified Bitumen roof system (Mod. Bit.) installed by Crowther Roofing in October of 2023. The pricing for this system has been provided by management. This type of roof system has a typical useful life of 20 to 25 years under normal operating conditions with routine yearly maintenance. It is understood that the roof project for the main tower included approximately \$670,000 of collateral costs and no deterioration is remaining above the roof deck. At the time of our site visit, ongoing work to finish installing the main roof system was observed to be in-progress.

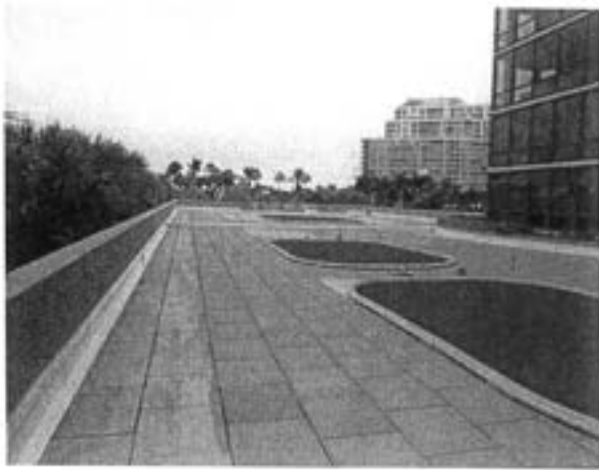
## 2 - Garage Roof

Garage Roof - Replacement - The roof area over the upper-level garage includes a pedestal paver with a thermoplastic polyolefin (TPO) underlayment roof system. This type of roof system typically has a useful life of 20 to 25 years under normal operating conditions with routine yearly maintenance. However, a slightly greater useful life of 30 years has been allocated to the pedestal paver system considering UV/direct exposure protection provided by the pedestal pavers. It is understood that the perimeter of this roofing system has been repaired, and the majority of the roof system has approximately 10 years of remaining useful life. At the time of our site visit, this roof system was observed to be in good overall condition. This SIRS cost estimate provided considers 18,000 square feet of TPO replacement and does not consider the pavers and turf grass costs.

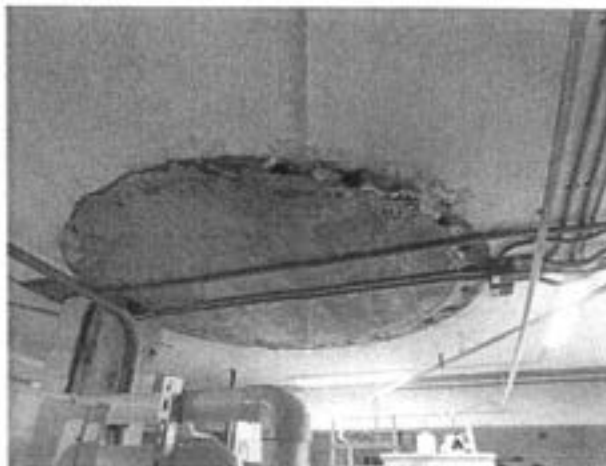
### 3 - Concrete Restoration W/ Reinforcement Budget

The load bearing structural members include cast-in-place concrete elements with reinforced concrete, structural decks supported by concrete shear walls, and columns. Exterior walls consist of stucco covered concrete masonry unit (CMU) block in-fill. This type of primary structural members typically has a useful life of 100 or more years when properly maintained/repared. However, during the life of this type of structure it is common for periodic maintenance to be required to correct localized deterioration. We have included a reserve item for completing required periodic maintenance to the cast-in-place concrete structural elements.

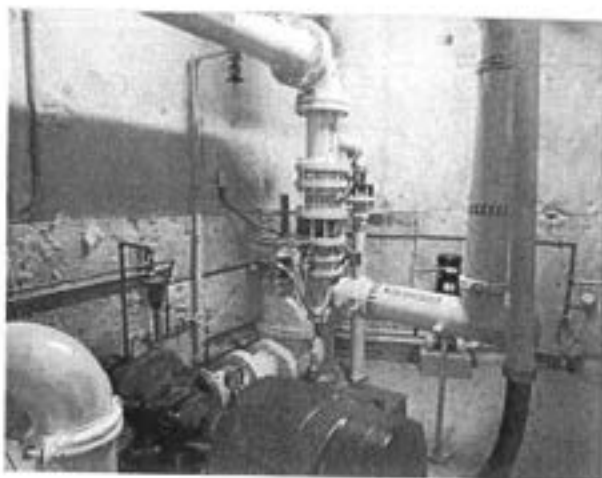
## 5 - Fire Pump & Controls Replacement

Fire Pump and Controls - The fire pump and controls are located on the 2<sup>nd</sup> level of the building in the fire pump room. The fire pump and controls are original and were installed circa 1990. These types of systems generally have a useful life of 35- to 40-years under routine maintenance. We have included a reserve for replacement/repairs to the system as needed.

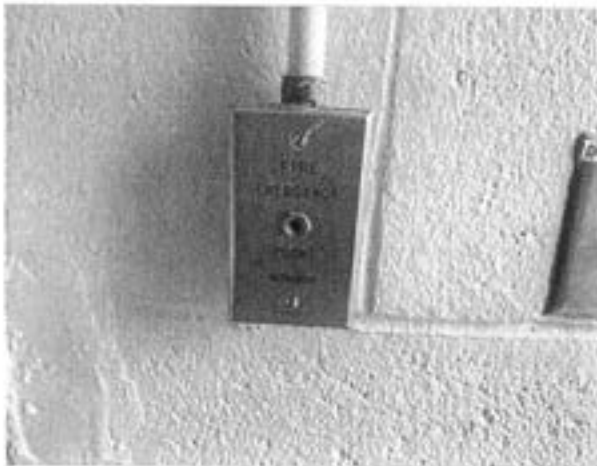
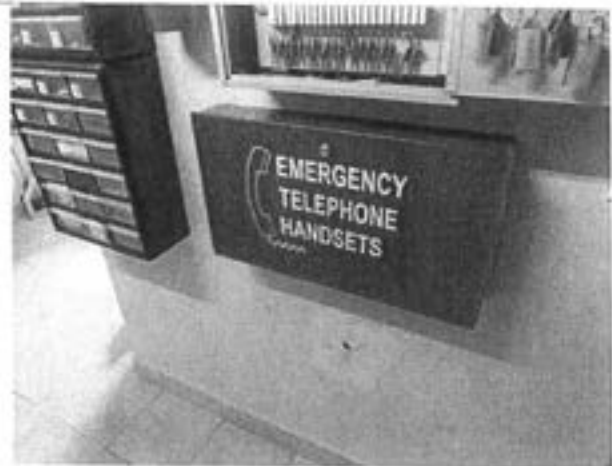
## 6 - Fire 2-Way Radio Replacement

Fire Two-Way Radio - The fire communications two-way radio system includes emergency headsets located near the FACP. The fire communications two-way radio system was updated with the FACP circa 2008. These types of systems generally have a useful life of 20- to 25-years under routine maintenance. We have included a reserve for replacement/repairs to the system as needed.

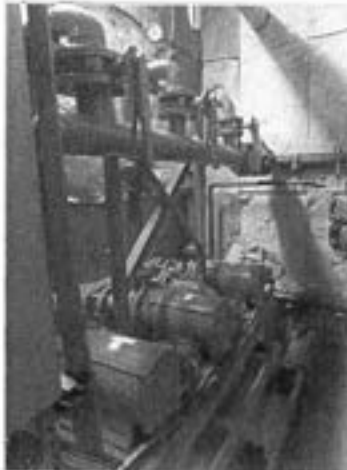
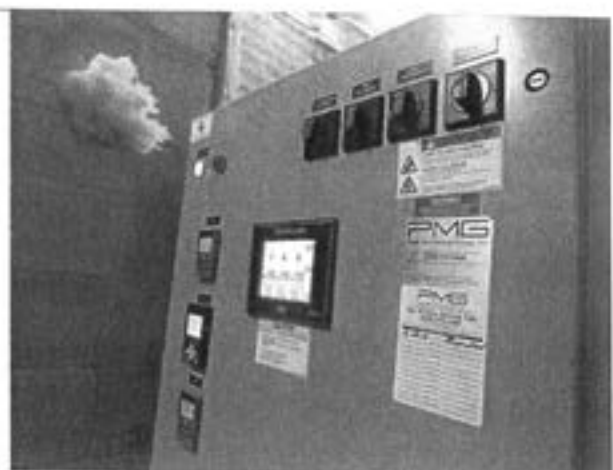
## 9 - Domestic Water Pump System Replacement

Domestic Water Pump System - The domestic water pump and control system for the building are located in the upper-level garage of the building within the fire pump room. The building includes a variable speed domestic water pump system which includes three Tigerflow 15hp domestic water pumps and a main control panel that were installed circa 2019. Our experience indicates that the main controller can achieve a typical useful life of 15- to 20-years, whereas the pumps typically require replacement on an 8- to 12-year useful life. This reserve budget includes the replacement of the control panel and repairs or replacement to the motors/pumps as needed.

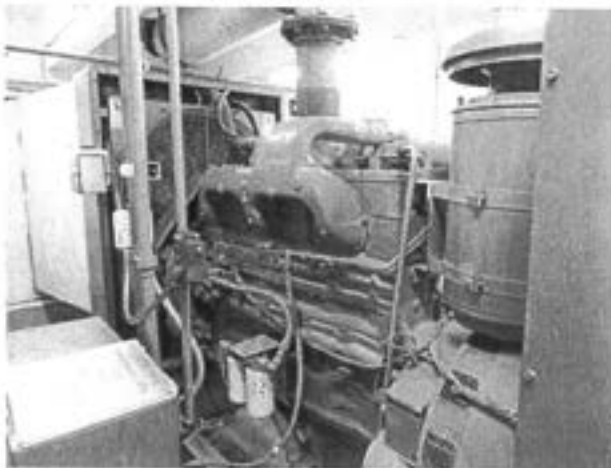
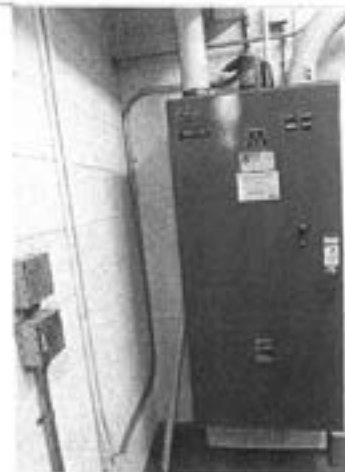
## 10 - Emergency Generator and Transfer Switch Replacement

Emergency Generator and Transfer Switch Replacement - The building is provided with a 300kw diesel powered generator and 1000A transfer switch located in the upper-level garage. The generator, pad, fuel tank and transfer switch are original components. From discussions with the general manager, the generator has been maintained well. Typically, diesel generators and related equipment have a useful life of approximately 35 to 40 years. A reserve has been included for replacement of the generator and related equipment in 2030.

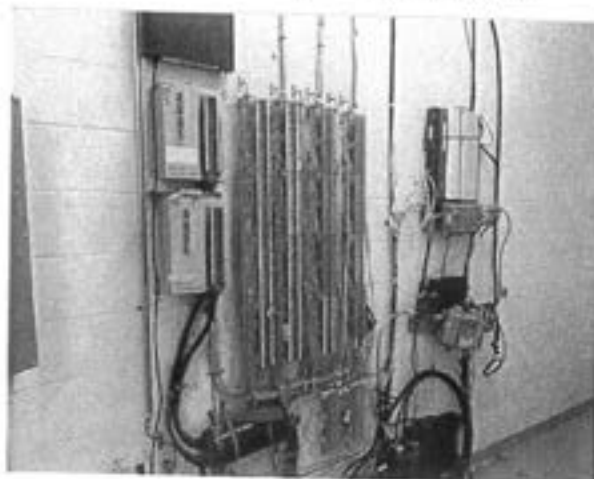
## 11 - Electrical System Deferred Maintenance

Electrical System Deferred Maintenance – Currently there are no indications of any deterioration or issues with the electrical system for the building. It is understood that an electrical load study was completed. It is understood that a Square-D panel has been replaced and another is stored on-site. The main disconnects for the building are located within a room in the upper-level garage of the building. Localized breaker panels and branch circuits are typically replaced during common area or individual unit renovations as required to accommodate the renovation. Therefore, a reserve has been included for periodic replacement/upgrades of a portion of major electrical system components such as main service panels and feeder lines. This is because buildings generally do not replace all electrical systems at the same time, but rather as needed.

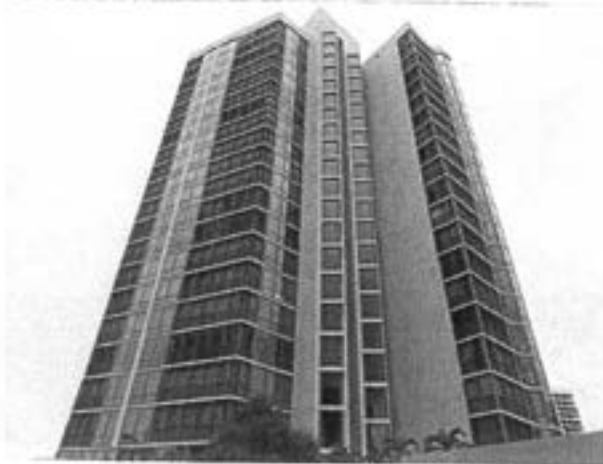
## 12 - Exterior Building Paint & Seal

Exterior Painting - We understand the building was last recoated circa 2020. During our site inspection the existing paint was observed to be in good to fair overall condition. Buildings located in the Southwest Florida region, are recommended to have their exteriors recoated on a 7-year basis. A reserve has been included for periodic recoating of the buildings' exterior on a 7-year cycle.

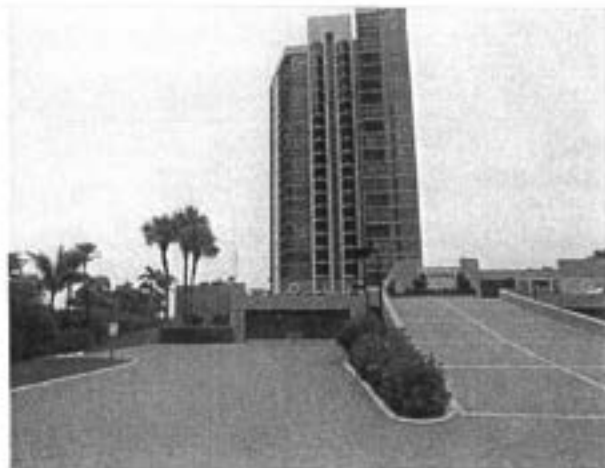
## 13 - Exterior Restoration Budget

Exterior Restoration Budget - During the recoating of a building, it is typical to find distressed stucco and exterior sealants. A reserve has been included for periodic repairs/restoration of the buildings' exterior envelope components including sealants and stucco repairs. The reserve is based on an 7-year cycle to coincide with every exterior re-coating project.

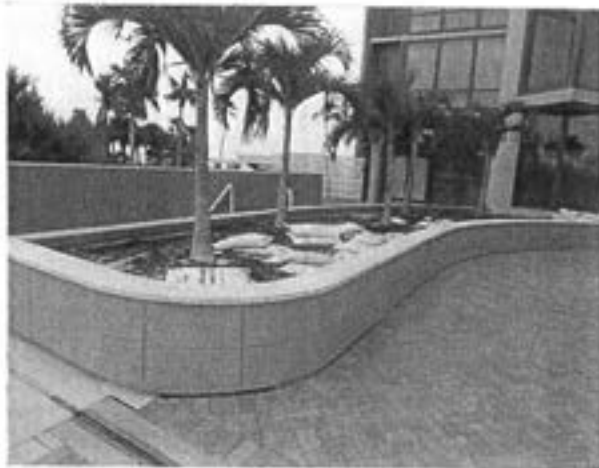
Waterproofing - Front Planters - We understand that the waterproofed planter at the second level entry deck near the lobby was replaced circa 2021. Typical systems installed generally have a useful life of 20- to 25-years before having to be replaced. Therefore, we are recommending the replacement of the waterproofing system for the planter as needed.

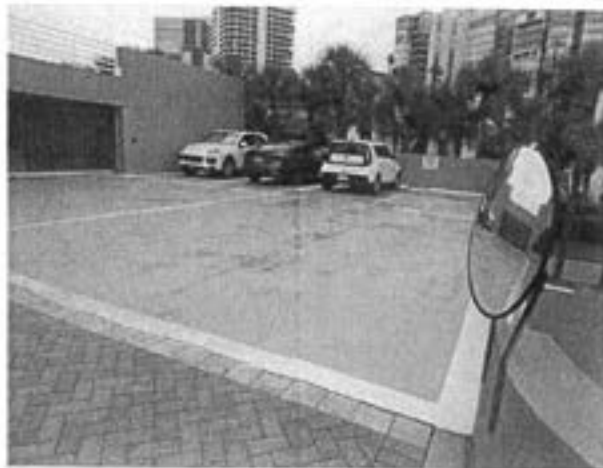
Waterproofing - Entrance to 2nd Level Garage  
- During our inspection we observed one area of waterproofing deterioration along the second level entry deck surface that did not include pavers. We understand this section of waterproofing was repaired in the summer of 2024. This cost was provided by management from a quote by Marzucco's Construction & Coatings.

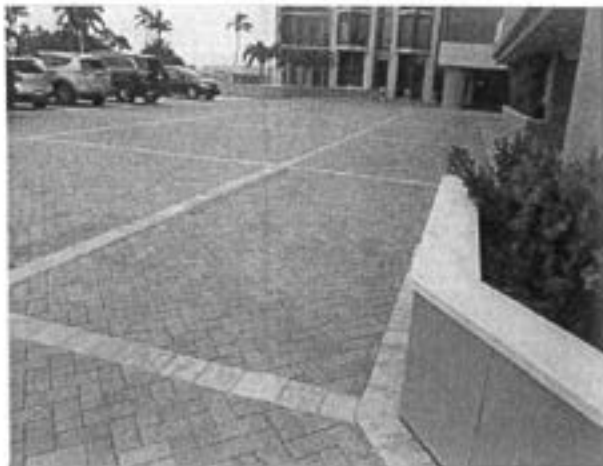
Waterproofing - Lobby Level Entry Deck - We understand the second level Lobby entry deck is surfaced with pavers over a Tremco 250 cold applied waterproofing system. Typical systems installed generally have a useful life of 20- to 25-years before having to be replaced. This cost estimate is for the waterproofing system alone, and does not include the cost of replacement pavers.

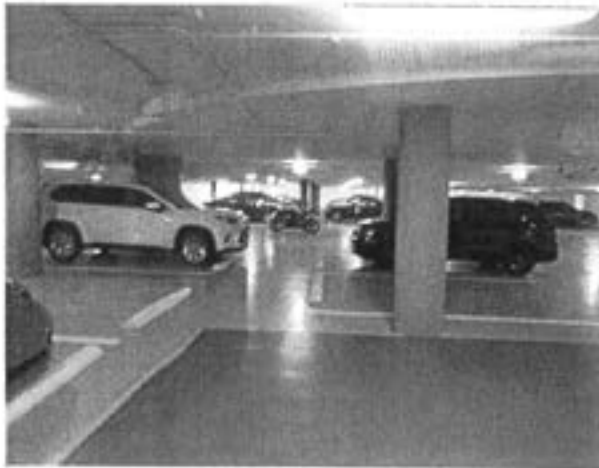
Waterproofing - Upper Garage Floor Coating - We understand the upper level garage has been recently recoated. Typical systems installed generally have a useful life of 20- to 25-years before having to be replaced. Therefore, we are recommending the upper level garage floor waterproofing system to be replaced as needed.

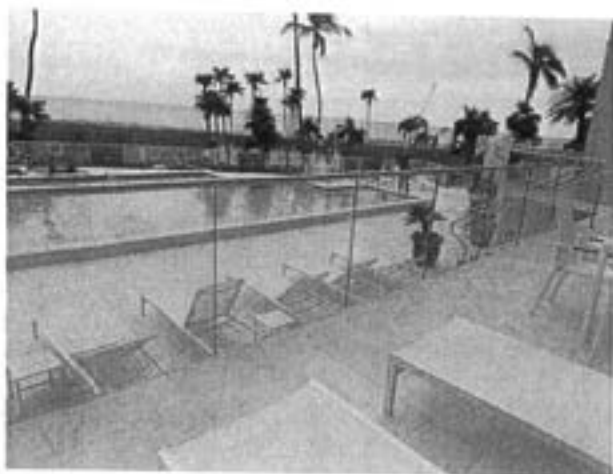
Waterproofing - Pool Deck & Tile Removal - We understand the second level pool deck is surfaced with tile which is assumed to be over a cold applied waterproofing system. We understand the pool deck renovation project included new waterproofing and tile circa 2020. Typical systems installed generally have a useful life of 20- to 25-years before having to be replaced. However, a slightly greater useful life of 30 years has been allocated to the waterproofing system considering UV/direct exposure protection provided by the tiles. Therefore, we are recommending the second level pool deck waterproofing system to be replaced as needed or in 2050. This cost estimate is for the waterproofing to the portion of the pool deck above equipment below, and does not include tile replacement or other pool amenities.

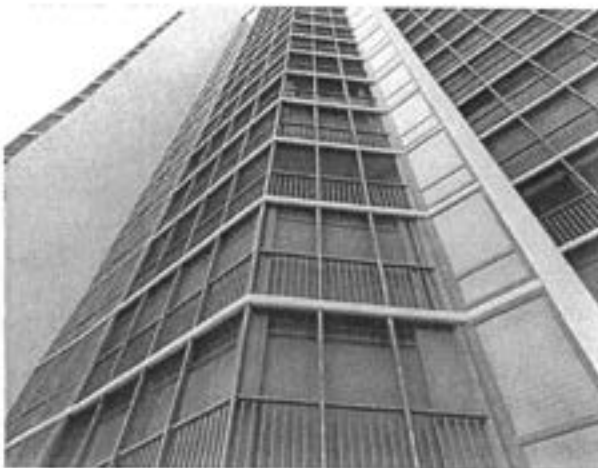
## 19 - Waterproof - Balconies Deferred Maintenance

Waterproofing - Balconies Deferred Maintenance - We understand the balconies have association owned waterproofing systems under resident owned flooring systems. We understand approximately 5-7 units are renovated each year, however, we do not have an estimated number of balconies that have received new waterproof coatings. Typical waterproofing systems installed under tile generally have a useful life of 10- to 15-years before having to be replaced. Therefore, we are recommending the balcony waterproofing systems to be replaced as needed on a deferred maintenance schedule.

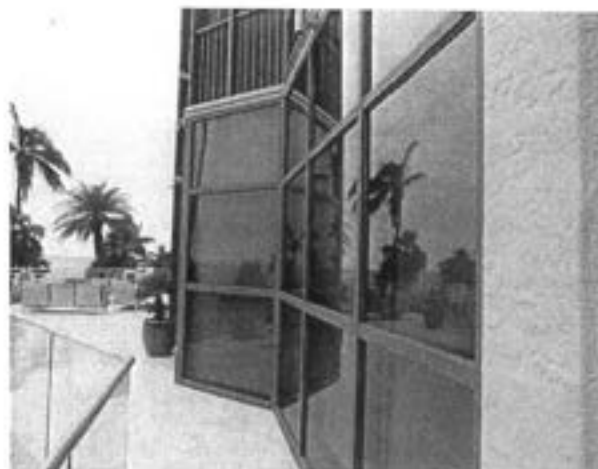
## 20 - Common Area (Lobby Level) Windows Replacement

Common Area (Lobby Level) Windows Replacement - There are commonly owned glass windows along the second level common areas. These include the fitness center, social room, and lobby windows. We understand the common areas windows to be original to the building. SOCOTEC calculated approximately 2,300sf of common lobby level windows, which at \$125 per square foot gives an estimated replacement cost of \$287,500 in 2023. This estimate has been increased by 2% for inflation to \$293,250. We noted corrosion of the metal window frames during our site visit. Therefore, we are recommending the replacement of all commonly owned windows to be replaced in 2030.

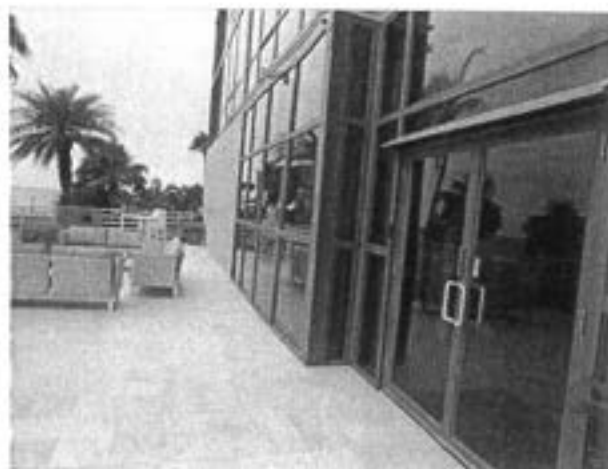
## 21 - Common Area (Lobby Level) Glass Doors Replacement

Common Area (Lobby Level) Glass Doors Replacement - There are commonly owned exterior glass doors along the second level common areas for the lobby, social room, fitness center, and pool deck. We understand the common areas doors to be original to the building. We noted corrosion of the metal door frames during our site visit. Therefore, we are recommending the replacement of all commonly owned exterior glass doors to be replaced in 2039.

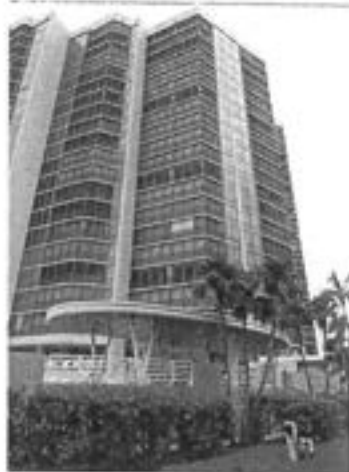
## 22 - Common Area (Original Unit) Windows Replacement

Common Area (Between Balconies) Windows Replacement - We understand that the unit owners are responsible for their own windows and doors, however, there are several commonly owned glass windows between balconies. From discussions with the property manager, there are approximately 880 windows between balconies. SOCOTEC calculated 874 windows for a total of approximately 38,000sf. At \$145 per square foot, the replacement cost was estimated at \$5,510,000 in 2023 for these windows. Management provided a recent quote of \$5,560,000 which has been used in this analysis. We noted corrosion of the metal window frames during our site visit. Therefore, we are recommending the replacement of all commonly owned windows to be replaced in 2030.

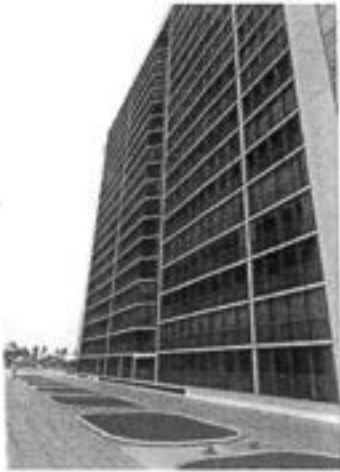
## 23 – Screen Enclosures & Railings Replacement

Screen Enclosures & Railings Replacement – We understand that the screen enclosures and balconies were last replaced in 2006 with plans to replace again in 2025. The screen enclosures and balcony railings have been contributing to water intrusion through the balcony waterproofing. This may lead to structural deterioration of the slab, and has been included into the SIRS as a deferred maintenance expense that exceeds \$10,000 effecting a previously listed statutorily mandated component. Management provided quotes for the railings and screen enclosure replacement. SOCOTEC is recommending the replacement in 2025 as previously planned. Waterproofing under the railings/enclosures shall be replaced as part of this project, and can be later tied in to the balcony waterproofing.
