Pre-Demolition Regulated Building Materials Inspection

Town of Sodus – Highway Department
8 Bay Truck Garage
84 Rotterdam Road
Sodus, New York 14551

LaBella Project No. 2201129

May 5, 2020

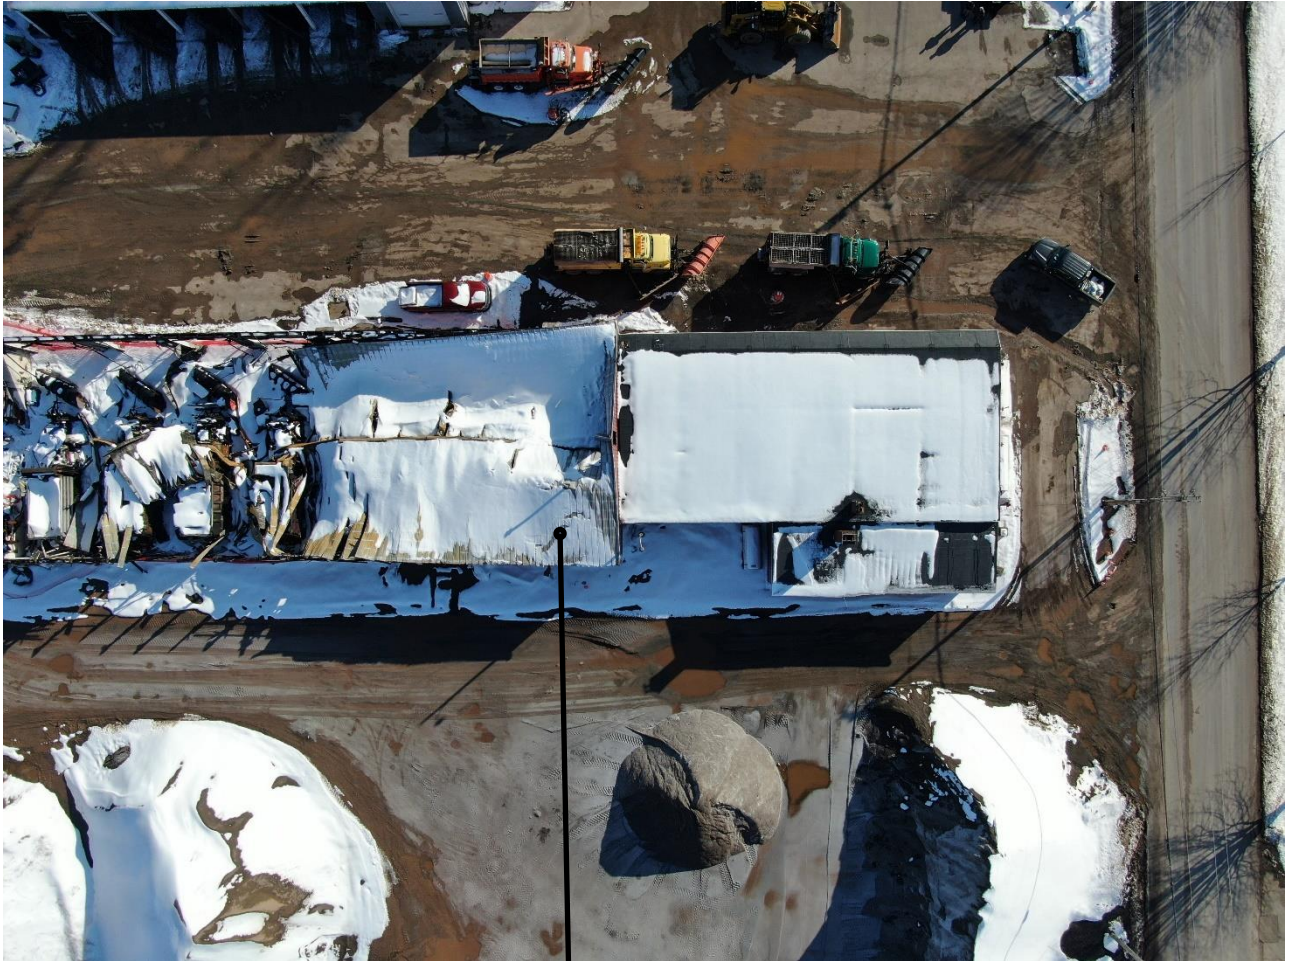
Sample Location Drawing

* = Sample taken from interior second floor bathroom

1A,B*
2A,B*
