**RE: West Central Fire District Station Scoping Services  
Phase 1 Report**

# ***WEST CENTRAL FIRE DEPARTMENT***

## **FACILITY ASSESSMENT**

# ABOITE STATION 180

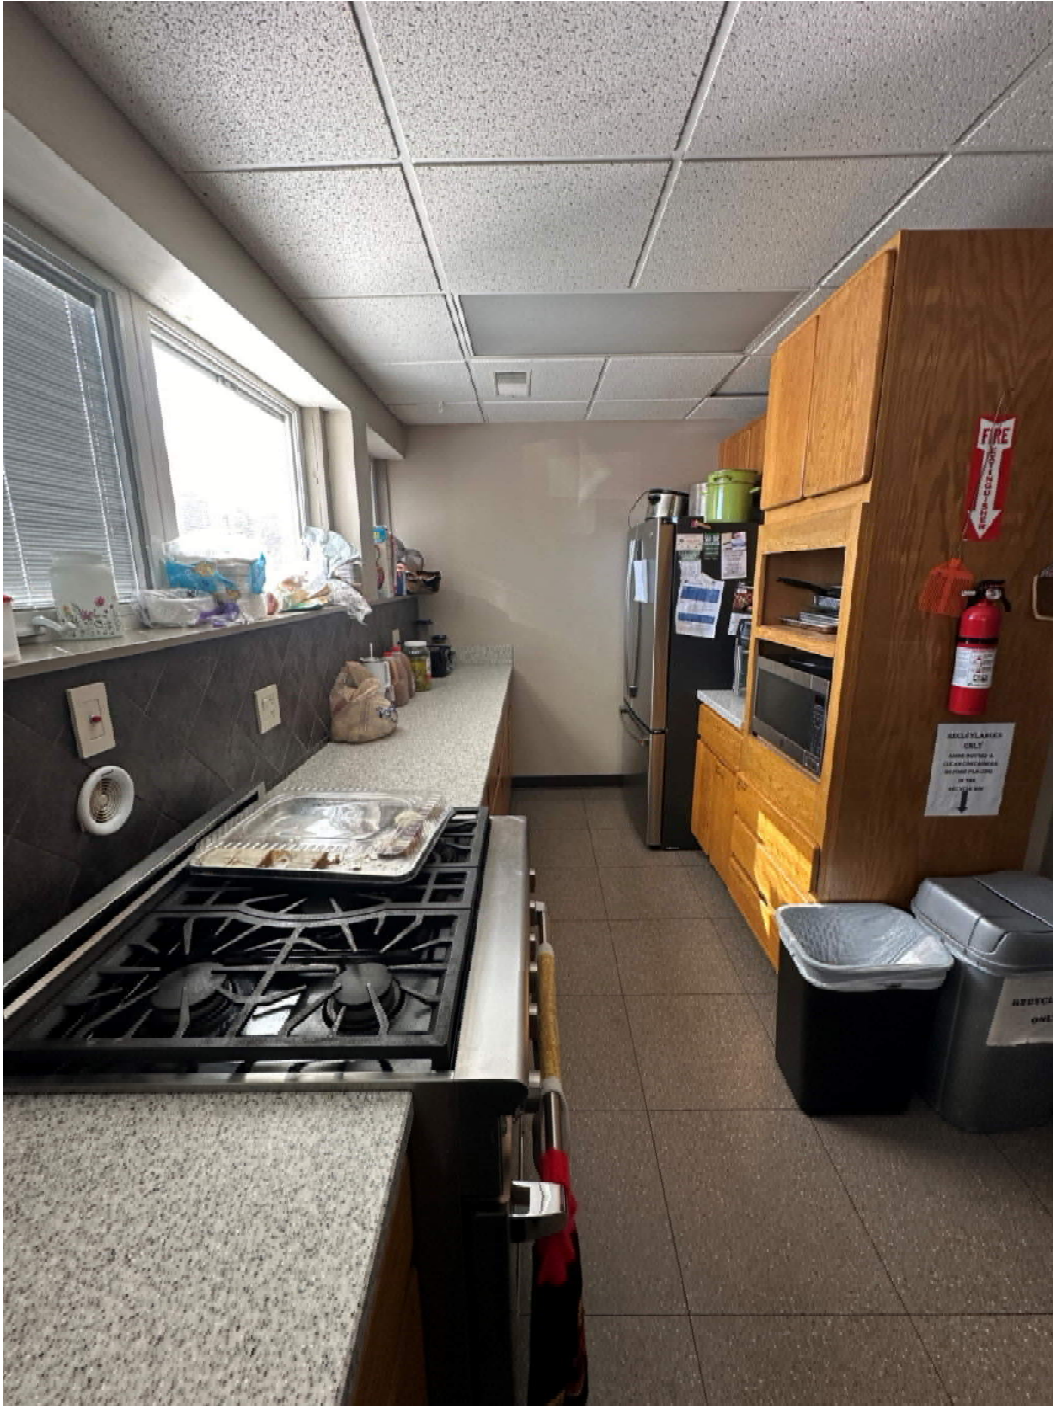
The Kitchen is undersized and doesn't have several essential appliances such as an exhaust hood for the range, and more than one fridge for the 3 shifts. There is very little storage in the Kitchen as well.

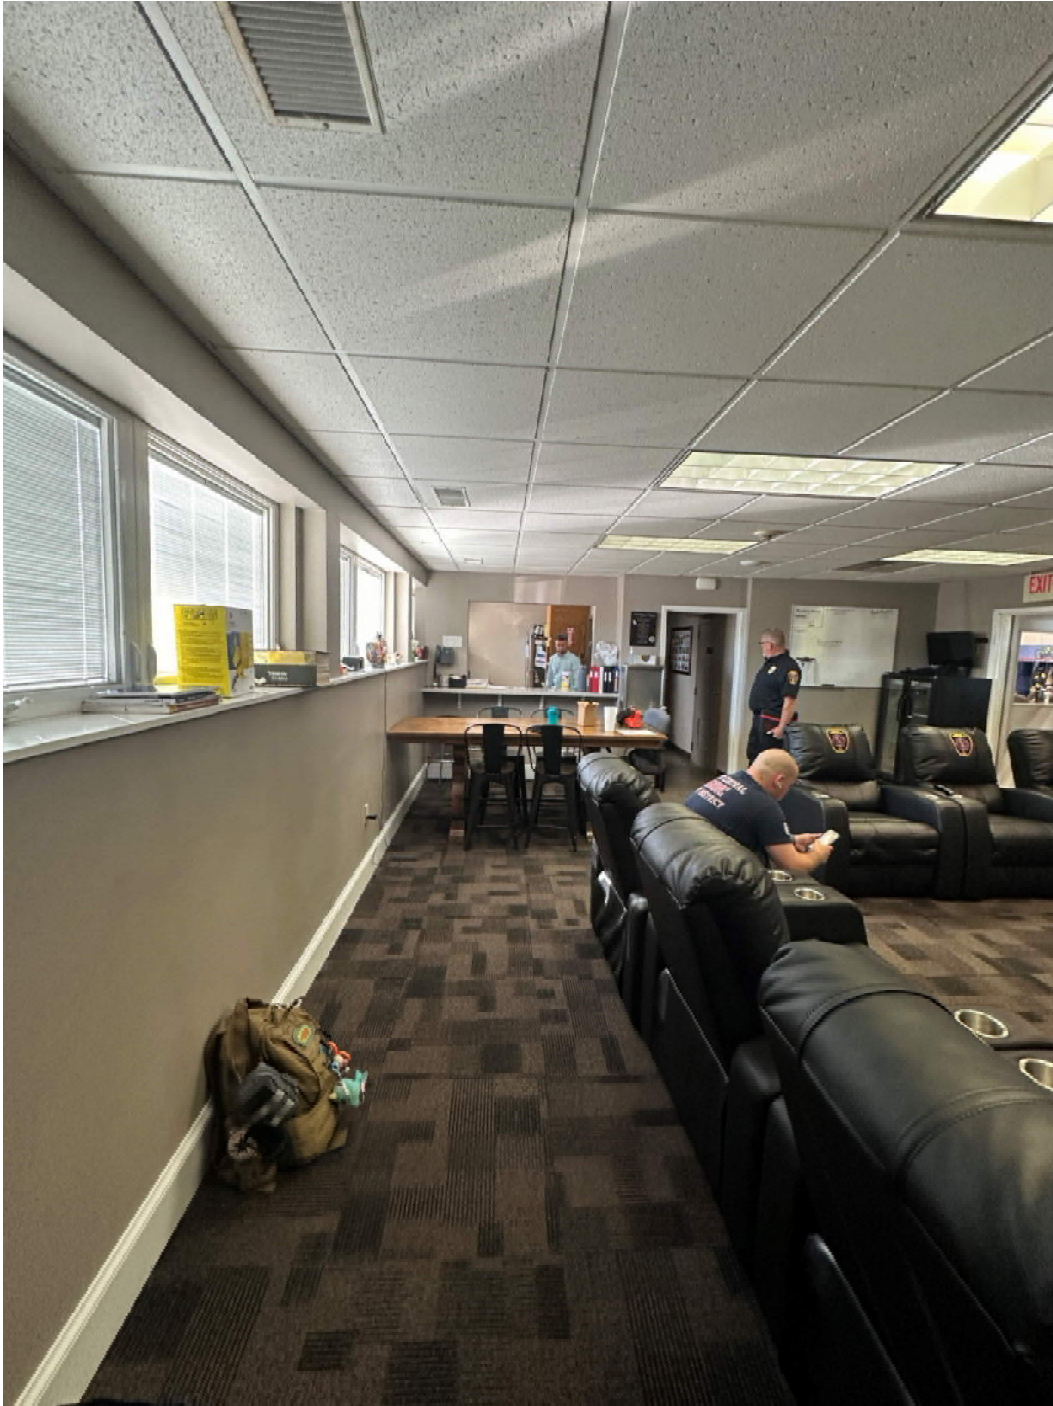
The Dayroom and Dining areas are undersized and below standards for today's fire stations.

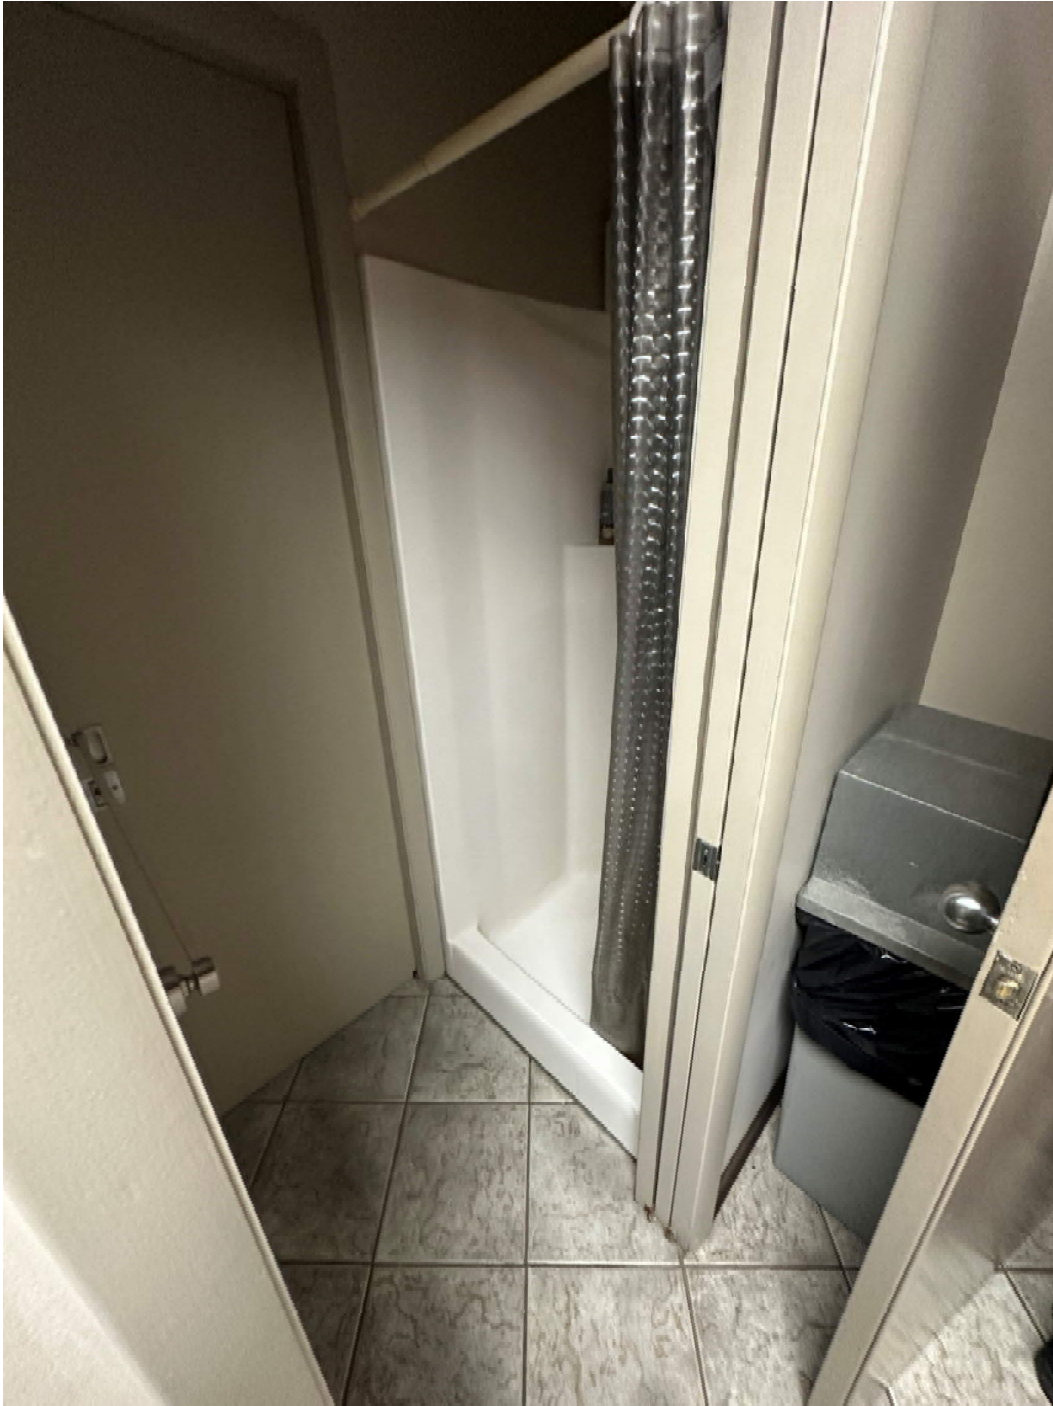
There is only one shower serving the whole station. With the potential to sleep six staff, this is well below the standard for a contemporary fire station.

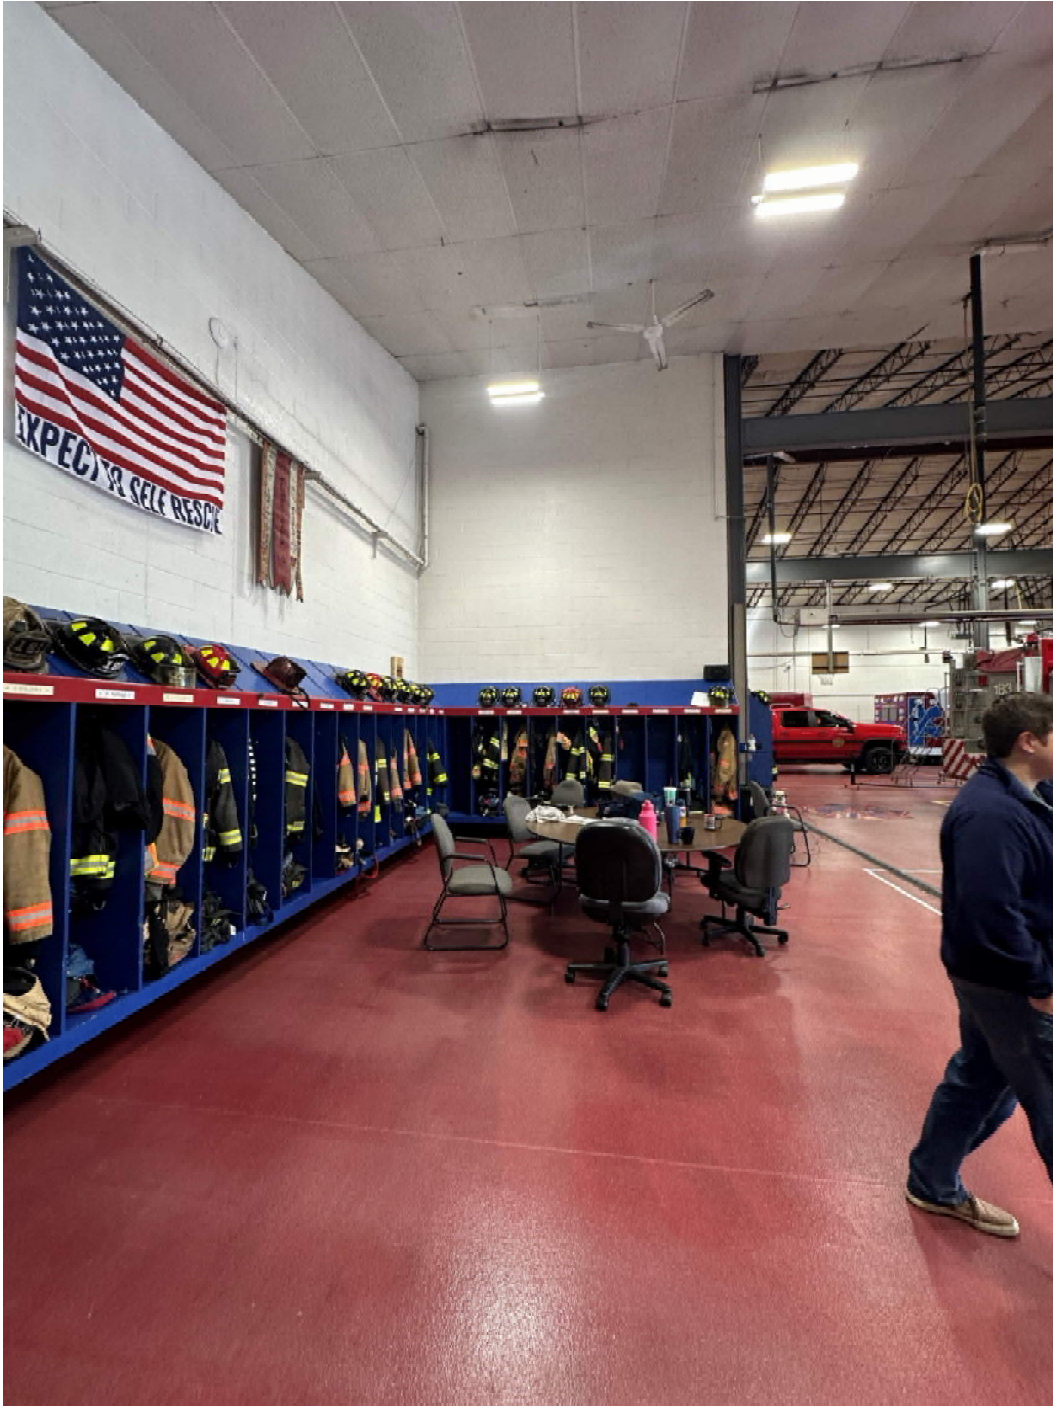
Gear Storage shares space in the App Bay which leaves it open to carcinogens associated with the vehicles.

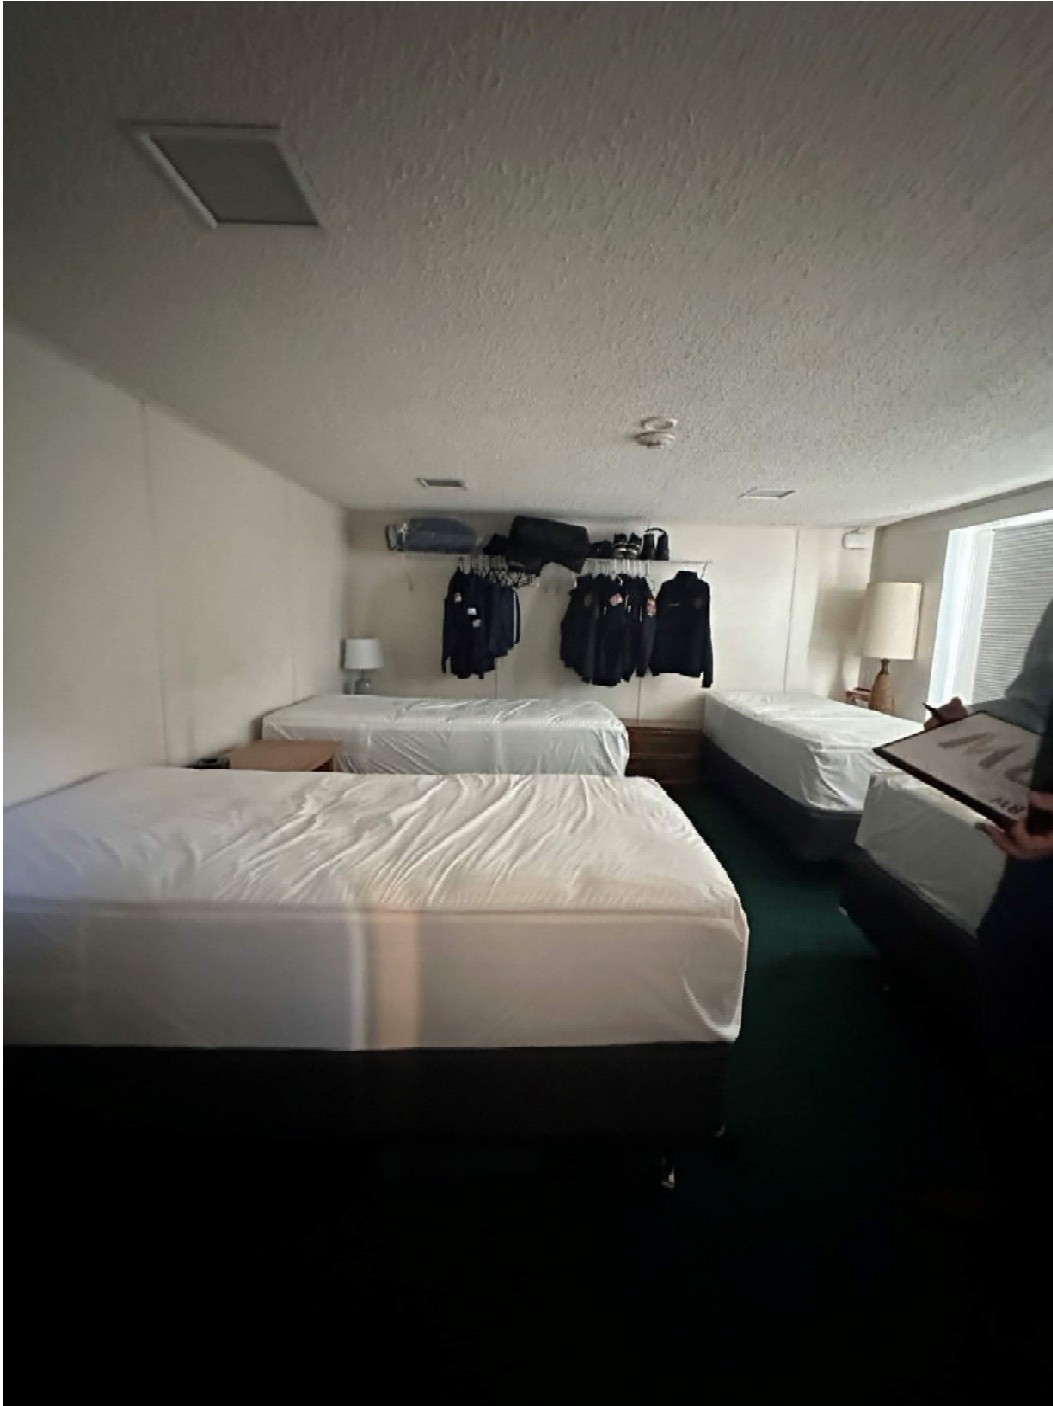
Four of the beds in the Sleeping Quarters are in a mezzanine-type space within the App Bay. Without an airlock or airtight door seals, carcinogens from vehicle exhaust can easily seep into this room. This is a serious health concern for the occupants of the station.

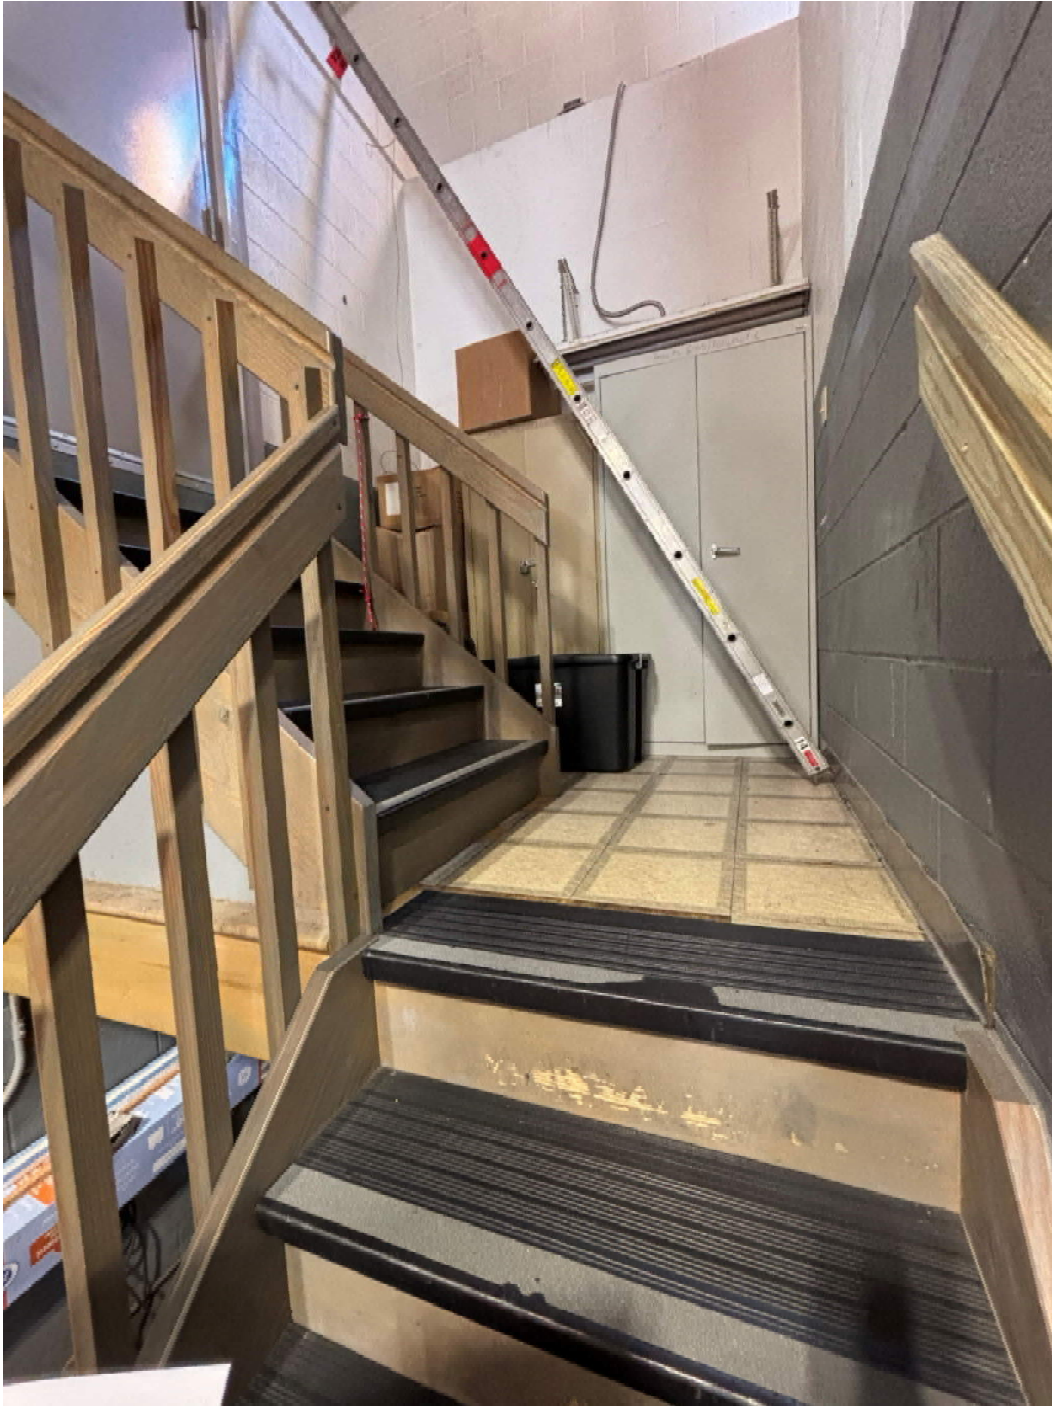
The Sleeping Quarters in the mezzanine can only be accessed by this set of stairs which does not meet current standards of code. There is also no landing outside the door, so it swings over the first stair treads. The windows need to be verified for meeting egress requirements as well. There is a ladder being used to access storage on top of the Bunk Room.

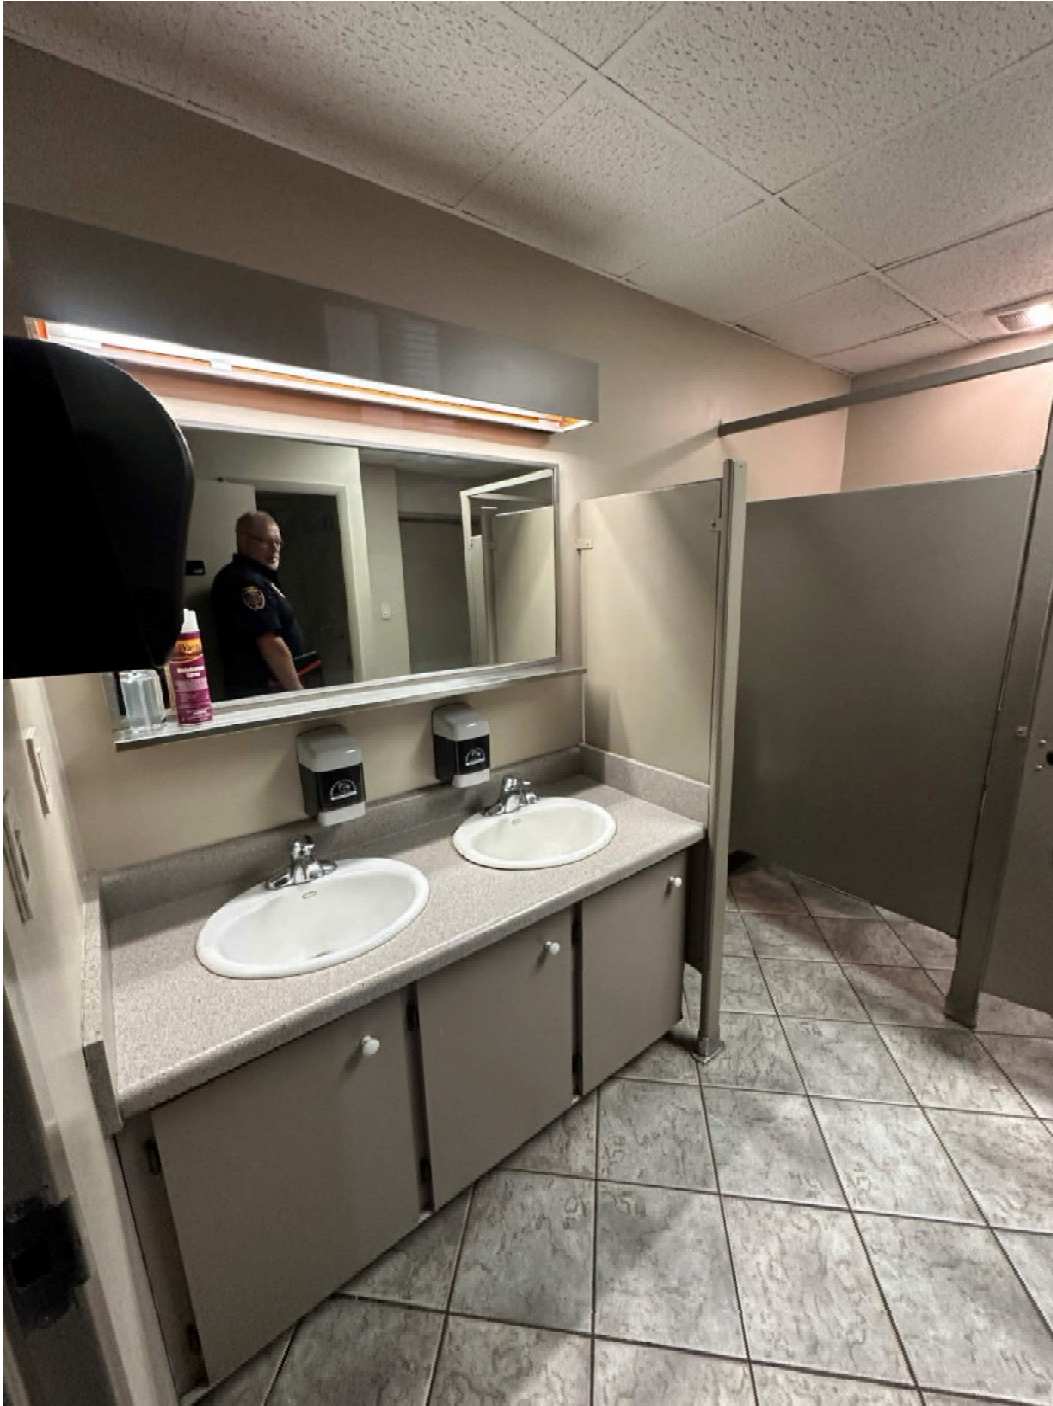
Restroom and fixture count for the station doesn't meet the requirements of the staff in the station and certainly not when the Training Room is at full capacity.

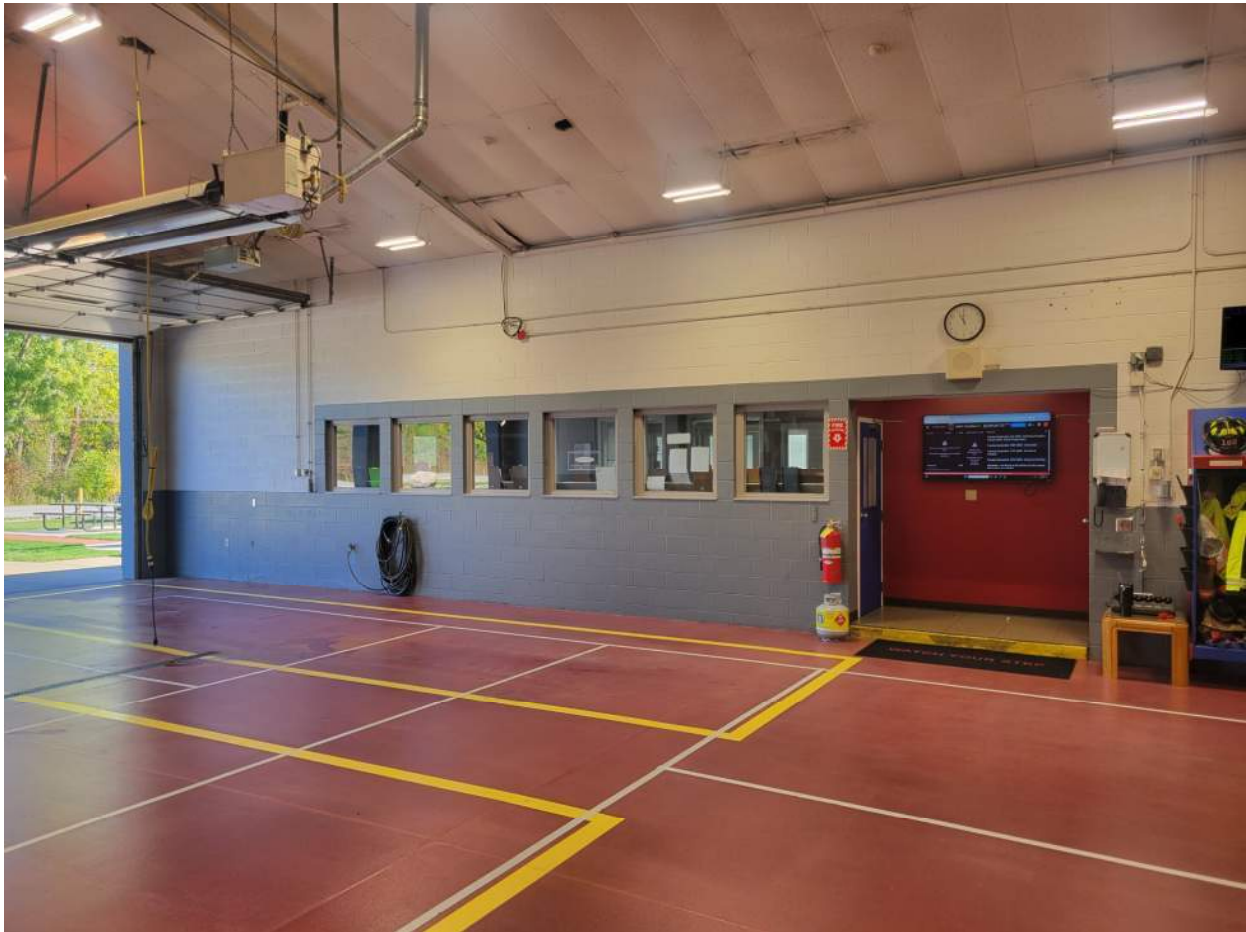
The App Bay connects to the rest of the facility without an airlock or airtight door seals. Carcinogens from vehicles and exhaust can infiltrate the rest of the adjacent rooms.

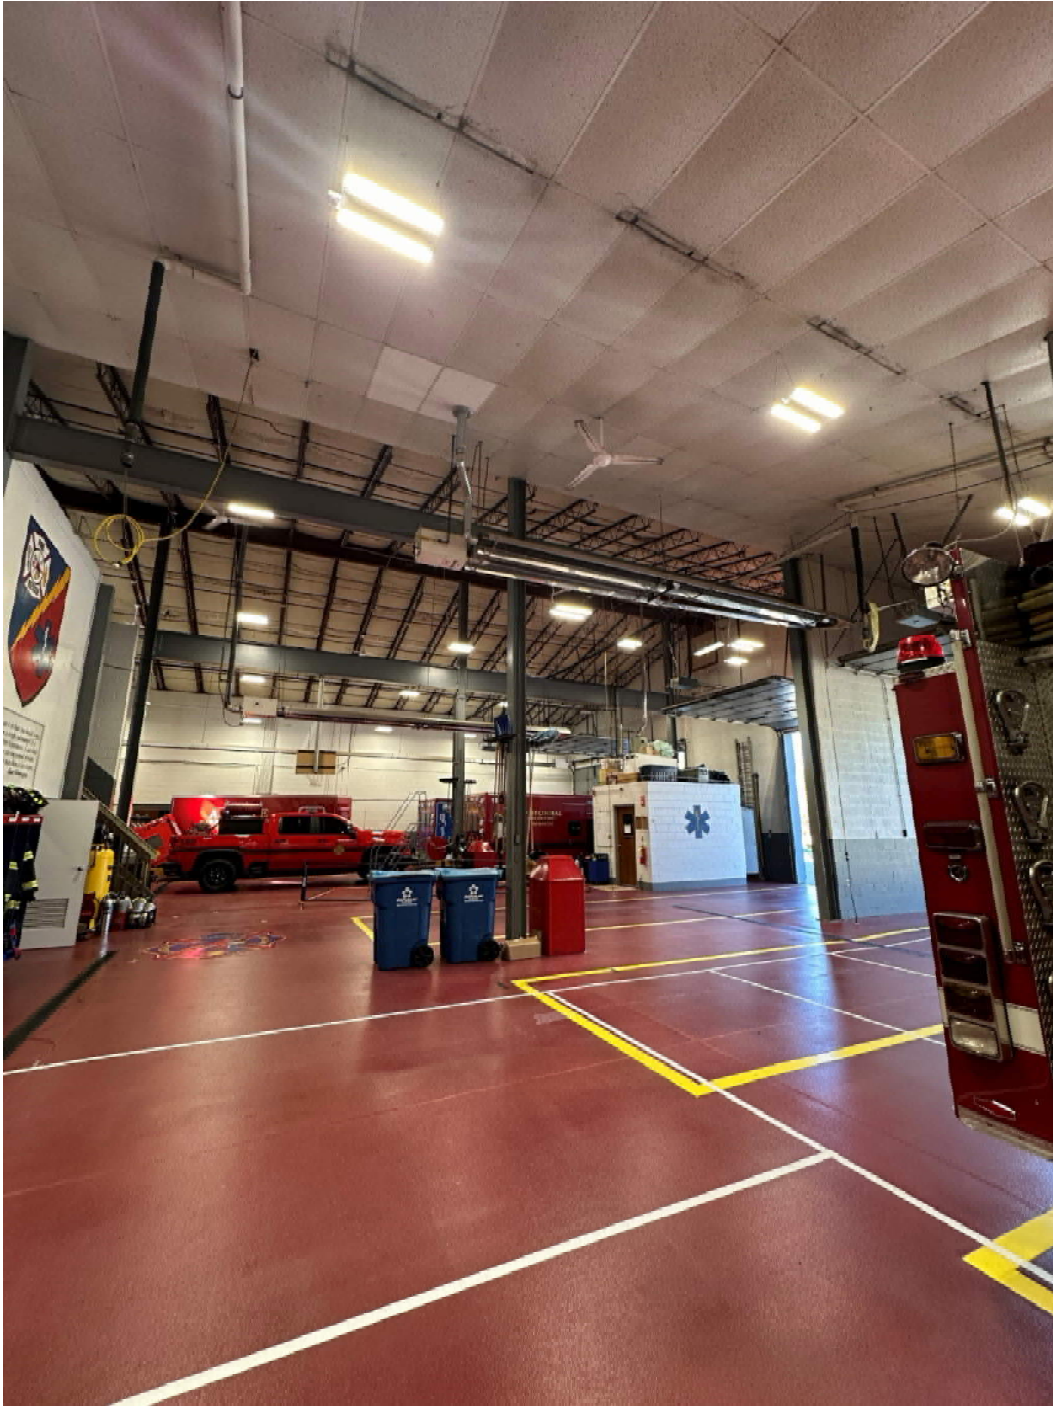
Acoustic ceiling tiles in this area of the App Bay are no longer flat and are visibly sagging in the grid. Many tiles are starting to grow mold as well.

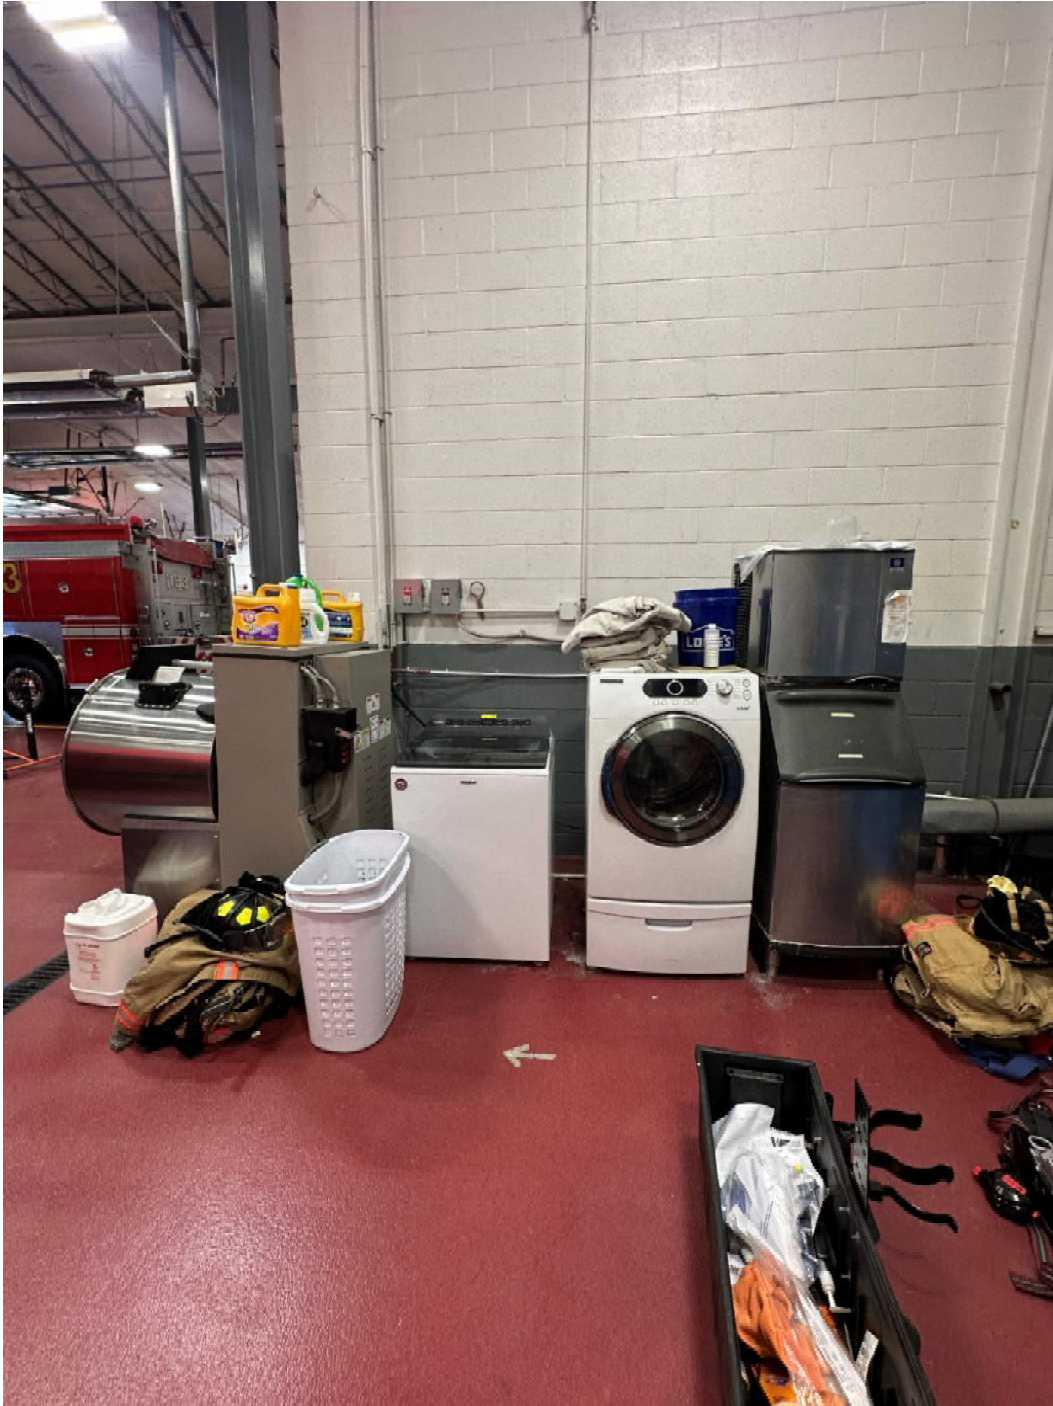
Laundry equipment is used in the App Bay without separation from vehicle exhaust. This space is also shared with other functions, so it is cluttered and inefficient.

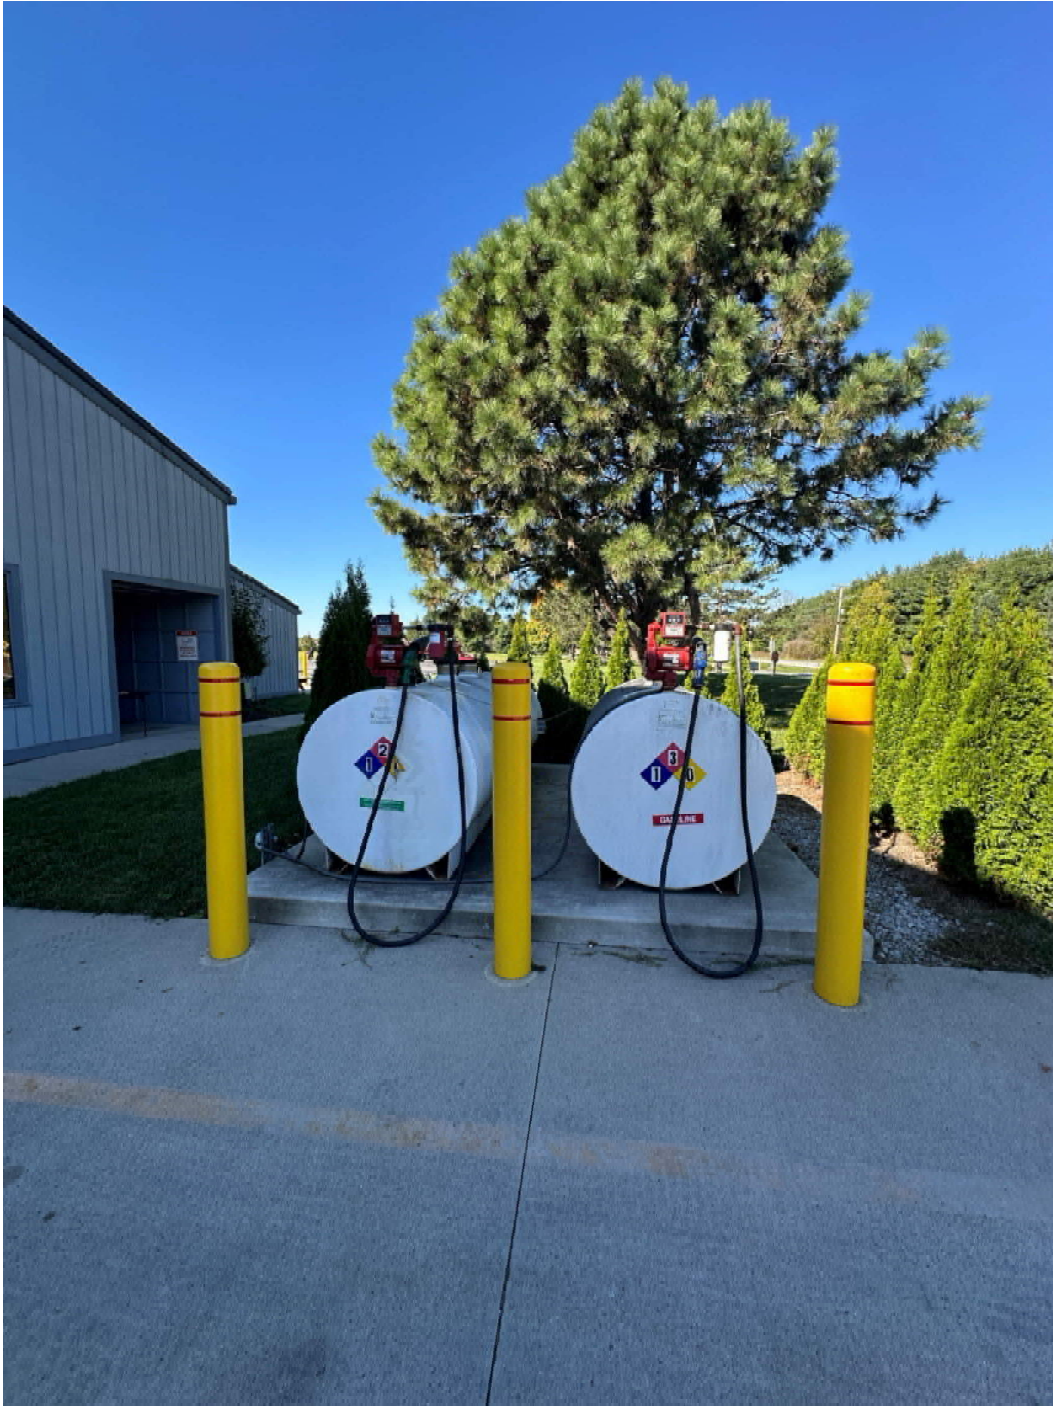
These two large fuel tanks are adjacent to the App Bay apron which sees frequent vehicle traffic. Bollards are somewhat of a deterrent for accidental impact, but ideally, these tanks would be away from the drive.

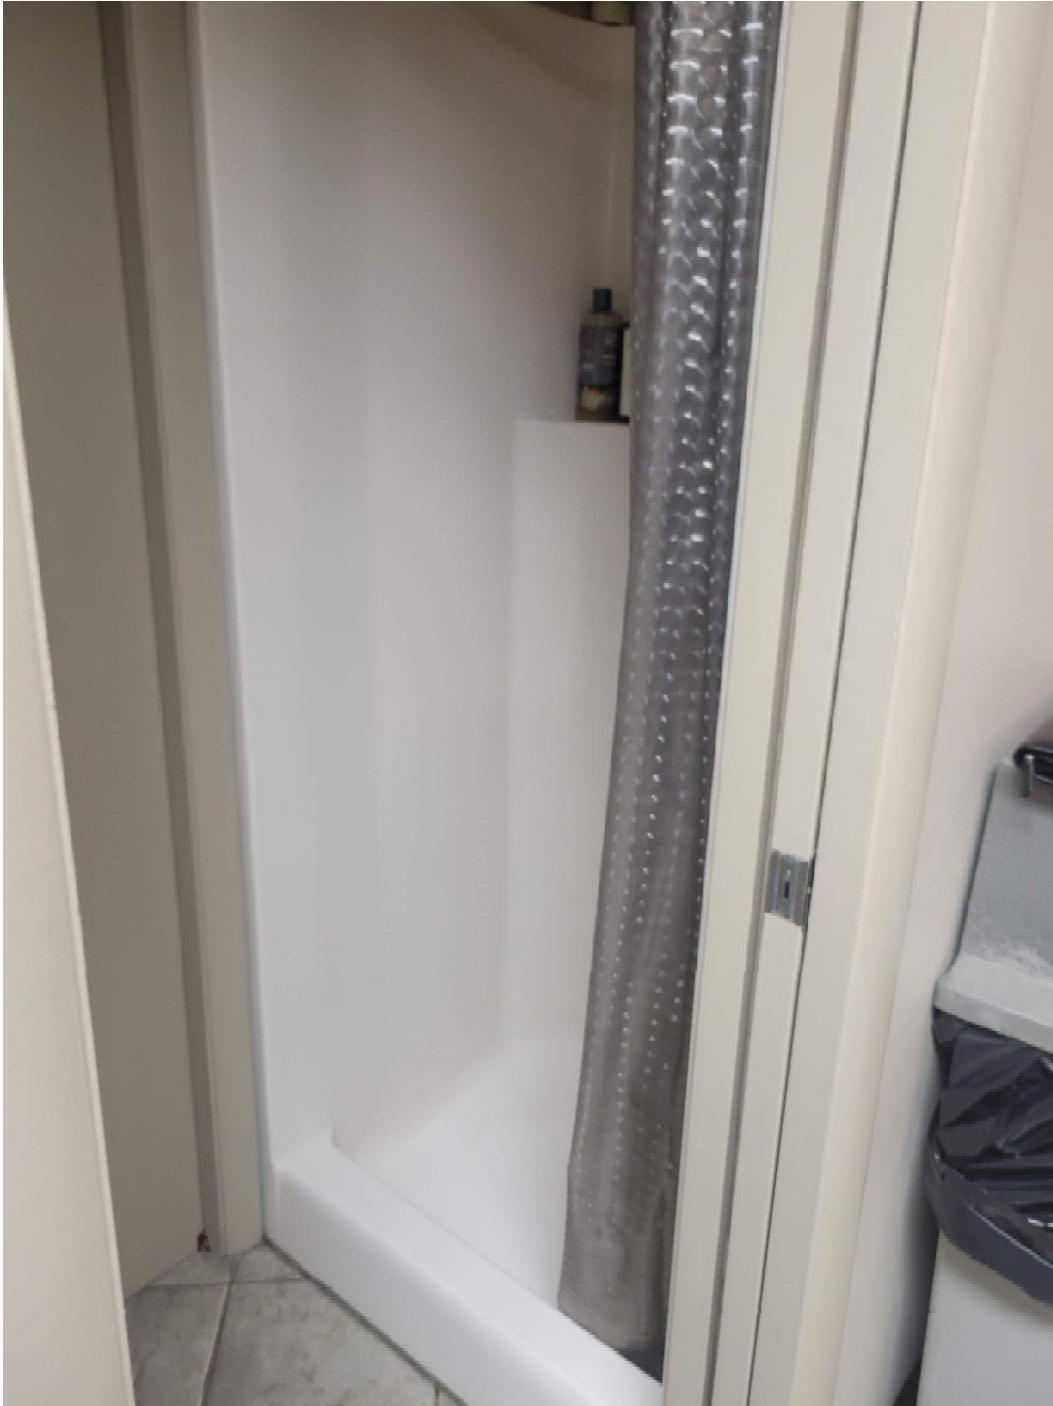
Fiberglass shower is too small and inadequate for proper use.

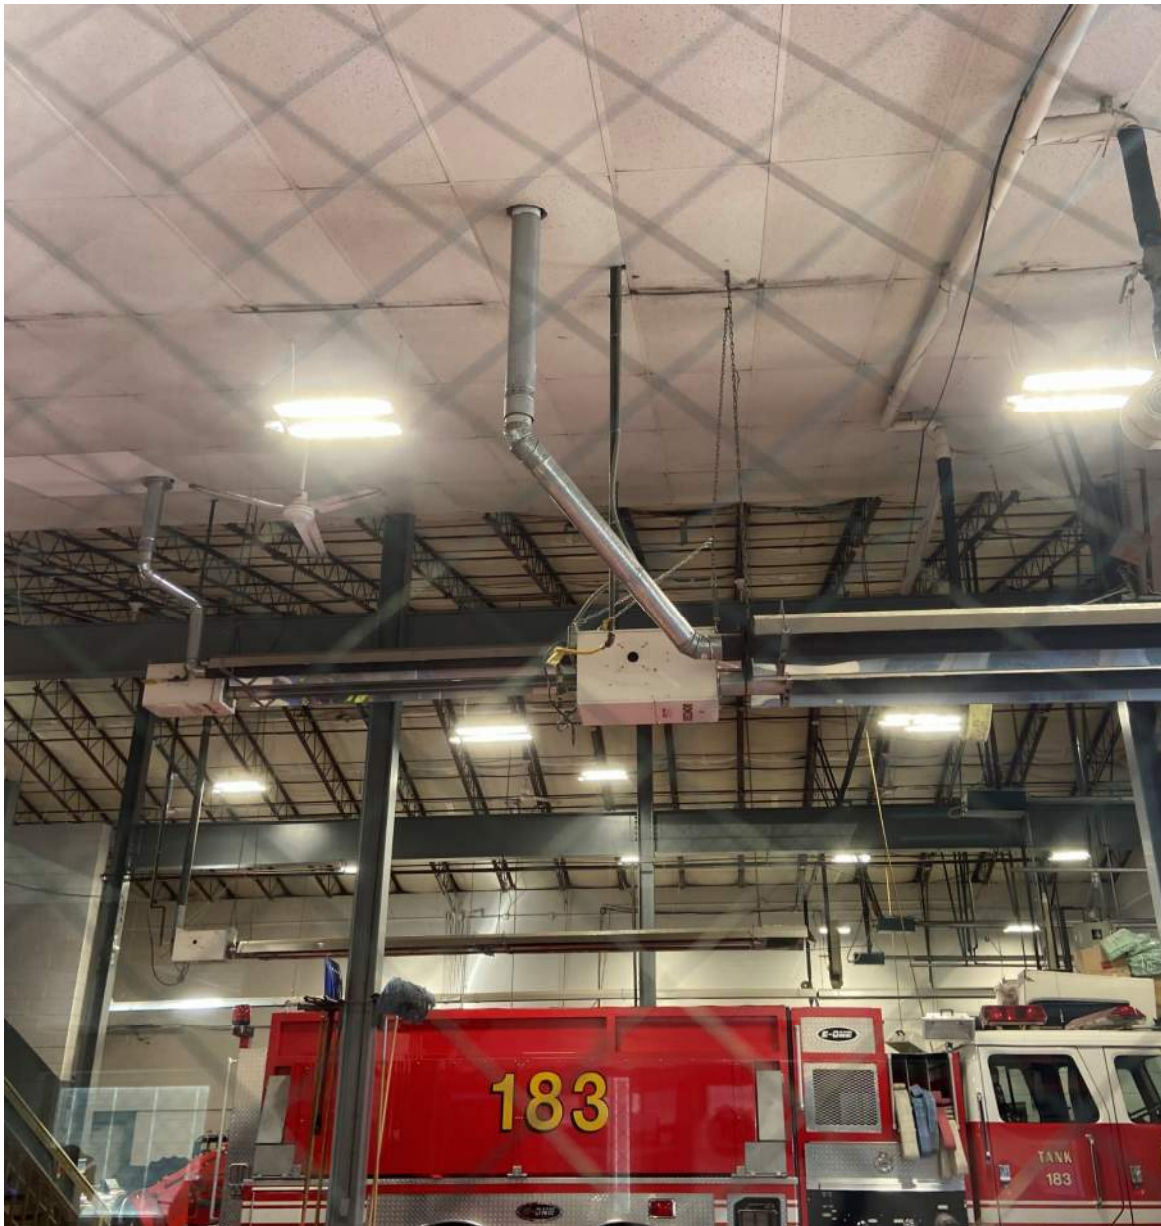
There is currently no mechanical exhaust system in the apparatus bay. This does not meet current codes and is exposing the building and mezzanine sleeping area to carcinogenic fumes from truck exhaust. At minimum, an exhaust fan system tied to a carbon monoxide system should be installed. A direct connect vehicle exhaust system or an air scrubber system would be recommended as well.

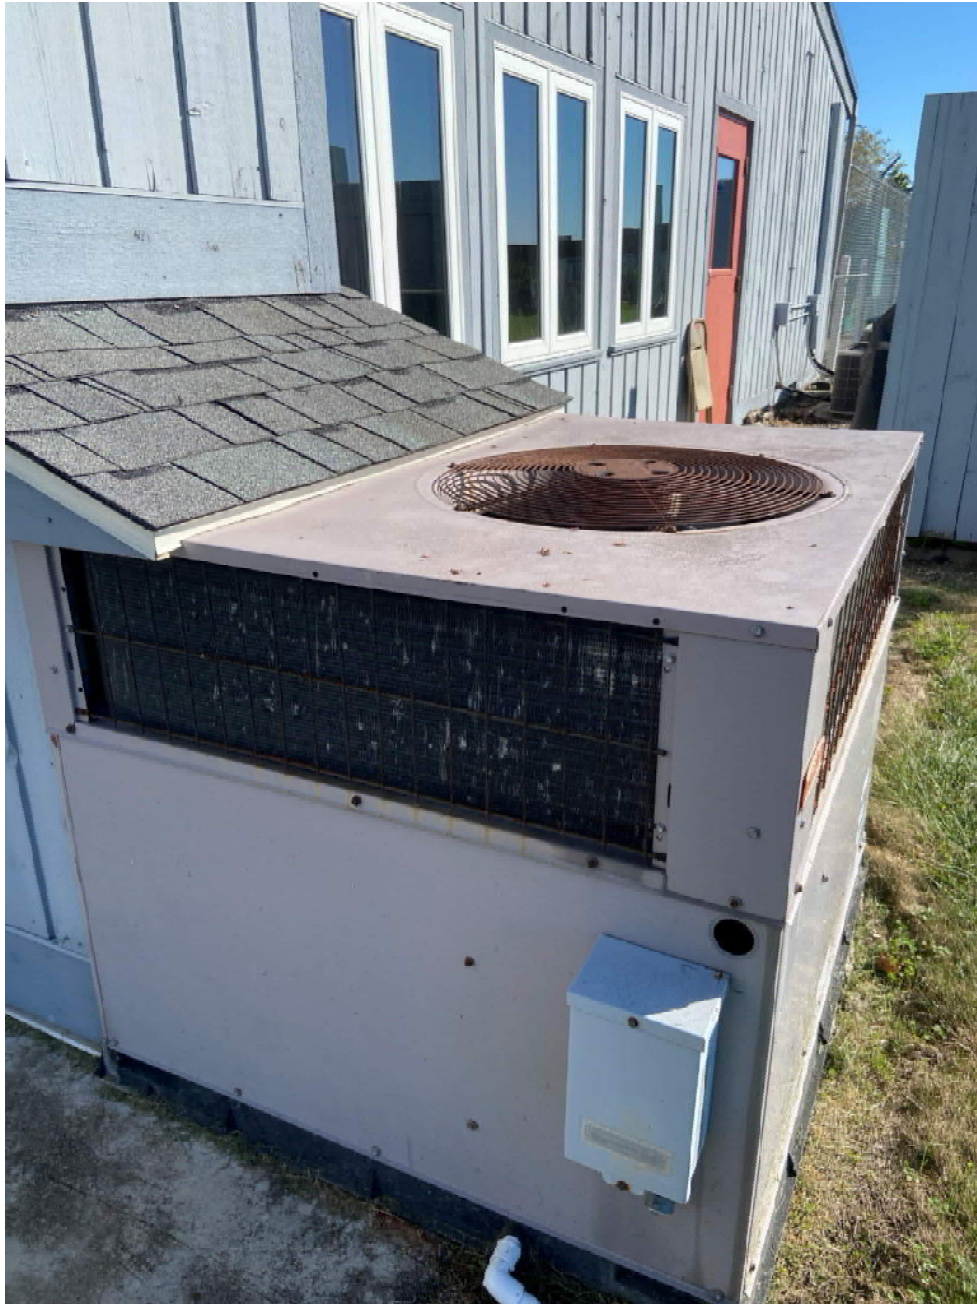
Existing AC system serving training room is at end of life. Recommend replacing with a modern 5 ton packaged AC unit. Associated ductwork appears to be original and should be replaced as well.

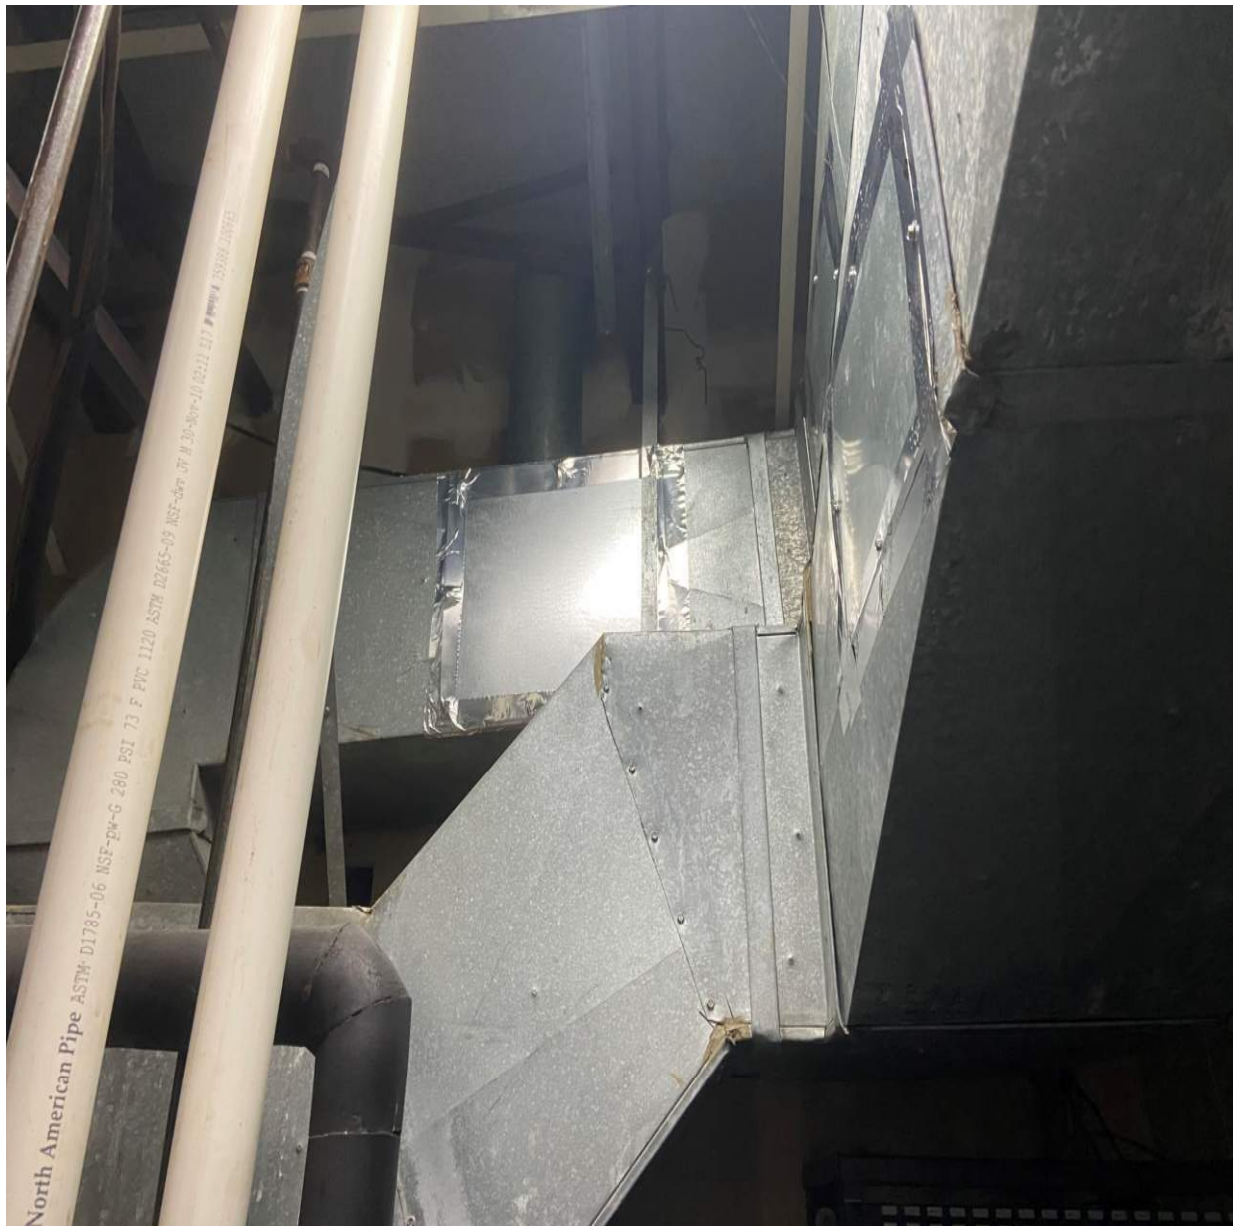
The outdoor air intake ducts for the main building HVAC systems have been capped and are no longer bringing in fresh air. New outdoor air intake ducts must be provided and routed through roof to meet current ventilation codes.
