**RE: West Central Fire District Station Scoping Services  
Phase 1 Report**

# ***WEST CENTRAL FIRE DEPARTMENT***

## **FACILITY ASSESSMENT**

# ABOITE STATION 180

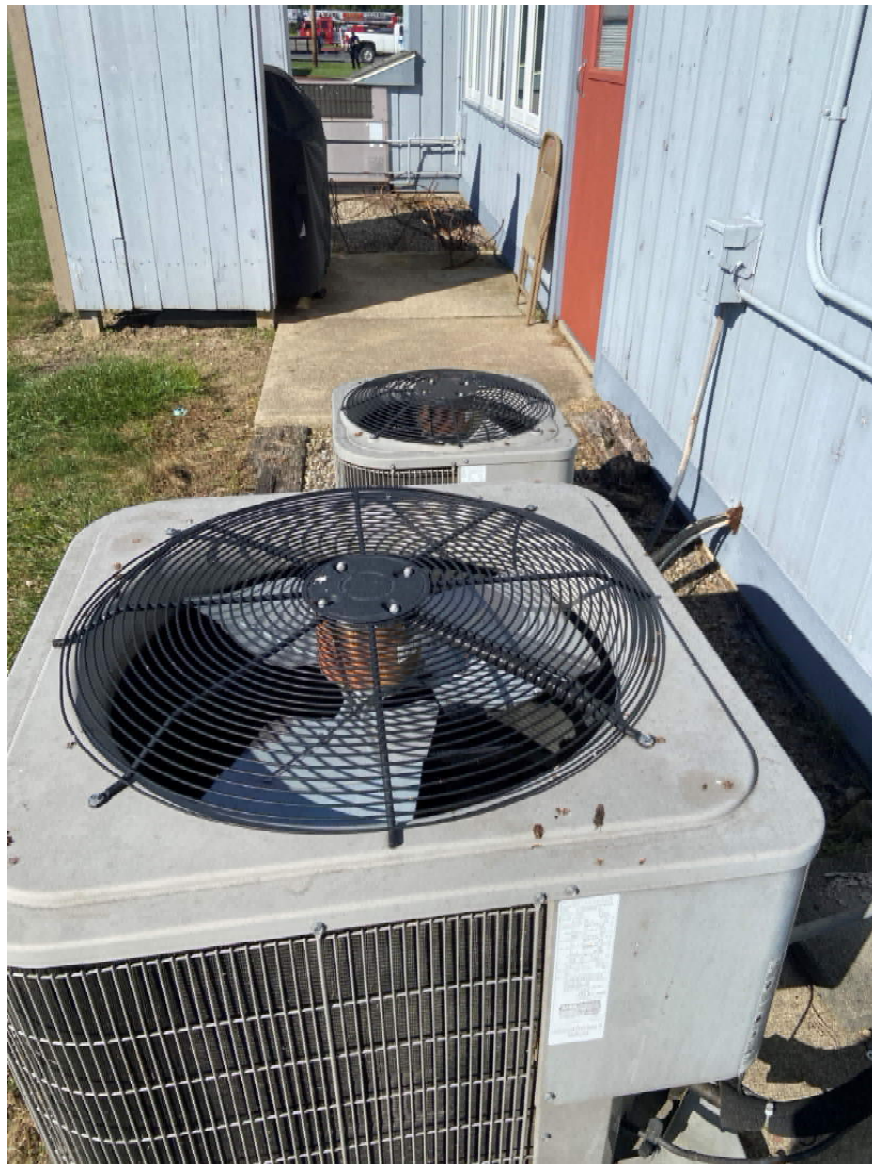
Additionally, the existing systems are single stage systems which are not well suited for the varying needs of a system delivering continuous outside air ventilation. Systems with at least 2-stages of cooling capacity are recommended for this application to prevent humidity issues.

Recommend replacing at least the small system, but replacing both as part of the project would be recommended for the longevity of the building and to allow for adequate performance once ventilation is added.

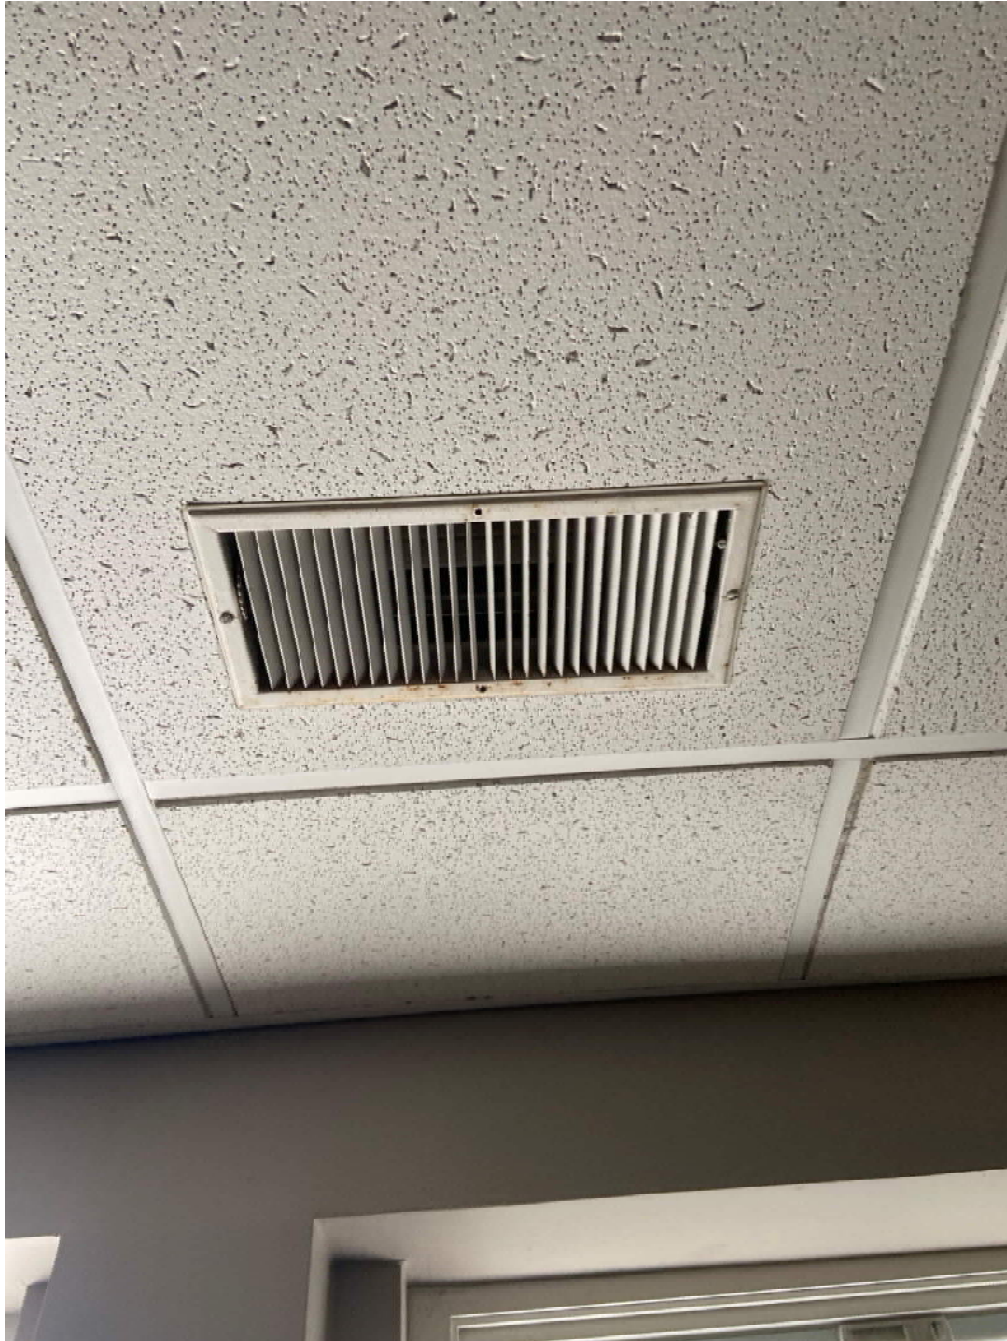
Diffusers / Grilles throughout building are beginning to rust/degrade.  
Recommend replacement of all grilles and a professional duct cleaning.

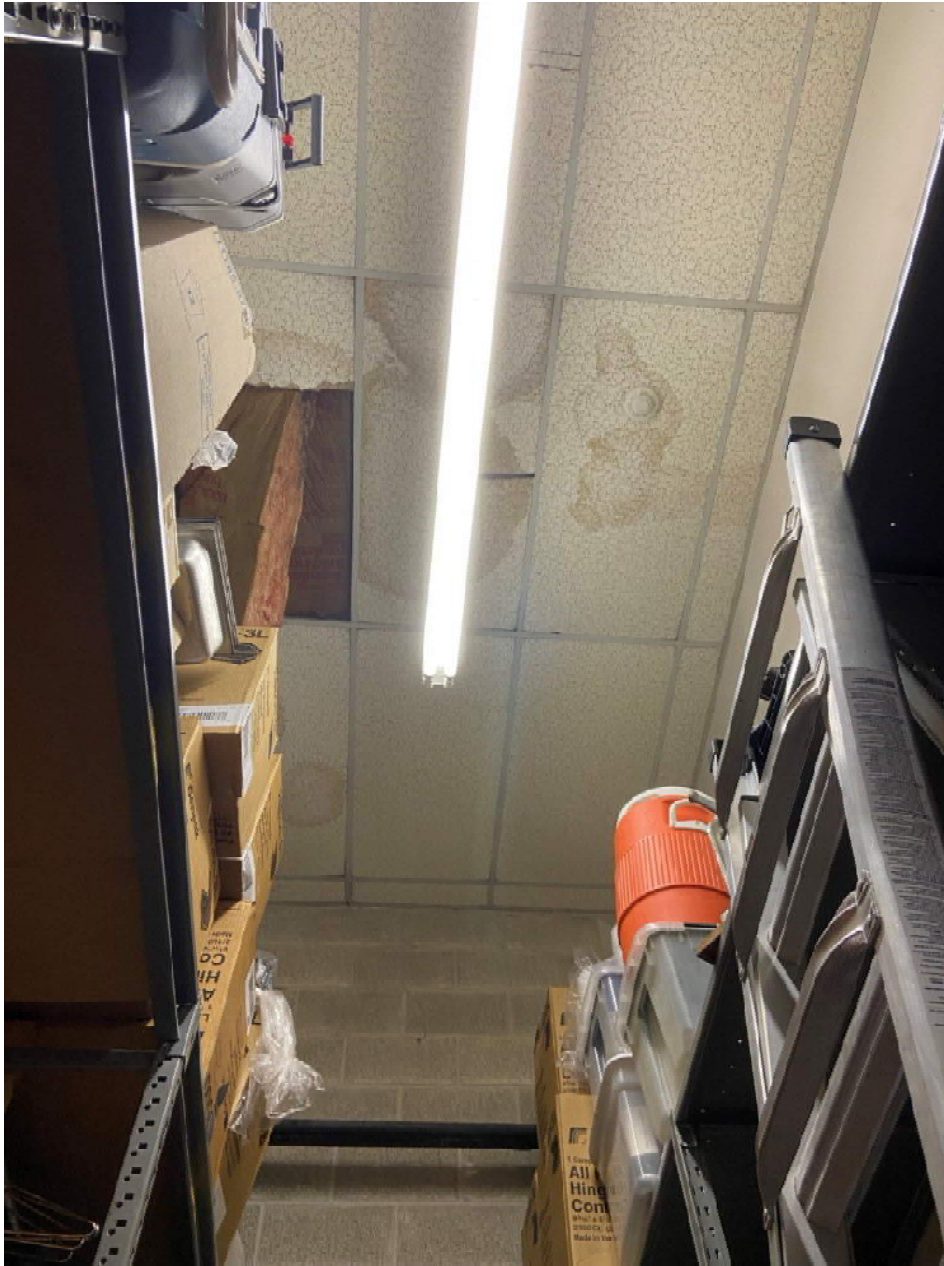
Gear and turnout storage rooms do not have dedicated exhaust. To meet current code, these rooms should have dedicated exhaust tied to a fan. Additionally, if the gear storage is moved out of the apparatus bay into a separate room, new exhaust will need to be provided for that room as well.

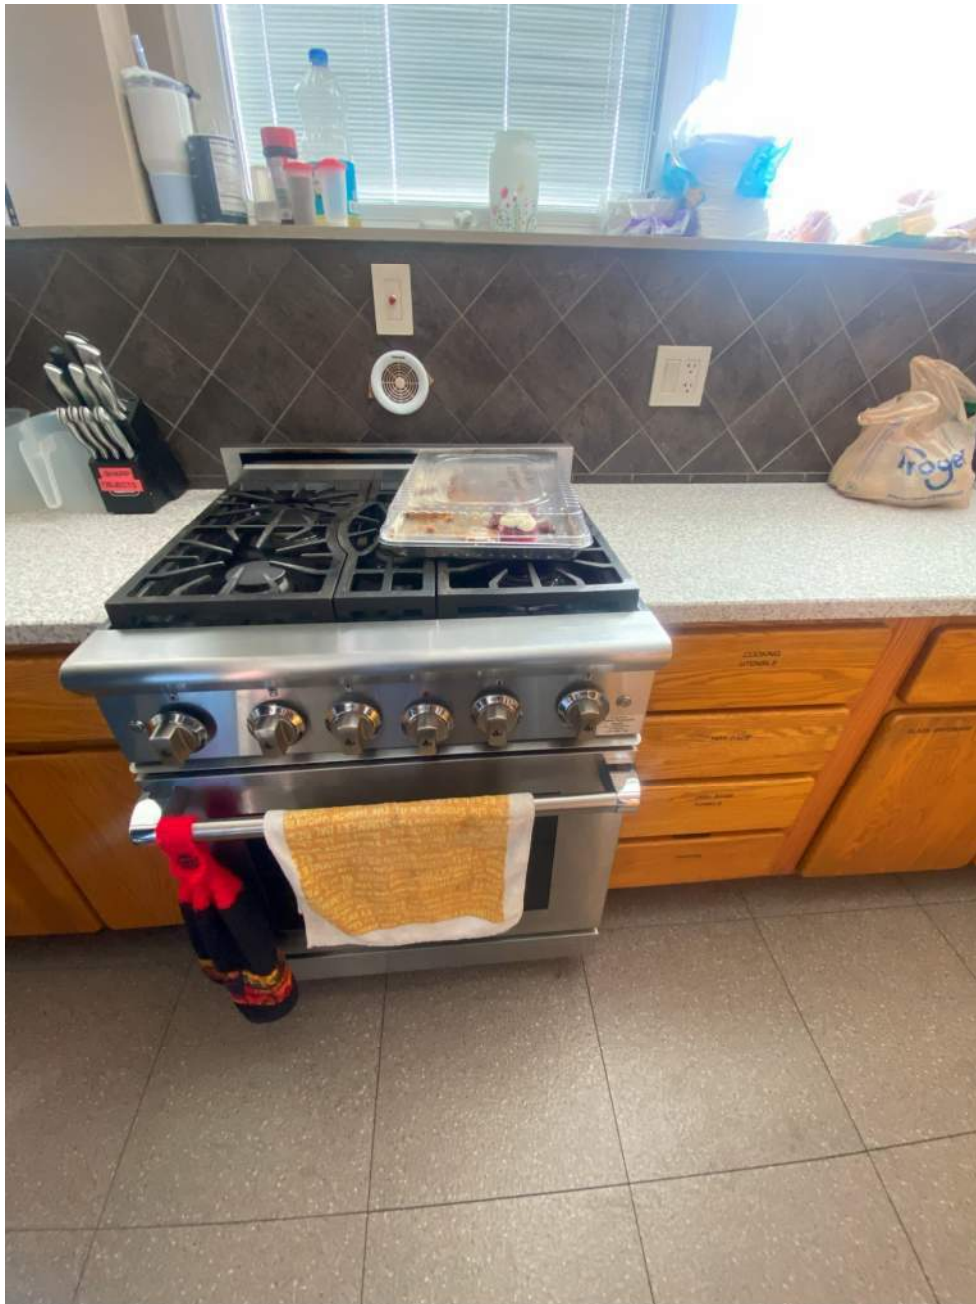
Existing stove does not have a hood installed above it. A new range hood should be installed to meet current codes.

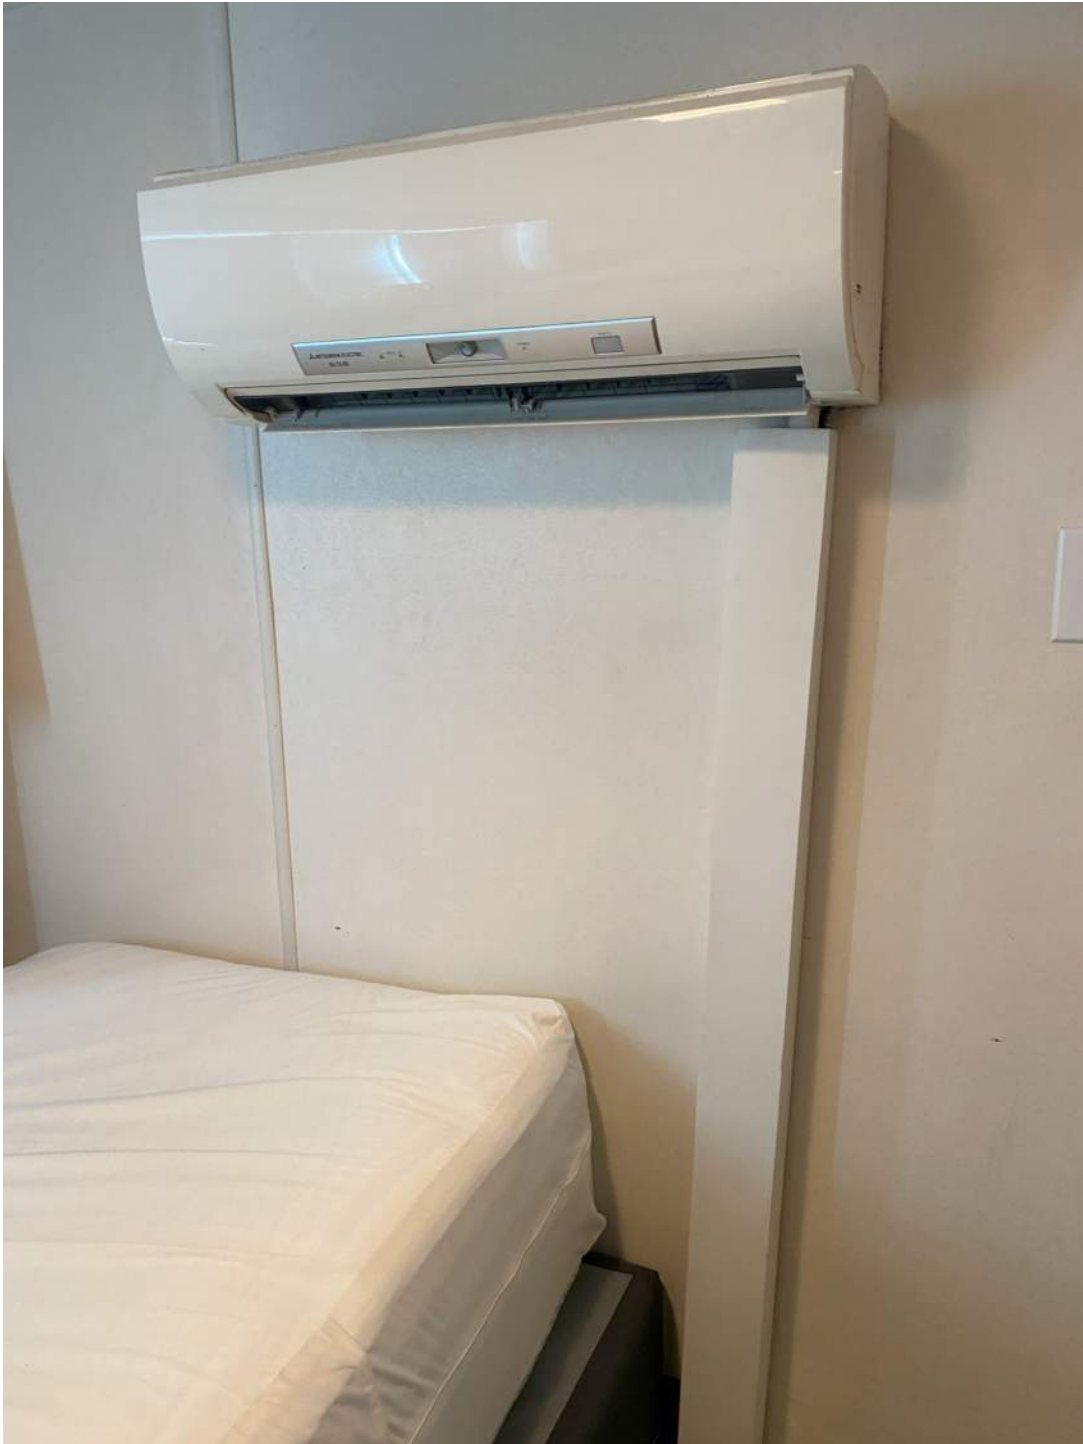
Apparatus bay bunk room is served by a single minisplit system with no ventilation. A new split HVAC system should be provided with outdoor air intake to meet building codes and prevent carcinogenic fumes entering the room from the apparatus bay.

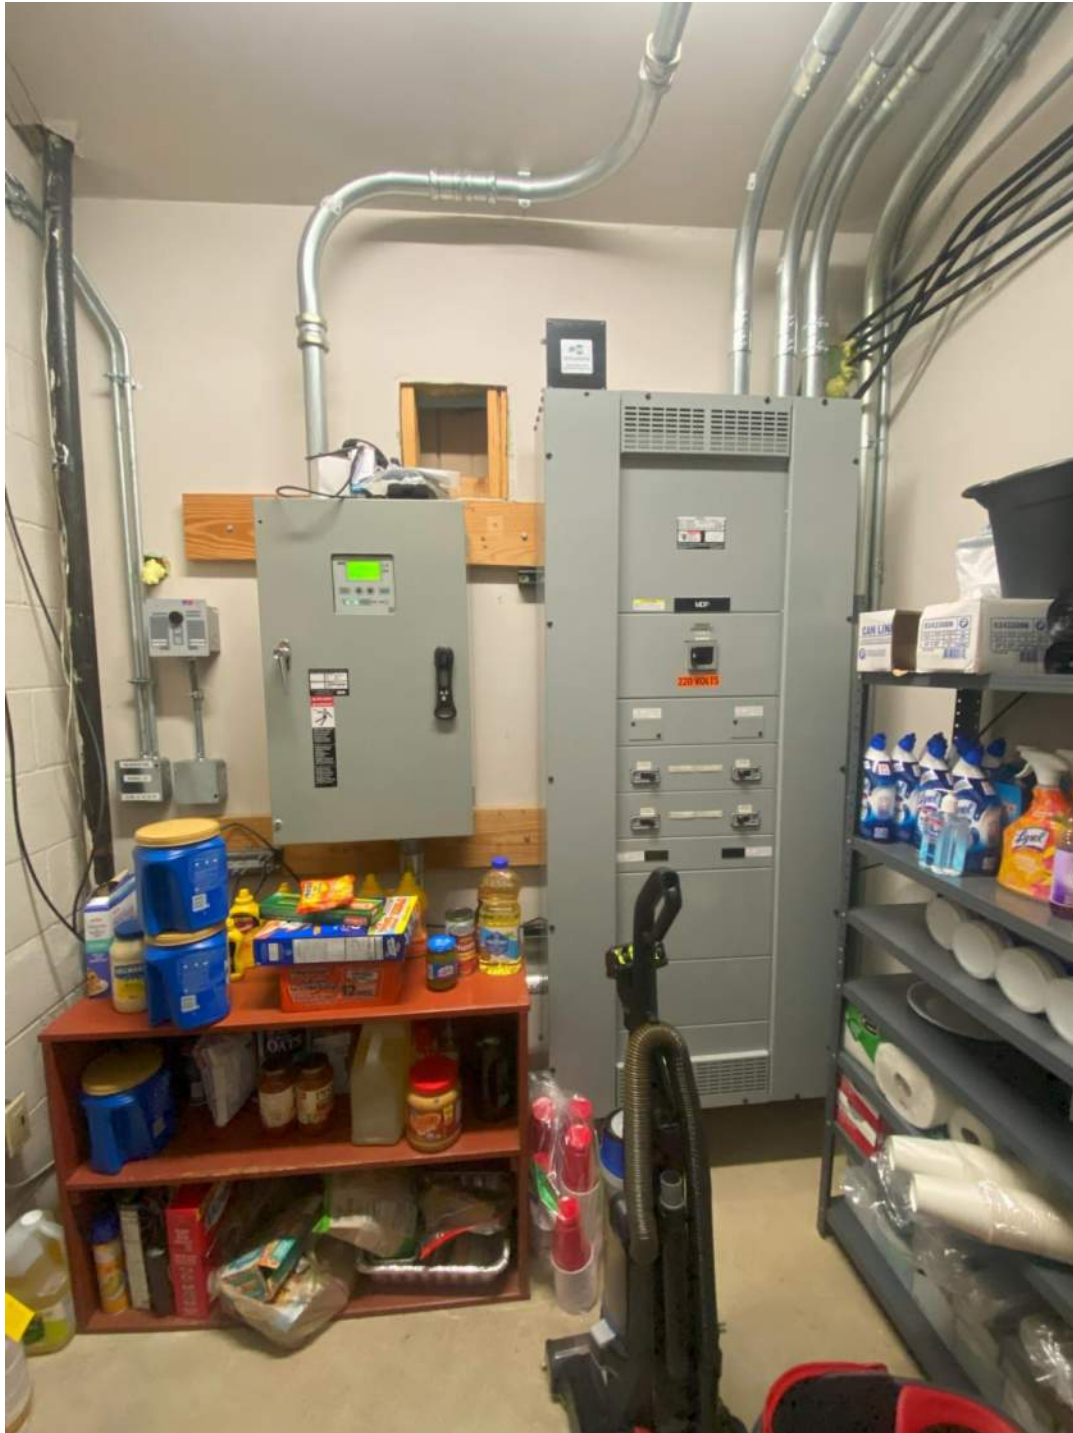
Existing electrical service and transfer switch. NEC working clearance issues can be seen in this photo.

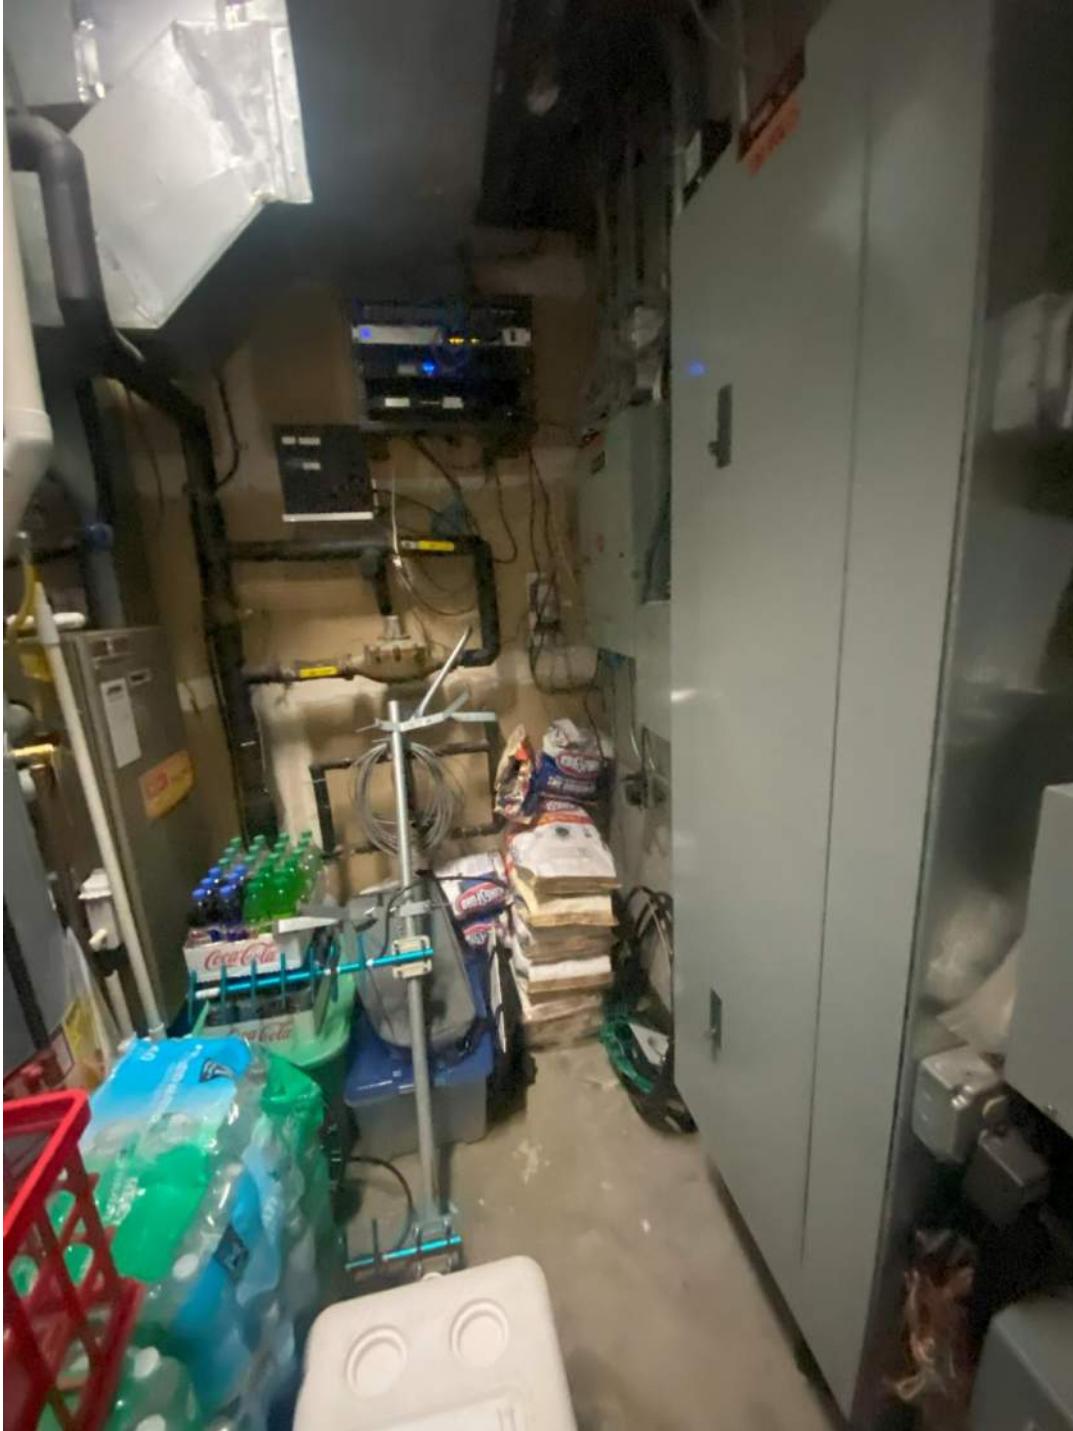
Existing panels "B" and "C" shown near water service. NEC working clearance issues can also be seen in this photo.

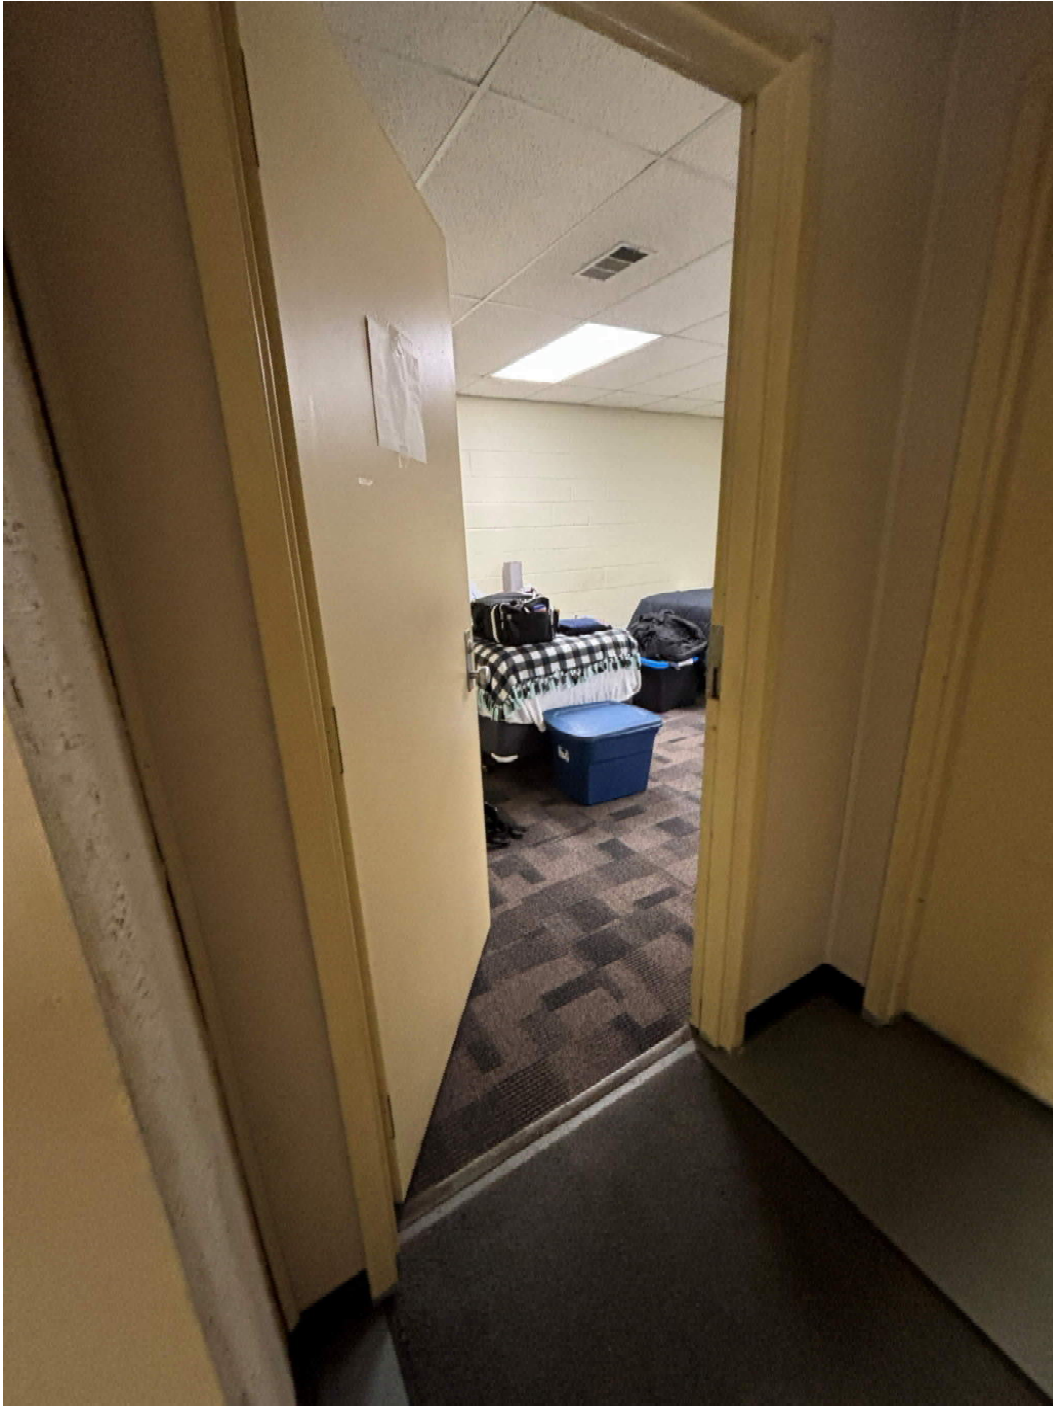
The Sleeping Quarters and other living spaces are directly adjacent to the App Bay and Vehicle Garage. Without an airlock or airtight door seals, carcinogens from vehicle exhaust can easily seep into these rooms. This is a serious health concern for the occupants of the station.

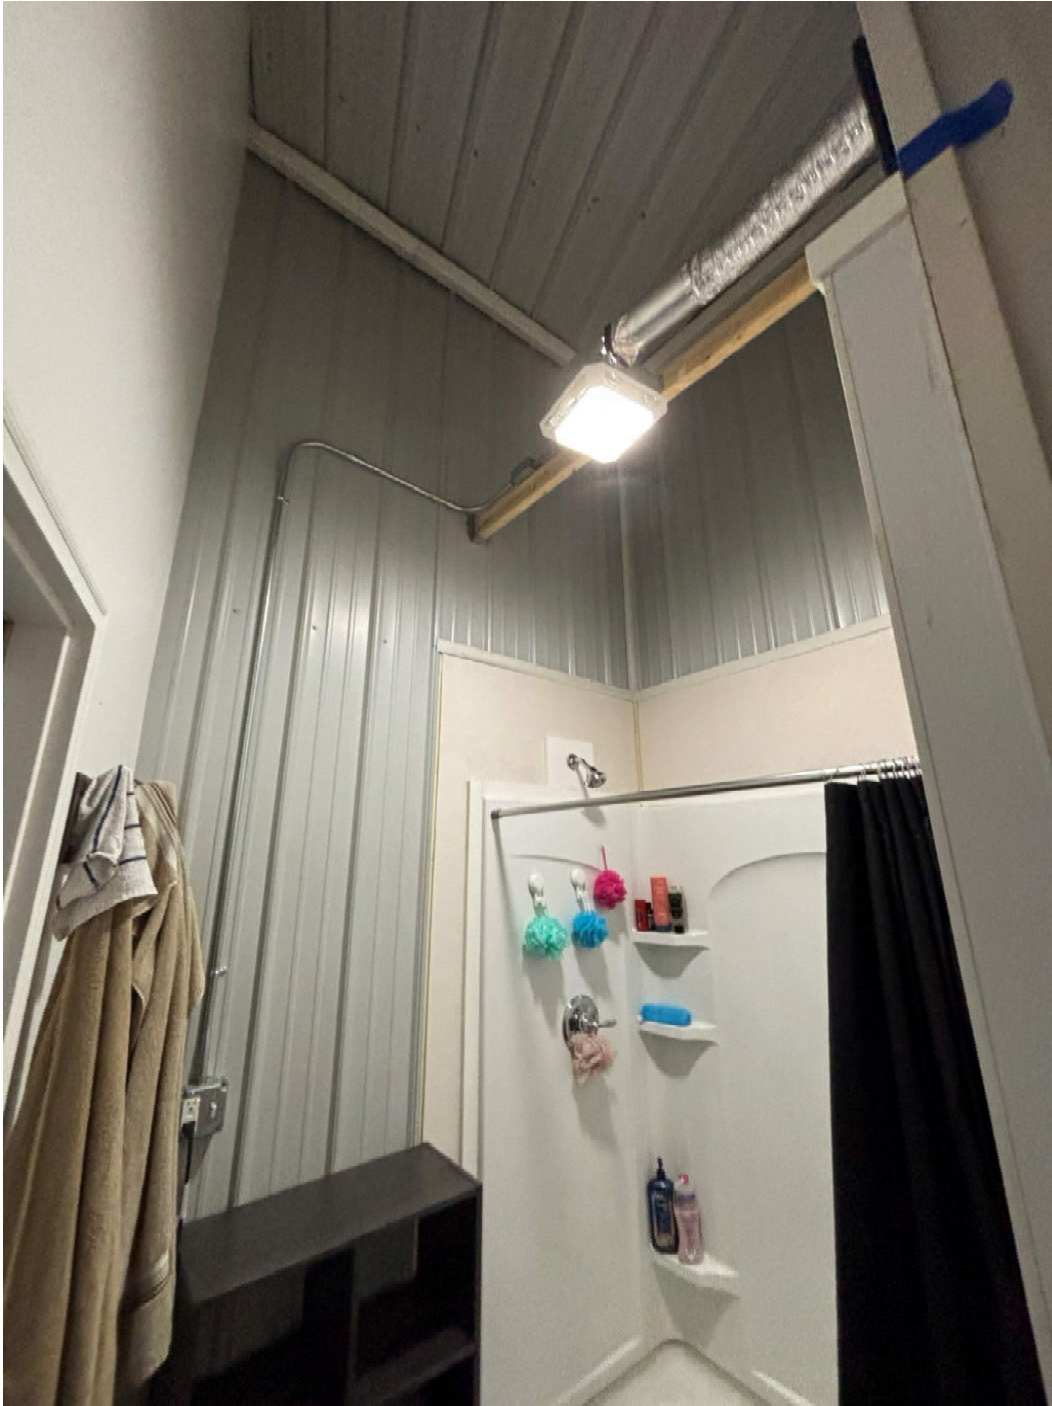
There is only one shower in the station, and it was built in a corner of the App Bay meaning little if any treatment was done to surfaces for humidity. Fixtures and equipment were installed makeshift. A station this size needs more than one shower and the factor of humidity should be addressed.

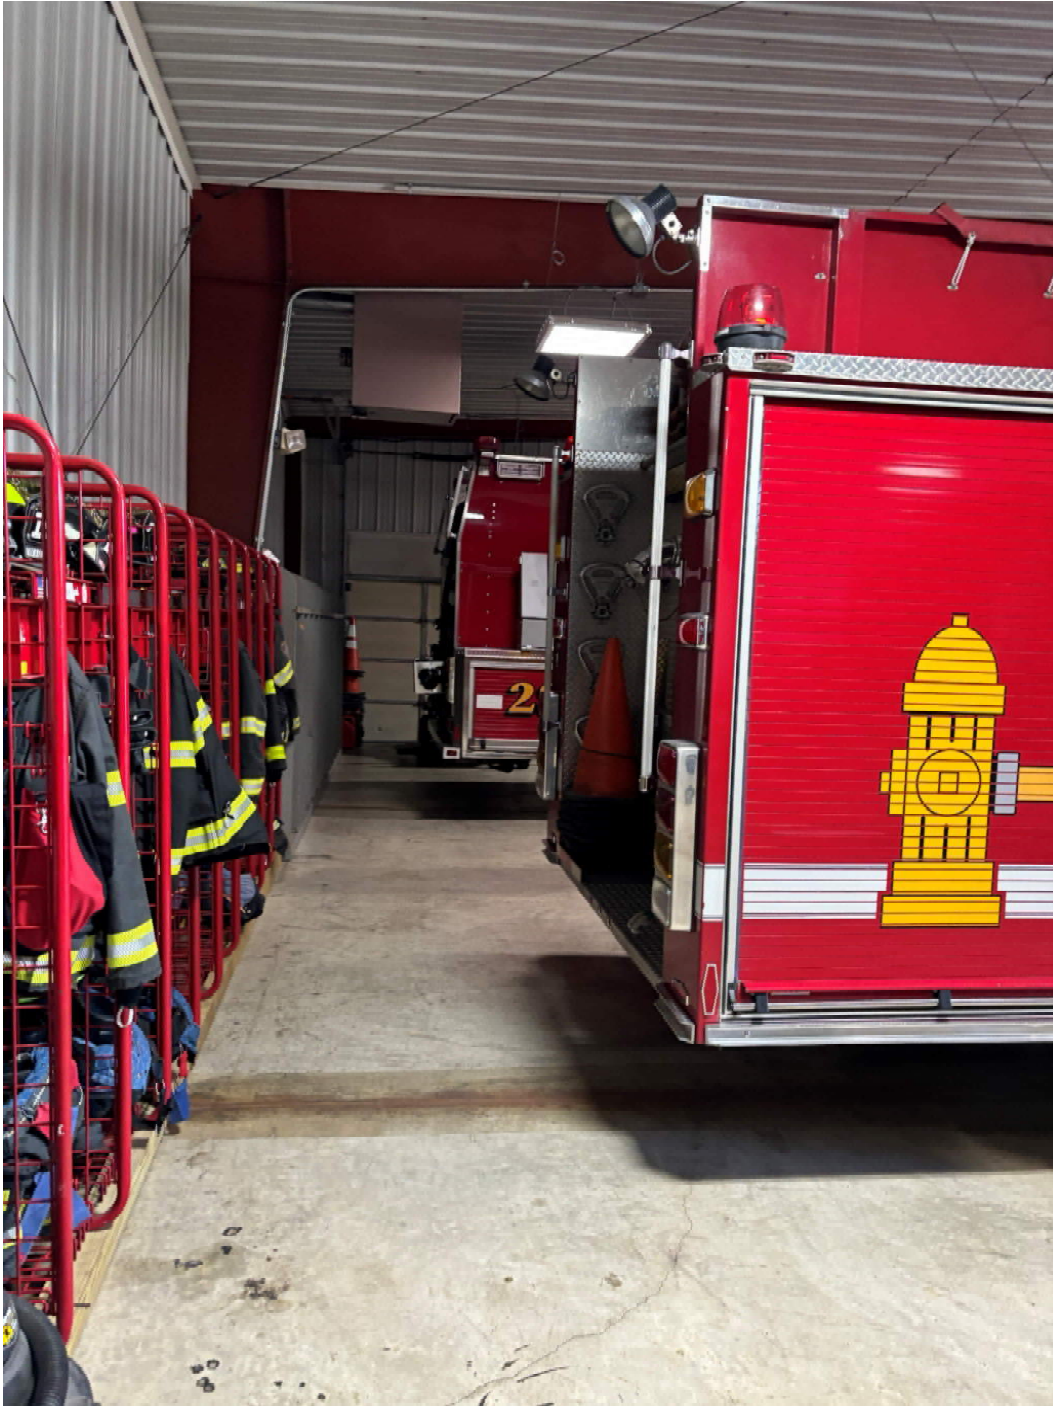
The engines must be backed into the App Bay, and the overlap between the gear prep area and the engines is inefficient and conflicting. Should a driver reverse too far, there's a potential to injure someone or damage equipment. Clear floor markings should also be present.

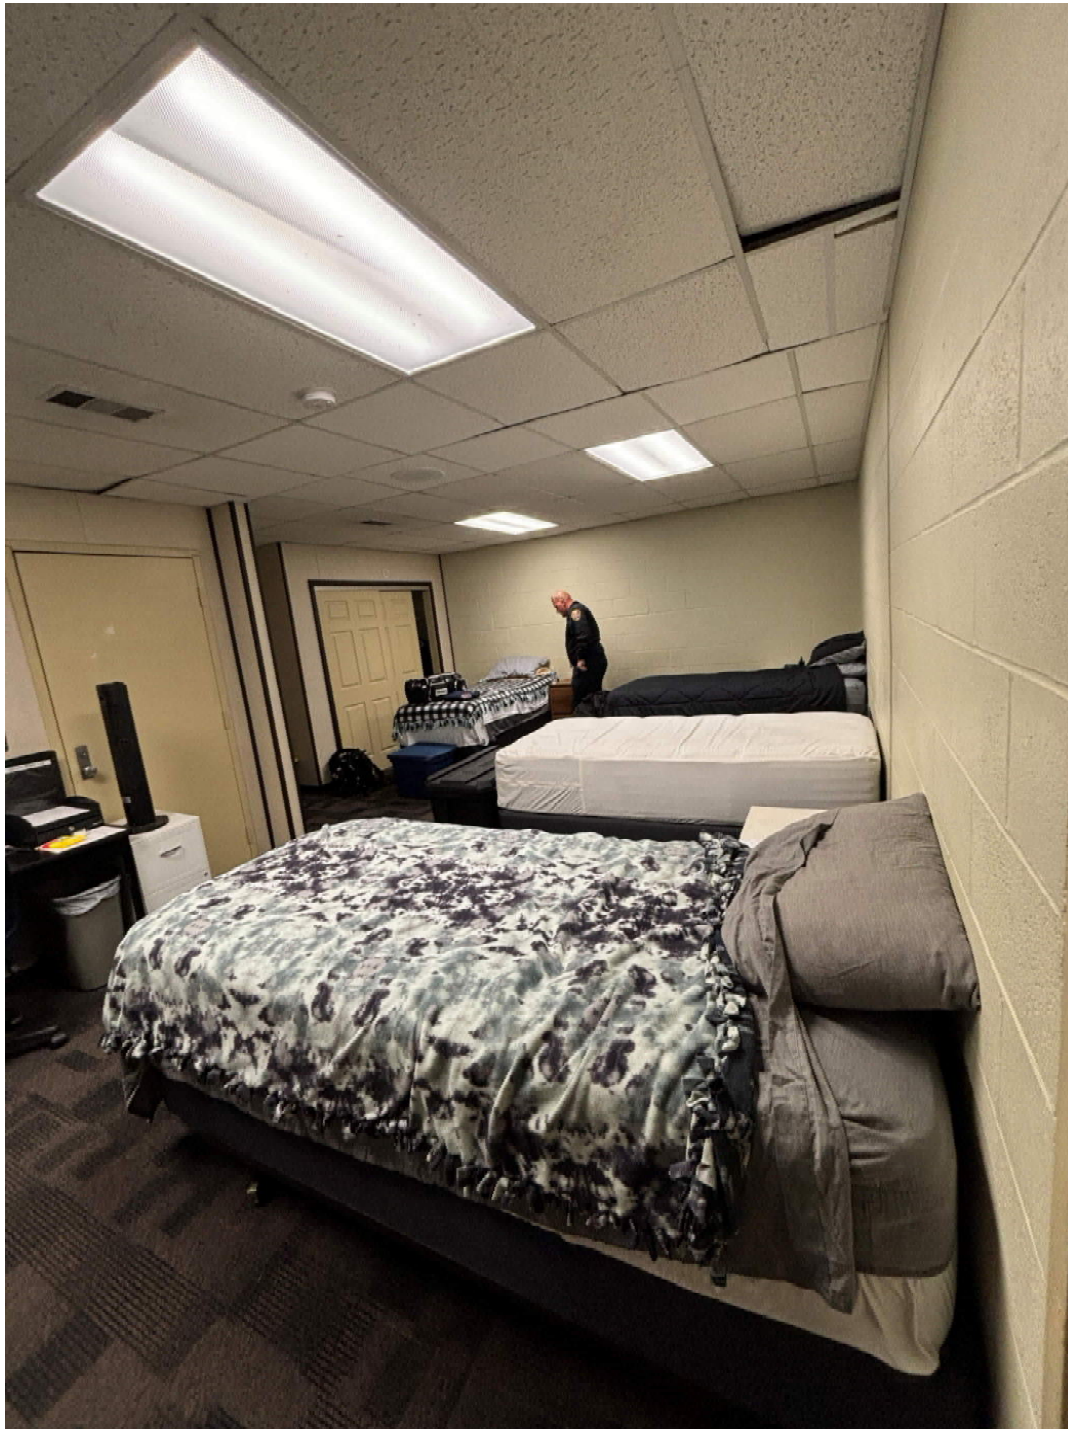
The station only has the capacity for 4 beds despite there being more than 12 staff operating at the facility. This space also does not have lockers for personal items, so rubber tubs are being used which can inhibit egress.

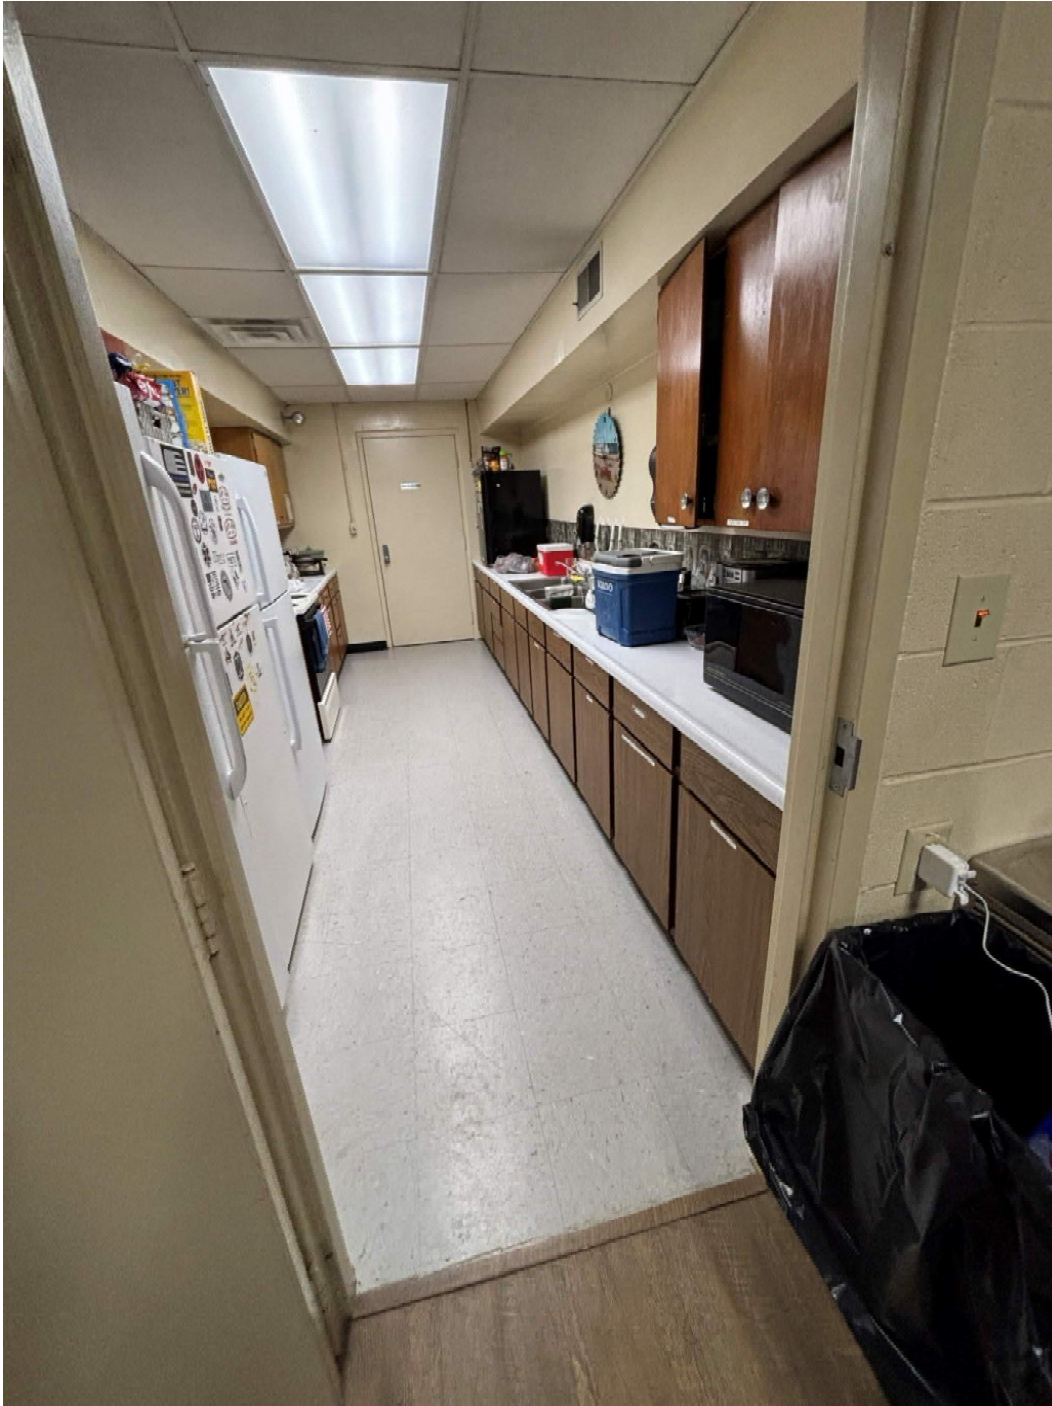
The Kitchen is very narrow, typically only allowing for one person to occupy and cook in the space at a time. Fridge doors swing into the path of travel interrupting this flow even more. There is also a concern for carcinogens from the garage entering the Kitchen and other nearby spaces.

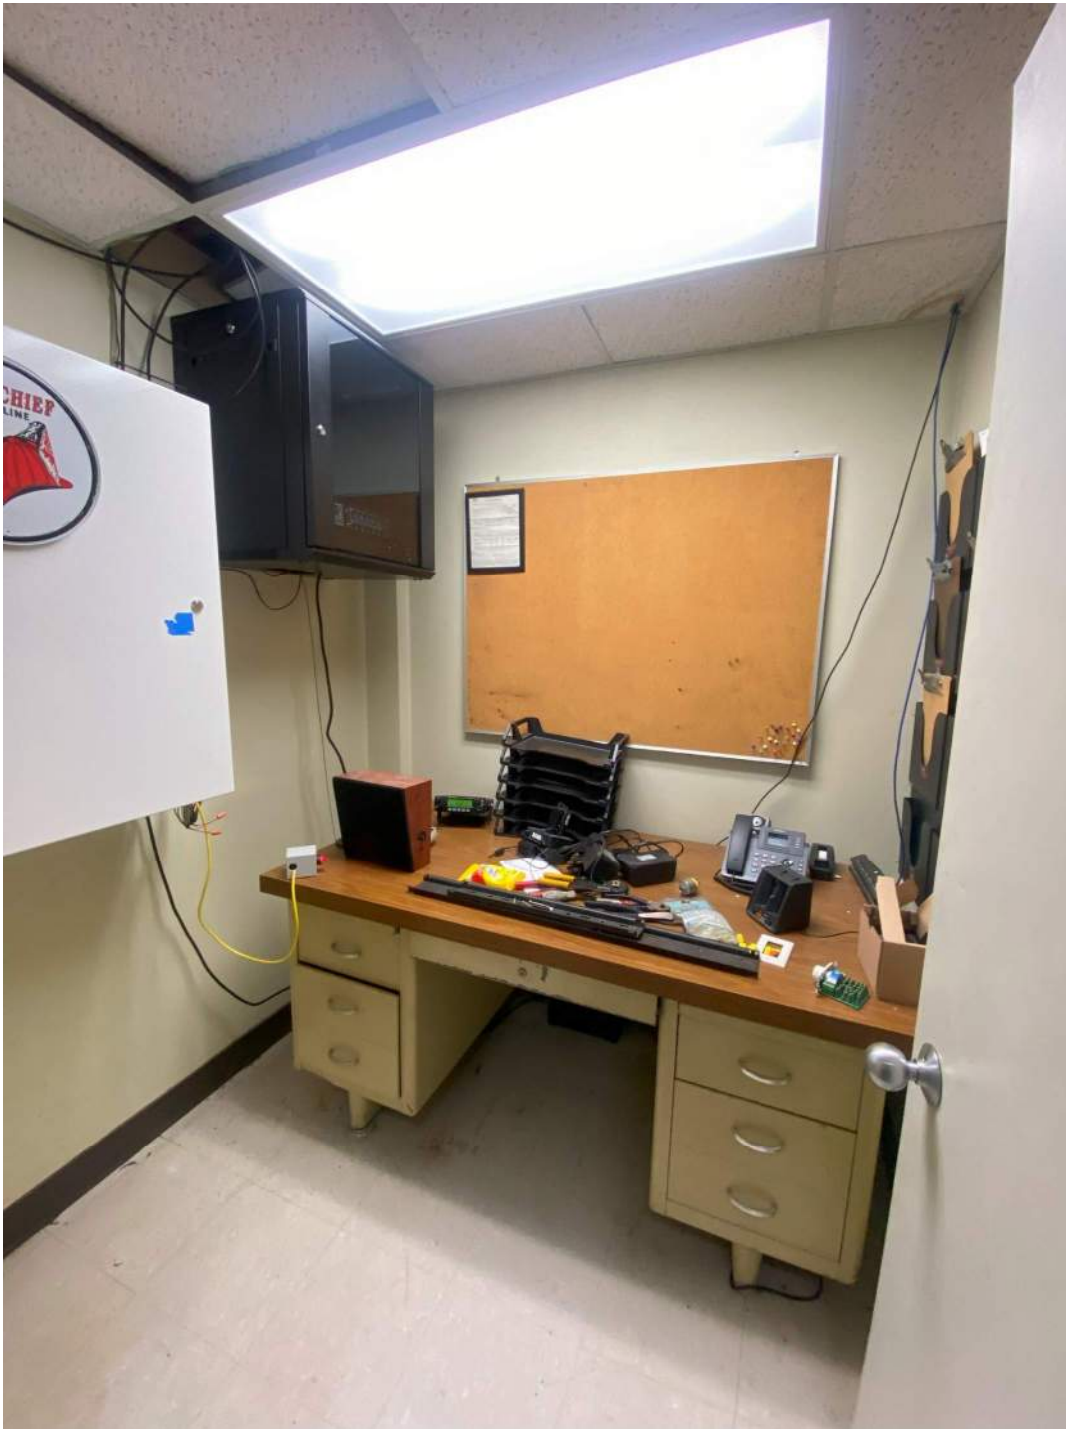
The Dispatch Room is undersized and in the corner of the App Bay detached from the rest of the facility. It is not very efficient in size or layout, and it lacks a window to the outside or into the App Bay.

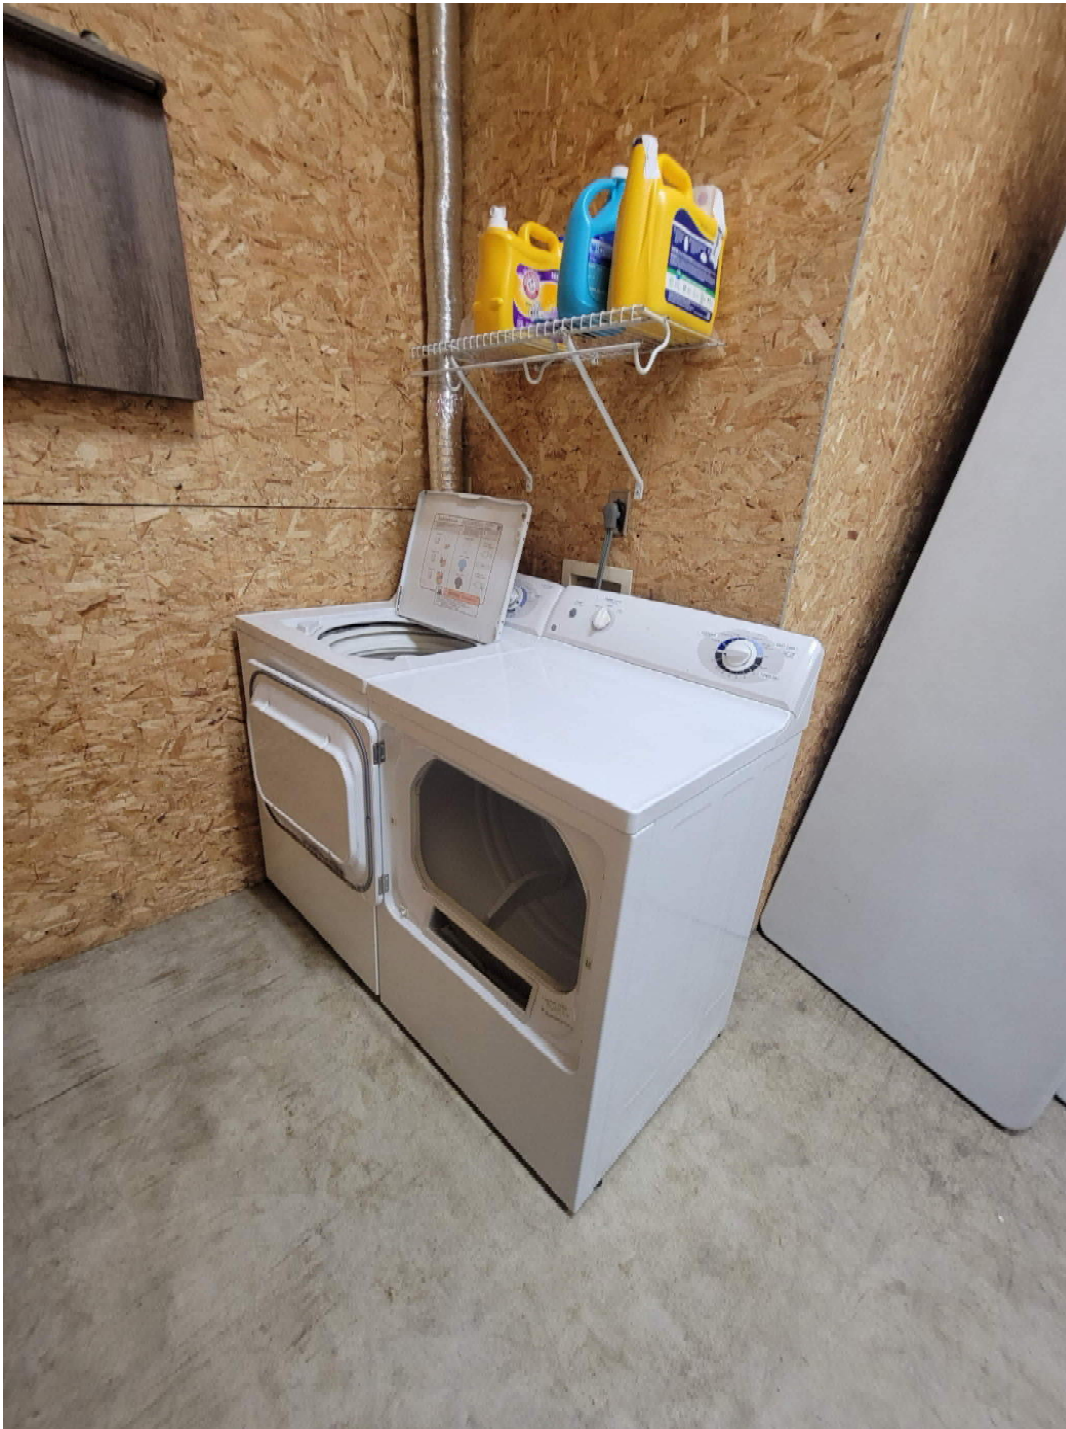
There is only one washer and dryer in the station. Gear should be cleaned in a separate gear washer and extractor so there isn't contamination with normal laundry. Residential units are not technically capable of properly cleaning firefighter's gear.

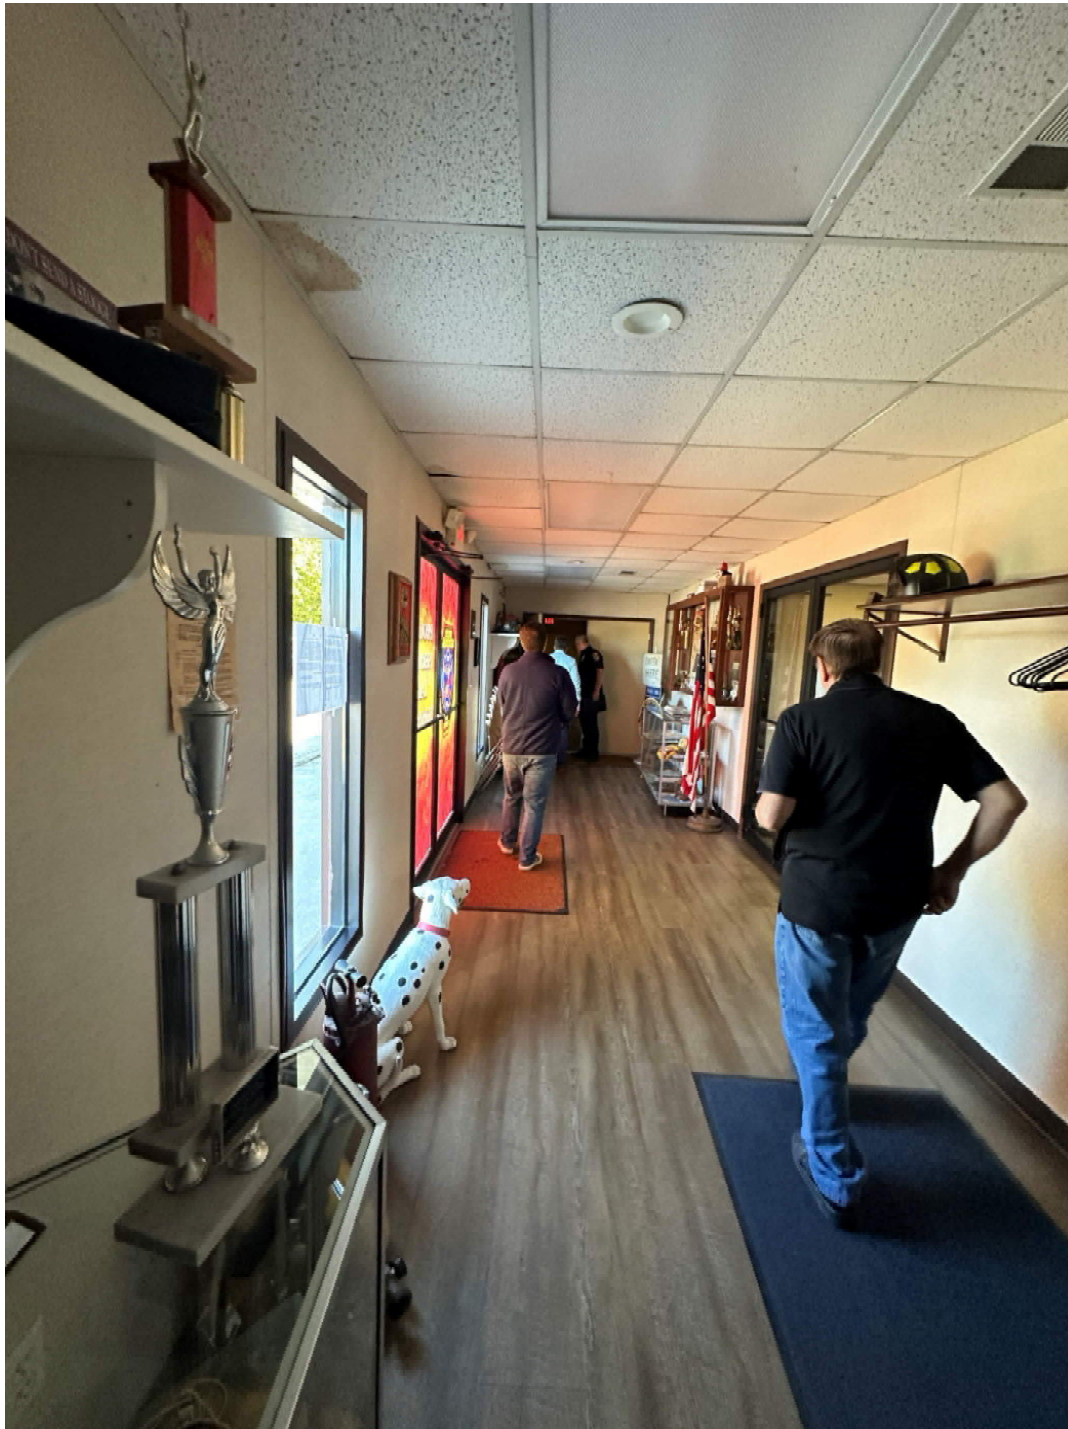
The Lobby Vestibule is not well lit and has experienced several roof leaks. The other doors in this space access other parts of the station but are not lockable currently.
