**RE: West Central Fire District Station Scoping Services  
Phase 1 Report**

# ***WEST CENTRAL FIRE DEPARTMENT***

## **FACILITY ASSESSMENT**

# ABOITE STATION 180

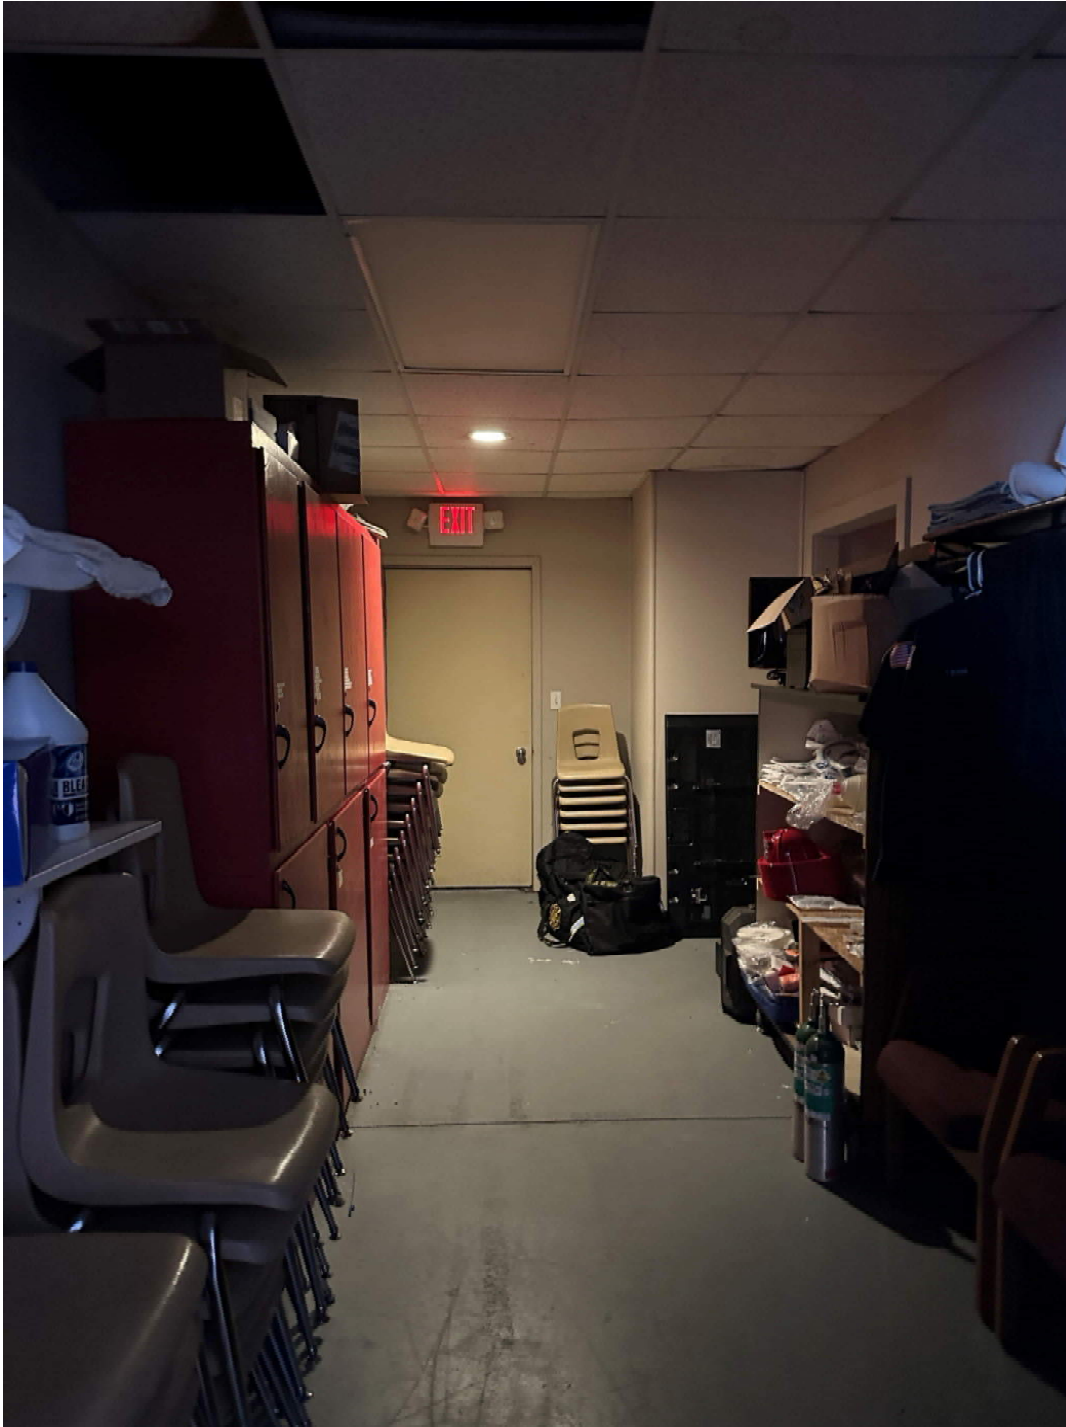
The storage room next to the Lobby Vestibule contains medication and supplies but is not secured in any way, and is very poorly lit. There is no lockable storage solution available for drugs or medications in the station.

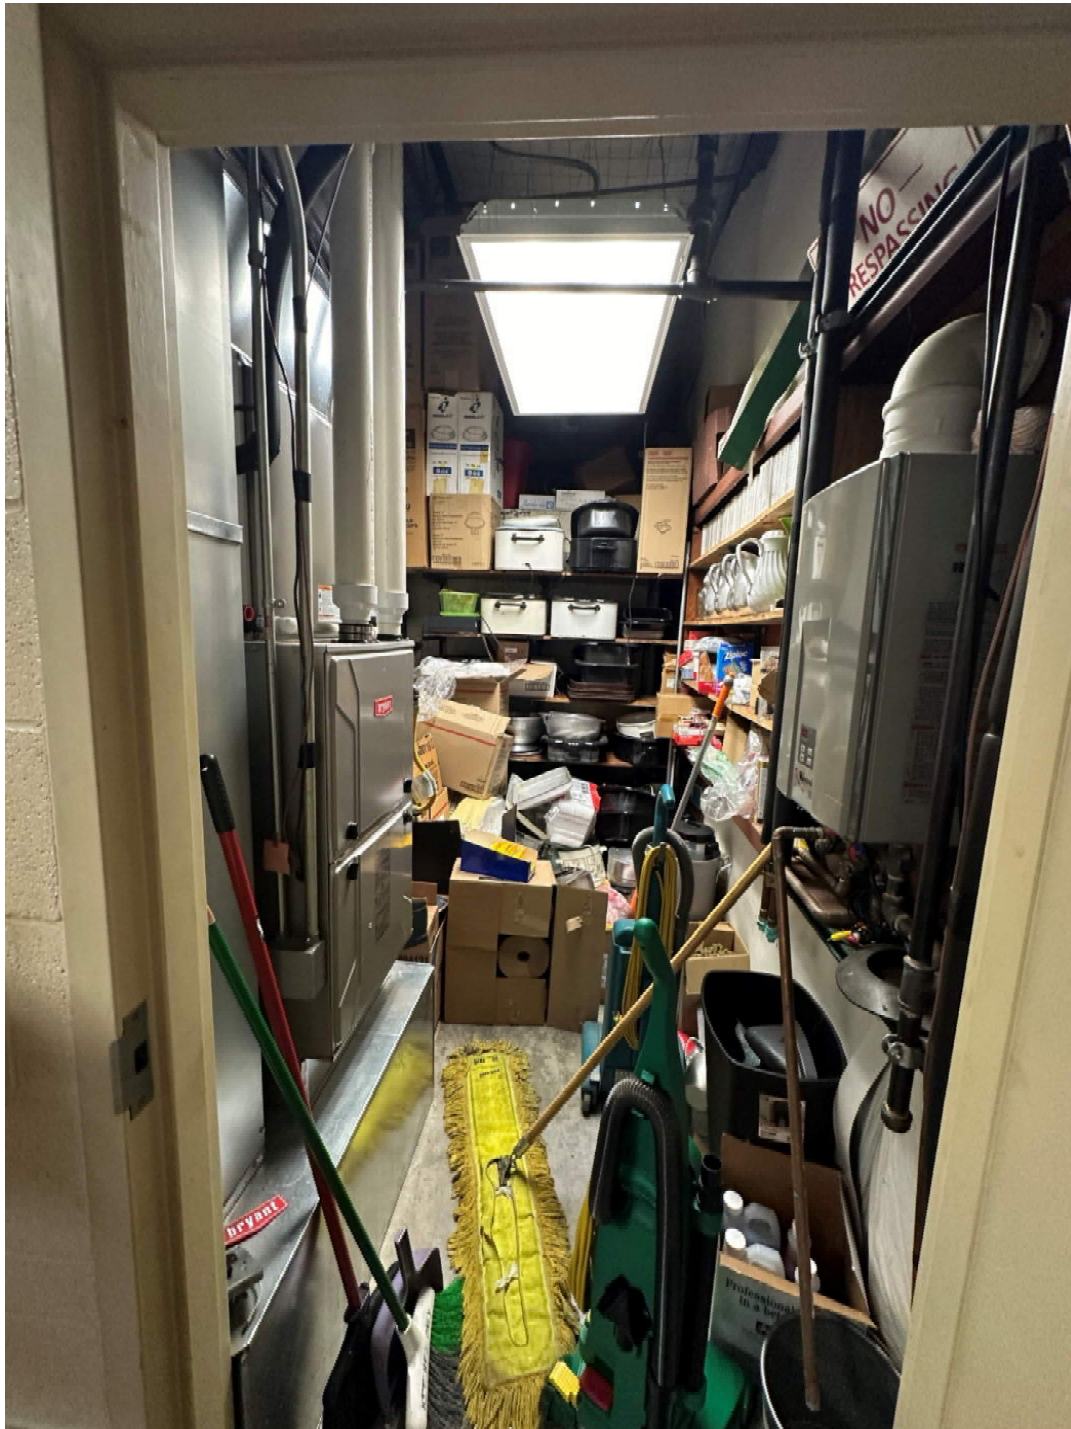
Due to lack of space and storage space, the Mechanical Room has now become a storage room and even includes kitchen supplies which is not ideal. This space has become overcrowded as well.

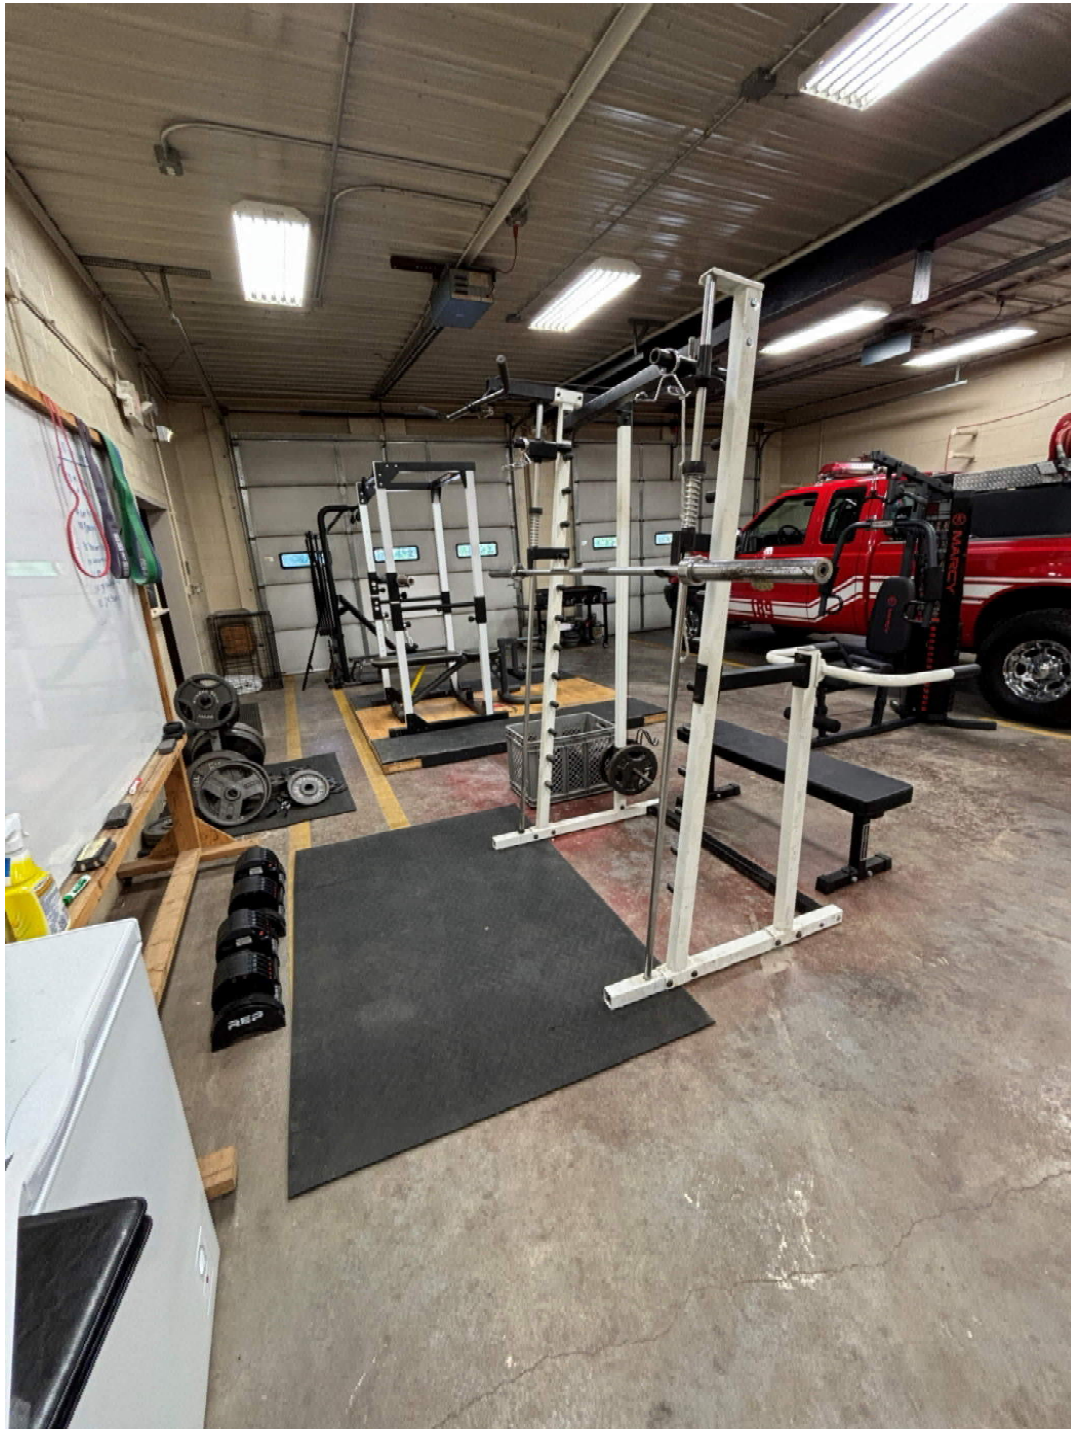
There is no separation or distinction between spaces in the secondary garage. Fitness, storage, electric panels, vehicle storage, and maintenance all overlap in this space which make it quite cluttered and inefficient.

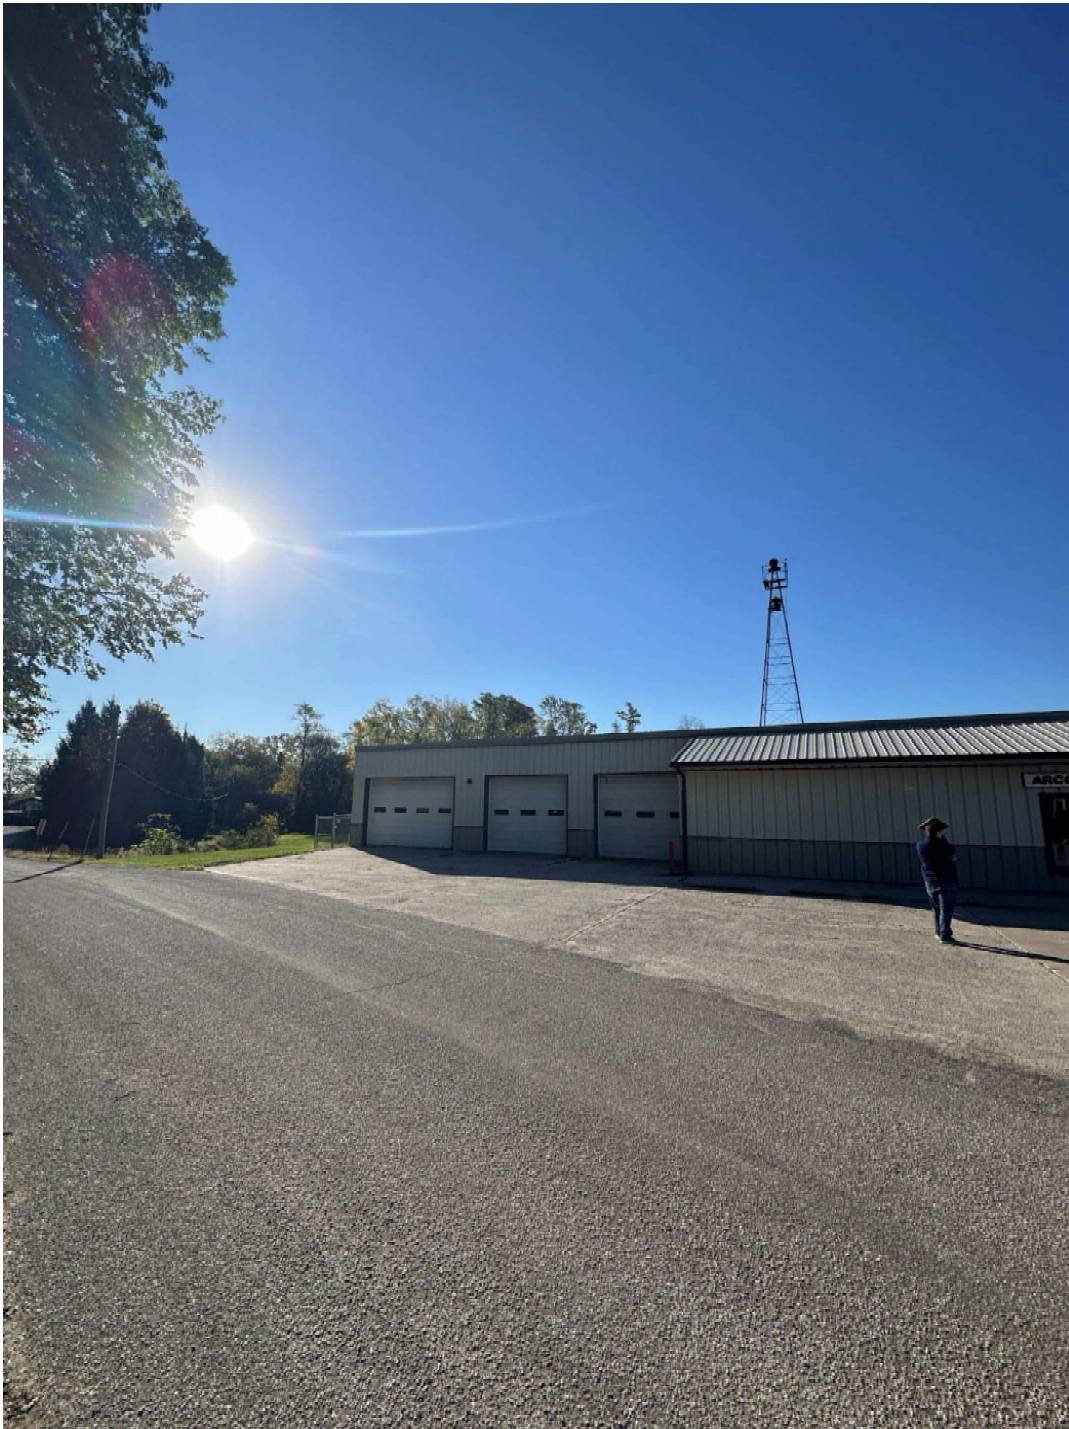
There is no clear delineation between the road and the App Bay apron. The positioning of the station on the site, and near the roads, is also far from ideal for access to main roads for efficient travel and response times.

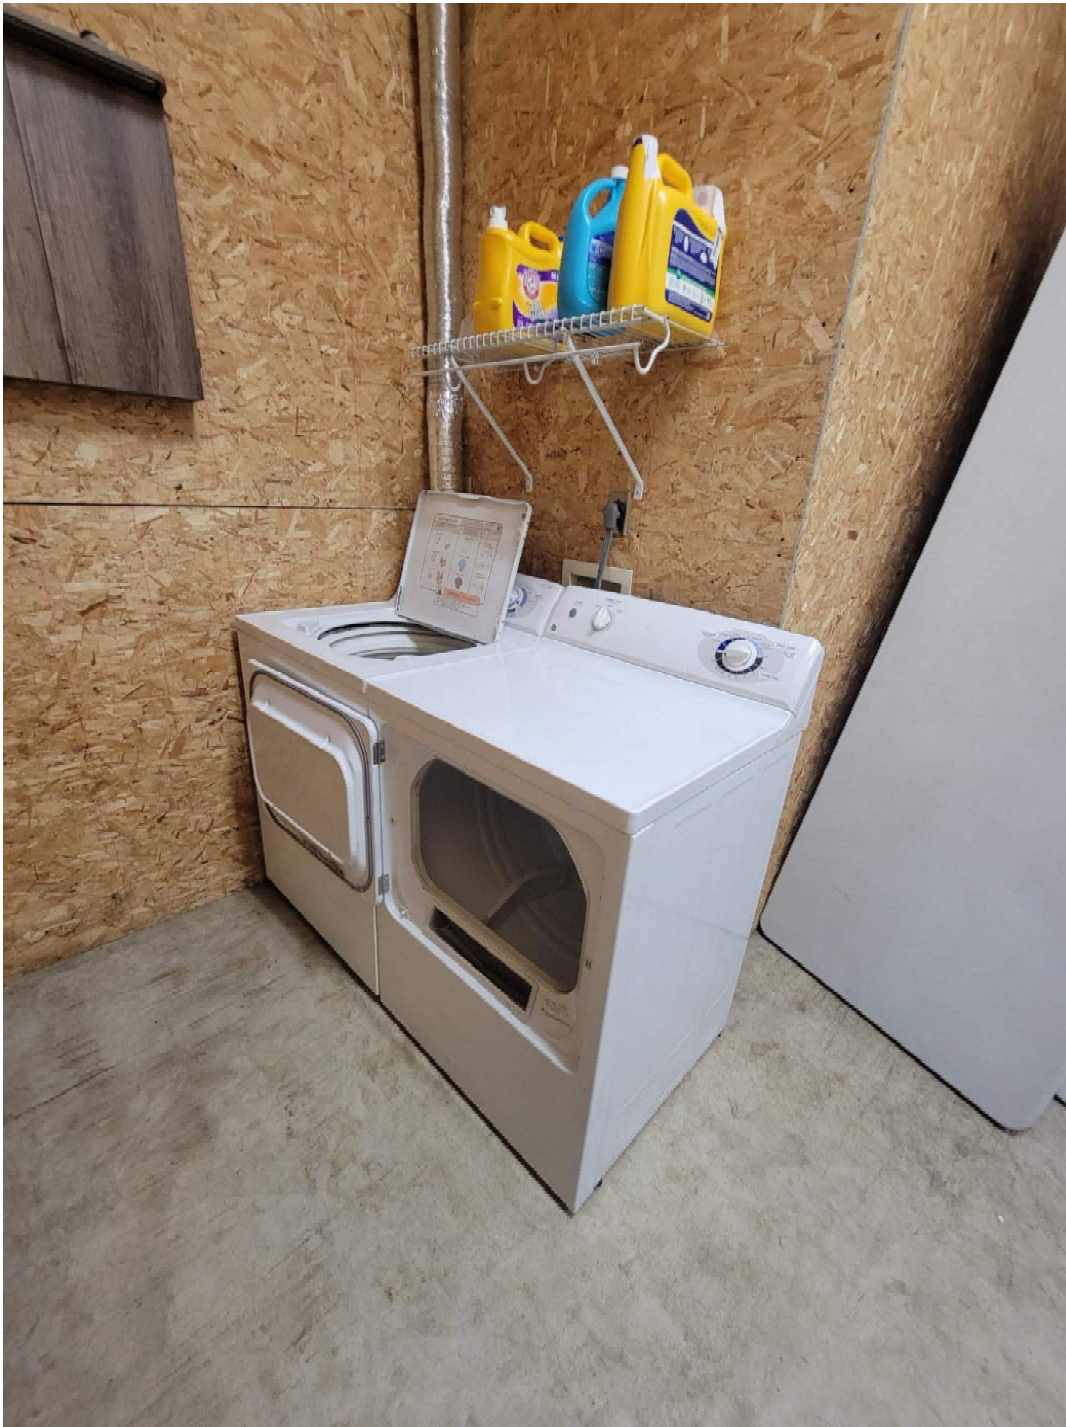
Laundry facilities are inadequate and does not meet the needs of the station. No provision for operation of a Uniform / Gear wash area.

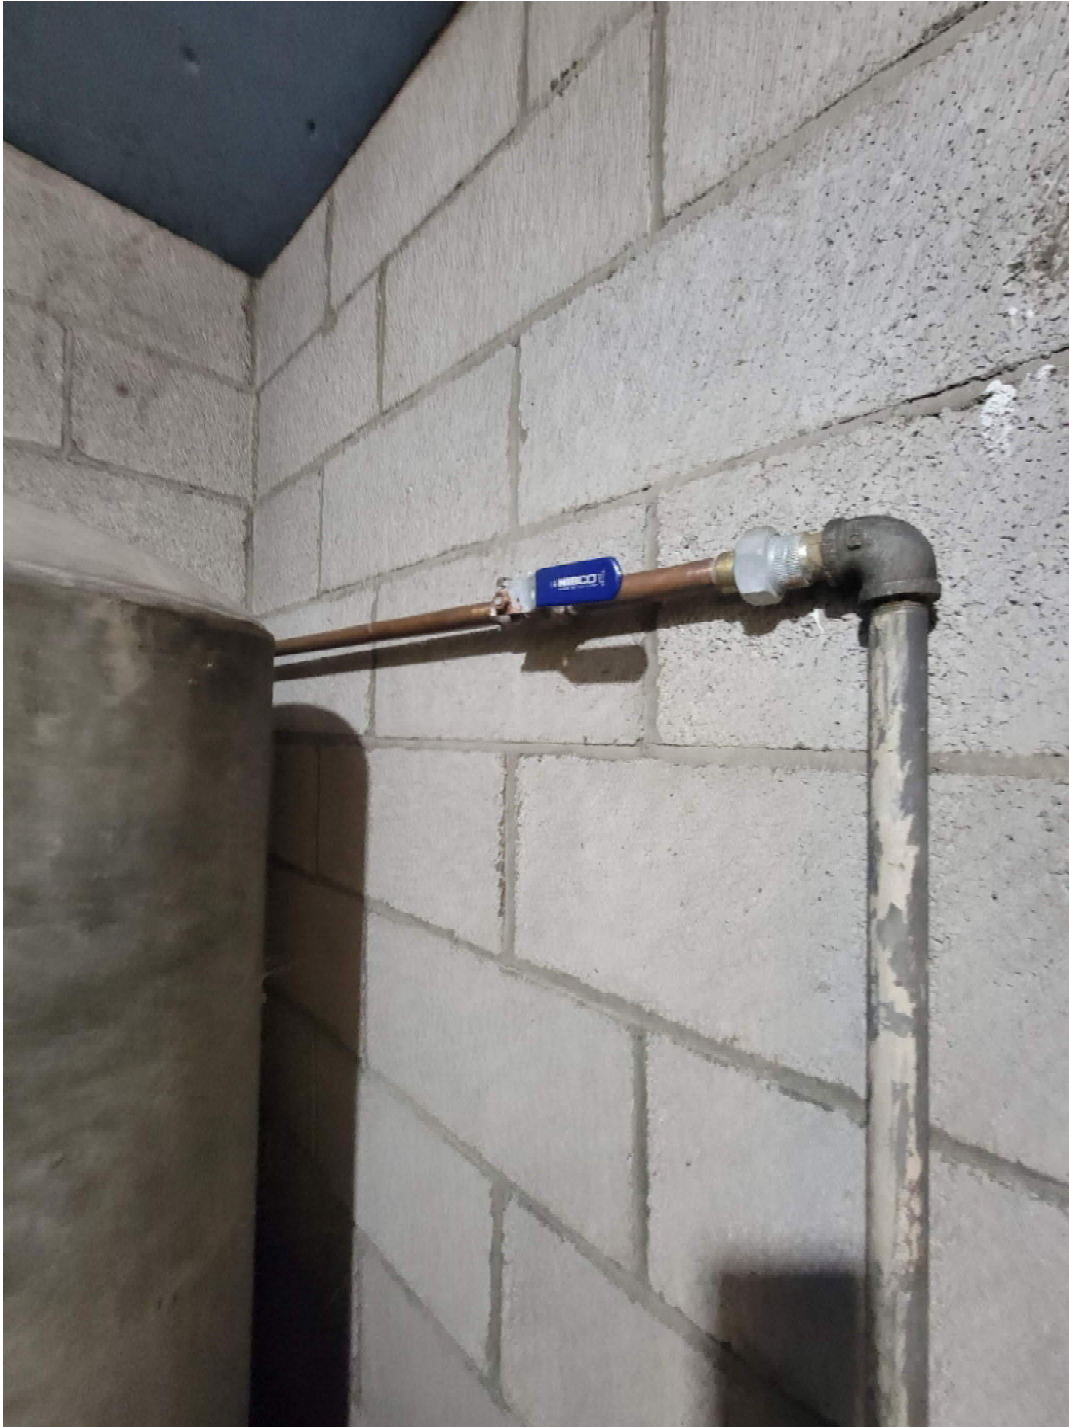
Domestic cold water is supplied by a well system. The well-head is located inside the building. Entire building is served by one three-quarter inch water line, which is severely undersized for proper service. Water pressure is also low and limits water usage.

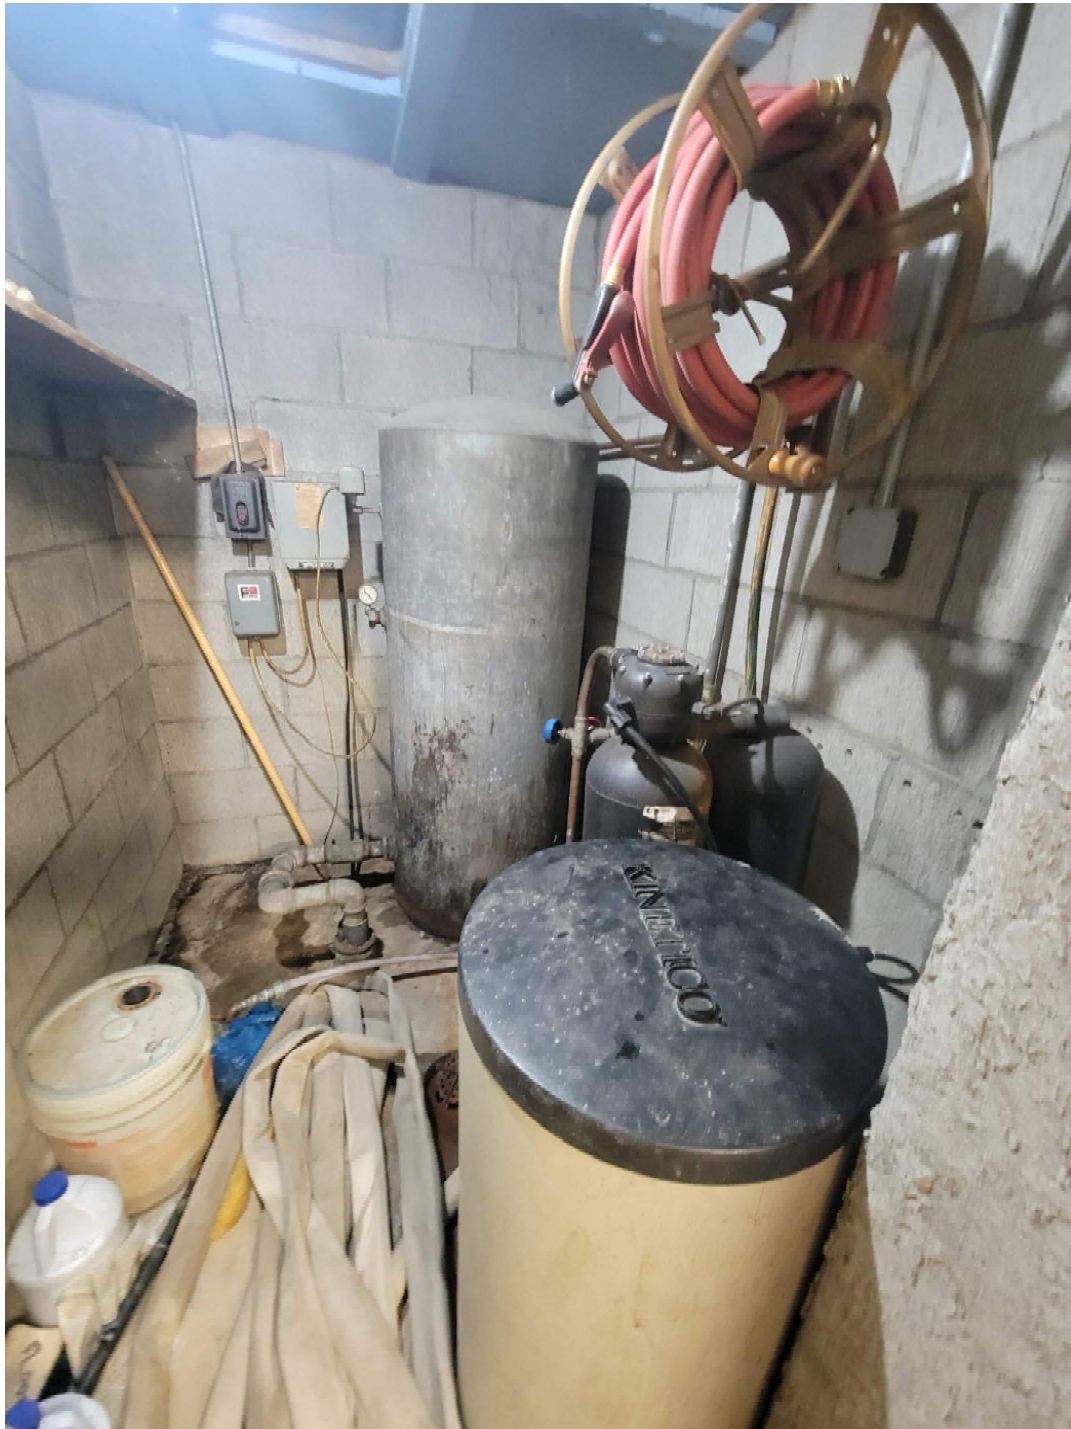
Water service from the well system is in poor condition. A piping water leak was observed. Water equipment (pump and expansion tank) is in poor condition.

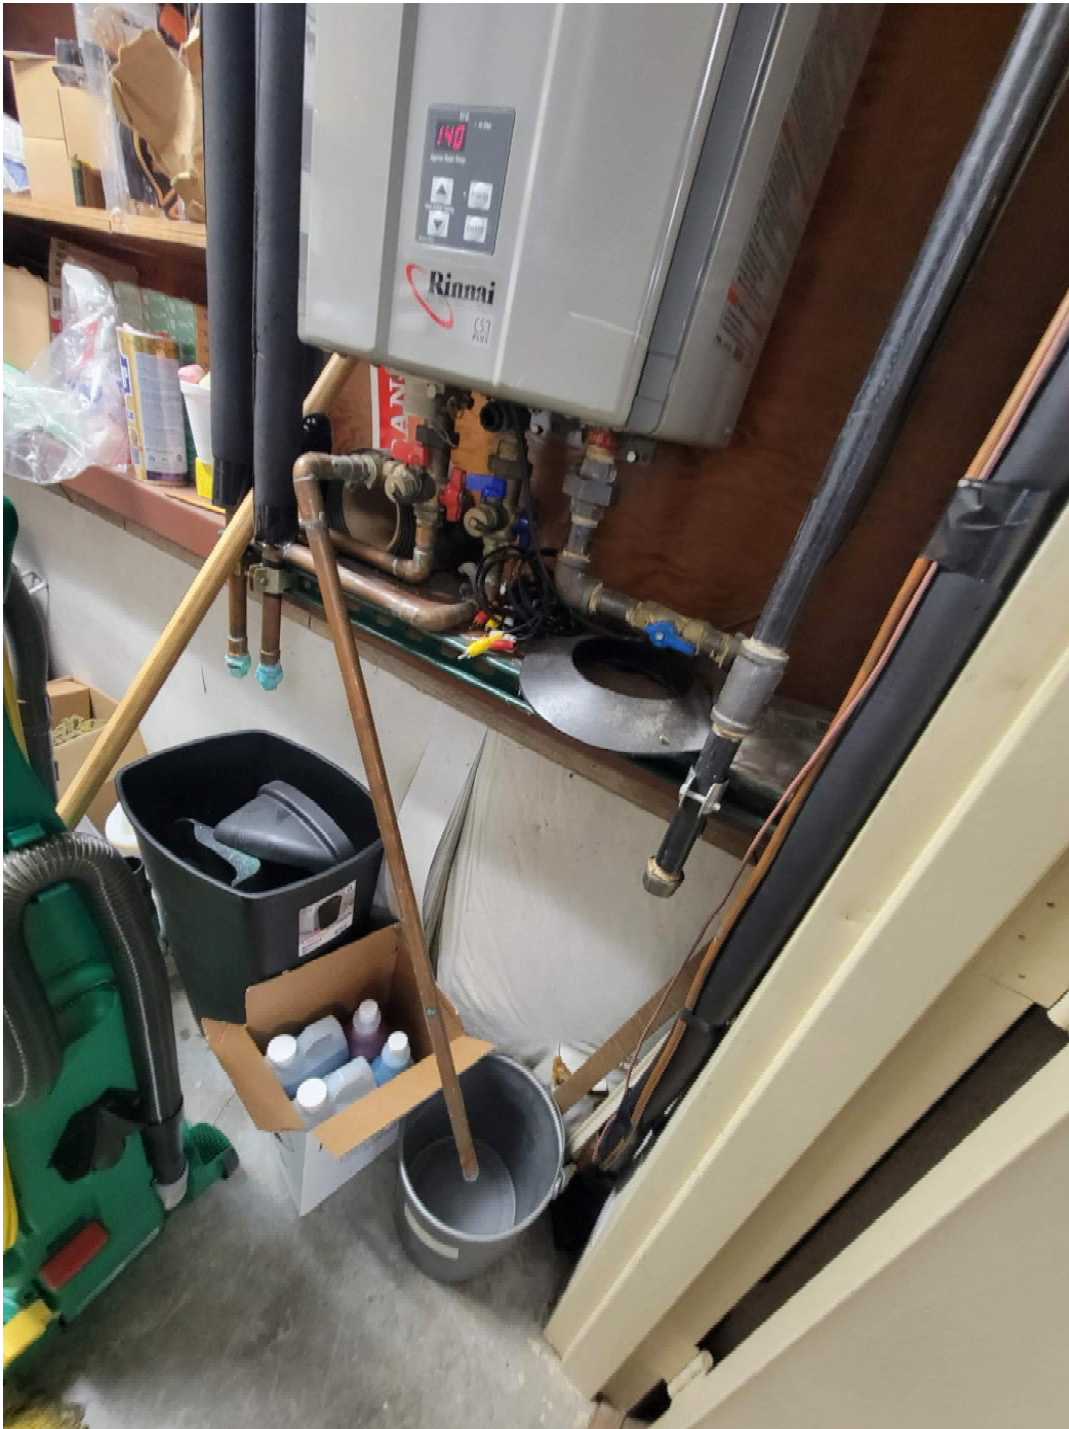
Domestic gas-fired water heater drain , now discharges into a bucket.  
Code requires a floor drain.

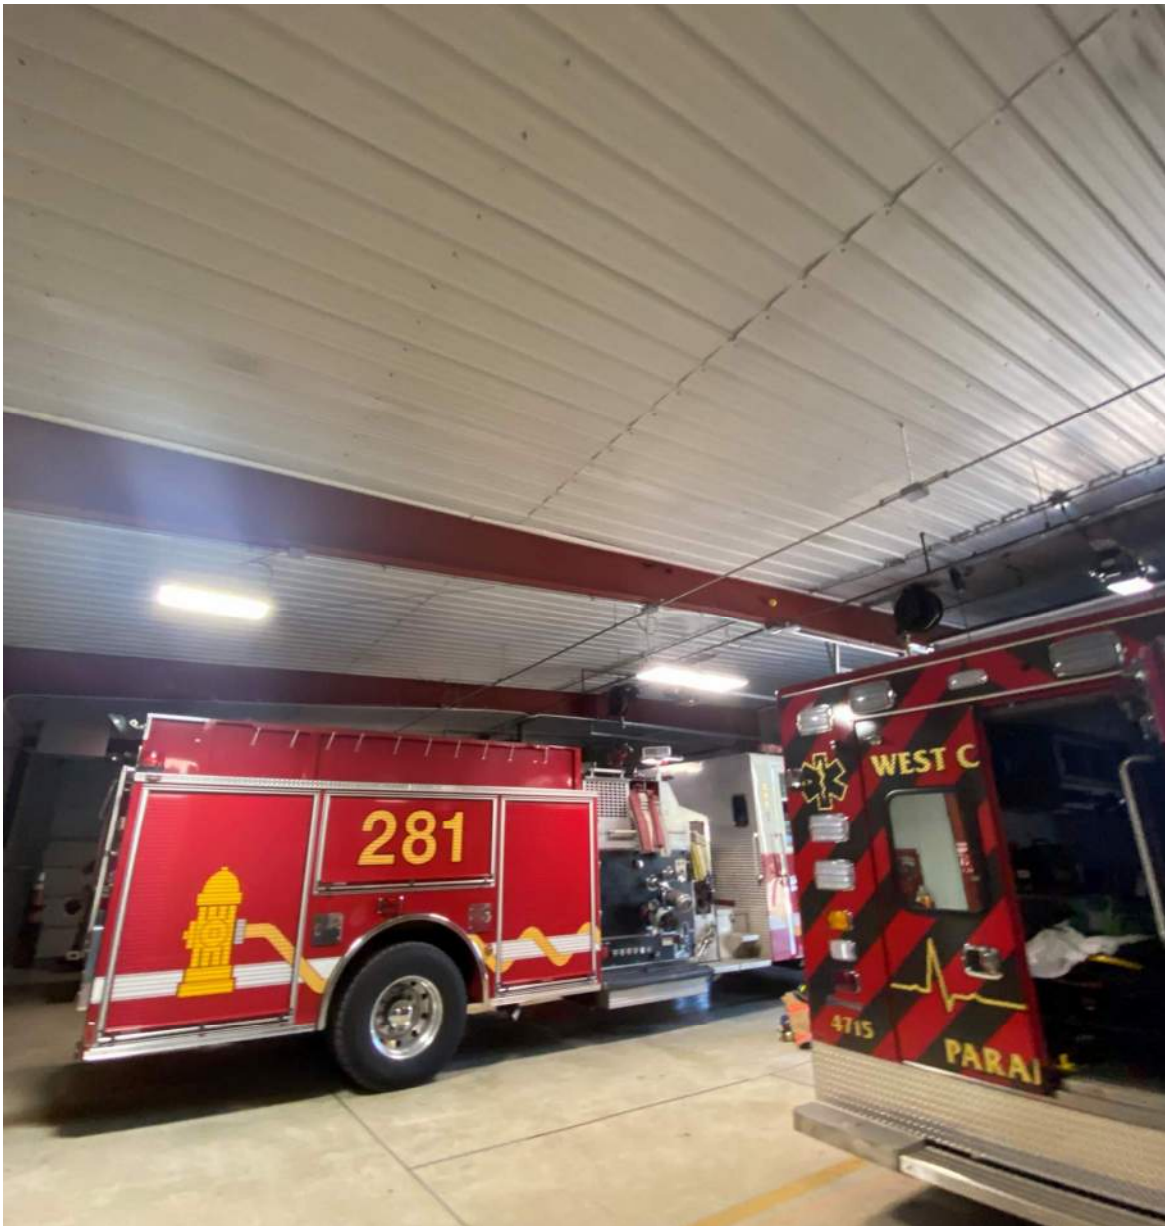
The existing unit heaters do not have sufficient capacity to handle the additional ventilation and will need to be upsized for this load (2 total)

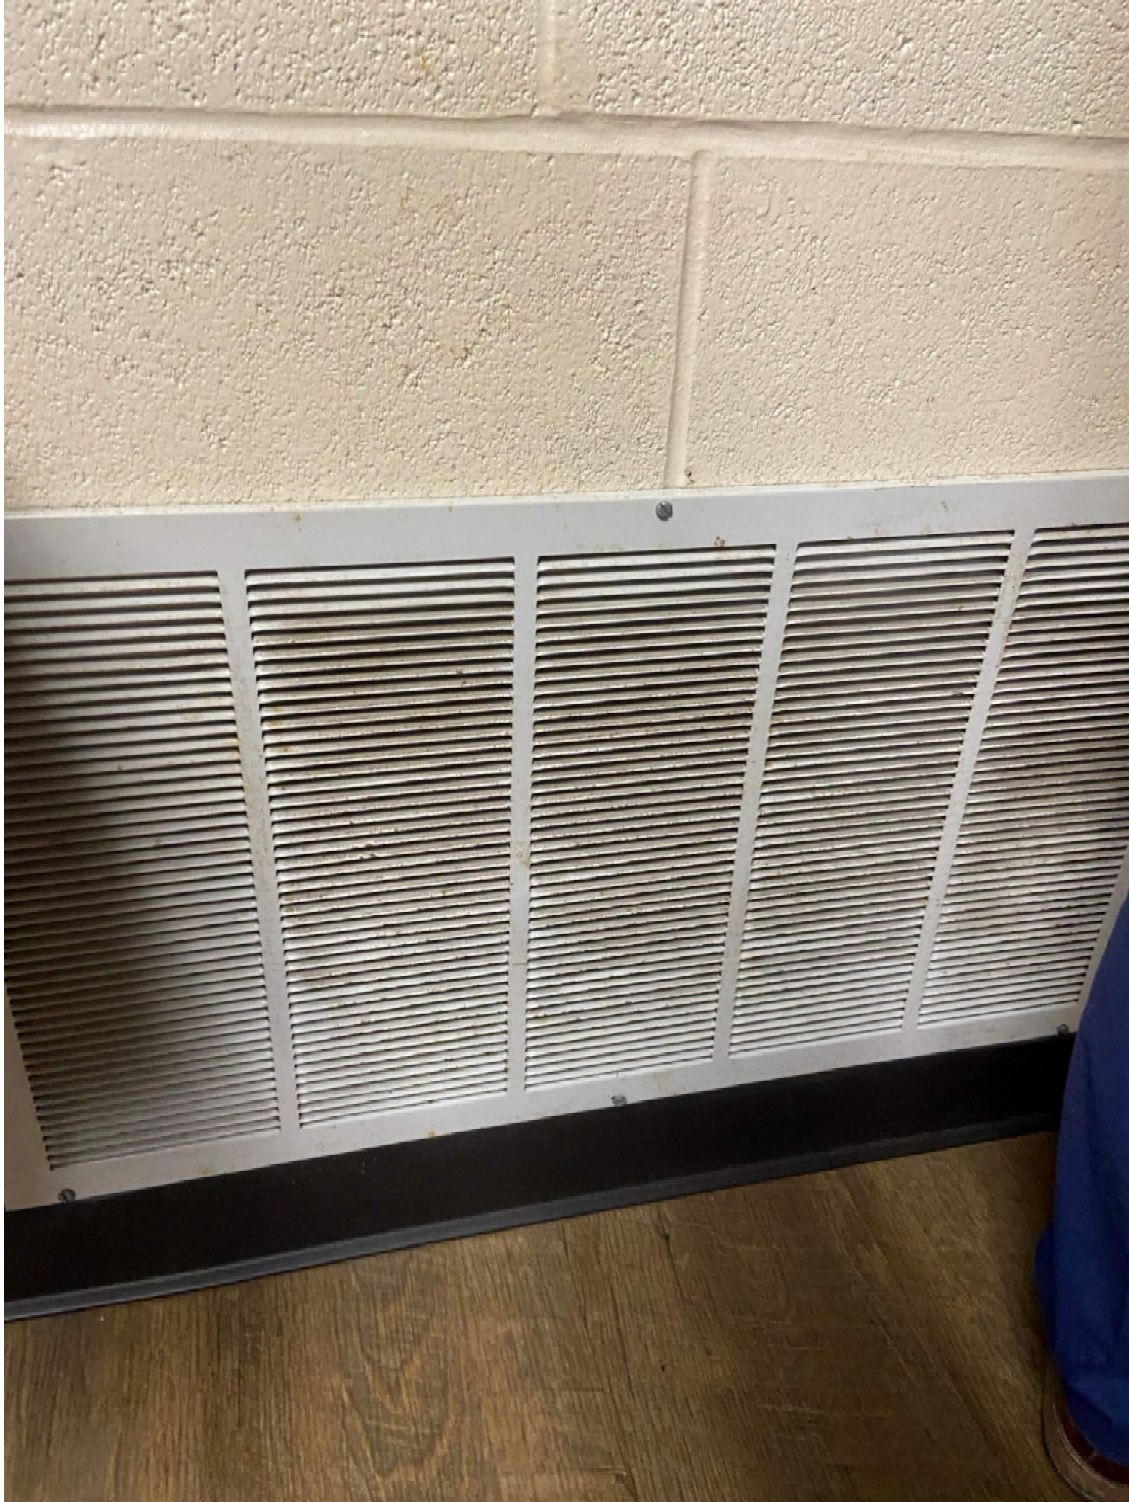
Grilles and diffusers are worn throughout building. Recommend replacing all diffusers and performing a duct cleaning.
