## Case Study of Medium Voltage Motor Trending

*Motor nameplate: Siemens-Allis, 4160V, 400HP, 1185RPM, frame 507US in an ODP enclosure, this is one unit of 6 roof mounted motors, each driving an ID Fan.*

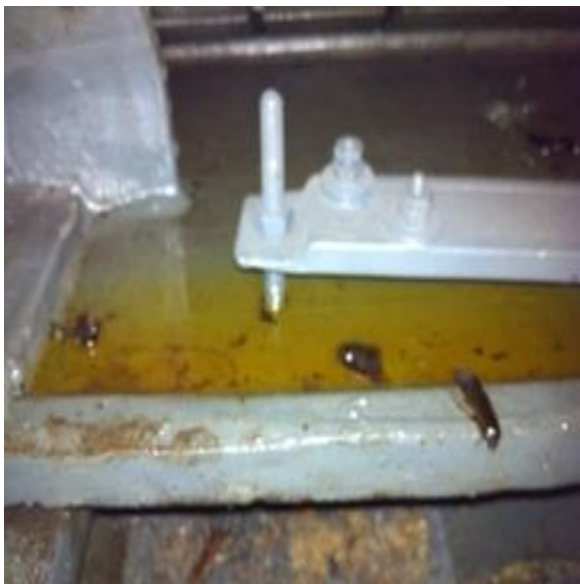
Upon further investigation the motor specialist found a puddle of oil in the motor frame, and the stator core was somewhat wet with oil. The customer was notified of the findings, and plans for corrective action were discussed.

Photo of oil puddle in the motor base:

The motor specialist was concerned about the very big difference in PI for last and this year and also stated he was worried about the DC Step Voltage results. Because of these findings, the motor specialist recommended that the motor should be taken out of service.

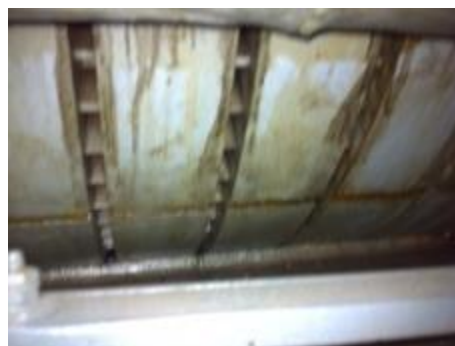
### **Photo of oil inside stator:**

In the above photo you can see where the oil is dripping through the stator. This contamination will eventually lead to electrical tracking because of the ODP type motor enclosure.
