Re: Former Deer Run Golf Club Property, Located at the Northeast Quadrant of Red Bug Lake Road and Eagle Circle, within Unincorporated Seminole County, Florida

Facility Conditions Assessment Report

GAI Consultants Community Solutions Group in association with **Rhodes+Brito Architects** developed this Conditions Assessment Report for the Deer Run Country Club facilities for the **Seminole County Leisure Services Department, Greenways and Natural Lands Division**. The Deer Run Clubhouse is located at 300 Daneswood Way, Casselberry Florida 32707. The Golf Course consists of an 18-hole course and is surrounded by residential property.

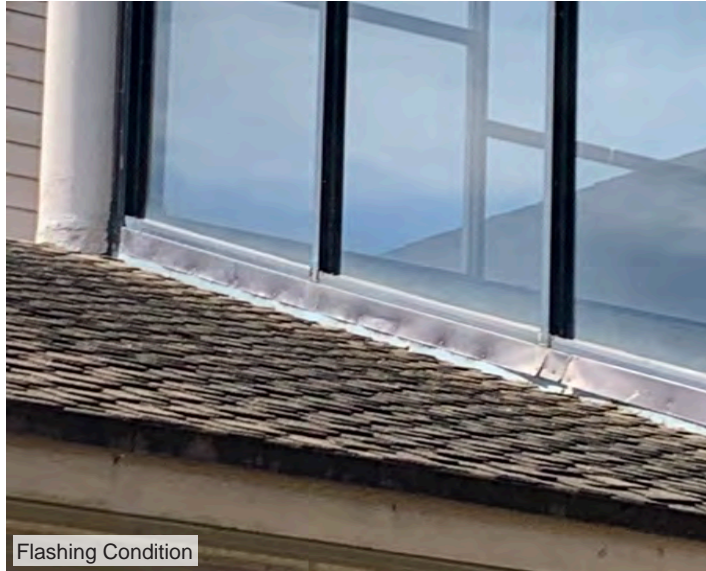
Flashing Condition

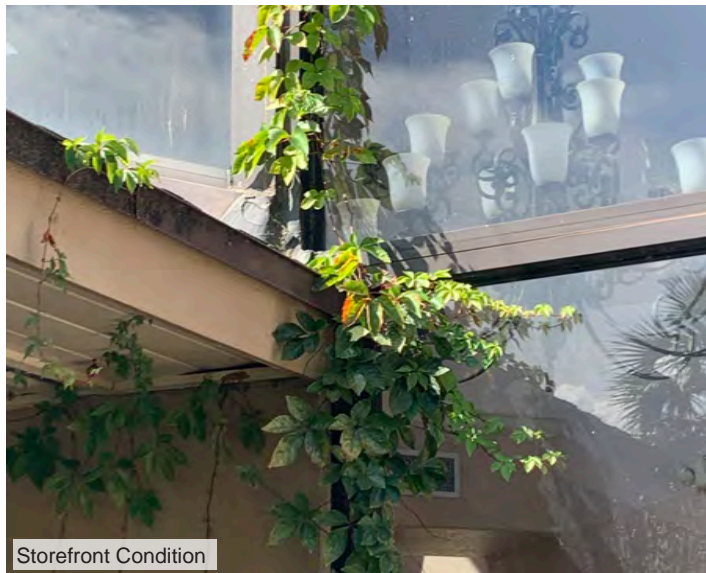
Storefront Condition

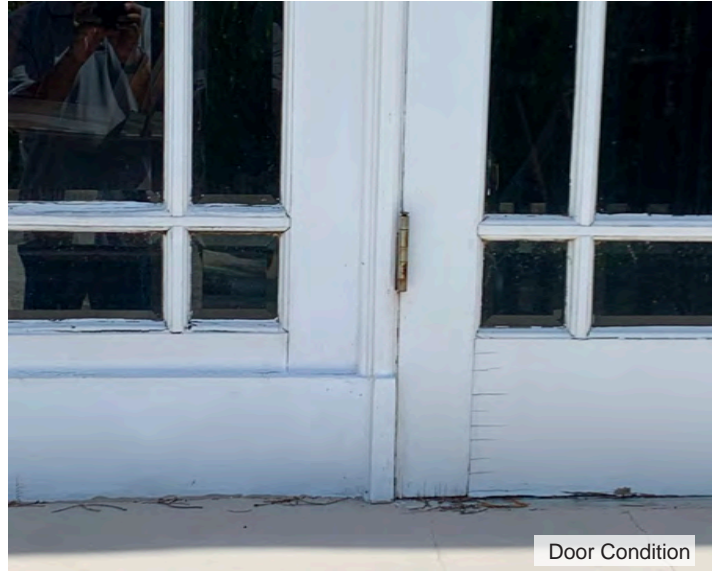
Door Condition

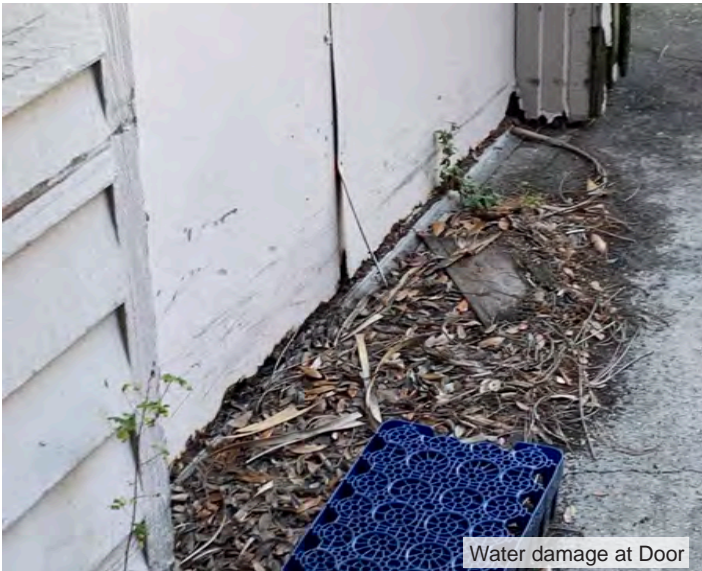
- Some doors and associated trim have water damage
- Some of the maintenance doors are damaged
- Overgrown vegetation on windows and doors
- Windows are non-insulated single pane

Water damage at Door

- Replacement and cleaning of windows, skylights, storefront, doors, and hardware where needed
- Clean and repaint framing of fenestrations where needed
- Replace threshold
- Seal all points

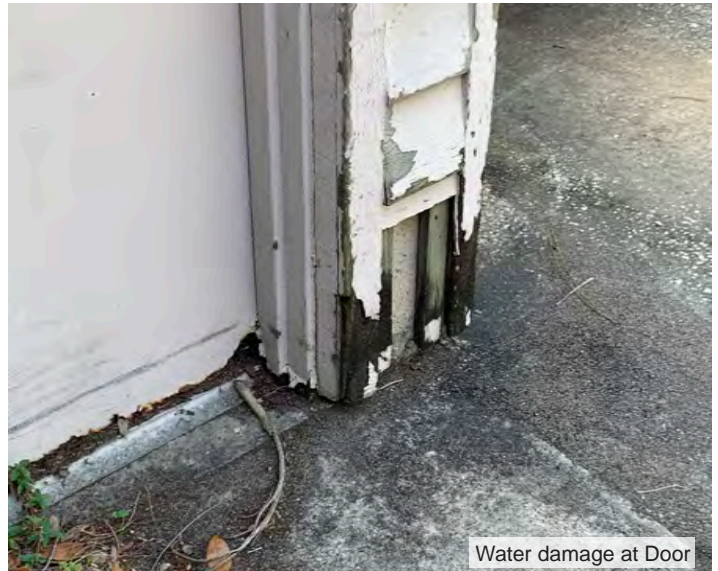
Water damage at Door

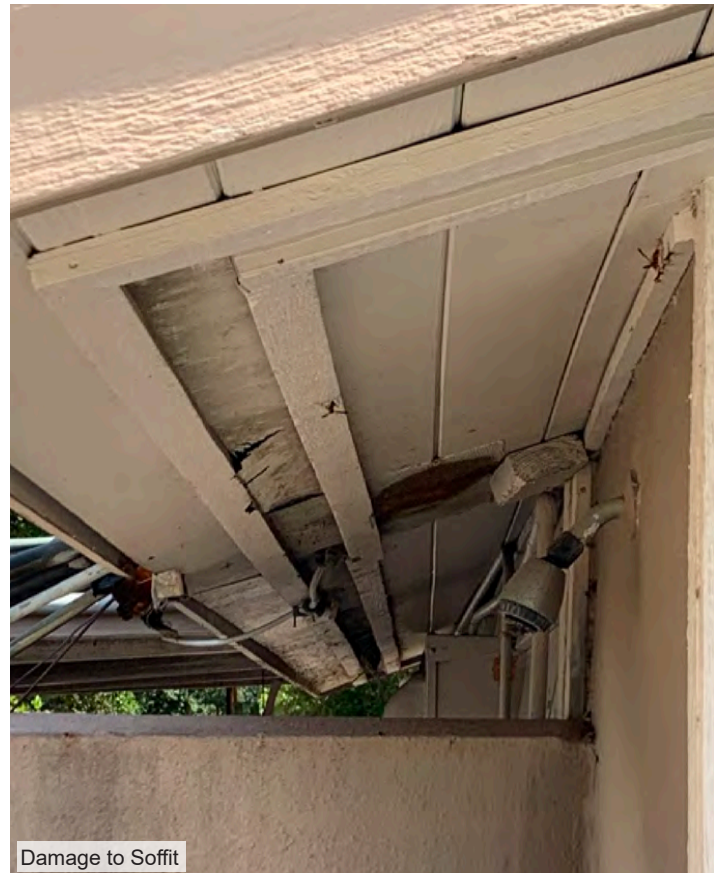
- Main room looks good, should have several more years of serviceable life
- Roofs near service area and external restrooms have structural and water damage
- Downspouts and some gutters are damaged
- Areas of roofs have openings

Damage to Soffit

- Replacement of gutter system
- Clean and repaint soffit
- Replace damaged roof structure and roofing

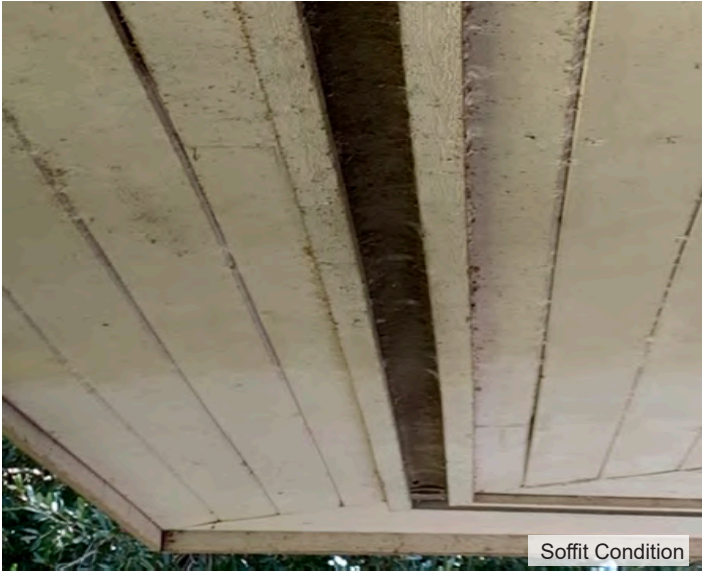
Soffit Condition

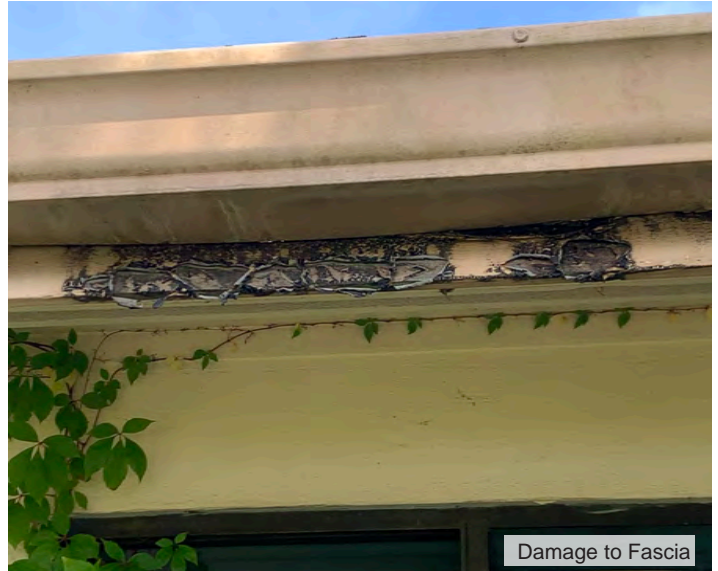
Damage to Fascia

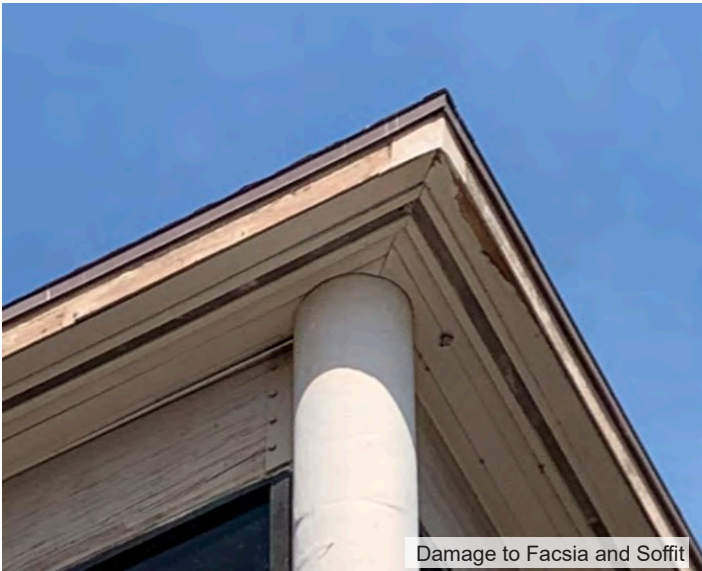
Damage to Fascia and Soffit

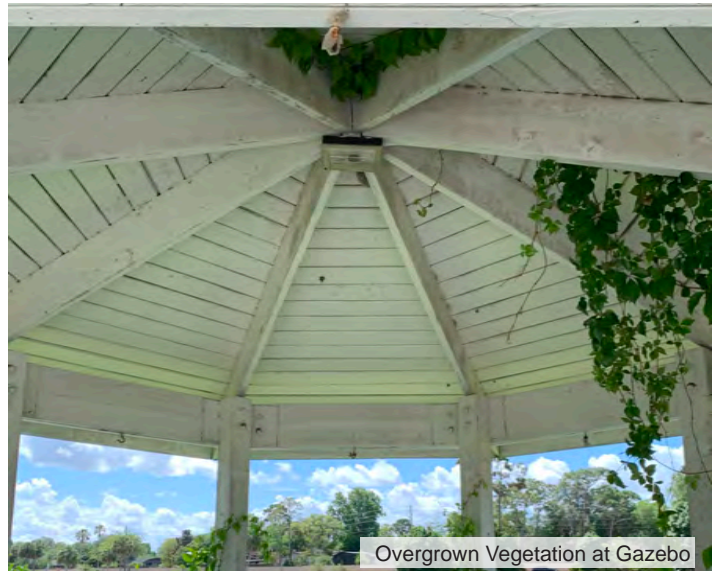
Overgrown Vegetation at Gazebo

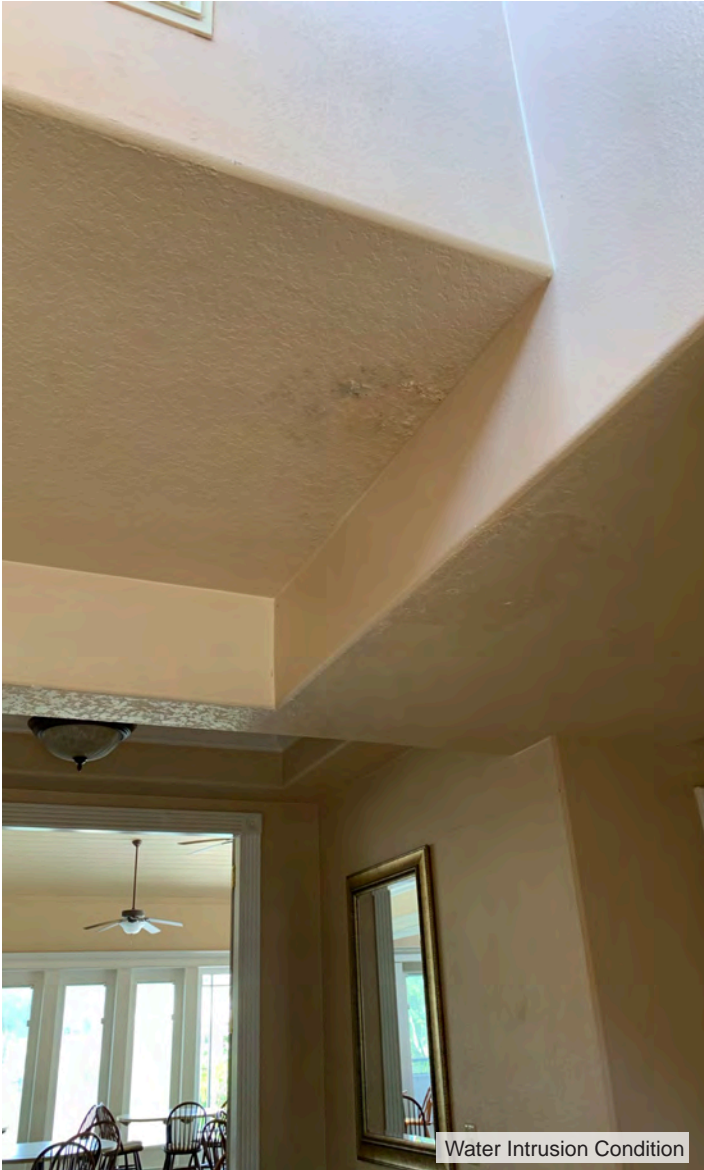
- HVAC has been turned off
- Mold visible in various areas of the vaulted ceiling
- Water intrusion visible at multiple areas of the ceiling
- Ceiling damaged in women's restroom, likely from HVAC condensations
- Non-energy efficient lighting

Water Intrusion Condition

- A mold inspection should be done to assess the degree of mold infiltration in ceilings
- Repair ceiling damage
- Replace existing light fixtures with LED

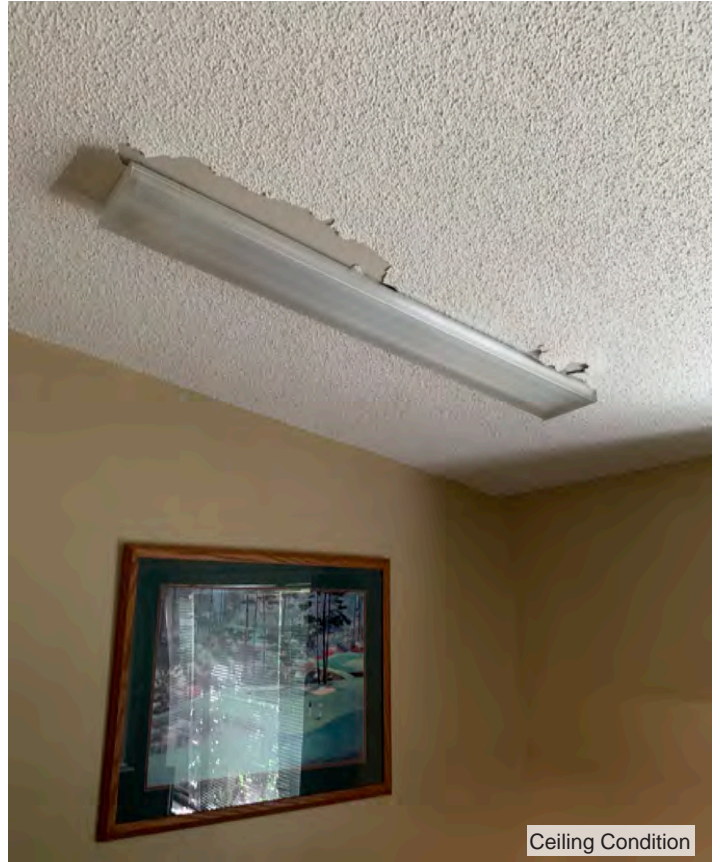
Ceiling Condition

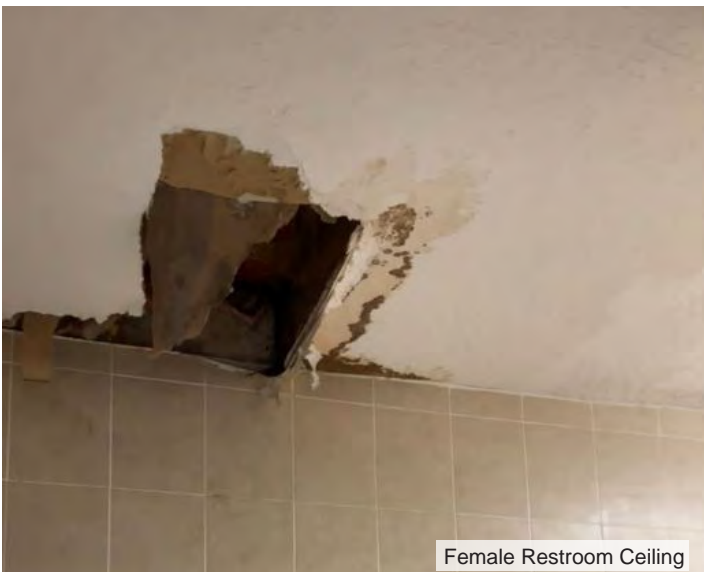
Female Restroom Ceiling

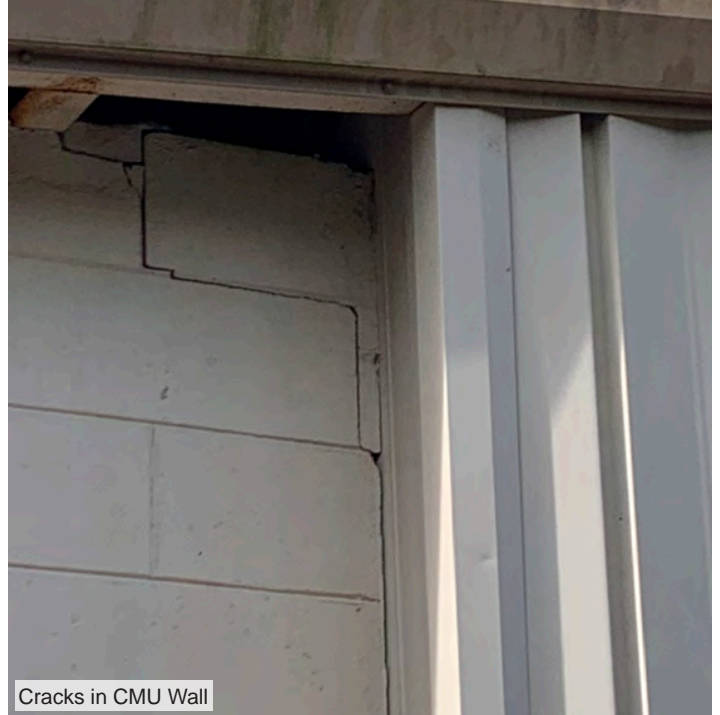
- Overgrown vegetation in various areas of the building envelope
- Cracks in the east elevation CMU infill wall
- Wear and tear in exterior finishes
- Damage to gutter and downspouts
- Damaged exterior lighting
- Exterior soffit material is missing
- No sign of insulation
- Fence enclosure is not operational
- Structural damage to several columns (due to vehicle impact) and beams (rust)
- Damage to metal siding

Cracks in CMU Wall

- Remove overgrown vegetation on building envelope and walkways
- Repair cracks in CMU wall
- Clean and repaint exterior walls
- Replace exterior lighting
- Replace gutter and downspout system
- Repair structural damage
- Install shop ventilation system
- Repair roof
- Install new fence gates

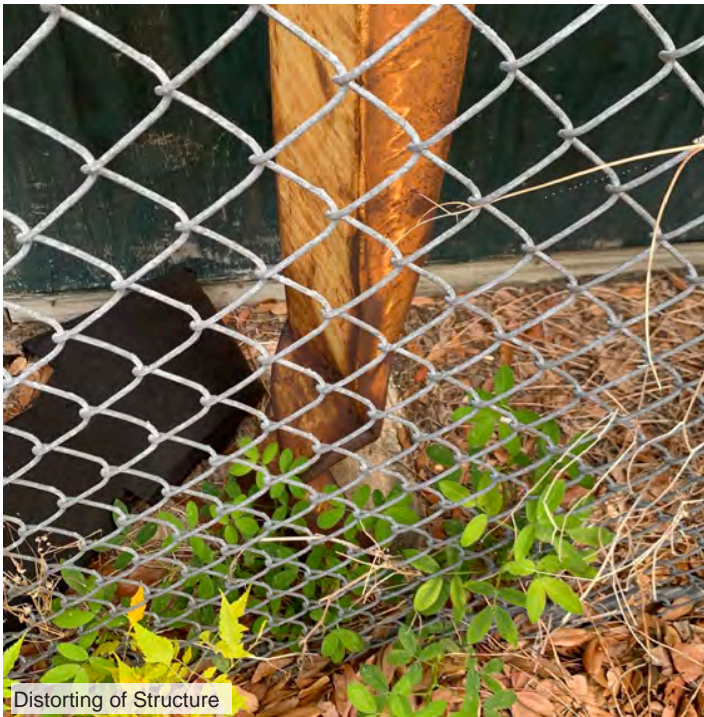
Distorting of Structure

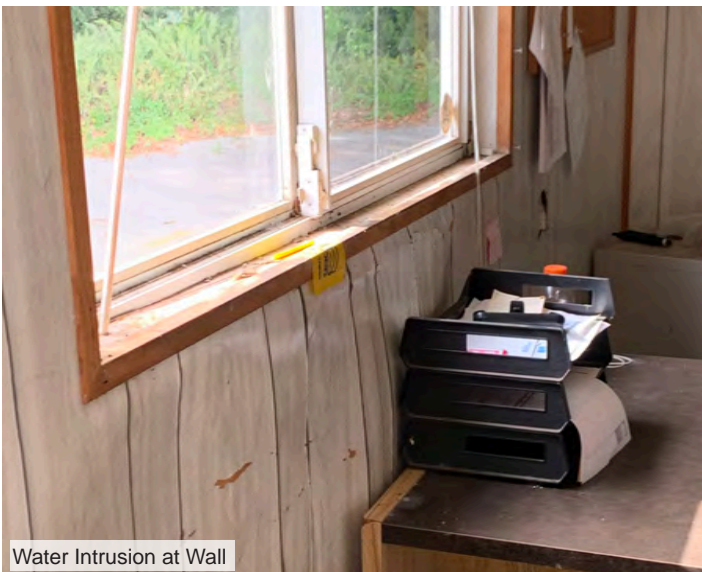
Water Intrusion at Wall

- Water intrusion apparent in ceiling, walls, and doors
- Wear and tear with finishes, fixtures and equipment
- Various door thresholds do not meet current Florida Building Code accessibility requirements
- Electrical panels do not have spares
- Rusting in structural elements
- Unsealed wall penetrations
- Lighting components damaged
- Restrooms are not ADA compliant
- No apparent insulation in office or restroom
- Office suite HVAC (window unit) needs updating

- Address the water intrusion issues in the ceiling, walls and doorways
- Clean, repair and replace fixtures where needed
- Repair or replace lighting components
- Properly seal wall penetrations
- Consult a structural engineer to address the degree of damage to the structural framing elements
- Consult an electrical engineer to address the panel overloading issue
- Replace interior lighting
- Renovate office and restroom

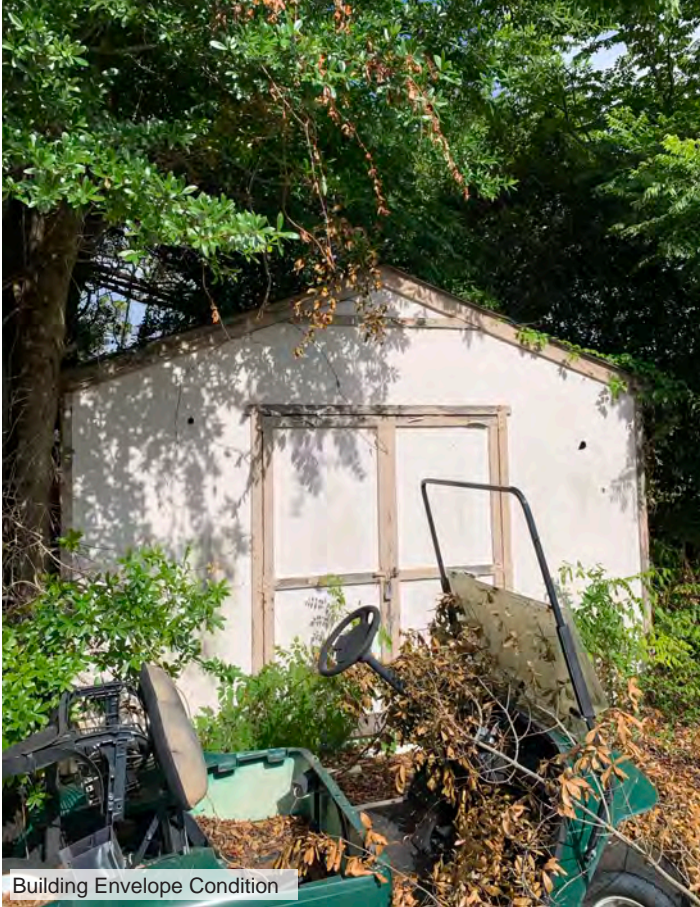
Building Envelope Condition

- Overgrown vegetation in various areas of the building envelope and walkways
- Debris on roof system
- Wear and tear on finishes
- Water damage at fascia
- Gutter system needs replacement
- Fuel tank containment area is overgrown with vegetation, needs refurbishment

- Remove overgrown vegetation from building envelope and walkways
- Remove debris from roof and assess any damage caused by vegetation
- Clean and repaint building envelope
- Repair/replace roofing
- Have a structural audit to confirm wood frame stability

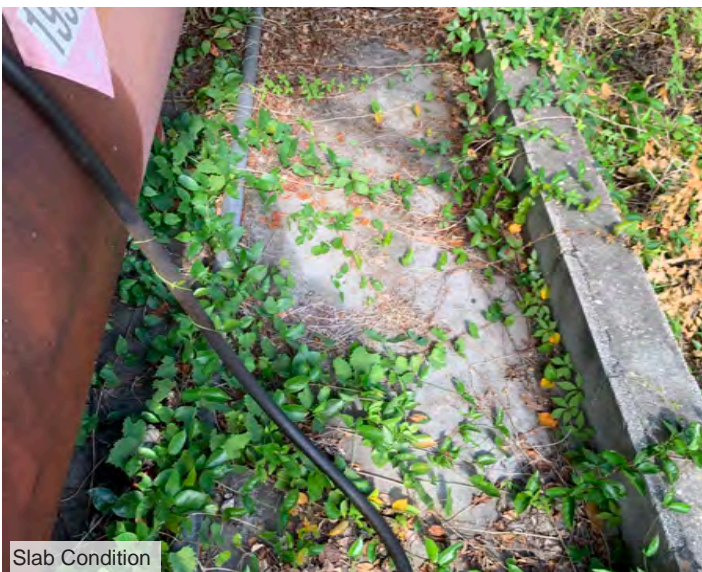
- Overgrown vegetation in various areas of the building envelope and floor slab
- Wear and tear on finishes
- Fuel tanks pose a potential environmental issue

Slab Condition

- Remove overgrown vegetation from building envelope and floor slab
- Clean and repaint building envelope

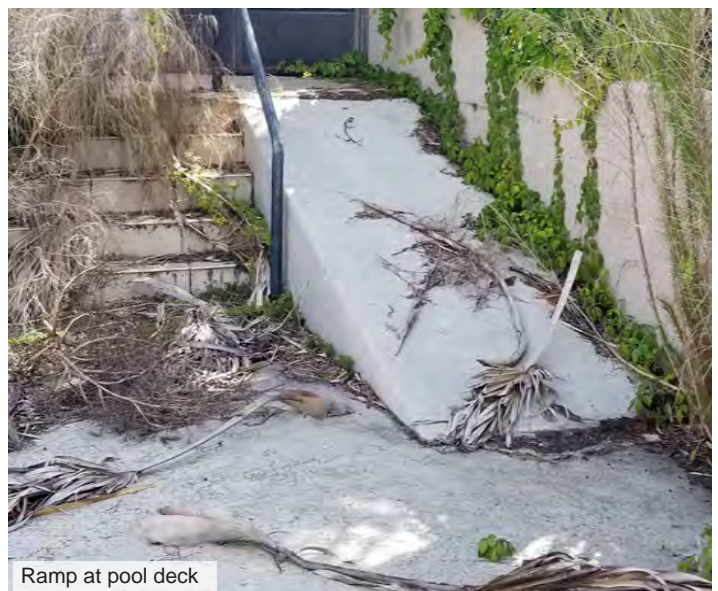
1. With the property no longer serving as a golf course, there are excessive concrete and asphalt access ways as well as curbing.
2. Ramps at the main entry (9% slope) and from the pool deck (24% slope) exceed ADA standards (8% slope with handrails)
3. CMU walls in the service area of the clubhouse are in good structural condition with minimal cracking visible
4. Some rust is visible on walls at locations or railing connections and along the edge of face.
5. All roadway light poles are rusted. Some fixtures are functional

Ramp at pool deck

- Remove any paving not necessary for future use and replace with grass or other permeable material
- Remove and replace ramp at the main entry to comply with ADA standards. If the pool deck area is redesigned for future use the ramp and stair in its current location should be removed. A new accessible route from this area into the building will be needed.
- Have a structural engineer verify the structural integrity of any perimeter walls
- If the wall at the pool deck is retained, repair or replace rusted railings and repair the wall.
- Replace all roadway fixtures and light poles. Existing fixture locations should remain. Use LED fixtures throughout.
