**Tiffany Lake Association, Inc.**  
**West Palm Beach, FL**

Report #: 46769-0  
Beginning: January 1, 2023  
Expires: December 31, 2023

**RESERVE STUDY**  
**"Full"**

March 15, 2023

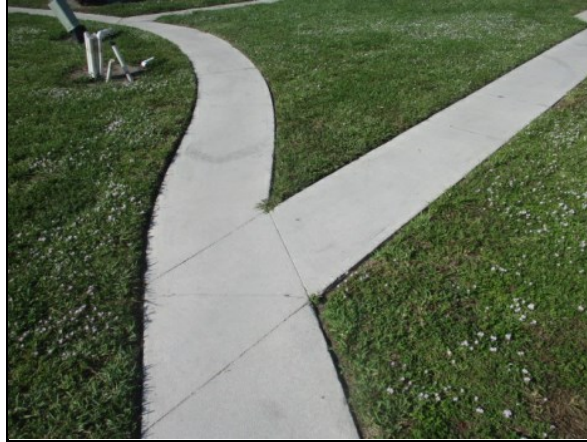
**Comp #: 2107 Roots/Sidewalks - Repair Allowance**

Useful Life:  
3 years

Remaining Life:  
2 years

Lower allowance to repair
