Report: 224 N Anywhere **Address:** 224 N Anywhere

Confidential Inspection Report

224 N Anywhere St.
Wichita, KS 60000

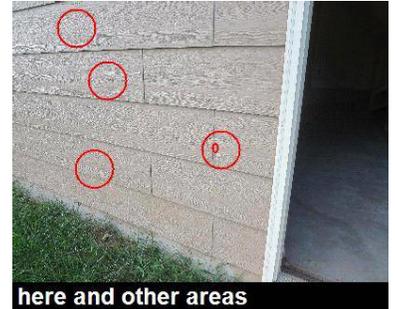
MATERIAL: Brick and wood.
CONDITION: Nail heads exposed, caulk and/or painting recommended to avoid future damage..

here and other areas

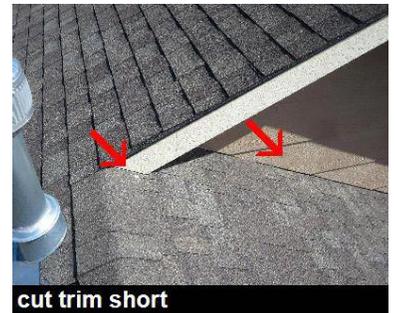
cut trim short

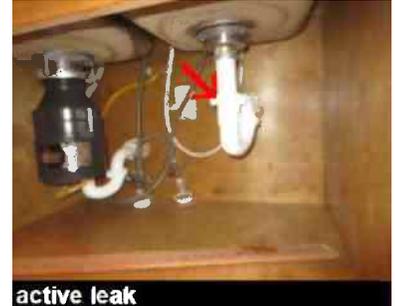
TYPE AND CONDITION: Stainless Steel, Leakage is present- drain pipe. Repairs needed

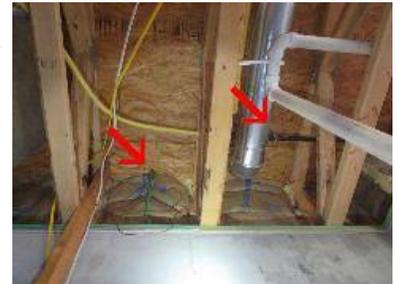
Sizing is improper on stove. The following was noted about the grounding system- ground is connected to gas line and this is improper and needs repairs, no water pipe ground is found. Note- CSST gas tubing should grounded/bonded during lighting, this is not noted unless the ground wire on gas is for grounding

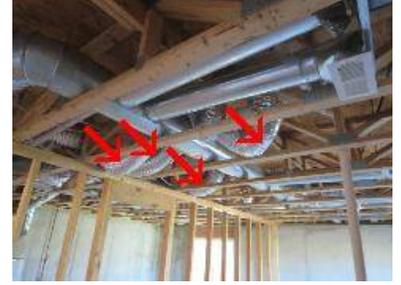
Crushed, loose or excess flex duct, this will cut down on the airflow.

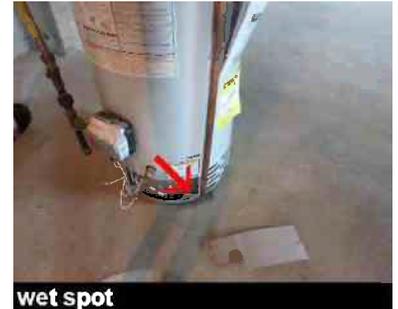
TYPE: Gas.
SIZE: 40 Gallons.
LOCATION: Basement.
CONDITION: Leaking from the pressure relief valve, Call a license plumber or an expert to correct the problems and update as necessary.

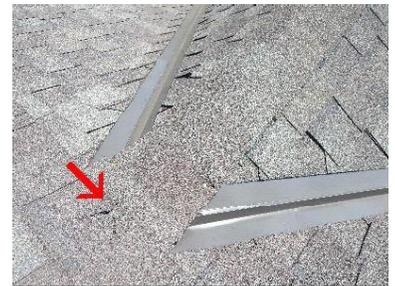
damage ridge shingle

Nails/Fastener heads are seen from the roof surface, improper and needs covered, poor workmanship. The is seen in areas, if this is not off shingles will not stick together. Damage ridge shingle. A licensed roofing contractor should be called to make further evaluation and repairs as needed.

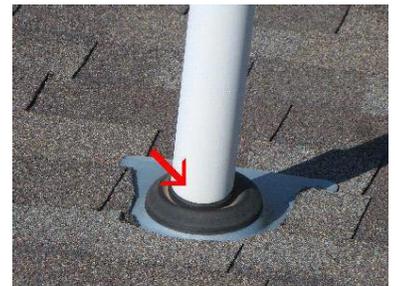
inverted boot

Metal, Rubber, Inverted boot, this can be caused due to lack of pipe bracing in the attic. Metal flashing and ridge shingles has exposed nail heads, sealing is recommended.
