Quality Home Inspections , LLC
12720 Castlewood
Wichita Ks 67206
316 990-0600
francisthehomeinspector@gmail.com

Confidential Inspection Report

224 N Anywhere St.
Wichita, KS 60000

January 21, 2014

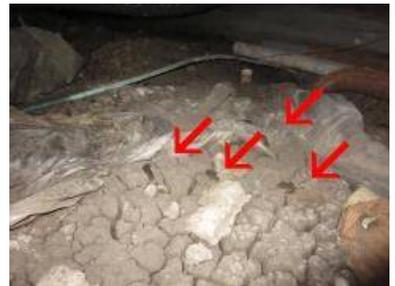
1. Vents notes- Blocked and needs to be opened, Suggest installing vapor barrier due to the high humidity/moisture in the crawl spaces. Remove animal feces mainly at the opening.

CRAWL SPACE: Vents notes- Blocked and needs to be opened, Suggest installing vapor barrier due to the high humidity/moisture in the crawl spaces. Remove animal feces mainly at the opening.

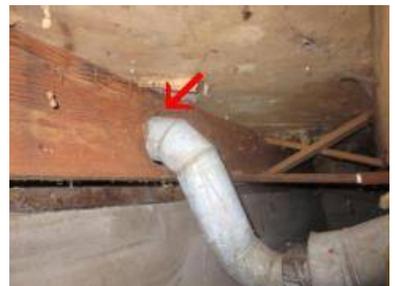
2. Damage joists, it is cut to make room for duct, A qualified carpentry contractor should be called to make further evaluation and repair as needed.

FLOOR JOISTS: Damage joists, it is cut to make room for duct, A qualified carpentry contractor should be called to make further evaluation and repair as needed.

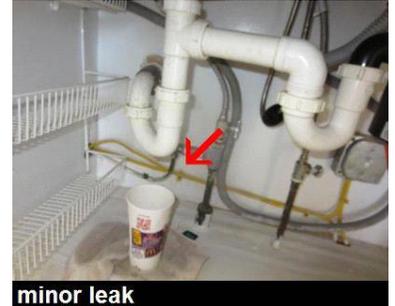
3. Stainless Steel, Faucet- Low water volume is noted, hot side, could be galvanized stubs or a clogged faucet. Leakage is present- drain pipe.

Stainless Steel, Faucet- Low water volume is noted, hot side, could be galvanized stubs or a clogged faucet. Leakage is present- drain pipe.

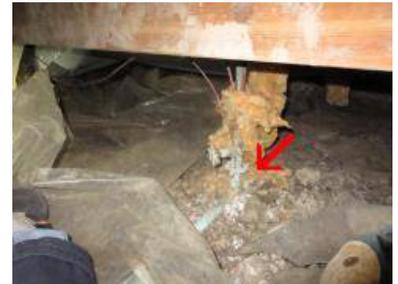
8. Circuit and wire sizing correct so far as visible, 2-Grounding system is present The following was noted about the grounding system- corroded at the connection, clean up or replace/repairs corroded pipe at the water main valve.

Circuit and wire sizing correct so far as visible, 2-Grounding system is present The following was noted about the grounding system- corroded at the connection, clean up or replace/repairs corroded pipe at the water main valve.

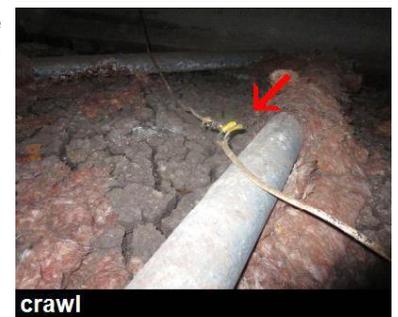
9. Copper sheathing, Open junction boxes are noted-in the furnace room, Connections not made within junction boxes- Hazard condition exists, in crawlspace towards the front of the home.

Copper sheathing, Open junction boxes are noted-in the furnace room, Connections not made within junction boxes- Hazard condition exists, in crawlspace towards the front of the home.

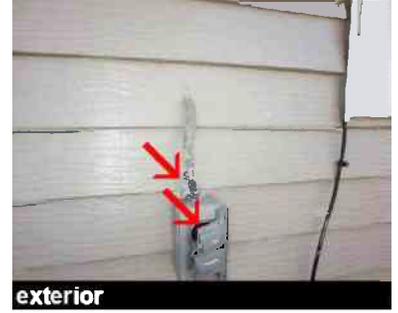
11. Wire sheathing on the exterior back outlet is damaged, exterior outlet has no/broken weather tight cover on the same.

Wire sheeting on the exterior back outlet is damaged, exterior outlet has no/broken weather tight cover on the same.

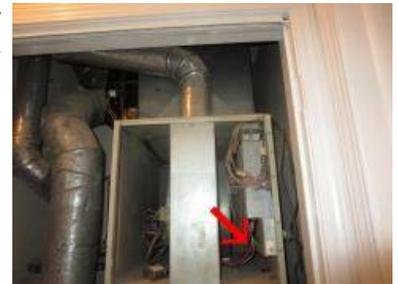
12. Switch bad/sticking at the blower door compartment, needs repaired or replaced. A licensed technician should be called to make further evaluation and repairs as needed.

PRIMARY UNIT: Appears operational.
BURNERS: Burner Flame(s) appear typical.
BLOWER FAN: Switch bad/sticking at the blower door compartment, needs repaired or replaced. A licensed technician should be called to make further evaluation and repairs as needed.

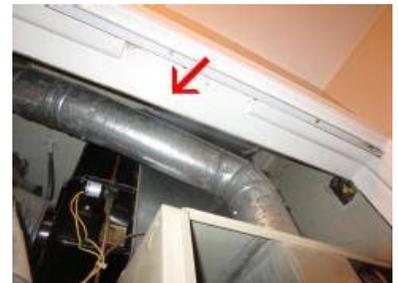
13. Inadequate pipe clearance- Combustibles are nearby at the furnace. Vent pipe notes-very rusty on the roof.

COMBUSTION AIR: Appears serviceable.
VENTING: Inadequate pipe clearance- Combustibles are nearby at the furnace. Vent pipe notes-very rusty on the roof.

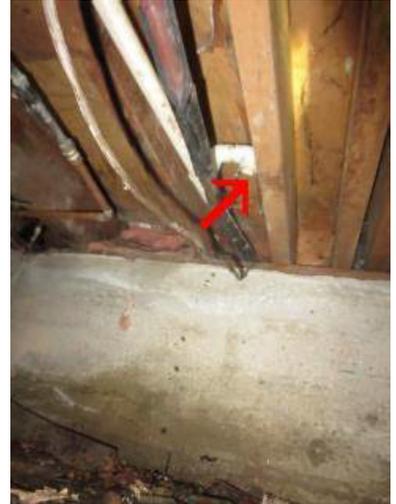
14. Leaking under in the crawl, an addition T-fitting is used where water is pouring in the crawl..

Leaking under in the crawl, an addition T-fitting is used where water is pouring in the crawl..

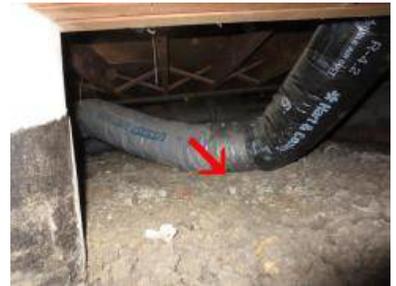
17. Crushed ducts noted, air leaking by the furnace area, Duct is in contact with dirt, recommend bracing or getting

it off the ground. Low air volume noted on some runs, A licensed mechanical contractor should be called to make further analysis of the ductwork system and do necessary repairs

Crushed ducts noted, air leaking by the furnace area, Duct is in contact with dirt, recommend bracing or getting it off the ground. Low air volume noted on some runs, A licensed mechanical contractor should be called to make further analysis of the ductwork system and do necessary repairs

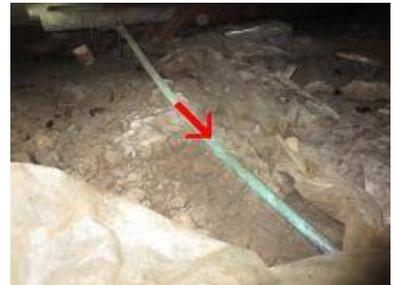
18. Water meter is located- at the south side of the house. The main shut off- crawl space on the floor, Suggest moving it to an accessible area. rusty, might be hard to operate
Minor corrosion is noted on the line, typical with age and when it is in contact with dirt.

Water meter is located- at the south side of the house. The main shut off- crawl space on the floor, Suggest moving it to an accessible area. rusty, might be hard to operate
Minor corrosion is noted on the line, typical with age and when it is in contact with dirt.

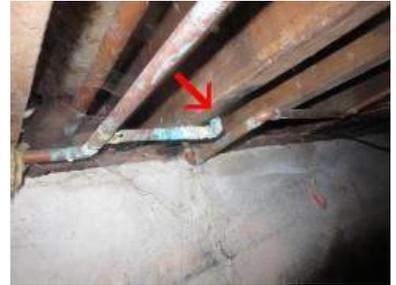
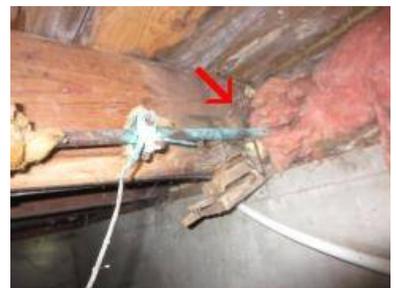
19. Major corrosion is noted, below/by tub area and by the kitchen sink, both on the back wall could be more, I recommend call a licensed plumber to review, evaluate and do repairs and updates as necessary.

Major corrosion is noted, below/by tub area and by the kitchen sink, both on the back wall could be more, I recommend call a licensed plumber to review, evaluate and do repairs and updates as necessary.

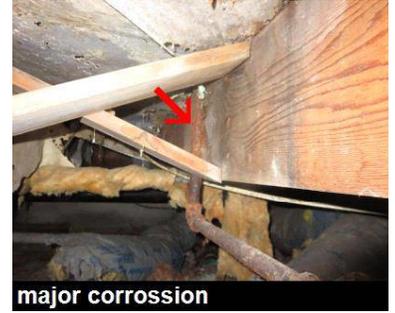
20. Gas. Rusty pipes are noted-in the crawl, Call an license plumber to correct the problems and update as necessary.

Gas. Rusty pipes are noted-in the crawl, Call an license plumber to correct the problems and update as necessary.

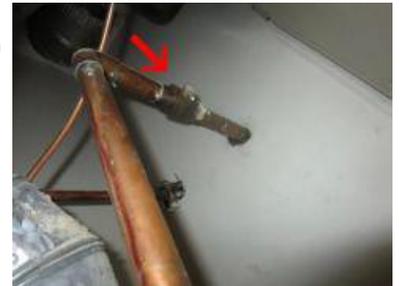
22. Venting notes- Inadequate pipe clearance- Combustibles are nearby, Missing valve handle on the top and has an active leak. Call a license plumber or an expert to correct the problems and update as necessary

Venting notes- Inadequate pipe clearance- Combustibles are nearby, Missing valve handle on the top and has an active leak. Call a license plumber or an expert to correct the problems and update as necessary

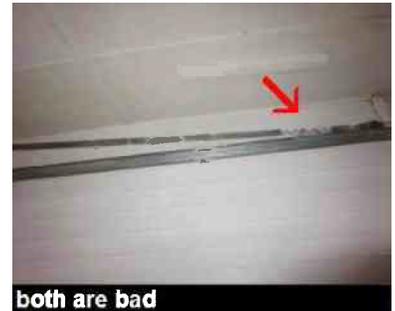
23. Adjustment or service needed- Weak/damaged spring, replacement recommended. Sensors needs to be installed to the right height, usually 2-6 "

CONDITION: Adjustment or service needed- Weak/damaged spring, replacement recommended. Sensors needs to be installed to the right height, usually 2-6 "

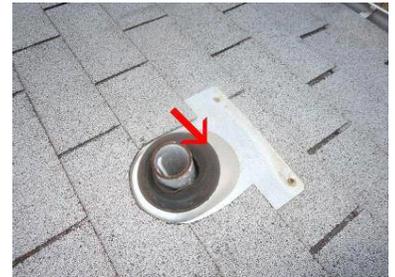
24. Bad repair job is noted, nail heads exposed, Hail damage is noted, minimal. Check with your insurance agent about coverage prior to closing, A licensed roofing contractor should be called to make further evaluation and repairs as needed. Exterior outlet has no/broken weather tight cover.

Bad repair job is noted, nail heads exposed, Hail damage is noted, minimal. Check with your insurance agent about coverage prior to closing, A licensed roofing contractor should be called to make further evaluation and repairs as needed. Exterior outlet has no/broken weather tight cover.

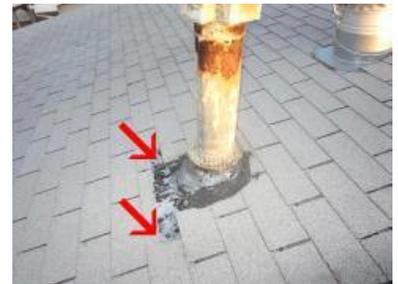
25. Metal, Rubber, Inverted boot, this can be caused due to lack of pipe bracing in the attic. Damage is noted on the same. at the vents, Popping up, loose nails-needs repairs on the furnace vent.

Metal, Rubber, Inverted boot, this can be caused due to lack of pipe bracing in the attic. Damage is noted on the same. at the vents, Popping up, loose nails-needs repairs on the furnace vent.
