Confidential Inspection Report

224 N Anywher Street
Wichita, KS 60000

Prepared for: Mr John Doe

January 21, 2014

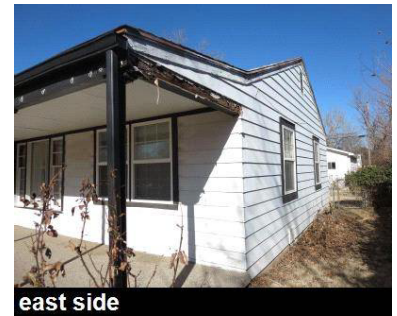
TRIM:

1. Damage noted- Loose or deteriorated material major on fascia all around, Damage noted- due to no gutters, will cause more damage in the future. A qualified trim carpenter should be called to make further evaluation and repairs as needed.

MATERIAL: Wood.
CONDITION: Damage noted- Loose or deteriorated material major on fascia all around, Damage noted- due to no gutters, will cause more damage in the future. A qualified trim carpenter should be called to make further evaluation and repairs as needed.

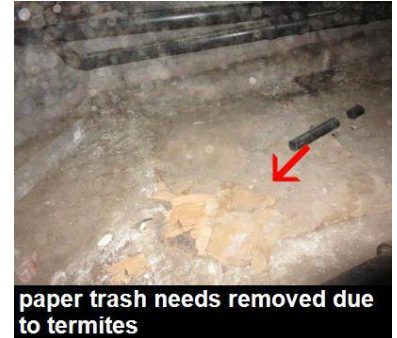
BASEMENT/CRAWL SPACE:

ACCESSIBILITY: Crawl space is fully accessible.
CRAWL SPACE: Remove wood debris and trash from the crawl space area, Suggest installing vapor barrier due to the high humidity/moisture in the crawl spaces.

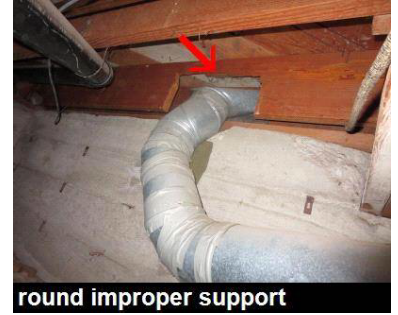
FLOOR JOISTS:

Prefabricated floor trusses are in use, Damage joists, it is cut to make room for duct

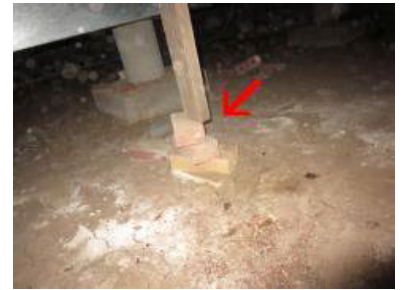
COLUMNS/SUPPORTS:

Column/pier is undersized and needs replacement, Post is not properly secured in two or more areas.

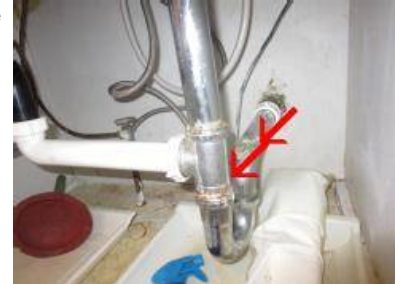
2. Porcelain, Drain pipes notes- Plumbing under the sink is deteriorated, not leaking but old.

Porcelain, Drain pipes notes- Plumbing under the sink is deteriorated, not leaking but old.

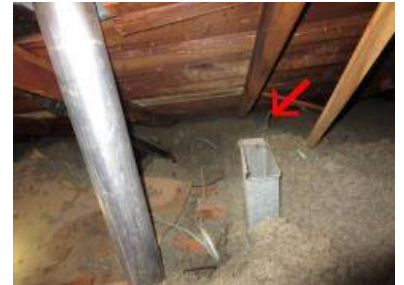
4. External, In the attic, needs to be vented to the exterior Need repairs, high speed will not work.

External, In the attic, needs to be vented to the exterior Need repairs, high speed will not work.

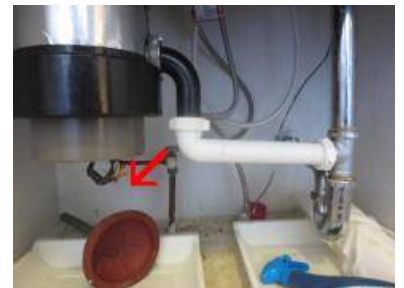
5. Wiring notes- Wires hanging outside the unit and should be in a j-box with a cover, No proper grounding system

is noted. Humming sound, possibly stuck.

Wiring notes- Wires hanging outside the unit and should be in a j-box with a cover, No proper grounding system is noted. Humming sound, possibly stuck.

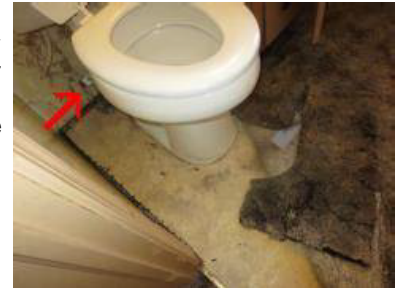
CONDITION OF TOILET:

6. The following problems were noted at the toilet: Leak is active at the supply tube to the tank, very wet floor . Have a licensed plumber make proper repairs as needed.

Minor plumbing repairs will be needed to restore proper operation or to save future problems. Ball valve rod is rusty.

The following problems were noted at the toilet: Leak is active at the supply tube to the tank, very wet floor . Have a licensed plumber make proper repairs as needed.

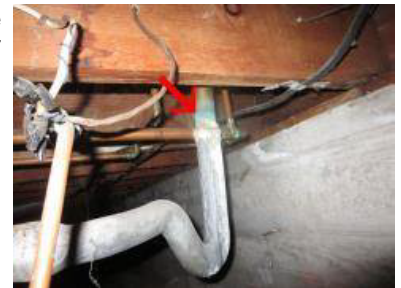
TUB/SHOWER PLUMBING FIXTURES:

7. Minor leakage is noted at faucet handles. The following problems were noted at the tub/shower drain: is leaking under tub/shower on the bottom, minor leak.

Minor leakage is noted at faucet handles. The following problems were noted at the tub/shower drain: is leaking under tub/shower on the bottom, minor leak.

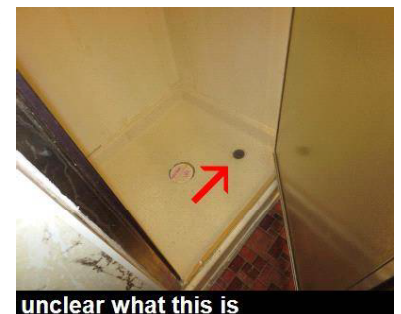
TUB/SHOWER PLUMBING FIXTURES:

10. The following problems were noted at the tub/shower drain: cover loose, unclear about the round piece on the bottom.

The following problems were noted at the tub/shower drain: cover loose, unclear about the round piece on the bottom.

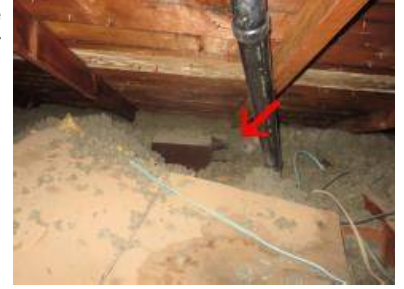
BATH VENTILATION:

11. Extend discharge pipe from the fan above the insulation in the attic, prefer taking it to the exterior vent.

Extend discharge pipe from the fan above the insulation in the attic, prefer taking it to the exterior vent.

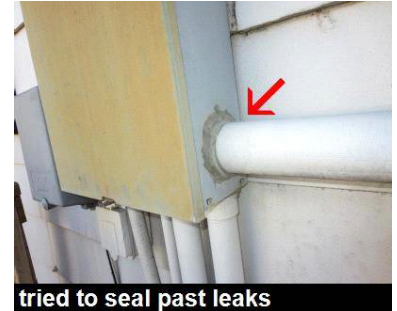
Overhead, 110/220 Volt, caulking noted on water tight conduit fittings.

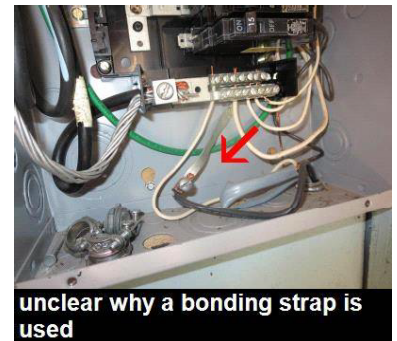
Inspector Notes:

14. Multiple wires are connected to a single lug on a circuit breaker where only one wire should be connected (this can add load to the circuit) on both sub panels, unclear why a bonding strap is used for ground. Have a licensed electrician make further evaluation and corrections as needed. Unused openings in the panel are missing covers (minor fix) in the utility room. in garage.

Multiple wires are connected to a single lug on a circuit breaker where only one wire should be connected (this can add load to the circuit) on both sub panels, unclear why a bonding strap is used for ground. Have a licensed electrician make further evaluation and corrections as needed. Unused openings in the panel are missing covers (minor fix) in the utility room. in garage.

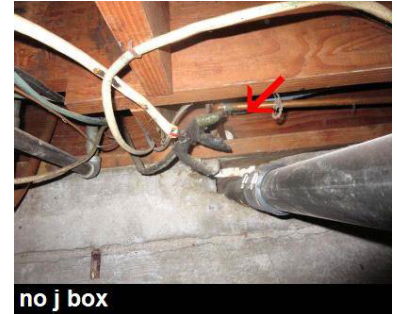
BRANCH WIRING:

16. Copper sheathing. Open junction boxes are noted- in the attic, Connections not made within junction boxes-

Hazard condition exists, in crawlspace in three or more areas, below bath, below cook top and other areas.

Copper sheathing. Open junction boxes are noted in the attic, Connections not made within junction boxes- Hazard condition exists, in crawlspace in three or more areas, below bath, below cook top and other areas.

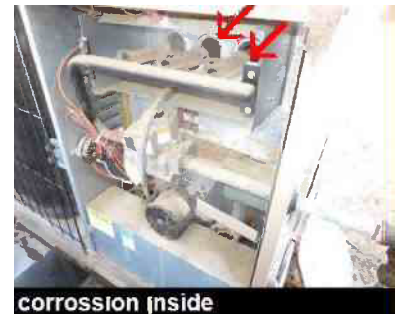
HEATING SYSTEM CONDITION:

18. Operational but needs clean/service,

19. Excessive scale and corrosion is noted in the burn chamber typical for outdoor units.

PRIMARY UNIT: Operational but needs clean/service,
BURNERS: Excessive scale and corrosion is noted in the burn chamber typical for outdoor units.

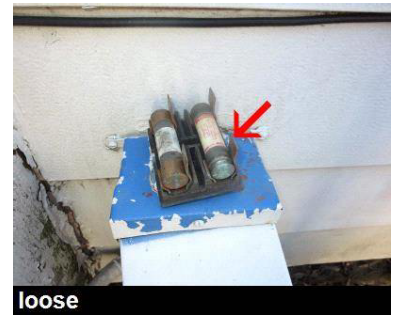
POWER SOURCE:

22. 220 Volt, Oversize fuses at disconnect box at the condensing unit.. Check unit data plate and have a license electrician install a right fuses. Loose connection and corrosion at fuses. Water tight conduit is caulked and will need checked.

220 Volt, Oversize fuses at disconnect box at the condensing unit.. Check unit data plate and have a license electrician install a right fuses. Loose connection and corrosion at fuses. Water tight conduit is caulked and will need checked.

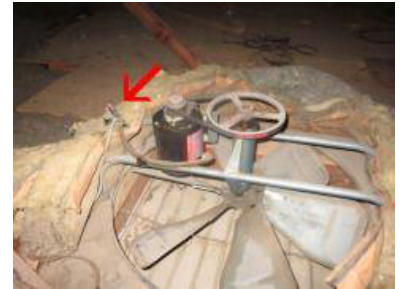
WHOLE HOUSE ATTIC FAN:

23. Connections not made within j-boxes.

Connections not made within j-boxes.

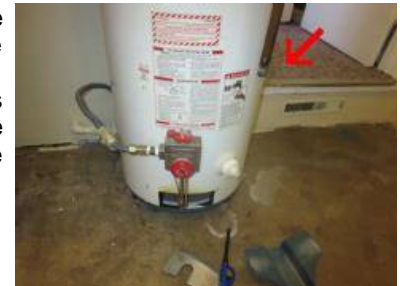
24. Venting notes- duct tape is used, pipe temperature will damage the tape, hard to see what is behind the tape. Pressure relief valve drain line is missing or ends prematurely. This is a SAFETY HAZARD. We recommend this drain line be extended to a safe location

Venting notes- duct tape is used, pipe temperature will damage the tape, hard to see what is behind the tape.

Pressure relief valve drain line is missing or ends prematurely. This is a SAFETY HAZARD. We recommend this drain line be extended to a safe location

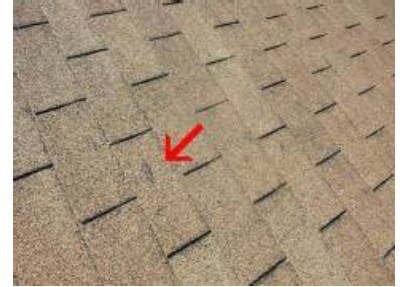
ROOF:

CONDITION: Wear on shingles, check with insurance agent.

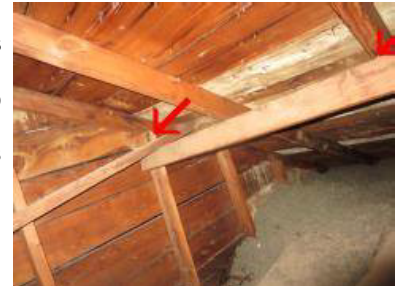
ACCESSIBILITY AND CONDITION:

26. Attic is full size- from the addition. Repairs recommended 2x4 split/damage in the attic, repairs needed on the

west side, bowed decking Call an expert and further evaluate the situation and do changes/repairs as necessary.
Ladder notes- Weak ladder, needs secured/repaired.

Attic is full size- from the addition. Repairs recommended 2x4 split/damage in the attic, repairs needed on the west side, bowed decking Call an expert and further evaluate the situation and do changes/repairs as necessary.

Ladder notes- Weak ladder, needs secured/repaired.

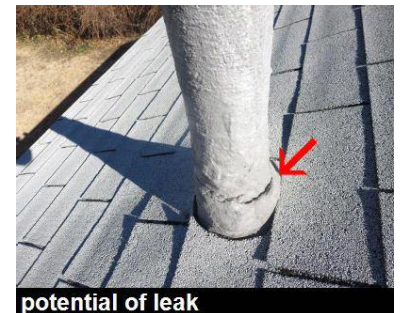
28. Metal, Rubber, Rubber flashing is cracked at the boots, replacement/repairs needed, Metal flashing has exposed nail heads, sealing is recommended.

Poor job on the valleys.

Metal, Rubber, Rubber flashing is cracked at the boots, replacement/repairs needed, Metal flashing has exposed nail heads, sealing is recommended. Poor job on the valleys.
