## **Infrared Thermographic Report**

July 30, 2014

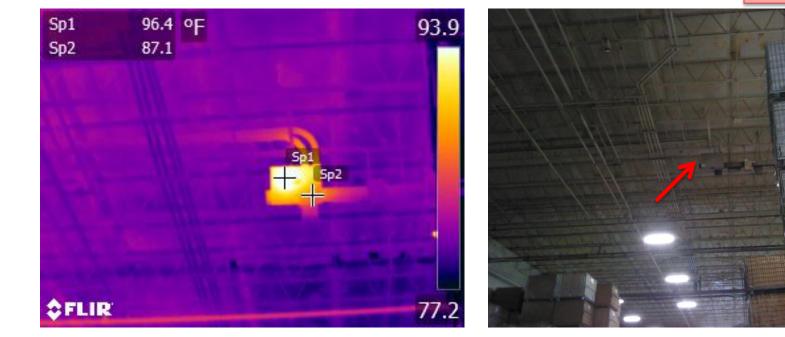
Location: Building 5 Component: Buss Fault Area: Investigate Rating / T-Rise: Minor 9.3F

Notes: Open and investigate, see page 5.

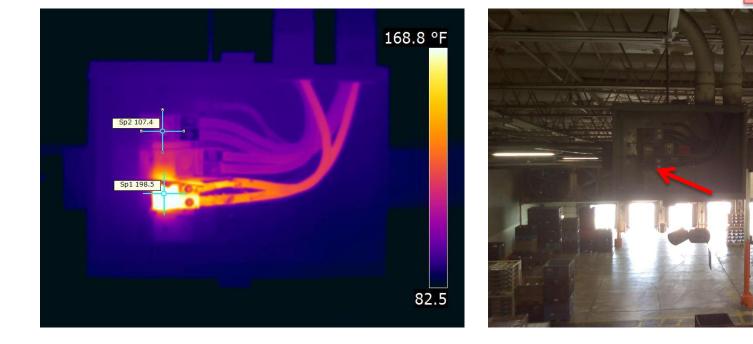
Location: Building 5 Component: Buss Main Fault Area: C-phase Rating / T-Rise: Critical 71.1F

Notes: Replace lug and trim back conductors.
