UPRIGHT PIANO PIANO SERIAL NO.28021

CHRONICLE OF THE RESTORATION PROCESS OF A BLUTHNER UPRIGHT PIANO OF 1885

By RICHARD YOUNG PIANO RESTORATIONS IN THE YEAR OF 2019

BLUTHNER UPRIGHT PIANO REBUILD:

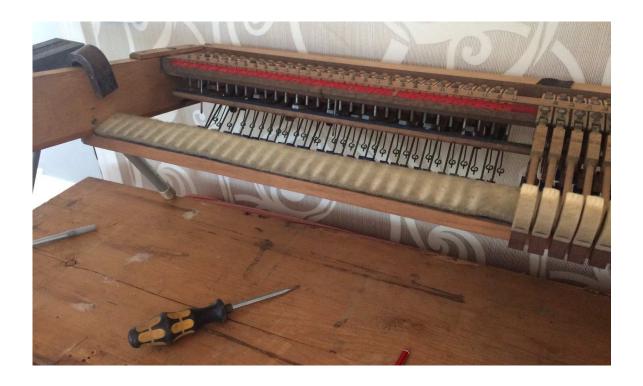
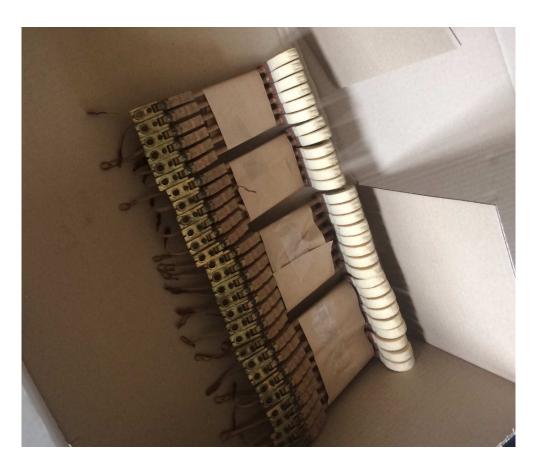
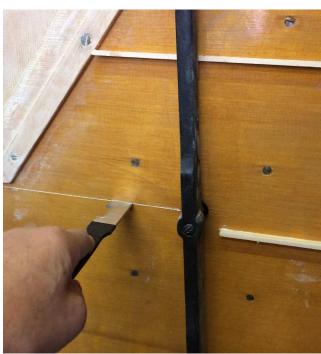
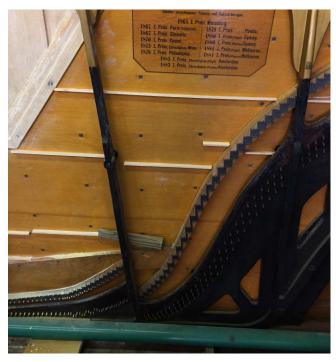
4/7/19 The hammers ... They are are totally worn out and need to be replaced. Because of the age of the piano there are no off the shelf replacements anymore so the best option is to have the heads recovered with new German felt. This will bring the hammers up to spec with the correct shape and sound quality.

The photos below show start of removing the hammers and packing them ready to be sent for re felting and also 2 pics of the start of shimming the soundboard cracks prior to refinishing same. The original soundboard transfer will be lost sadly as stripping the old finish will take the transfer with it. A new one of same design will be installed.

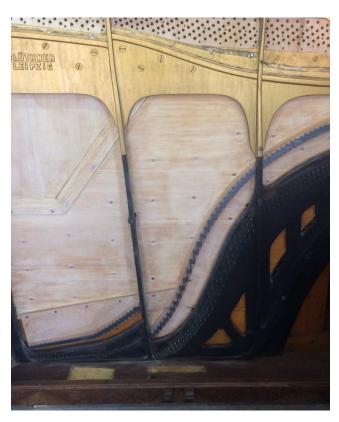
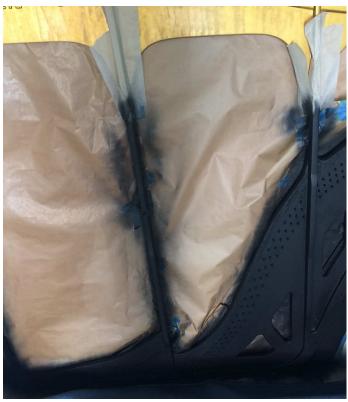
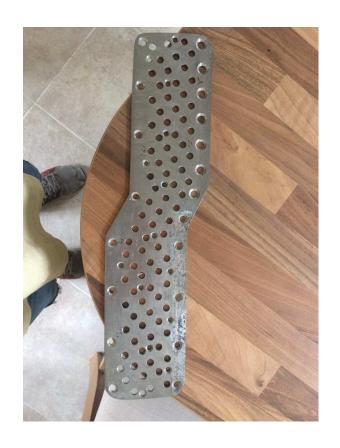
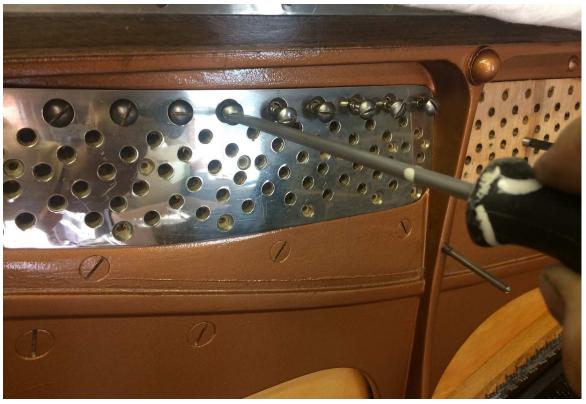
8/7/19 After the soundboard shims were glued in, they were planed flush with the soundboard. The whole was then sanded in preparation for coats of varnish. The bridges were checked and 2 minor splits were dealt with. The bridge pins were cleaned and the tops of the bridges treated with graphite. The black finish on the frame was sanded and primed, then sprayed with gloss black. The gold part of the frame (upper section) was primed and sprayed with antique gold lacquer.

The tuning pin area had plates which had been crudely painted gold by a previous repairer. I decided to dip the plates in paint stripper and found that they were chrome on brass which after hours of cleaning and buffing, looked beautiful. The plates were then screwed to the tuning pin wrest plank. It only remains for the soundboard to have its coats of varnish and the frame was completed in readiness for re stringing.

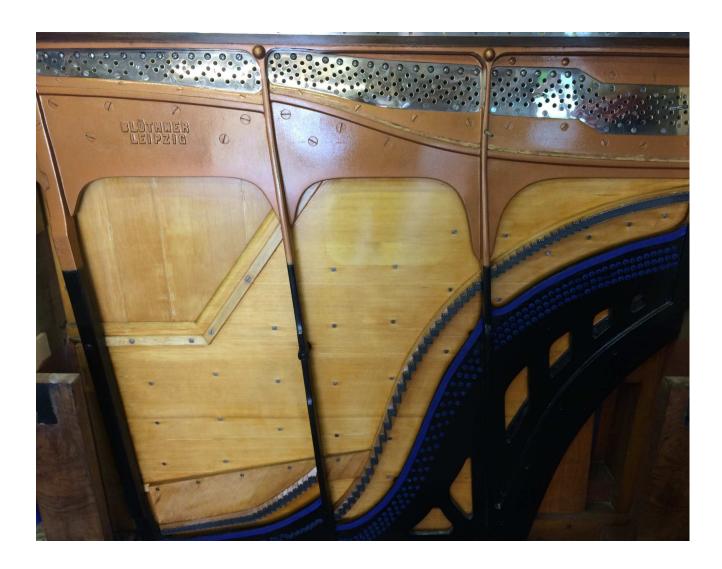
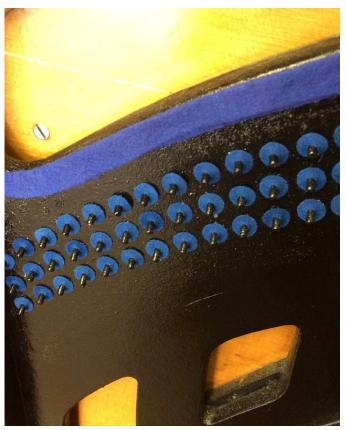
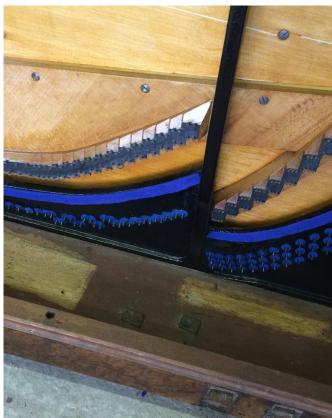
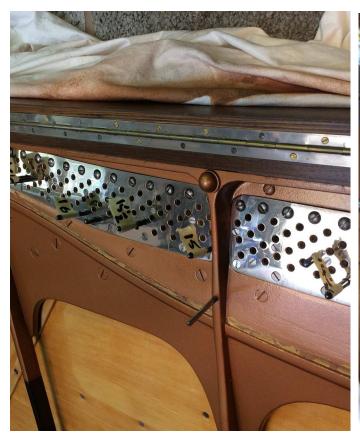
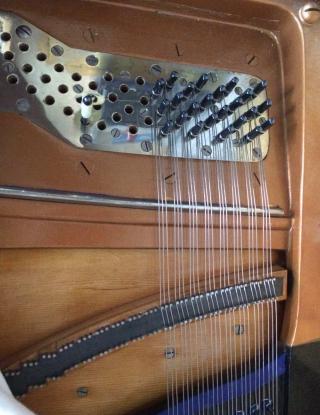
12/07/19 This week saw the start of the re stringing process. This takes many hours of meticulous work.

Starting at the treble side and driving in new tuning pins of increased size to restore the tightness and stability of tuning. It takes about 5 minutes to install just one string and there are over 200 in the piano!

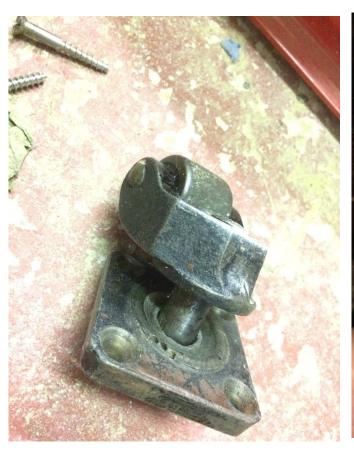
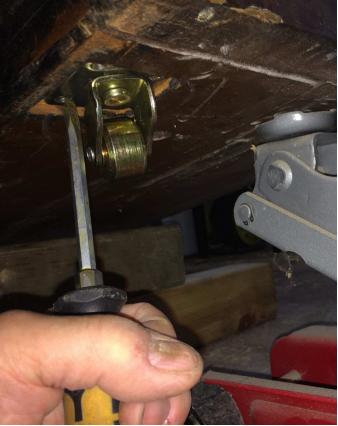
Replacing the castors.

All 4 were replaced as one of them has failed (see pic) and the others were seized.
