DANEMMAN PIANO RESTORATION

RESTORED BY YOUNGS PIANOS

Danemann Restoration

The rebuilding of Danemann piano in words and pictures
This piano was made in 1905

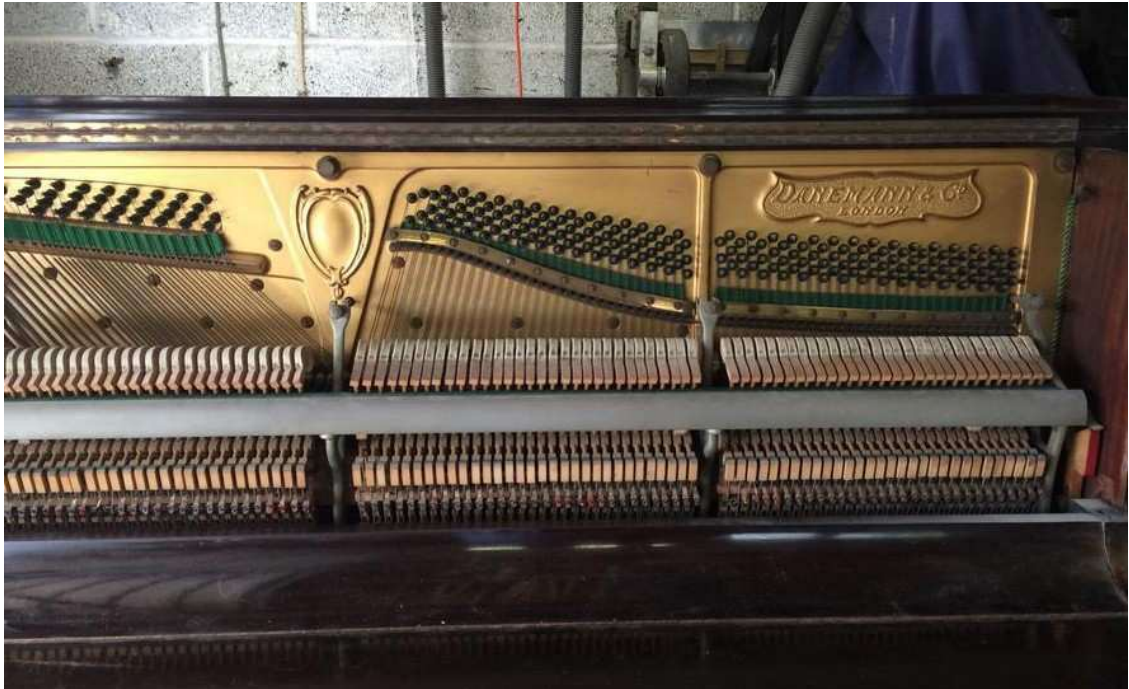
The internal view of the piano in original condition

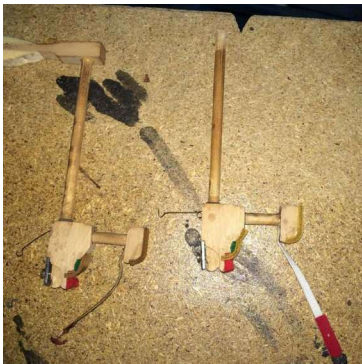
Just one part of the process showing a hammer component in unrestored condition on the left and the restored one on the right with the old hammer removed ready for fitting of new ones at a later stage

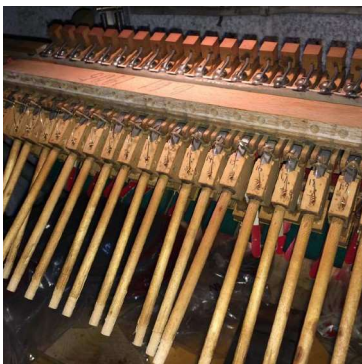
A close up view of the new butt springs. These springs help the hammer to repeat quickly when playing fast passages. Most of the original springs had broken due to fatigue and corrosion. All were replaced with new.

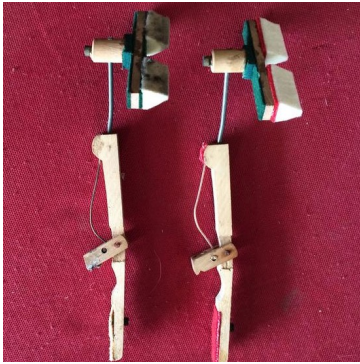
This picture shows the damper assembly. The original one on the left and the restored one on the right with the new felt and springs assembled. The dampers stop the vibration of the string when the key is released. They rest on the string with the long brass spring shown. These springs often suffer from fatigue and corrosion which leads to weak pressure on the string leading to the string ringing on after a key is released.

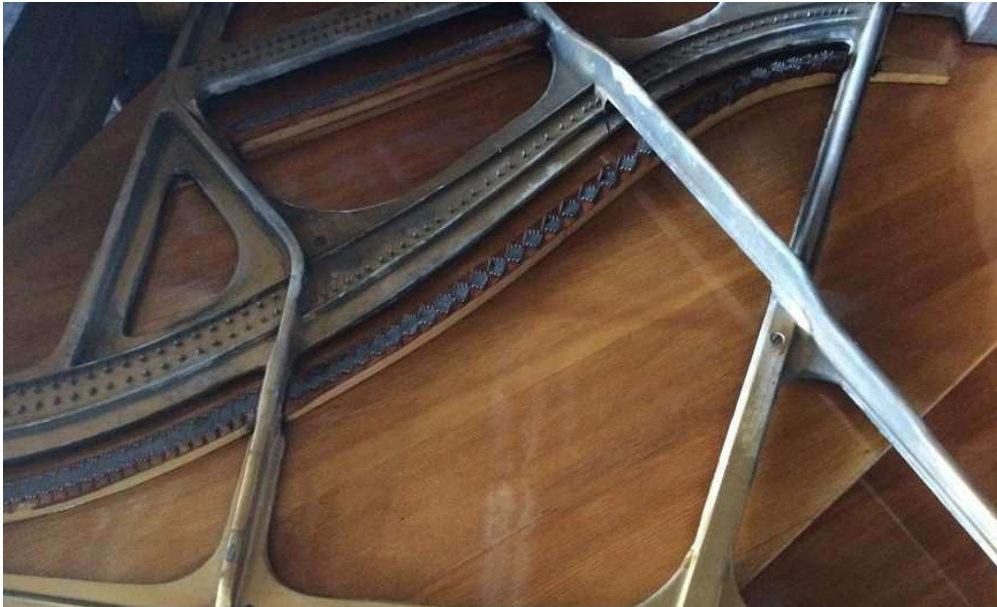
The soundboard: Checked for cracks and small crack near bass bridge repaired by routing a 'V' along the crack and glueing in a wood fillet to make good. The soundboard and bridges were then sanded back and 2 coats of varnish applied (pic).

Soundboard repaired and refinished with 2 coats varnish

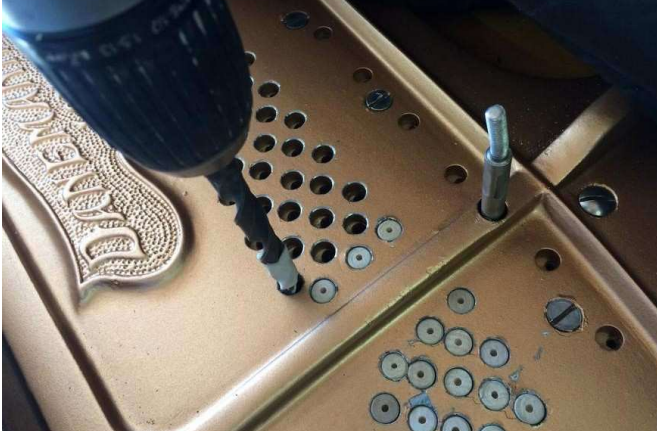
The frame required new set of tuning pin wood bushings before re stringing could start. It was found that the size of the holes in the frame were slightly too large diameter for current available size bushings. The only way forward was to specially order bespoke made bushings to correct size for this piano from Germany. The tuning pin holes in the frame had then to be drilled larger to accomodate the new bushings.

This picture shows the frame being drilled to correct diameter for the new tuning pin bushings.

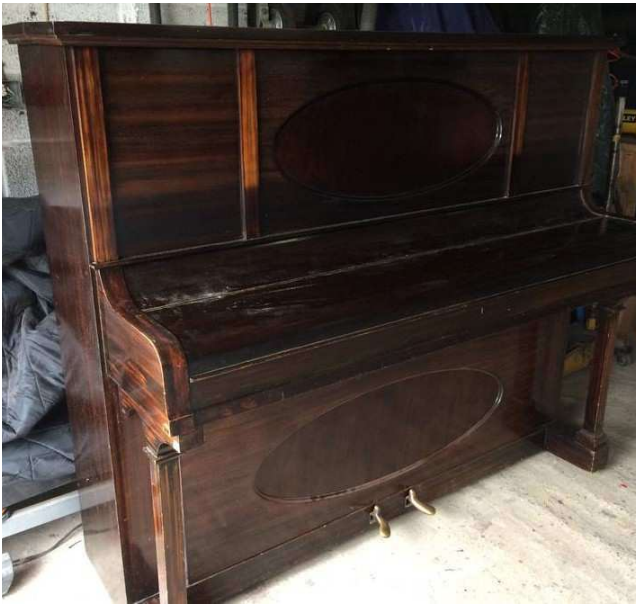
Its not hard to see the areas that have had the grain brushed on. This was to disguise different wood (possibly walnut) to make it pass for mahogany and it was done very successfully on many pianos through the years. Now after so many years the finish breaks down and sunlight has had the affect of highlighting the brush marks and spoiling the effect.

To restore the casework to its best potential it is proposed that the compromised parts are veneered in actual mahogany . This takes away the uncertainty of trying to produce a perfectly matched shading process that the skilled craftsmen of yesteryear achieved when the piano was made over a 100 years ago. This process will be a much better result as all of the piano that one can see will be of the same wood.

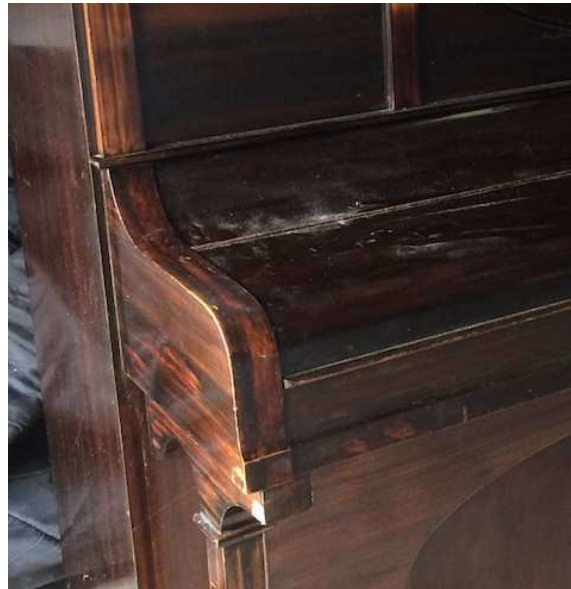
A closer view of the left cheek.
These areas will be veneered in real mahogany thus eliminating the problem altogether.
