Behavior of Galvanized Steel in Tropical Marine Environments

The Patina Project

A global investigation project was initiated to study the performance of galvanized structures in tropical marine environments. This article describes the results of the study and makes recommendations on more effective corrosion protection for those atmospheres. The study included two evaluation phases for metallic and nonmetallic coating systems.

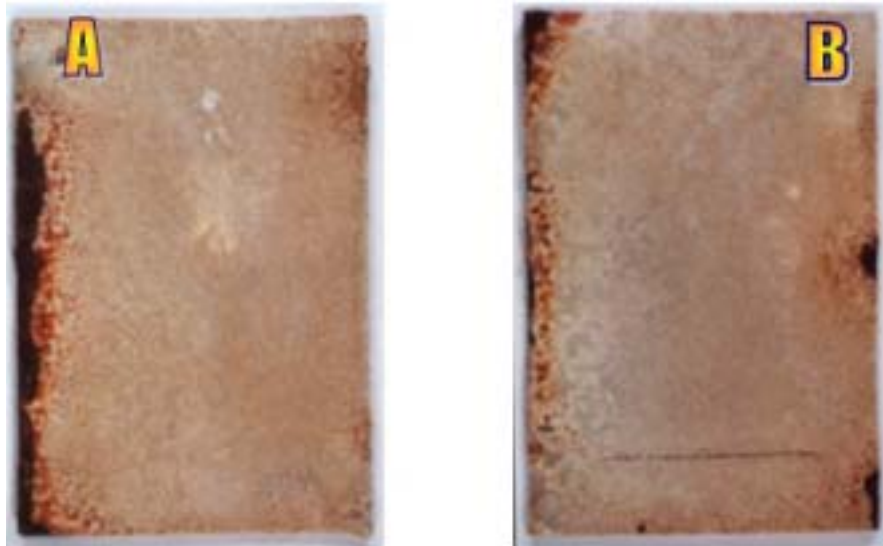
FIGURE 1

The galvanized probes had a 60- μ m thickness. After just 24 months' exposure, the formation of white corrosion products on the coating in the form of scales on 100% of the surface and on 7% of the base steel was observed. In addition, severe corrosion was found on the borders (Lmax = 12.5 mm/0.49 in.) because of the strong winds, which have an erosive effect on the corrosion products formed on the galvanized steel. Although the coating provided galvanic protection to the substrate in the incision area after 42 months' exposure, the base steel began to corrode at a rate of 100% at this location. Figure 1 shows the effects on two different sheets, with and without incision.

Galvanized steel: a) without incision, and b) with incision, after 42 months' exposure at La Voz Station.

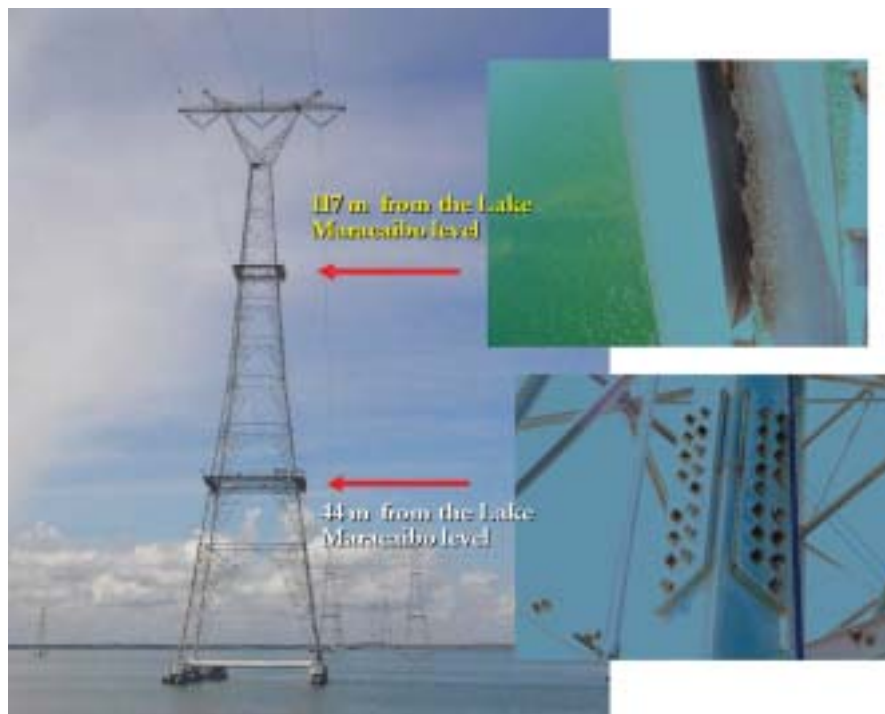
FIGURE 2

Figure 2 shows one of the towers where some of the stations are located. Visual inspection of the towers revealed severe corrosion in the area exposed to the prevailing winds, where there is no longer any zinc because of the erosive action of the winds on the corrosion products. Erosion varies with the height, being more severe at higher levels. This erosion effect was not observed on the leeward (downwind) side (Figure 3), as there was corrosion on 100% of the surface, with the characteristic white products on galvanized steel exposed to marine environ-

Towers (Cruce del Lago de Maracaibo project).

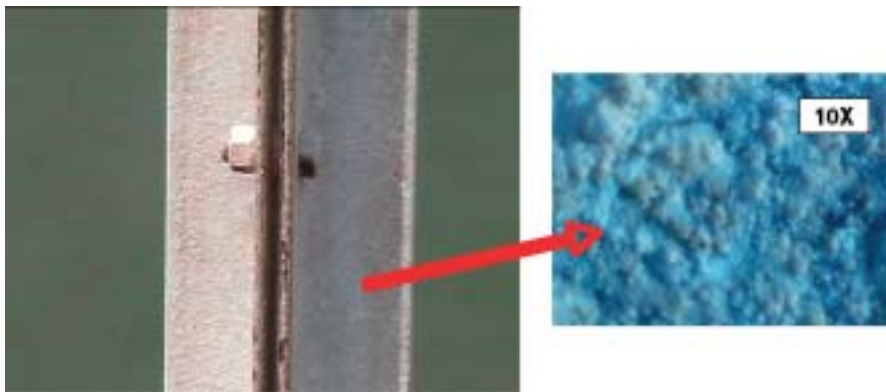
FIGURE 3

White products on galvanized steel exposed to marine environments.

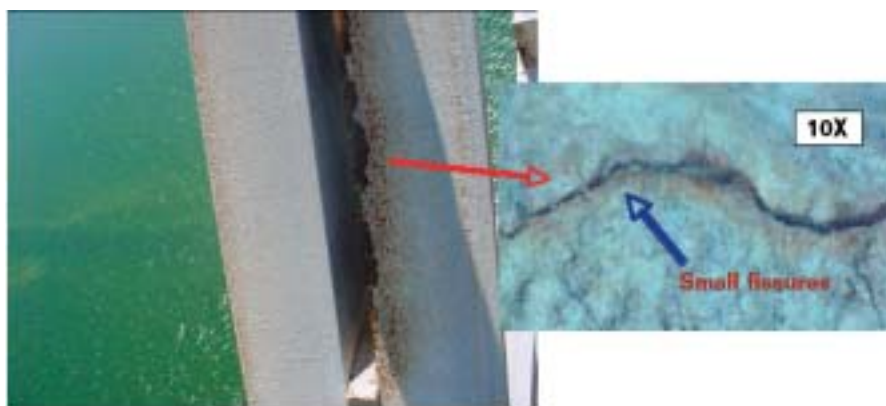
FIGURE 4

Initial phase of the exfoliation process.

ments. In each of the corroded profiles (Figure 4), there were small fissures, which constitute the initial phase of the exfoliation process. This is because of severe erosion in the border zones, caused by wind incidence on such a small area. High relative humidity (RH) and chloride concentrations, which diffuse toward the interface between the corrosion products, accelerated the process, originating voluminous products that cause exfoliation of the coating.

These tests indicate that bare galvanizing is not the most adequate coating for a high-chloride-content environment and high RH, especially with high wind speeds that slowly erode the galvanized steel. It is suggested that galvanized steel has to be protected by a high-performance coating system, which must resist erosion, high-temperature gradients, and high ultraviolet exposure.
