STUDY OF CPAC* TREATMENT FOR MOTORCYCLES

2002 V Rod treated

2003 V Rod untreated

Written by Rich Moran – May 2012 – Images taken May 2012

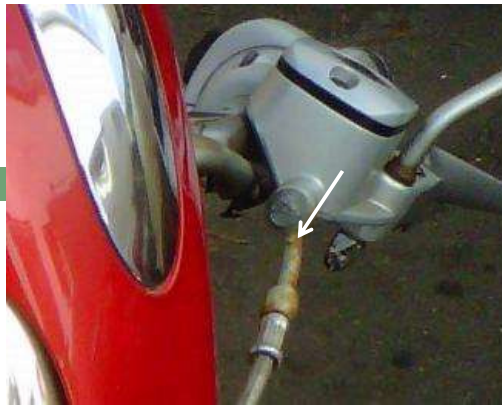
Left handlebar
control
assembly

2002 V-Rod – Maintained
Regularly rinsed with Salt Away and
treated with Rust Cop

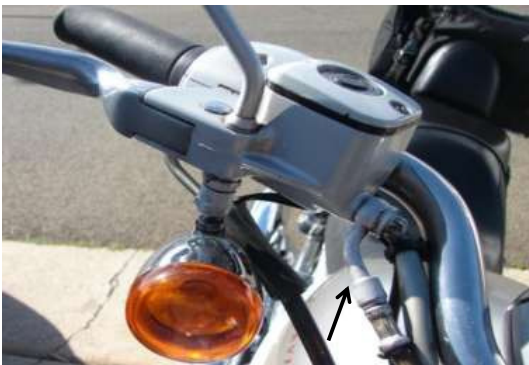
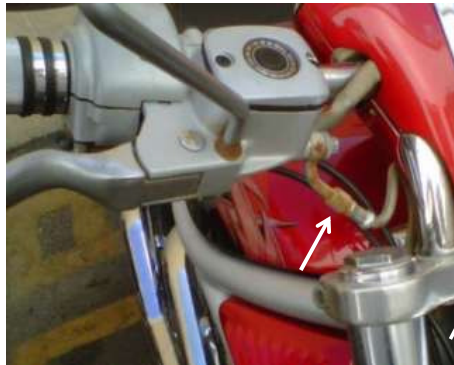
2003 V-Rod Untreated
Correct damage with Rust Cop.
Contact us at (808) 676-1963

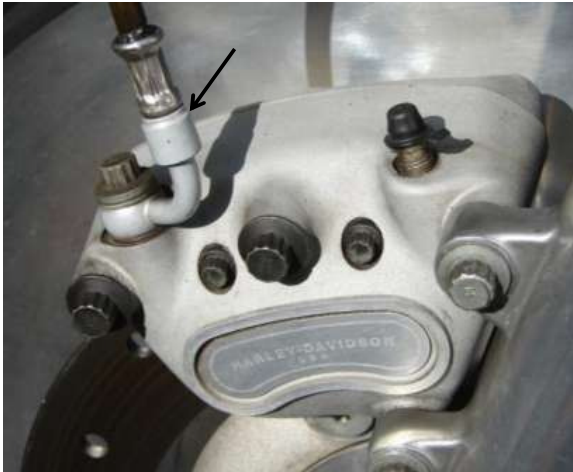
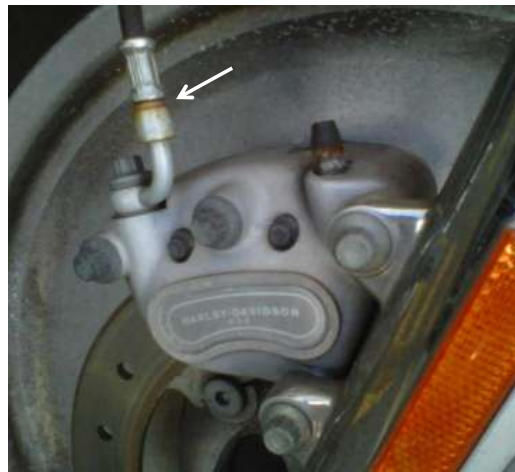
Treated with an exception here - This brake line part used by Harley Davidson is inexpensive tubing and hydraulic block.

This component is obnoxious with corrosion as we have had to service this part 3 times during ownership new-September 2002 and we believe we finally have defeated the corrosion issue with this part with an elevated service procedure. Contact us at (808) 676-1963 for more information.

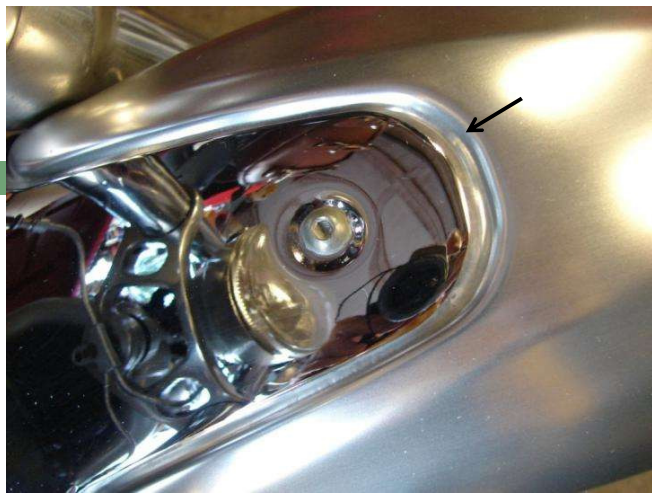
Treated and maintained with Rust Cop
– this 2002 chrome fender bracket
remains free of corrosion.

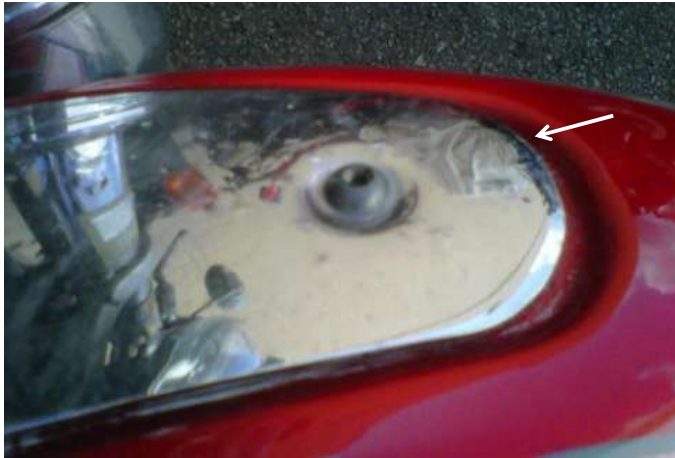
Untreated the chrome plating on this
fender bracket has lifted and is curling
due to sandwich corrosion from between
the fender and bracket.

This is easily prevented with regular
applications of Rust Cop.

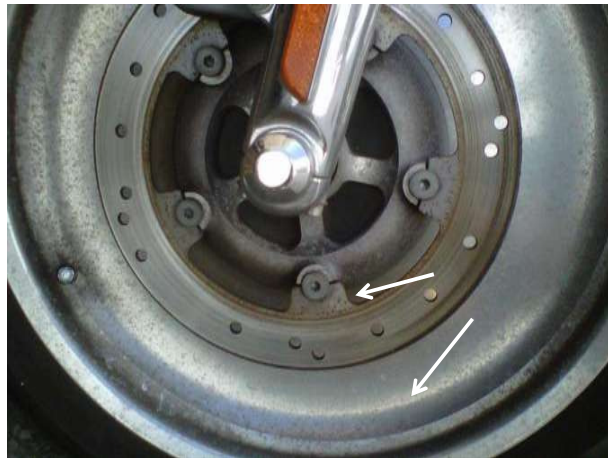
Untreated

Brake rotors can be treated with CarWell CP 90/Rust COP.

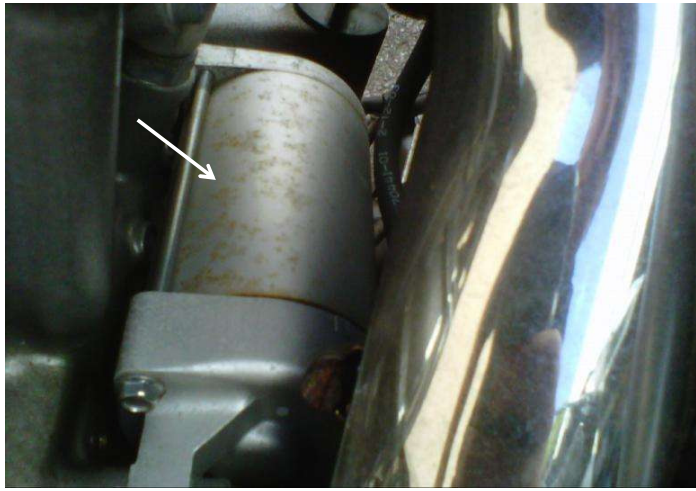
Starter housing

Untreated
