SUMMARY

1234 Main St. Winterville GA 30683

11/28/2021 9:00AM

Javie Farmer
ASHI member
Alpha Home Inspections LLC
706-340-3366
alphahomeinspections79@gmail.com

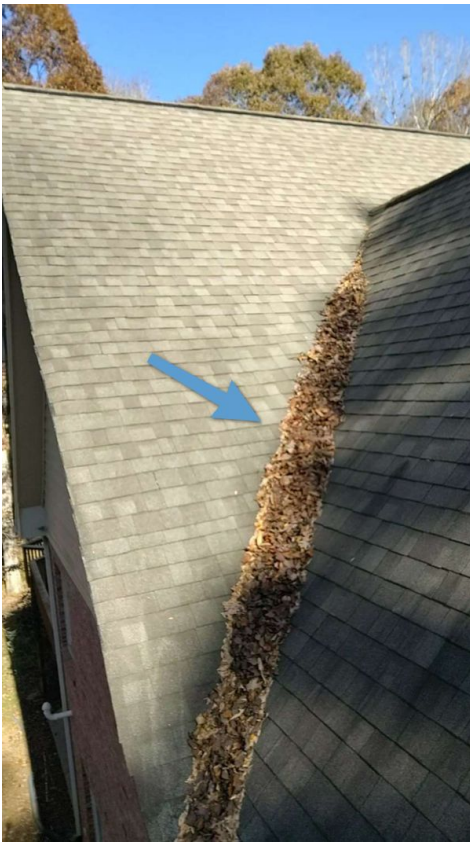
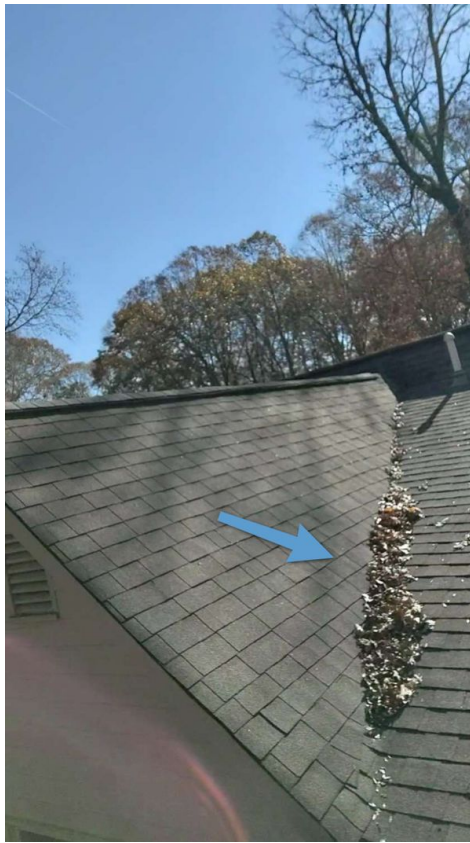
2.1.1 Coverings

LEAF BUILD-UP ON ROOF

NUMEROUS AREAS

Build-up of leaves in valleys of roof. Recommend removing any debris from roof to prevent deterioration of shingles as well as proper flow of rain water off the home structure.

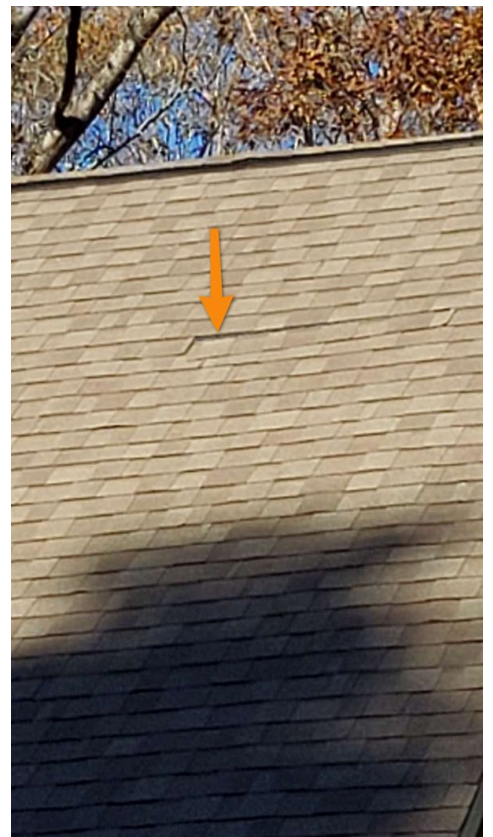
2.1.2 Coverings

UNATTACHED SHINGLES

Row of shingles on the main area roof are unattached. Recommend evaluation and repair by qualified roofing professional to prevent any further damage to the roofing shingles and integrity of roof.

Contact a qualified roofing professional.

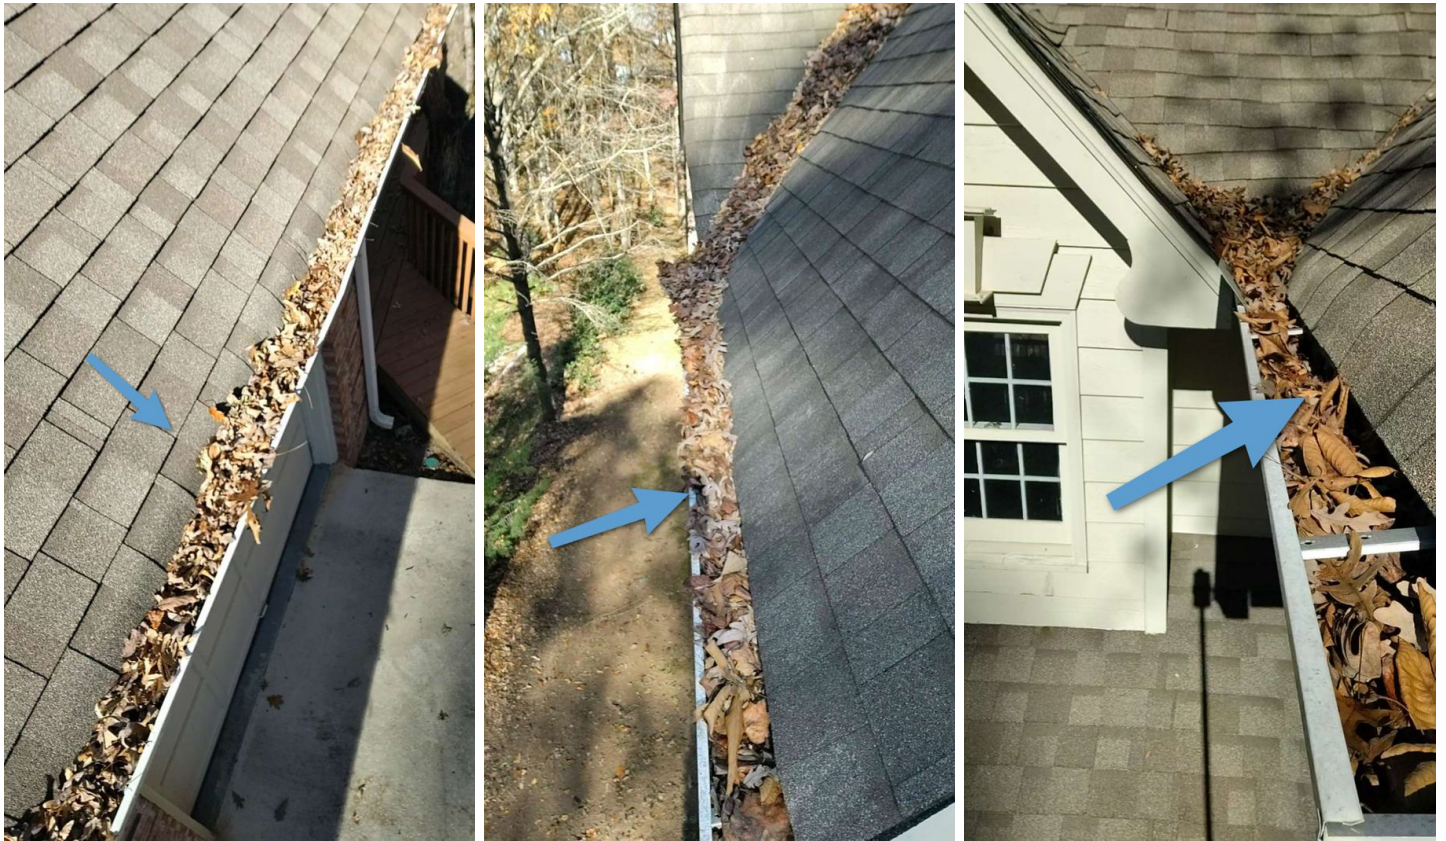
2.2.1 Roof Drainage Systems

GUTTERS NEED CLEANING

Debris has accumulated in the gutters. Recommend cleaning to facilitate water flow.

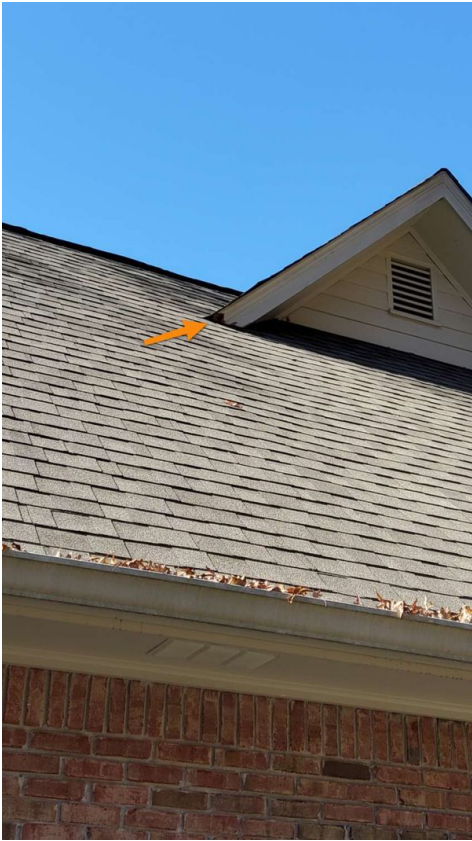
Gable above garage

DAMAGED WOOD TRIM

Wood trim is showing signs of damage. Recommend repair by qualified professional to prevent further deterioration and water intrusion.

Contact a qualified professional.

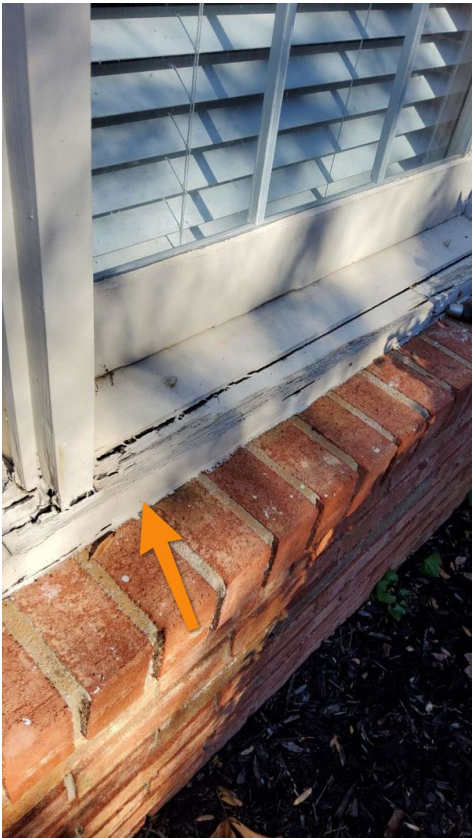
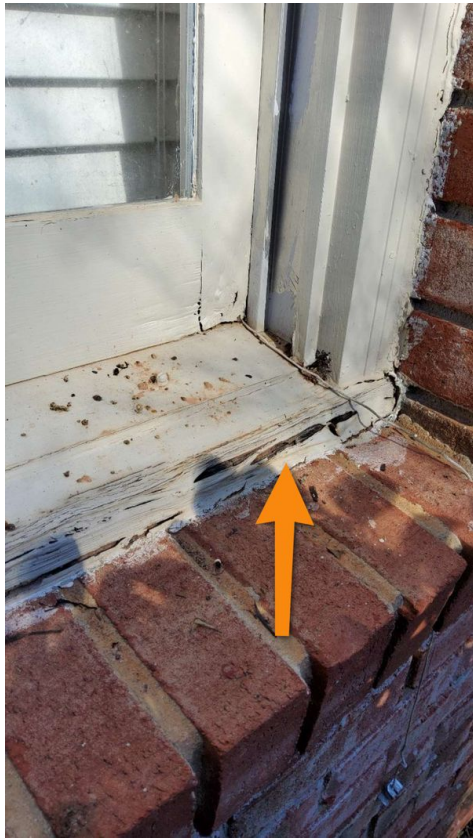
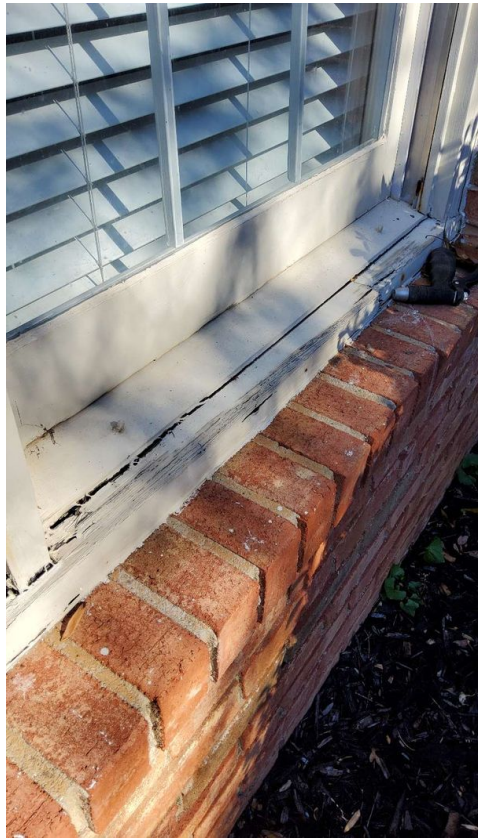
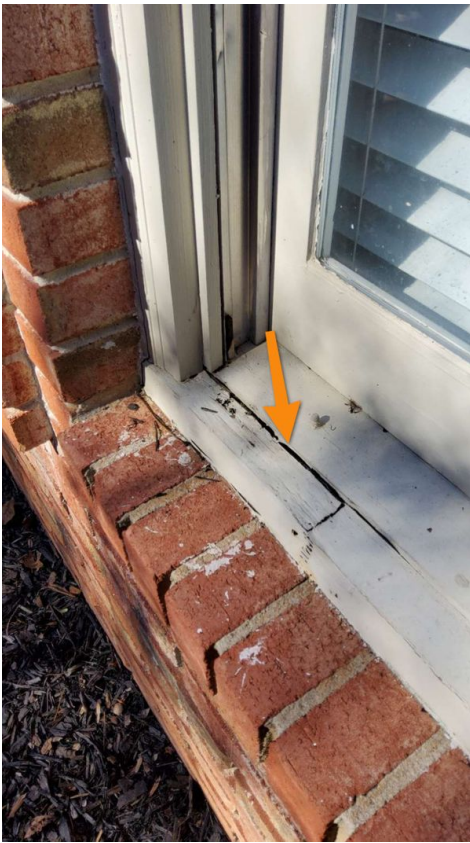
3.1.1 Siding, Flashing & Trim

1. Small Gable on Right Side of Home above Garage
2. Corner on Right Side of Home above Front Porch
3. Window Sills on Front of Home (Main Level)

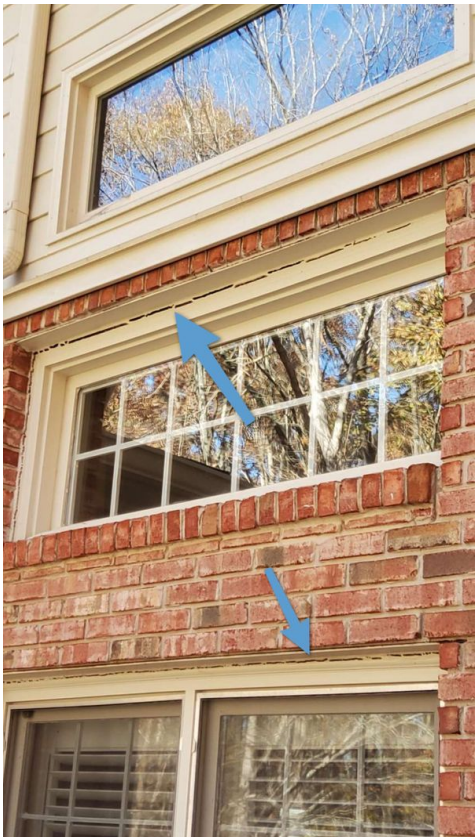
3.1.2 Siding, Flashing & Trim
CAULKING NEEDED

REAR DECK WINDOWS

Recommend caulking around the exterior of the windows to prevent water penetration.

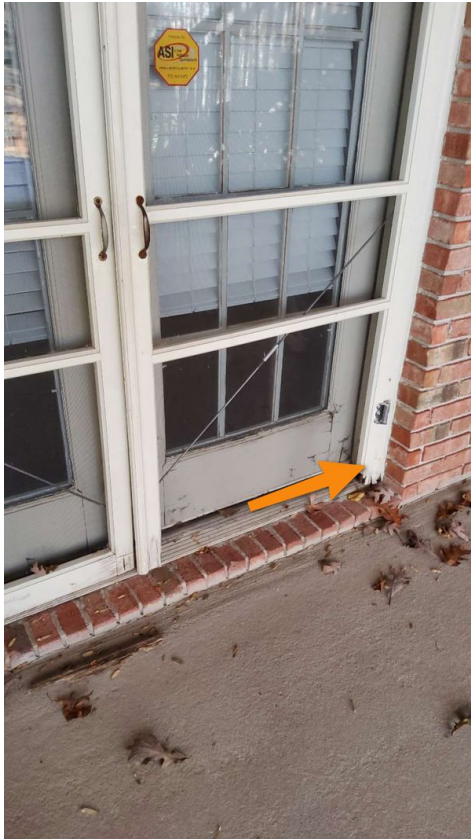
Lower screen door

Screen doors on the basement level, are damaged on the bottom of the wooden frame.

Recommend evaluation and repair/replacement by qualified professional of the damaged wooden and screen doors.

Contact a qualified professional.

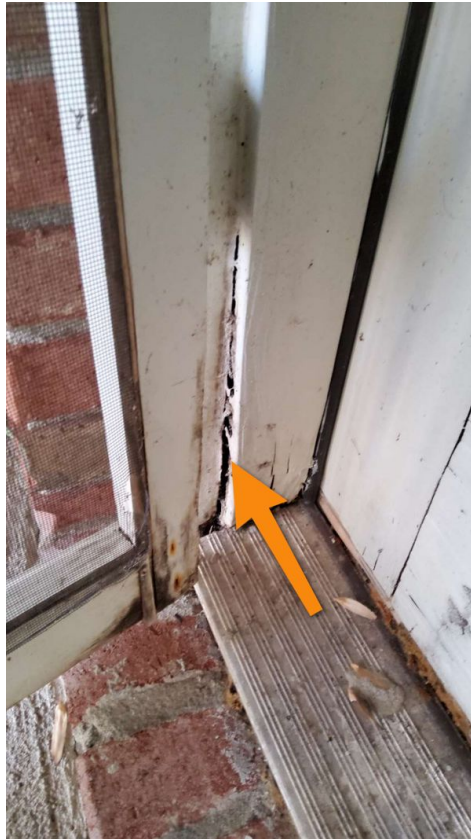
Lower door

Water damage noted on the bottom of the wooden exterior French doors, both rear main level doors and rear basement doors.

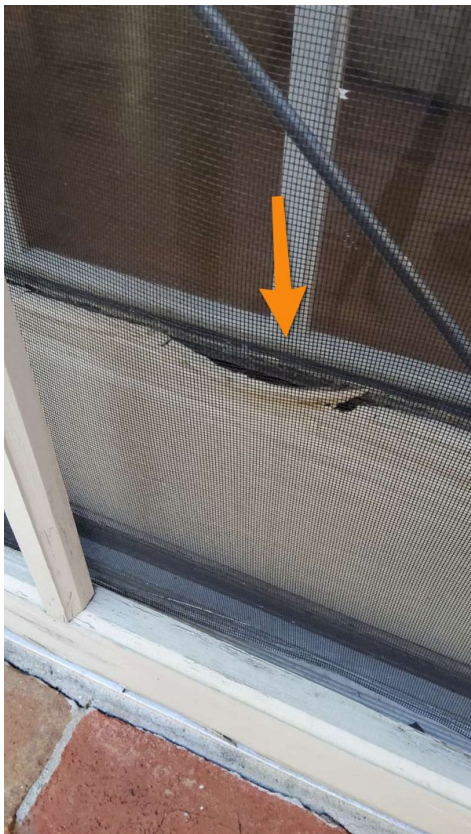
Upper deck door

Screen is detaching from the wooden frame on the main level.

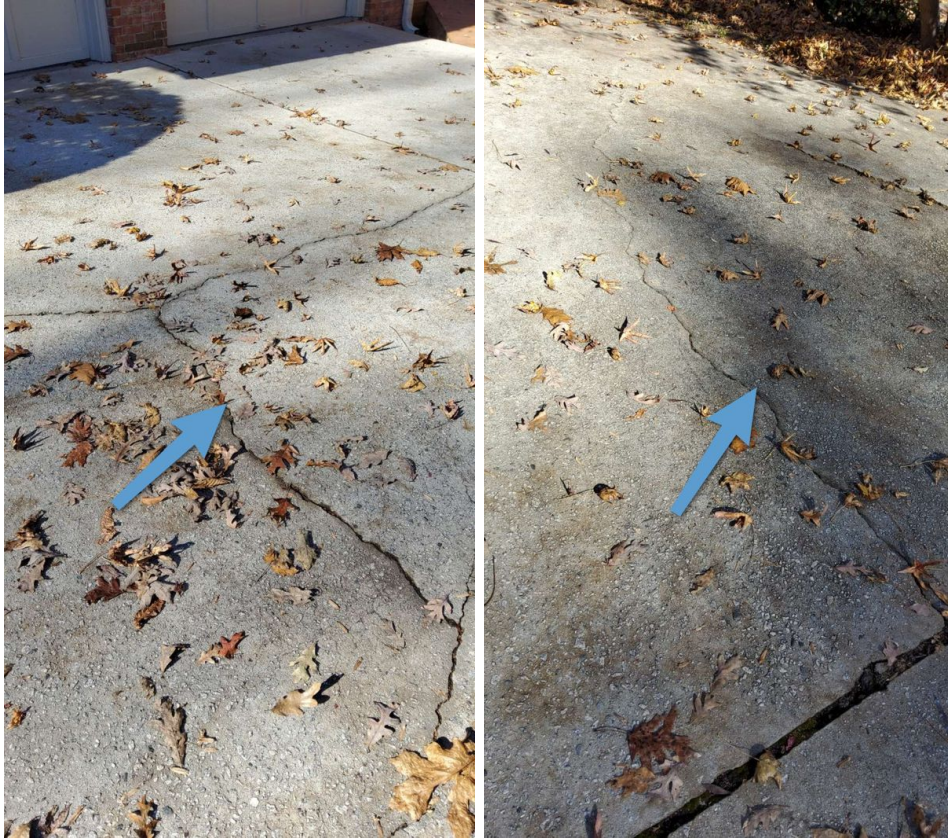
3.3.1 Walkways, Patios & Driveways

DRIVEWAY CRACKING - MINOR

Minor cosmetic cracks observed, which may indicate movement in the soil. Recommend monitor and/or have concrete contractor patch/seal.

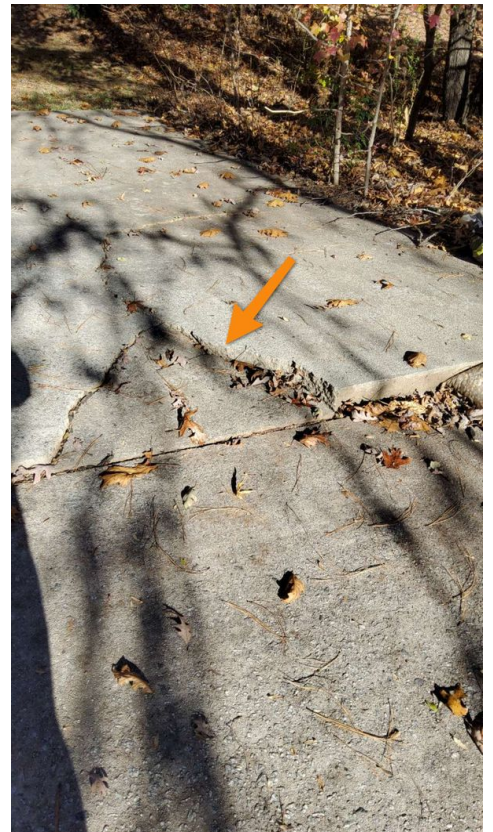
3.3.2 Walkways, Patios & Driveways

DRIVEWAY PARKING PAD - HEAVING

Settling & heaving observed. Further deterioration could result. Recommend concrete/driveway contractor evaluate & repair.

Contact a qualified driveway contractor.

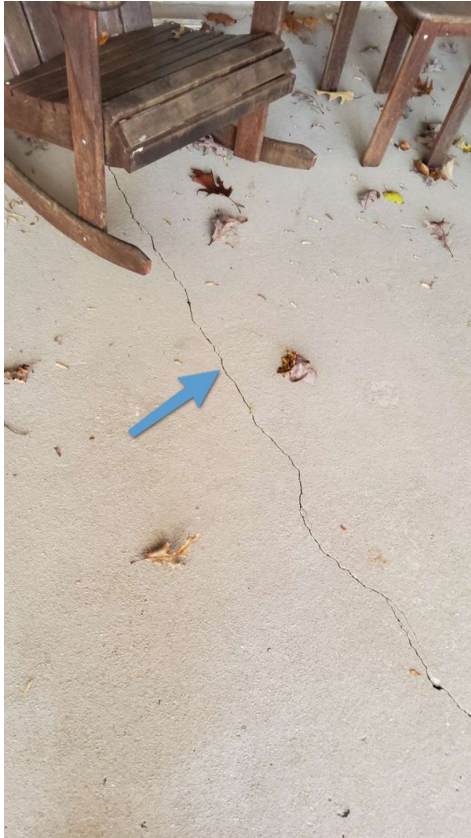
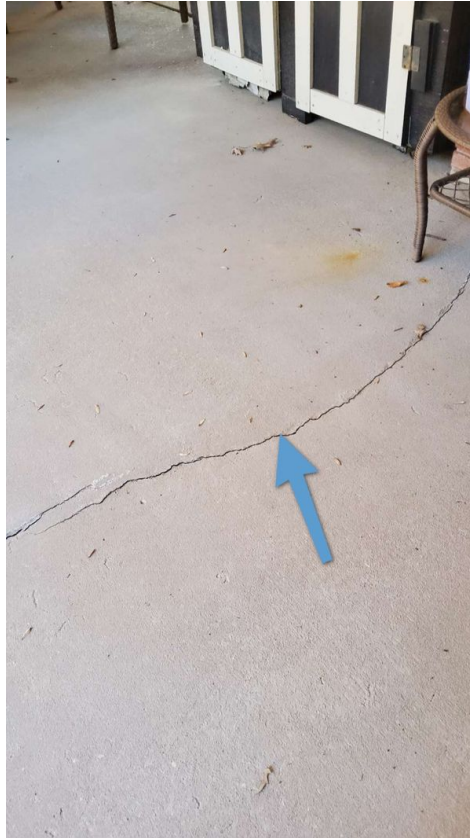
3.3.3 Walkways, Patios & Driveways

PATIO CRACKING - MINOR

BASEMENT PATIO

Normal settling & cracking observed. Recommend monitor and/or patch/seal.

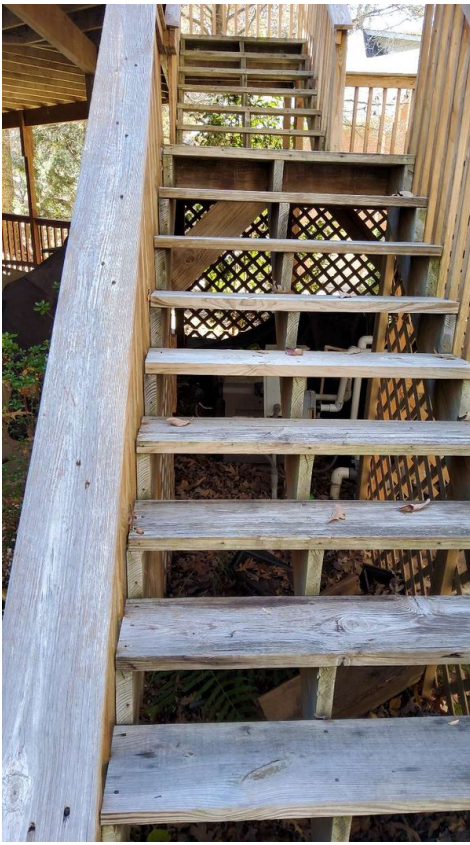
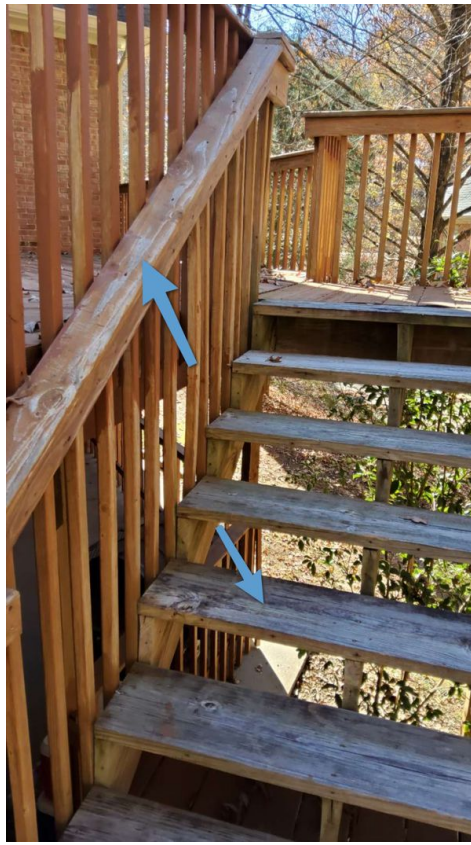
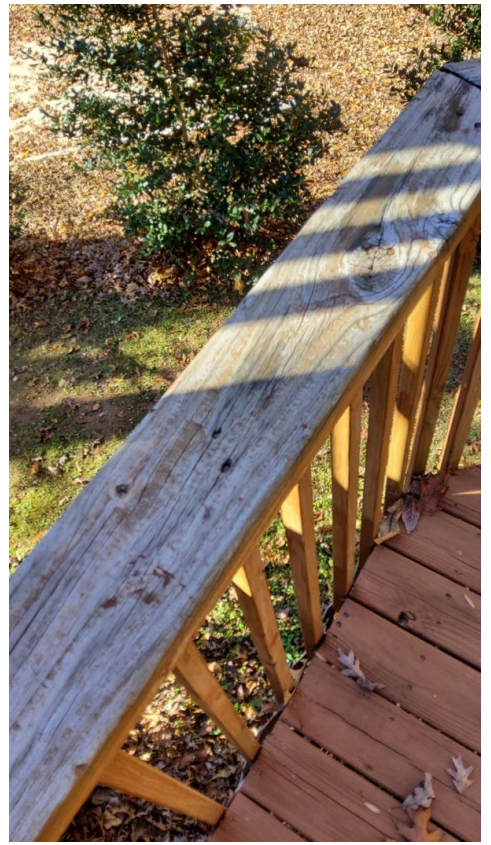
3.4.1 Decks, Balconies, Porches & Steps

WATER SEALANT REQUIRED

Some areas of rear deck (steps, handrails, lower deck) is showing signs of weathering. Recommend water sealant/weatherproofing be applied.

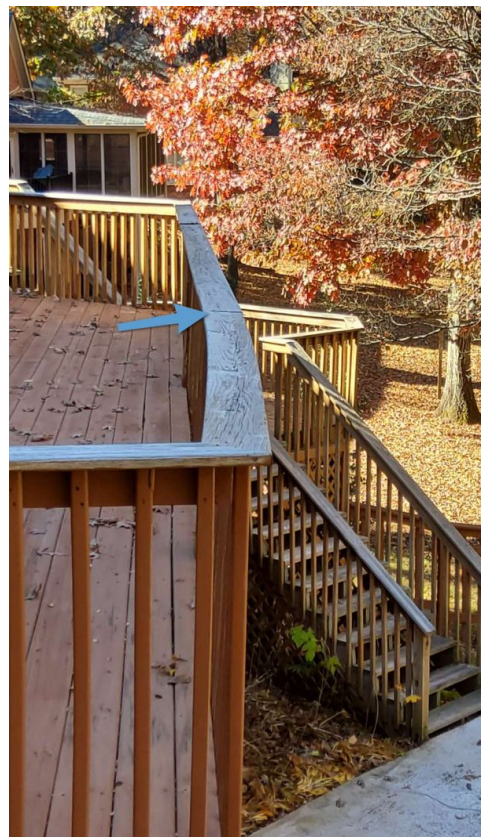
3.4.2 Decks, Balconies, Porches & Steps

DECK RAILING - SLIGHT CURVATURE

Slight curvature of exterior handrail on rear deck. The handrailing was secure and not loose at time of inspection. Recommend monitoring and if handrail loosens, securely attach for safety.

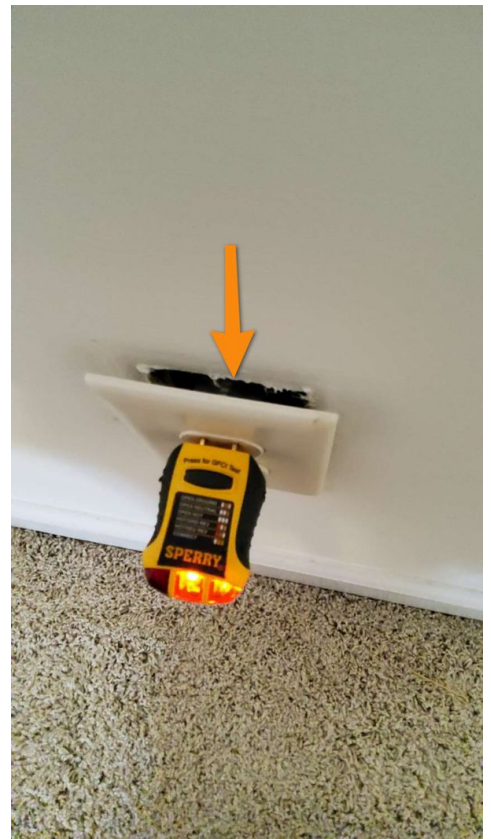
8.4.2 Lighting Fixtures, Switches & Receptacles

LOOSE RECEPTACLE

2ND LEVEL - LEFT BEDROOM

Receptacle is loose on the rear wall of the left bedroom.

Recommend properly securing by a qualified professional.

Contact a qualified professional.

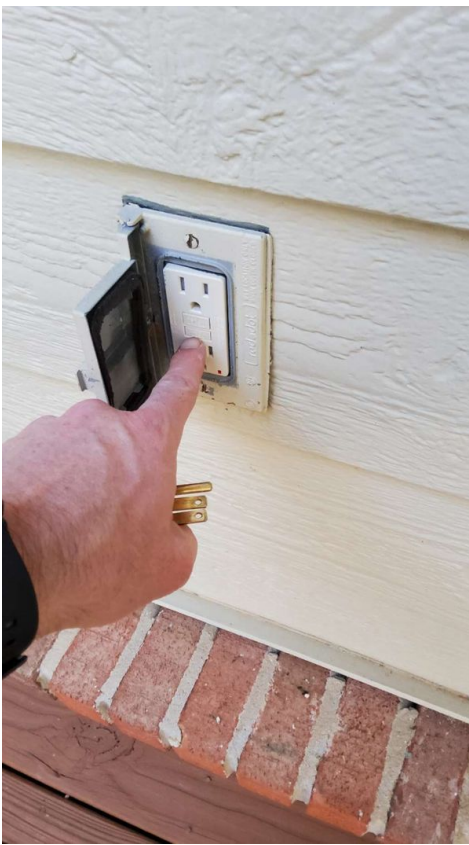
8.5.1 GFCI

GFCI - TEST/RESET BUTTON

RIGHT SIDE OF HOME ON DECK

GFCI test/reset button is stuck and inoperable, thus no power is coming to the receptacle. This receptacle also appears to protect the other exterior receptacles on the front porch and back deck that are not receiving any power. Recommend evaluation and repair by qualified electrician for proper function of the GFCI and other exterior receptacles.

Contact a qualified electrical contractor.

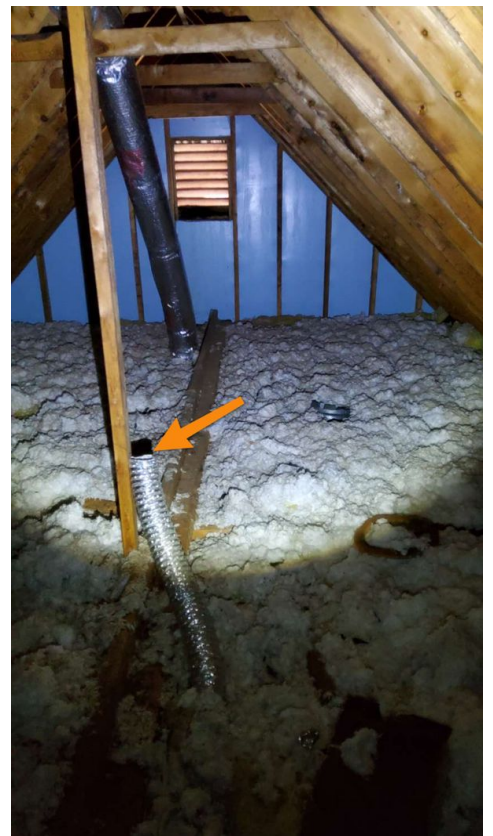
10.4.1 Exhaust Systems

BATHROOM VENTS INTO ATTIC

Bathroom fan vents into the attic, which can cause moisture build-up. Recommend a qualified professional properly install exhaust fan to terminate to the exterior.

*Appears to be the vent to the Jack-and-Jill bathroom

Contact a qualified professional.

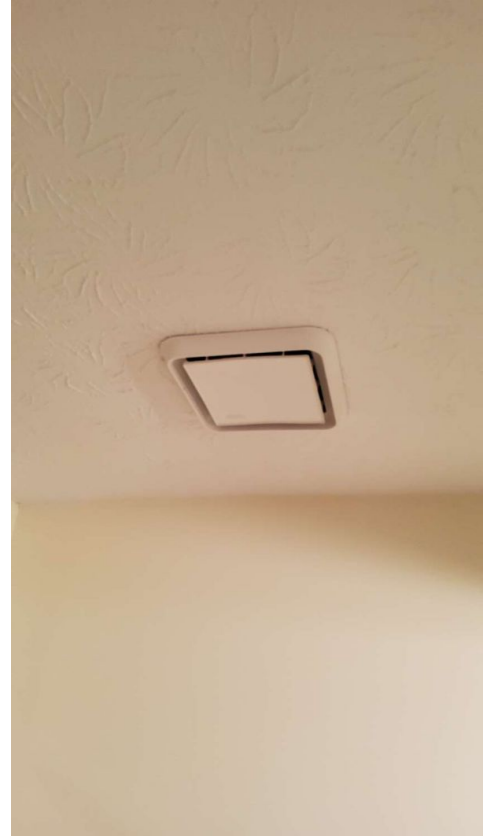
10.4.3 Exhaust Systems

NOISY EXHAUST FAN

2ND LEVEL BATHROOM - LEFT SIDE OF HOME

Cleaning, adjusting, or lubricating the bathroom ceiling exhaust fan will usually fix the problem.

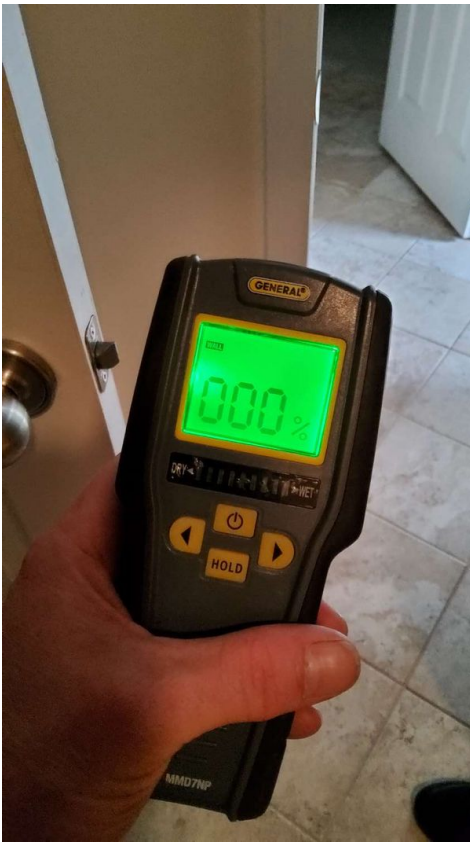
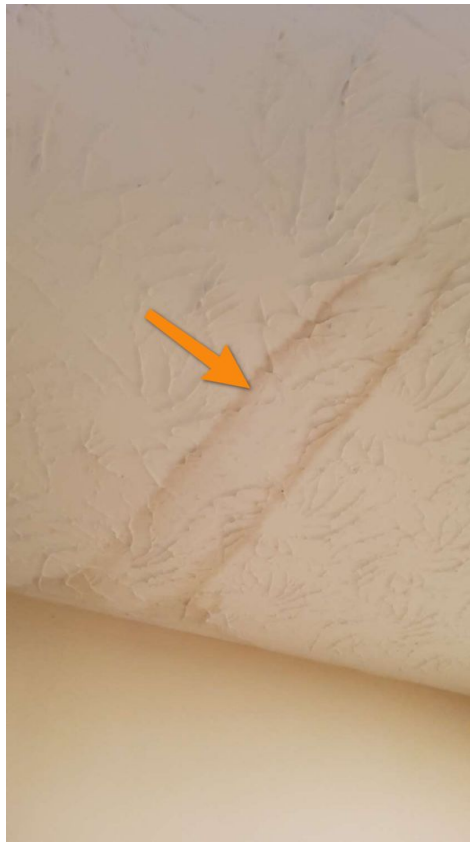
11.5.1 Ceilings

STAIN(S) ON CEILING

2ND LEVEL: JACK-AND-JILL BATHROOM

There is a stain on ceiling above shower that appears to be from a prior leak. The stain tested dry with moisture meter at time of inspection. Source of stain could not be determined at time of inspection. Recommend further evaluation by roofing professional to ensure no active leak.

Contact a qualified roofing professional.

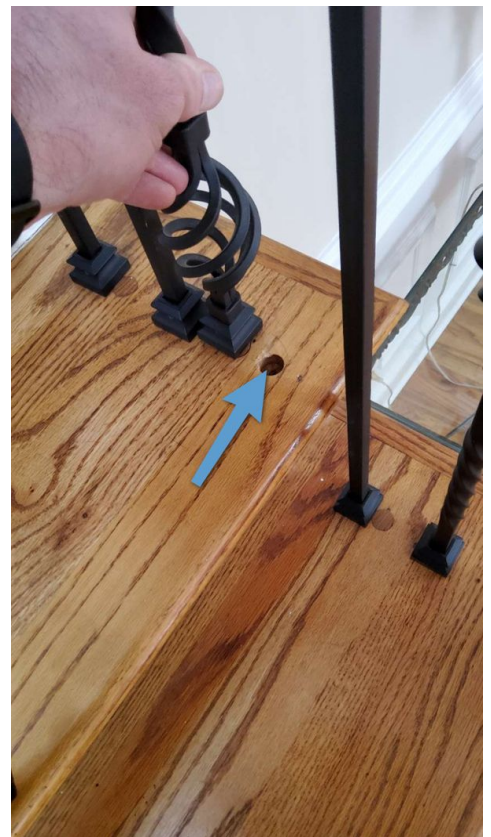
11.6.1 Steps, Stairways & Railings **BALUSTER UNATTACHED**

Bottom of baluster unattached to the stair. Recommend securing and attached for proper handrail security.

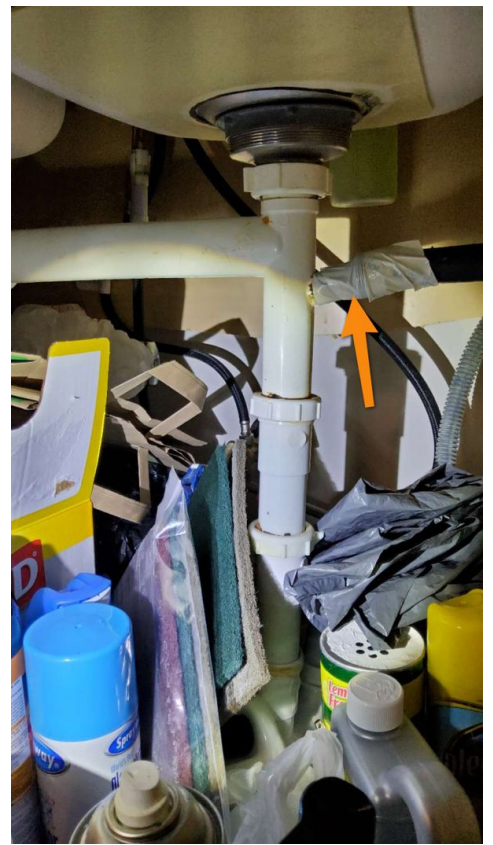
12.1.1 Dishwasher **DRAIN HOSE TAPED TO DRAIN**

Basement dishwasher drain hose was taped to the drain pipe and drain hose appeared clogged/dirty. There was also a strong odor when the rinse cycle was ran. Recommend evaluation and repair by qualified professional (appliance repair/plumber).

Contact a qualified professional.

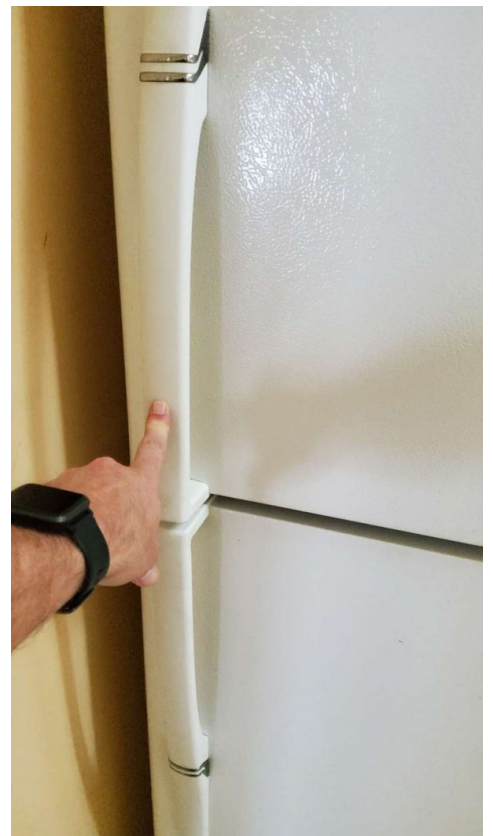
12.2.1 Refrigerator

FREEZER DOOR FROZEN SHUT

LAUNDRY ROOM

Laundry room freezer door was frozen shut at the time of inspection. A freezer door that's frozen shut could be due to a faulty door seal or because it hasn't been defrosted in a while. The freezer should be defrosted at least once a year to keep ice from building up on rails or around the interior of the compartment. Recommend defrosting the freezer and if that doesn't resolve the issue, have the door seal replaced by appliance professional.
