# Rob Smith Property Investigations

## Property Inspection Report - Confidential

1234 Happy Trails Dr., New Place MO, 23777  
Inspection prepared for: Larry & Mary Sample  
Agent: Im A. Realtor - Best Home For You

Inspection Date: 9/1/2012 Time: 8am to 11am  
Age: Built in 2004  
Weather: Sunny

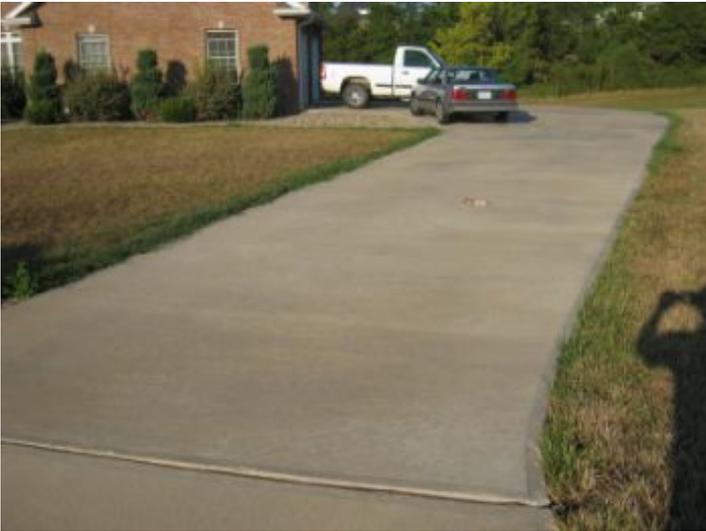
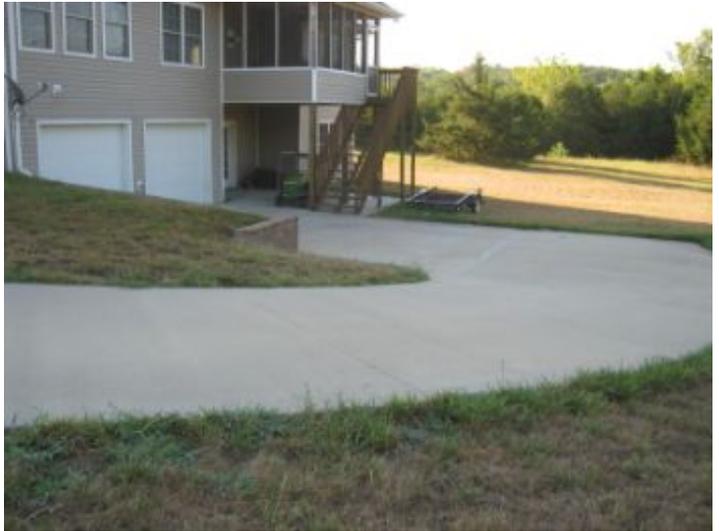
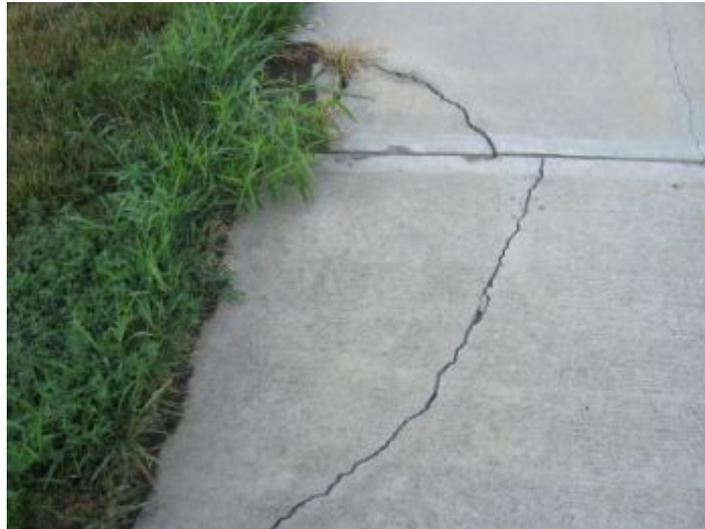
Driveway in good shape for age and wear. Some common cracking/pitting observed. Recommend clean and seal surface to extend life.

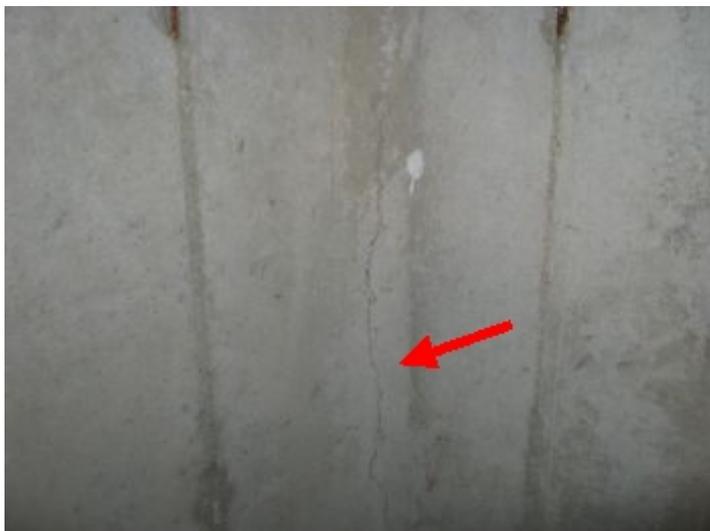
Common cracks. Recommend monitoring over time for increased cracking activity. Recommend sealing of current cracks to minimize intrusion of water/moisture/insects/radon into the building.

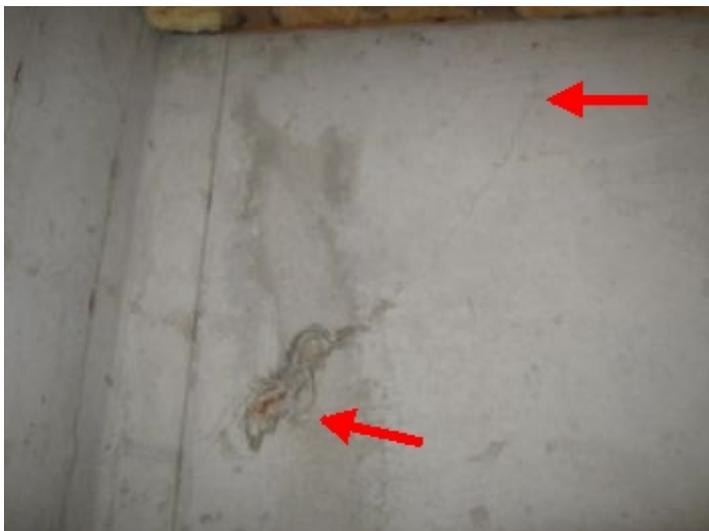
Common cracks. Recommend monitoring over time for increased cracking activity. Recommend sealing of current cracks to minimize intrusion of water/moisture/insects/radon into the building.

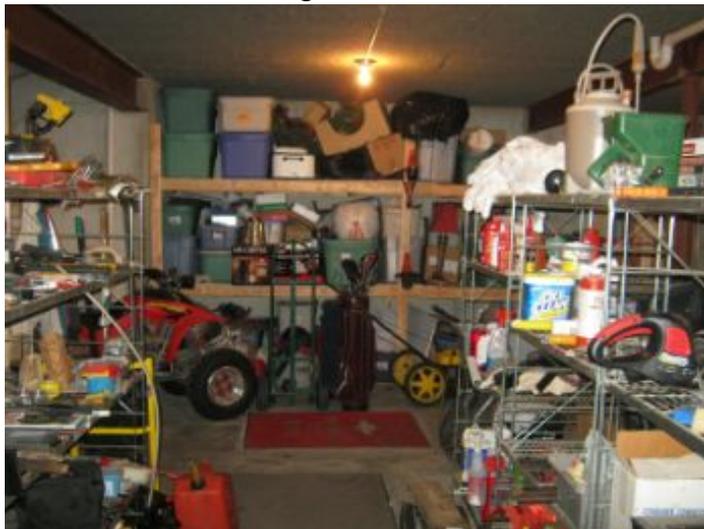
Limited review due to storage of personal property and finished walls.

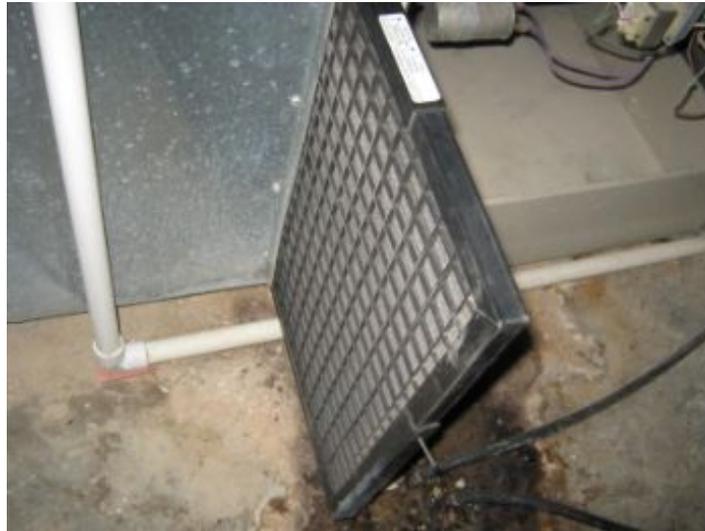
- The furnace filter is dirty. Filters help clean the house air, making the environment more pleasant. Filters also clean the air before it passes through the blower and heat exchanger. This helps to keep these furnace components working efficiently. It is recommended to change the filter and then regular inspection & maintenance is advised.

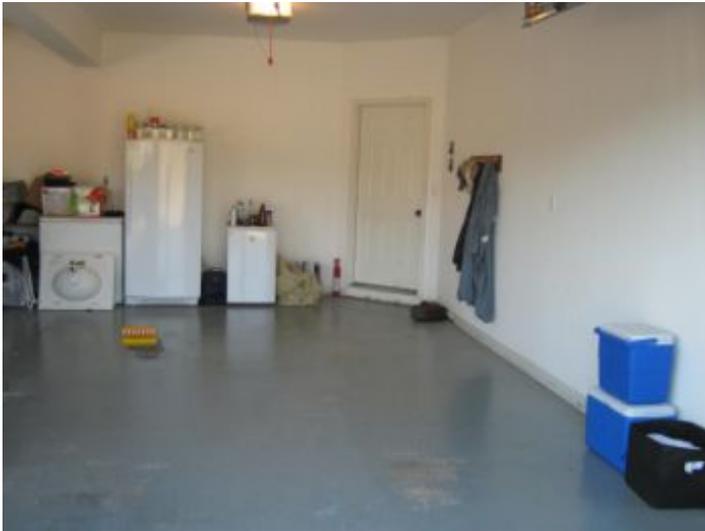
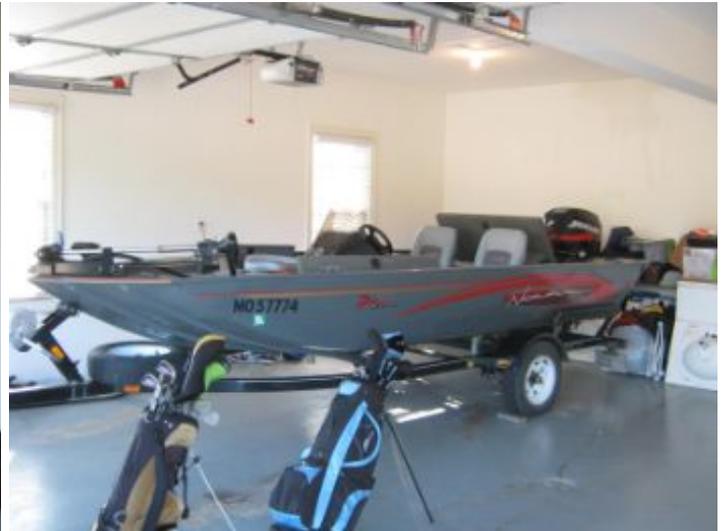
- Sill plates behind finished surfaces could not be viewed.
- Garage floor is in good and serviceable condition.
- Observed common pitting/surface deterioration of concrete garage floor. This is typically from road salt. Keep floor surface cleaned, patched, and sealed to preserve the garage floor condition.

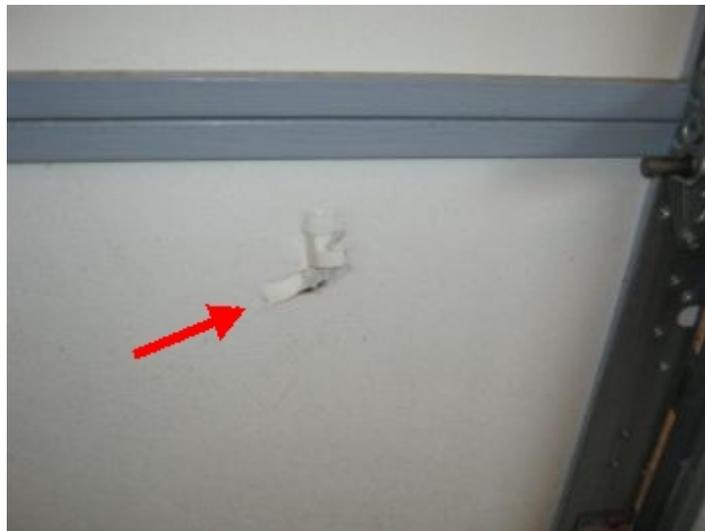
Damaged

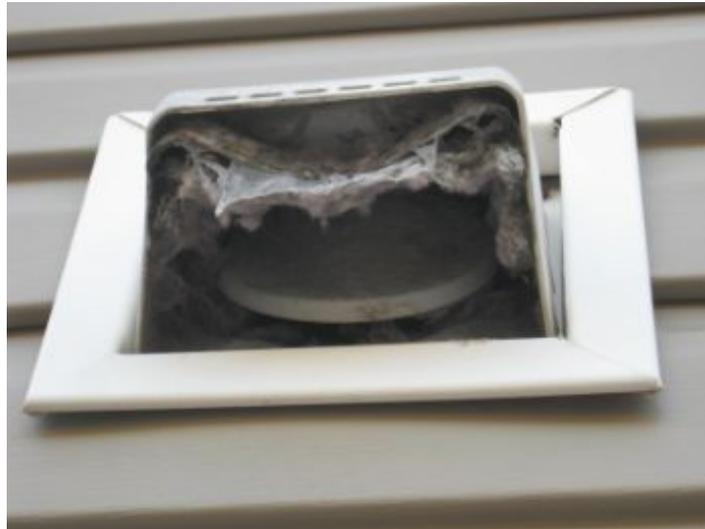
Exterior dryer vent at Northwest corner of house is clogged with lint. Recommend cleaning of unit to minimize fire hazard and improve dryer unit operation.

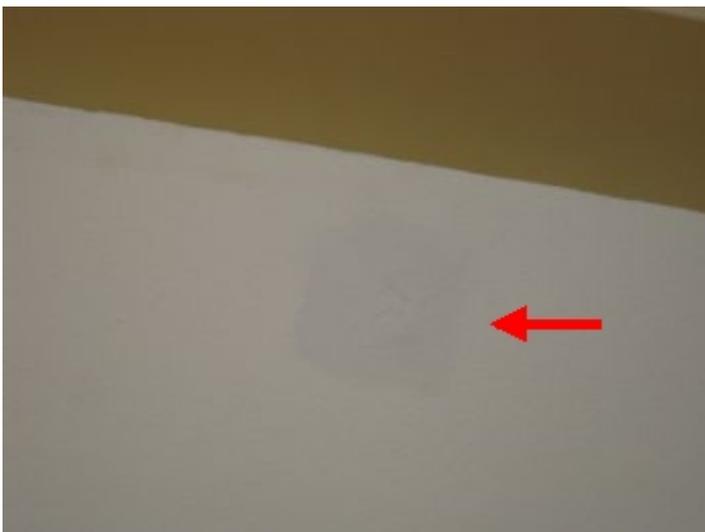
patched areas

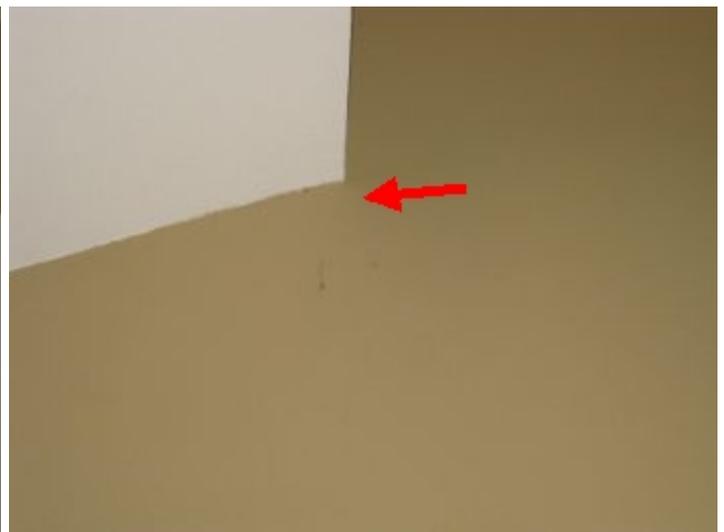
Common small settling cracks in wall and ceiling finish observed. This normal wear for age of home. Recommend repair and paint

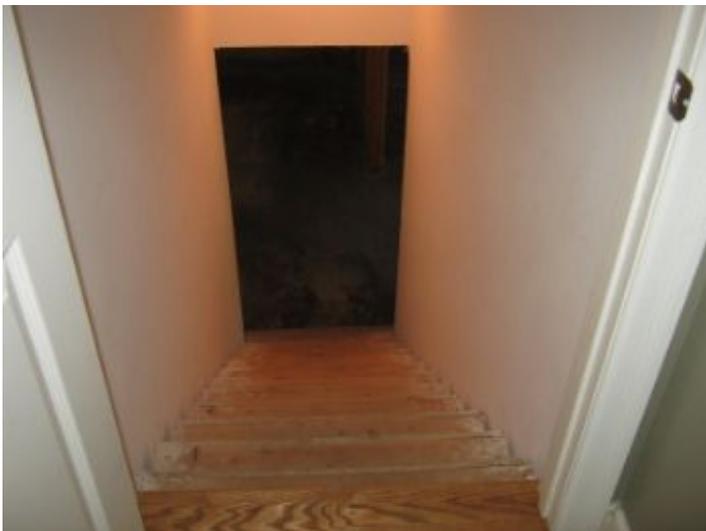
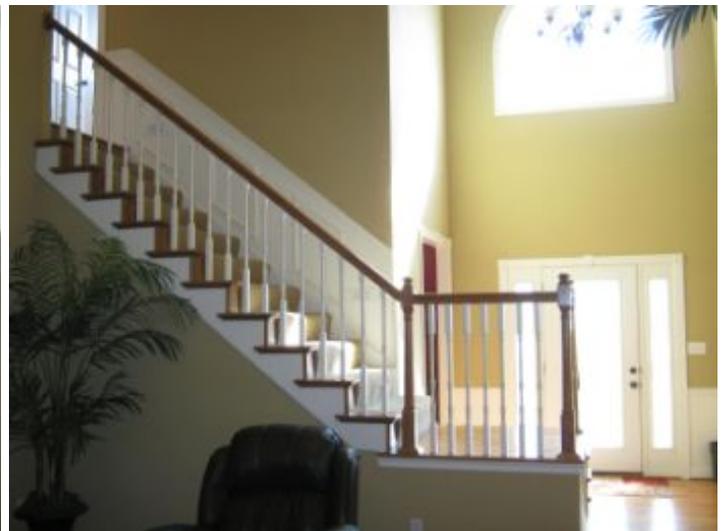
Missing handrails at the interior basement steps.  
Some one can slip & fall. Recommend having railings at all interior steps including the attic.
