# Home Inspection Report

123 ABC Street  
Anytown, USA

Inspected by:  
Greg Glendenning  
Inclusive Home Inspection

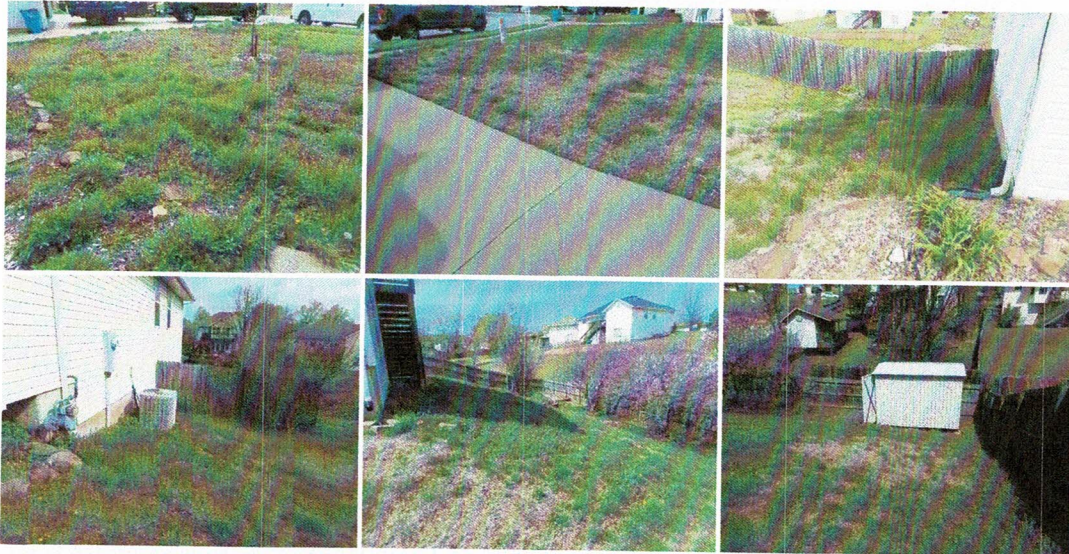
7.      Fences: Wood - Gates on West side of house need adjustment and maintenance.

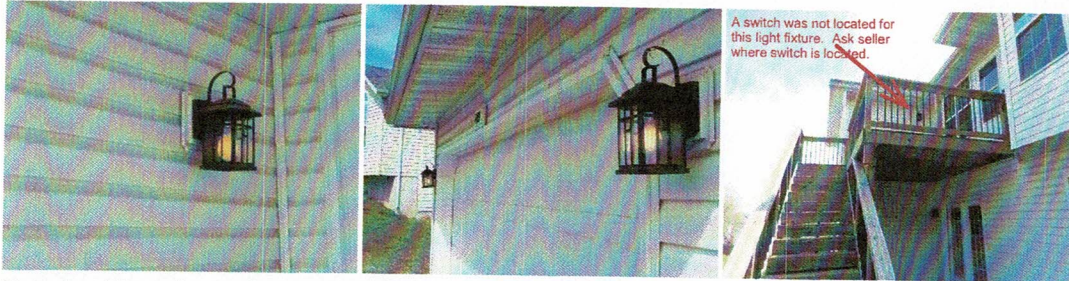
11.  Exterior Lighting: Surface mounted lamps front and rear - All lights work minus the light on the rear deck. A light switch was not found for that light. Ask seller for location of switch and or how it is controlled.

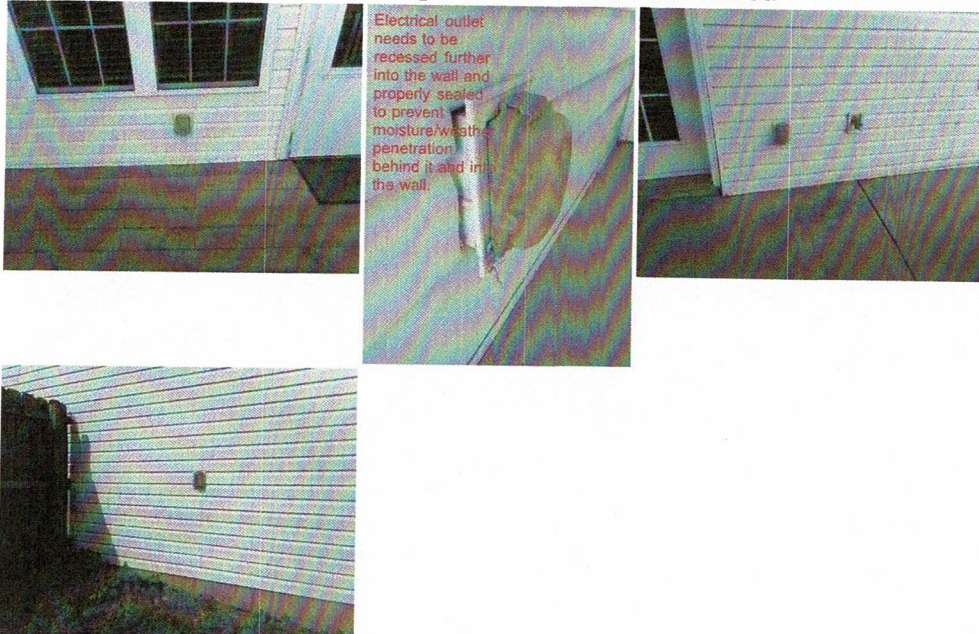
12.  Exterior Electric Outlets: 110 VAC - 3 total exterior electrical outlets. One located at the main entrance, second at rear of home and the third on the east side of the house. These outlets should be converted to GFCI. The outlet at the entrance of the home is not secure and should be remounted to ensure there is no water/weather penetration. Recommend a licensed electrician adjust electrical box in front of home as well as ensure that the exterior outlets are GFCI. Vinyl siding contractor repair the siding and seal around the outlet.

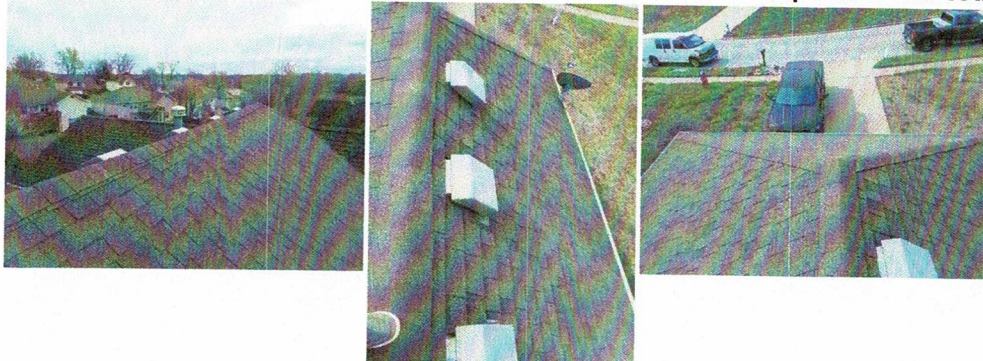
1. Method of Inspection: On roof
2.      Material: Asphalt shingle - In 3 locations on the ridge caps, shingles need to be repaired and or replaced. It appears in at least 2 of the locations, prior repairs may have been attempted. A qualified roofing contractor should be contacted for further inspection and estimate for repairs.

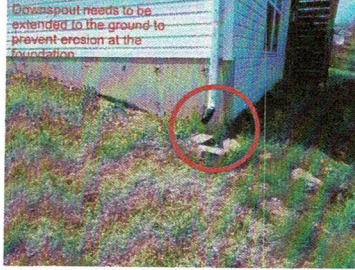
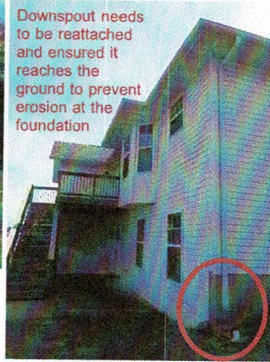
9.      Downspouts: Aluminum - The downspout on the West rear corner of the home needs to be reattached and ensured it reaches the ground and is directed away from the home to prevent erosion at the foundation. The East rear corner of the home needs to have the downspout extended to the ground and is directed away from the home to prevent erosion at the foundation. A gutter/downspout contractor needs to be contacted for repair estimate.

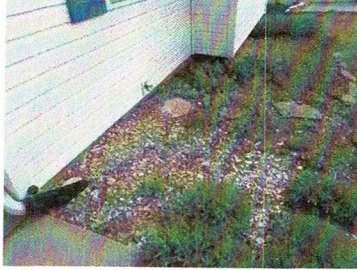
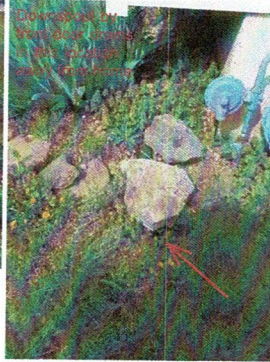
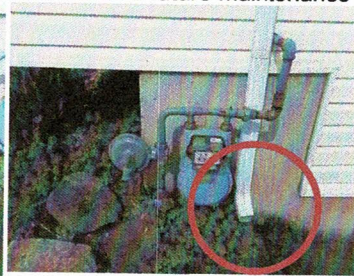
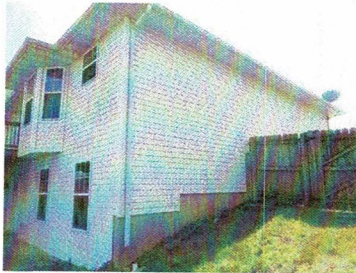
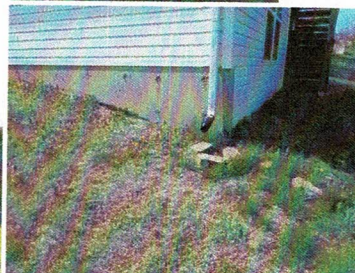
10.     **Leader/Extension: Missing** - The leaders on all 4 corners of the home are missing. A 5 foot leader needs to be added to direct water away from foundation. This could be considered a future maintenance project.

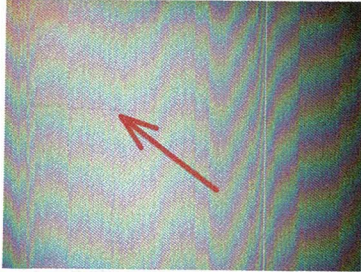
9.      Ceiling: Painted gypsum board. Crack is present in the gypsum board seam. This crack is due to expansion/contraction. A qualified drywall contractor should be contacted for estimate of repair.

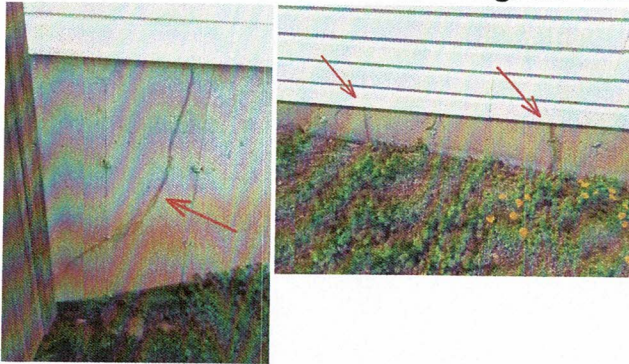
- 1.      Structure Type: Wood frame
- 2.      Foundation: Poured
- 3.      Differential Movement: Crack with minor displacement - 1 crack on west foundation wall. Looks to have been sealed prior. Little displacement, interior cannot be observed due to gypsum wall board covering wall. 2 cracks on east foundation wall. Prior repairs have been made. Little displacement, interior cannot be observed due to gypsum wall board covering wall. If there is concern from the client, a structural engineer will need to be contacted.

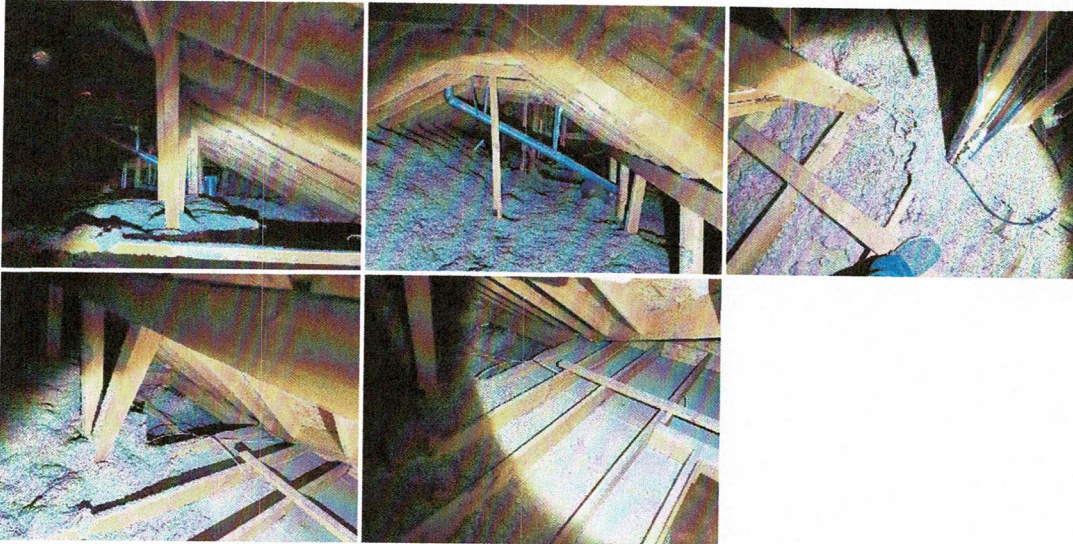
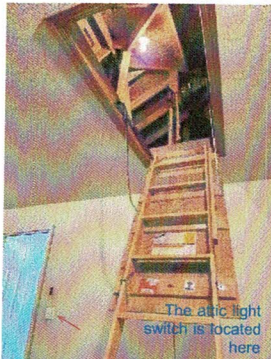
5.  Insulation: Blown in - The blown in insulation has been moved and compressed. Recommend insulation contractor to inspect and provide estimate. Adequate insulation in the attic will help with heating and cooling bills.

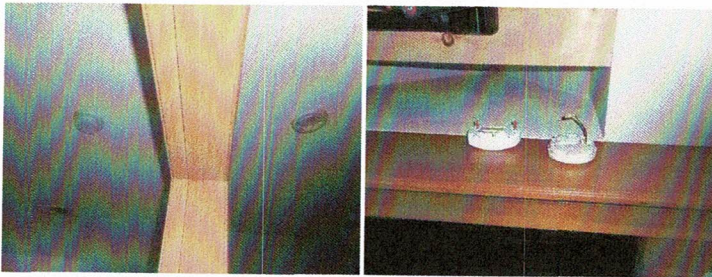
- 5.  Doors: Hollow wood
- 6.  Windows: Vinyl double hung - All windows, open, close & lock.
- 7.  Electrical: 110 VAC outlets and lighting circuits
- 8.  Smoke Detector: Not inspected - Basement smoke detector and carbon monoxide detector found on top of fireplace mantel. Recommend replacement and installation per fire department recommendations.

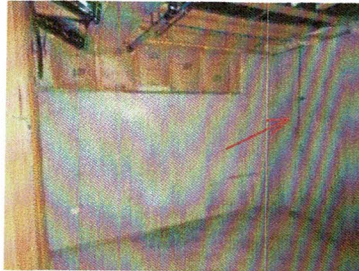
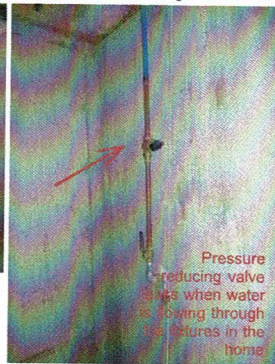
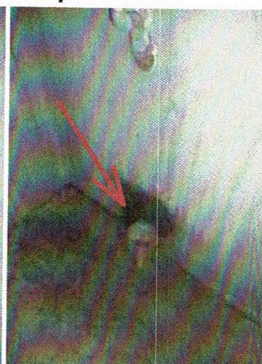
- 1.  Service Line: Galvanized - Pressure reducing valve leaks when water is flowing through the fixtures of the home. Recommend replacement by a licensed plumber.

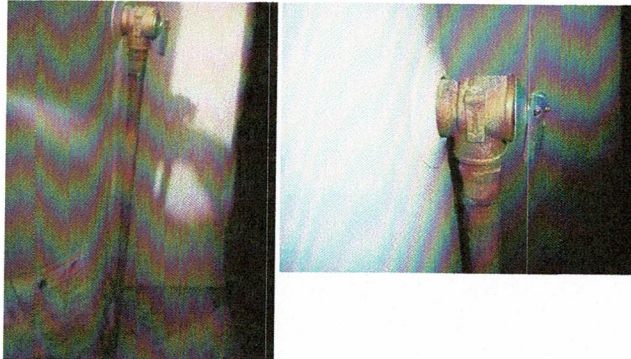
14.      TPRV and Drain Tube: Copper - Blow down and drain from water heater drains in a room that does not have a floor drain. It needs to be piped to the drain in the neighboring laundry room. If the TPRV activates, it will discharge water onto the floor of the basement. Recommend further investigation and pricing from licensed plumber.

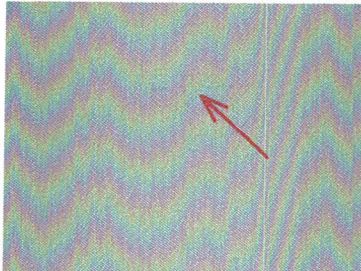
- 1.      Closet: Double walk-in closets, linen closet
- 2.      Ceiling: Painted gypsum board - Crack is present in the gypsum board seam. This crack is due to expansion/contraction. A qualified drywall contractor should be contacted for estimate of repair.

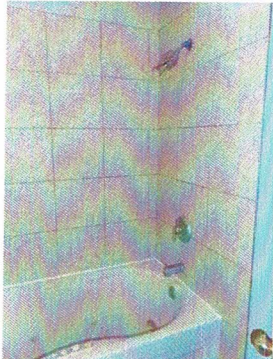
- 3.      Walls: Painted gypsum board
- 4.      Floor: Ceramic tile
- 5.      Doors: Hollow wood
- 6.      Windows: Non-opening
- 7.      Electrical: 110 VAC GFCI
- 8.      Counter/Cabinet: Laminate and wood
- 9.      Sink/Basin: Porcelain double sinks
- 10.      Faucets/Traps: Moen fixtures with a PVC trap
- 11.      Spa Tub/Surround: Fiberglass tub and ceramic tile surround - The spa includes a shower head. A shower curtain will need to be installed. Spa portion of tub was not tested. Recommend licensed plumber verify condition and functionality of spa tub.

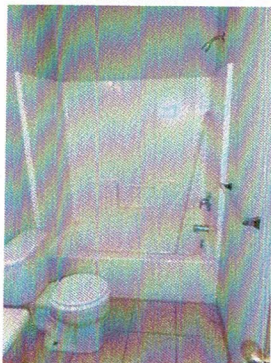
- 20.      Electrical: 110 VAC GFCI
- 21.      Counter/Cabinet: Laminate and wood
- 22.      Sink/Basin: Porcelain
- 23.      Faucets/Traps: Moen fixtures with a PVC trap
- 24.      Tub/Surround: Fiberglass tub and fiberglass surround - Shower/tub combo, need shower curtain rod installed.

- 25.      Toilets: Crane - The toilet is loose at the floor and will require replacement of the wax seal by qualified plumber.
- 26.      HVAC Source: Heating system register
- 27.      Ventilation: Electric ventilation fan

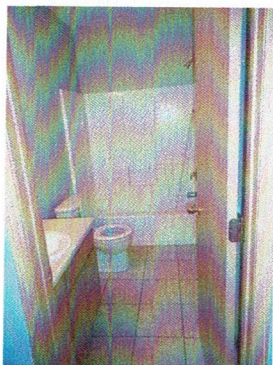
- 28.      Closet: None
- 29.      Ceiling: Painted gypsum board
- 30.      Walls: Painted gypsum board
- 31.      Floor: Ceramic tile
- 32.      Doors: Hollow wood
- 33.      Electrical: 110 VAC GFCI
- 34.      Counter/Cabinet: Laminate and wood
- 35.      Sink/Basin: Porcelain
- 36.      Faucets/Traps: Moen fixtures with a PVC trap
- 37.      Tub/Surround: Fiberglass tub and fiberglass surround - Shower/tub combo, need shower curtain rod installed.

- 38.      Toilets: Crane - The toilet is loose at the floor and will require replacement of the wax seal by qualified plumber.

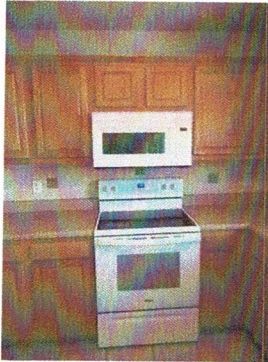
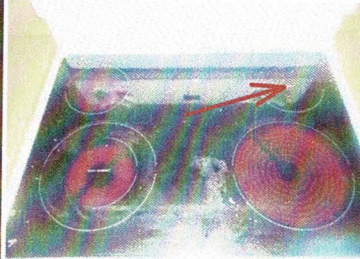
- 1.      Cooking Appliances: Whirlpool - Right rear burner does not come on, all other burners and over function.

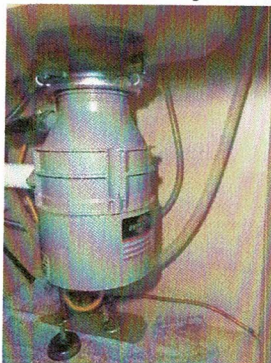
- 3.      Disposal: Evergrind - Disposal seems to be bound, recommend further inspection and or replacement by a licensed plumber.

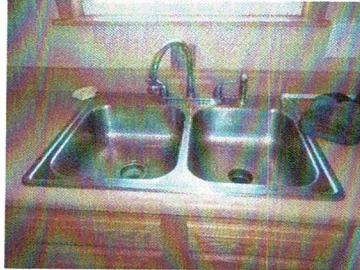
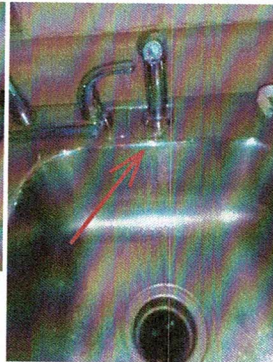
8.      Sink: Stainless Steel - Sprayer leaks, may need tightening and or replacement.

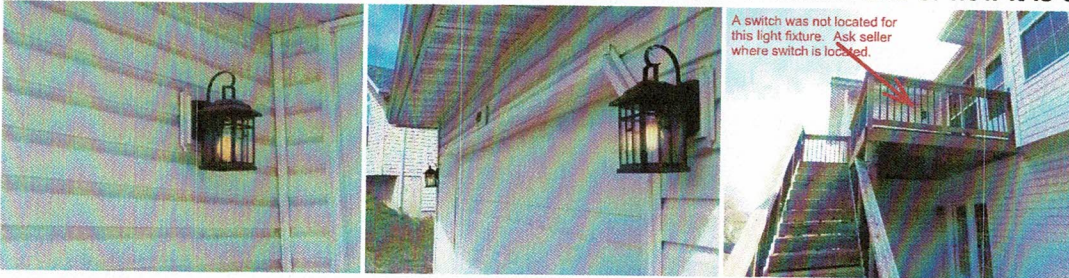
- 1. Exterior Lighting:** Surface mounted lamps front and rear - All lights work minus the light on the rear deck. A light switch was not found for that light. Ask seller for location of switch and or how it is controlled.

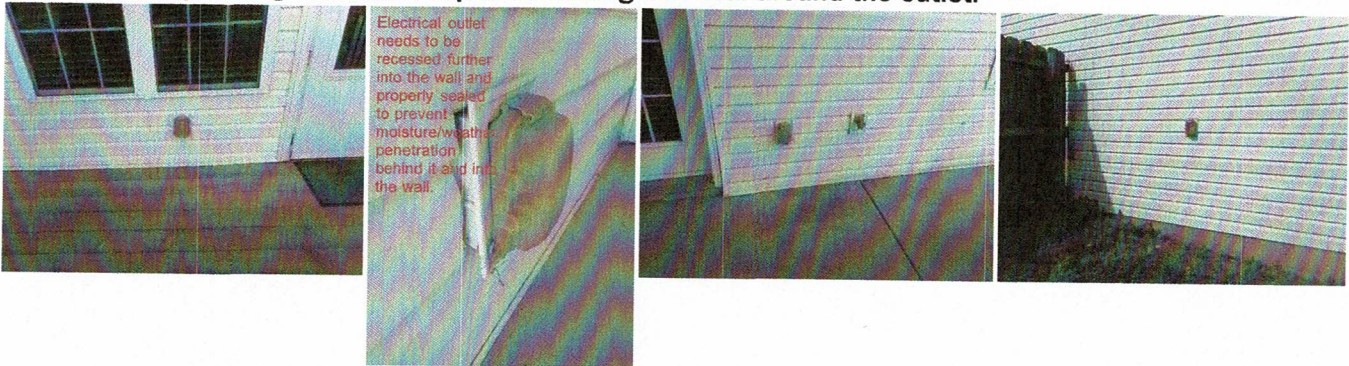
- 2. Exterior Electric Outlets:** 110 VAC - 3 total exterior electrical outlets. One located at the main entrance, second at rear of home and the third on the east side of the house. These outlets should be converted to GFCI. The outlet at the entrance of the home is not secure and should be remounted to ensure there is no water/weather penetration. Recommend a licensed electrician adjust electrical box in front of home as well as ensure that the exterior outlets are GFCI. Vinyl siding contractor repair the siding and seal around the outlet.

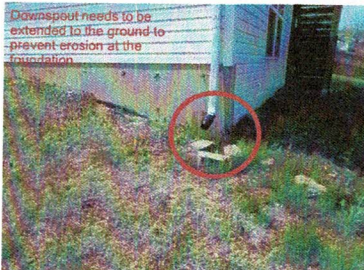
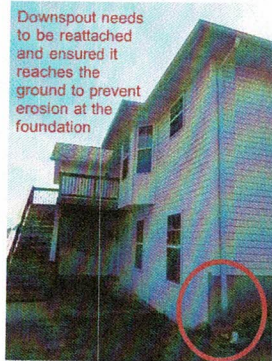
- 3. Downspouts:** Aluminum - The downspout on the West rear corner of the home needs to be reattached and ensured it reaches the ground and is directed away from the home to prevent erosion at the foundation. The East rear corner of the home needs to have the downspout extended to the ground and is directed away from the home to prevent erosion at the foundation. A gutter/downspout contractor needs to be contacted for repair estimate.

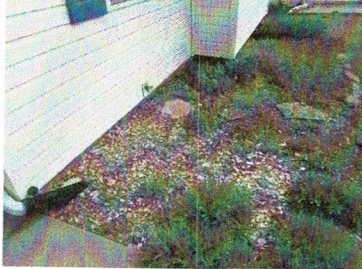
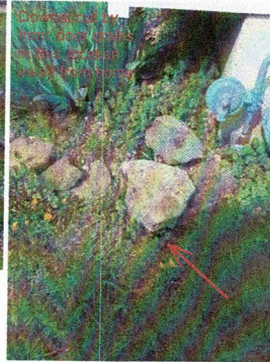
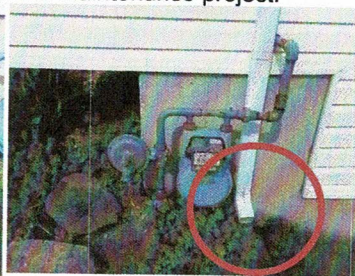
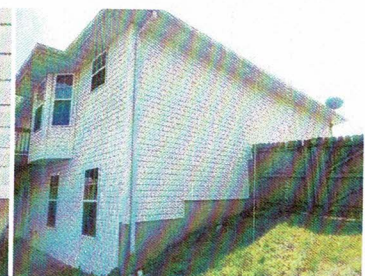
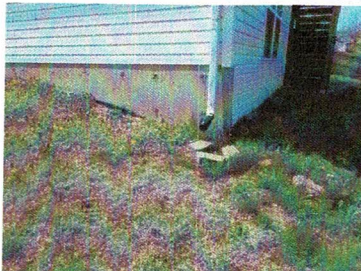
4. **Leader/Extension: Missing** - The leaders on all 4 corners of the home are missing. A 5 foot leader needs to be added to direct water away from foundation. This could be considered a future maintenance project.

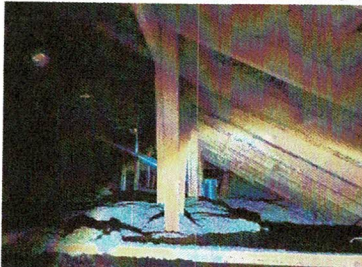
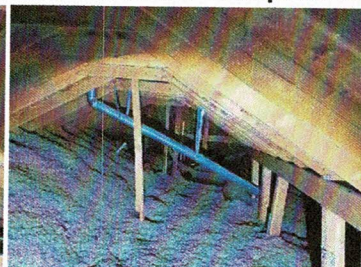
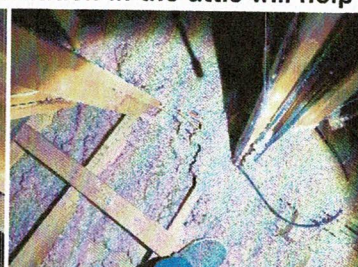
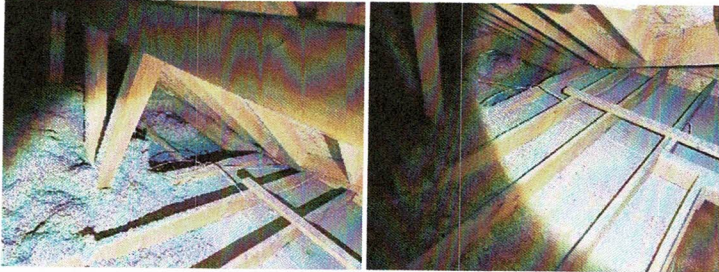
5. **Main Attic Insulation: Blown in** - The blown in insulation has been moved and compressed. Recommend insulation contractor to inspect and provide estimate. Adequate insulation in the attic will help with heating and cooling bills.

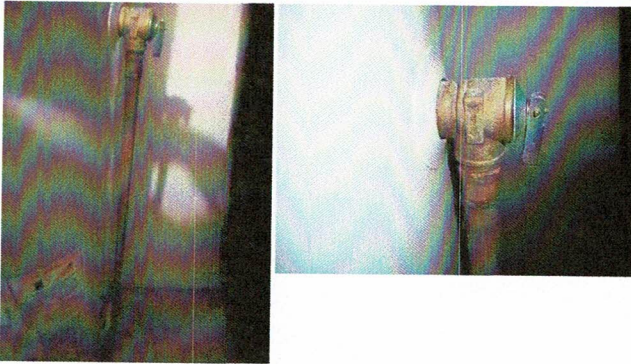
6. **Basement Water Heater TPRV and Drain Tube: Copper -** Blow down and drain from water heater drains in a room that does not have a floor drain. It needs to be piped to the drain in the neighboring laundry room. If the TPRV activates, it will discharge water onto the floor of the basement. Recommend further investigation and pricing from licensed plumber.

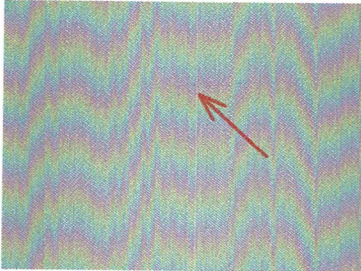
7. **Master Bathroom Ceiling: Painted gypsum board -** Crack is present in the gypsum board seam. This crack is due to expansion/contraction. A qualified drywall contractor should be contacted for estimate of repair.

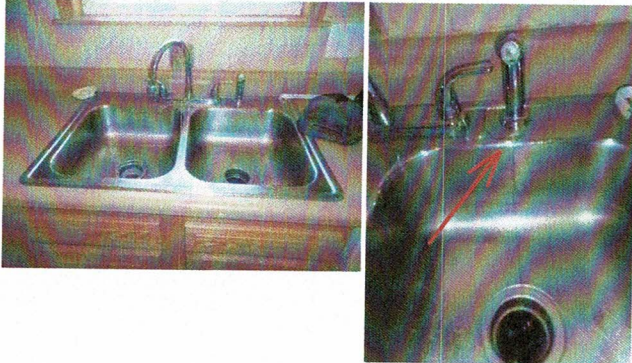
10. 1st Floor Kitchen Sink: Stainless Steel - Sprayer leaks, may need tightening and or replacement.

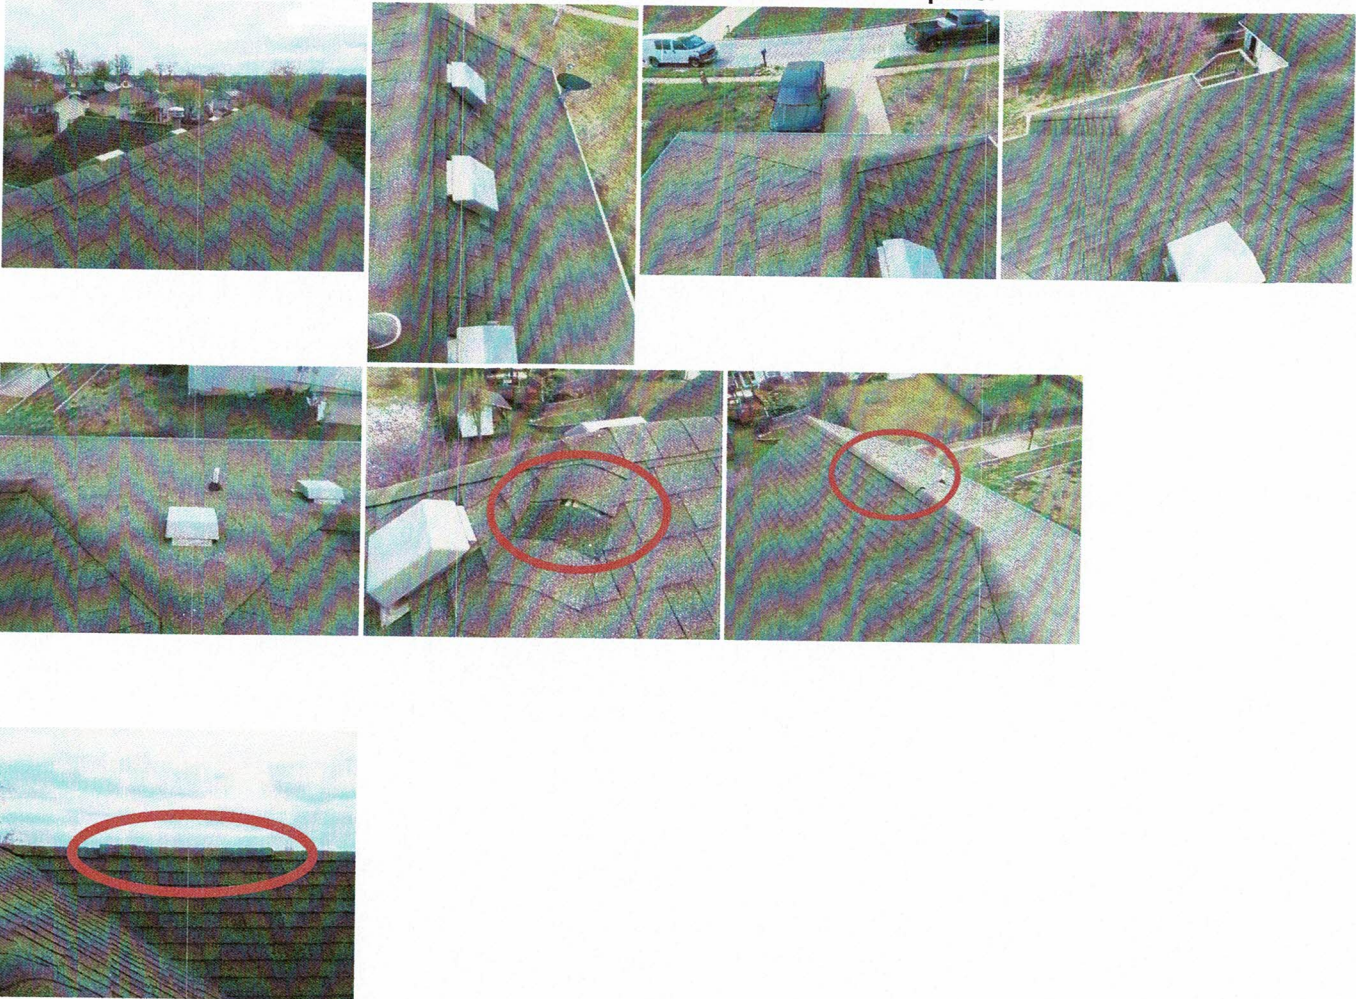
- 1. Main Roof Surface Material: Asphalt shingle -** In 3 locations on the ridge caps, shingles need to be repaired and or replaced. It appears in at least 2 of the locations, prior repairs may have been attempted. A qualified roofing contractor should be contacted for further inspection and estimate for repairs.

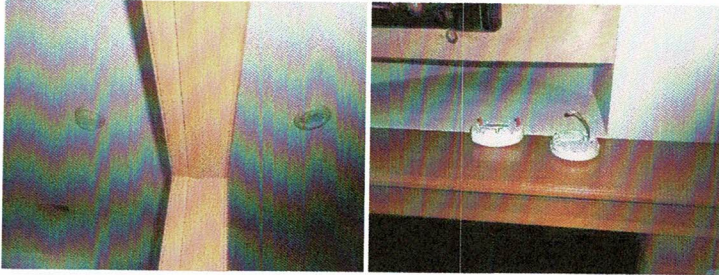
3. **Main Basement Smoke Detector: Not inspected** - Basement smoke detector and carbon monoxide detector found on top of fireplace mantel. Recommend replacement and installation per fire department recommendations.

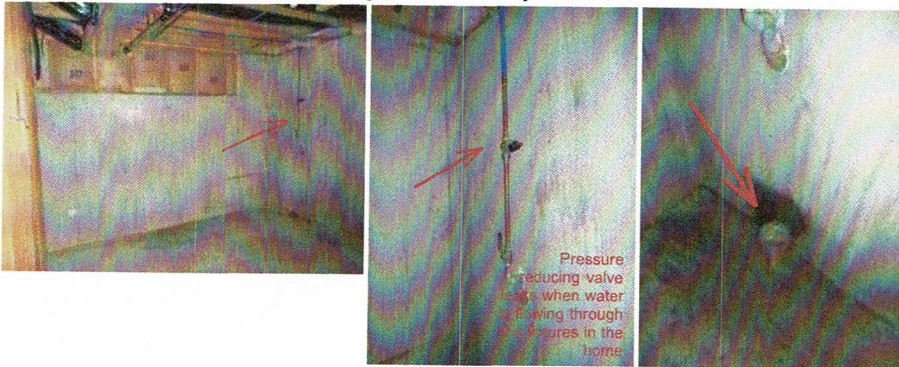
4. **Service Line: Galvanized** - Pressure reducing valve leaks when water is flowing through the fixtures of the home. Recommend replacement by a licensed plumber.

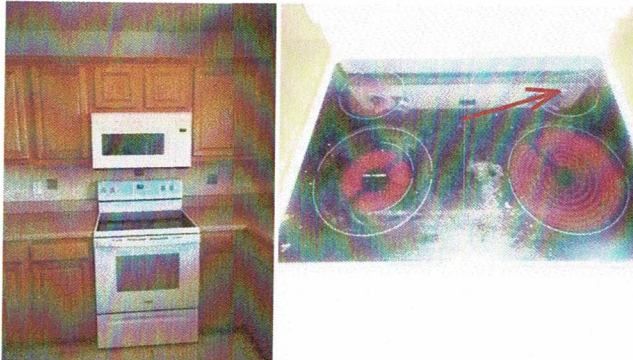
5. **1st Floor Kitchen Cooking Appliances: Whirlpool** - Right rear burner does not come on, all other burners and over function.

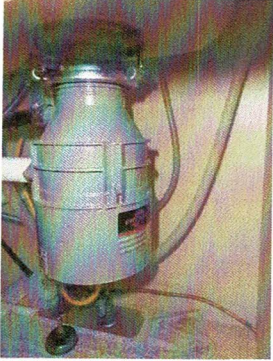
6. 1st Floor Kitchen Disposal: Evergrind - Disposal seems to be bound, recommend further inspection and or replacement by a licensed plumber.
