Energy Audit Report

Fairfield Common School, 52 Soule Drive

4/27/23
16534
Fairfield Common School
52 Soule Drive
Fairfield, VT 05455

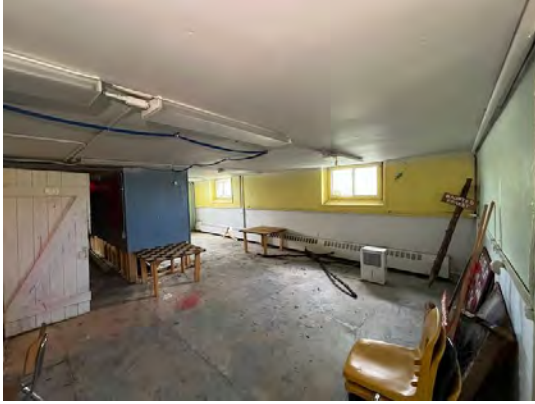
Heated basement section

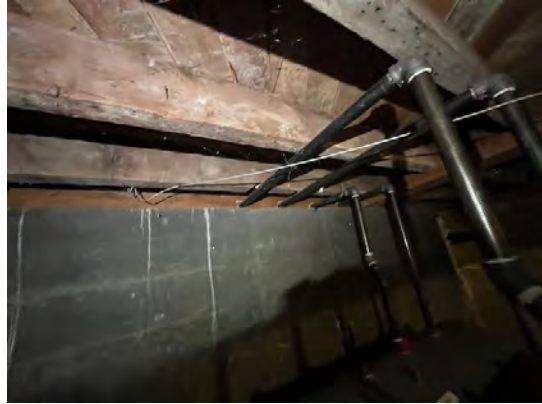
Unfinished basement section. Foundation and rim joist not insulated.

4	Basement rim joist: Air seal and insulate with closed cell foam. R-value increases to R-20.	184	\$3,500	10%
5	Basement foundation wall: Insulate with white-face Thermax foam board. R-value increases to R-18. Mechanically fastened with taped seams. In the partially finished section, foam board covered by drywall would be more durable.	1,132	\$12,000	
6	Cold-climate heat pump. Mitsubishi hyper heat. Heating and cooling. Estimated price includes Efficiency Vermont incentive. There may be federal tax credits available for this purchase. There may be additional bill credits available from your electric utility. These can be substantial. Size: 18,000 Btu on top floor and two 15,000 Btu units on first floor. (leaving basement for boiler for now) Joe Cobb, Energy Co-op Service Manager, will finalize installation and pricing details. jcobb@ecvt.net	3	\$20,000	see chart below, also with upgrading the building shell, this reduces the heating load for the building at coldest temperatures from about 150,000 Btu/hour to 50,000 Btu/hr (which heat pumps can better handle)

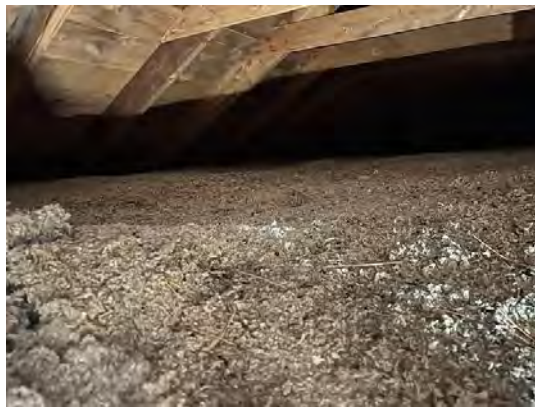
Attic flat insulation, combination of cellulose covering vermiculite.

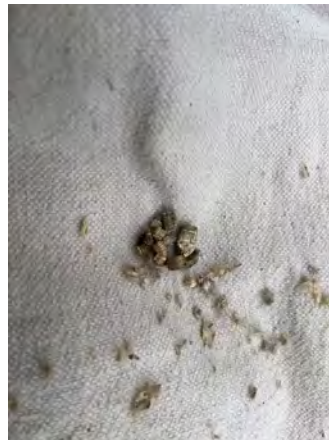
- Vermiculite in attic contains trace amounts of asbestos (a health hazard). Not a danger if not disturbed. Needs to be treated as hazardous.
- Also there is some fiber board labeled as asbestos in the boiler room.
- There are some buckets of tar material in the basement oil tank room. Looks like one has spilled or leaked.

Vermiculite from the attic.

1. We can schedule a time to review the report by phone to answer questions.
2. I recommend getting an estimate for vermiculite abatement in the attics.

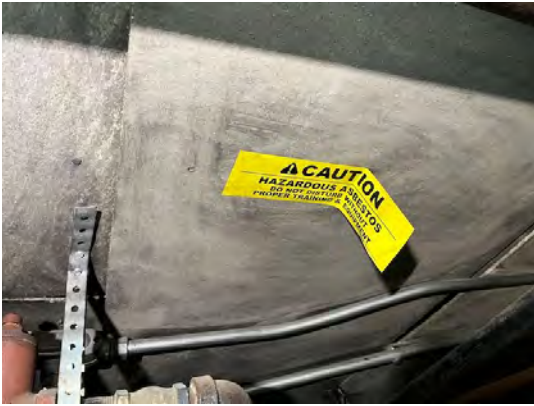
Asbestos hazard sticker in boiler room

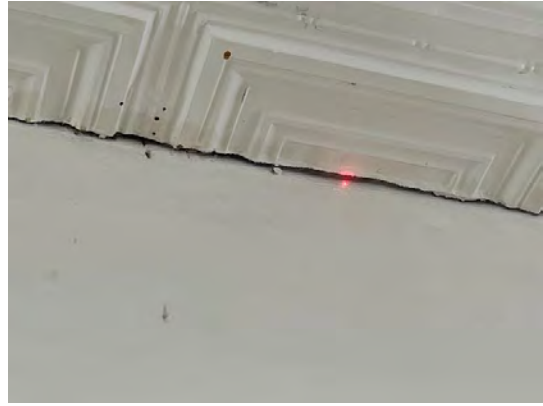
Example of air leak.

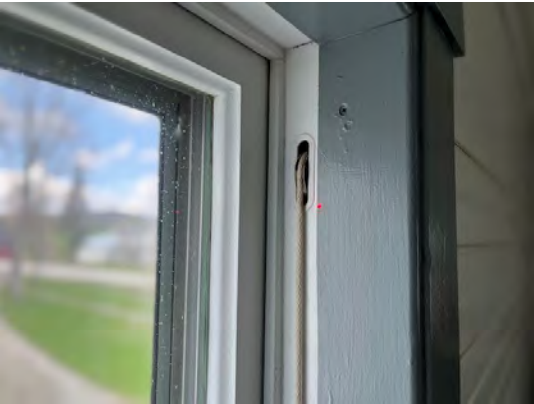
Example of air leak.

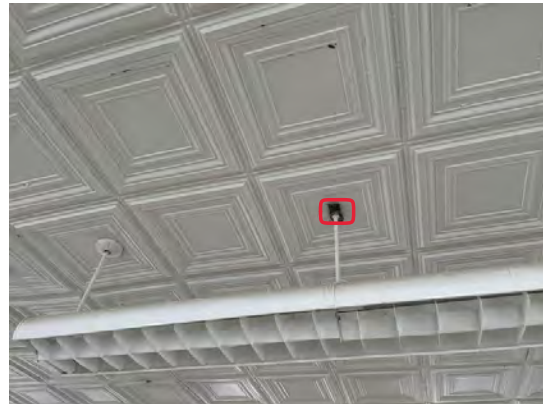
Example of air leak.

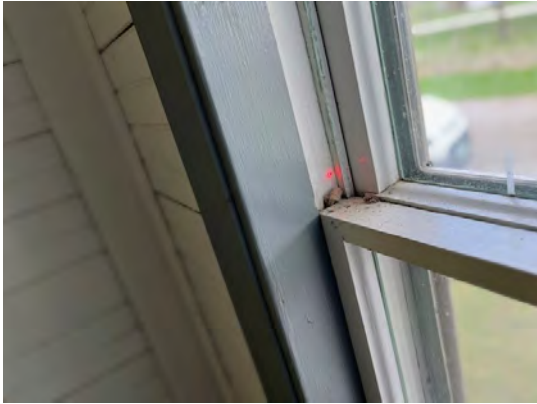
Example of air leak.

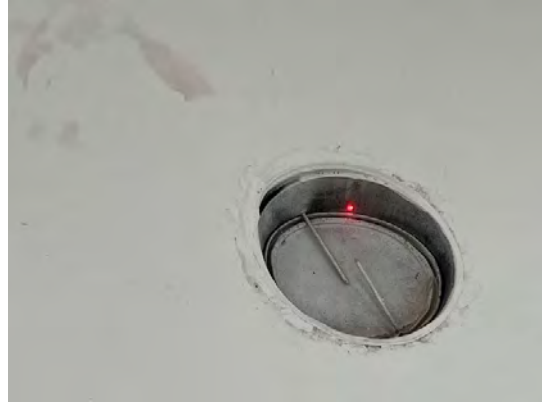
Example of air leak.

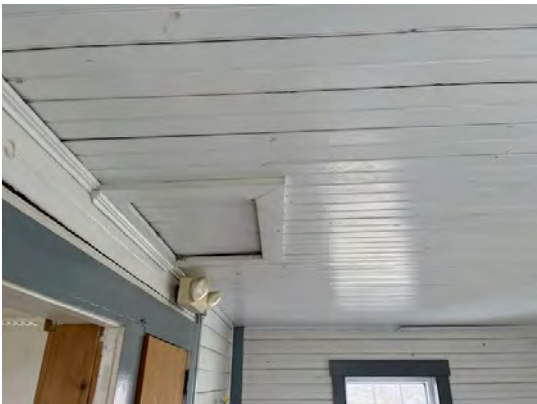
Hatch in stairway section. Tongue and groove boards are leaky.
