# Precision Home Inspections

## Property Inspection Report

1234 Your Street, Tacoma, WA 98404  
Inspection prepared for: Your Name  
Date of Inspection: 10/22/2016 Time: 11:00 PDT  
Age of Home: Built 1962 Size: 1940 sq ft  
Weather: Sun, recent heavy rain

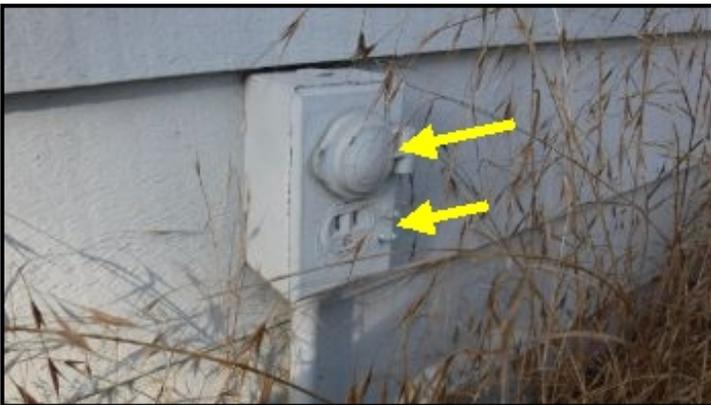
- Outlet covers at east wall are broken and in need of repair, recommend replace outlet covers with a modern accessible cover
- Exterior wiring is exposed and presenting a hazard at the south side walkway steps, recommend remove or finish this area with an exterior light fixture if desired
- Former pool electrical apparatus is causing a trip hazard on the back yard concrete slab

Exterior outlet covers in need of repair

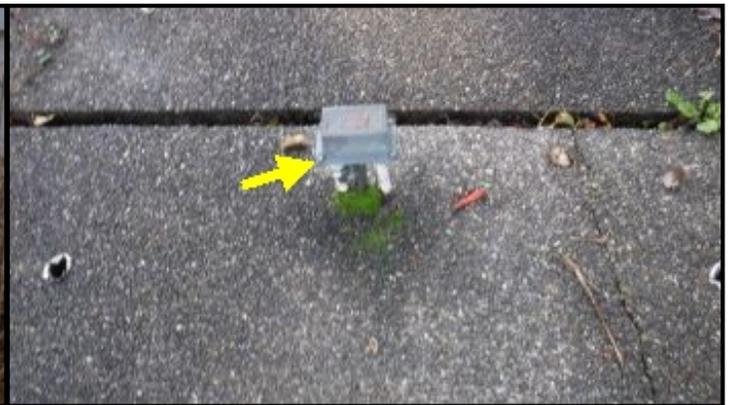
Electrical equipment is a trip hazard

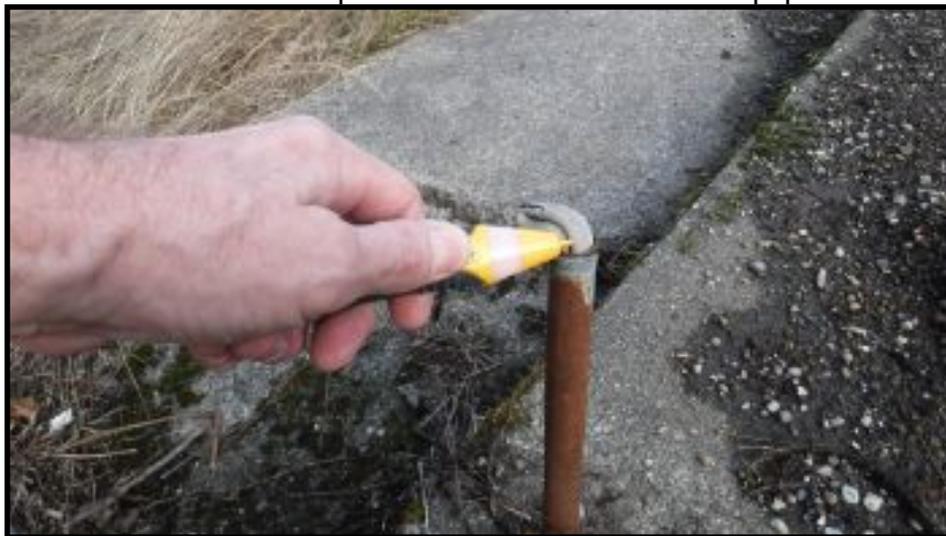
Exposed energized electrical line is a hazard

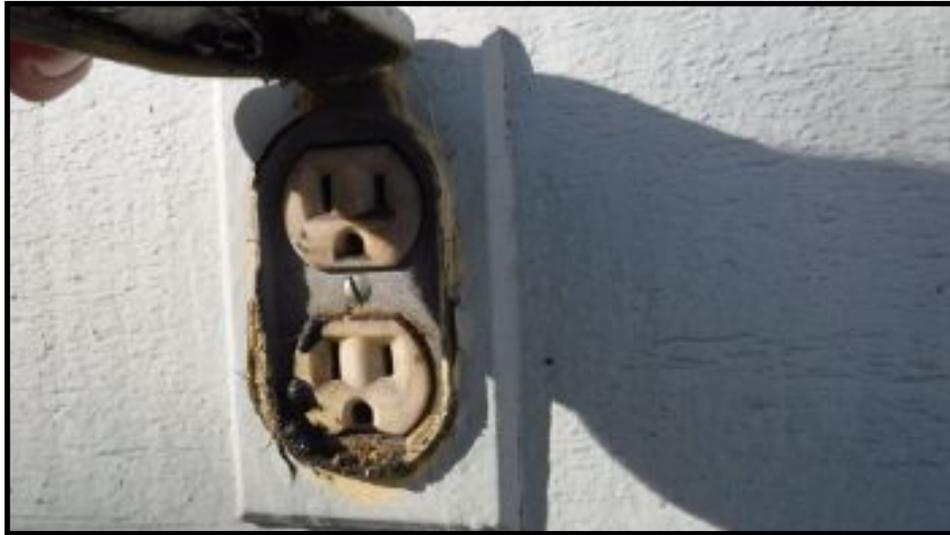
- Exterior circuits are not protected by **GFCI** circuit interrupter, recommend install exterior GFCI circuit interrupter at exterior circuit
- Exterior covered outlets are in need of replacement

Exterior outlets in are not GFCI protected

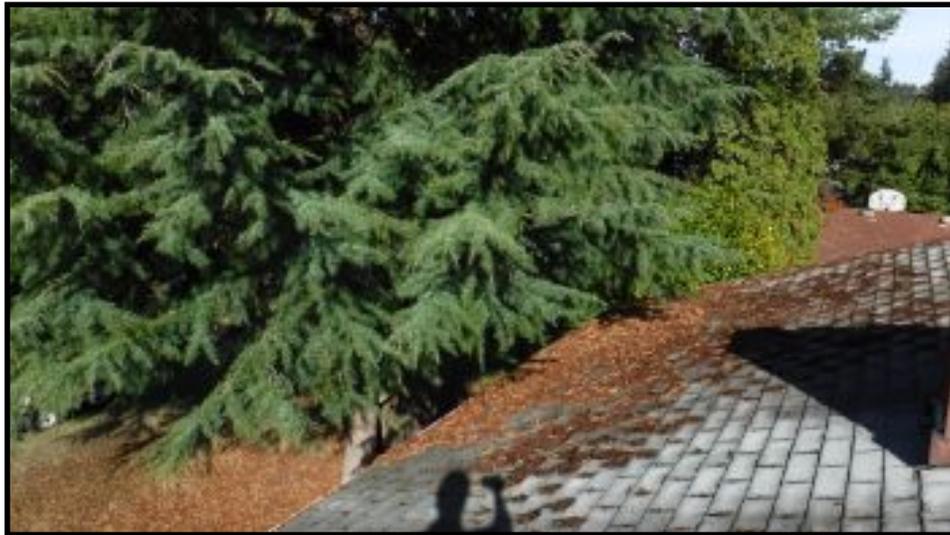
Observations:  
 • Tree branches overhanging roof will put debris in the gutter system.  
 Regular gutter and roof cleaning will be advisable  
 • Trees that grow too close, or overhang property, should be trimmed back.  
 This will help reduce the frequency of having to clean out the gutters, which should be done on a regular basis.

Tree overhanging roof

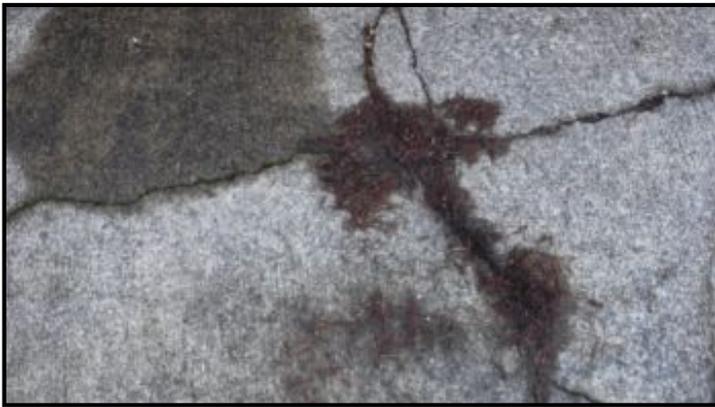
Common fractures in driveway

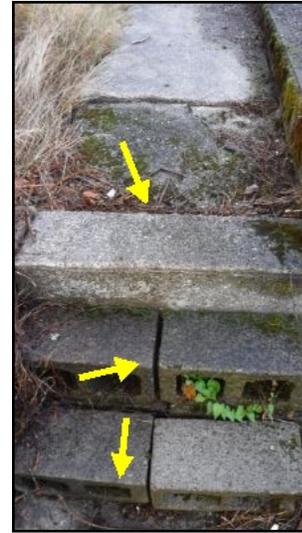
- The walkways are in a state of disrepair and serious trip hazards exist, recommend repair cinder block steps at south area, trip hazard at walkway leading to the steps, sunken walkway slabs and protruding electrical apparatus
- Driveway is in fair condition considering the age of the home, however numerous cracks have developed and the french drain grate is missing causing a trip hazard in the driveway, recommend replace missing drain grating

Walkway & brick steps are a trip hazard

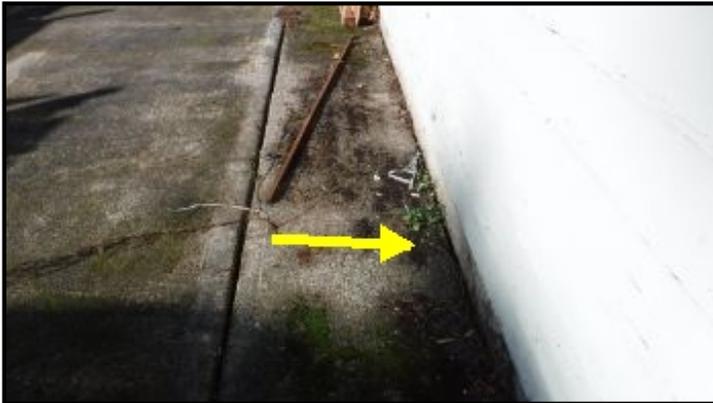
- The concrete slabs next to the foundation walls are improperly sloped in all areas and are pooling excessively, putting runoff water into the grade next to the foundation walls. This has caused a moisture intrusion issue in the basement at the laundry area and possibly in the living area as well, with damaged drywall at the base of the wall on the east side of the home. Recommend remove old concrete slabs and add a perimeter drain system to the grade next to the foundation walls

Concrete in perimeter grade slopes toward foundation wall

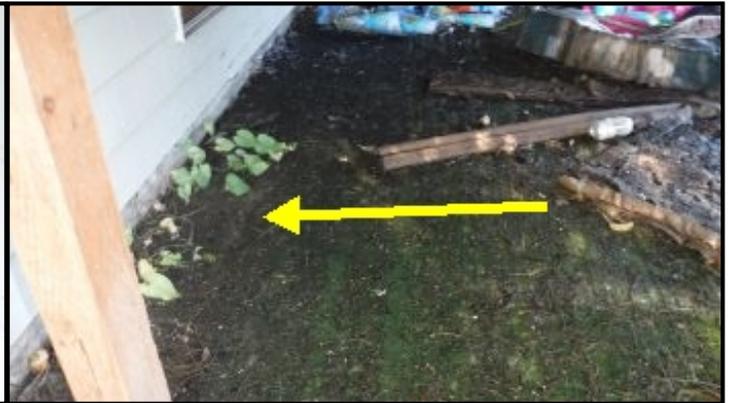
Concrete slab is improperly sloped toward foundation wall

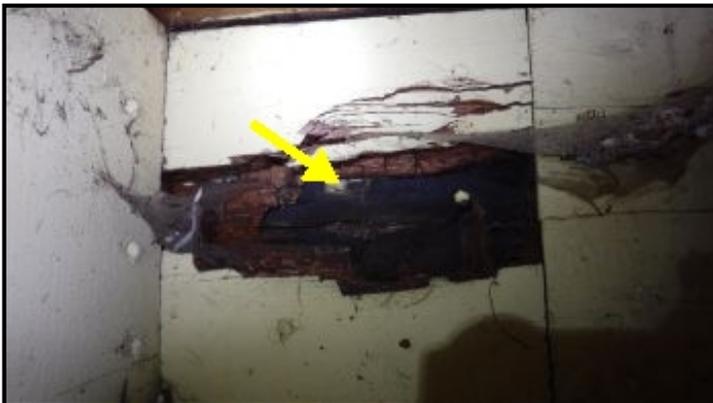
- Improper attachment of ledger board noted, recommend apply one 6-inch lag screw at each joist bay
- Baluster rails are not secure and balusters are improperly attached using nails instead of screws
- Ledger board and part of sill plate structure are heavily damaged by wood rot due to improperly attached and unflashed deck attachment. Recommend remove deck, repair wood rot, replace ledger board properly and rebuild the deck as desired

Deck ledger board heavily rotted

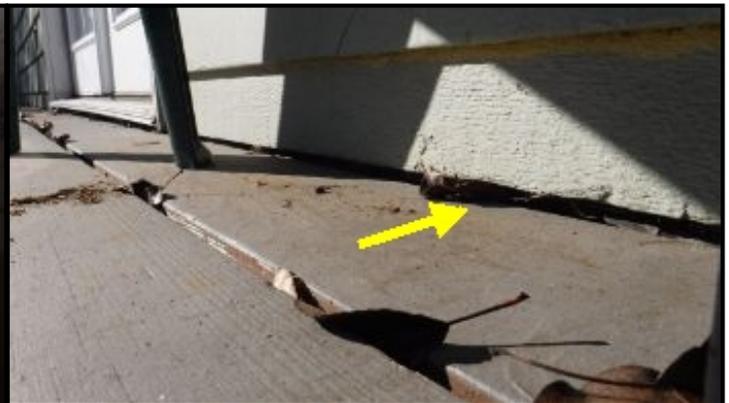
Deck is improperly attached and unflashed at wall

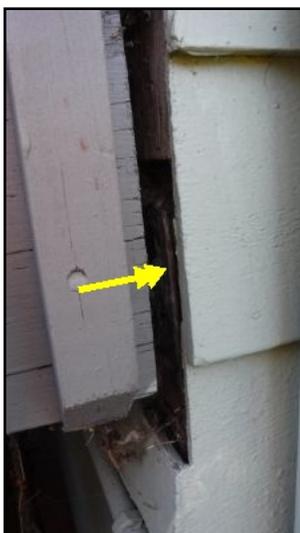
Siding has been cut away and left unflashed for deck attachment

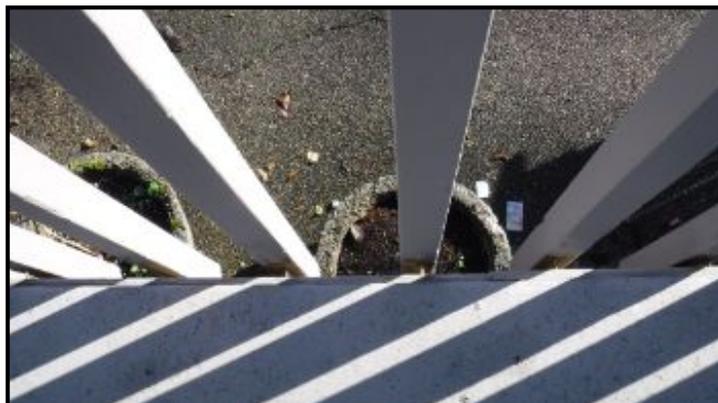
Deck ballusters are not secure

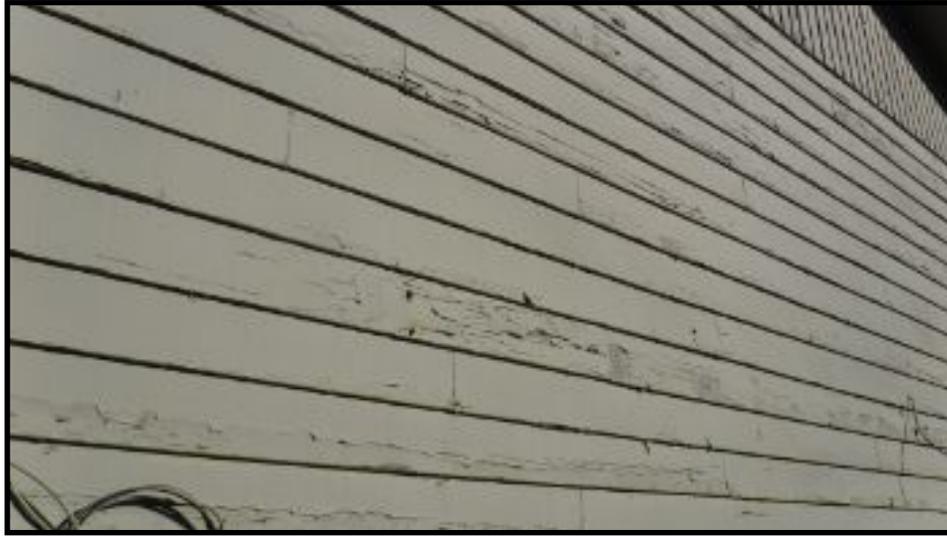
- Some areas need restaining, or priming and repainting.

South end wall in need of prep & paint

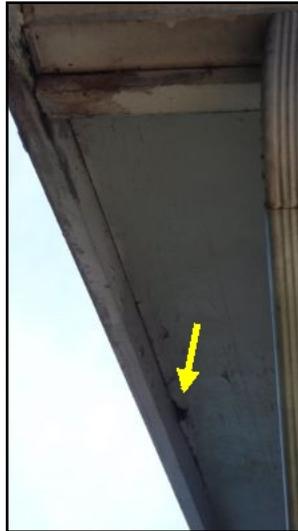
- A small area of moisture damage is noted on the north gable overhang, recommend repair as desired of apply paint to protect against further moisture intrusion at this location

Gable overhang on north end has minor moisture damage

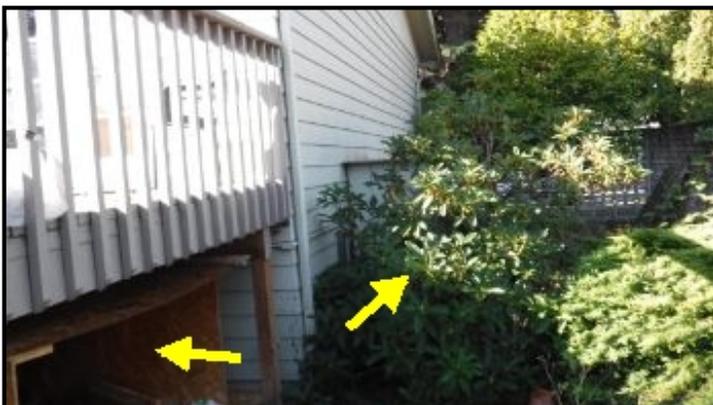
- Shed at north side is in need of complete removal
- The A frame shed is in need of general maintenance and roof replacement

Outbuildings in need of removal

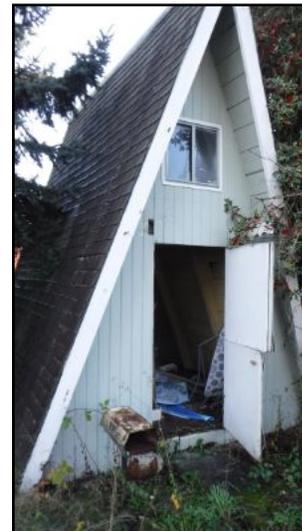
A frame outbuilding in need of maintenance

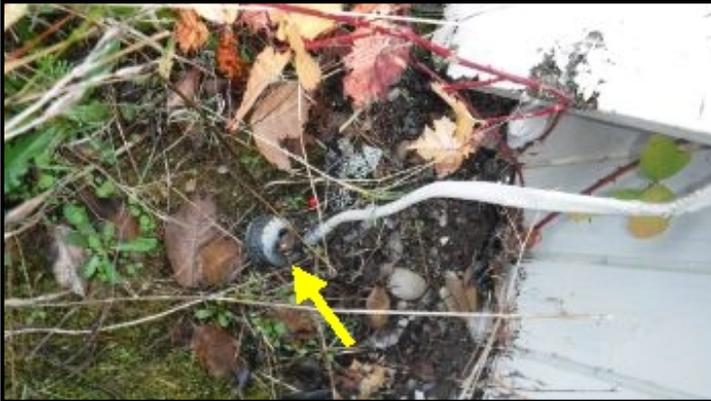
Outbuilding wiring in need of conduit

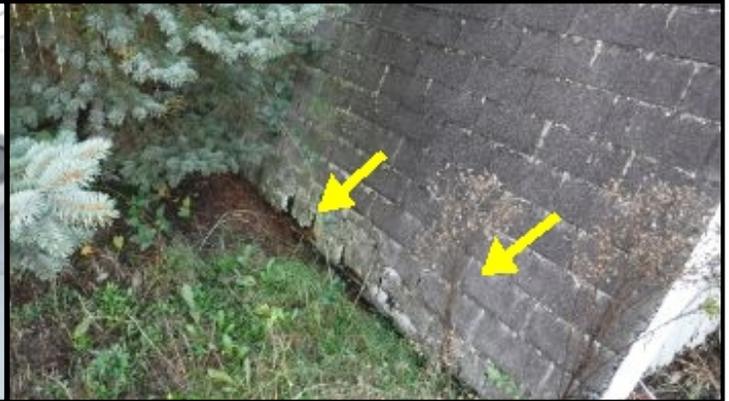
A frame shed in need of roof repair

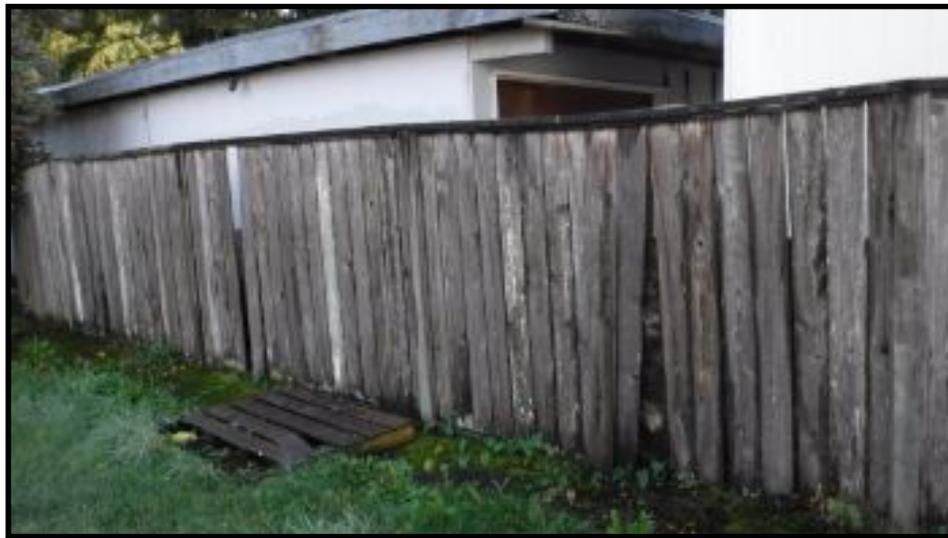
- Areas of the wooden fence are in need of maintenance for broken boards or rot at the base, repair as desired

South fence in need of rot repair

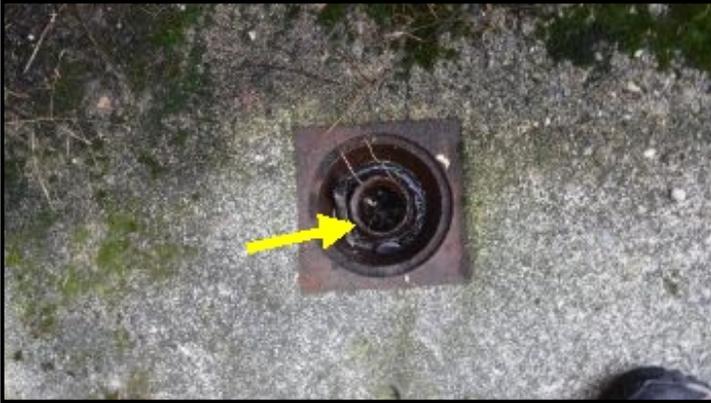
- The french drain is not functioning as intended due to blockage and inadequate screening issues, recommend clear drain lines and install drain grates at the garage access door and the driveway

French drain is clogged with debris

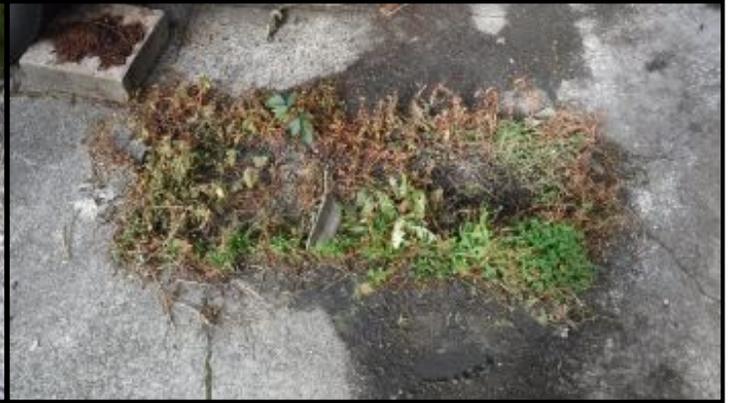
French drain is clogged and missing grate cover

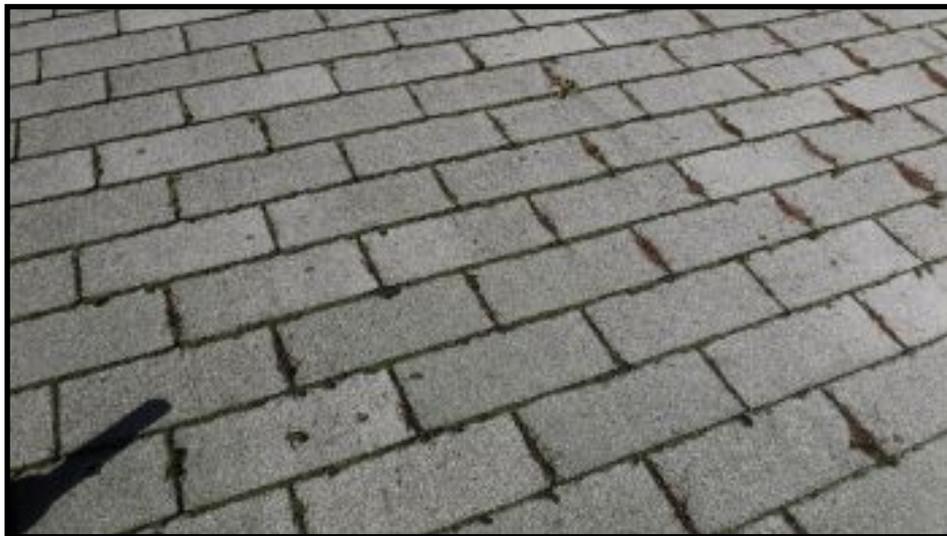
- The roof appears to be approximately 12-15 years of age and is aging normally
- Significant amounts of organic debris was noted on the roof, recommend clean roof and treat for moss if desired

Roof is in need of cleaning for moss buildup

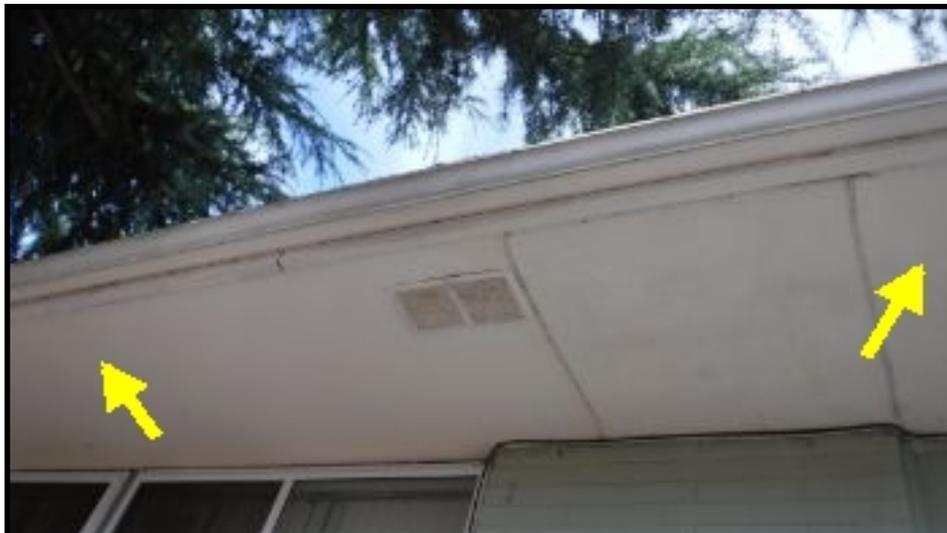
- It is advisable to add ventilation openings to the enclosed soffit to maximize ventilation performance of this attic

Roof is in need of additional soffit vents

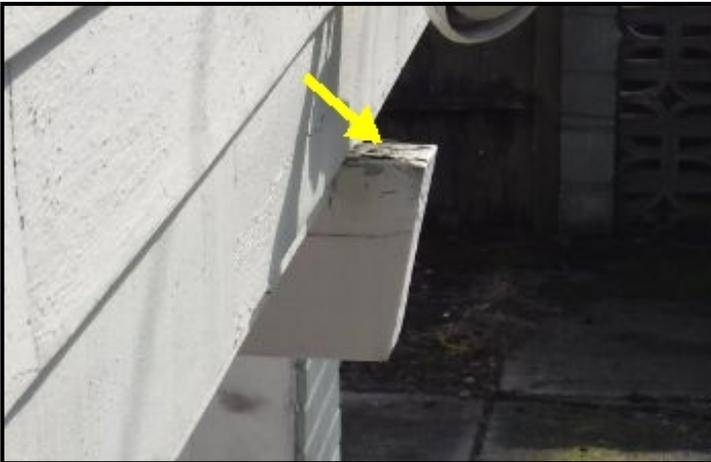
- Rafter fly-ends are missing roof cover strip & flashing, recommend apply roof cover to the rafter fly-ends to slow the rot damage
- Architectural beams at the garage are exposed to the elements and in need of flashing, roofing protection and siding protection, recommend cover and seal the beam extensions to completely seal against water intrusion in order to prevent major rot repairs in the near future.

Beam is missing flashing

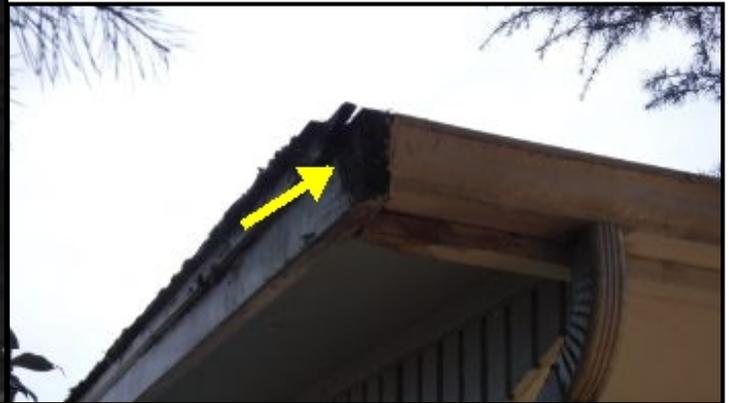
Rafter fly ends missing flashing, in need of rot repair

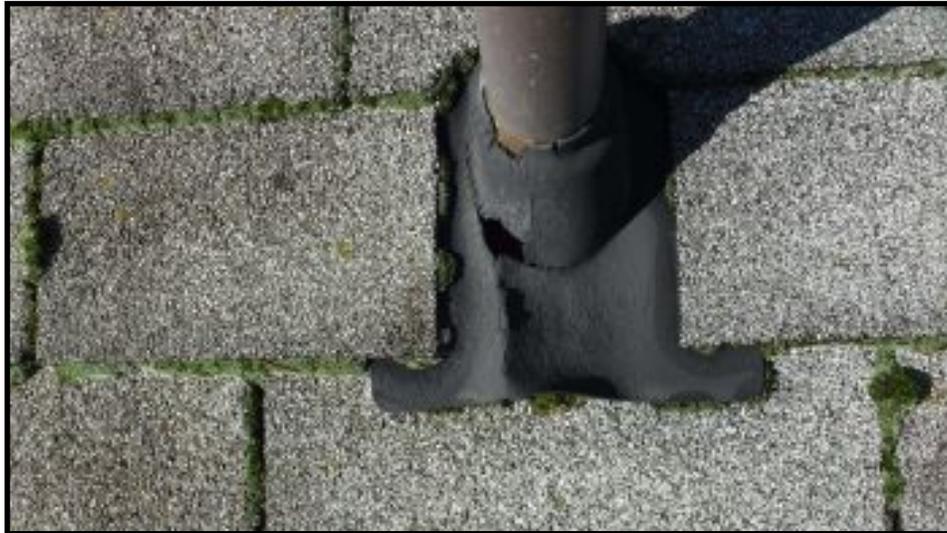
- The plumbing vent boots are in need of replacement on all vent outlets, recommend install new plumbing vent boots

Plumbing vent boots are in need of replacement

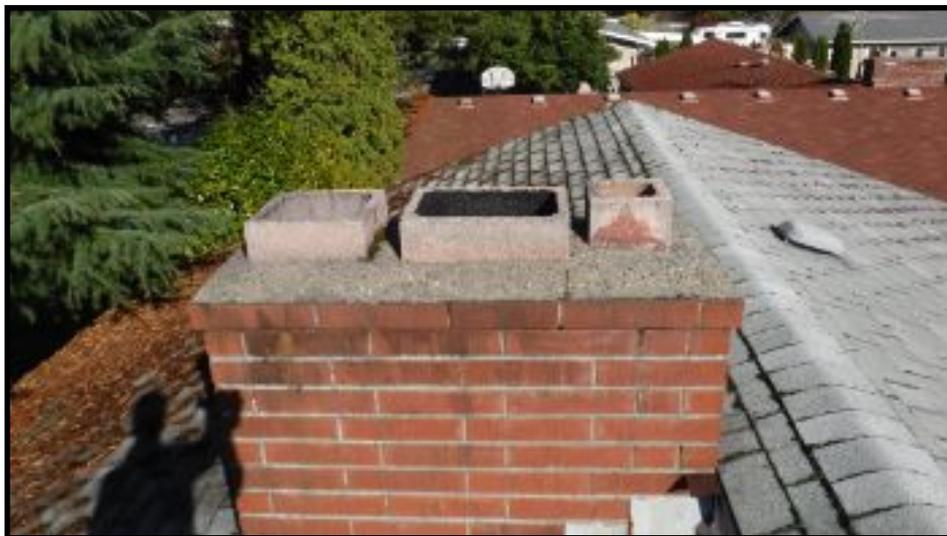
- No chimney cap present on chimney outlet. Recommend installation of chimney cap/screen to prevent premature weathering, water intrusion, and entrapment of wildlife.
- Missing flue liner for furnace use of chimney, it may be necessary to install a steel flue liner to the chimney with a vent cap assembly when a new furnace is installed

Chimney in need of wildlife caps, B-vent flue lining

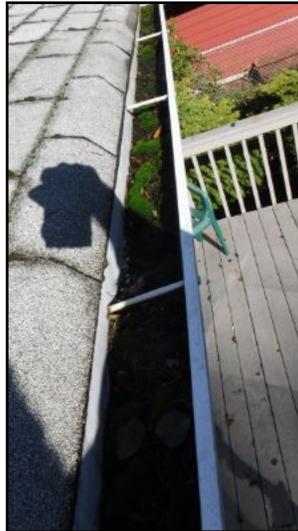
- Some roof gutters may not be performing as intended due to buildup of debris, recommend clean blocking debris from roof gutters

Gutters are clogged with debris

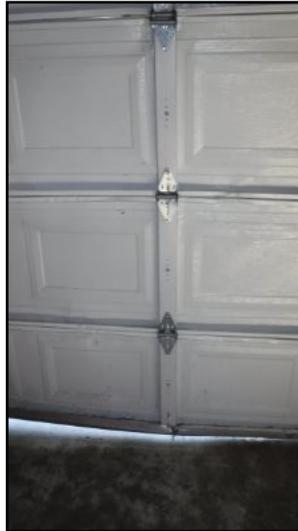
- The south garage door is heavily damaged and in need of replacement

South garage door heavily damaged

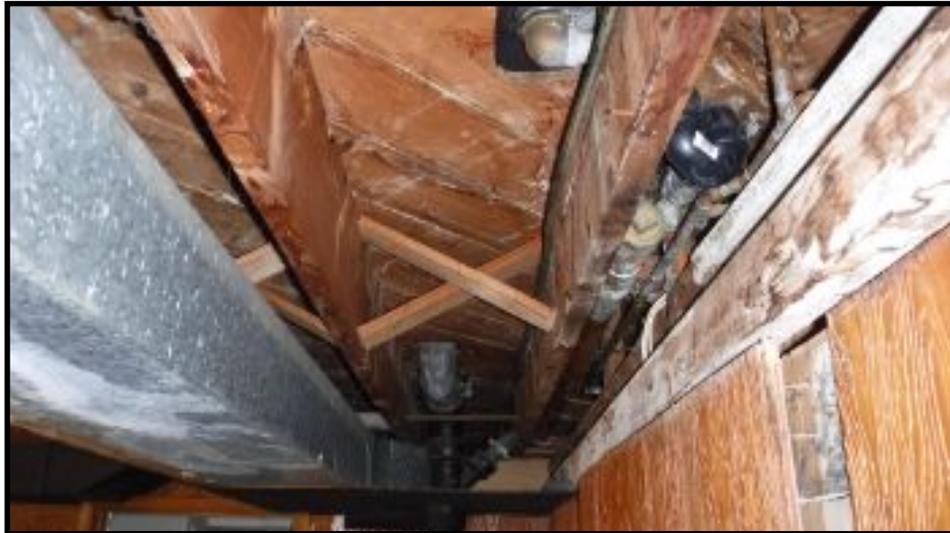
- Ceiling is open to the living area and in need of finish and seal for smoke & fire safety, see smoke & fire safety notes

Garage ceiling missing firewall enclosure

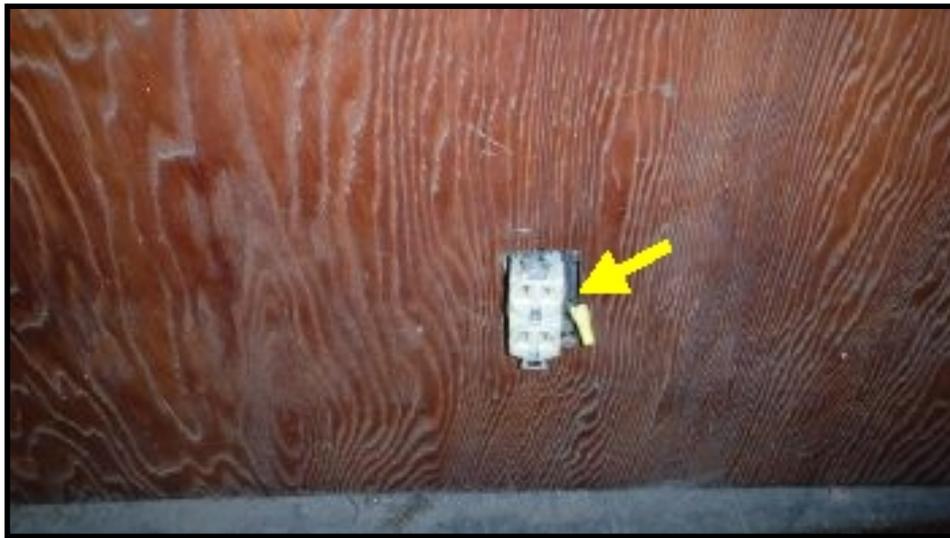
- Missing outlet covers should be replaced wherever they are found

Outlets missing outlet covers

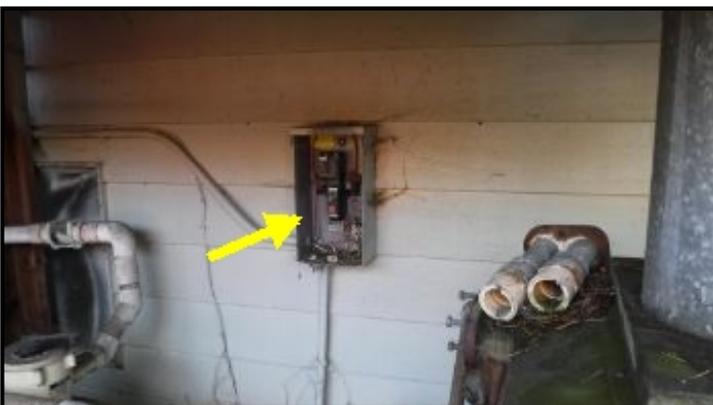
- There is a Federal Pacific Electric panel in service. There are studies that show that some FPE circuit breakers are prone to problems that can lead to failures, lack of proper protection of circuits and other serious issues, including fire and electrocution. Although the Consumer Products Safety Commission has not issued a formal product recall, the panel is old and the company is now out of business. It is recommended that this panel be replaced with a modern 200 amp load center
- The sub panel at the former pool pump location is missing it's safety cover and energized with 220 volts. This is a significant hazard and should be addressed immediately by disconnecting at the main panel, or installing a cover

Uncovered subpanel is an extreme hazard

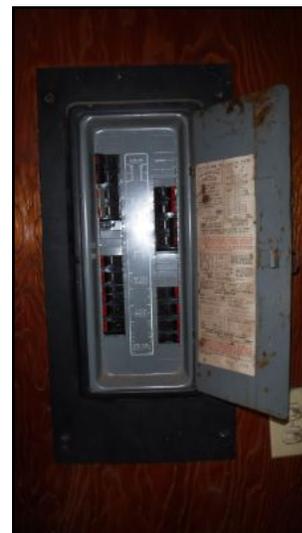
Federal Pacific panel is in need of replacement

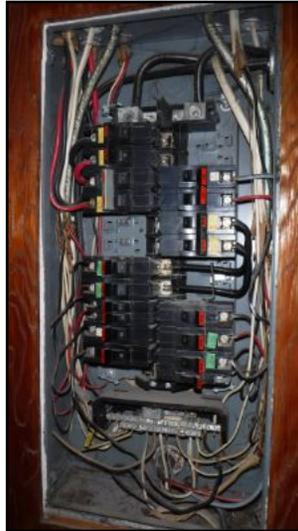
- Breakers are loose in the panel, recommend replace panel and breakers

Stab Lok breakers are obsolete

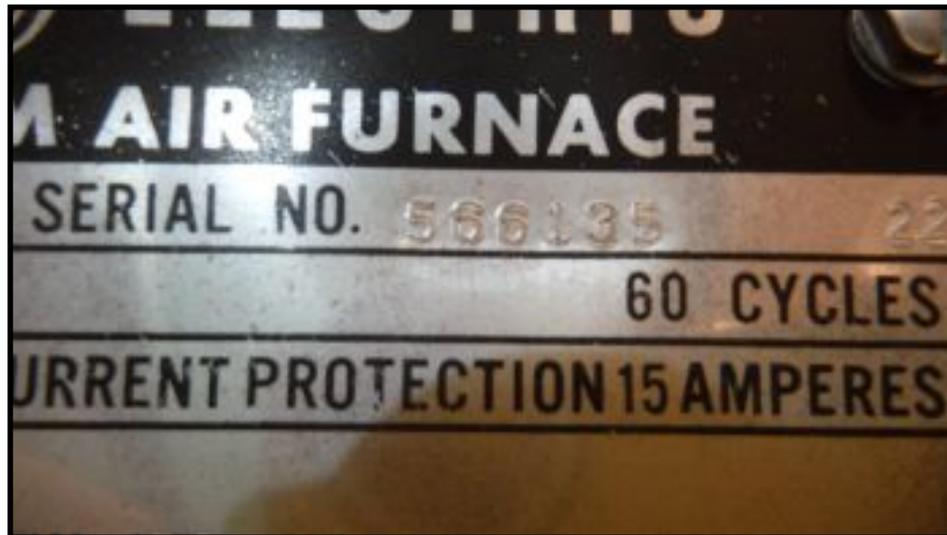
- The furnace is in a condition and of an age that the inspector considers it to be highly hazardous to the occupants of the home. It is recommended that the furnace not be used, and replaced before any occupation of the home commences.

Furnace age could not be determined

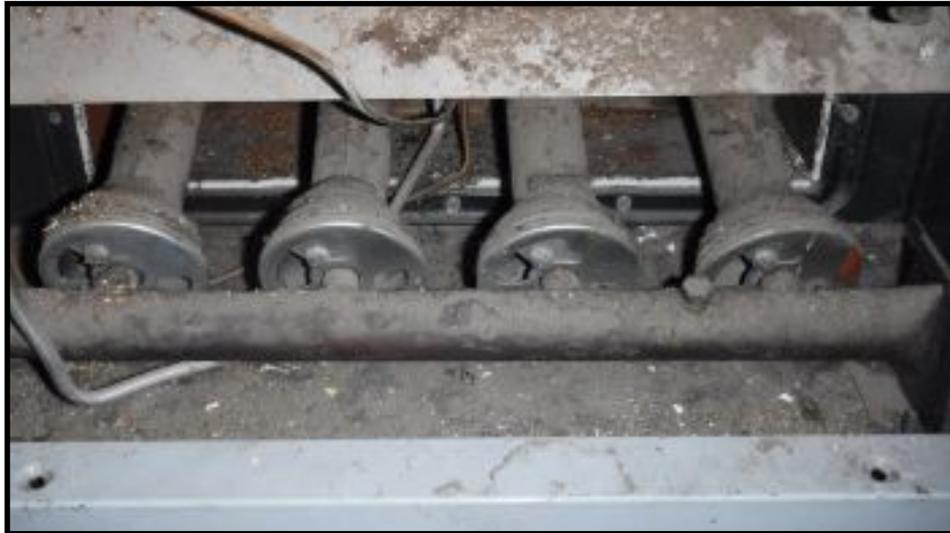
Heat exchanger is in poor condition

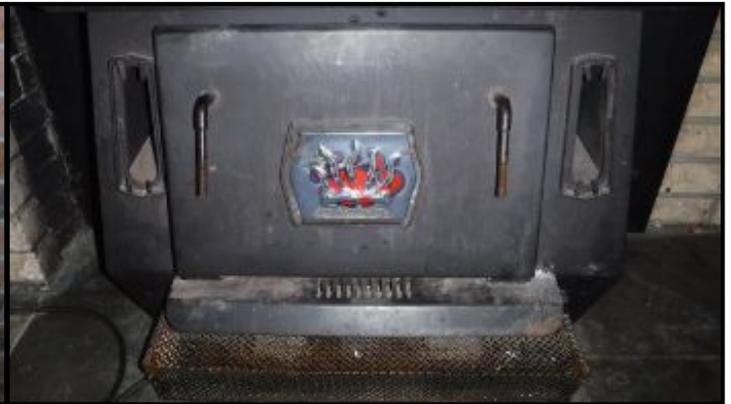
- The wood-burning fireplace may not be in compliance with new regulations
- There are new regulations regarding the ownership and use of wood-burning fireplaces. See [www.ecy.wa.gov](http://www.ecy.wa.gov) for further reference
- **The fireplace insert is in need of cleaning and ash removal**

Fireplace insert in need of cleaning

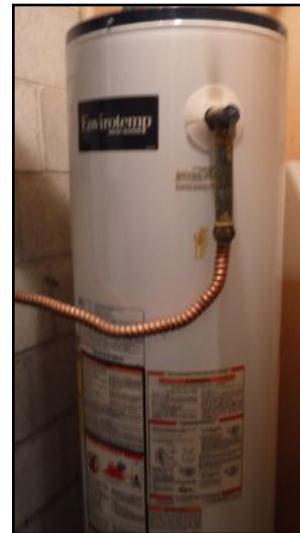
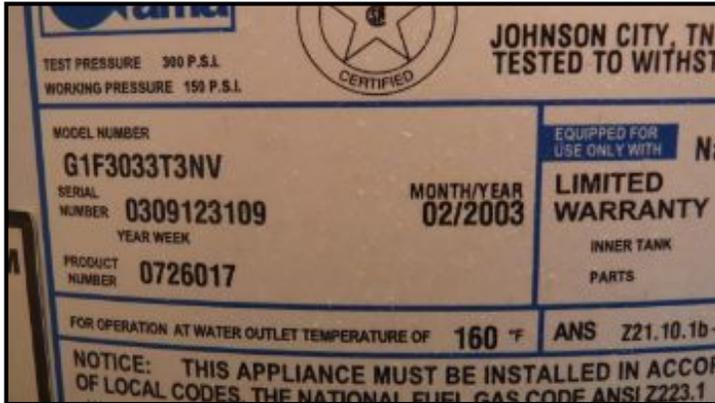
- The water heater is a year 2003 model, in service for 13 years. Gas water heaters have a normal life expectancy of 17-20 years but can last longer if properly maintained.
- It should be noted that the water heater is nearing the end of its typical service life.
- The water heater is an inadequate size for the application and will not provide enough hot water for the intended use of the occupants, due to this and other factors, it is recommended that this unit is replaced with a new 50 gallon unit equipped with a sealed combustion chamber and FEMA approved earthquake straps

Water heater is a 30 gallon 2003 gas model, Water heater size is inadequate for the home size

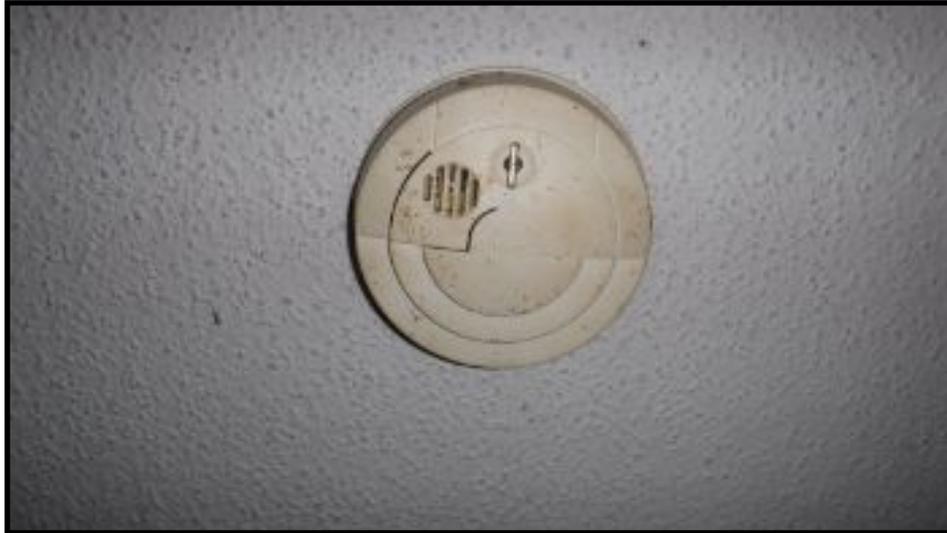
- Modern building standards require smoke detectors to be located inside each bedroom and in the hallways where bedrooms are present, and on all levels of a home
- **The smoke alarm(s) did not operate when tested.**
- **there were no smoke detectors in the bedrooms, recommend equip each bedroom with a working smoke detector alarm unit**

Smoke alarm inoperable

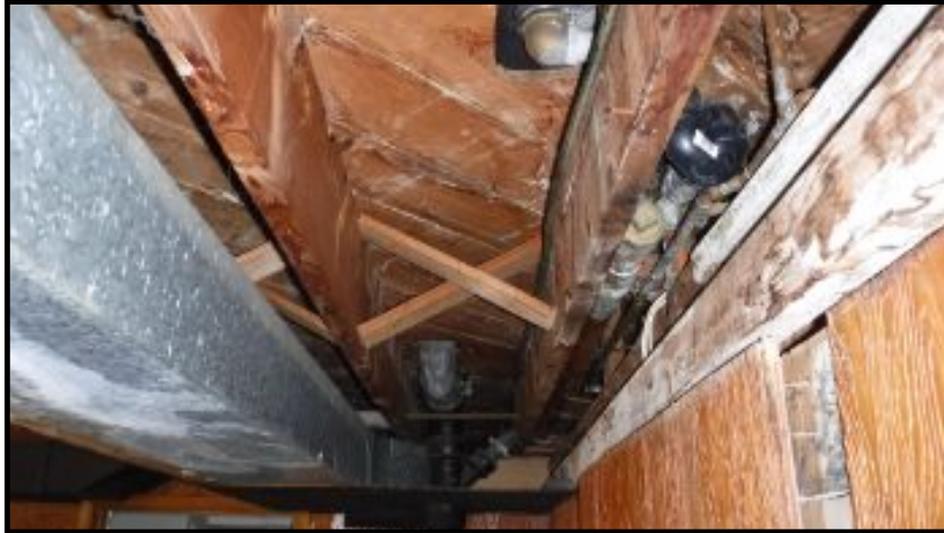
• An area of ceiling near the garage is unsealed to smoke & fire. In the event of a garage fire, some smoke could find it's way into the living area at this opening and gain access to the living area. This can be addressed by simply by installing finish ceiling material at this location. It is recommended that this area be sealed for fire & smoke safety

Garage firewall is missing, smoke & fire hazard exists

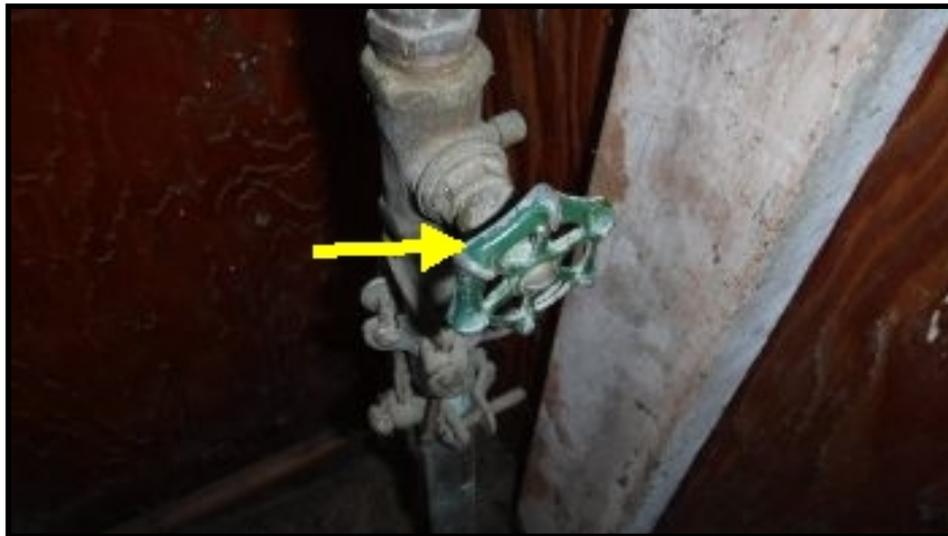
Observations:  
 • The main emergency plumbing shutoff valve is located in garage  
 • **The emergency plumbing shutoff valve is leaking and in need of replacement**

Main shutoff valve is in need of replacement or repair for leaks

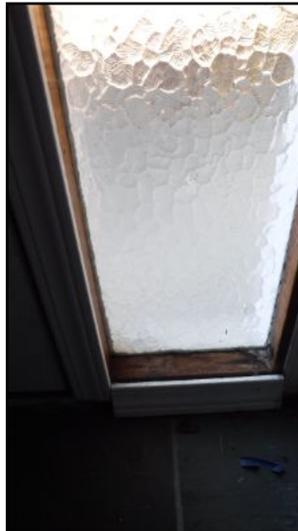
- Windows were found to be in good condition at the time of the inspection
- Modern building standards require windows next to doors, at the base of staircases or in doors to be made of tempered safety glass. The door side windows are not safety glass, recommend replace these windows with modern tempered glass panes

Door side windows are not made of tempered safety glass

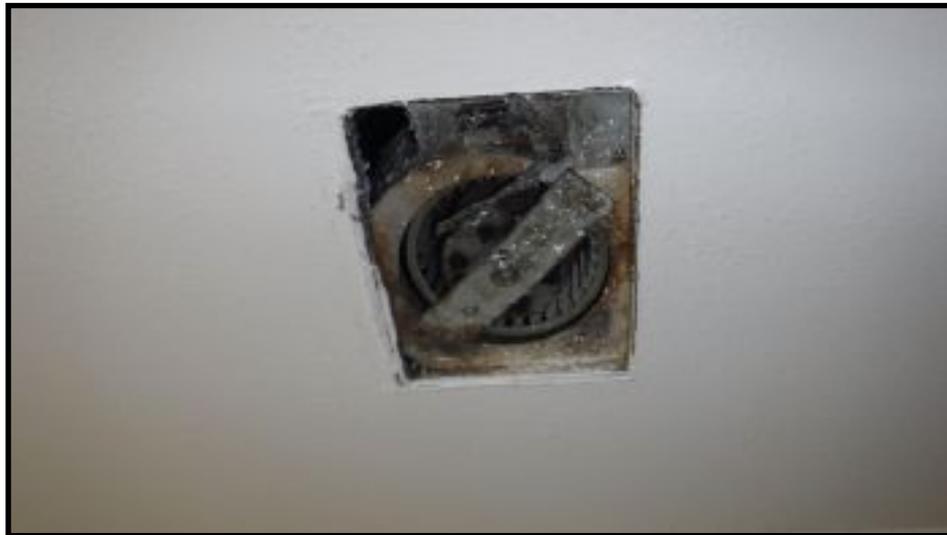
- Guest bath exhaust fan in need of replacement

Master bath exhaust fan is inoperable

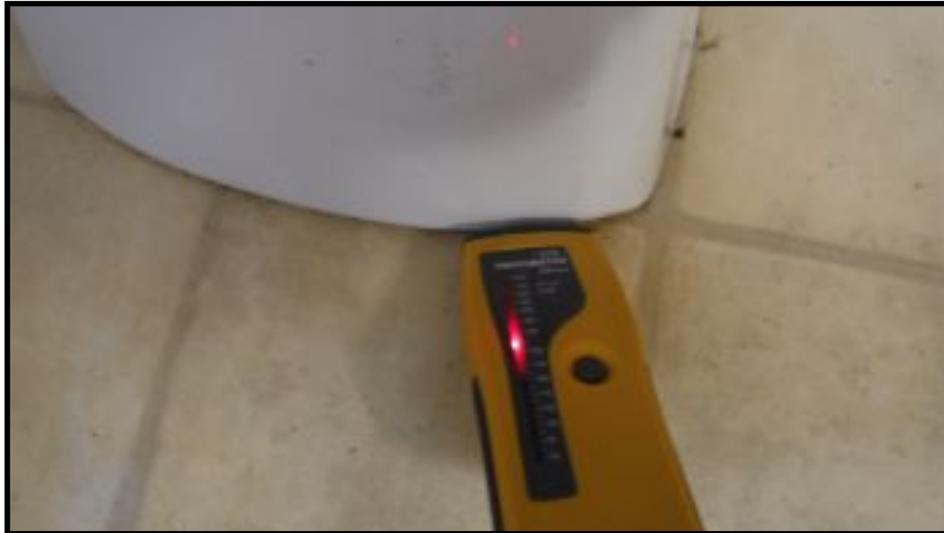
- Toilet in basement bathroom is leaking badly at the wax seal, recommend replace wax ring seal at the toilet flange.

Basement toilet may be leaking at wax seal

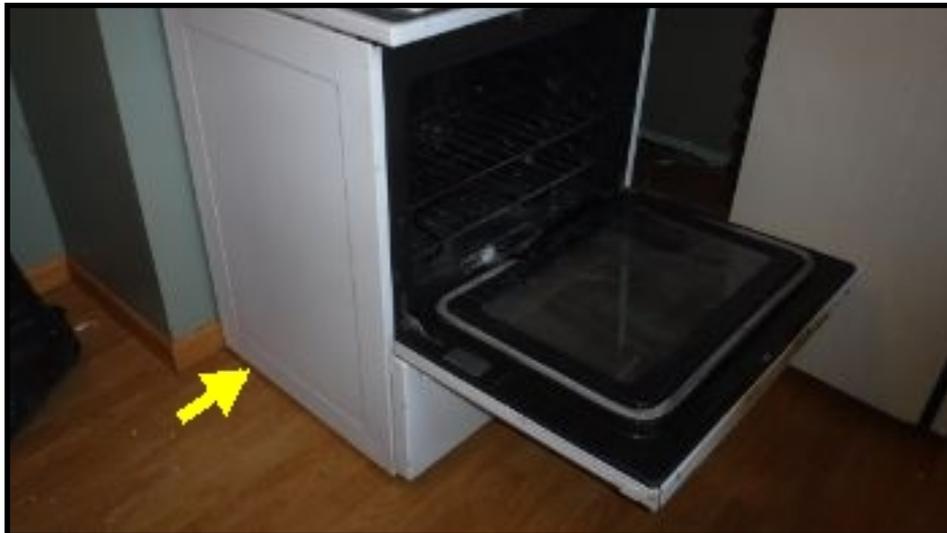
- **SAFETY CONCERN: Free standing range missing anti-tip bracket/device, recommend install anti tip clamp**

Free standing oven is missing anti tip clip

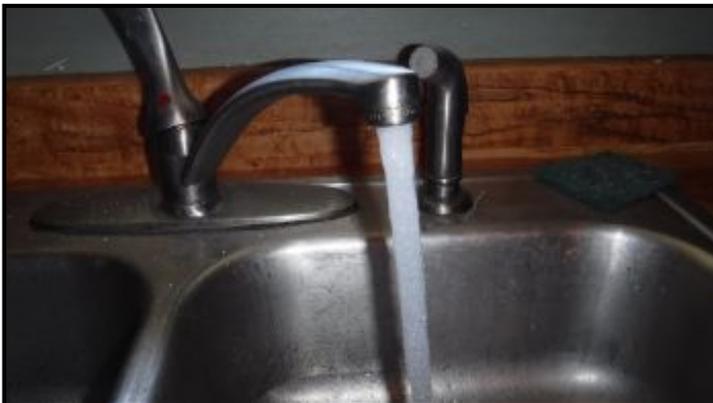
- The faucet and spray wand may be in need of replacement due to a hammering condition when in use, recommend install new faucet and check for the hammering effect noted in the inspection. If it persists, further maintenance may be necessary in the plumbing system at the kitchen

Kitchen faucet in need of repair or replacement for hammering

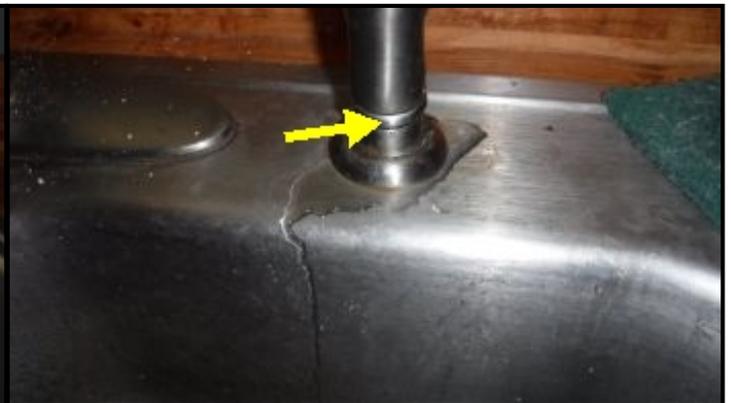
Spray wand leaks at hose connection

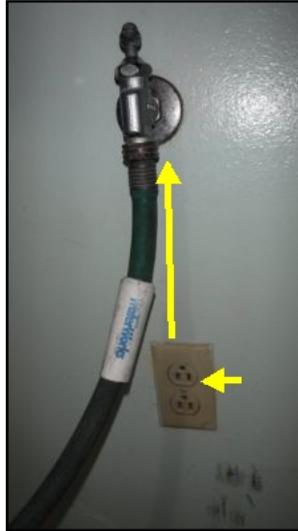
- The laundry outlet is not GFCI equipped, recommend replace standard outlet at the washing machine with a GFCI outlet
- The laundry outlet is in a position which is hazardous in the event of a leaking washer line, recommend move to a location not directly under a plumbing outlet

Laundry electrical outlet improperly located and not GFCI equipped

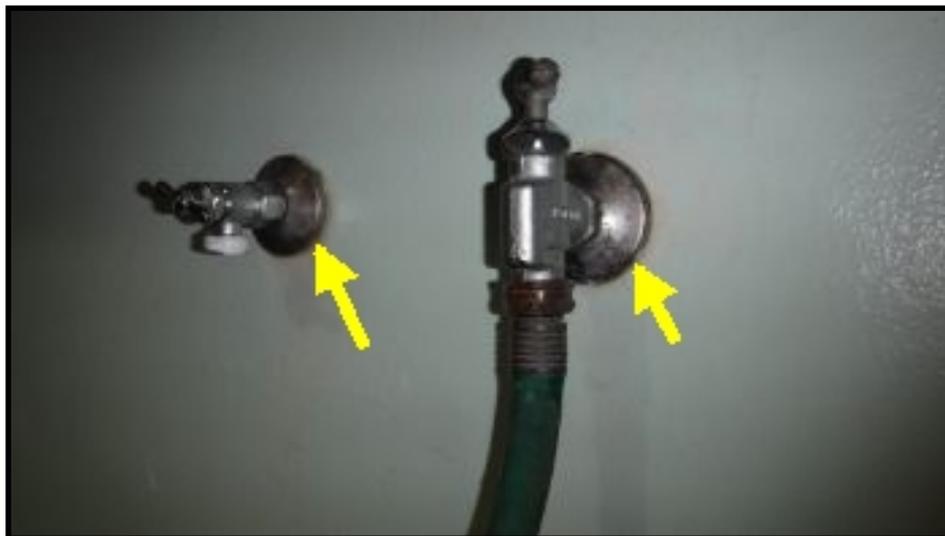
• Both laundry plumbing fixtures appear to be leaking at the time of the inspection, recommend replace plumbing outlets in laundry and repair drywall damage from moisture in the wall

Laundry plumbing valves may be leaking inside wall

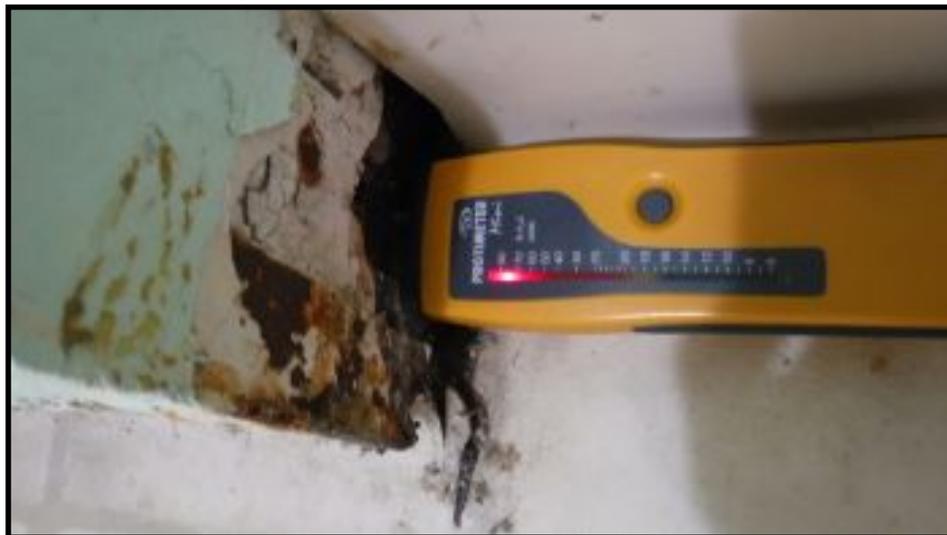
- Moisture intrusion was observed in the east wall where the improper slab on grade is located, see grade notes
- Drywall repair will be needed in the areas of the basement where moisture has damaged the drywall

High moisture content at basement wall
