Project: Mayfair Gardens

Re: 5-Year Roof Performance Summary

**SITE NAME: Mayfair Gardens**

**Re: RCABC 5 YEAR RE INSPECTION REPORT**

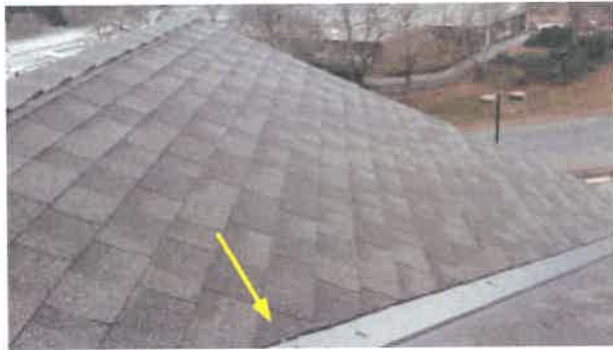
**1**  
**An overview of the NE corner area. Overall the shingles and components are in good condition with a very minor deficiency noted**

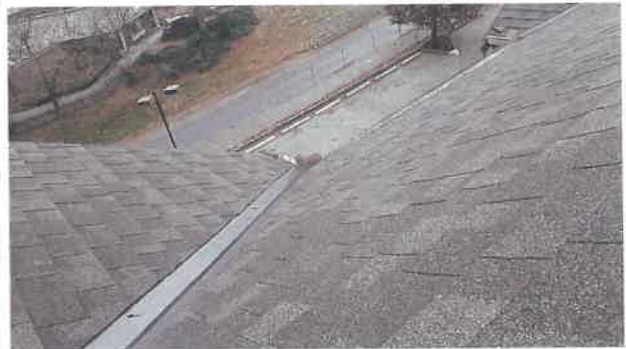
**2**  
**Shows the mainfield shingles are in good condition and well fastened , with the metal valleys in good condition. This is typical throughout the entire roof area**

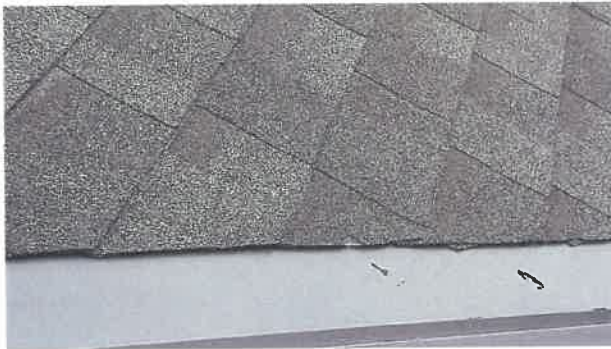
**3**  
**A closer view of the very minor deficient area with the shingle at the valley having a very small area of damage**

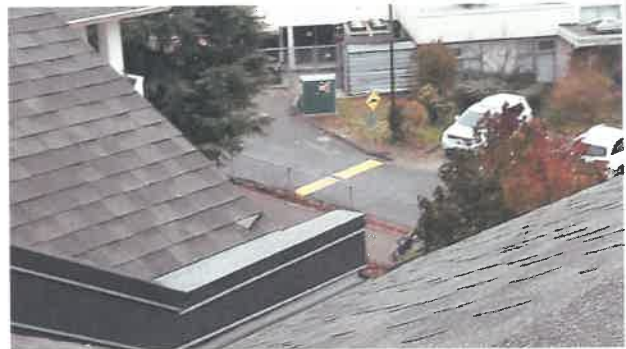
**4**  
**An overview of the east facing roof area**

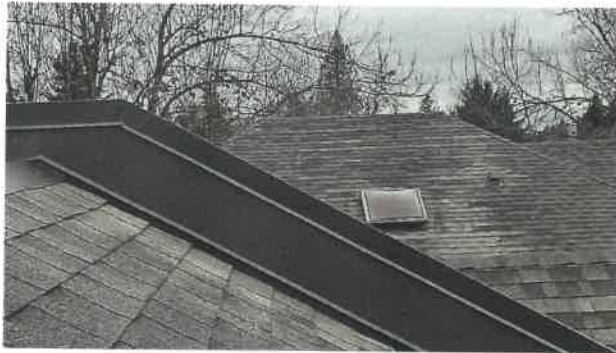
**5**  
**Shows the separation/Firewall metal flashing details in good condition and well fastened**

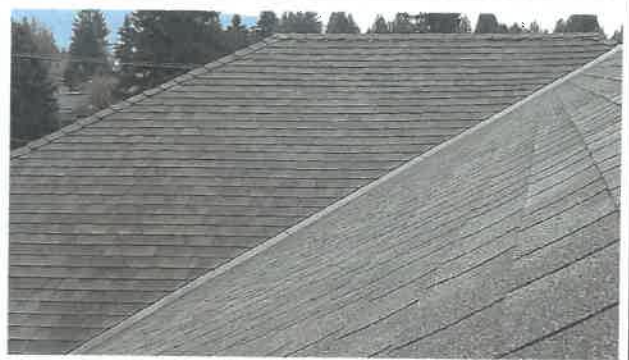
**6**  
**The shingles are in good condition and well fastened throughout the area**

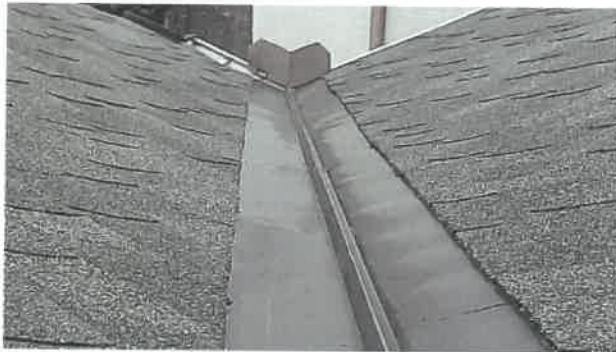
**7**  
**Shows the metal valleys in good condition being clear of debris**

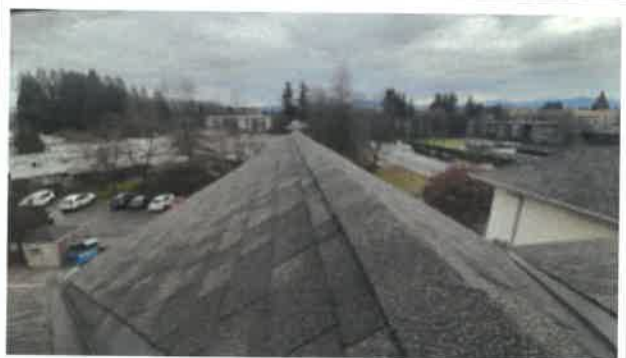
**8**  
**Shows the ridge cap shingles in good condition and well fastened**

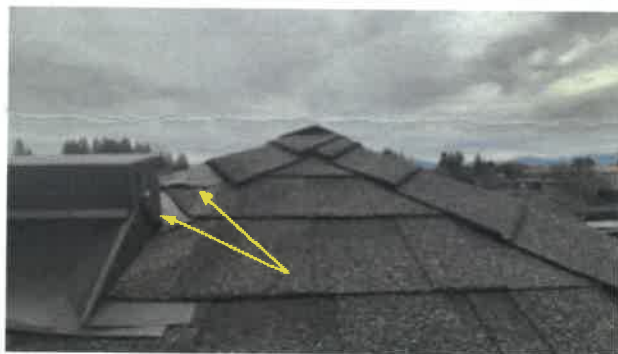
**9**  
**Shows 2 exposed common fasteners at the South facing roof area**

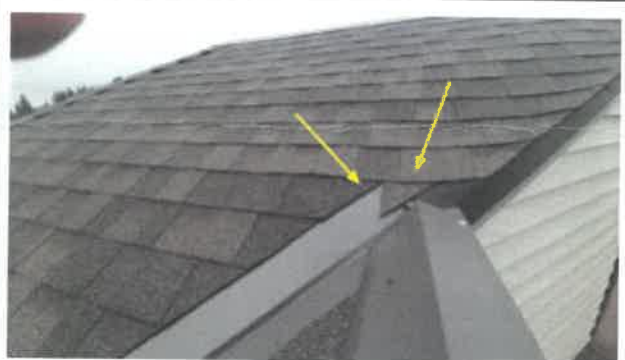
**10**  
**Shows an exposed common fastener in the valley and a shingle that has slipped**

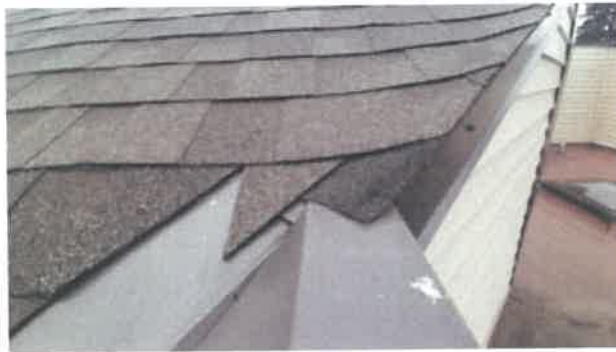
**11**  
**A closer view showing the deficient area on the adjacent South facing corner**

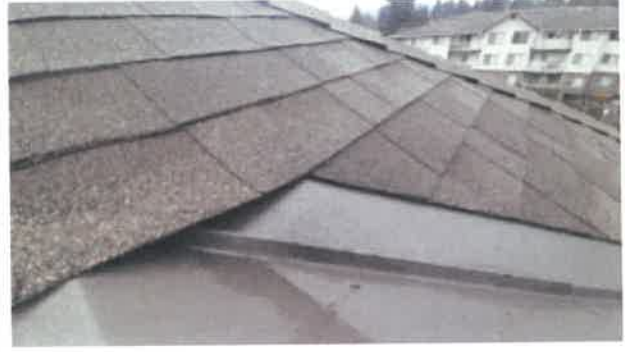
**12**  
**Shows the shingles in good condition**

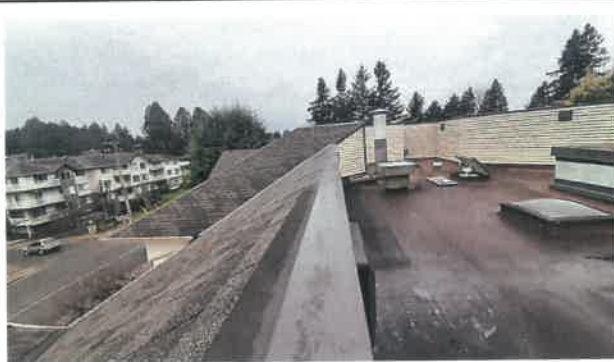
**13**  
**An overview of the metal cap flashings**

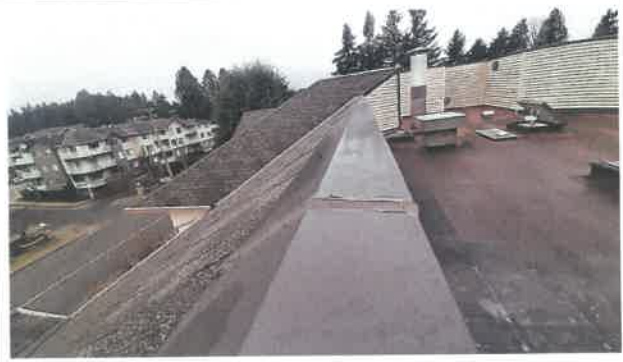
**14**  
**The metal cap flashings are in good condition, being well fastened and the sealants in good condition and sealed. This is typical throughout the roof area**

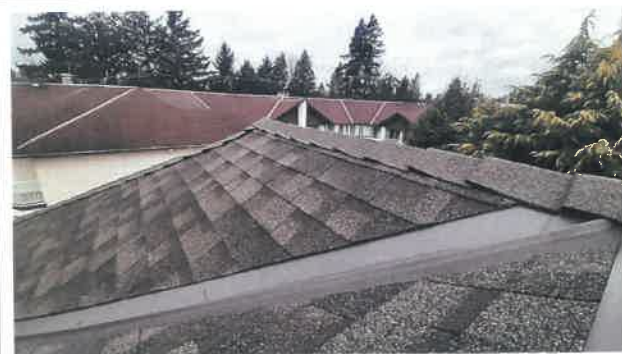
**15**  
**An overview of the West facing roof area. The shingles and ridge cap shingles are in good condition throughout**

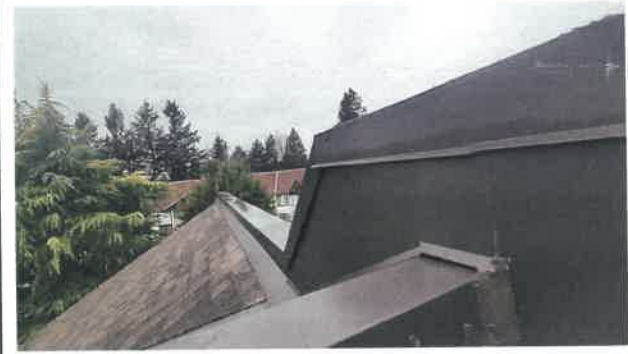
**16**  
**All areas on the North facing areas are in good condition with no noted deficiencies**

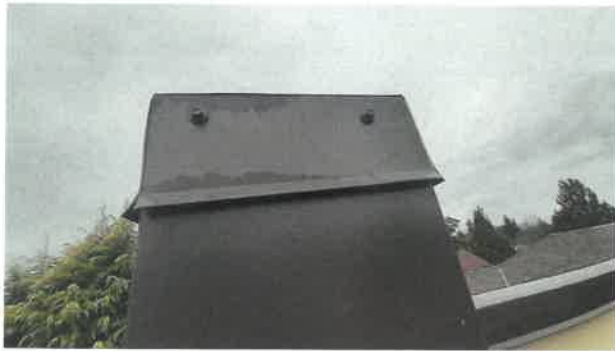
**17**  
**A closer view showing the metal cap flashings in good condition and well fastened with the fasteners properly driven and seated**

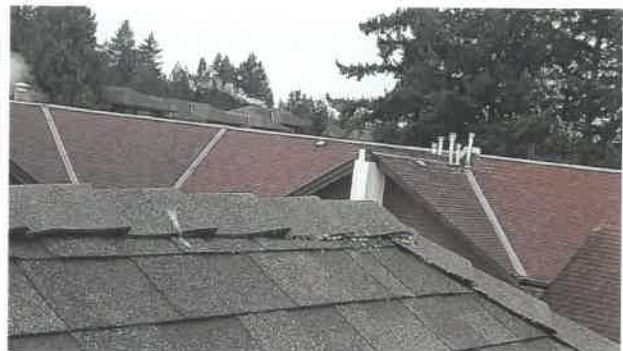
**18**  
**Shows a minor area of organic growth(moss) at the ridge of the NW corner area**

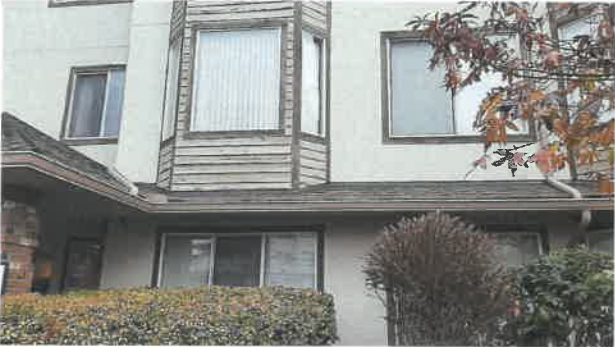
**19**  
**An overview of the lower roof area(s)**

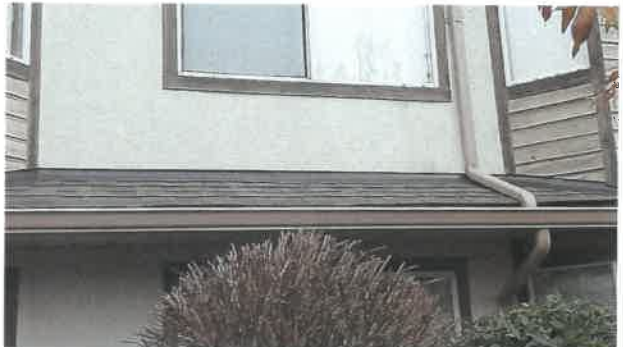
**20**  
**The metal transition wall flashings are in good condition and well fastened throughout the lower area**

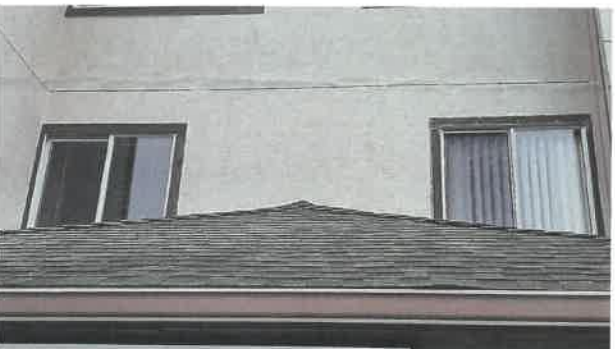
**21**  
**The shingles and ridge cap shingles are in good condition and well fastened throughout the lower roof area**
