Mayfair Gardens

2021 Depreciation Report Update

Mayfair Gardens
33401 Mayfair Avenue, Abbotsford, British Columbia
April 21, 2021

Project Number: 211-01151-00

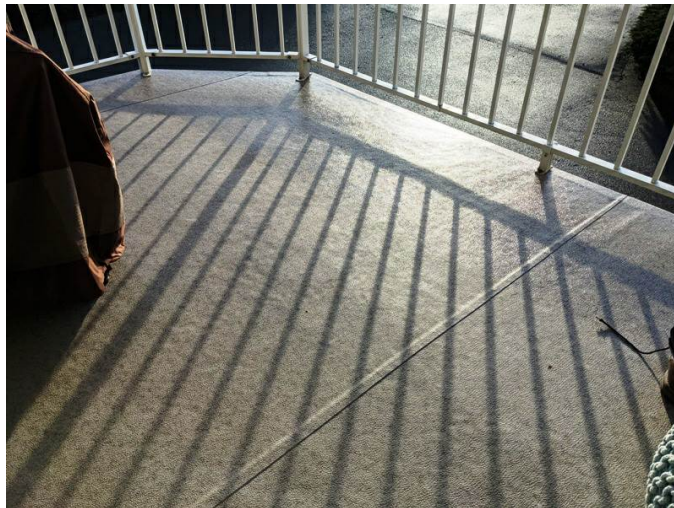
Photo No. 2: Vinyl balcony membrane

The extent of deterioration is currently minor. As the balconies were completed over the span of several years, we noted varying construction practices were used, resulting in varying levels of deterioration. Conditions observed include the following:

- small holes or tears in the membranes;
- unsealed fasteners at the guardrail baseplates;
- missing fasteners at guardrail baseplates (observed at Unit 203);
- splitting seams; and
- insufficient overlap at seams.

We have included an allowance for the replacement of the membranes later in the report term. As this will be the second membrane replacement project completed, we recommend the guardrails be replaced at this time. The new guardrails should be face-mounted to the balcony edges to limited the number of penetrations through the membrane. The budget also includes an allowance for wood framing repair, should balconies become damaged from undetected water leakage.

This project budgets for the replacement of the balcony guardrails and membranes. The project may be phased over several years, similarly to how it was completed during the last membrane replacement project; however, we recommend completing all balcony membranes simultaneously to take advantage of economies of scale, as well as ensure the aesthetics and construction practices of all balconies are the same.

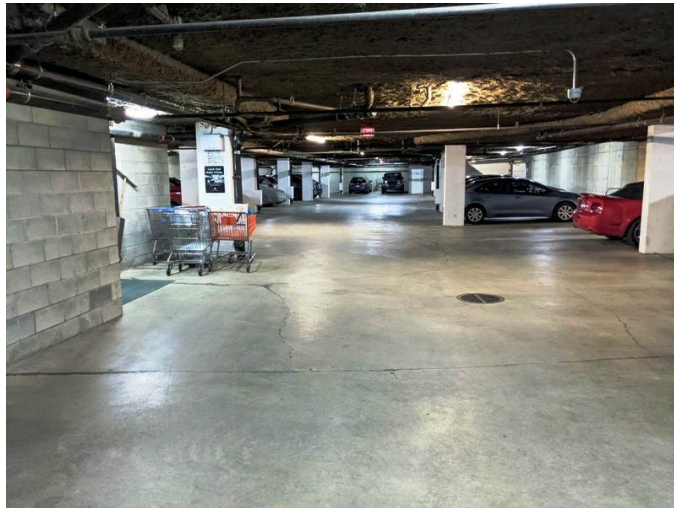
Photo No. 3: Parking garage

During our review, we did not observe locations where water ingress is occurring at the foundation walls, where reviewed. The slab-on-grade was free from significant cracking.

The small area of the garage outside of the building footprint at the east side of the building has a waterproofing membrane that has failed. We recommend the area be reviewed and repaired. We assume this can be paid for out of the operating budget.

Leakage problems may develop if ground water drainage systems become plugged or if waterproofing systems deteriorate at cracks or penetrations. These types of problems can usually be managed by injection sealing; however, local excavation outside of the foundation wall and repairing the waterproofing or drainage system may be required. This project is a general allowance to cover minor injection sealing repairs, should they be required.

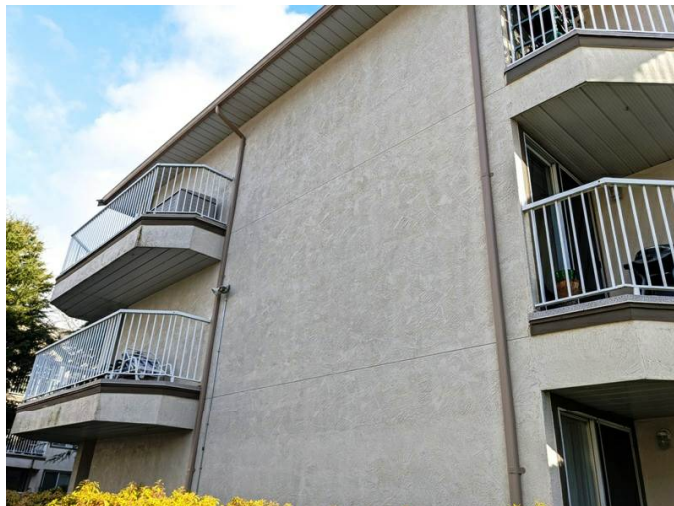
Photo No. 5: Stucco cladding

The stucco cladding was generally in acceptable condition. We observed minor settlement and cracking consistent with stucco cladding of this age.

This project budgets for the replacement of the wood and stucco cladding. This project is timed to occur alongside the next window replacement project to save on mobilization costs and improve transitions and detailing at the windows.

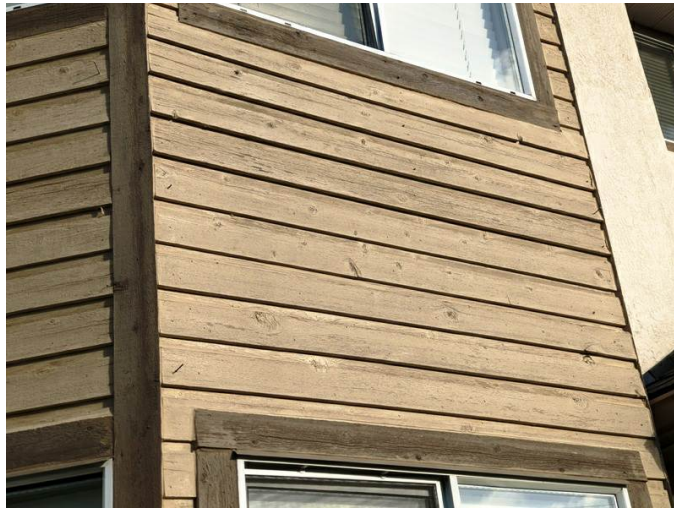
Photo No. 6: Wood cladding and trims

Wood siding performance is dependant upon being maintained in a dry condition and relies upon the protective finish and the design of the original installation. We noted the paint finish was deteriorated in some locations, notably those exposed to significant UV exposure. Splitting and warping of the wood siding was also observed.

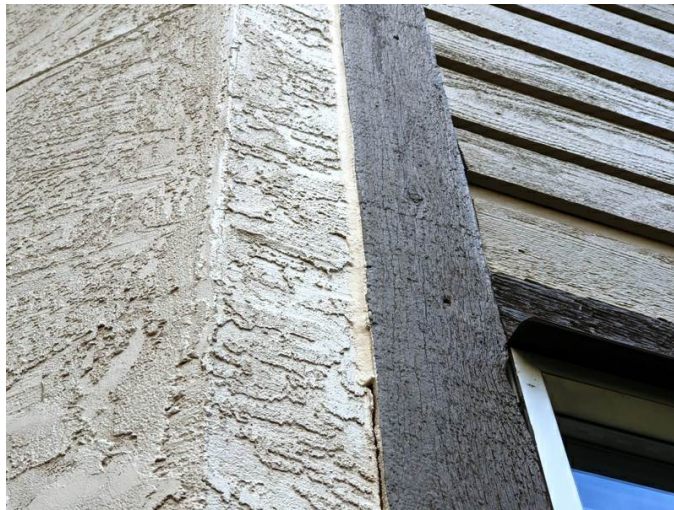
Photo No. 7: Joint sealants

The exterior joint sealants generally appeared to be performing as intended; however, several locations where we would expect to see sealants were missing it. We assume local sealant replacement and installation will be handled as-needed as a maintenance expense until a whole-building cladding replacement project is completed.

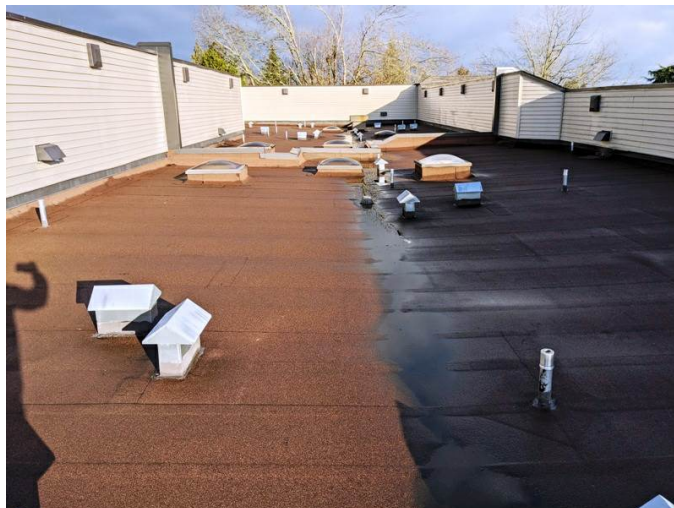
Photo No. 8: Low-sloped roofing

The low-sloped roof is about 14 years old and is generally free of major, widespread problems. We noted only minor deficiencies, including degranulation due to foot traffic, construction debris left on the roof, and ponding between drains. Based on a typical service life of between 20 and 30 years, we have budgeted for replacement during the report term.

This project budgets for replacement of the low-sloped roofing and includes the replacement of the roofing accessories and skylights.

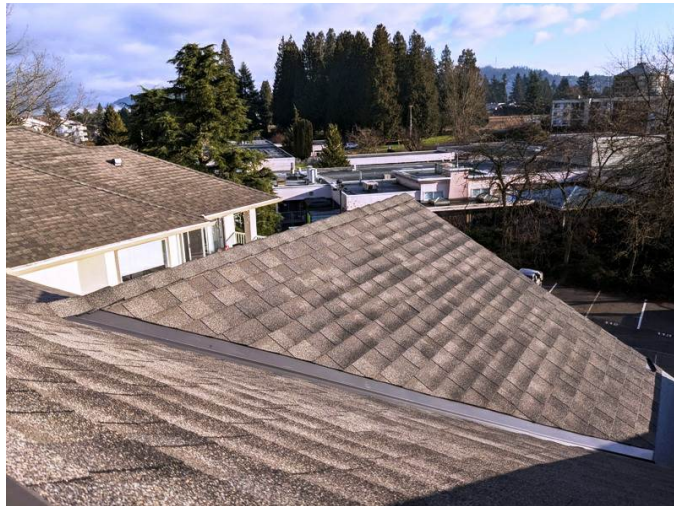
Photo No. 9: Sloped roofing

The asphalt shingles at the sloped roof were installed in recent years. As such, they are in good condition and appear to be functioning as intended. Asphalt shingles are typically expected to last between 20 and 25 years before requiring replacement.

This project budgets for the replacement of the sloped roofing and includes an allowance for sheathing repairs that may be required.

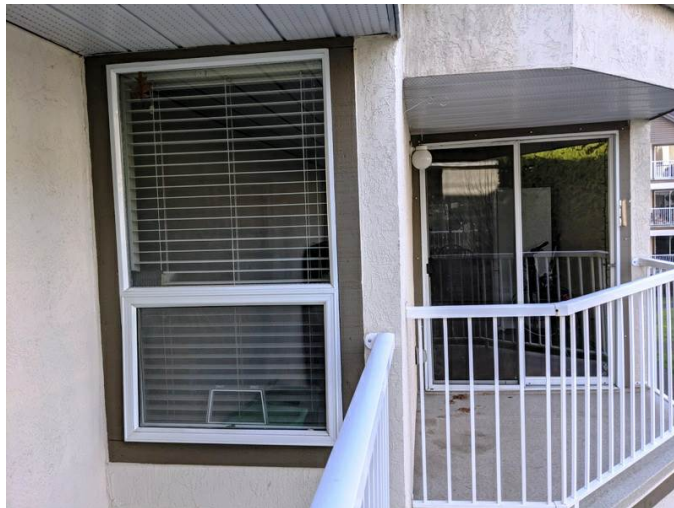
Photo No. 10: Aluminum-framed window and sliding door

We noted the mitre joint sealants within the frames of the windows are starting to become brittle. Should water or condensation accumulate in the track of the window, these sealants are relied upon to keep the water out of the wall assembly. Should the drainage holes become clogged (which is common in windows of this age), the water may potentially drain past these failed sealants. We also observed some glazing tapes are exuding out of the joints between the IGUs and the window frames, also typical of windows of this age.

The windows are original, and thus are approximately 33 years old. This type of window system has a service life of about 35-40 years. We have included a budget for general window replacement to occur alongside the cladding replacement project to improve detailing at the window perimeters and to maximize economies of scale and minimize access and mobilization costs. We assume ongoing repairs (i.e., replacing IGUs, replacing weather stripping and rollers, adjusting frames, etc.) will be completed as-needed as maintenance expenses.

This project budgets for the replacement of the window and balcony/patio door systems (including frames, infill panels, etc.). Costs related to mobilization and design and tendering are included in the "Replace Cladding" project, in order to maximize economies of scale and to minimize access and mobilization costs. If the projects are completed separately, additional costs will apply.
