NORWICH NEW BUILD SNAGGING
Covering all of Norfolk

New Build Snagging Survey

Homeowners Name: Joe Sample
Address: 456 Sample Avenue, Sprowston, Norwich, NR13 6**
Plot Number: 123
Developer Name: Sample Homes
Inspection Number: 1447
Inspection Type: Post completion inspection
Date: 24/04/2026
Issue Count: 146

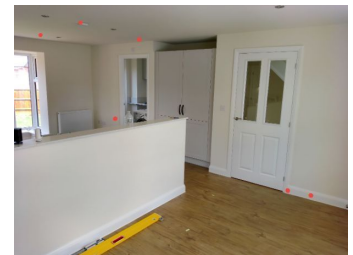
Making good maybe required, minor imperfections, sealant smear by French doors sill, scuffs and debris under paintwork, filler needed in areas.
