## Department of Toxic Substances Control

Ms. Pamela Gray, Compliance Manager  
Schnitzer Steel Products (Schnitzer Oakland)  
1101 Embarcadero West  
Oakland, California 94607

### ISSUANCE OF INSPECTION REPORT AND NOTICE OF PROVISIONAL INSPECTION VIOLATION SCORE

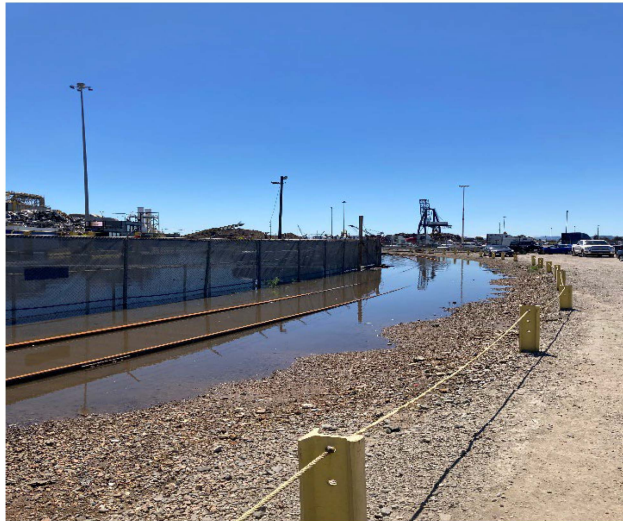
**Caption:** Perimeter fence line along the northern facility entrance - flood water observed, 8/10/23, Schnitzer.

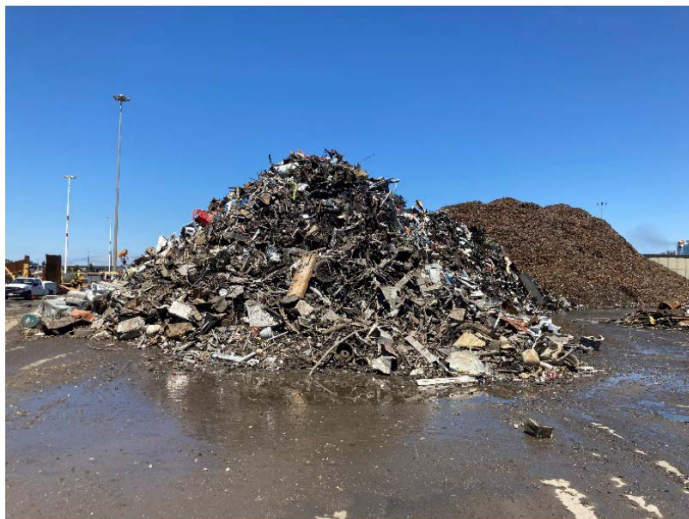
**Photo Number: 3**

**Violation:** Schnitzer Oakland failed to maintain and operate the facility to minimize the possibility of fire and/or release of hazardous waste or hazardous waste constituents to the air, soil, or surface water which could threaten human health or the environment.

**Photograph Evidence:** Photographs 4 through 10 document the site conditions on August 10, 2023, which is the day after the onsite fire started. Schnitzer Oakland facility grounds were significantly flooded by emergency response fire management activities.

**Observation Evidence:** I observed several areas of Schnitzer Oakland's facility to be flooded by fire response activities. I observed the entrance to the facility, leading to the conveyor pier to be flooded with standing water. Immediately east of the conveyor pier, I observed Oakland Fire Department spraying a large mass (approximately half the size of a car) that appeared to be a smoldering piece of metal impacted by the fire. Large portions of the scrap metal pile located immediately east of conveyor pier showed signs of ash and had a charred appearance consistent with fire-impacted material.

**Caption:** Tin pile immediately east of the Conveyor Pier, 8/10/23, Schnitzer.

**Amended Corrective Actions:** Schnitzer Oakland shall immediately minimize the potential for fire, explosion, and release(s) of hazardous waste or hazardous waste constituents to the air, soil, or surface water. In addition, Schnitzer Oakland shall develop a written plan that describes the additional actions Schnitzer Oakland will immediately implement to prevent fires in the future that includes an implementation timeframe. The plan shall be submitted to DTSC within 30 calendar days of the date of the Summary of Violations. Following implementation of each plan component, Schnitzer Oakland shall then provide substantiating documentation to DTSC within five (5) calendar days.

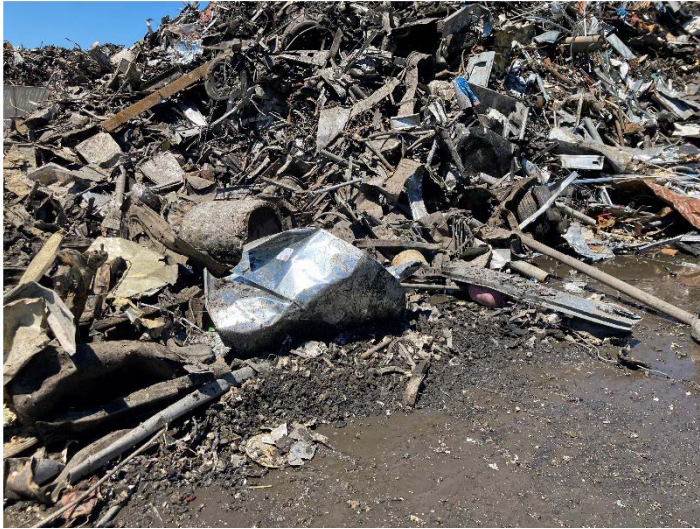
**Photo Number: 4**

**Caption:** Tin pile - sample area 1, 8/10/23, Schnitzer.

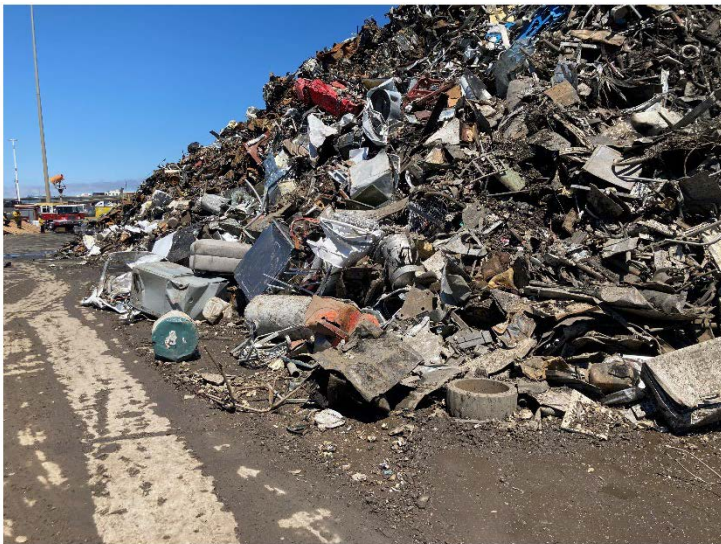
**Photo Number: 5**

**Caption:** Tin pile - sample area 2, 8/10/23, Schnitzer.

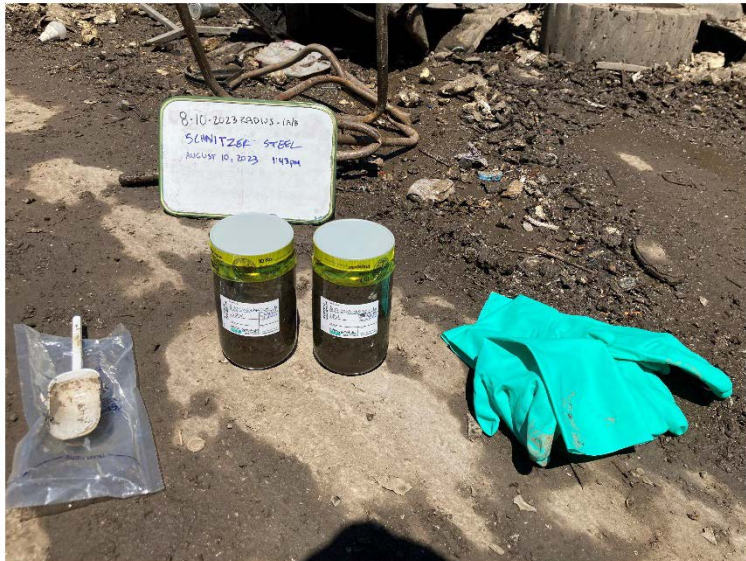
**Photo Number:** 6

**Sample Evidence:** Two samples (8-10-2023RADIUS-1B and sample 8-10-2023RADIUS-2B) exceeded hazardous waste regulatory thresholds specified in the Title 22 California Code of Regulations for total metals in Zinc and Copper.

**Caption:** Tin pile – solid samples 8-10-2023RADIUS-1A/B, 8/10/23, Schnitzer.

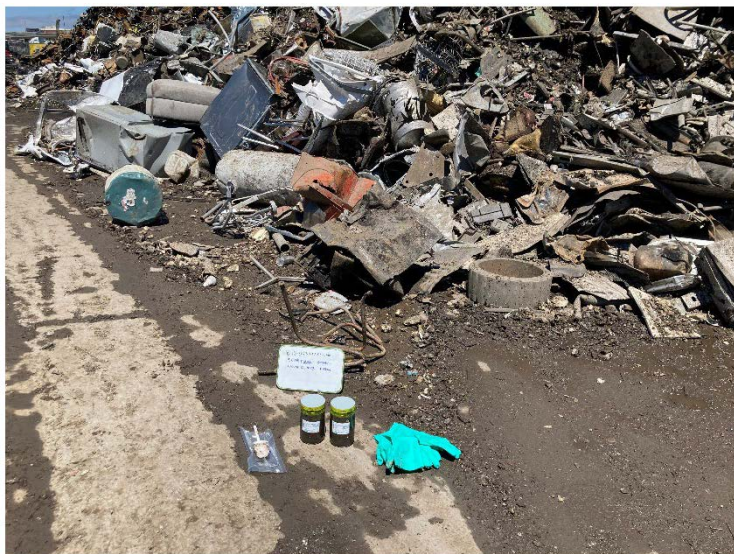
**Photo Number:** 7

**Caption:** Tin pile – solid samples 8-10-2023RADIUS-1A/B, 8/10/23, Schnitzer.

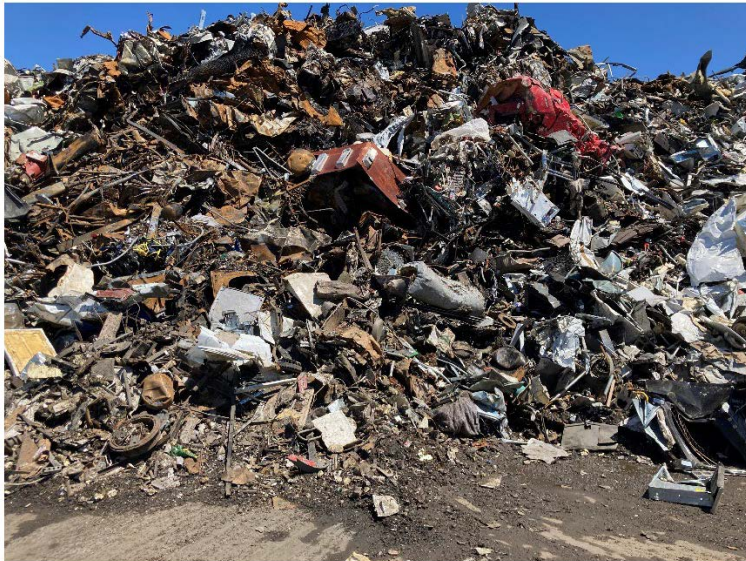
**Photo Number:** 8

**Caption:** Tin pile - Scrap metal mixed with burned material, 8/10/23, Schnitzer.

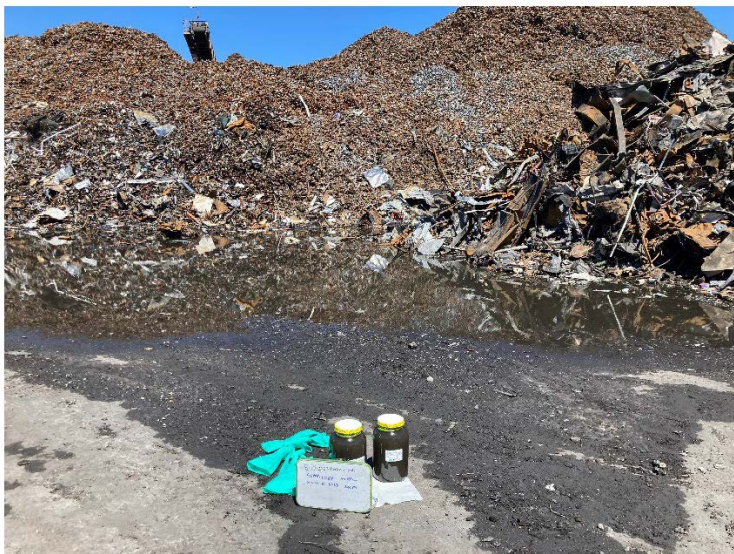
**Photo Number:** 9

**Caption:** Tin pile - Liquid samples 8-10-2023-3A/B, 8/10/23, Schnitzer.

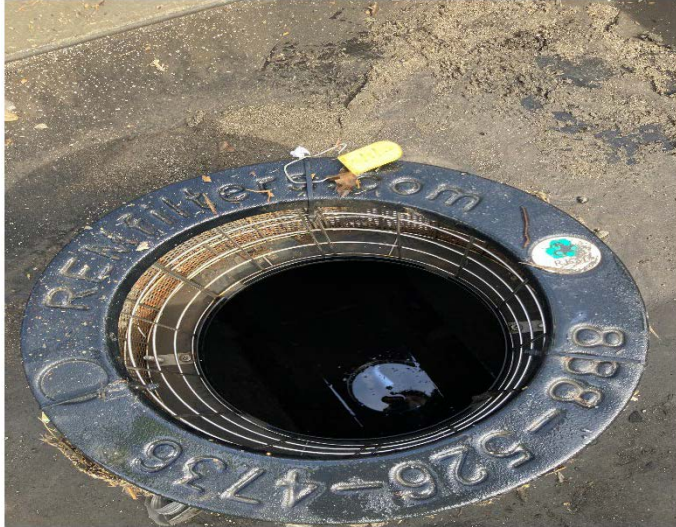
**Caption:** Storm drain sampling - Space X69/121- oily sheen observed, 8/14/2023, Port of Oakland.

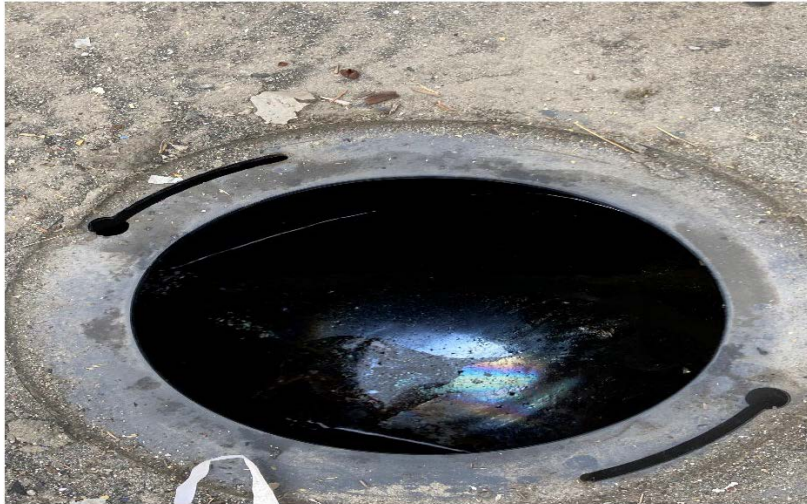
**Caption:** Storm drain sampling - Space X86/87 - oily sheen, 8/14/2023, Port of Oakland.
