## SENTRY MOLD PROTECTION

AIR QUALITY TEST

## Summary

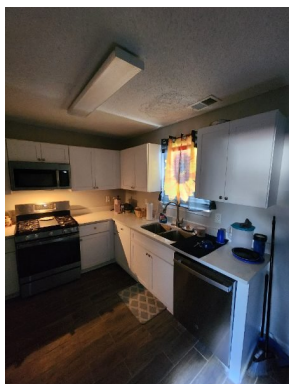
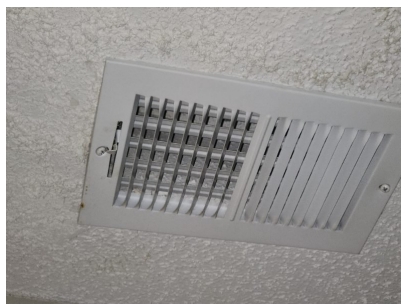
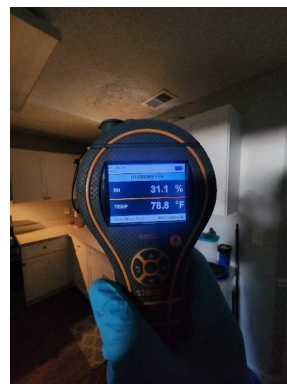
### Kitchen

**Condition:** Needs Maintenance

Discoloration on supply vent above cabinets. Cause - hvac system issue.

- It is the recommendation of this Inspector that treatment occur to remove and/or inhibit growth.
- It is the recommendation of this Inspector that HEPA vacuuming occur to remove growth control.
- It is the recommendation of this Inspector that a HVAC contractor be contacted in order to further assess and address observed issues.
- It is the recommendation of this Inspector that an air quality testing be performed due to tenant's health concern.

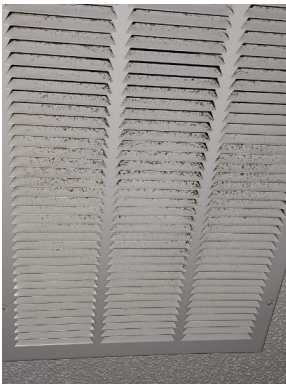
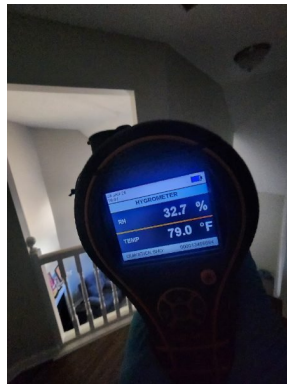
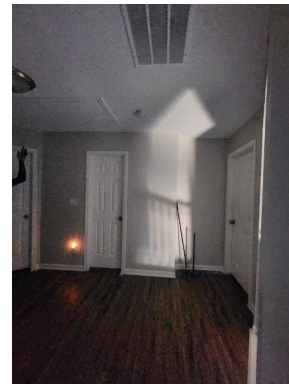
### Extra Room

**Condition:** Needs Maintenance

Heavy dust accumulation on return vent. Cause - hvac system issue.

- It is the recommendation of this Inspector that treatment occur to remove and/or inhibit growth.
- It is the recommendation of this Inspector that HEPA vacuuming occur to remove growth control.
- It is the recommendation of this Inspector that a HVAC contractor be contacted in order to further assess and address observed issues.

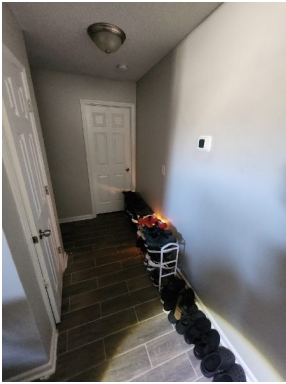
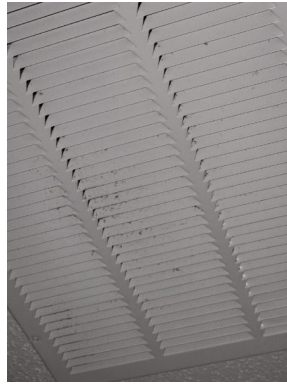
## Hall

**Condition:** Needs Maintenance

Heavy dust accumulation on return vent. Cause - hvac system issue.

- It is the recommendation of this Inspector that treatment occur to remove and/or inhibit growth.
- It is the recommendation of this Inspector that HEPA vacuuming occur to remove growth control.
- It is the recommendation of this Inspector that a HVAC contractor be contacted in order to further assess and inspection of duct.

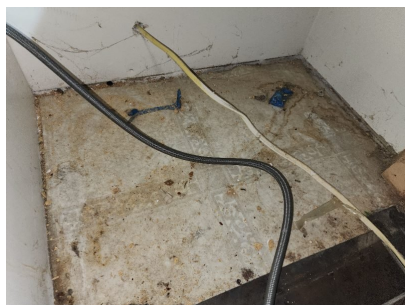
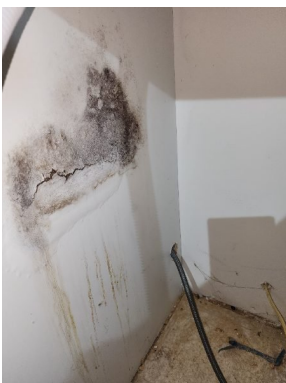
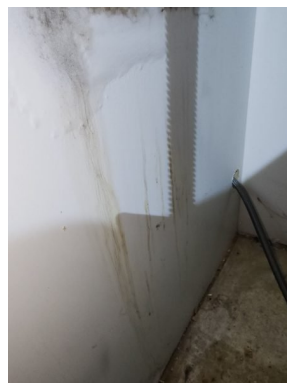
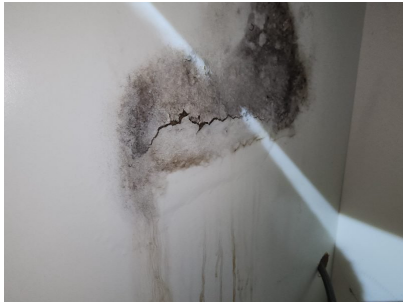
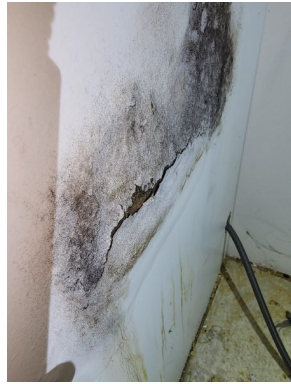
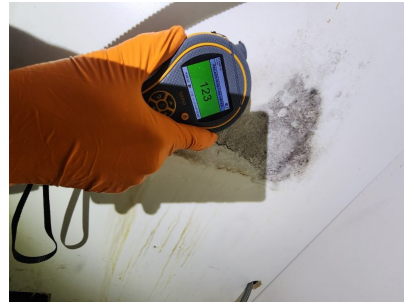
### Kitchen

**Condition:** Needs Maintenance

Discoloration on exterior of base cabinet alongside the dishwasher. Minor water damage to inside of cabinet. Water staining on slab under dishwasher. Cause - prior leak from dishwasher connection.

- It is the recommendation of this Inspector that treatment occur to remove and/or inhibit growth.
- It is the recommendation of this Inspector that HEPA vacuuming occur to remove growth control.

- It is the recommendation of this Inspector the removal/scraping of affected materials.
- It is the recommendation of this Inspector the application of antimicrobial paint to the affected area to prevent future mold growth or staining.

- It is the recommendation of this Inspector that content manipulation be done.
- It is the recommendation of this Inspector that local containment be constructed in order to prevent cross contamination into unaffected areas.

- It is the recommendation of this Inspector that a dehumidifier and air mover be deployed in order to address issues related to elevated RH and moisture readings.

- It is the recommendation of this Inspector that AFD be deployed in order to assist containment to prevent cross contamination.
