2004 Formula 40 PC

Power Sample

Report of Marine Survey

July 03, 2011

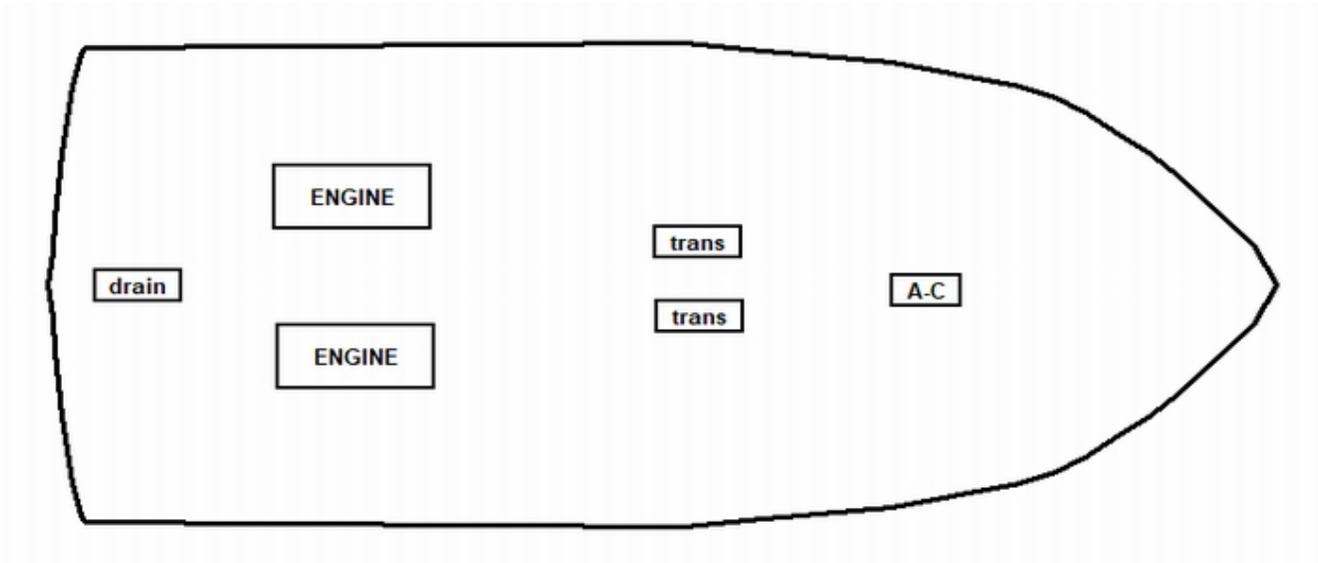
THRU-HULLS BELOW WATER LINE (DIAGRAM):

The below the water line thru-hull valves on this vessel were ball bronze valve type and were all operable and in good condition.

All were in good condition with no corrosion.

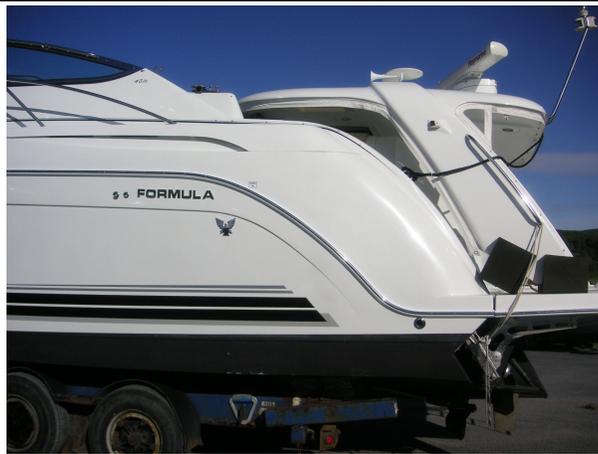
The hard top was stored on the transom of the boat (see photo) for the winter (inside). The yard personnel attached the top at the launch site (see photo).

Hard top in stored position.

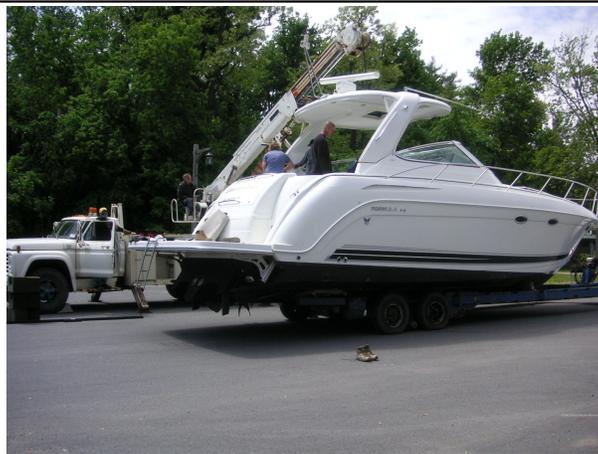
Hard top installation.

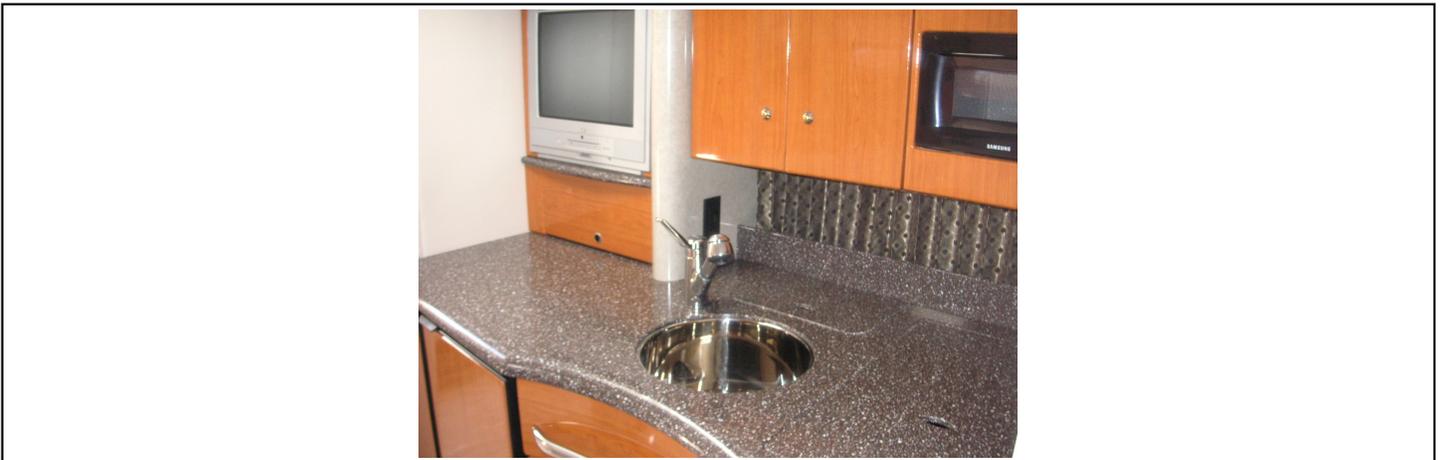
Galley

The galley is in the main cabin forward of the head (see photo).

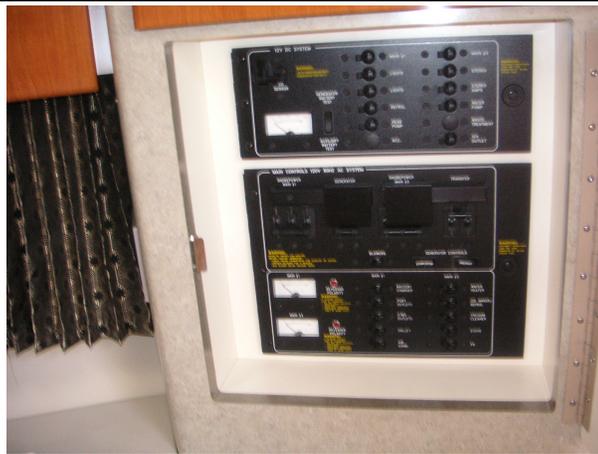
electrical panel

PANEL:
Factory installed (see photo).

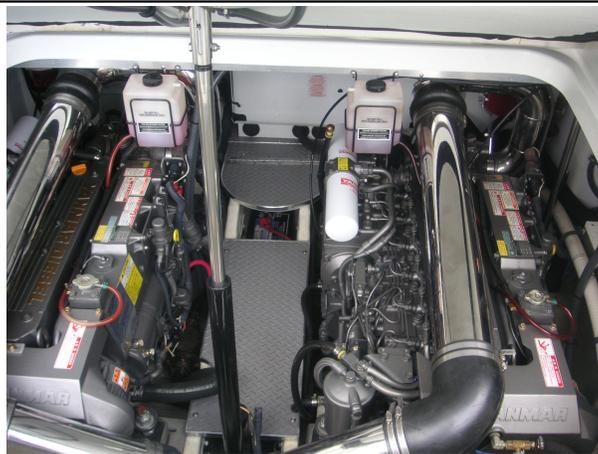
Twin Yanmar turbo diesels (6LY2A-STP). See photo.

The engines and engine room are very clean and have had continual professional servicing.
