Bartlett Marine Services & Consulting
MARINE SURVEYOR AND CONSULTANT

1998 Catalina Mark II

Report of Marine Survey

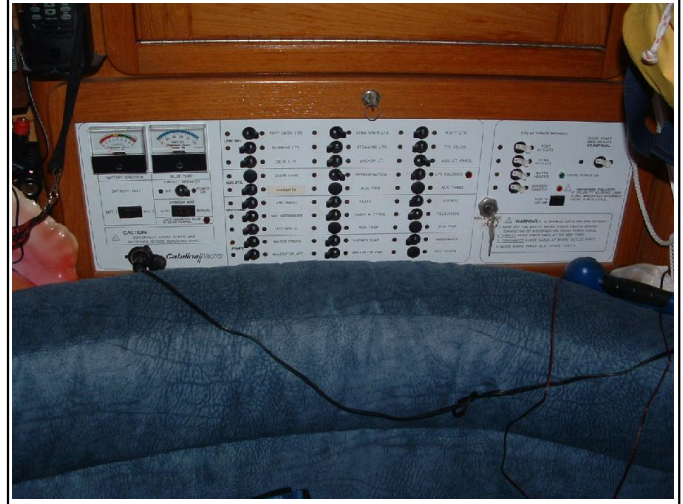
Electrical Panel

Catalina panel (see picture 2)

Breakers. Serviceable.
