# Energy Report

EDR-5389

Nuclear Products  
Requalification Testing  
Phase 2

Report Number: Date:  
EDR-5389 – Rev. 0 12/10/2004

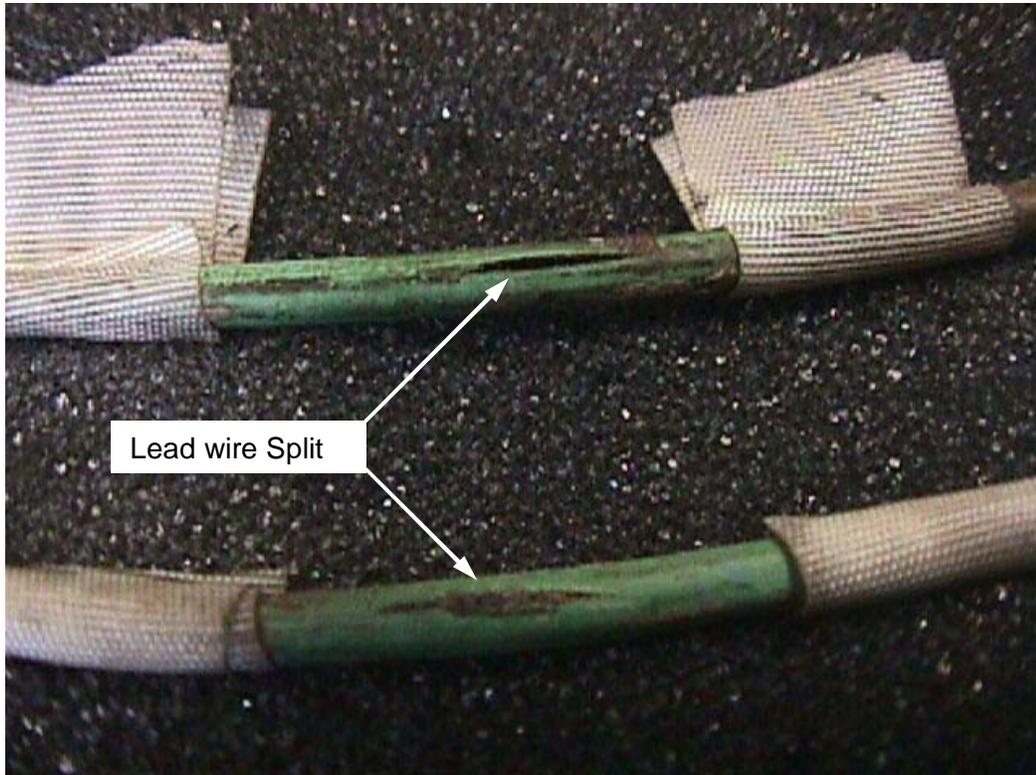
**Figure 9:** Damage to the lead wires of Sample #9

Sample #9 showed progressively lower IR readings during the LOCA exposure after the chemical spray. It must be mentioned that these IR readings are not necessarily an accurate indication to the performance of the tested sample because it integrates the insulation resistance of the whole tested circuit including the sample leads, the test leads and the additional connecting (sample/test lead) splices that are inside the test vessel. Initial investigation of the sample after

removal from the chamber revealed no damage to the sample or the adjacent sample leads as evidenced by the high IR values, the successful voltage withstand test as well as the high breakdown voltage value at the end of the test which demonstrates the high residual margin in the insulation performance. Further investigation revealed a longitudinal split of the lead wires approximately 31" away from the splice on both sides. Figure 9 shows the damage to the lead wires of Sample #9.

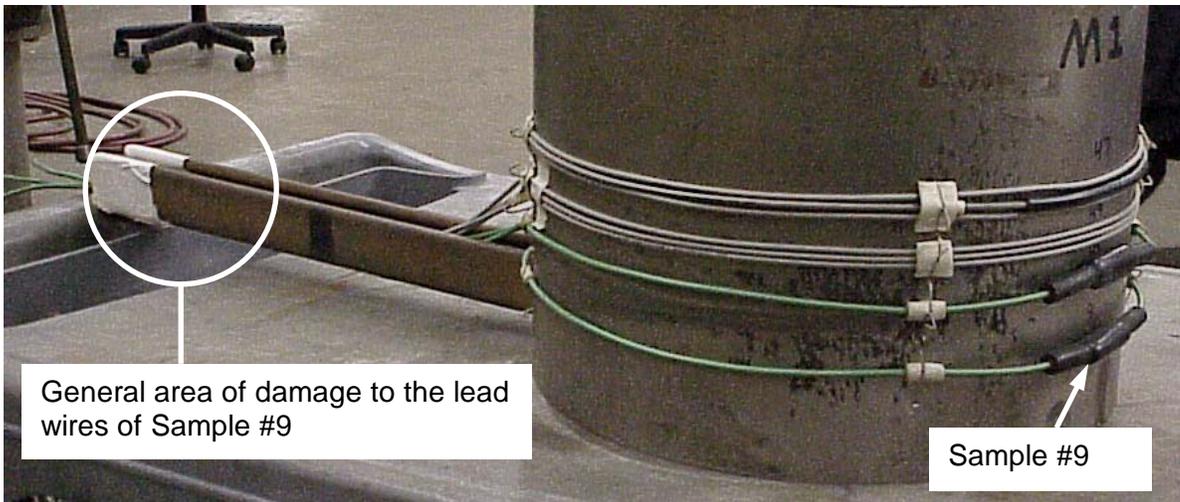
**Figure 10:** Side view of Mandrel #1.

The damage to the lead wires may have been caused by a sharp edge of the mandrel handle. Figure 10 shows a picture of Mandrel #1 where Sample #9 has been installed. The position of the damage to the wires corresponds approximately to the end of the handle. Tyco Electronics concludes that the low IR values recorded during the accident simulation were due to these longitudinal splits.

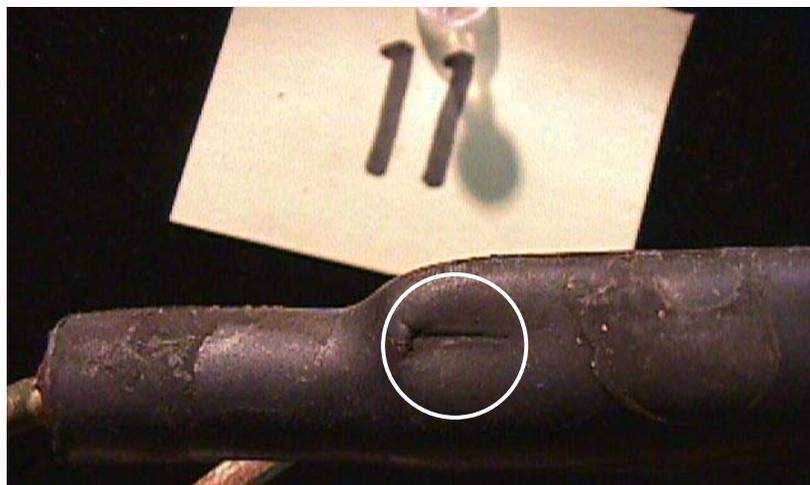
**Figure 11:** External damage to Sample #11

Sample #11 exhibited low insulation resistance values only after the sample was removed from the chamber. Physical examination determined that these low IR's were caused by a depression on the surface of the sleeve. It appears as though a corner of the internal vessel support frame may have pinched into the WCSF cover sleeve (see Figure 11). This is also where the dielectric strength test failed. All measurements taken prior to removal from the chamber rendered acceptable values. However, due to this damage, the sample did not meet the post-simulation Function Test acceptance criteria.

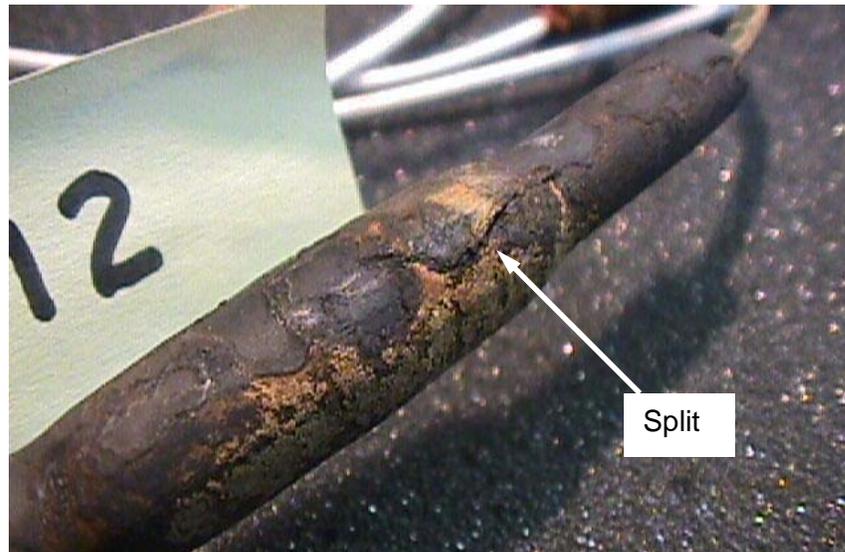
**Figure 12:** Fracture on sample #12

12	1.5E05	1.8E05	The sample split with an unusual fracture that curves around the general area of the end of the bolt pad.

Sample #12 exhibited low IR values during the two “in vessel” immersion tests and subsequently failed the post-accident Function Tests. During the post-test visual examination the sample was found to be split with an unusual fracture that curves around the general area of the end of the bolt pad. (See Figure 12)

During the investigation, a definitive cause for this unusual failure was not determined. Several factors were considered to have possibly contributed to the split which likely occurred sometime during the first transient possibly as the pressure dropped. These factors include, construction at greater than the 2.5x holdout (2.6x as measured), excess free volume within the splice, a poor bolted electrical connection which resulted in excessive splice temperatures, steam injection during the accident simulation directed toward this point of the splice. Another possible factor was any of the pre-test 24 hour immersion highpots – if water got into the sample (e.g., a cable end was accidentally submerged) then water would be trapped there after splicing to the test leads), and/or an undetected flaw or damage which pre-existed the accident simulation testing. Evaluation of the sample #12 failure also considered the performance of 30 similar bolted connection splices with 2.5x holdout during qualification testing documented in EDR-5336. In EDR-5336 a total of 24 bolted splices with shim sleeves and a WCSF-200-18/5-N sealing sleeve

but with no bolt pad were subjected to a qualification test sequence that was essentially identical to the sequence used for sample #12. One of the 24 splices split during the accident simulation and another failed the post-accident high potential test. Both failures were from wall thinning due to the sharp edges of connection washers (no bolt pad was used on either sample). None of the other 22 splices exhibited any tube splitting or dielectric withstand problems. The testing reported in EDR-5336 also included 4 bolted splice samples with bolt pads, shims, and a WCSF-500-38/13-N sealing sleeve. All 4 samples met the test acceptance criteria. Since the WCSF-500-38/13-N sleeve has a thicker wall than the WCSF-200-18/5-N at the same holdout, it should be less prone to splitting or dielectric failures due to wall thinning.

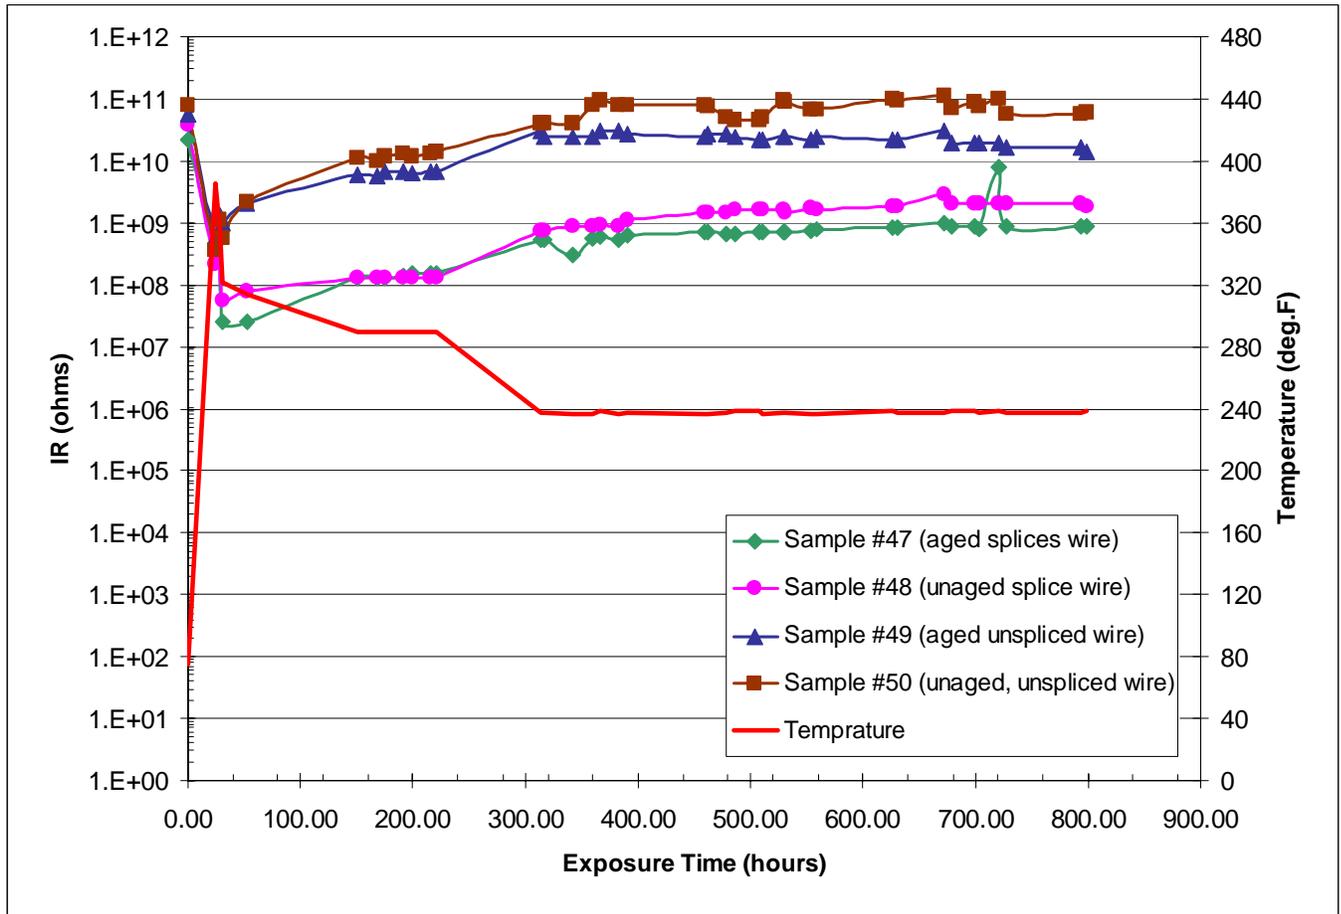
**Figure 13:** Chart of Insulation Resistance measurements during LOCA Transient #2.

**Results Discussion:** These samples and associated IR data were included in this test program for information only and were not intended to establish qualification for particular splice configurations. The IR readings represent the integrated insulation resistance of the entire test circuit, including the sample splice and sample leads. Reasonable efforts were made to use the same length sample leads and to similarly configure the samples on the test mandrels and within the test vessel. The IR data in Table 13 and Figure 13 indicates that reasonably similar IR values

were measured for the spliced and unspliced samples during the pre and post-simulation ambient temperature tests. The IRs were also similar during the peak conditions although the values for the spliced samples were slightly lower than those for the unspliced samples. Subsequent measurements during transient #2 indicate the IR values for the spliced samples were substantially lower than those for the unspliced samples.
